NUREG/CR-6931/V1 SAND2007-600/V1

CAROLFIRE Test Report Volume 1:
**General Test Descriptions and the Analysis of Circuit Response
Data**

Steven P. Nowlen and Francis J. Wyant
Risk and Reliability Analysis Department 6761
Sandia National Laboratories
Albuquerque, New Mexico

Project Manager: Hugh W. Woods
Fire Research Branch
Division of Fuels, Engineering, and Radiological Research
Office of Nuclear Regulatory Research
U.S. Nuclear Regulatory Commission
Under JCN N6125

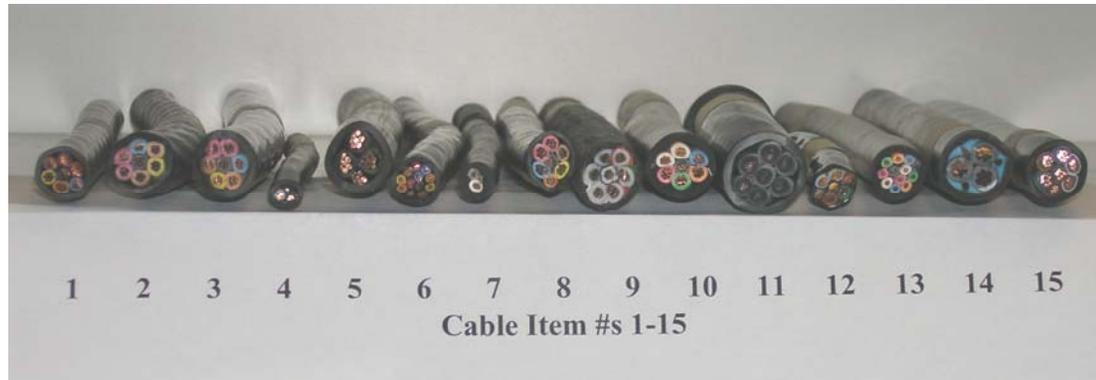
Figure 3.8: Photograph of the 15 different cables tested in CAROLFIRE.

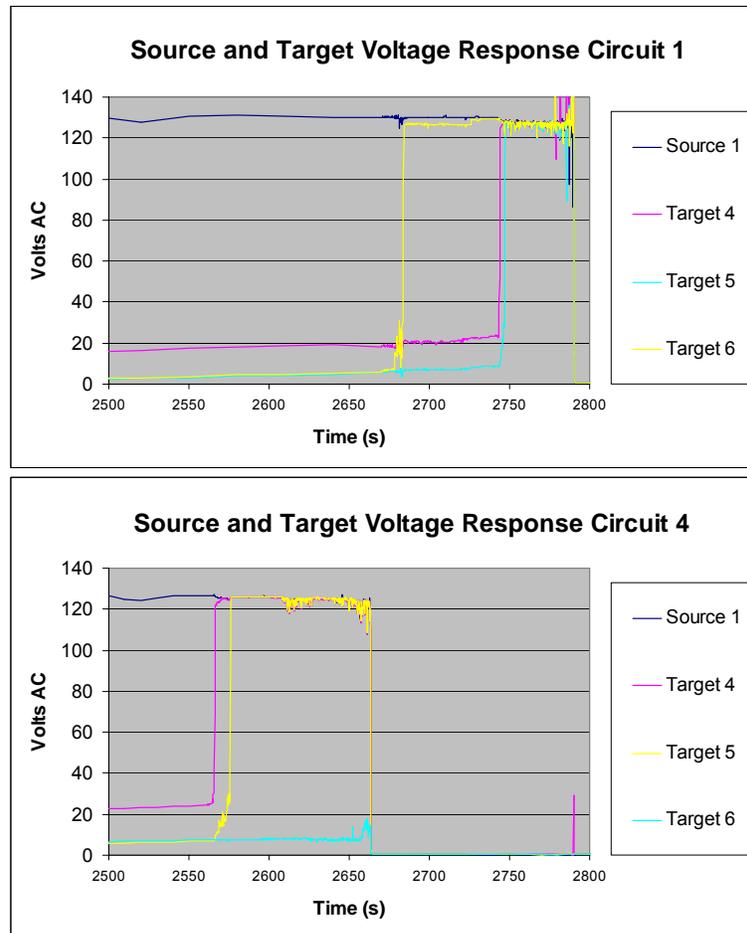
Figure 7.6: Illustration of the inter-cable interactions observed between circuits 1 and 4 in Test IT-1. Note the voltage spike to Target 4 in Circuit 4 after that circuit had experienced a fuse blow.

This particular case is actually quite typical of the inter-cable interactions that were detected with the SCDU. Similar momentary inter-cable shorts were also observed in Tests IT-3 (with two of the three IC configurations present) and IT-7 (between two MOV-1 configurations). In the case of the IT-3 interactions, it is apparent that one of the cables had shorted to ground and subsequently shorted to an energized conductor in the second circuit creating a momentary voltage/current spike. In Test IT-7, the behavior is essentially identical to that described above for Test IT-1. That is, one circuit had already shorted to ground and experienced a fuse blow. The second circuit then hit the cable for the first circuit with a momentary voltage/current spike as the second circuit was itself cascading to failure. Neither case led to a spurious actuation due to insufficient current/voltage.
