**Salmon River Uranium Development Mill
Removal Assessment Report**

TDD: 06-03-0013

TechLaw Inc.
Contract: EP-S7-06-03
April 13, 2007

SALMON RIVER URANIUM DEVELOPMENT MILL REMOVAL ASSESSMENT/SITE INSPECTION REPORT

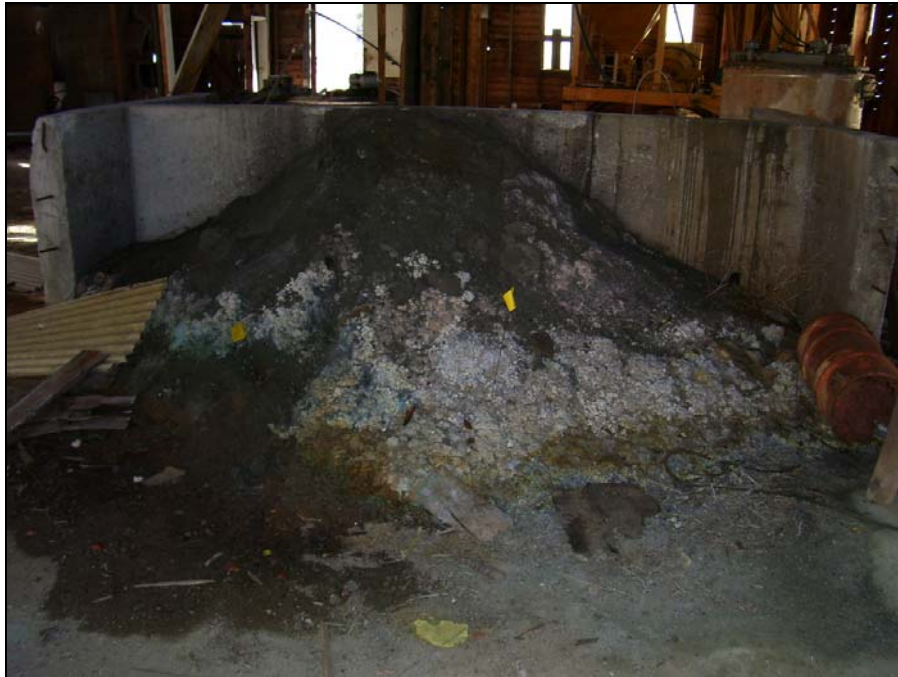
SRUD 05 Inside Former Processing Building

XRF screening showed large concentrations of arsenic and copper in a spent processed ore pile within the building. Laboratory results (sample ID **BLDG-SS-01**) confirm the XRF results. Arsenic concentration was 116,000 mg/Kg (11.6%) and the copper concentration was 178,000 mg/Kg (17.8%). The pile contains about 14 cubic yards of material. The material is black with greenish mineral discolorations. A GIS reading could not be taken as the pile was inside the covered building. If entering the building from the southwest, the pile is 50 feet inside the building, 12 feet from the southern wall. Photographs of the site are labeled SRUD-05 and SRUD-27.

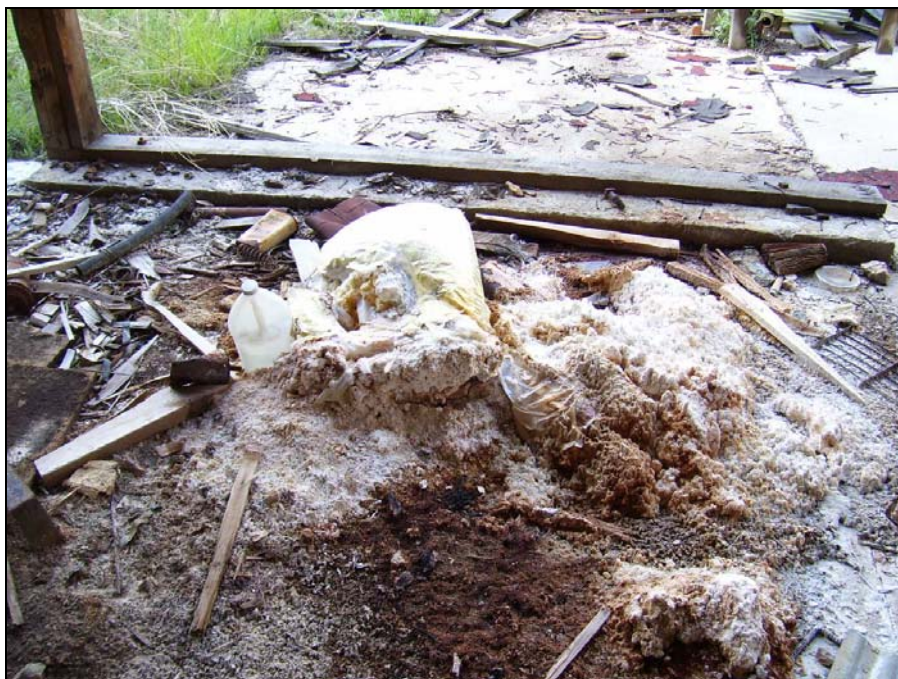
SRUD 06 Broken Caustic Soda Bag

The interior of the building contained numerous items of debris, including small containers of unknown liquids and solids. These materials were documented with photos found in the appendix labeled SRUD-06 to SRUD-13. Due to the limited scope of the RA, these items were not characterized except with screening by the gamma detector and the PID, where no readings above background were detected. The bags of solid material were labeled as caustic soda or soda ash. Two plastic one-gallon jugs contained visible liquid. An unopened container labeled Texaco appeared to contain grease. The other containers shown in the photos were not opened.

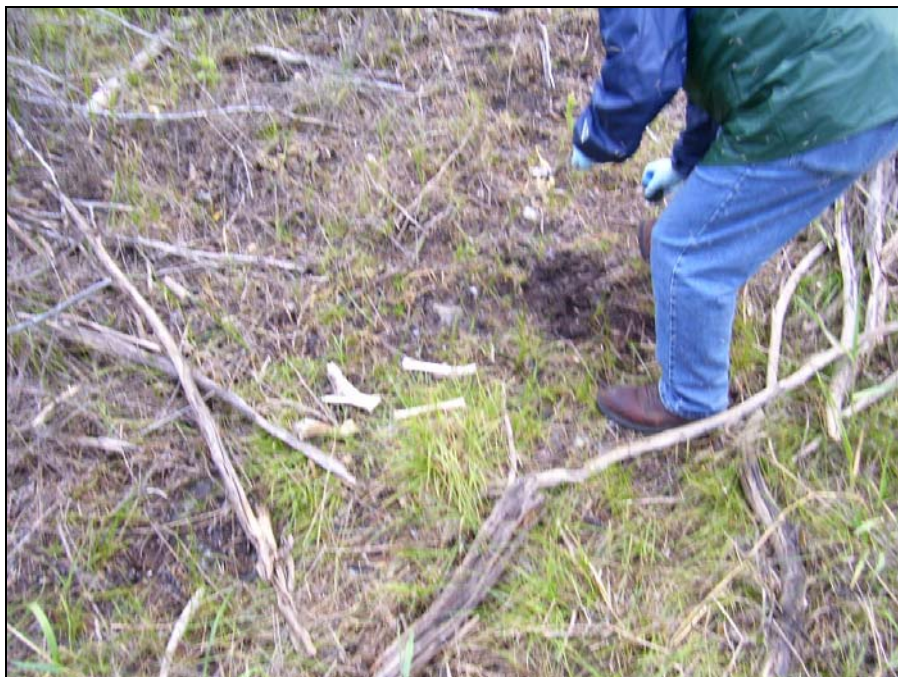
SRUD 14 Buster Gulch Down Gradient Soil Sampling

- One soil sample was collected down gradient of the site in Buster Gulch. The sample ID is **BGDG-SS-01**. This location is at the lowest elevation of the property near the property line. From this point there is no direct surface water runoff to the Salmon River do to embankment grades constructed for dike or road construction. The location was moist indicating surface water goes underground. The sample was selected based on the location to determine if potential contaminate migration was occurring from the mine site potentially contaminating water sources.

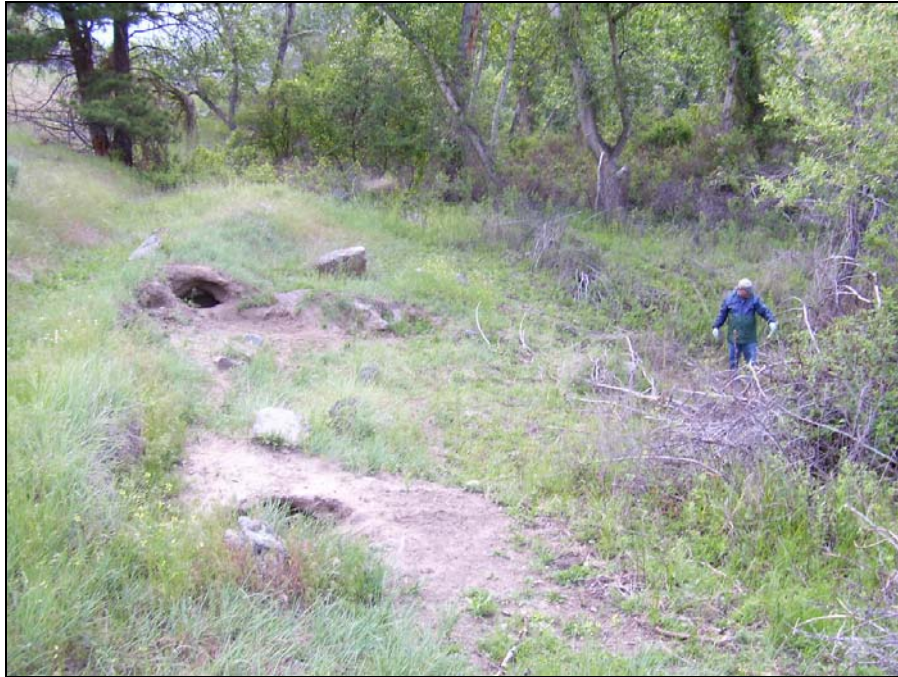
SRUD 17 Low Point of Buster Gulch where Natural Drainage is Blocked by Road Grade

Down gradient of the former processing building are two dry holding ponds. A direct surface water runoff path no longer exists from the Site to the Salmon River. Berms created for the holding ponds and road construction block the natural drainage path named "Buster Gulch".

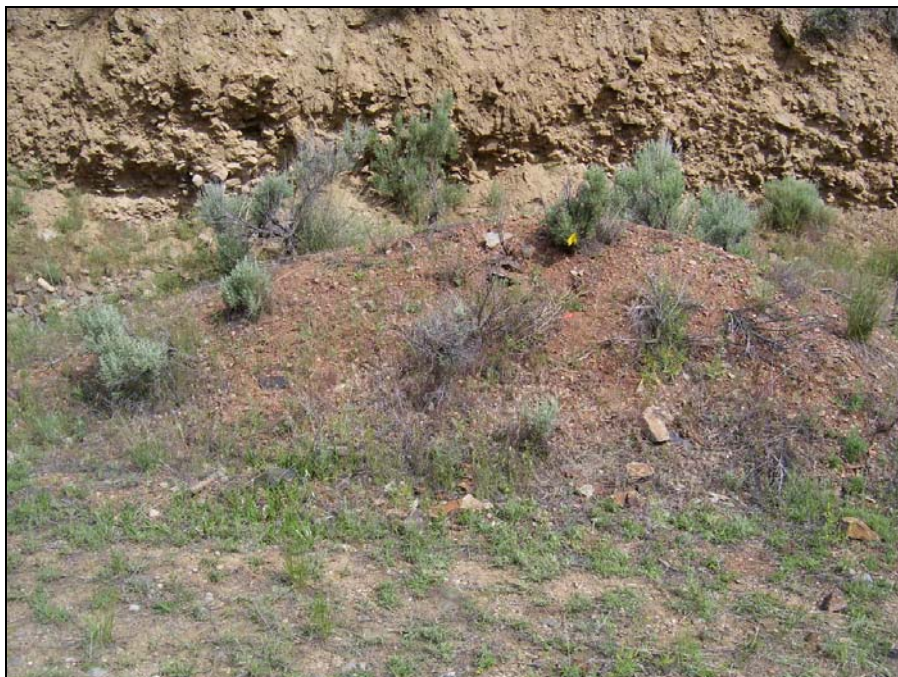
SRUD 22 Sampling Location XRF-SS-005

Thorium waste pile. This sample is from a waste pile located west of the building that showed high gamma radiation during the field survey. The pile is approximately 15 cubic yards in volume. The laboratory sample ID is **XRF-SS-05**.

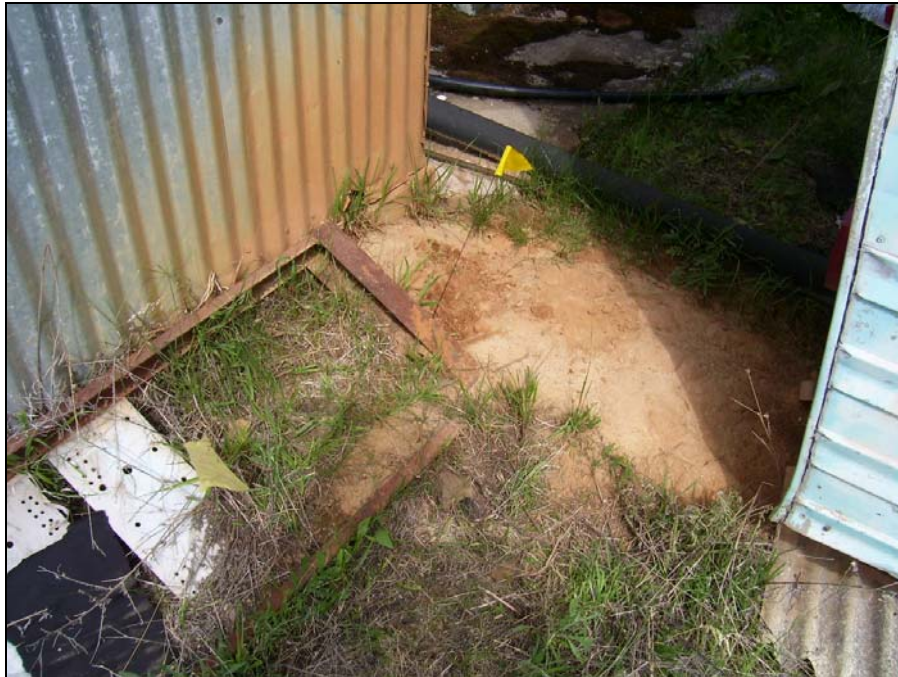
SRUD 24 Sampling Location XRF-SS-002

Potential Uranium Pile. One soil sample was taken from a pile outside of the building that according to the site owner is processed waste from an off site source containing uranium ore. The laboratory sample ID is **XRF-SS-02**. The location is at the northern most corner of the building with two distinct disturbed small piles with a total volume of about two cubic yards.

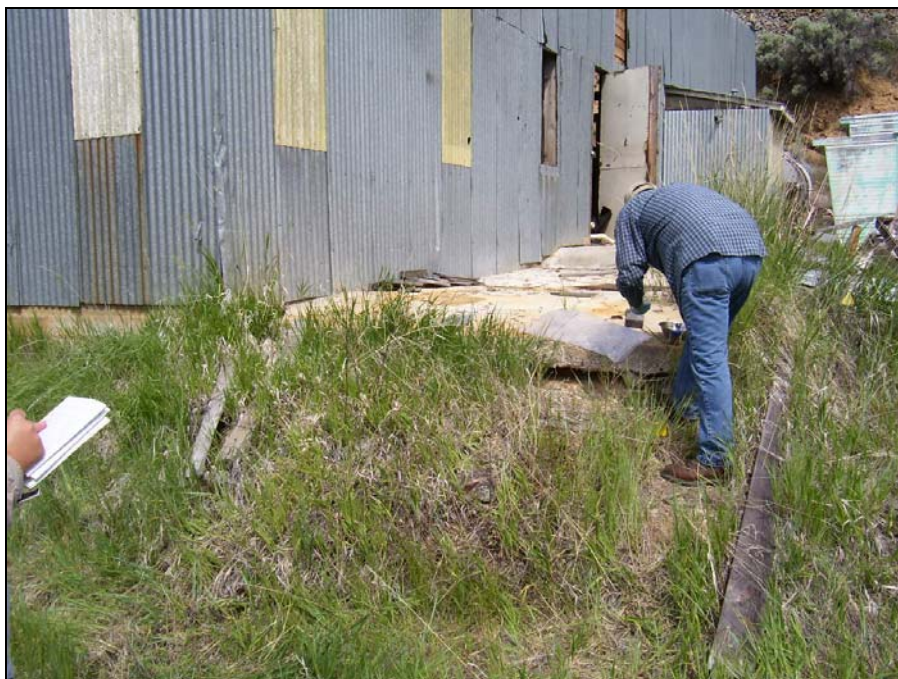
SRUD 25 Sampling Location XRF-SS-001

Potential Thorium Pile. One soil sample was taken from a pile outside of building that according to the current site owner contained processed thorium waste. The area was located with the high readings of the Ludlum gamma radiation detector. The pile is located just off the pad at the east corner of the building. The pile is not well defined and overgrown with weeds, so the exact amount of material is difficult to determine, but appears to be about ten cubic yards in volume. The laboratory sample ID is **XRF-SS-01**.

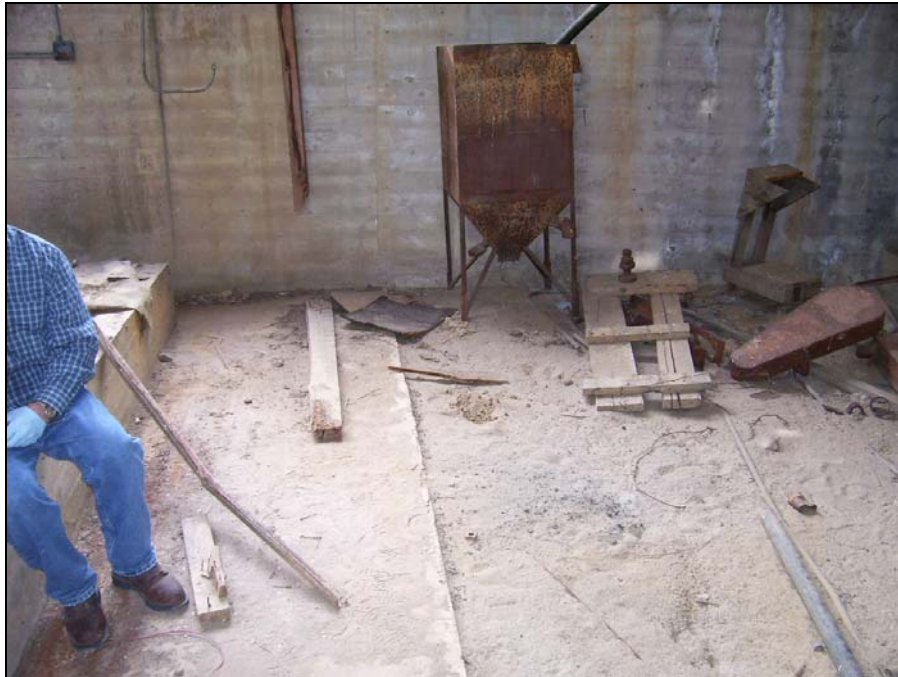
SRUD 26 Sampling Location BLD-SS-05

A high concentration of lead was detected with the XRF in sand located in the northeast corner of the building. This high concentration of lead was confirmed with laboratory analysis of sample ID **BLDG-005** with a lead result of 48,600 mg/Kg. The sandy material covers an area of approximately 100 square feet six inches deep, or about two cubic yards. The photograph is SRUD-26.

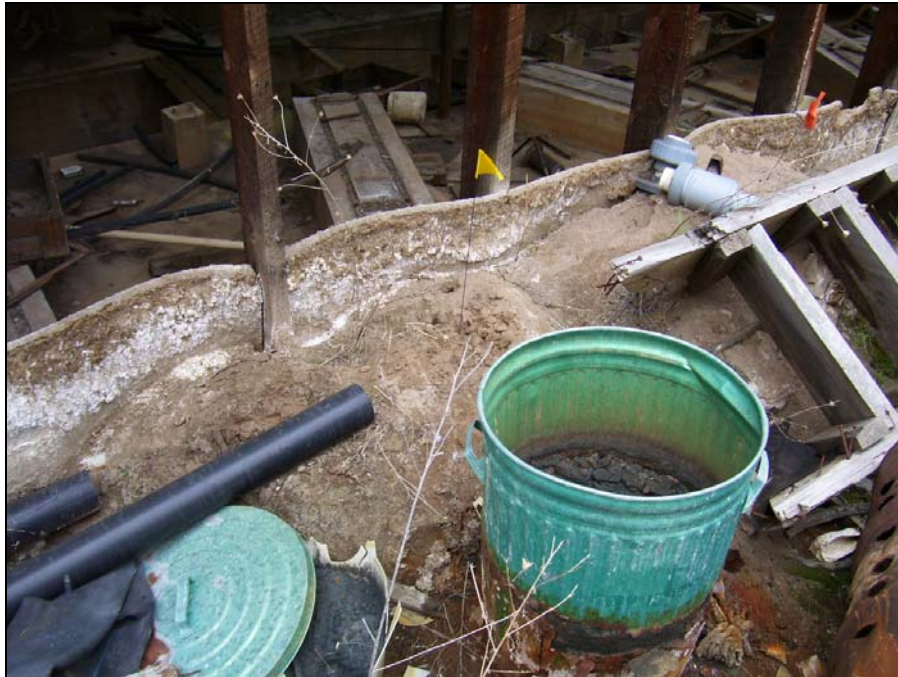
SRUD 28 Sampling Location XRF-SS-03

Waste area. An area along the northwest side of the building was identified with both the gamma radiation and the XRF metals detector as having high levels of contamination. The XRF field screening showed levels of arsenic between 99 to 2600 ug/Kg in this area. The area includes a “trash barrel”, a decomposed five gallon bucket and scattered material. The total volume is approximately 15 cubic yards. The laboratory sample ID is **XRF-SS-03**.

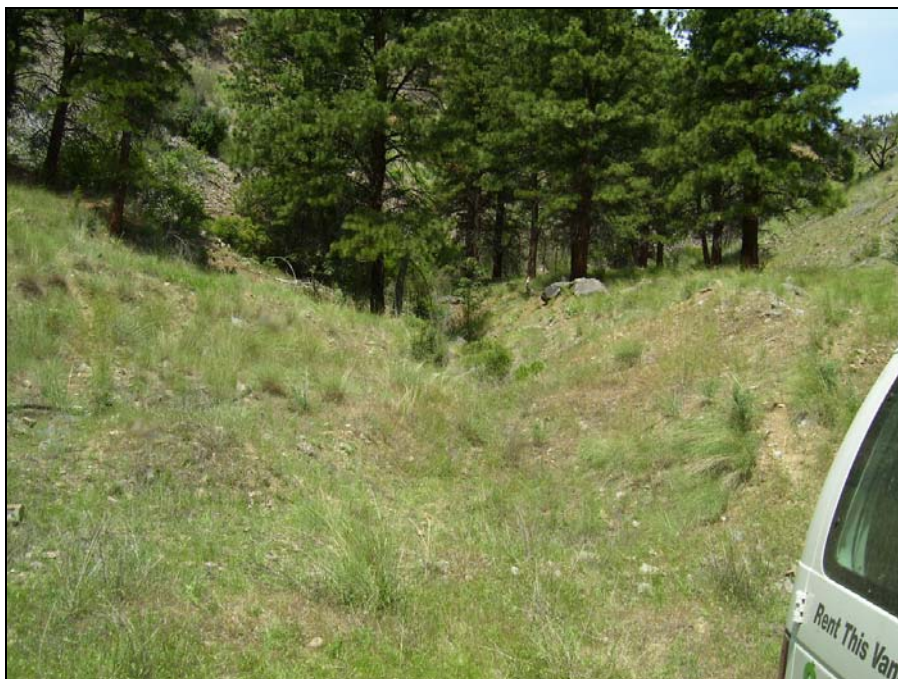
SRUD 29 Sampling Location BGUG-SS-01, Up Gradient on Buster Gulch

- One soil sample was collected up gradient of site in Buster Gulch, a natural surface water runoff entry point through the property. The sample identification (ID) is **BGUG-SS-01**. The sample was located approximately 30 feet north of the property survey marker where the entrance road crosses the gulch.

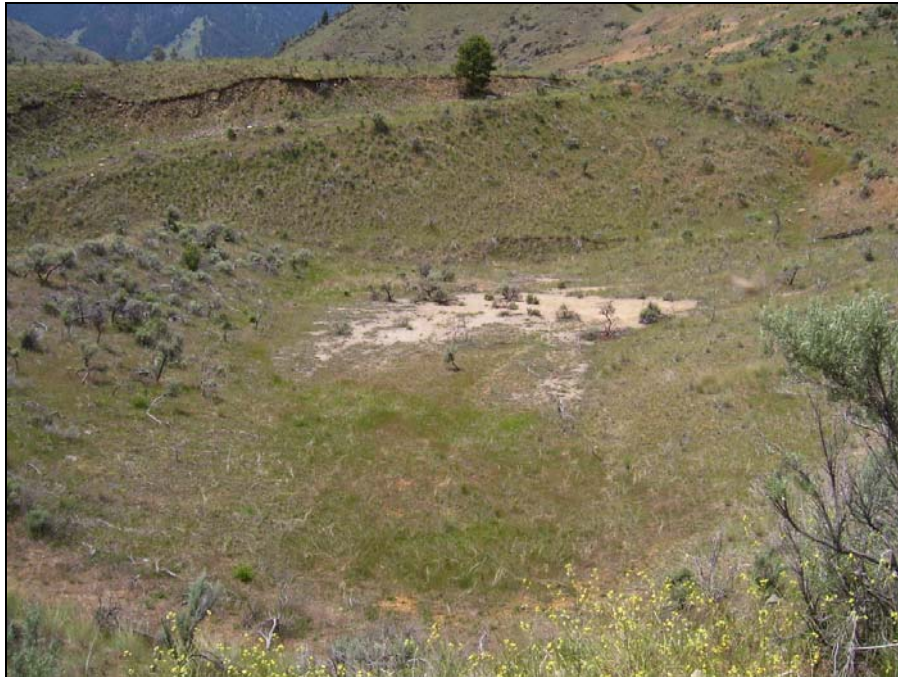
SRUD 31 Upper Tailings Pond Looking Southwest

Tailings Pond. The tailings pond showed no elevated gamma radiation, with reading similar with the gamma radiation levels at the site perimeter. Field survey results shown in Table 9. Two soil samples were taken from separate areas in the upper tailings ponds do to high arsenic screening levels found during the site survey (from 2200 to 4300 mg/Kg). The samples IDs are **XRF-SS-07** and **XRF-SS-09** with compiled documentation summarized in Table 10. The area of contamination is about 25 feet by 100 feet in area. The depth of contamination is unknown; however from visual observation the disturbed area does not extent beyond surface elevation. The area of the arsenic contamination is near the lowest elevation of the “upper” tailings pond. Photograph SRUD-031 shows this area.
