Surface Remediation for Mitigation of PWSCC in Nickel- Based Materials

Al Ahluwalia
EPRI

May 30, 2007
MRP/PWROG Briefing to NRC RES

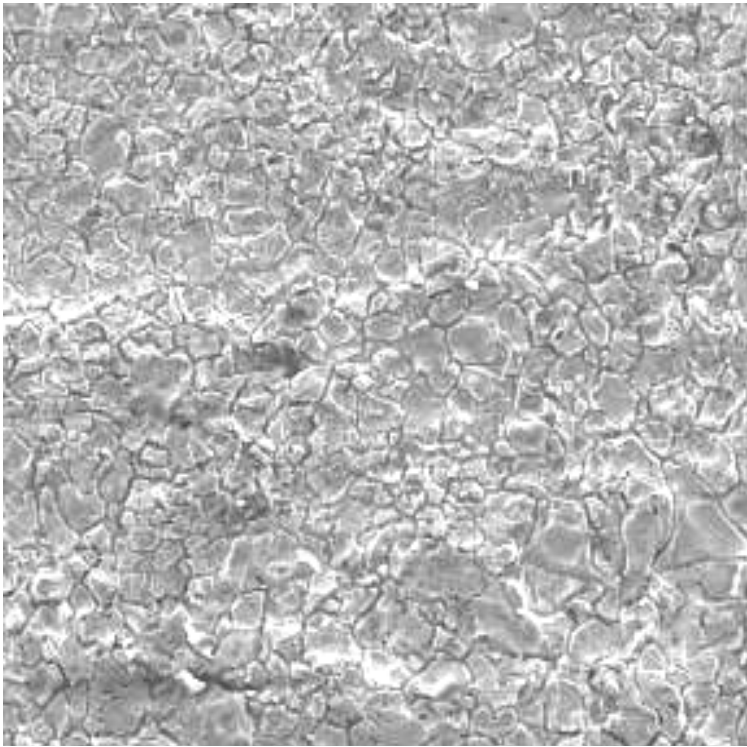
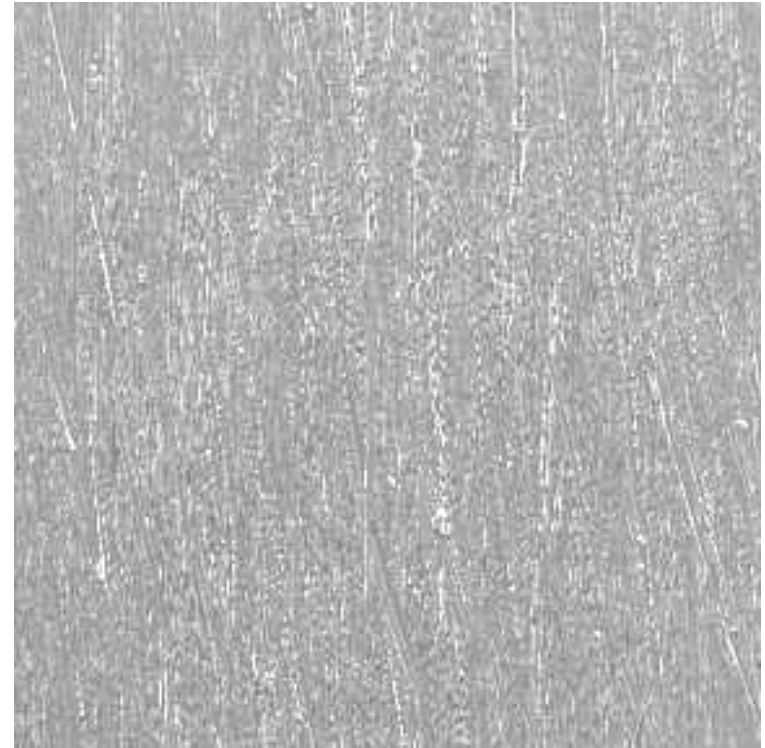
Scanning Electron Microscopy (SEM) of the Surface of Type 316L Stainless Steel Plate in Original Condition (Annealed and Pickled) (left), and After **ReNew** Application (right). Grain Boundary Ditching (Inter-Granular Attack) Has Been Removed.

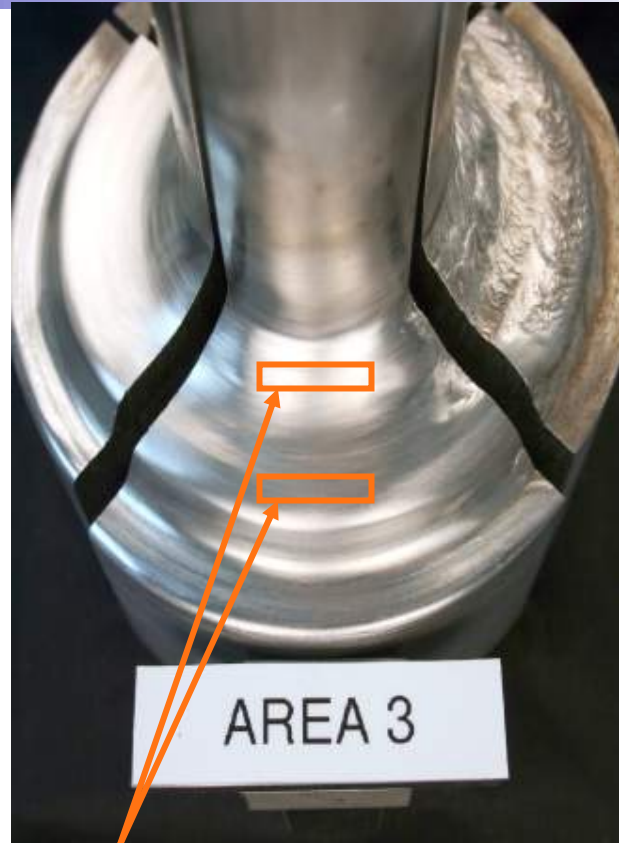
Figure 2

Residual Stress measurement areas

ICMH Weld Mockup, after ReNew and after sectioning for residual stress measurements in Housing and Weld

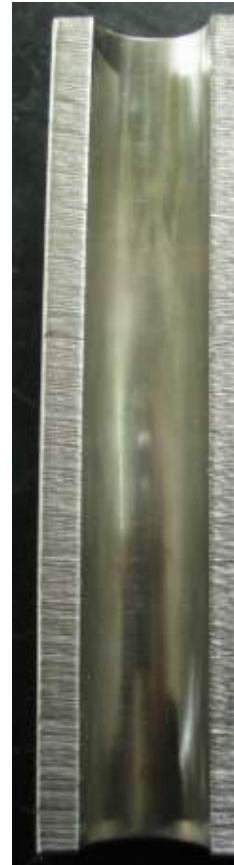
As Fabricated

PWR ID Bottom Mounted Instrumentation
