# **Integrated Chemical Effects Test Project: Consolidated Data Report**

**Los Alamos National Laboratory**

**U.S. Nuclear Regulatory Commission  
Office of Nuclear Regulatory Research  
Washington, DC 20555-0001**

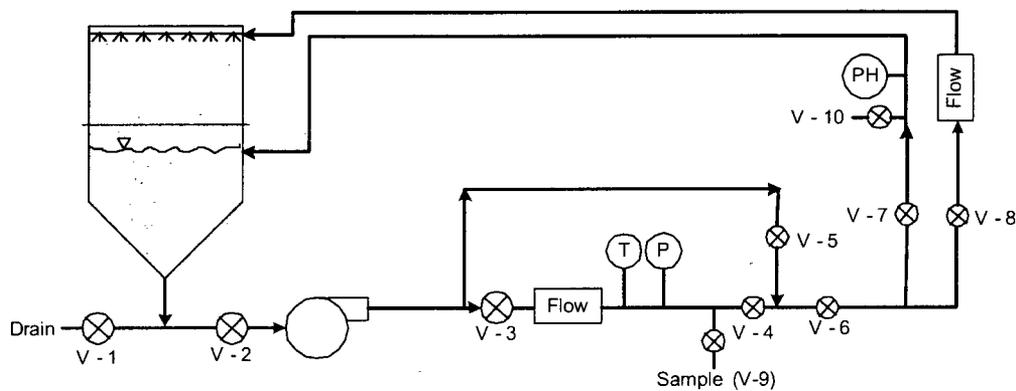
The as-built test loop consisted of a test tank, a recirculation pump, 2 flow meters, 10 isolation valves, and pipes that connect the major components, as shown schematically in Figure 2-1. The labels P, T, and pH represent pressure, temperature, and pH probes, respectively. Valves are numbered V-1 through V-10.

Figure 2-1. Test loop process flow diagram.

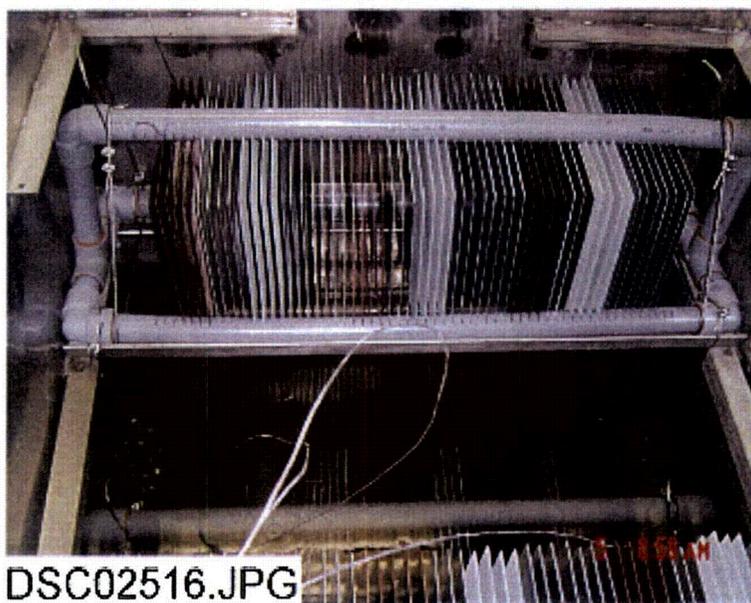
Figure 2-3 shows the configuration of a typical unsubmerged coupon rack loaded with metal coupons in the ICET tank. The loading pattern of all suspended racks was nearly identical, varying by only one or two coupons. Shown in the figure from left to right, the coupons are arranged as follows: four Cu, four Al, four coated with inorganic zinc (IOZ), seven GS, four Cu, three Al, four IOZ, and seven GS.

**Figure 2-3. A typical loaded coupon rack in the ICET tank.**

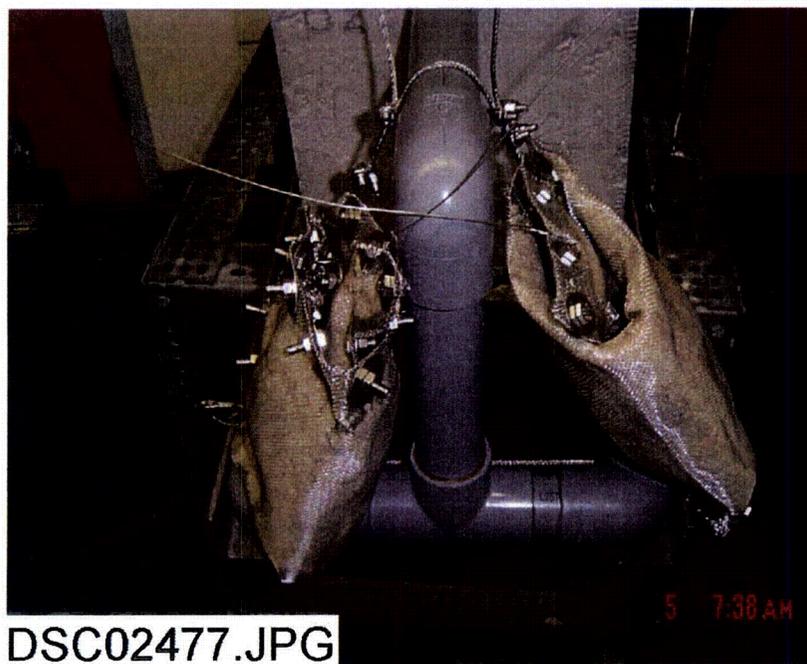
Several fiberglass samples were placed in the ICET tank. These samples were either submerged or suspended above the water level. The unsubmerged fiberglass samples were positioned so that they would be exposed to sprays. All fiberglass samples were contained in SS wire mesh bags or “pouches” that allowed water flow while confining the fiberglass material. Both loosely packed and more tightly packed samples were used. In addition, some submerged fiberglass samples were located where they would be exposed to relatively high-flow conditions, and others were located in quiescent regions of the tank. Figure 2-4 shows the so-called “sacrificial” fiberglass samples in wire mesh pouches attached to the submerged coupon rack (Rack 1 in Figure 2-2). Each pouch contained ~5 g of fiberglass. Sacrificial samples were attached with SS wire; removed from the tank on Days 4, 15, and 30; and examined for possible time-dependent changes. As shown in the figure, bigger insulation bags were wrapped around the sacrificial specimens during the test. In addition, small sacrificial samples called fiber pucks were added to the solution beginning with Test #3. Fiber puck fabrication and post-test analyses are described in Ref. 5. Appendix A contains more detailed descriptions of the standard fiberglass samples. Appendix B contains additional details on the fiberglass insulation, including heat treating.

Figure 2-4. Fiberglass samples attached to a coupon rack.

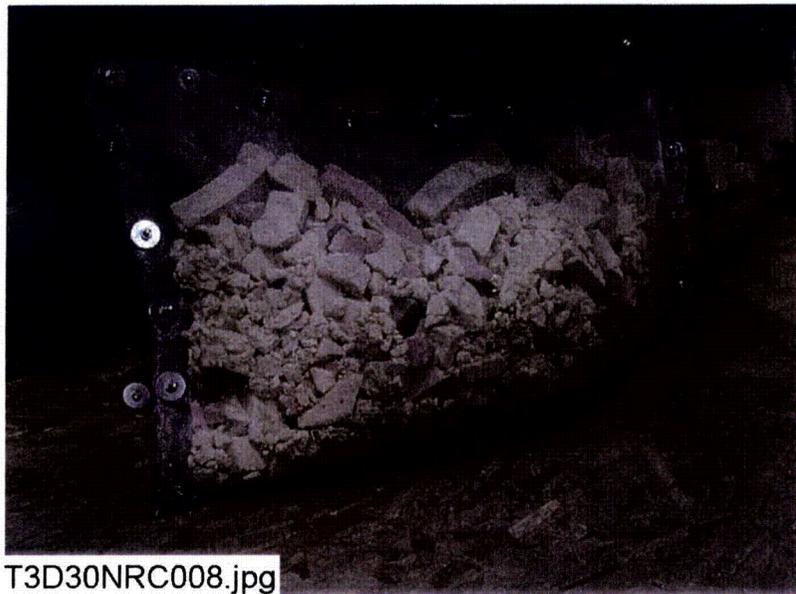
T3D30NRC008.jpg

**Figure 2-5. Solid pieces of cal-sil samples in SS mesh.**

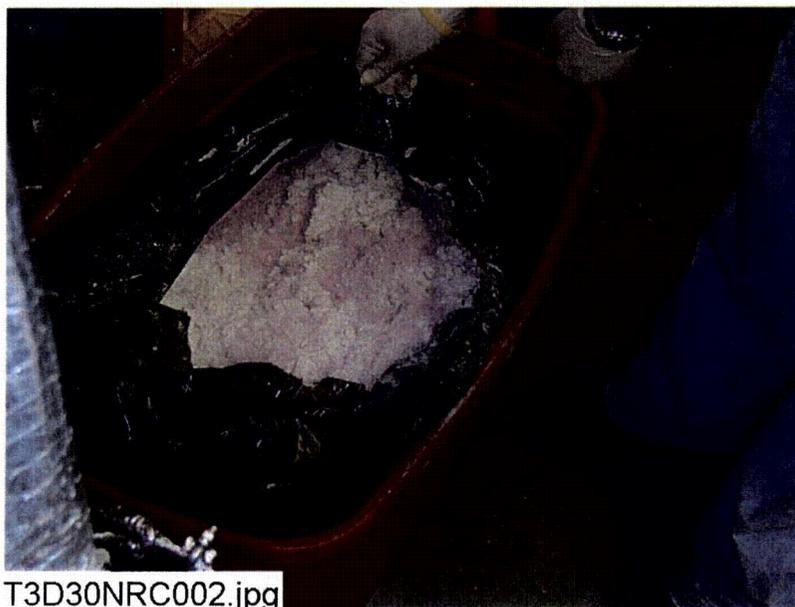
T3D30NRC002.jpg

**Figure 2-6. Pulverized cal-sil insulation before addition to the ICET tank.**

Several cal-sil samples were also placed in the ICET tank for Tests #3 and #4. Samples were either submerged or suspended above the water level. The unsubmerged cal-sil samples were positioned so they would be exposed to sprays. In addition to solid cal-sil pieces (Figure 2-5), 43.5 lb of cal-sil dust (Figure 2-6) were added to the tank solution before the test began. As with the fiberglass samples, all of the cal-sil samples (except for the dust) were contained in SS wire mesh that allowed water flow while confining the cal-sil material. Appendix B contains additional details on the cal-sil insulation, including heat treating.

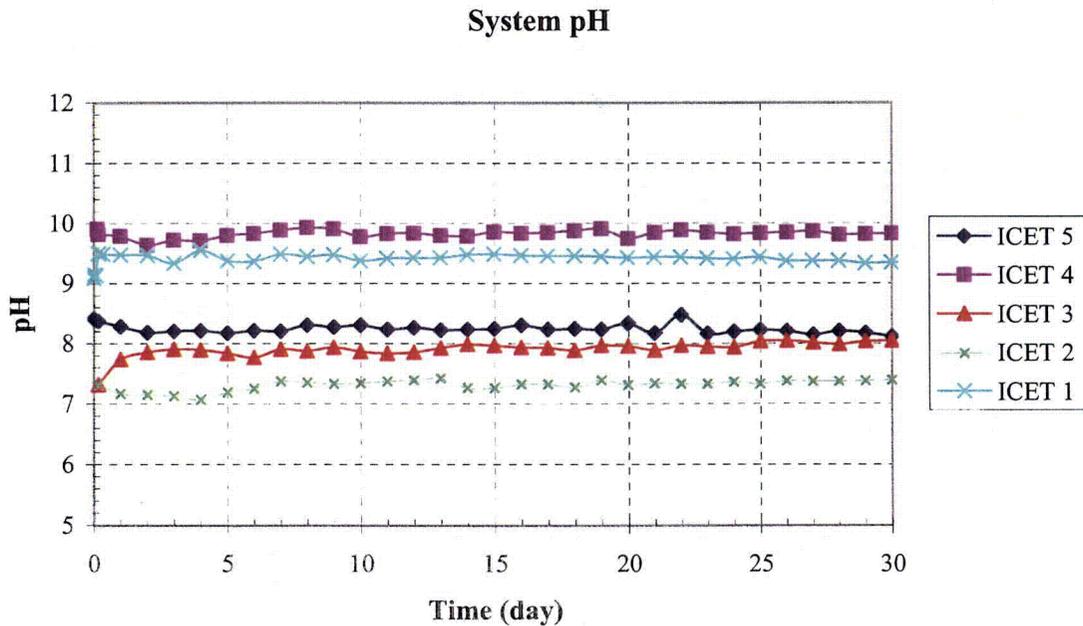
Each test had a different pH that was attributable to specific chemical requirements (Table 4-1). As shown in Figure 4-1, although the target pH was different between tests, all tests had a similar consistency with only a slight drift in pH throughout the test. The only exception to this trend was observed in Test #3, where the pH deviated from the initial pH by approximately 0.8 unit. In Test #3, phosphate precipitated out of solution early during the test which resulted in the diminished buffering capacity of the system. Without adequate buffering, the system pH could be more easily affected as varying chemical reactions occurred.

**Figure 4-1. ICET bench-top pH comparison.**

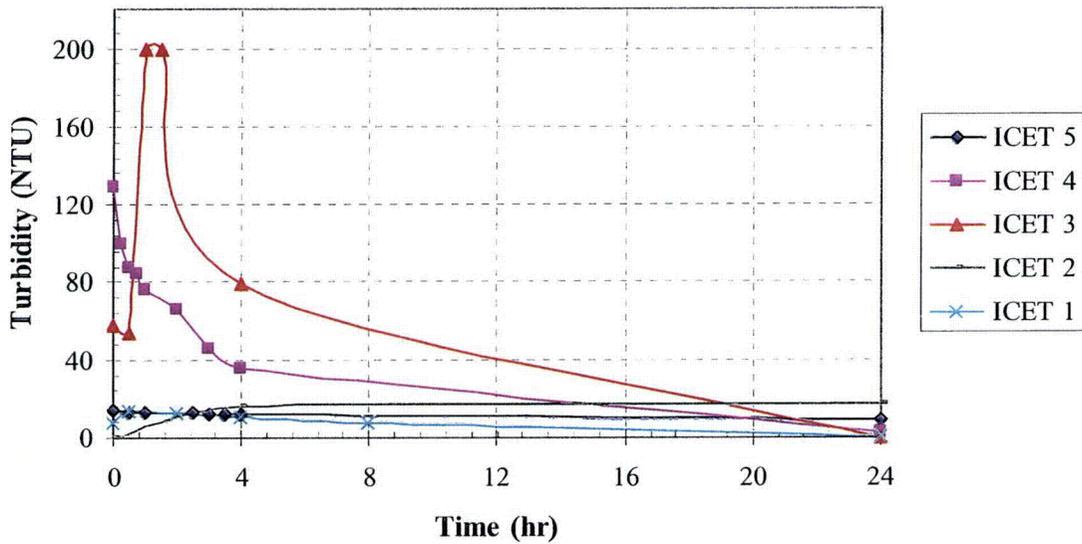
Figure 4-2. Day 1 turbidity.

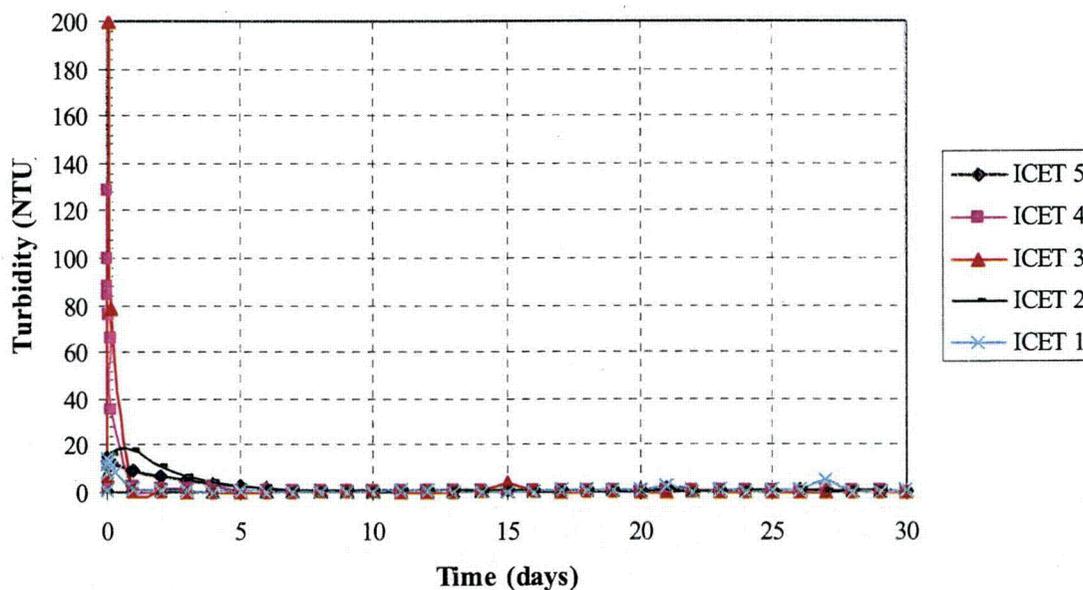
Figure 4-3. ICET 60°C turbidity.

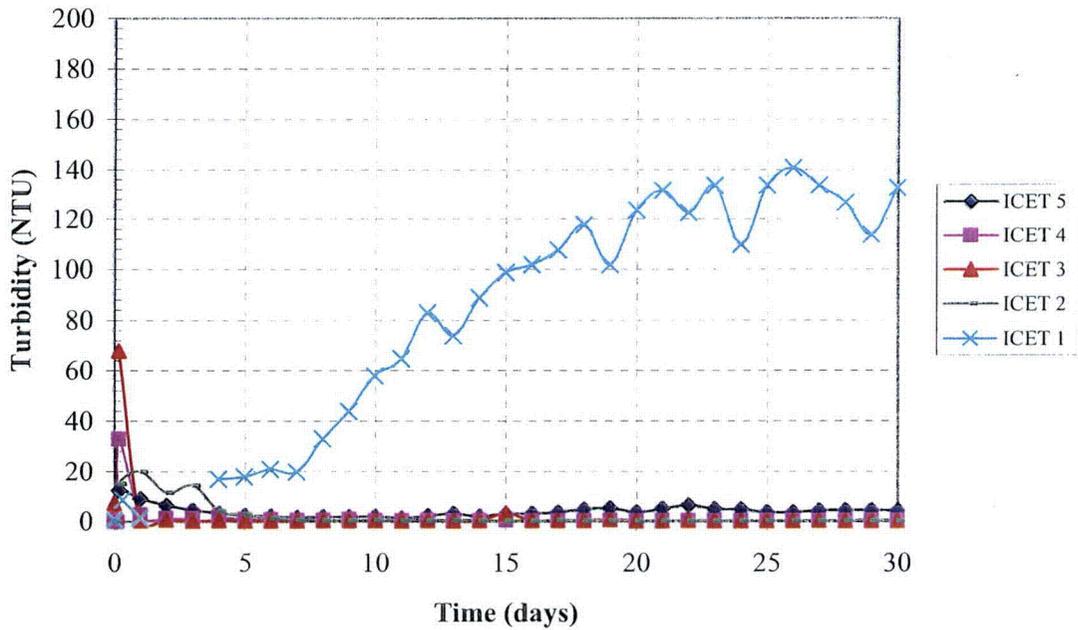
Figure 4-4. ICET 23°C turbidity.

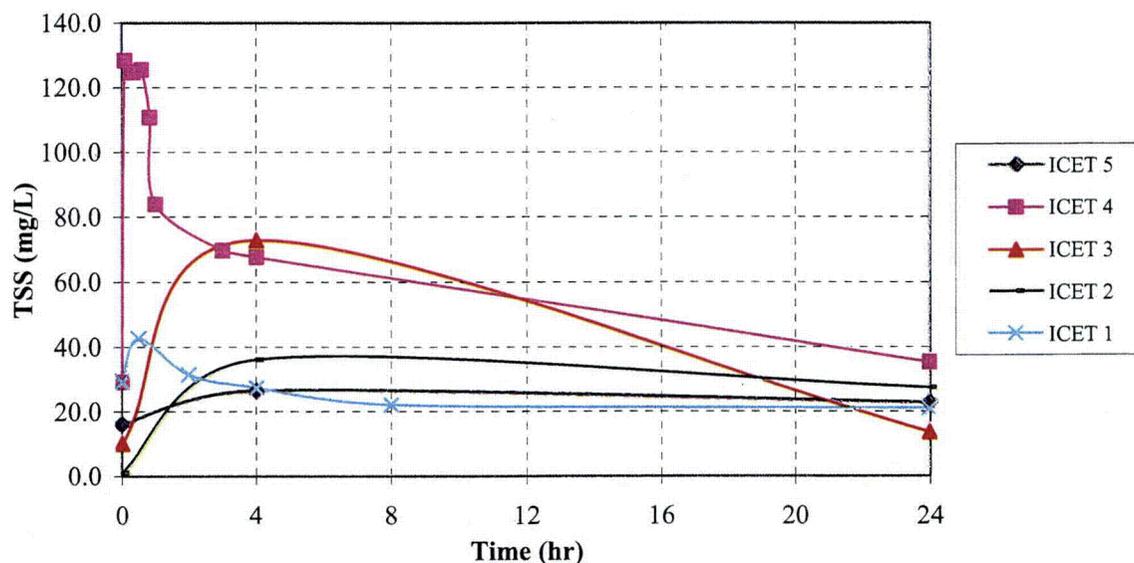
Figure 4-5. ICET Day-1 TSS.

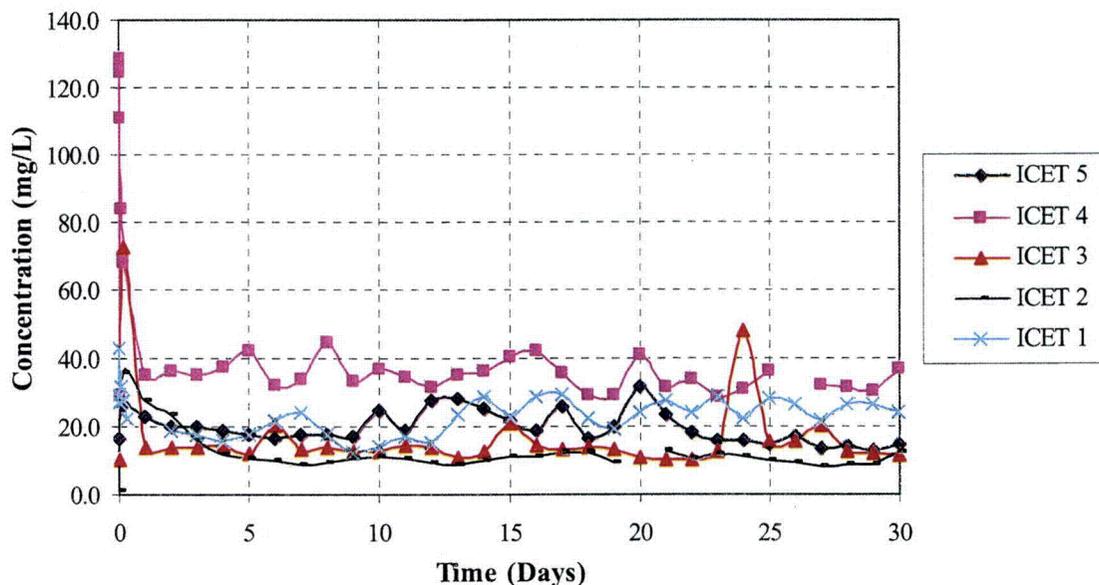
Figure 4-6. ICET TSS.

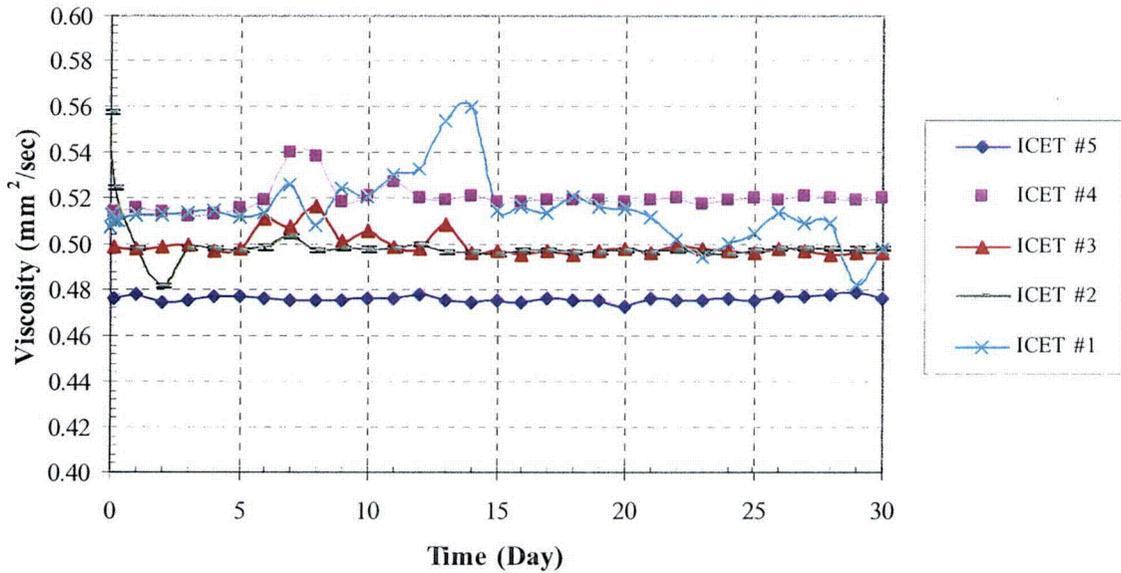
Figure 4-7. ICET 60°C kinematic viscosity.

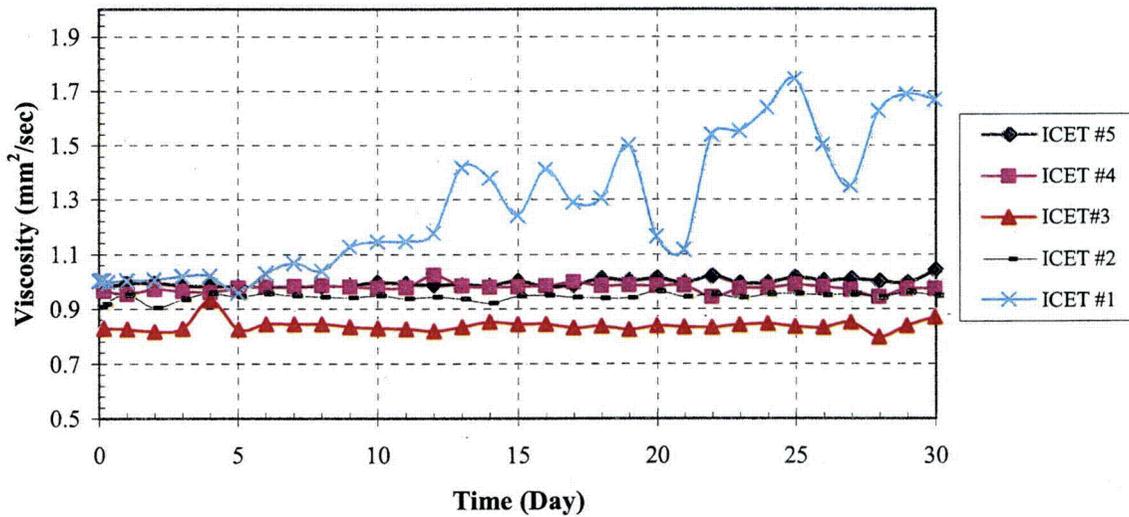
Figure 4-8. ICET 23°C kinematic viscosity.

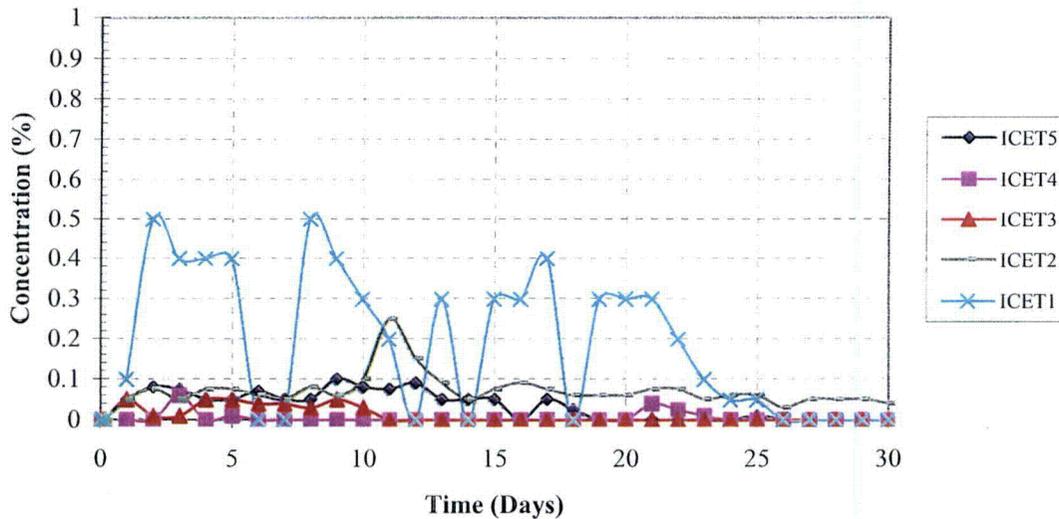
Figure 4-9. ICET hydrogen concentration.

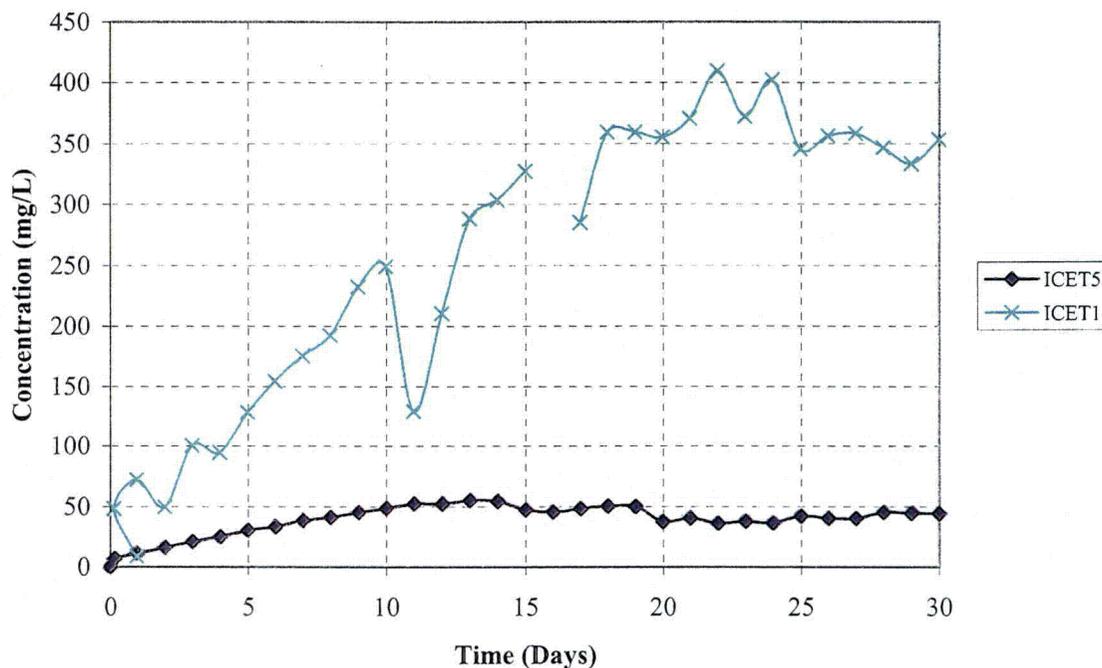
Figure 4-10. ICET Tests #1 and #5 unfiltered aluminum concentration.

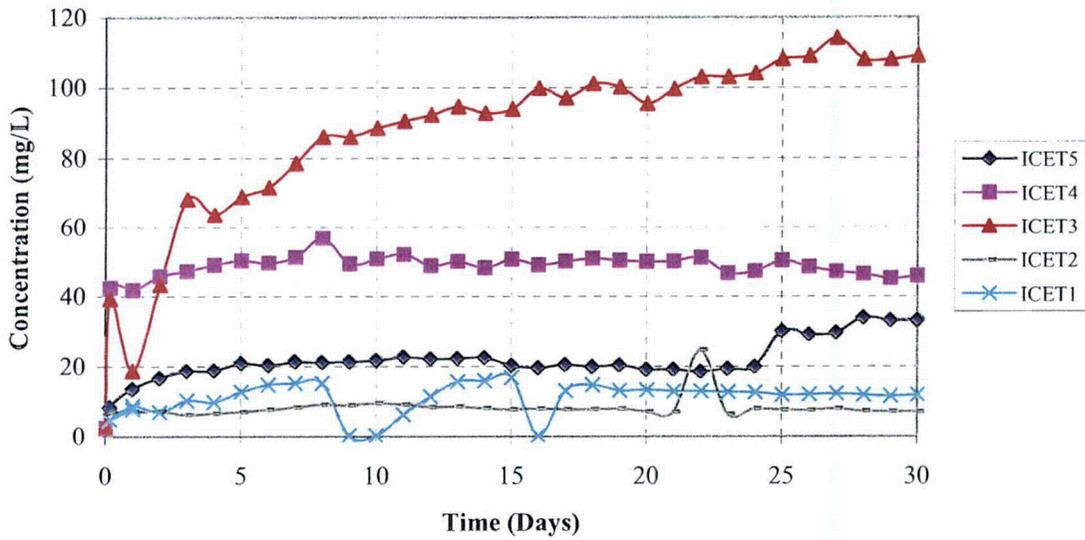
Figure 4-11. ICET unfiltered calcium concentration.

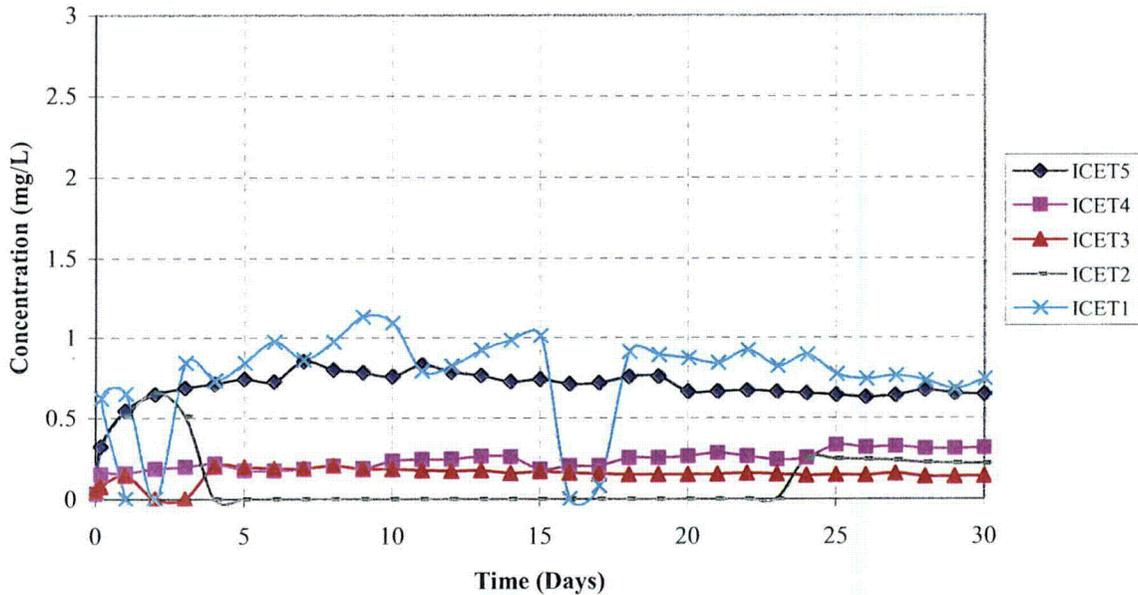
Figure 4-12. ICET unfiltered copper concentration.

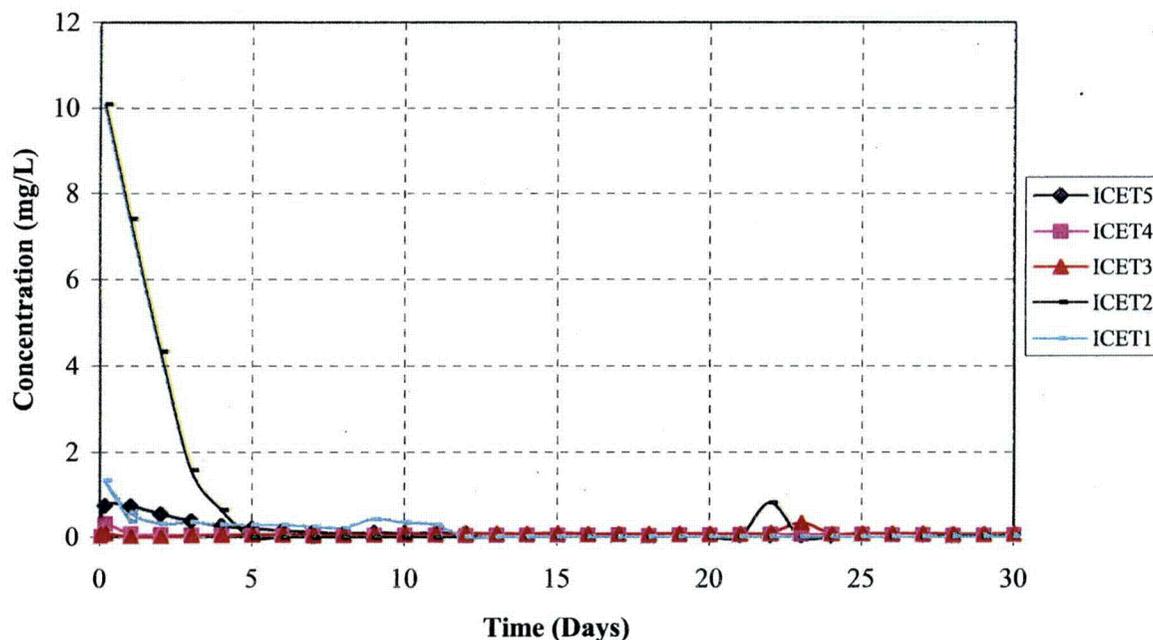
Figure 4-13. ICET unfiltered zinc concentration.

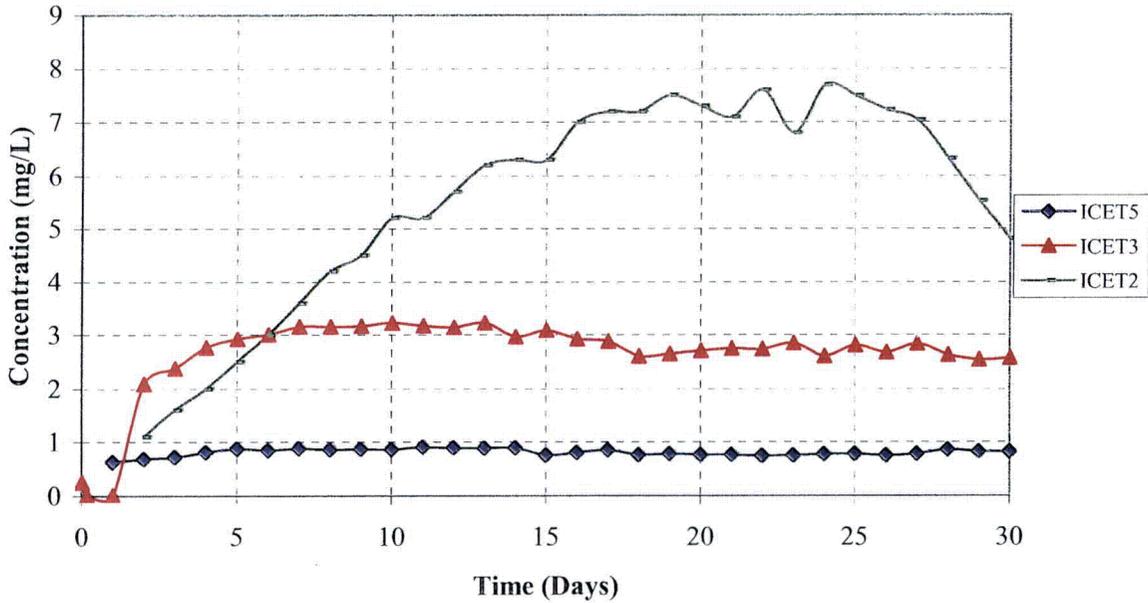
Figure 4-14. ICET Tests #2, #3, and #5 unfiltered magnesium concentration.

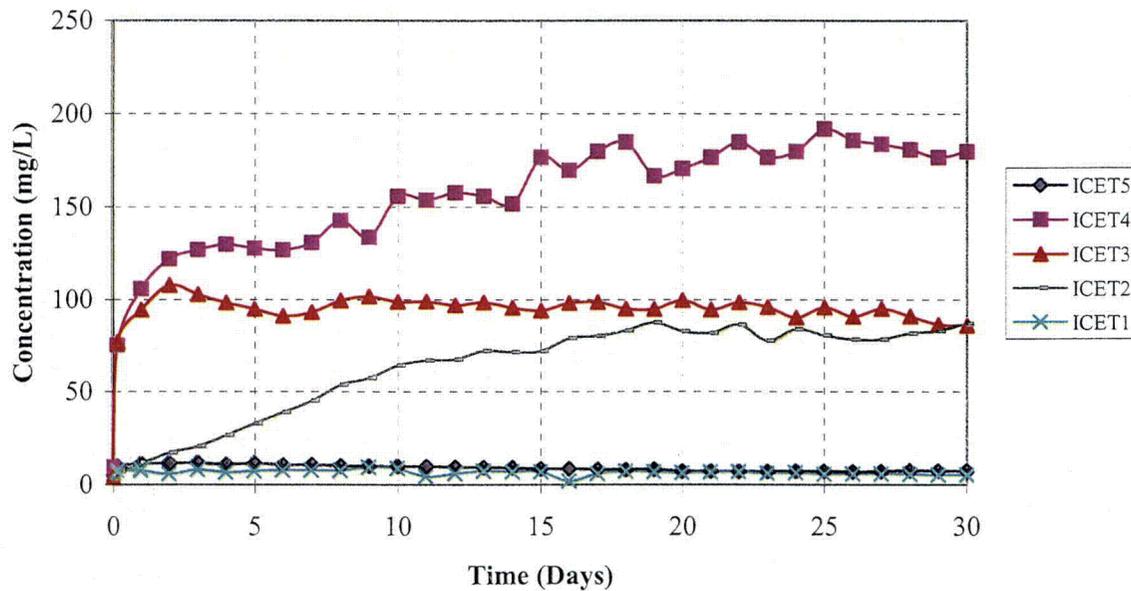
Figure 4-15. ICET unfiltered silica concentration.

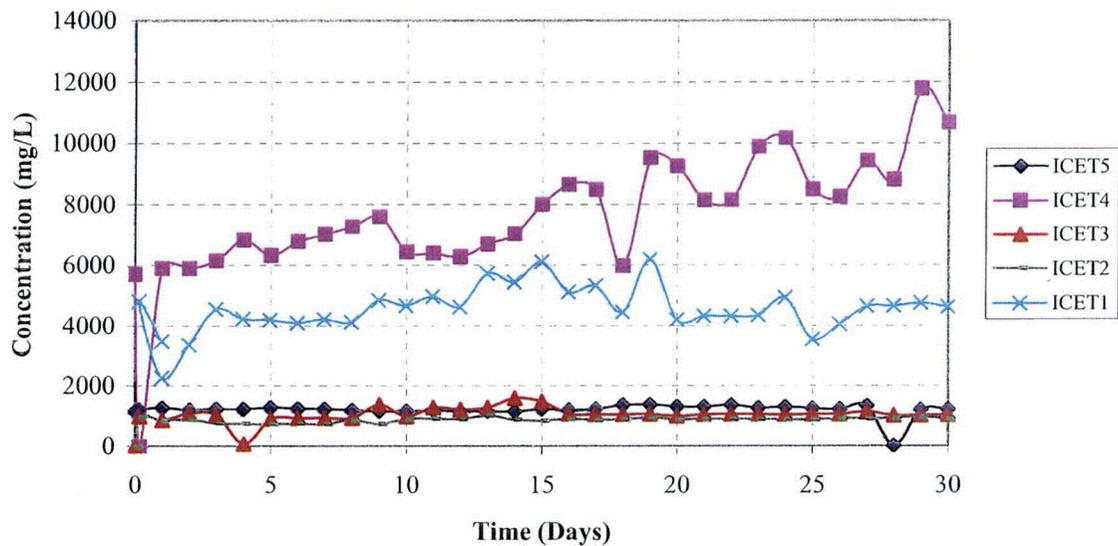
Figure 4-16. ICET unfiltered sodium concentration.

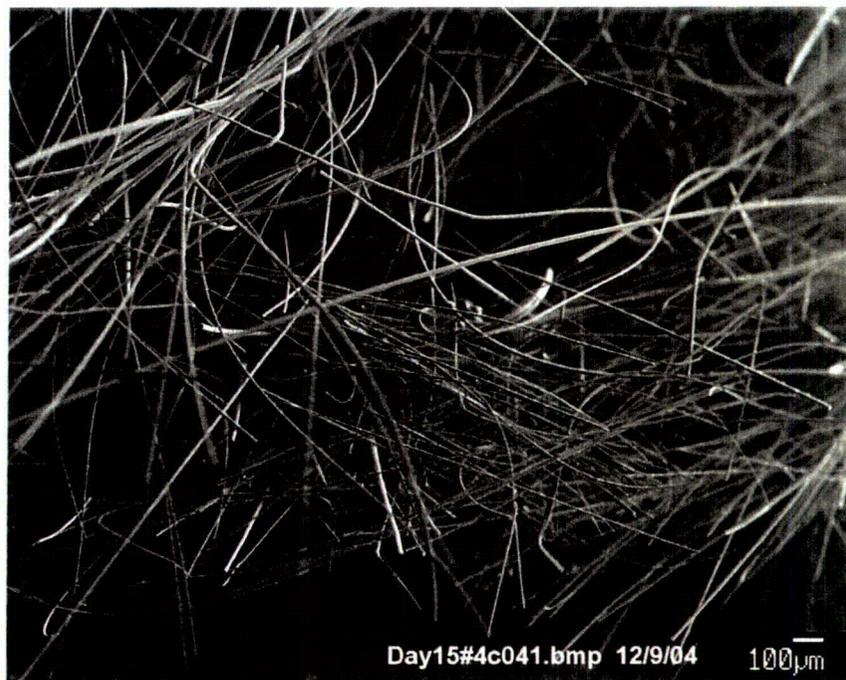
An SEM image of clean fiberglass, before exposure to the test solution, is shown in Figure 4-17. This SEM image provides a visual baseline as a comparison for images from samples taken after the tests began. As can be seen, there are no deposits on the clean fiberglass. Over the course of each test, deposits were observed throughout the fiberglass samples. These deposits could be of chemical origin (i.e., solids that formed at the surface of the fiberglass because of chemical reactions between soluble chemical species and the fiberglass or because of precipitation of soluble species at that location) or physically retained or attached (i.e., deposits that existed as solid particles in the test solution and were captured by the fiberglass). Because there was not significant water flow through the fiber, particle migration into the fiberglass interior was not likely; however, physical retention and attachment of particles at the exterior of fiberglass were possible. Therefore, deposits found in the interior of the fiberglass samples were likely of chemical origin, whereas the deposits on the exterior could have been of either origin.

**Figure 4-17. Clean fiberglass before exposure to test chemicals.**

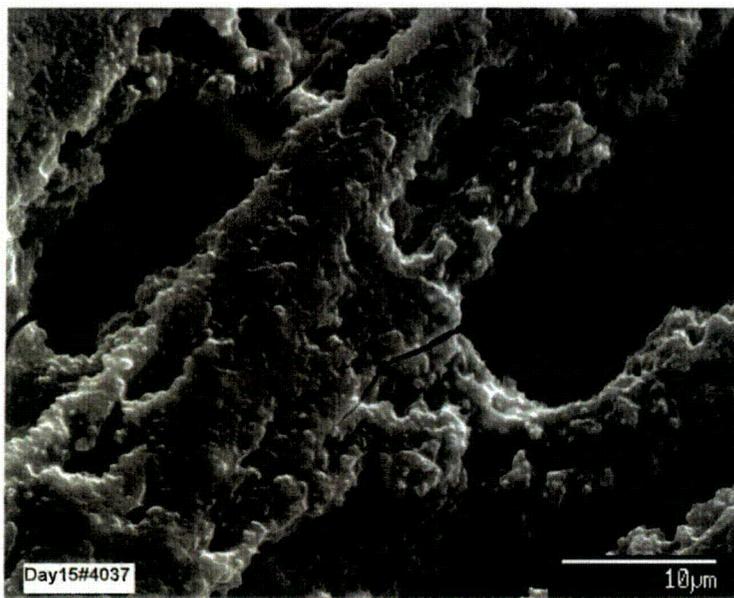
Figure 4-18. Day 15, sample #4 SEM image (#4037), magnified 2500 times; BSE close-up.

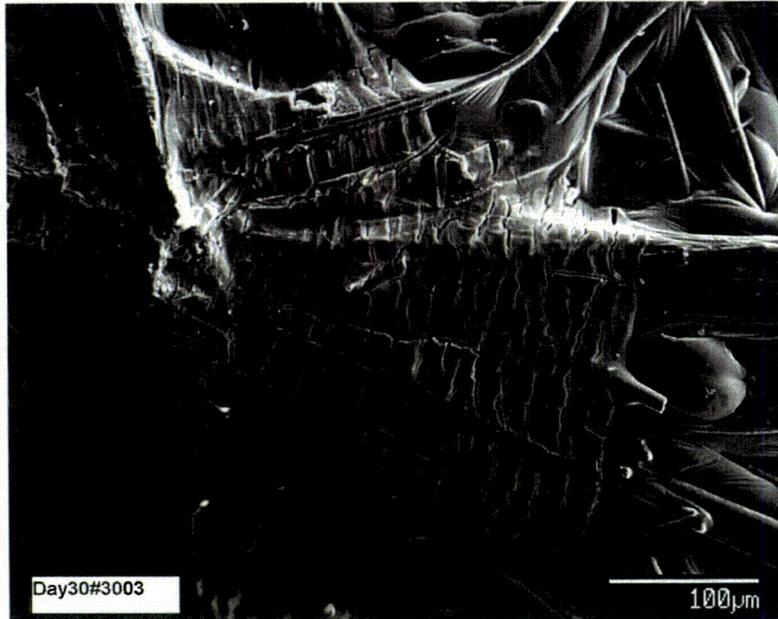
Figure 4-19. Day 30, sample #3 SEM image (#3003), magnified 250 times, of the fiberglass with surface coating.

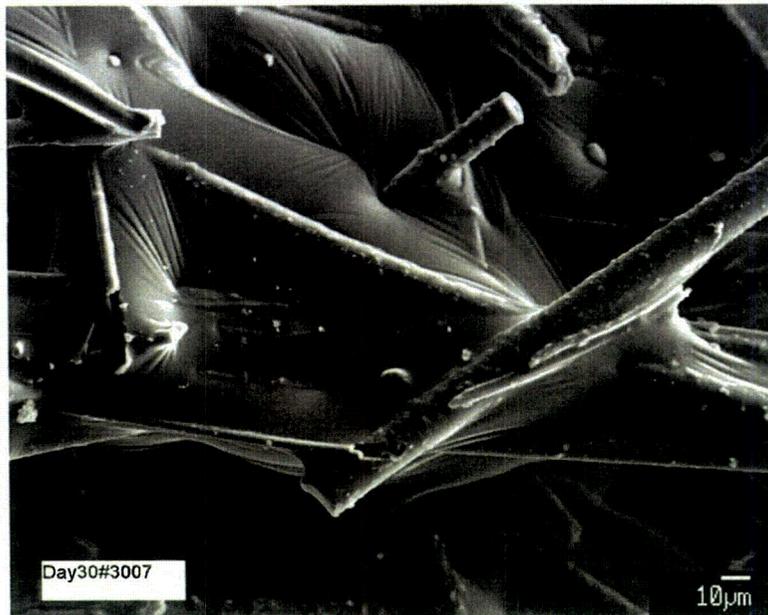
Figure 4-20. Day 30, sample #3 SEM image (#3007), magnified 500 times, of the film across the fibers.

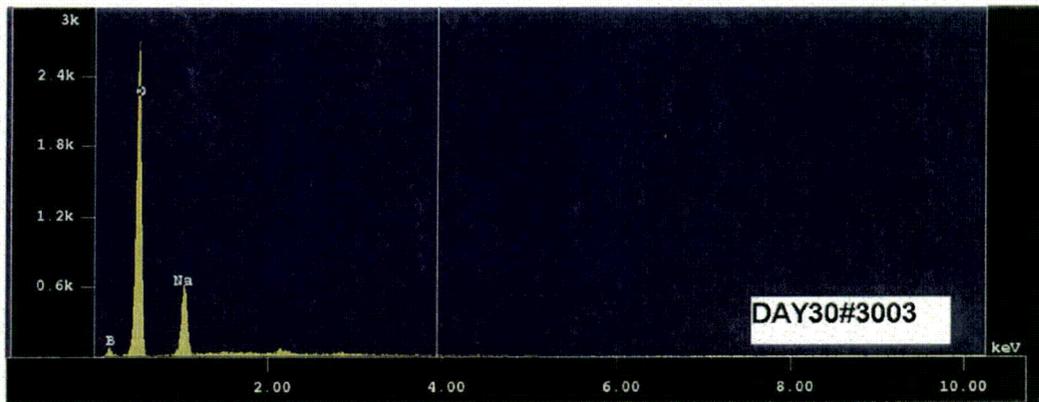
Figure 4-22. Day 30, sample #3 counting spectrum (EDS #3003) of the fractured coating, as shown in Figure 4-19.

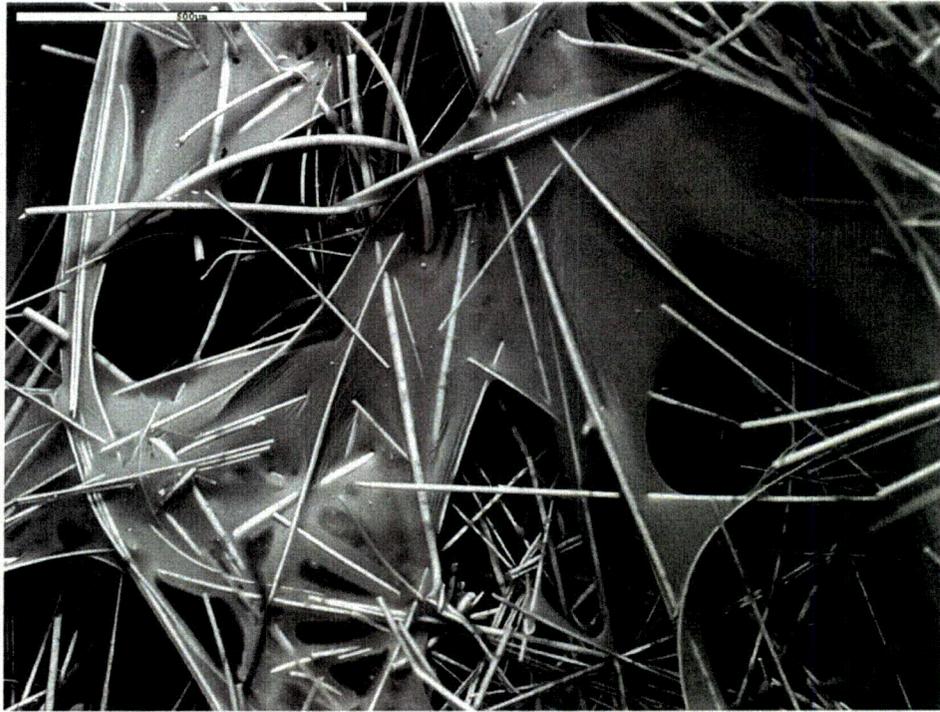
Figure 4-23. ESEM image, magnified 100 times, of raw fiberglass dipped in ICET Test #1 solution. (rfbt105.tif, 7/28/05)

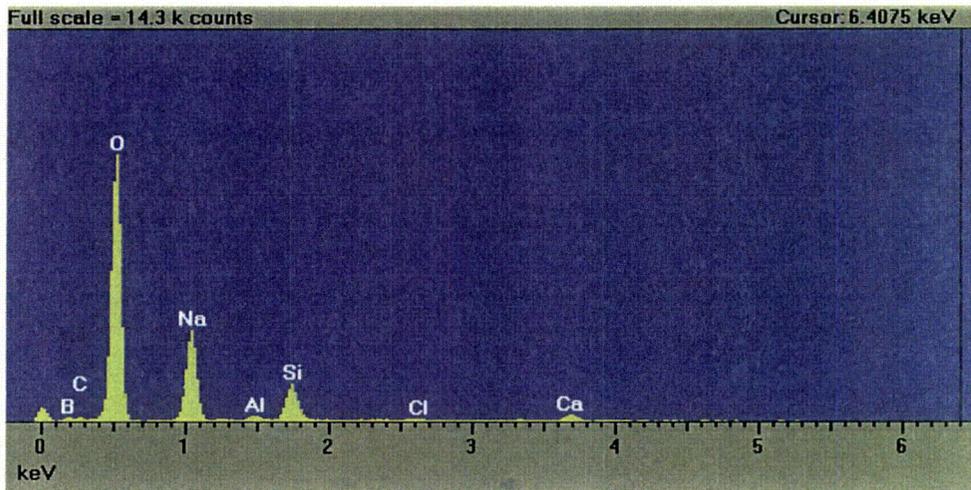
Figure 4-24. EDS counting spectrum for the film on fiberglass, as shown in Figure 4-23. (rfbt106.tif, 7/28/05)

Lab diagnostic tests revealed that the webbing material was likely an artifact of the sampling and analysis procedure and may not have existed when the fiberglass was submerged in the tank. On removal from the tank, the fiberglass was wet with the tank solution, and it appears that the webbing formed as the tank solution evaporated. A sample of clean fiberglass dipped momentarily in the ICET Test #1 solution and allowed to dry exhibited similar webbing, as shown in Figure 4-23. Moreover, the EDS analysis of this webbing (shown in Figure 4-24) indicated that the webbing produced in bench-top experiments exhibited elemental composition similar to the webbing observed in the Test #1 fiberglass (the silicon peak is likely from the fiberglass in the background of the webbing). This webbing was not observed when a sample of clean fiberglass was dipped momentarily in the ICET Test #1 solution, rinsed gently with RO water, and allowed to dry, as shown in Figure 4-25, thus demonstrating that the residual liquid on the surface of the fiberglass was responsible for film formation and that the webbing was actually soluble. Additional diagnostic tests indicated that sodium hydroxide did not contribute to the formation of webbing material (see Figure 4-26). However, a sodium borate solution at pH 9.5 did result in webbing on the fiberglass (see Figures 4-27 and 4-28). The elemental composition of the webbing after it was dipped in sodium borate, as shown in Figure 4-29 was consistent with the elemental composition after it was dipped in the ICET Test #1 solution (see Figure 4-24).

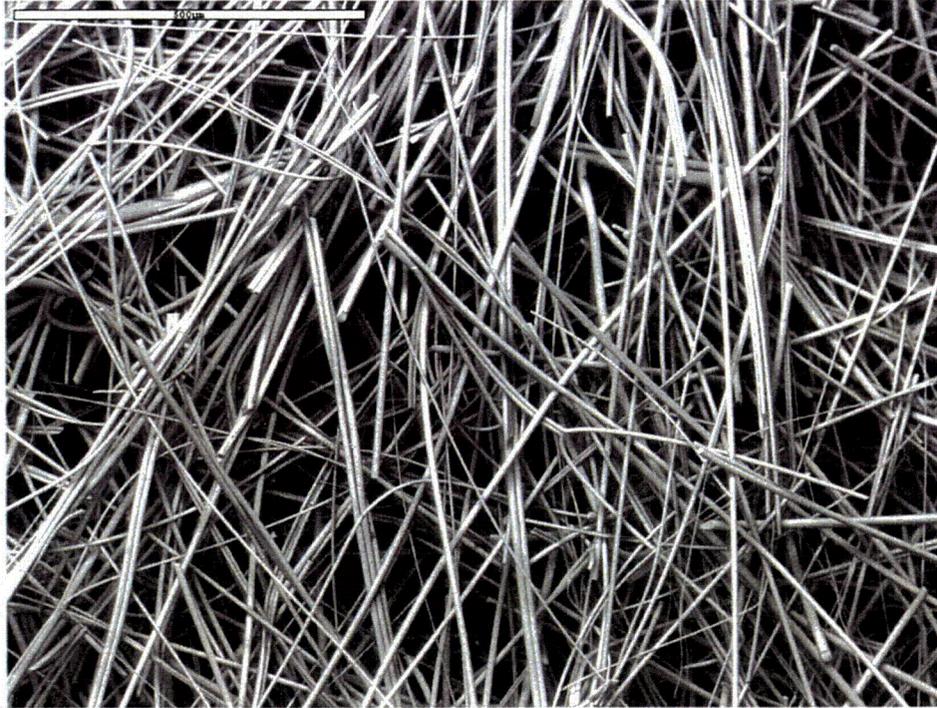
Figure 4-25. ESEM image, magnified 100 times, of raw fiberglass dipped in ICET Test #1 solution and then washed with RO water. (Difbrg15.tif, 8/3/05)

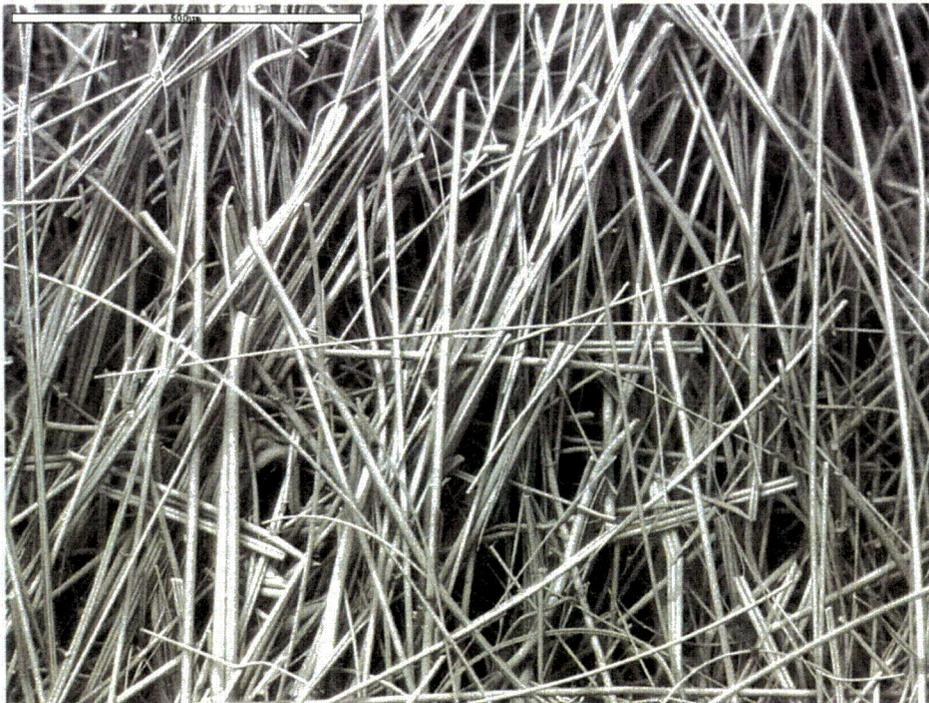
Figure 4-26. ESEM image, magnified 100 times, of raw fiberglass dipped in NaOH solution at pH 9.5. (OHFbrg07.tif, 8/3/05)

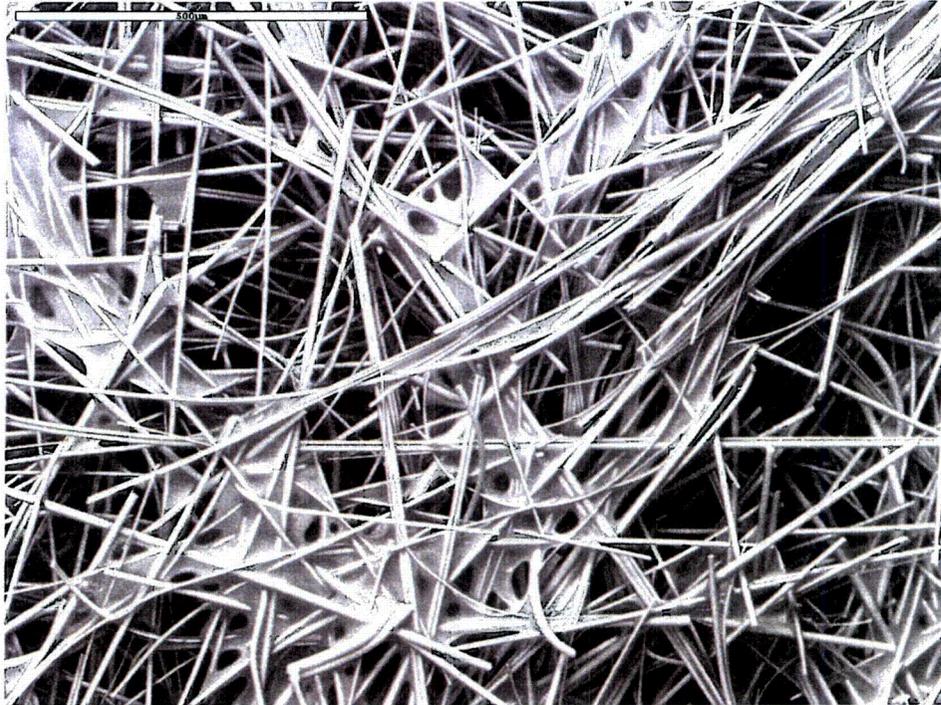
Figure 4-27. ESEM image, magnified 100 times, of raw fiberglass dipped in the solution containing 2800 mg/L boron and NaOH at pH 9.5. (Bofbrg09.tif, 8/3/05)

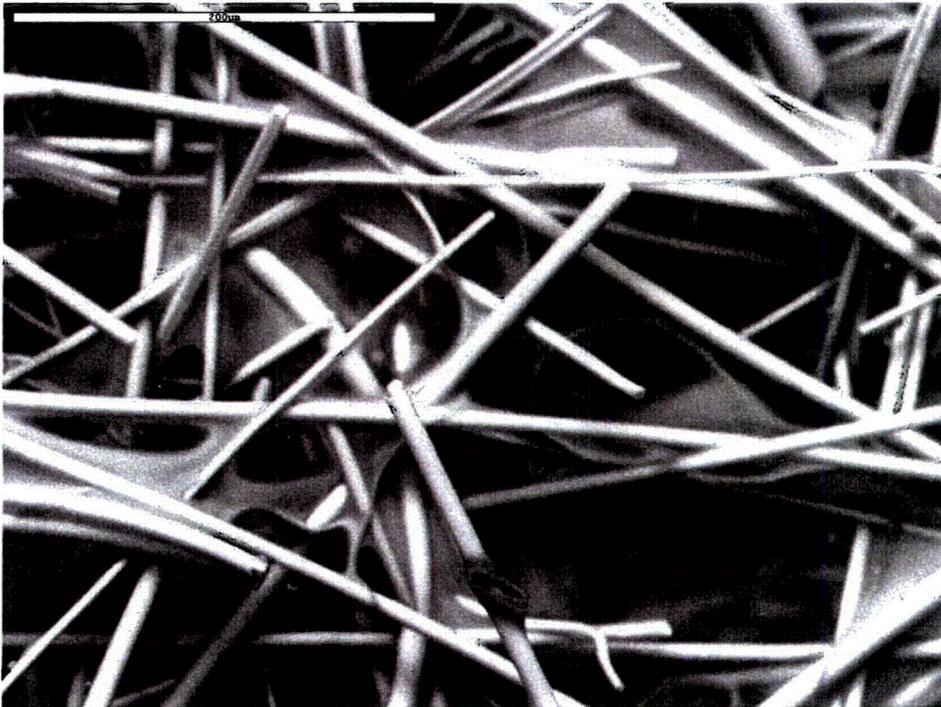
Figure 4-28. ESEM image, magnified 300 times, of raw fiberglass dipped in the solution containing 2800 mg/L boron and NaOH at pH 9.5. (rfgbn03.tif, 8/5/05)

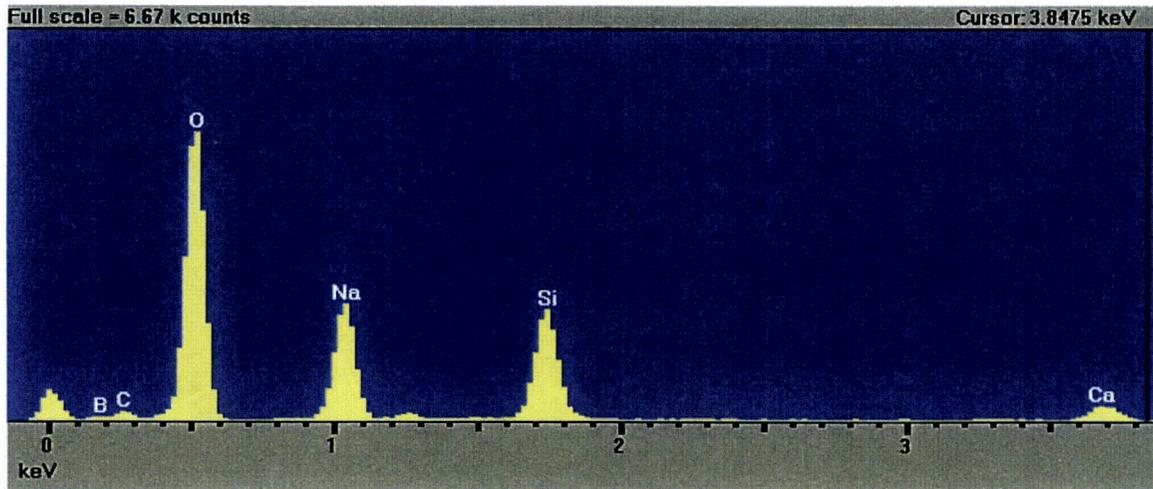
Figure 4-29. EDS counting spectrum for the film on fiberglass, as shown in Figure 4-28. (rfgbn05.tif, 8/5/05)

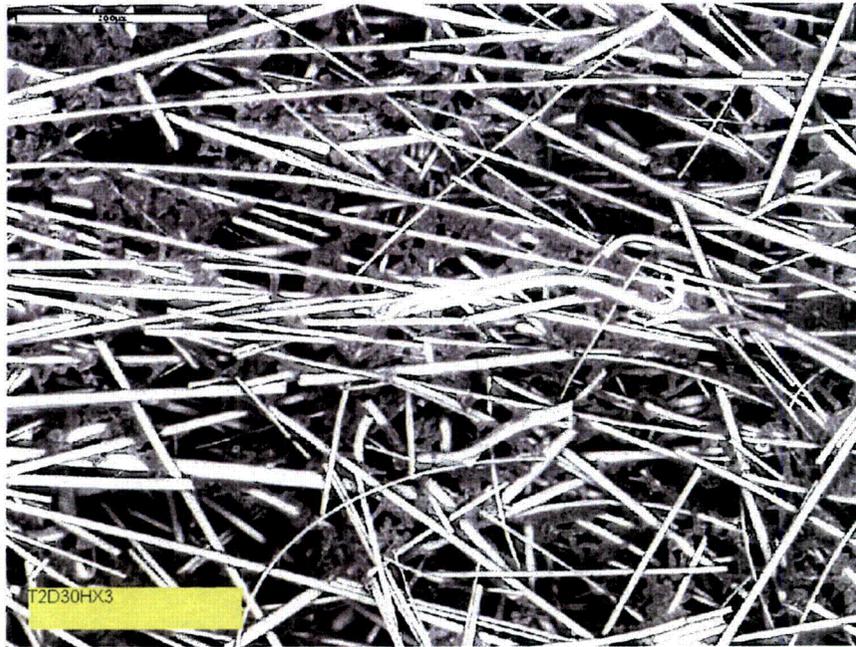
Figure 4-30. ESEM image for a Test #2, Day 30, high-flow exterior fiberglass sample.

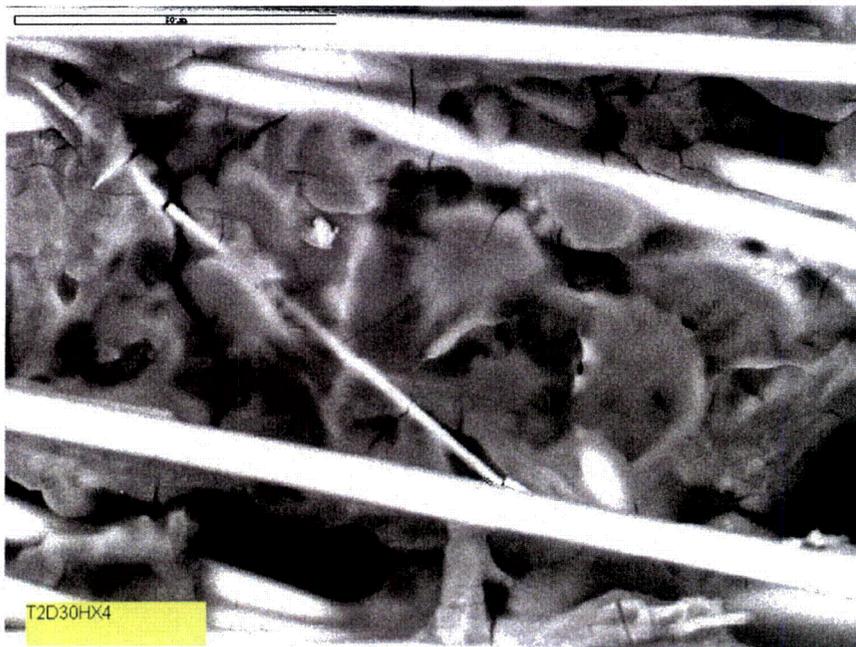
Figure 4-31. Higher-magnification ESEM image of a Test #2, Day 30, high-flow exterior fiberglass sample.
