# **Integrated Chemical Effects Test Project: Consolidated Data Report**

**Los Alamos National Laboratory**

**U.S. Nuclear Regulatory Commission  
Office of Nuclear Regulatory Research  
Washington, DC 20555-0001**

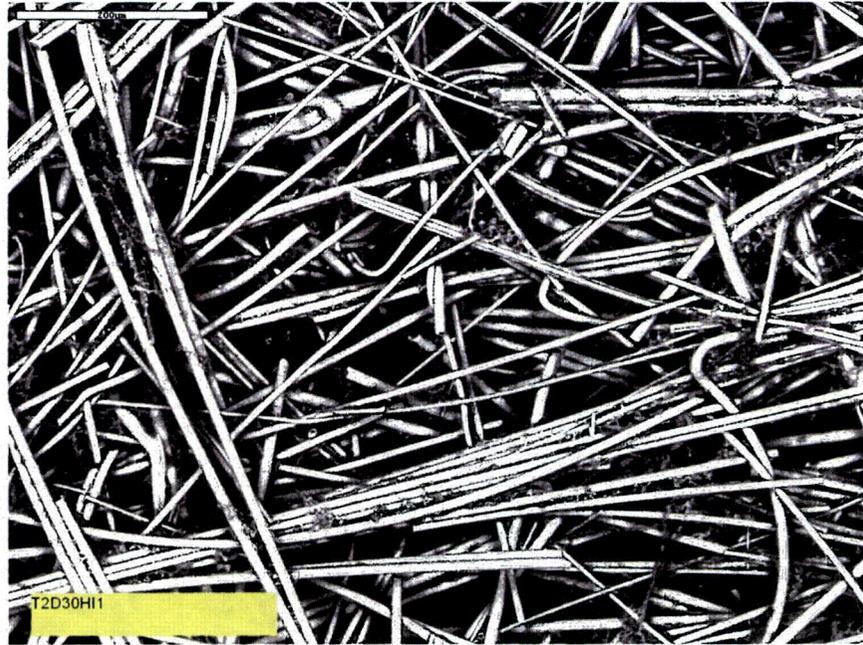
Figure 4-32. ESEM image for a Test #2, Day 30, high-flow interior fiberglass sample.

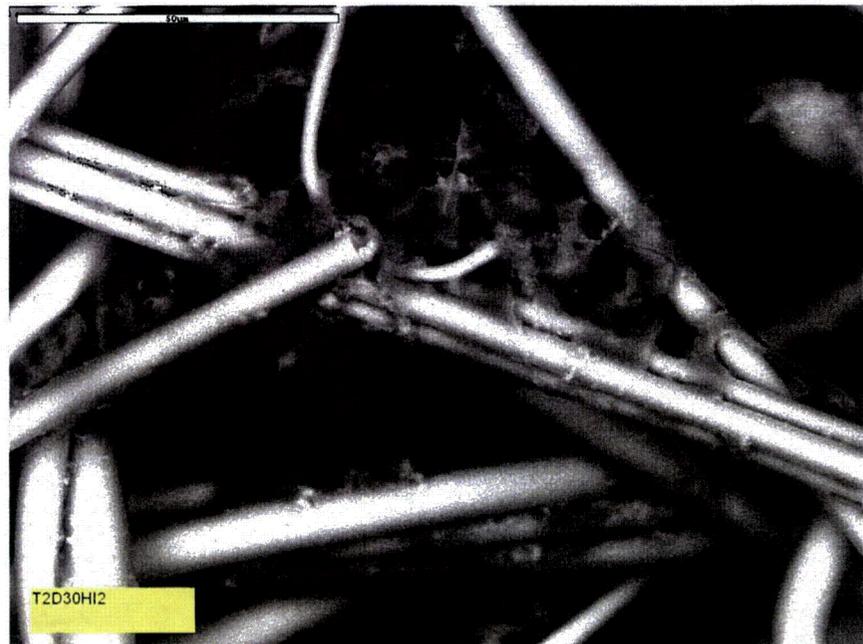
Figure 4-33. Higher-magnification ESEM image of a Test #2, Day 30, high-flow interior fiberglass sample.

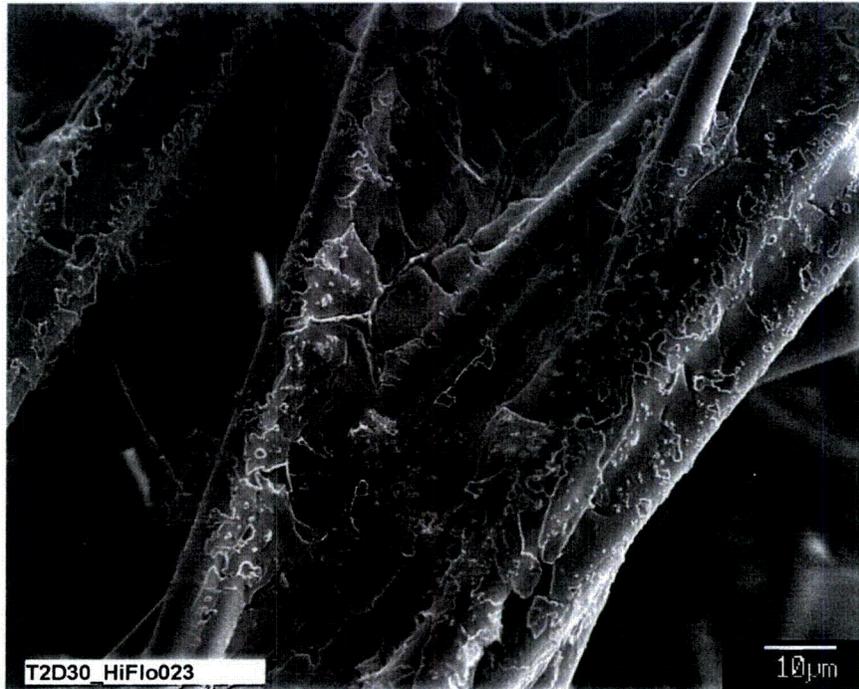
Figure 4-34. Probe SEM image at 1000× magnification for a Test #2, Day 30, high-flow interior fiberglass sample. (T2D30\_HiFlo023)

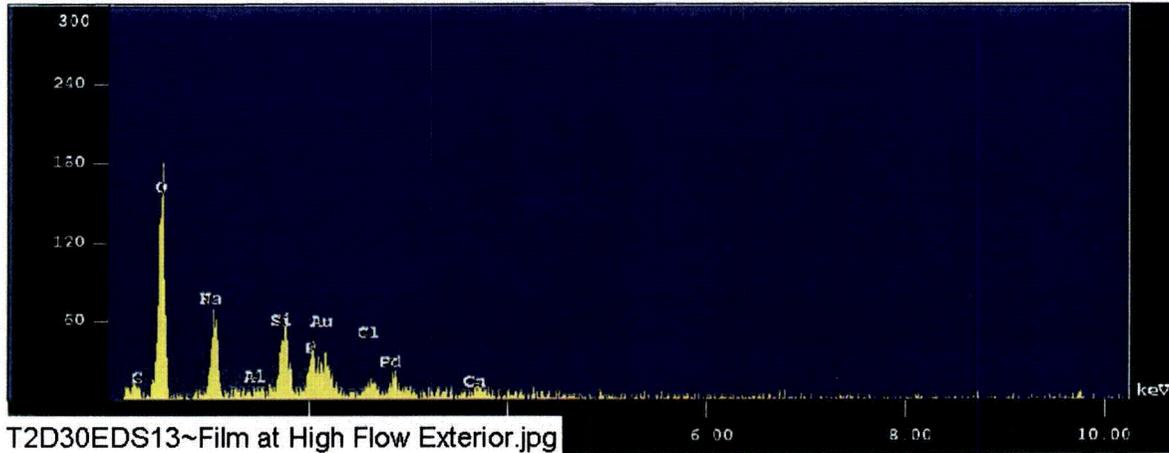
Figure 4-35. EDS counting spectrum for the deposits on a high-flow exterior fiberglass sample.

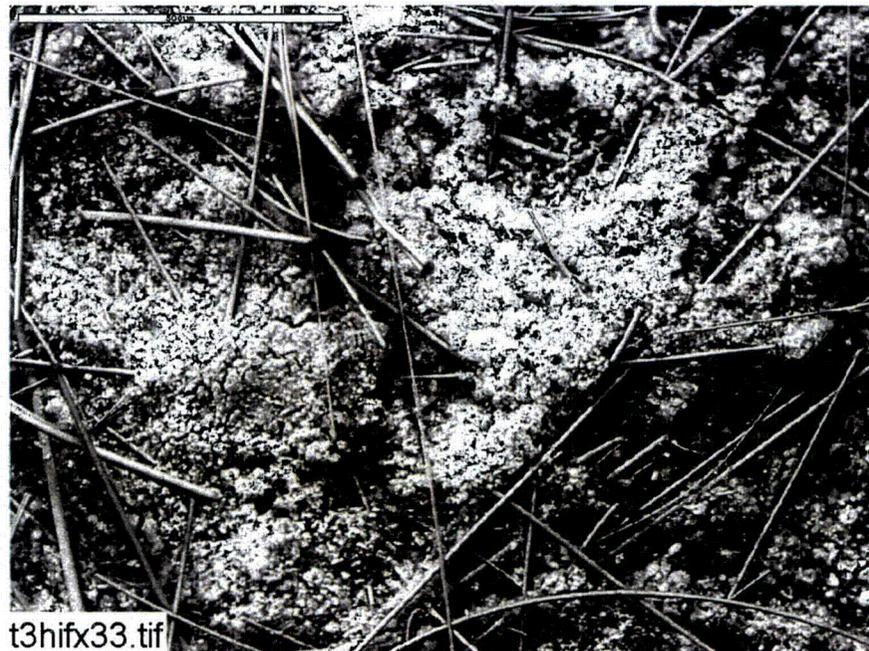
Figure 4-36. ESEM image of a Test #3, Day 30, exterior high-flow fiberglass sample, magnified 100 times. (t3hifx33, 5/11/05)

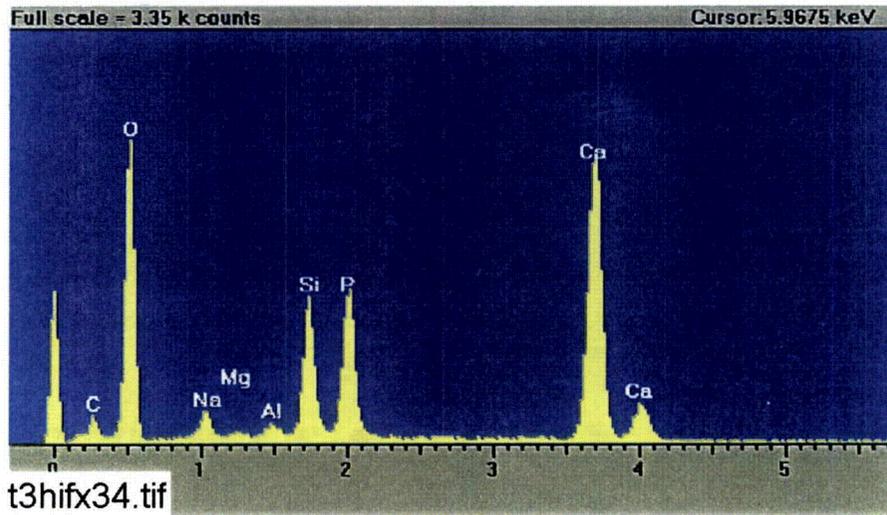
Figure 4-37. EDS counting spectrum for the large masses of particulate deposits shown in Figure 4-36. (t3hifx34, 5/11/05)

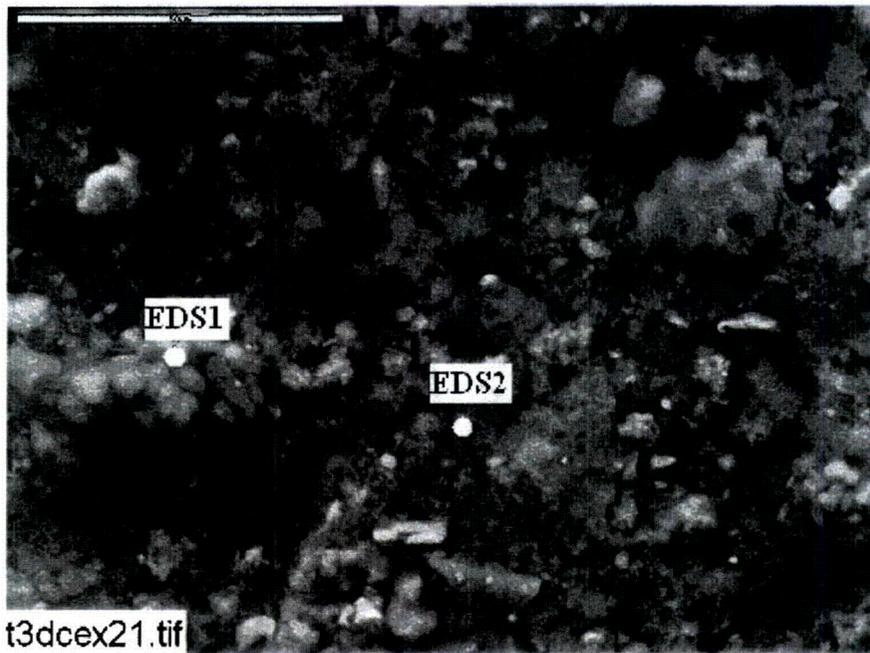
Figure 4-38. ESEM image of a Test #3, Day 30, exterior fiberglass sample on the drain collar (away from the drain screen), magnified 1000 times. (t3dcex21, 5/6/05)

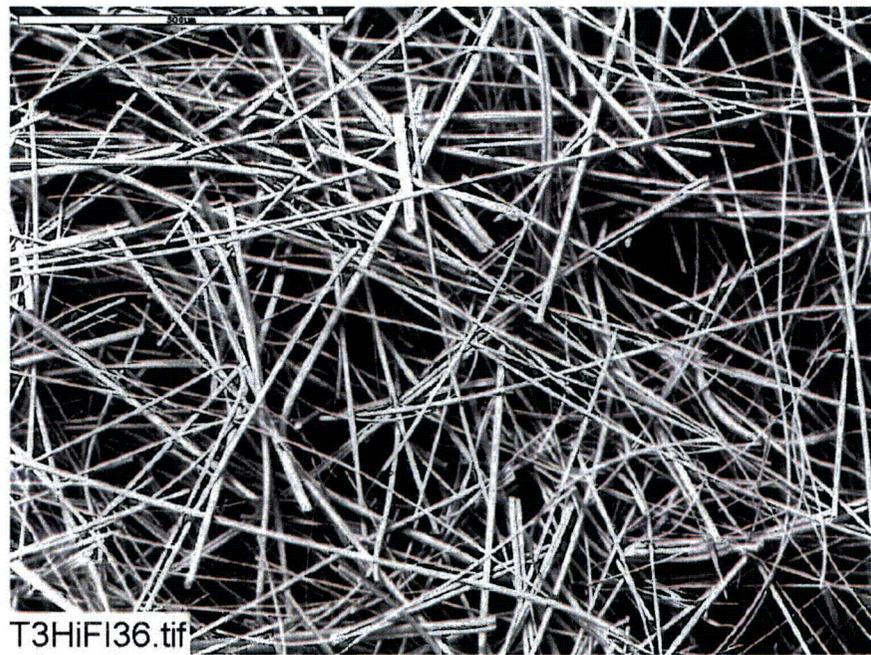
Figure 4-40. ESEM image of a Test #3, Day 30, interior high-flow fiberglass sample, magnified 100 times. (T3HiF136, 5/11/05)

In contrast to the exterior regions of the fiberglass, the interior fiberglass samples were relatively pristine, as shown in Figures 4-40 and 4-41. These results suggest that almost all of the particulate deposits were physically retained at the fiberglass exterior. Any deposits observed in the fiberglass interior likely were chemical byproducts in the test or formed by chemical precipitation during the sample-drying process for ESEM/SEM analysis (see Figure 4-42). EDS analysis indicates that the deposits in Figure 4-42 contained insignificant amounts of phosphorus (see Figure 4-43), meaning that the deposits were distinct from the white gel found in this test.

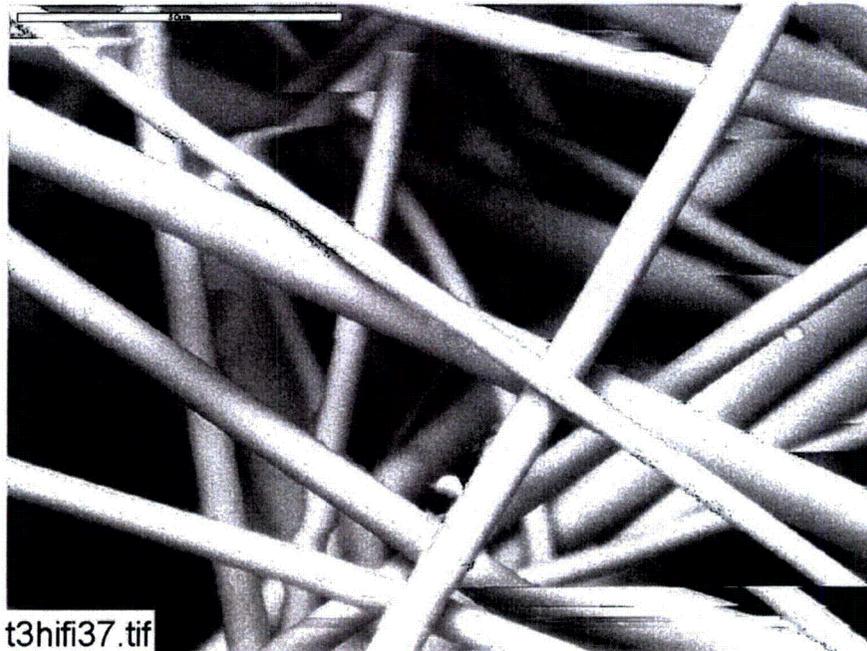
Figure 4-41. ESEM image of a Test #3, Day 30, interior high-flow fiberglass sample, magnified 1000 times. (t3hifi37, 5/11/05)

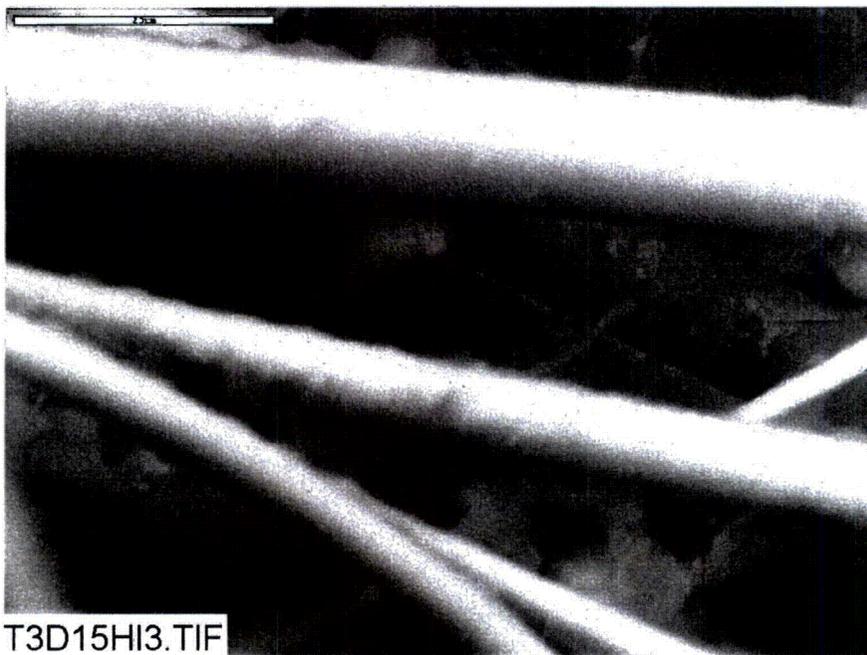
Figure 4-42. ESEM image of a Test #3, Day 15, high-flow interior fiberglass sample, magnified 2000 times. (T3D15HI3, 4/22/05)

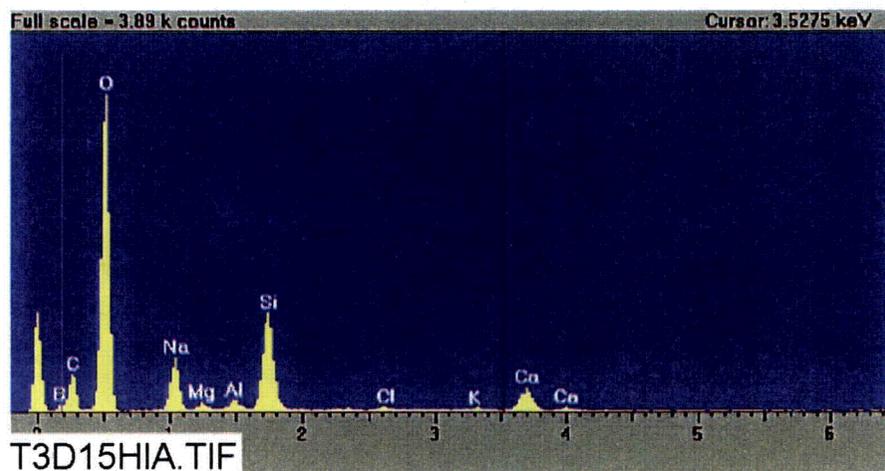
Figure 4-43. EDS counting spectrum for the flocculent deposits between the fibers on the ESEM image shown in Figure 4-42. (T3D15HIA, 4/22/05)

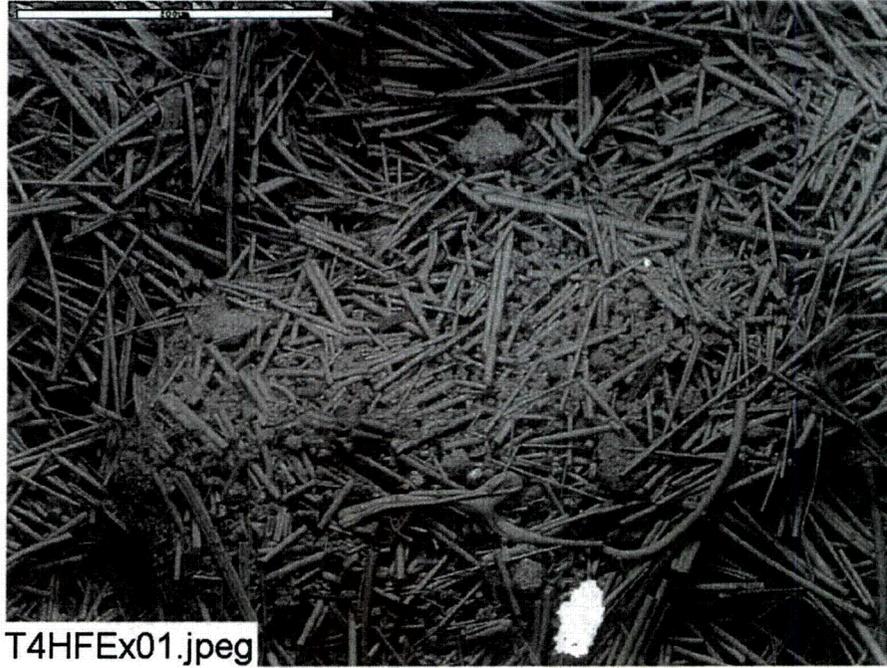
**Figure 4-44.** ESEM image, magnified 100 times, of a Test #4, Day 30, exterior high-flow fiberglass sample. (T4HFEx01.jpeg)

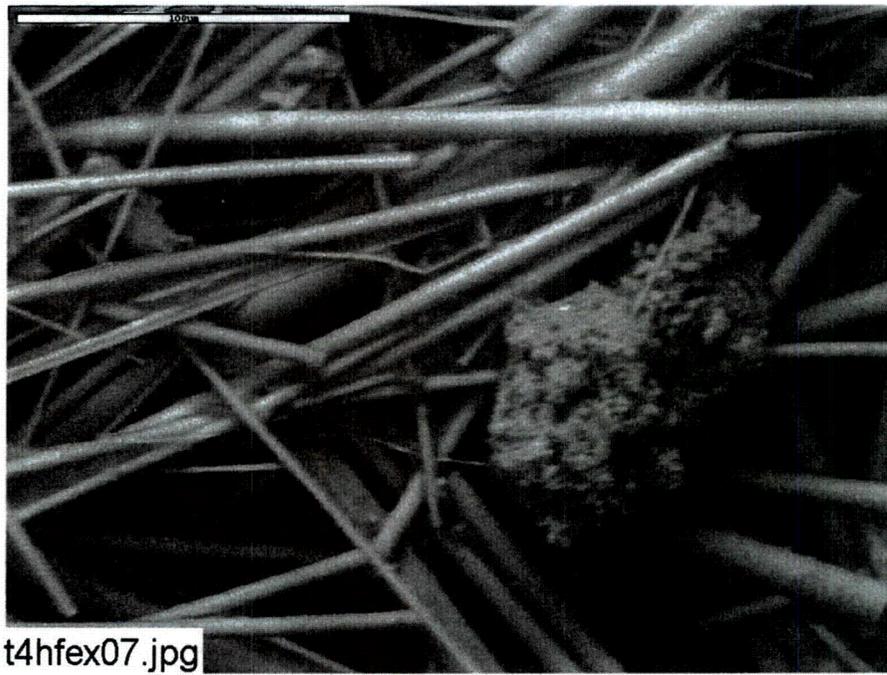
**Figure 4-45.** ESEM image, magnified 500 times, of a Test #4, Day 30, exterior high-flow fiberglass sample. (t4hfex07.jpg)

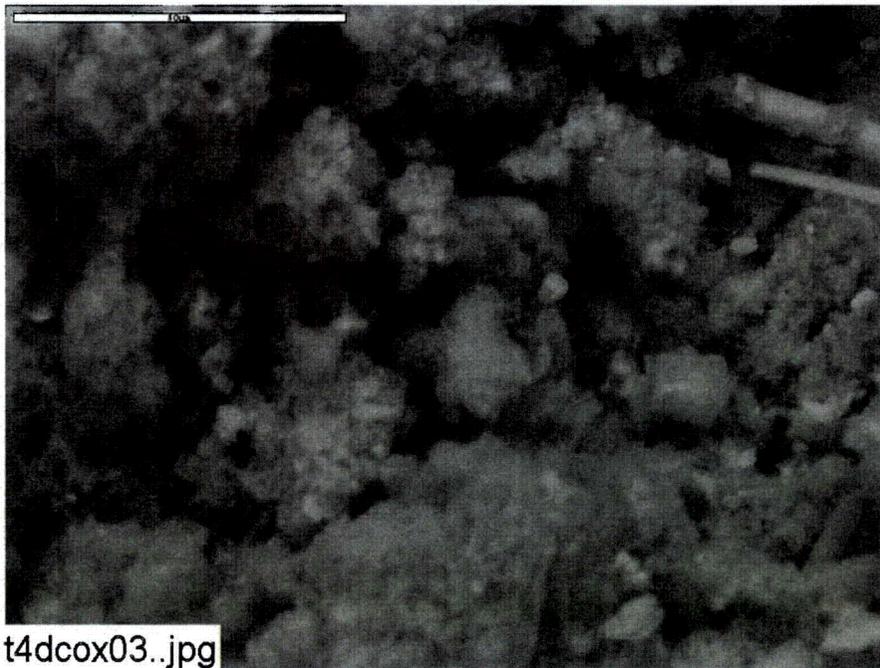
Figure 4-47. ESEM image, magnified 1000 times, of a Test #4, Day 30, exterior fiberglass sample on the drain collar (away from the drain screen). (t4dcox03.jpg)

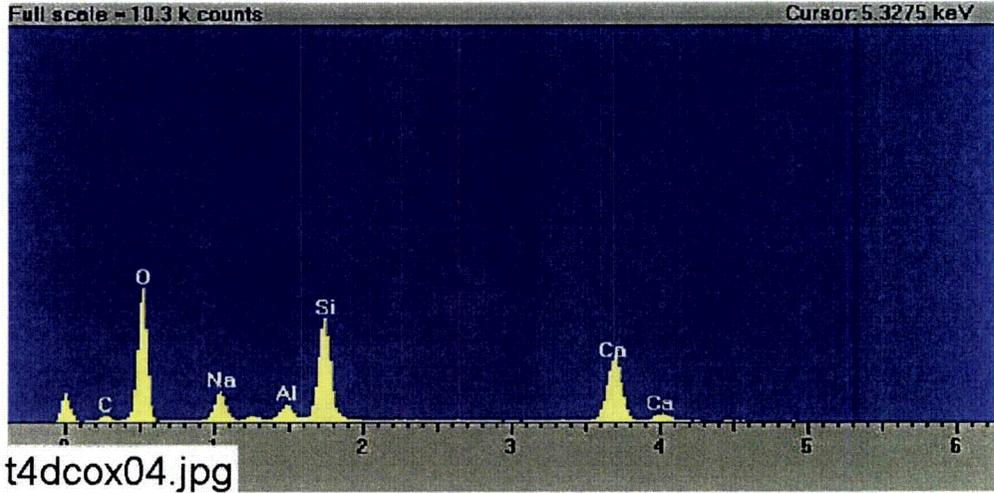
Figure 4-48. EDS counting spectrum for the large mass of particulate deposits on fiberglass shown in Figure 4-47. (t4dcox04.jpg)

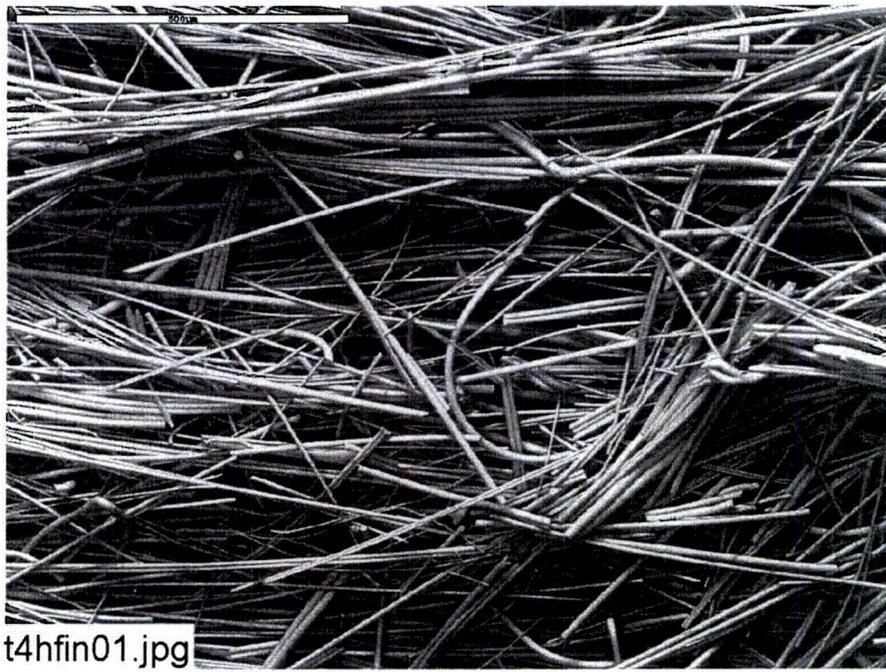
Figure 4-49. ESEM image, magnified 100 times, of a Test #4, Day 30, interior high-flow fiberglass sample. (t4hfin01.jpg)

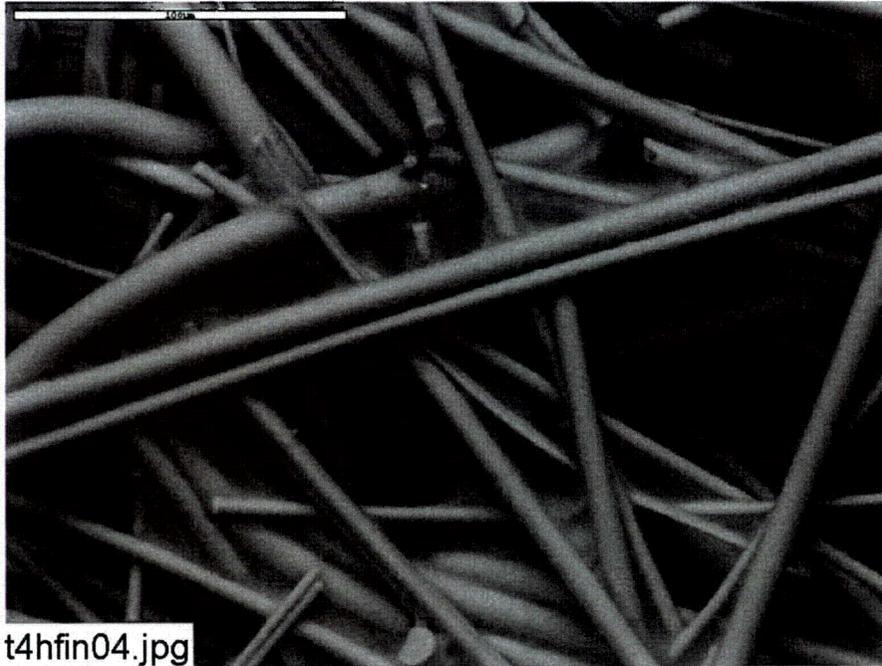
**Figure 4-50.** ESEM image, magnified 500 times, for a Test #4, Day 30, interior high-flow fiberglass sample. (t4hfin04.jpg)

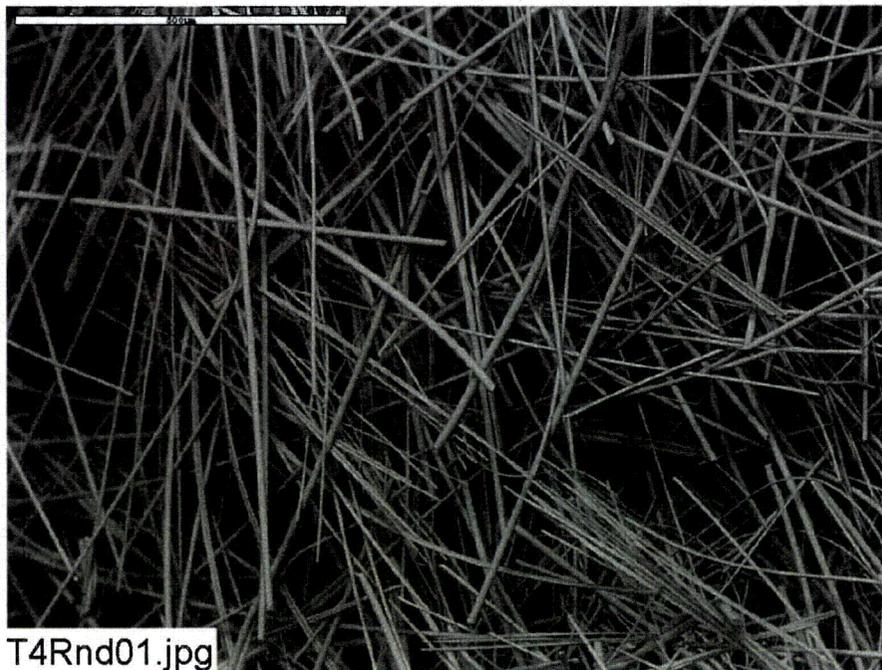
**Figure 4-51.** ESEM image, magnified 100 times, of a Test #4, Day 30, interior high-flow fiberglass sample. The sample was gently pre-rinsed with RO water. (T4Rnd01.jpg)

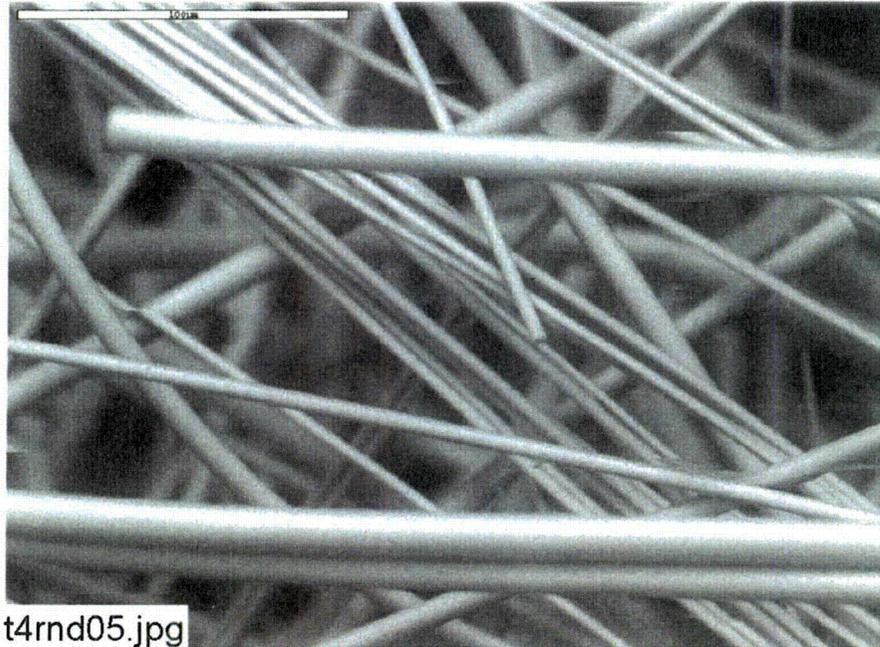
**Figure 4-52.** ESEM image, magnified 500 times, for a Test #4, Day 30, interior high-flow fiberglass sample. The sample was gently pre-rinsed with RO water. (t4rnd05.jpg)

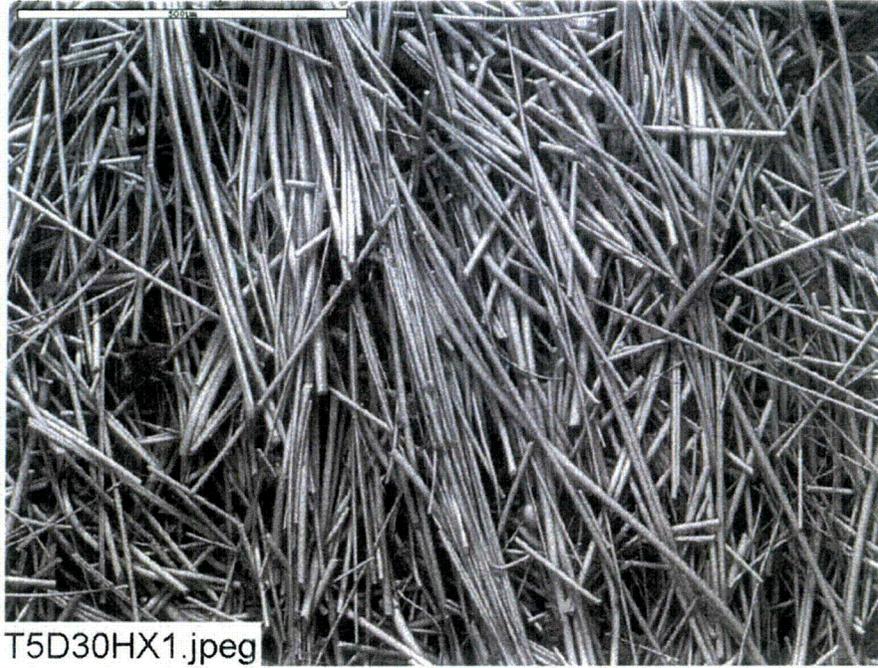
**Figure 4-53.** ESEM image, magnified 100 times, of a Test #5, Day 30, high-flow exterior fiberglass sample. (T5D30HX1.jpeg)

ICET Test #5 had the smallest amount of deposits in the fiberglass of any of the ICET tests. Day-30, high-flow fiberglass exterior samples are shown in Figures 4-53 and 4-54. The samples were relatively pristine, and they had the fewest particulate deposits. Similarly, interior samples shown in Figures 4-55, 4-56, and 4-57 were also relatively pristine. Only flocculent deposits were observed. The lack of deposits is likely because the smallest amount (compared to the other tests) of chemicals were added to the test solution. The flocculent deposits in the fiberglass interior were composed primarily of oxygen, sodium, calcium, magnesium, aluminum, and possibly silicon, as shown in Figure 4-58. These deposits likely were formed by chemical precipitation during dehydration of the samples, after the samples were removed from the tank, as demonstrated in the Test #4 results.

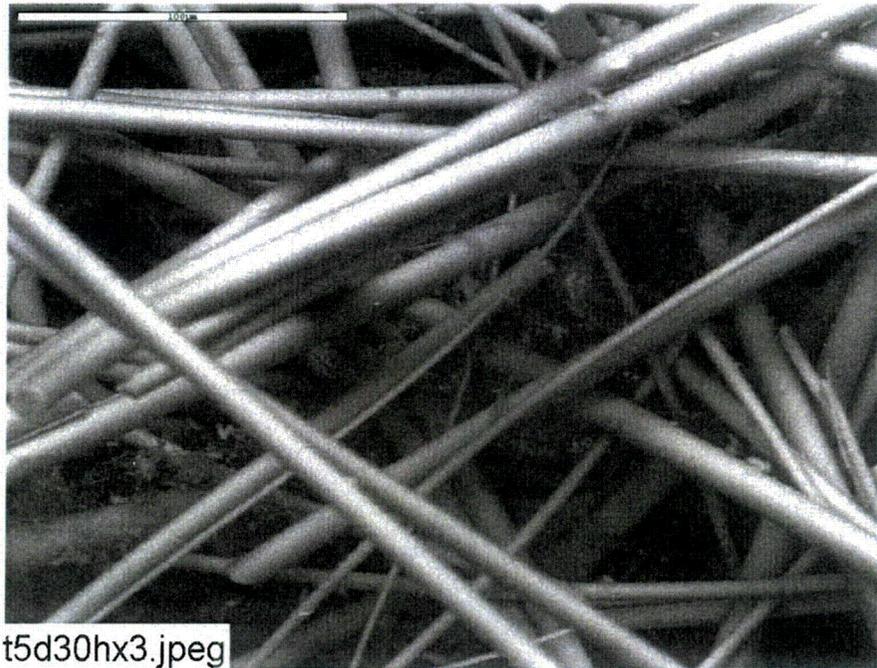
**Figure 4-54.** ESEM image, magnified 500 times, of a Test #5, Day 30, high-flow exterior fiberglass sample. (t5d30hx3.jpeg)

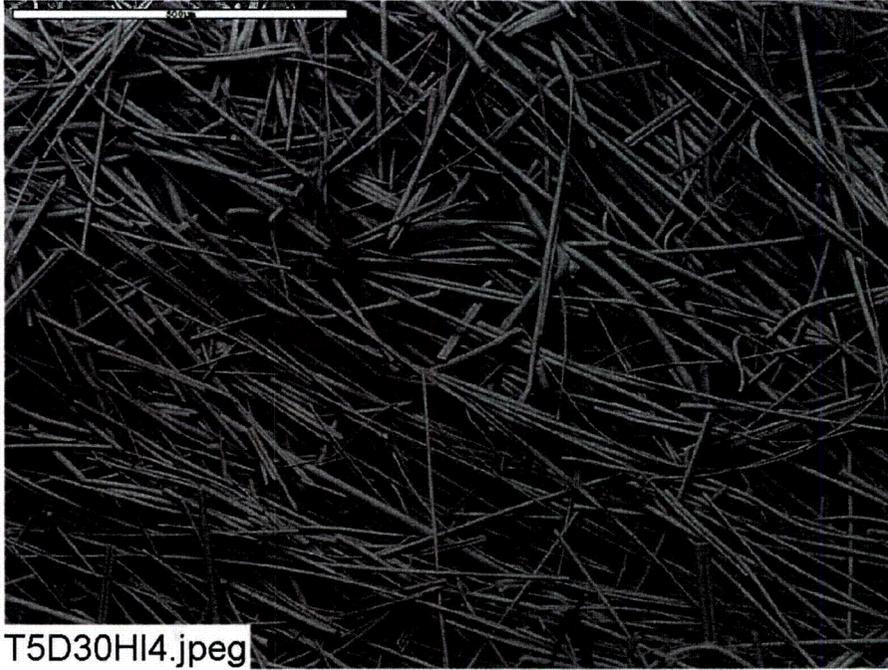
Figure 4-55. ESEM image, magnified 100 times, of a Test #5, Day 30, high-flow interior fiberglass sample. (T5D30HI4.jpg)

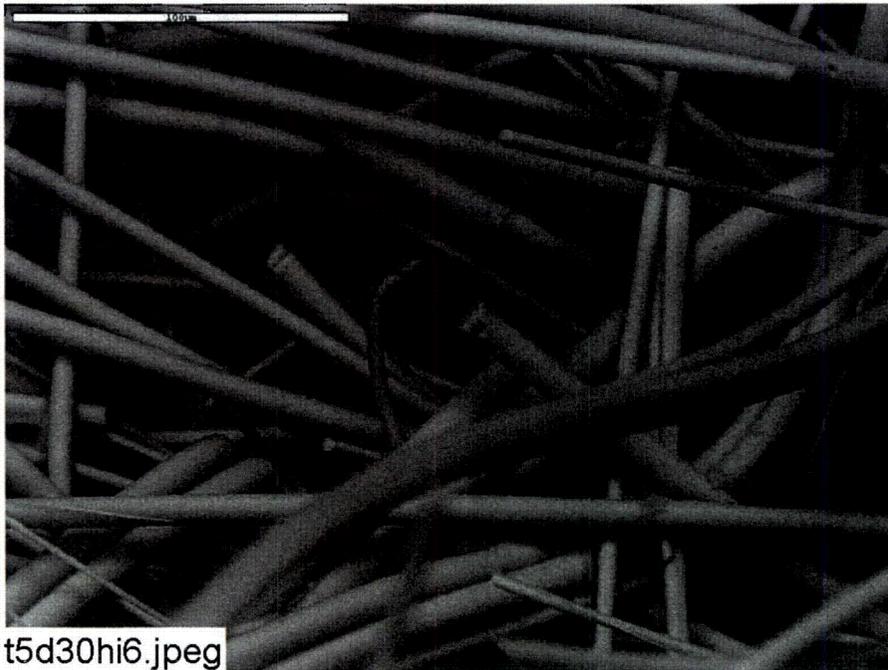
Figure 4-56. ESEM image, magnified 500 times, of a Test #5, Day 30, high-flow interior fiberglass sample. (t5d30hi6.jpg)

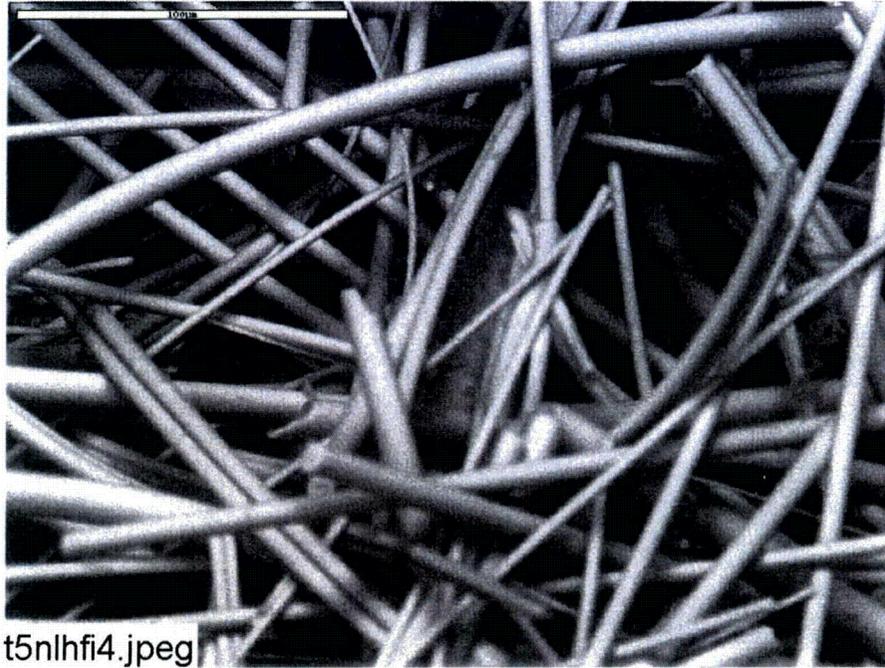
Figure 4-57. ESEM image, magnified 500 times, of a Test #5, Day 30 high-flow interior fiberglass sample in a nylon mesh.

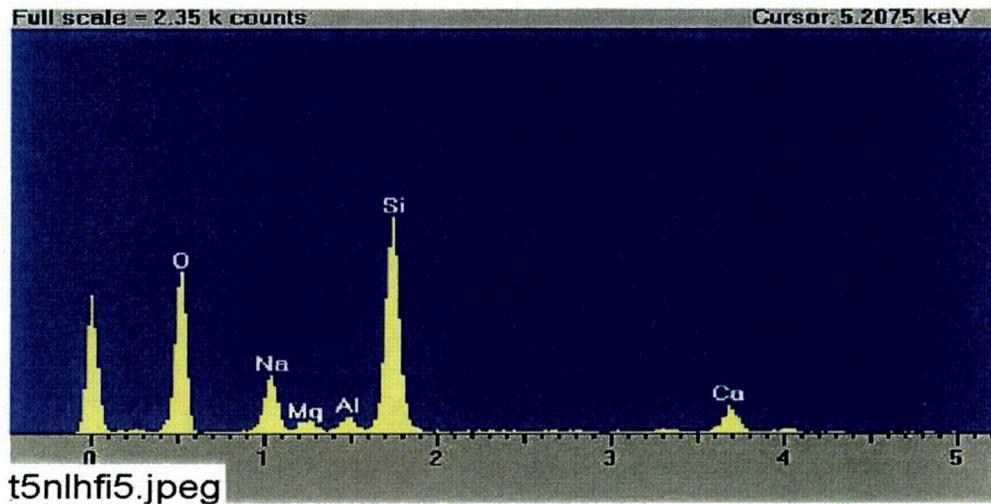
Figure 4-58. EDS counting spectrum for the deposits between the fibers shown in Figure 4-57.

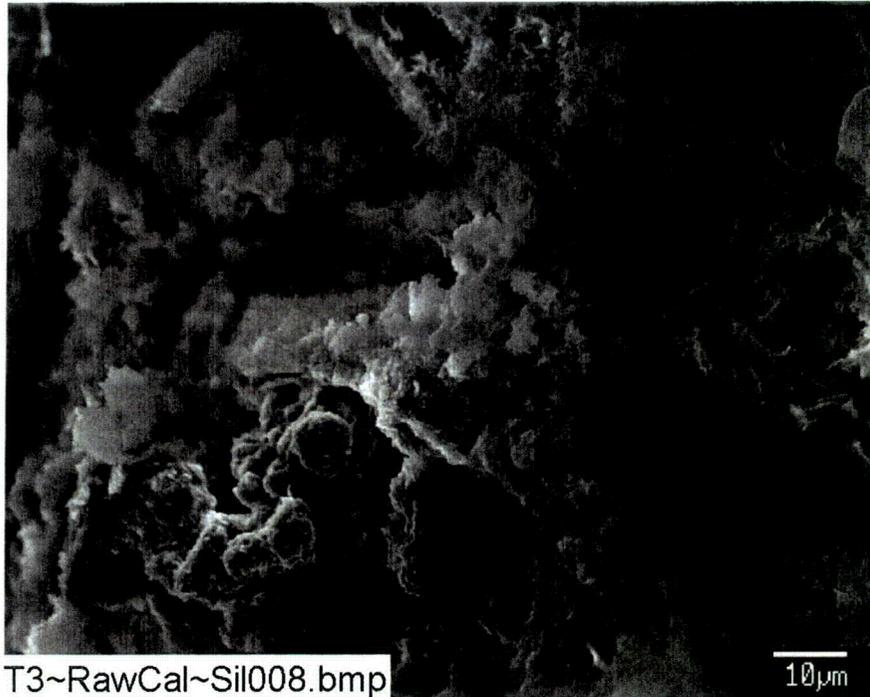
Figure 4-59. SEM image, magnified 1000 times, of an unused, unbaked cal-sil sample. (T3~RawCal\_Sil008)

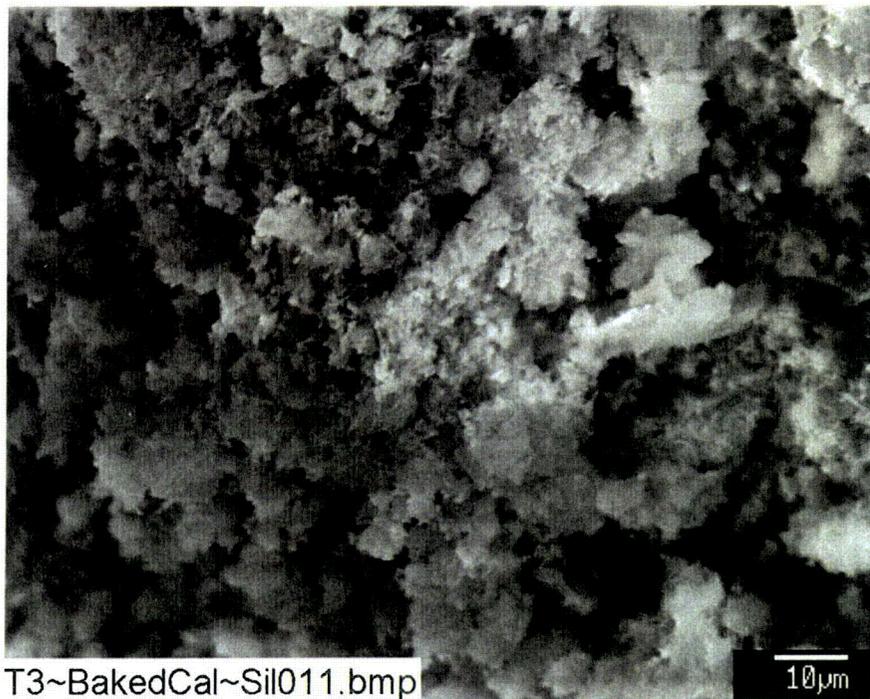
Figure 4-60. SEM image, magnified 1000 times, of an unused, baked cal-sil sample. (T3~BakedCal\_Sil011)

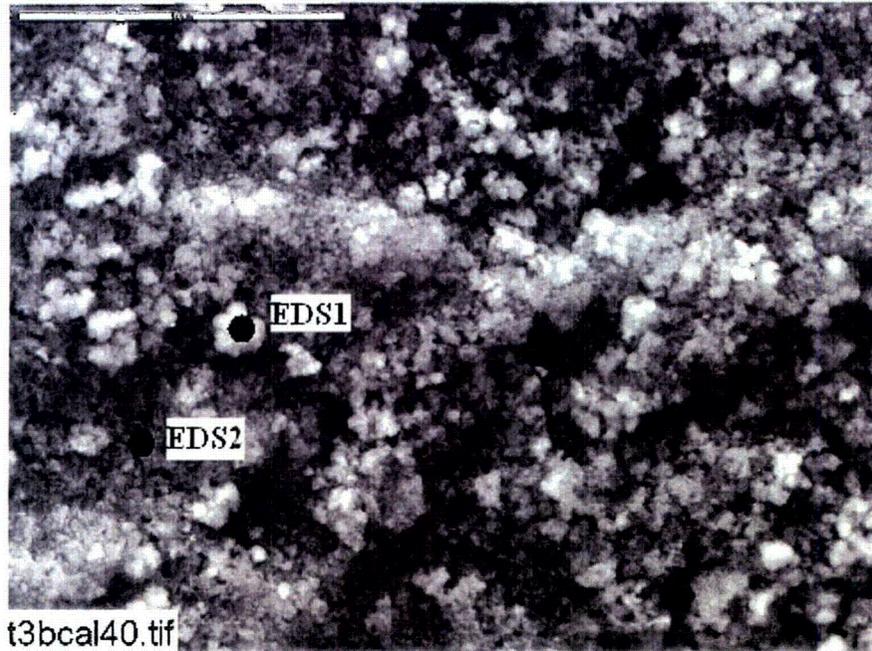
Figure 4-63. Annotated ESEM image, magnified 1000 times, of the exterior of a Test #3, Day 30, submerged high-flow baked cal-sil sample. (t3bcal40)

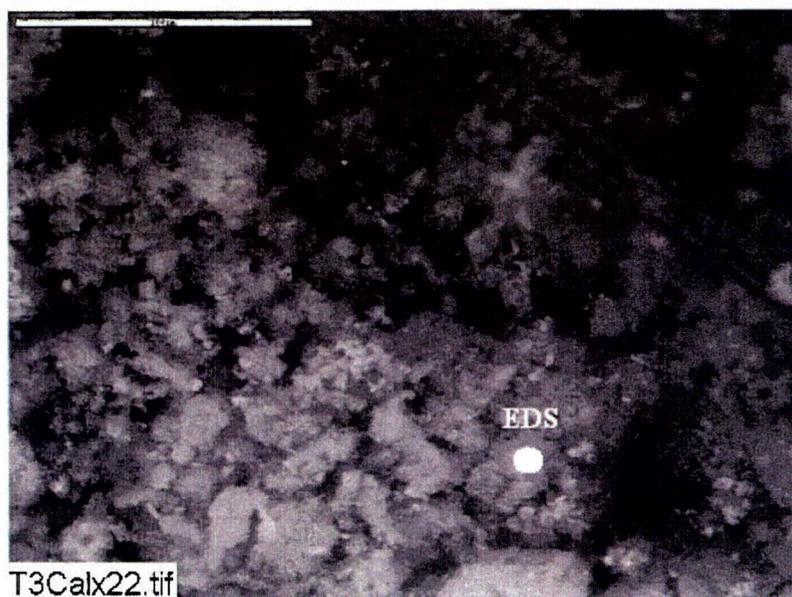
Figure 4-66. Annotated ESEM image, magnified 500 times, of the exterior of a Test #3, Day 30, unbaked cal-sil sample submerged in the birdcage. (T3Calx22)

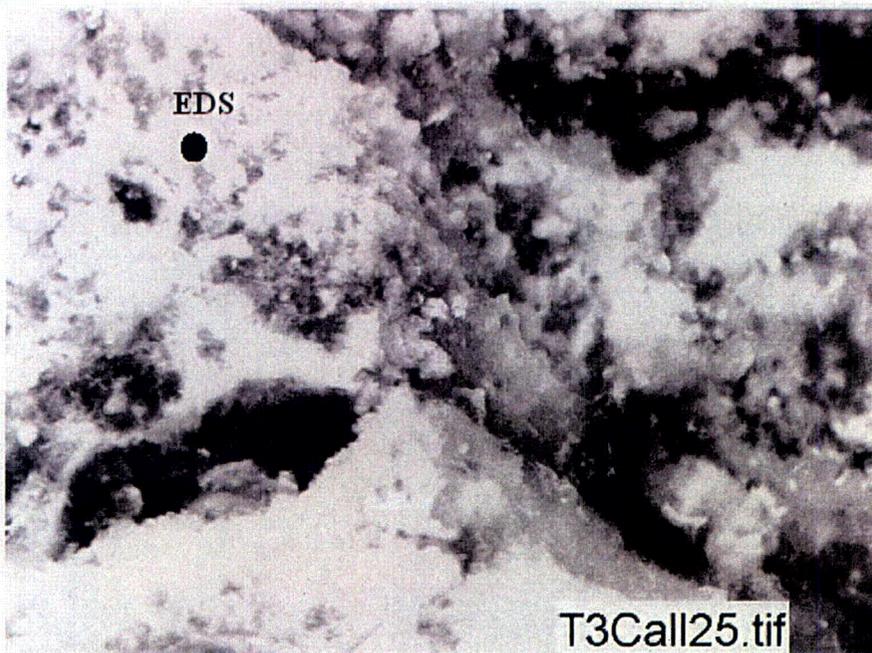
Figure 4-68. Annotated ESEM image, magnified 500 times, of the interior of a Test #3, Day 30, unbaked cal-sil sample submerged in the birdcage. (T3Call25)

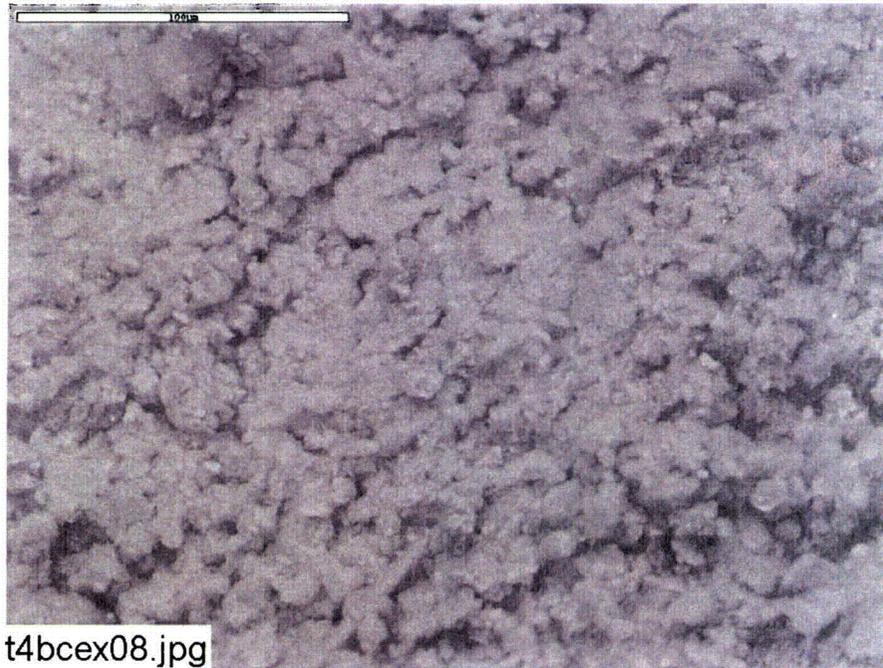
Figure 4-70. ESEM image, magnified 500 times, of a Test #4, Day 30, low-flow exterior baked cal-sil sample. (t4bcex08.jpg)

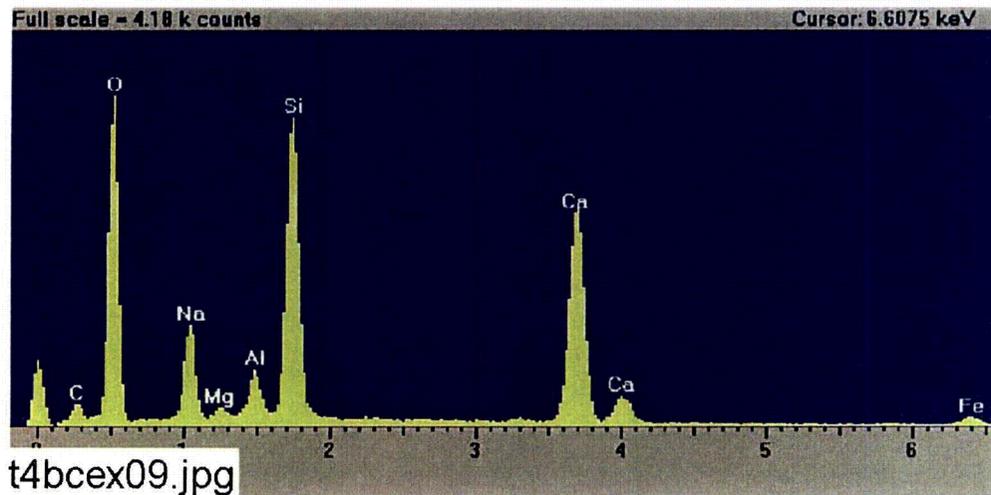
Figure 4-71. EDS counting spectrum for the whole image shown in Figure 4-70. (t4bcex09.jpg)
