## **Integrated Chemical Effects Test Project: Test #4 Data Report**

**Los Alamos National Laboratory**

**U.S. Nuclear Regulatory Commission  
Office of Nuclear Regulatory Research  
Washington, DC 20555-0001**

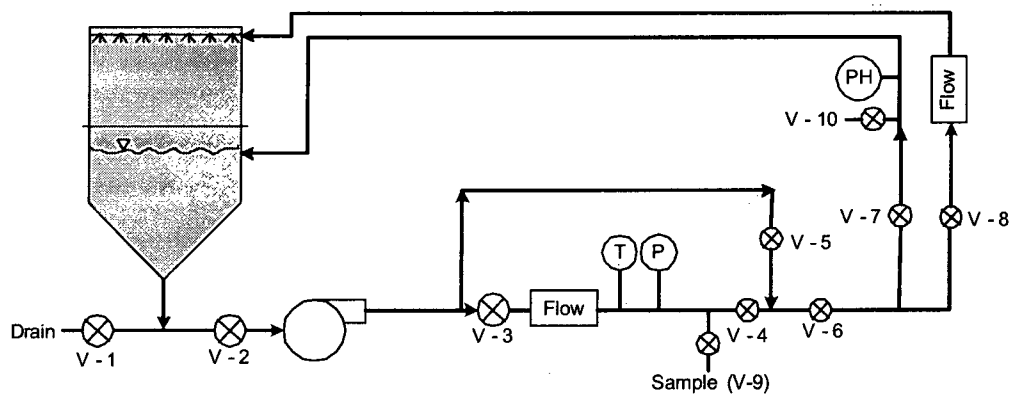
Figure 2-1. Test loop process flow diagram.

The as-built test loop consists of a test tank, a recirculation pump, 2 flow meters, 10 isolation valves, and pipes that connect the major components, as shown schematically in Figure 2-1. P, T, and pH represent pressure, temperature, and pH probes, respectively.

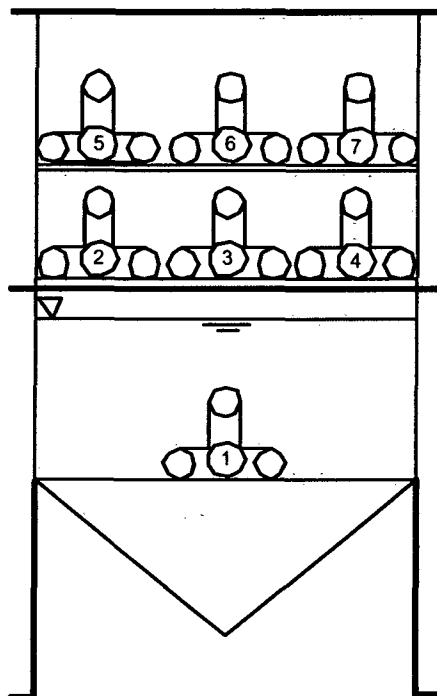
The arrangement of the coupon racks in the test tank is schematically illustrated in Figure 2-2. The figure shows a side view of the ICET tank, with the ends of the seven chlorinated polyvinyl chloride (CPVC) racks illustrated. The normal water level is indicated by the blue line in the figure. Rack #1 is the only submerged rack, and it sits on angle iron. It is centered in the tank so that flow from the two headers reaches it equally. Racks #2–#4 are positioned above the water line, supported by angle iron in the tank. Racks #5–#7 are positioned at a higher level, also supported by angle iron. Racks #2–#7 are exposed to spray. In the figure, north is to the right, and south is to the left. Directions are used only to identify such things as rack locations and sediment locations.

**Figure 2-2. Coupon rack configuration in the ICET tank. The blue line represents the surface of the test solution.**

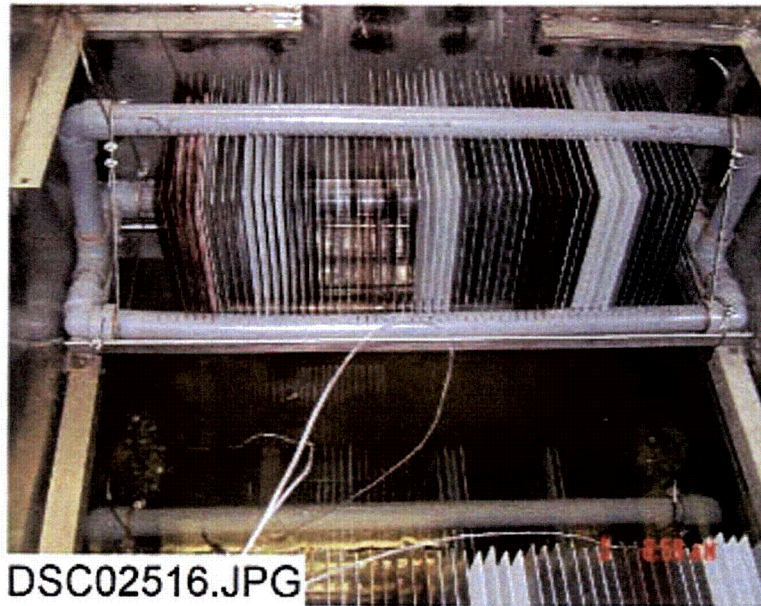
Figure 2-3 shows the configuration of a typical unsubmerged coupon rack loaded with metal coupons in the ICET tank. The loading pattern of the racks was nearly identical, varying by only one or two coupons. Shown in the figure from left to right, the coupons are arranged as follows: four Cu, four Al, four inorganic zinc (IOZ), seven GS, four Cu, three Al, four IOZ, seven GS, four Cu, three Al, four IOZ, and seven GS.

**Figure 2-3. A typical loaded coupon rack in the ICET tank.**

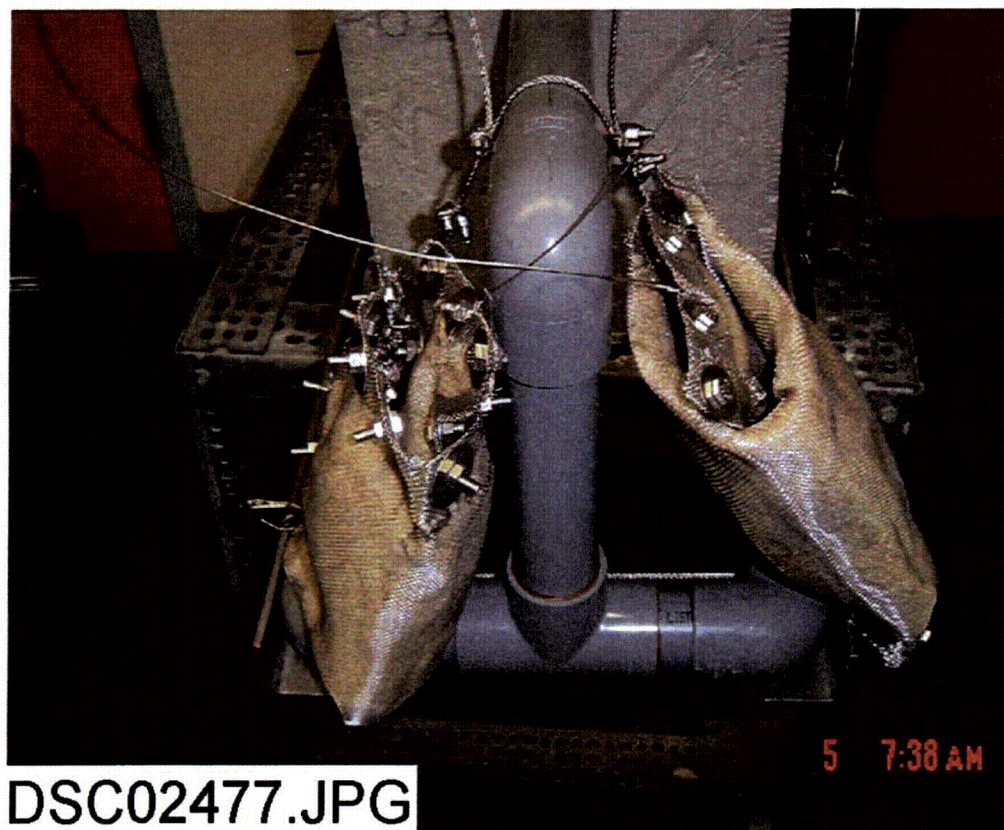
Several fiberglass samples were placed in the ICET tank. Samples were either submerged or held above the water level. The unsubmerged fiberglass samples were positioned so they would be exposed to sprays. The fiberglass samples were contained in SS wire mesh that allowed water flow while confining the fiberglass material. Both loosely packed and more tightly packed samples were used. In addition, some submerged fiberglass samples were located where they would be exposed to relatively high-flow conditions (in front of the flow header, attached to the submerged coupon rack), and others were located in quiescent regions of the tank (behind the flow header). Figure 2-4 shows what the so-called “sacrificial” fiberglass samples look like in wire mesh pouches attached to the submerged coupon rack (rack 1 in Figure 2-2). Each pouch contains approximately 5 g of fiberglass. Those samples were attached with SS wire; removed from the tank on Days 5, 15, and 30; and examined. As shown in the figure, bigger insulation bags were wrapped around the sacrificial specimens during the test. See Subsection 2.4.1.1 for descriptions of other fiberglass samples.

**Figure 2-4. Fiberglass samples attached to a submerged coupon rack.**

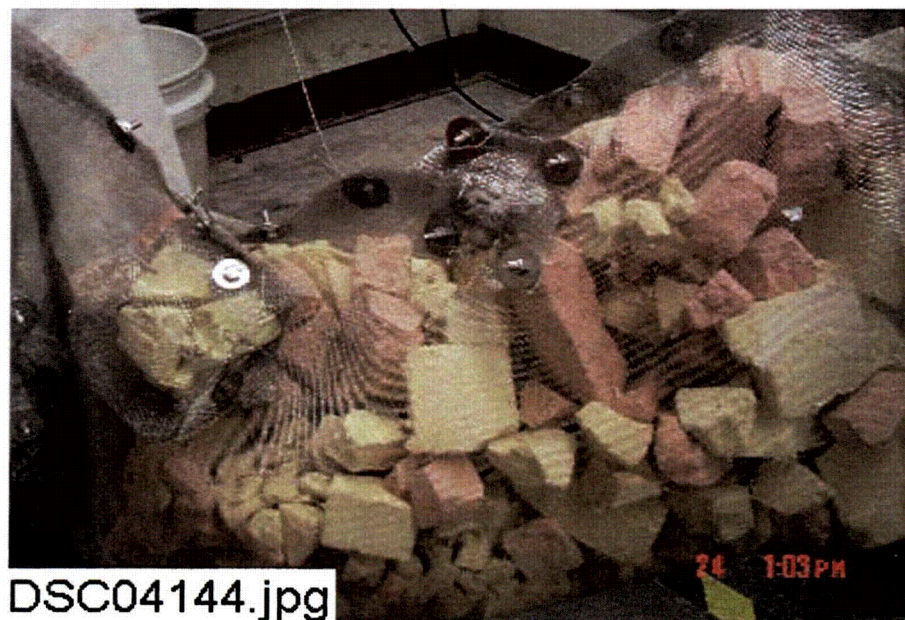
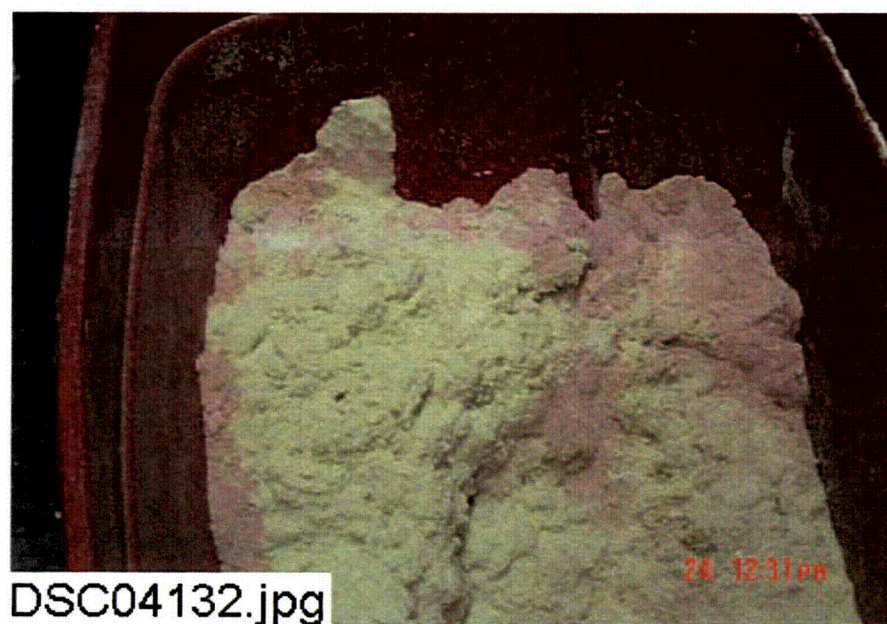
Several cal-sil insulation samples were also placed in the ICET tank. Samples were either submerged or held above the water level. The unsubmerged cal-sil samples were positioned so they would be exposed to sprays. As with the fiberglass samples, all of the cal-sil samples (except for the dust) were contained in SS wire mesh that allowed water flow while confining the cal-sil material. In addition to solid pieces of cal-sil, cal-sil dust (approximately 43.5 lb) was placed in the tank solution before the test began. Both types of samples are shown in Figures 2-5 and 2-6.

Figure 2-5. Solid pieces of cal-sil samples in SS mesh.

Figure 2-6. Cal-sil dust.

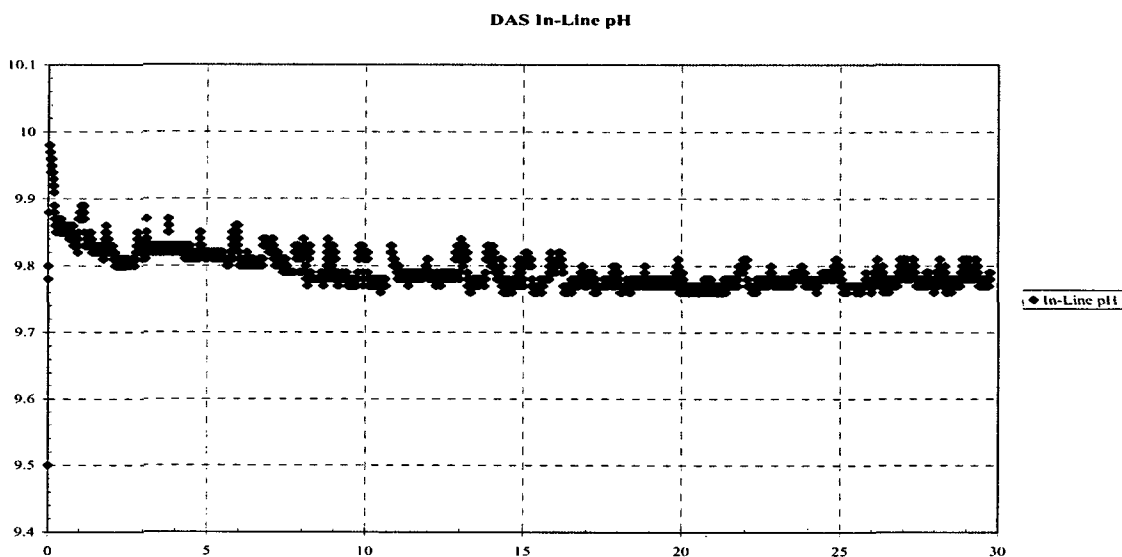
The in-line pH probe produced the data in Figure 3-1. At four hours, the in-line pH measurement was 9.9 and at Day 30, it was 9.8. The bench-top pH measurements, which are calibrated daily, are presented in Figure 3-2. At 4 hours, the bench-top pH measurement was 9.8 and at Day 30, it was also 9.8.

**Figure 3-1. In-line pH measurements.**

**pH:** Before time zero, 15.14 kg of boric acid, 8.47 kg of sodium hydroxide, 212 mL of 12.24 N hydrochloric acid solution, and 0.663 g of lithium hydroxide were dissolved into the ICET tank solution. The measured bench-top pH was 9.5. During the addition of the sodium hydroxide solution during the first 30 minutes, the pH rose to 9.8 and remained at that value through the spray cycle. The pH declined for the first 2 days to a value of 9.6, which was the predicted value for a solution in complete equilibrium with the atmosphere. After the second day the pH began to rise to a high value of 9.9 on Day 8. The pH varied between 9.7 and 9.9 from Day 9 to the end of the test. This can be seen in Figures 3-1 and 3-2.

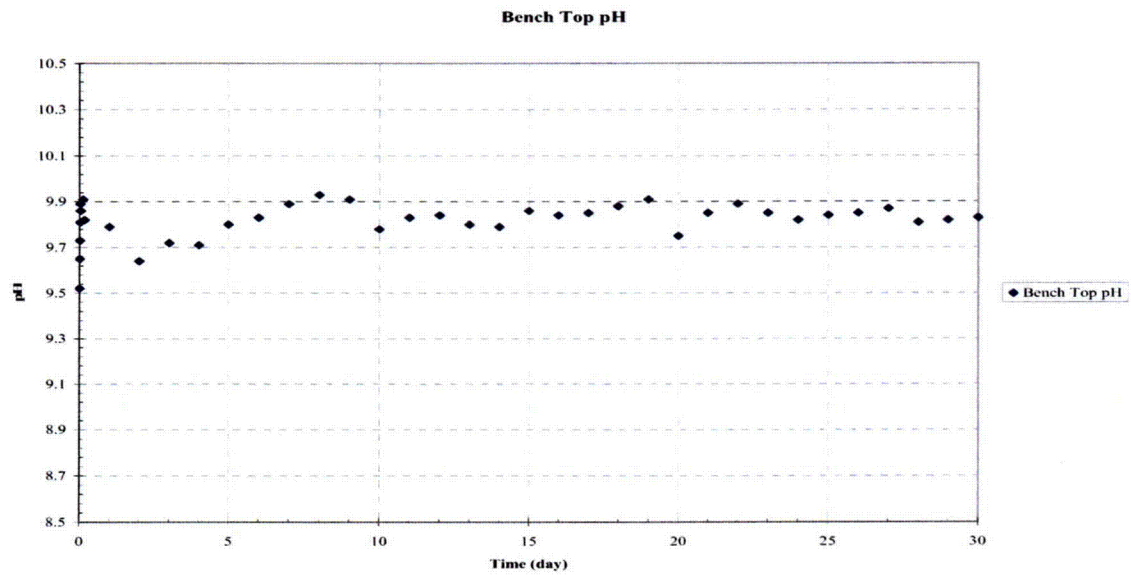
Figure 3-2. Bench-top pH meter results.

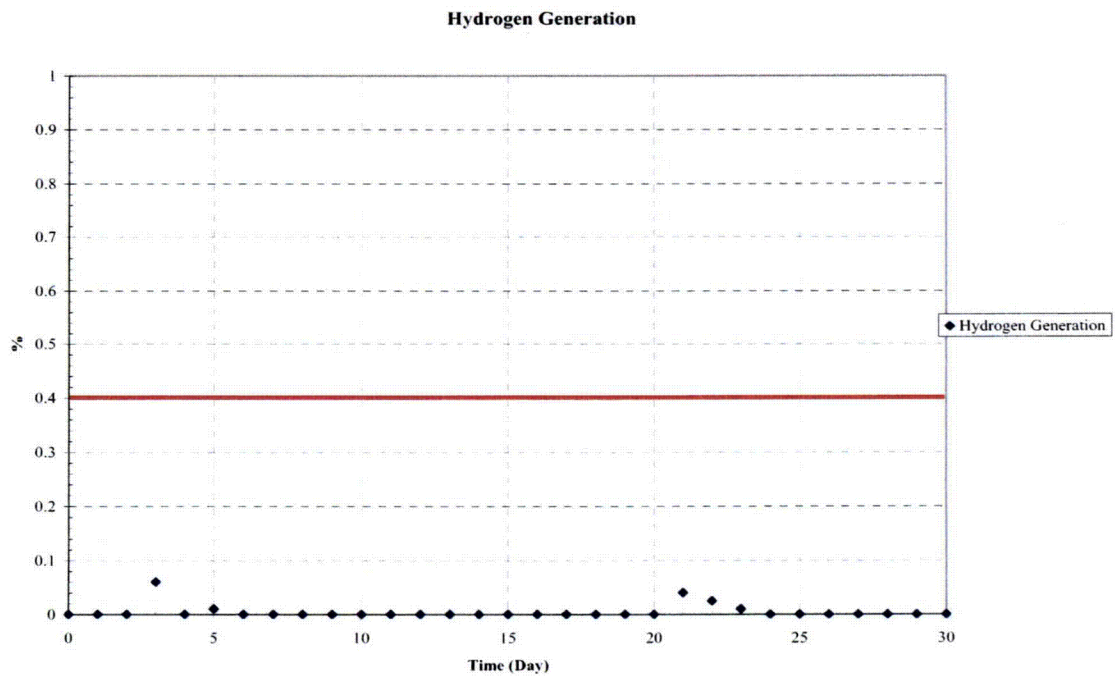
Hydrogen remained at or below 0.05% for the duration of the test as shown in Figure 3-3. All of the measured values are well below the hydrogen safety action threshold of 0.4%.

Figure 3-3. Hydrogen generation.

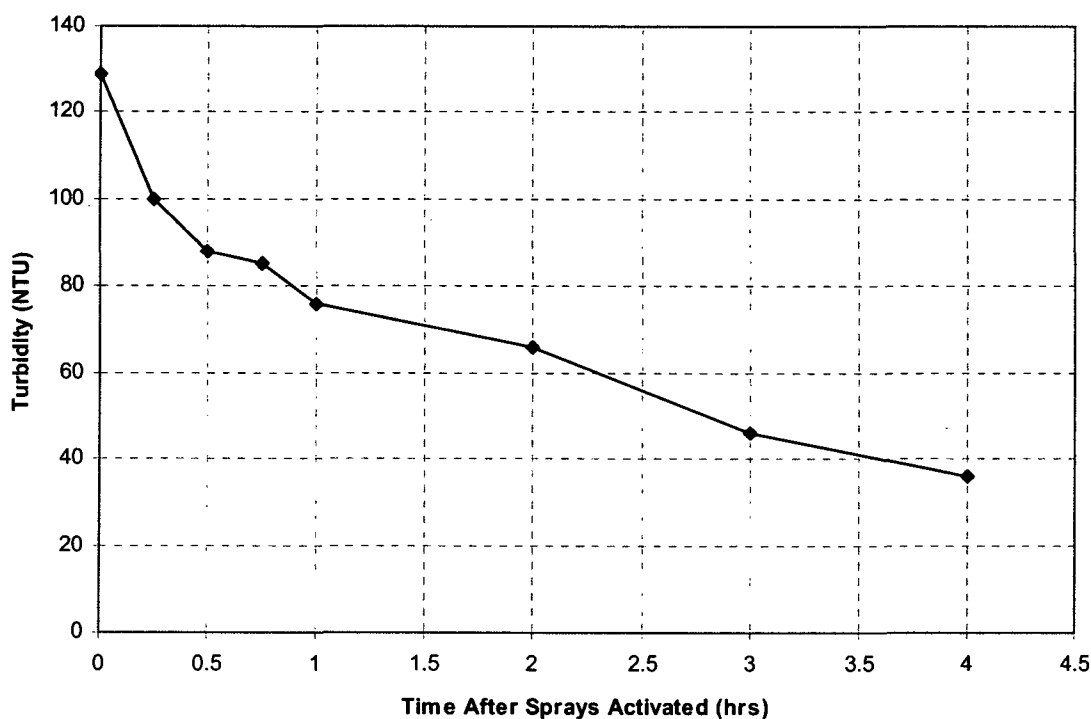
Due to the cloudy nature of the water in the tank after the recirculation pump was turned on, turbidity values were measured at 60°C over the initial 4-hour spray phase which were in addition to regular daily monitoring. Figure 3-4 shows the turbidity during this time period. The x-axis on the graph represents the time in hours after the spray nozzles were turned on. As can be seen, the turbidity gradually decreased from 129 NTU at the time-zero point to 36 NTU at the 4-hour point.

Figure 3-4. Day-1 turbidity results.

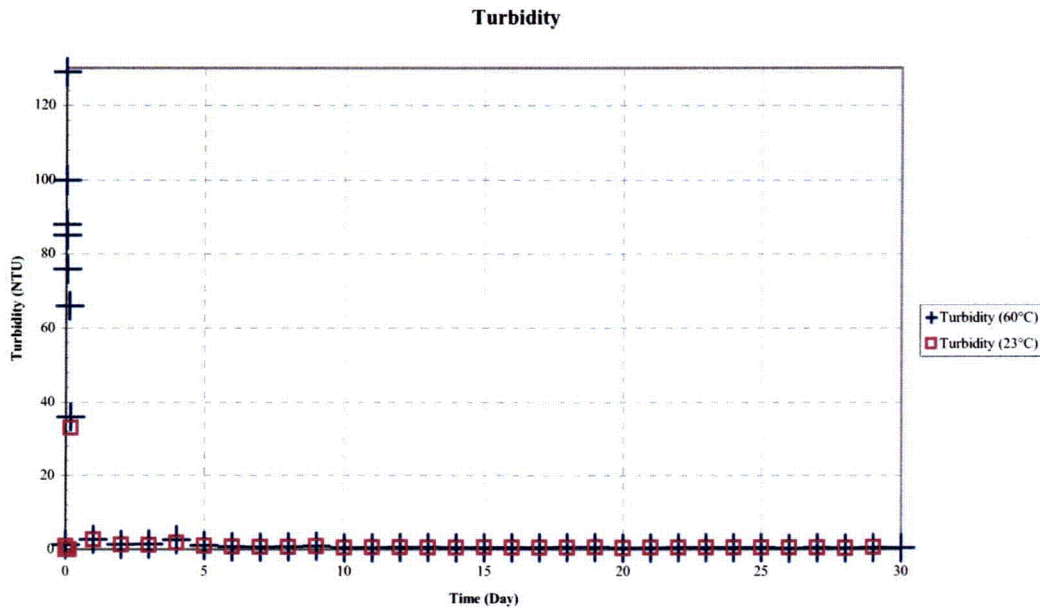
Figure 3-5 contains the daily turbidity values at 23°C and 60°C throughout the test. The trend of each curve exhibits an initial spike at the beginning of the spray cycle, followed by a sharp decline during the first four hours of the test. The turbidity results continued to decline and remained low from Day 1 until Day 30. During the last three weeks of

testing, the turbidity values for the 23°C and 60°C samples averaged 0.54 NTU and 0.56 NTU, respectively.

**Figure 3-5. Daily turbidity results.**

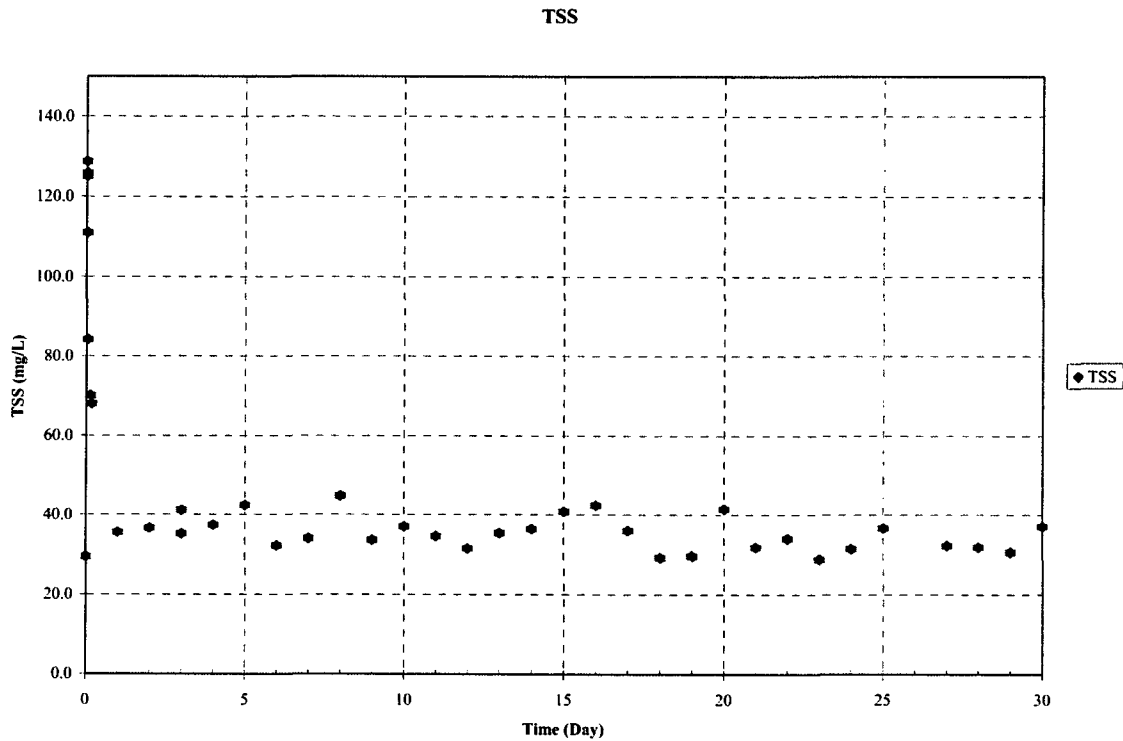
**Total Suspended Solids:** Total suspended solids (TSS) are measured by running a volume of approximately 500 mL through an in-line filter directly at the sample tap. The selected equipment assures that TSS measurements are not affected by temperature-dependent or time-dependent precipitation reactions that may occur once the process solution is removed from the tank. Figure 3-6 presents Test #4 TSS data as the experiment progressed. The baseline TSS measurement, taken before time zero, was 29.4 mg/L. Further TSS measurements were taken throughout the spray cycle. At the start of the spray cycle, the TSS measurement was at its highest value of 128.7 mg/L. At four hours, the TSS measurement had dropped to 68.0 mg/L. Following the spray cycle and beginning at 24 hours, the TSS measurements were performed daily. After 24 hours, TSS measurements varied approximately 16 mg/L over the 30-day test period, from a low of 28.8 mg/L to a high of 44.8 mg/L.

**Figure 3-6. Test #4 TSS results.**

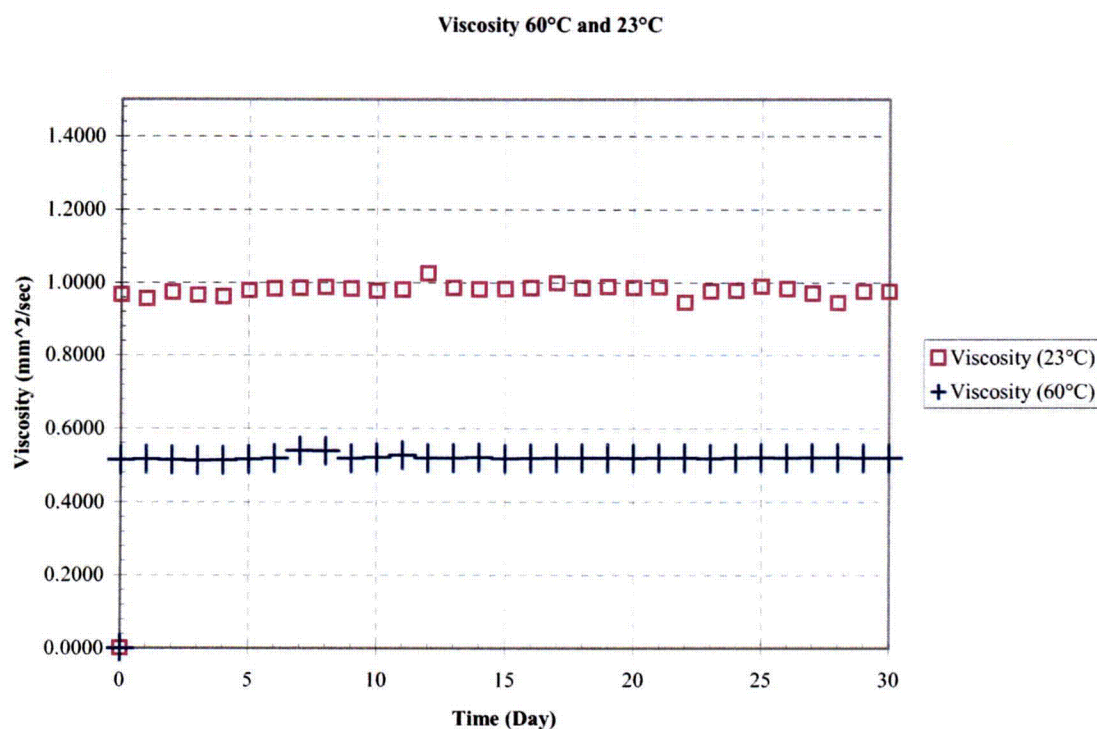
**Kinematic Viscosity:** Kinematic viscosity was measured with a Cannon-Fenske capillary viscometer. Viscosity was measured on unfiltered samples, each at a temperature of 60°C ( $\pm 1.0^\circ\text{C}$ ) [140°F ( $\pm 1.8^\circ\text{F}$ )] and 23°C ( $\pm 2.0^\circ\text{C}$ ) [73.4°F ( $\pm 3.6^\circ\text{F}$ )]. Viscosity of water is highly sensitive to temperature, and the allowed temperature range results in a variation of viscosity of 2.9% between 59°C (138.2°F) and 61°C (141.8°F), and a 9.3% variation between 21°C (69.8°F) and 25°C (77.0°F). For this reason, temperature was measured to 0.1°C accuracy with a NIST-traceable thermometer for all viscosity measurements, and the measured viscosity values were corrected to a common temperature to facilitate comparisons. The corrected temperatures were 60.0°C (140°F) and 23.0°C (73.4°F). The measured viscosity is shown in Figure 3-7. The values were steady throughout the test.

**Figure 3-7. Viscosity at 60°C and 23°C.**

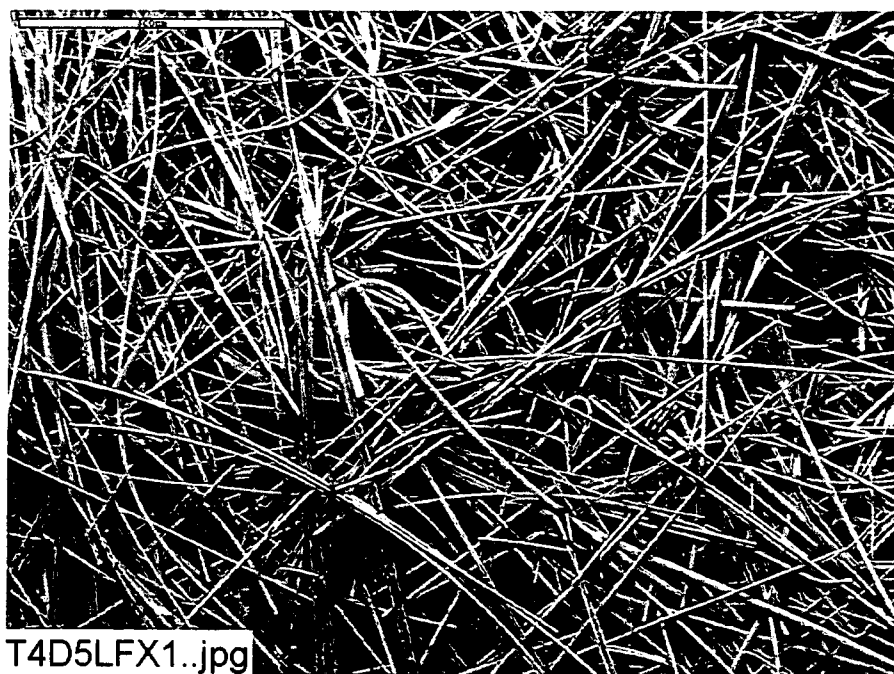
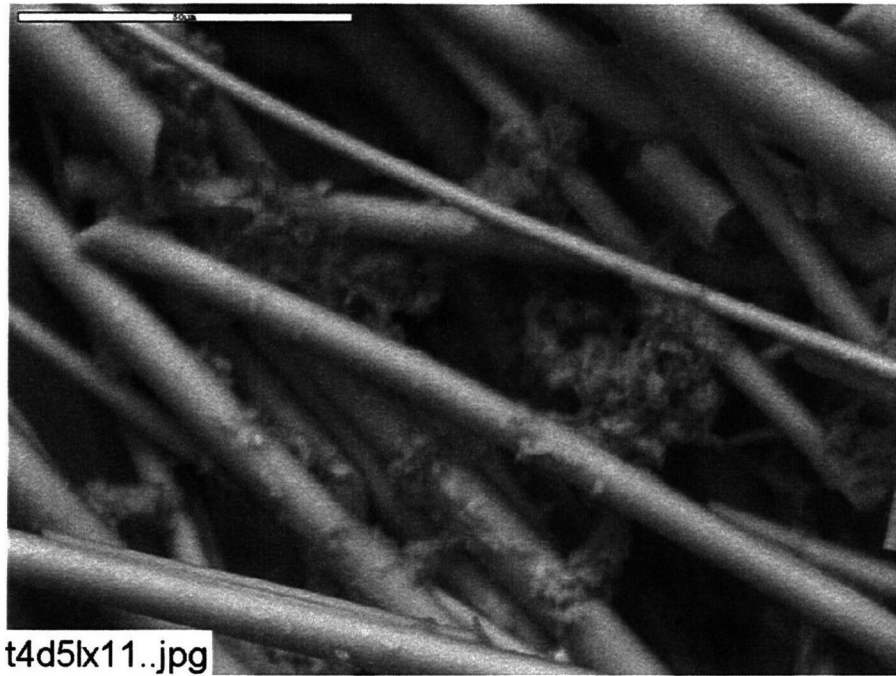
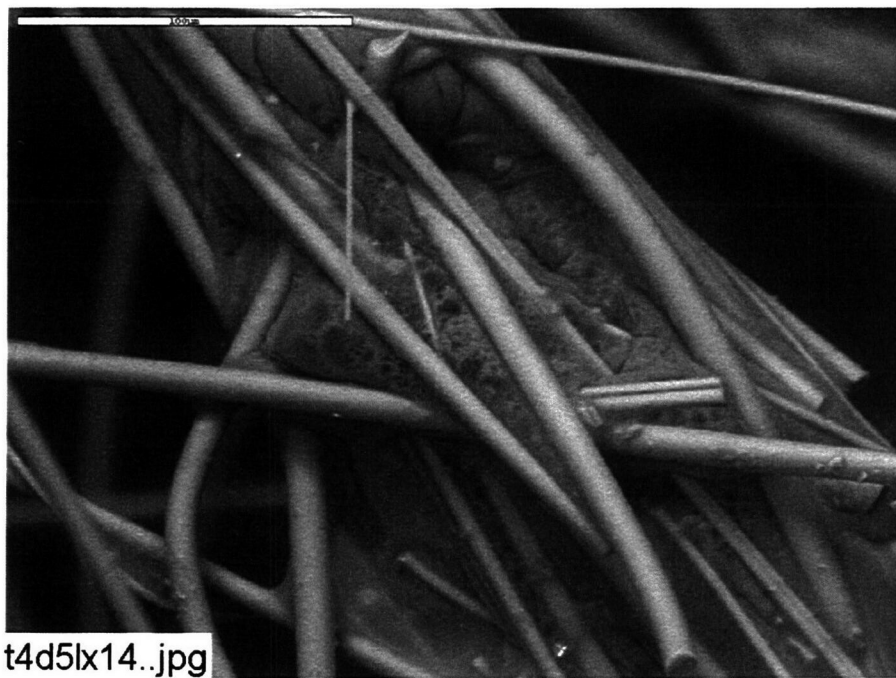
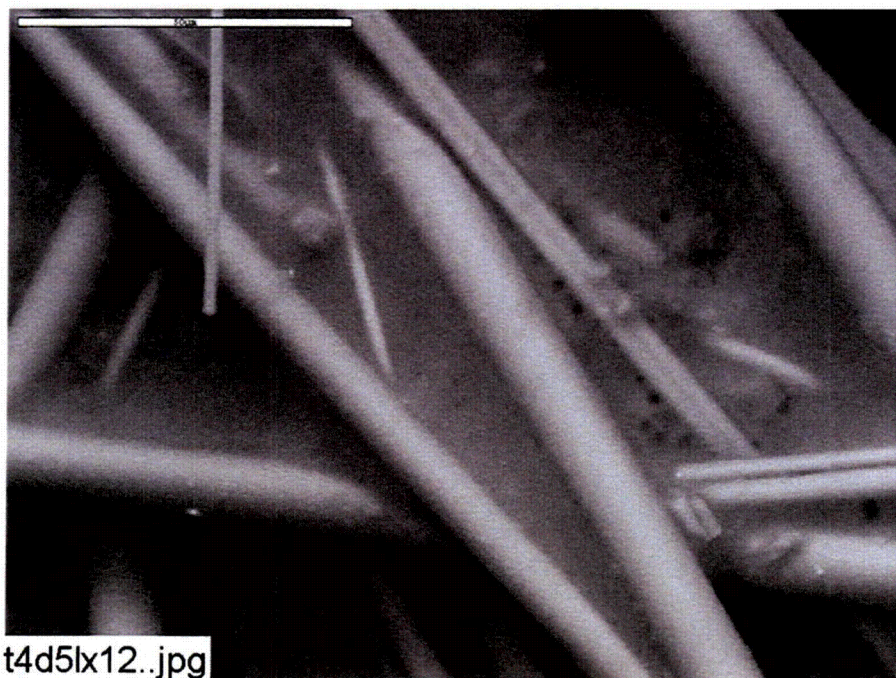
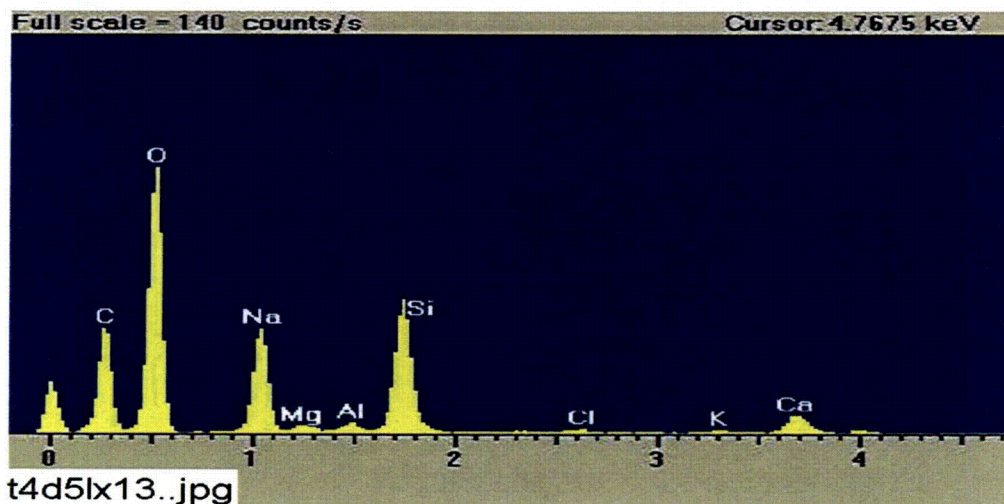
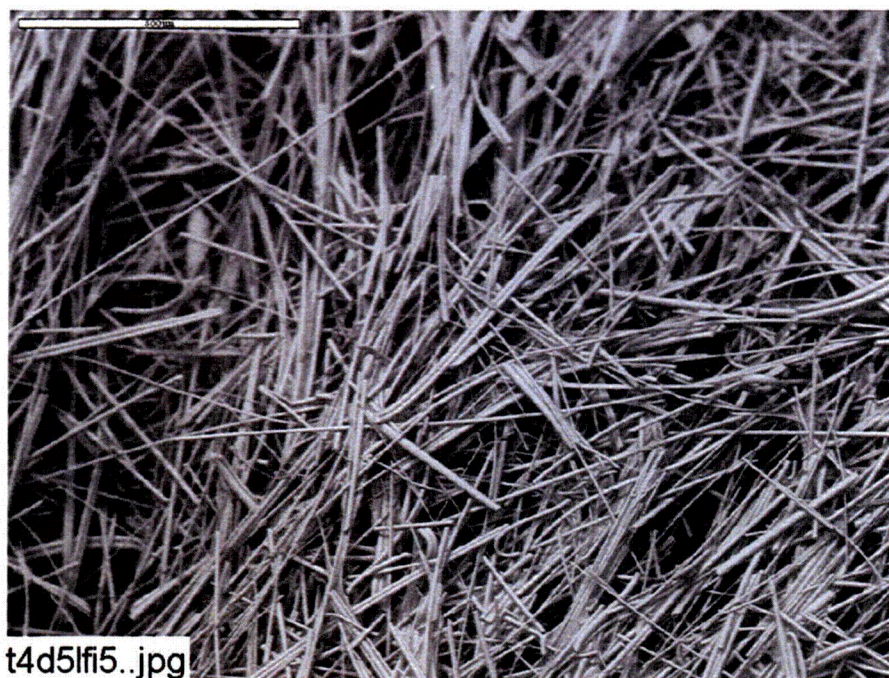
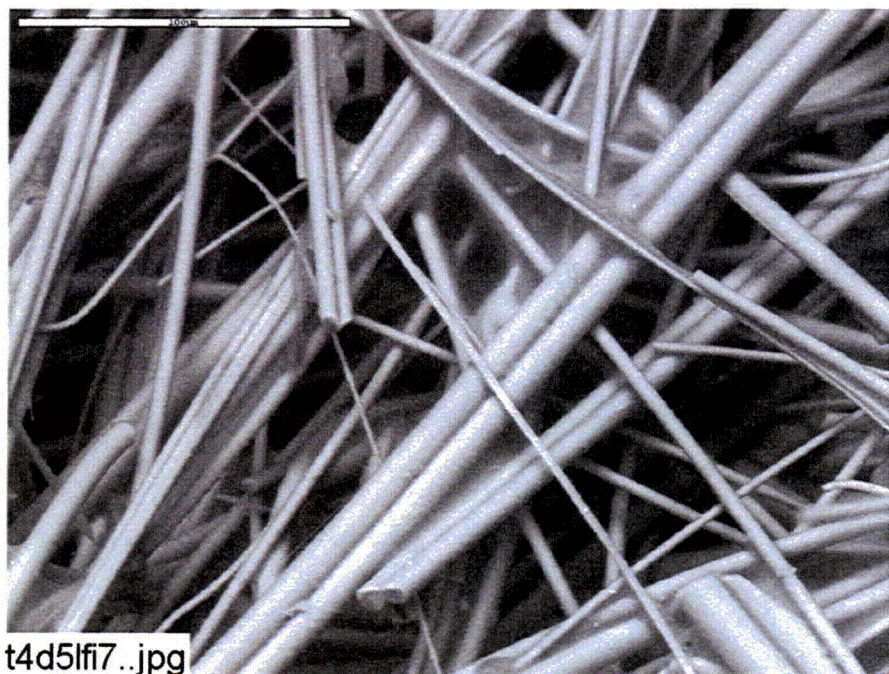
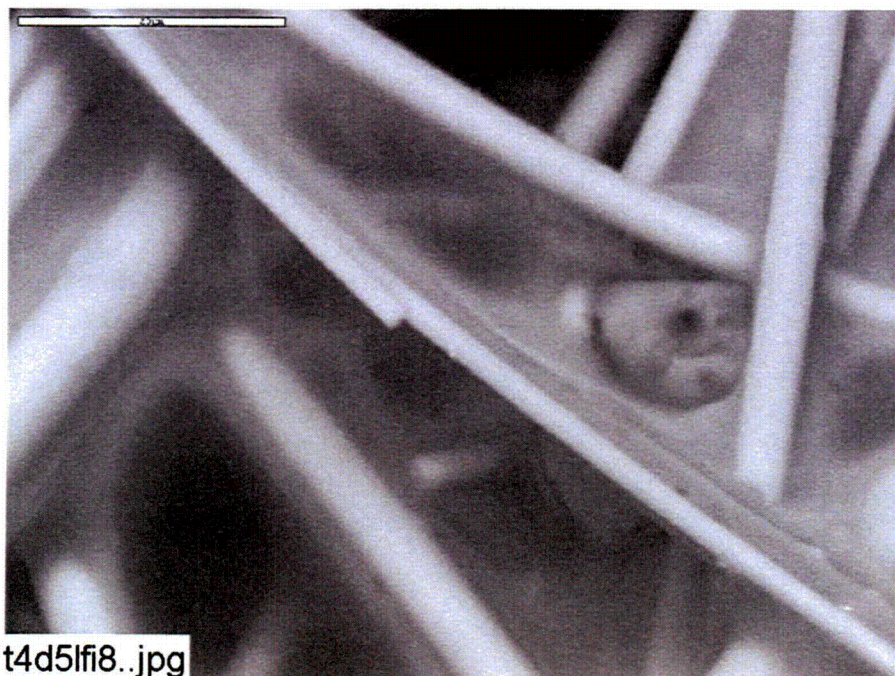
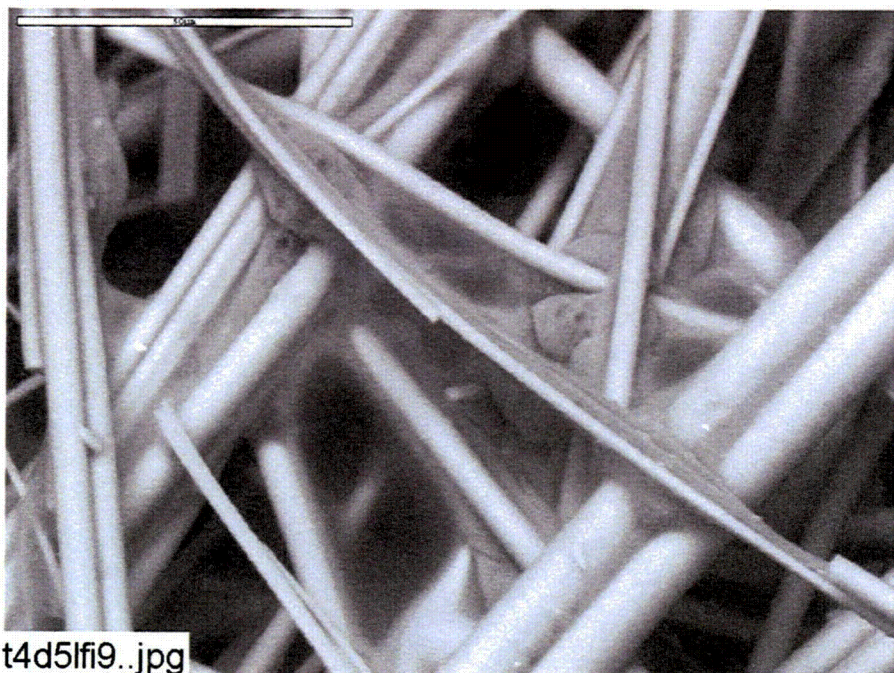
fiberglass revealed no significant difference between the interior and exterior samples. Again, this fact may be explained by the likely chemical origin of the deposits, since chemical precipitation would occur to a similar degree on both the exterior and the interior fiberglass samples if the concentrations were similar. Figures 3-16 through 3-24 show the Day-4 low-flow fiberglass results.

**Figure 3-16. ESEM image magnified 80 times for a Test #4, Day-5 low-flow exterior fiberglass sample. (T4D5LFX1.jpg)**

**Figure 3-17. ESEM image magnified 1000 times for a Test #4, Day-5 low-flow exterior fiberglass sample. (t4d5lx11.jpg)**

**Figure 3-18. ESEM image magnified 500 times for a Test #4, Day-5 low-flow exterior fiberglass sample. (t4d5lx14.jpg)**

Figure 3-19. ESEM image magnified 1000 times for a Test #4, Day-5 low-flow exterior fiberglass sample. (t4d5lx12.jpg)

Figure 3-20. EDS counting spectrum for the film between the fibers shown in Figure 3-19. (t4d5lx13.jpg)

**Figure 3-21. ESEM image magnified 80 times for a Test #4, Day-5 low-flow interior fiberglass sample. (t4d5lfi5.jpg)**

**Figure 3-22. ESEM image magnified 500 times for a Test #4, Day-5 low-flow interior fiberglass sample. (t4d5lfi7.jpg)**

**Figure 3-23. ESEM image magnified 2000 times for a Test #4, Day-5 low-flow interior fiberglass sample. (t4d5lfi8.jpg)**

**Figure 3-24. ESEM image magnified 1000 times for a Test #4, Day-5 low-flow interior fiberglass sample. (t4d5lfi9.jpg)**

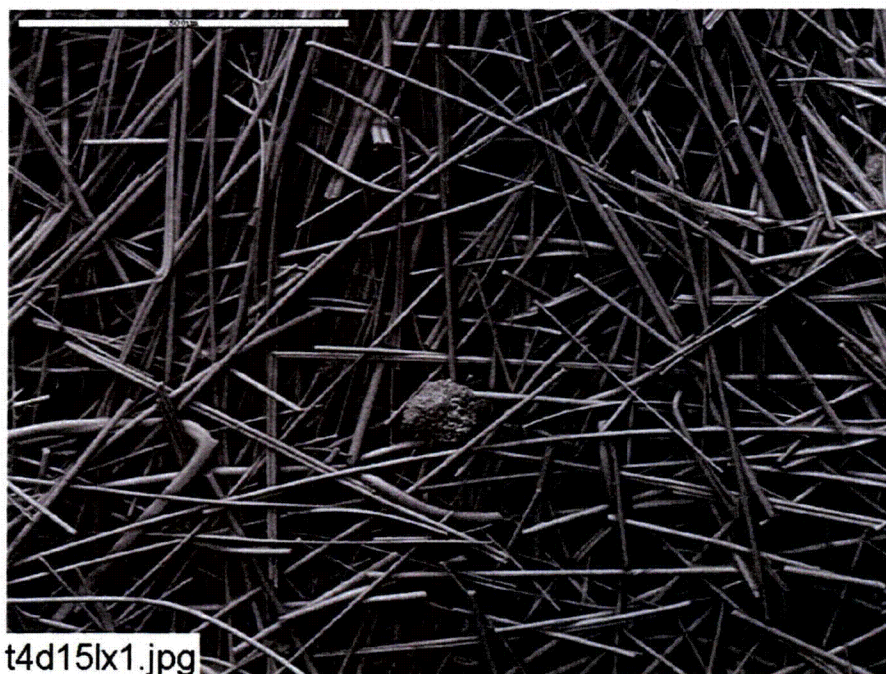
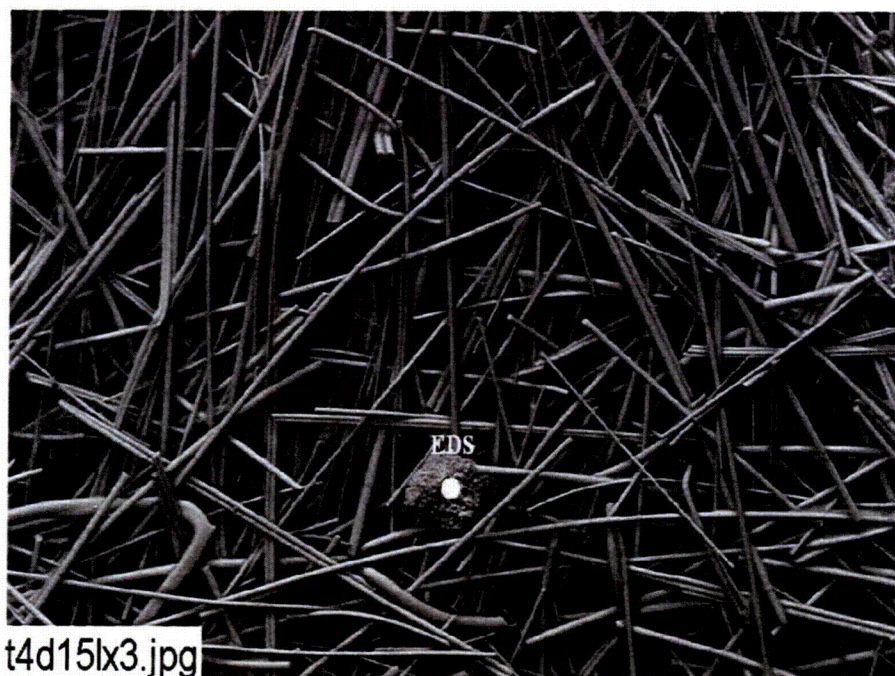
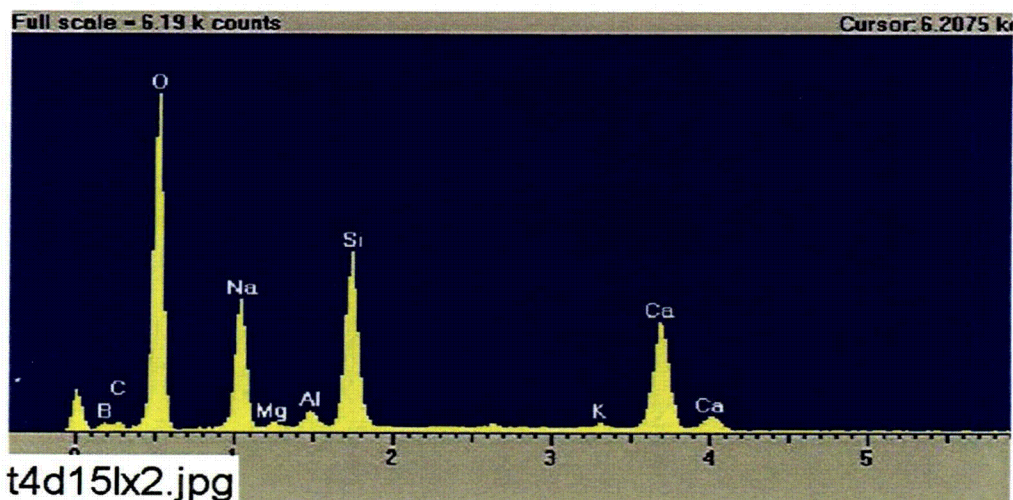
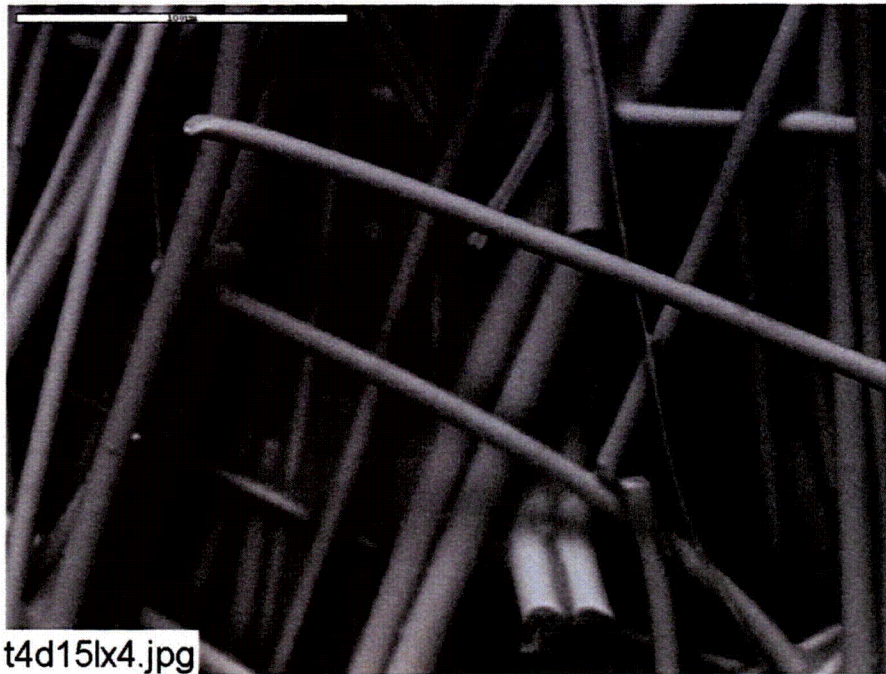
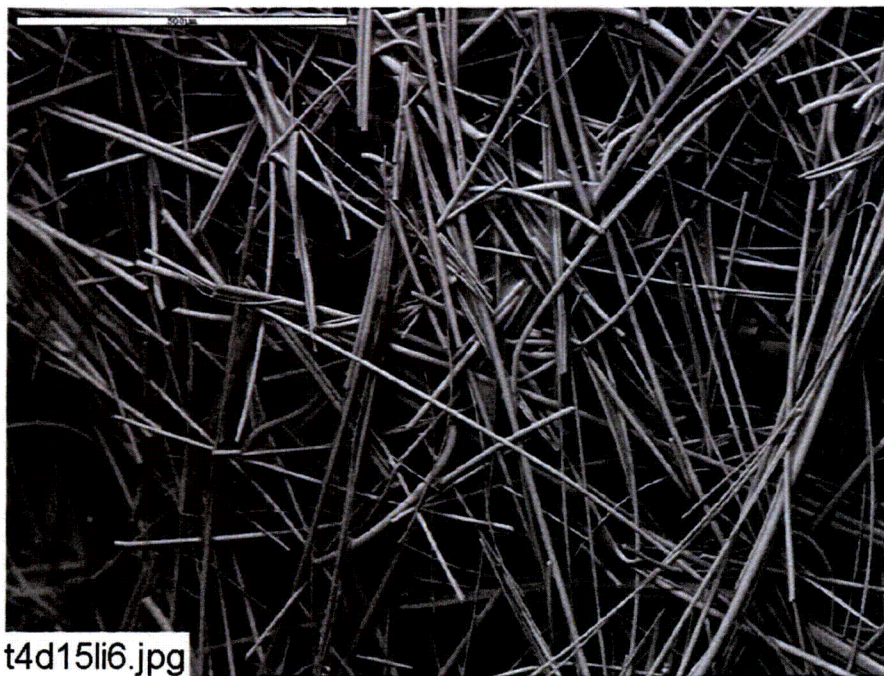
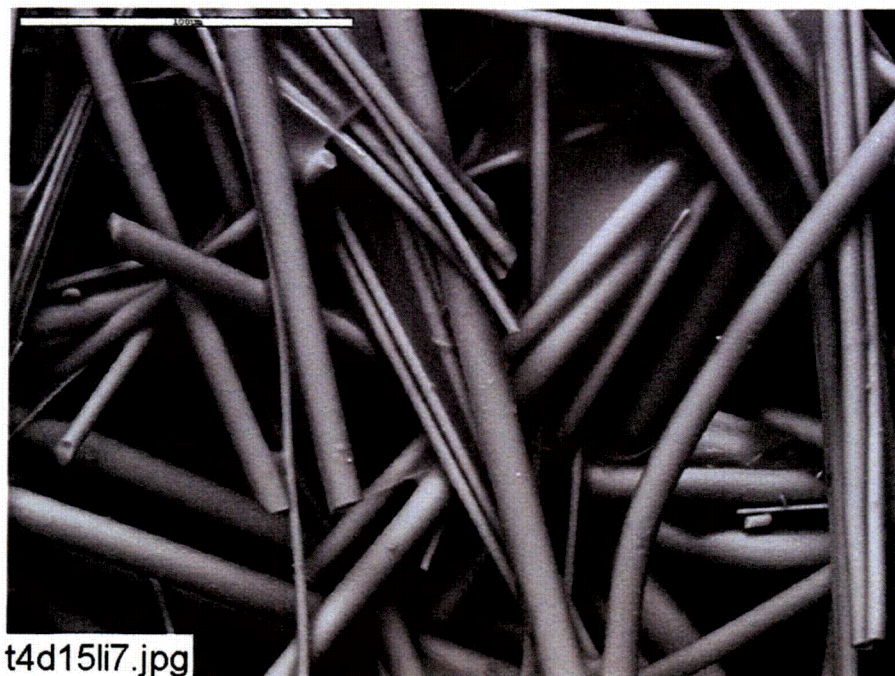
Similar to the Day-5 samples, a few particulate deposits were found on the fiberglass exterior. EDS analysis shows that the particulate deposits were mainly composed of O, Na, Ca, Al, Mg, B, C, K, and possibly Si. However, the film deposits were prevalent on both the exterior and the interior fiberglass samples. There was no significant increase in the amount of deposits on Day-15 samples compared to Day-5 samples. Comparing the amount of the film deposits on the exterior and the interior Day-15 low-flow fiberglass samples, the difference was insignificant. Figures 3-25 through 3-30 show the Day-15 low-flow fiberglass results.

Figure 3-25. ESEM image magnified 100 times for a Test #4, Day-15 exterior low-flow fiberglass sample. (t4d15lx1.jpg)

Figure 3-26. Annotated ESEM image magnified 100 times for a Test #4, Day-15 exterior low-flow fiberglass sample. (t4d15lx3.jpg)

Figure 3-27. EDS counting spectrum for the particulate deposit on fiberglass shown in Figure 3-26. (t4d15lx2.jpg)

**Figure 3-28. ESEM image magnified 500 times for a Test #4, Day-15 exterior low-flow fiberglass sample. (t4d15lx4.jpg)**

**Figure 3-29. ESEM image magnified 100 times for a Test #4, Day-15 interior low-flow fiberglass sample. (t4d15li6.jpg)**

**Figure 3-30. ESEM image magnified 500 times for a Test #4, Day-15 interior low-flow fiberglass sample. (t4d15li7.jpg)**
