## **Integrated Chemical Effects Test Project: Test #4 Data Report**

**Los Alamos National Laboratory**

**U.S. Nuclear Regulatory Commission  
Office of Nuclear Regulatory Research  
Washington, DC 20555-0001**

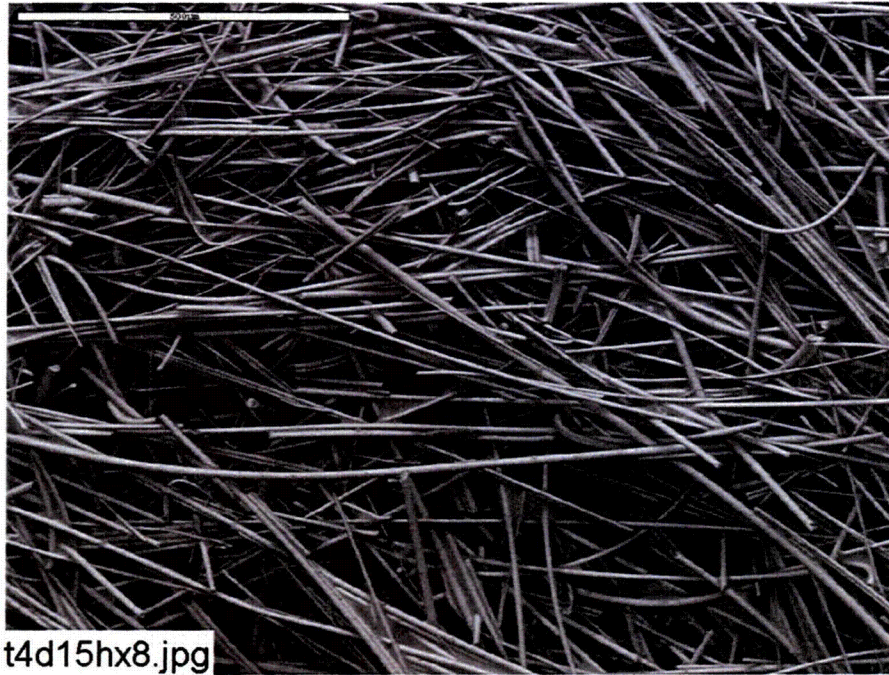
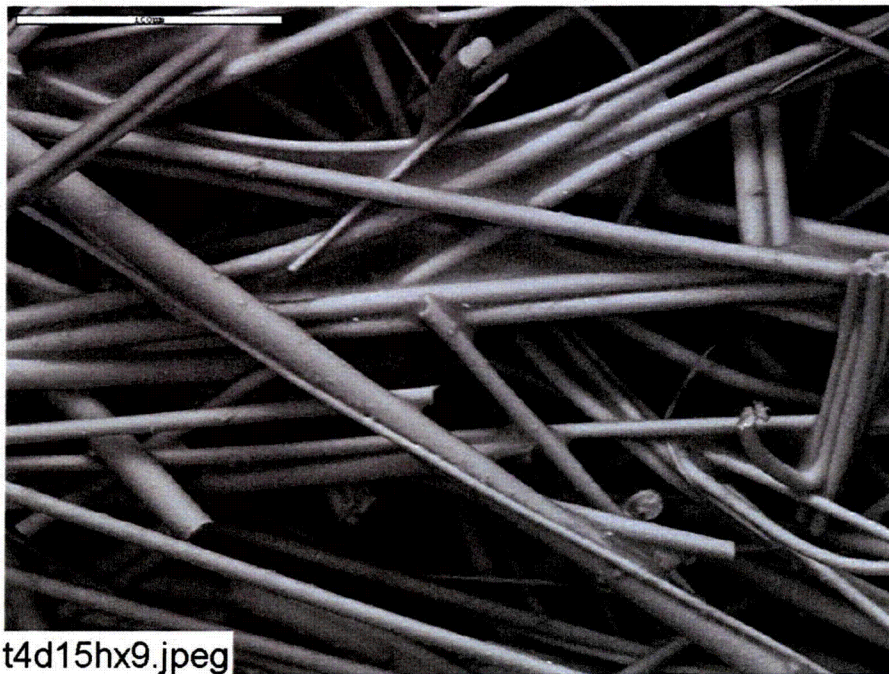
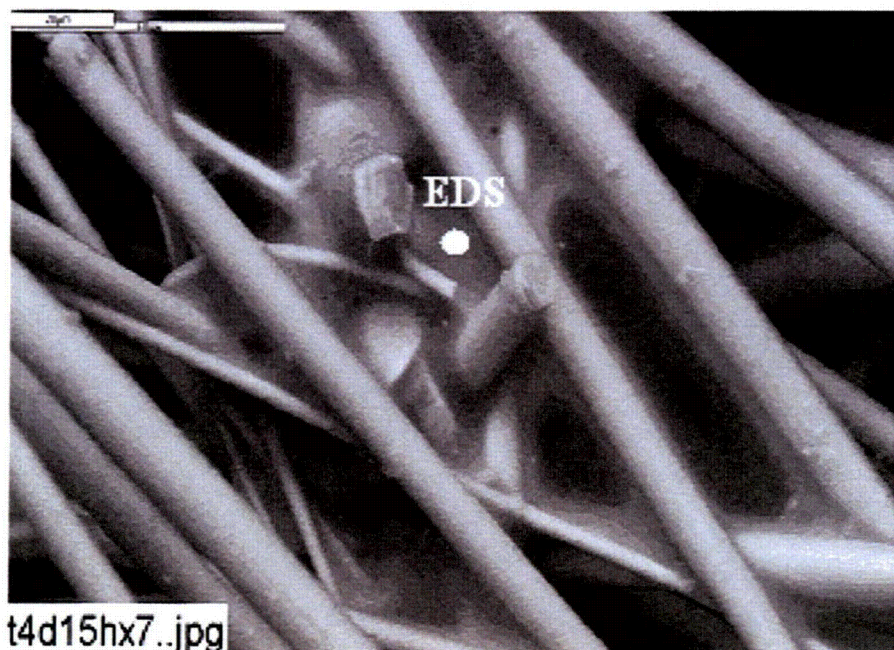
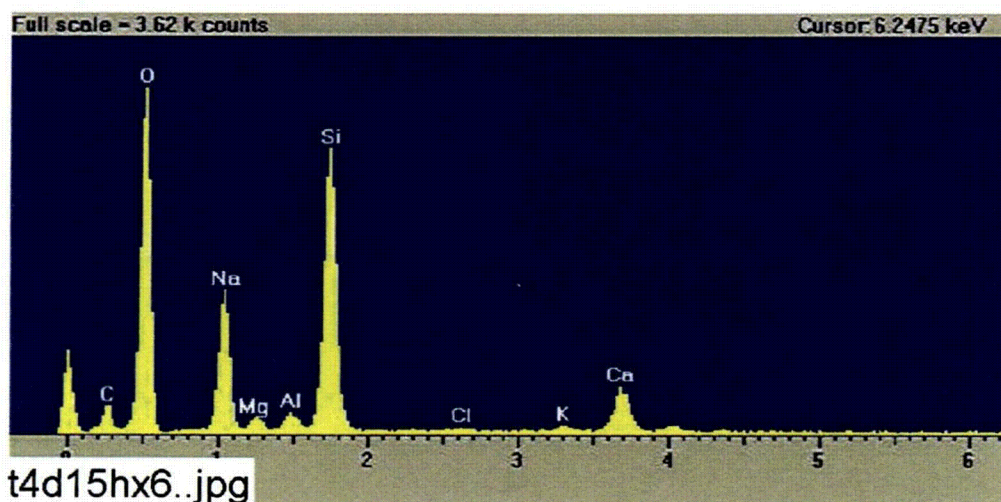
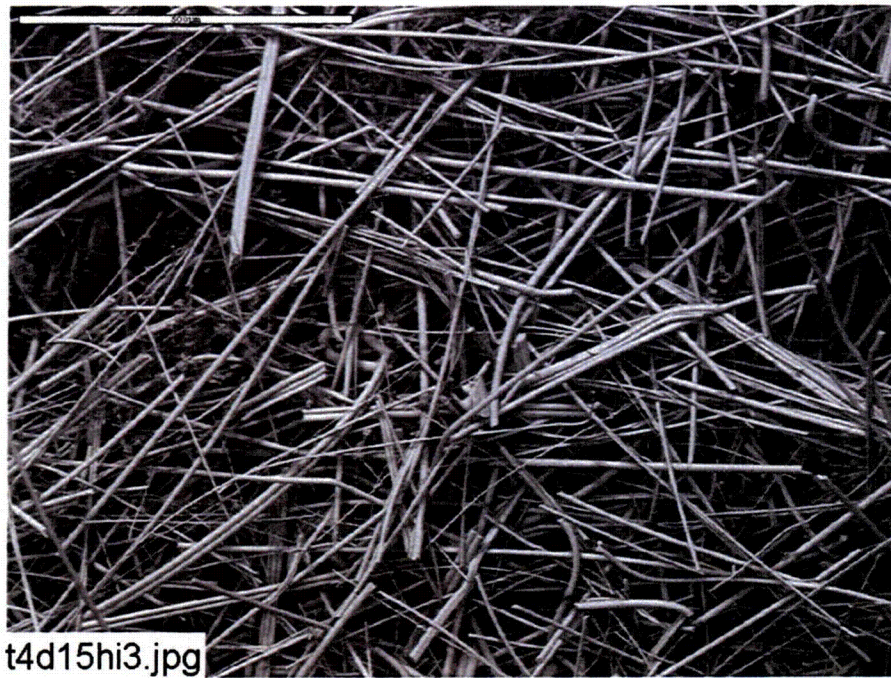
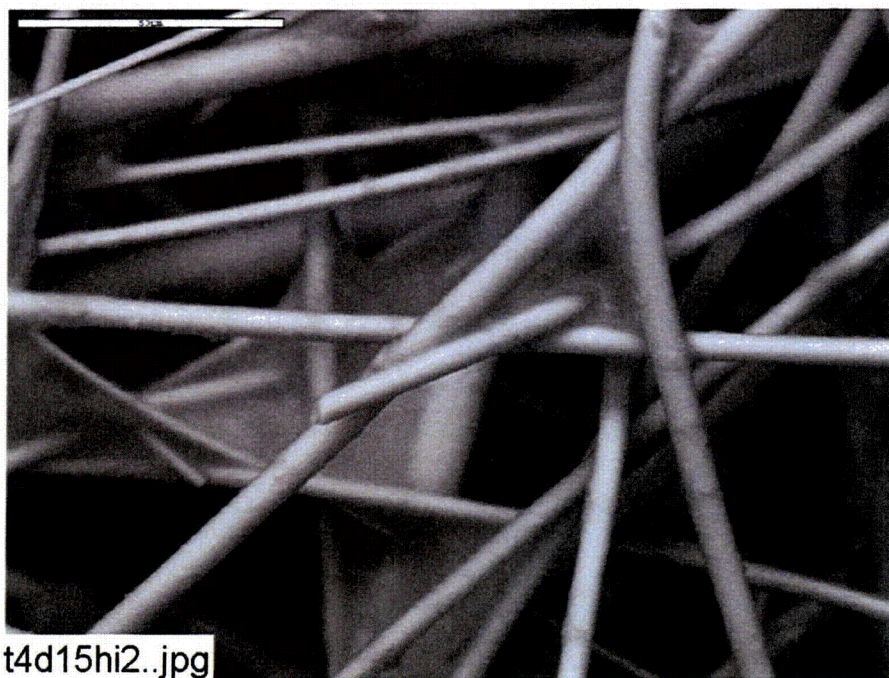
No significant difference was found between Day-15 high-flow and low-flow fiberglass samples. The film deposits were prevalent on both the exterior and interior fiberglass samples. Consistently, EDS analysis indicates that the film was composed of O, Na, Ca, C, Mg, Al, K, and possibly Si. There was no significant difference regarding the amount of the film deposits between the exterior and the interior fiberglass samples, suggesting the likely chemical origin of the film. In addition, no particulate deposits were observed on either the exterior or interior fiberglass samples. Figures 3-31 through 3-36 show the Day-15 high-flow fiberglass results.

**Figure 3-31. ESEM image magnified 100 times for a Test #4, Day-15 exterior high-flow fiberglass sample. (t4d15hx8.jpg)**

**Figure 3-32. ESEM image magnified 400 times for a Test #4, Day-15 exterior high-flow fiberglass sample. (t4d15hx9.jpg)**

Figure 3-33. ESEM image magnified 750 times for a Test #4, Day-15 exterior high-flow fiberglass sample. (t4d15hx7.jpg)

Figure 3-34. EDS counting spectrum for the spot on the film between the fibers shown in Figure 3-33. (t4d15hx6.jpg)

**Figure 3-35. ESEM image magnified 100 times for a Test #4, Day-15 interior high-flow fiberglass sample. (t4d15hi3.jpg)**

**Figure 3-36. ESEM image magnified 800 times for a Test #4, Day-15 interior high-flow fiberglass sample. (t4d15hi2.jpg)**
