Appendix F1

SEM/EDS Data for Test #4, Day-30 Aluminum Coupons

This appendix shows the SEM/EDS results for the metal aluminum coupons under two categories: (1) unsubmerged and (2) submerged. Unsubmerged refers to coupons held in the test tank gas space above the water level of the solution during ICET. Unsubmerged coupons were contacted by the solution only during the 4-hour spraying period at the initial date of the test. In addition, the surface of the unsubmerged coupons may also have been affected by the moisture in the gas space during the test. Submerged refers to the coupons that were under the solution during the test.

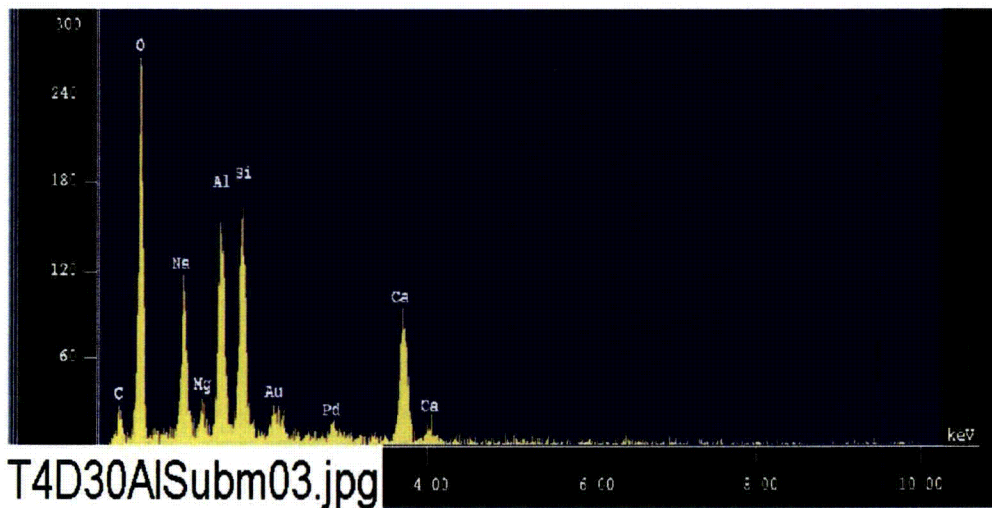
Figure F1-9. EDS counting spectrum for the deposits (EDS3) on the coupon surface shown in Figure F1-8. (T4D30AlSubm03.jpg)

Group : NRC
 Sample : T4D30 ID# : 3
 Comment : Particles on submerged Al
 Condition : Full Scale : 20KeV(10eV/ch,2Kch)
 Live Time : 60.000 sec Aperture # : 2
 Acc. Volt : 15.0 KV Probe Current : 1.067E-09 A
 Stage Point : X=74.706 Y=62.388 Z=10.786
 Acq. Date : Wed Jun 29 10:30:29 2005

The results from the chemical composition analysis for T4D30AlSubm03.jpg are given in Table F1-3.

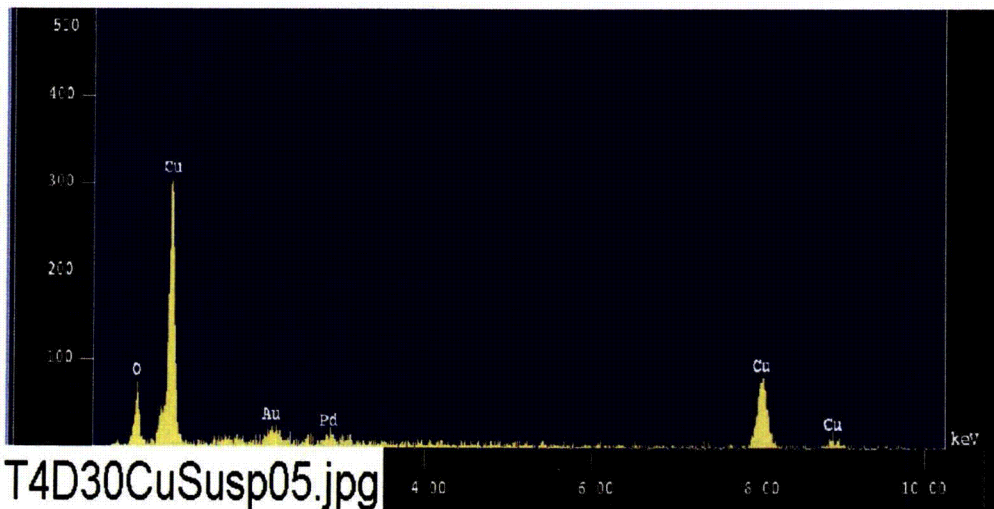
Figure F2-4. EDS counting spectrum for the deposits (EDS1) on the coupon surface shown in Figure F2-3. (T4D30CuSusp05.jpg)

Group      : NRC
Sample     : T4D30 ID# : 5
Comment    : particles on suspended Cu
Condition  : Full Scale : 20KeV(10eV/ch,2Kch)
            Live Time  : 60.000 sec Aperture # : 2
            Acc. Volt  : 15.0 KV Probe Current : 1.065E-09 A
            Stage Point: X=81.233 Y=71.962 Z=10.786
            Acq. Date  : Wed Jun 29 13:41:34 2005

The results from the chemical composition analysis for T4D30CuSusp05.jpg are given in Table F2-1.

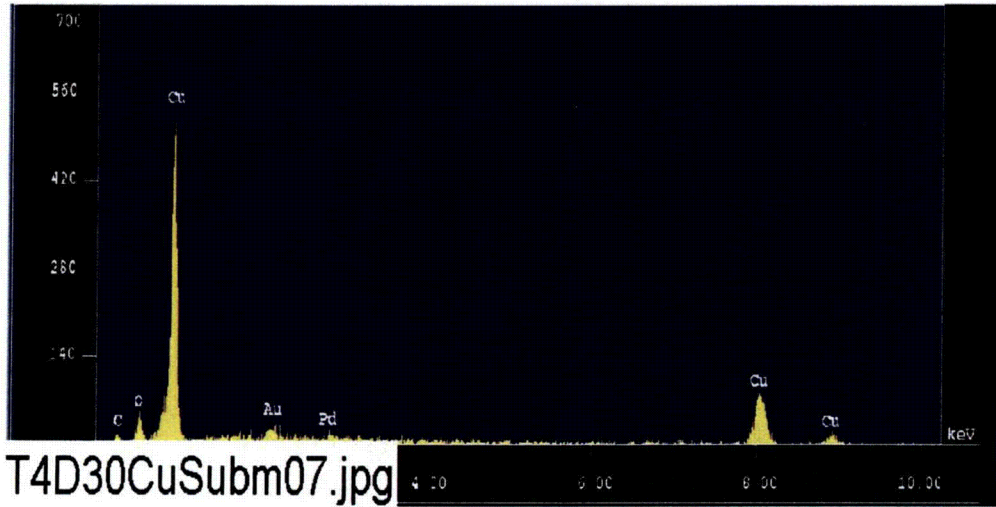
Figure F2-9. EDS counting spectrum for the flat coupon surface (EDS3) shown in Figure F2-7. (T4D30CuSubm07.jpg)

Group : NRC
 Sample : T4D30 ID# : 7
 Comment : surface of submerged Cu
 Condition : Full Scale : 20KeV(10ev/ch,2Kch)
 Live Time : 60.000 sec Aperture # : 2
 Acc. Volt : 15.0 KV Probe Current : 1.065E-09 A
 Stage Point : X=57.699 Y=58.376 Z=10.786
 Acq. Date : Wed Jun 29 13:59:37 2005

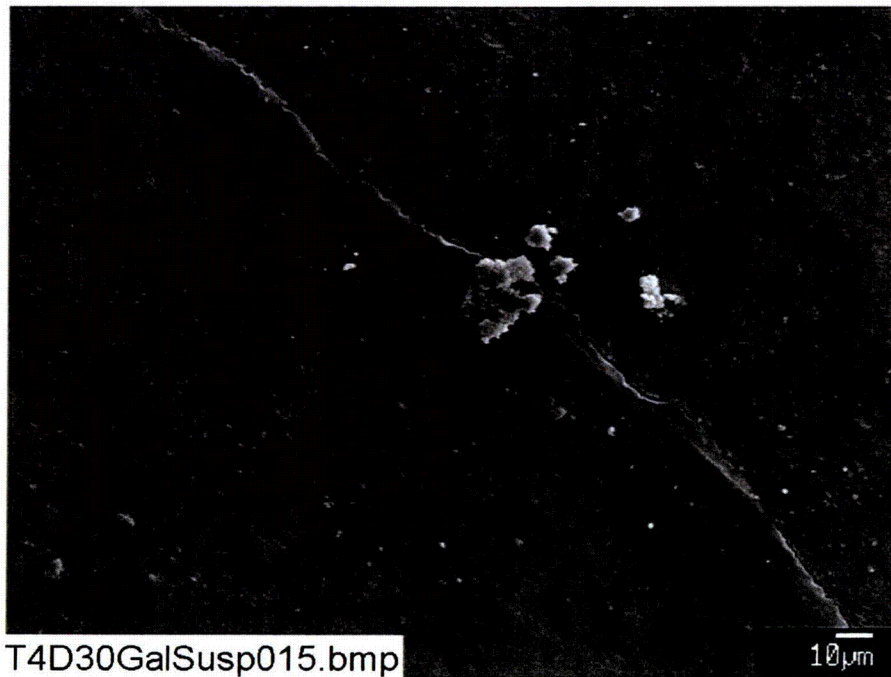
Figure F3-2. SEM image magnified 500 times for a Test #4, Day-30 unsubmerged galvanized steel coupon sample. (T4D30GalSusp015.bmp)

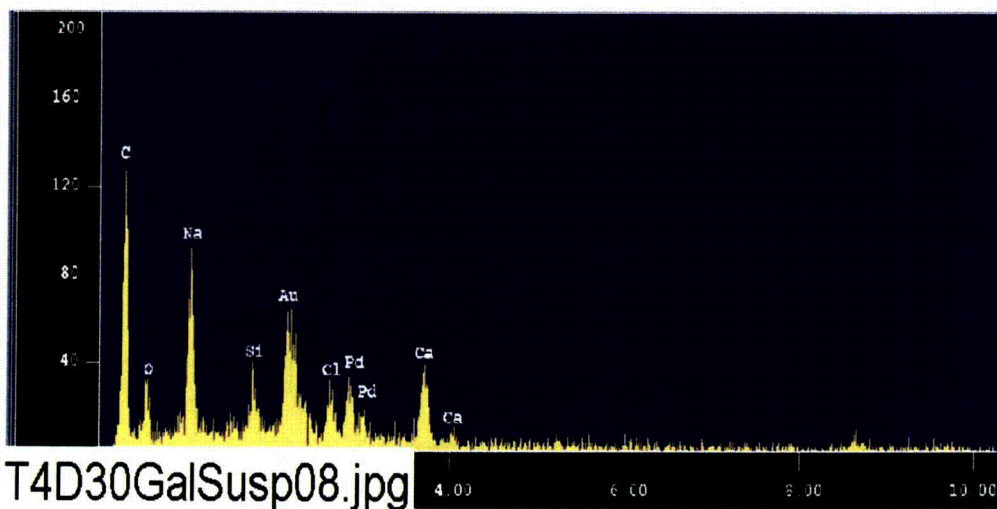
Figure F3-4. EDS counting spectrum for the deposits (EDS1) on the coupon surface shown in Figure F3-3. (T4D30GalSusp08.jpg)

Group : NRC
 Sample : T4D30 ID# : 8
 Comment : particle on suspended Gal-steel
 Condition : Full Scale : 20KeV(10eV/ch,2Kch)
 Live Time : 60.000 sec Aperture # : 2
 Acc. Volt : 15.0 KV Probe Current : 1.064E-09 A
 Stage Point : X=44.143 Y=59.814 Z=10.786
 Acq. Date : Wed Jun 29 14:12:20 2005

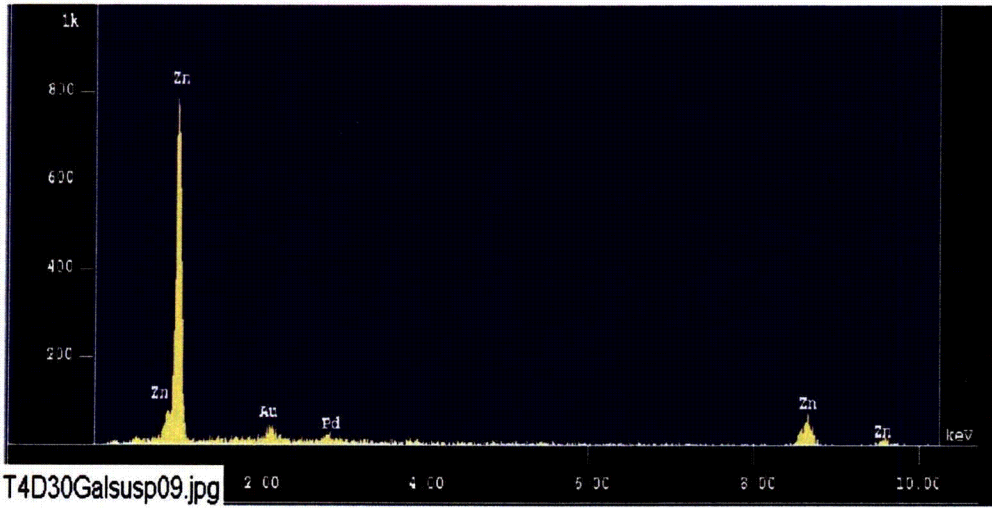
Figure F3-5. EDS counting spectrum for the flat coupon surface (EDS2) shown in Figure F3-3. (T4D30Galsusp09.jpg)

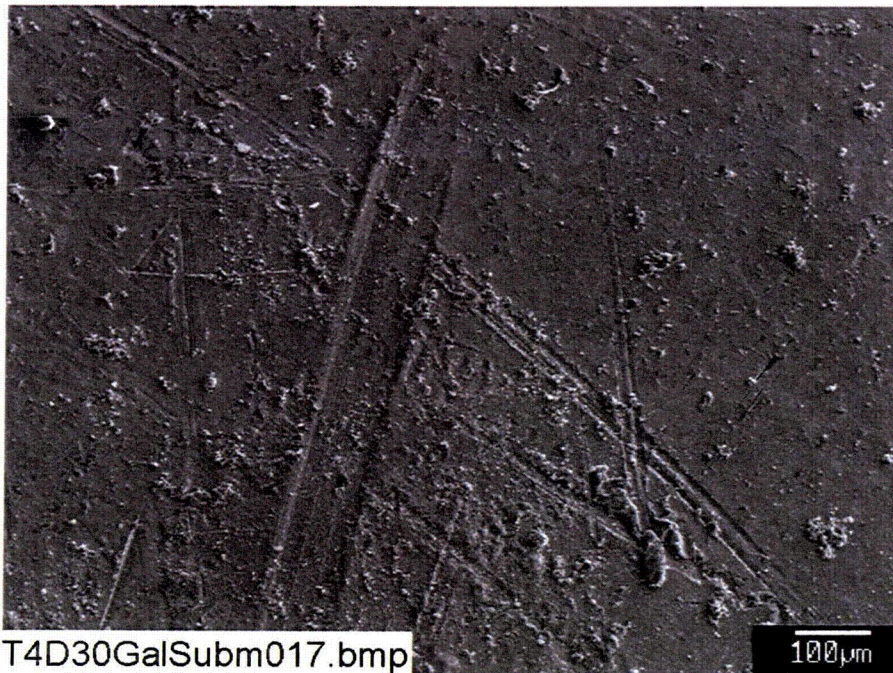
Figure F3-6. SEM image magnified 100 times for a Test #4, Day-30 submerged galvanized steel coupon sample. (T4D30GalSubm017.bmp)

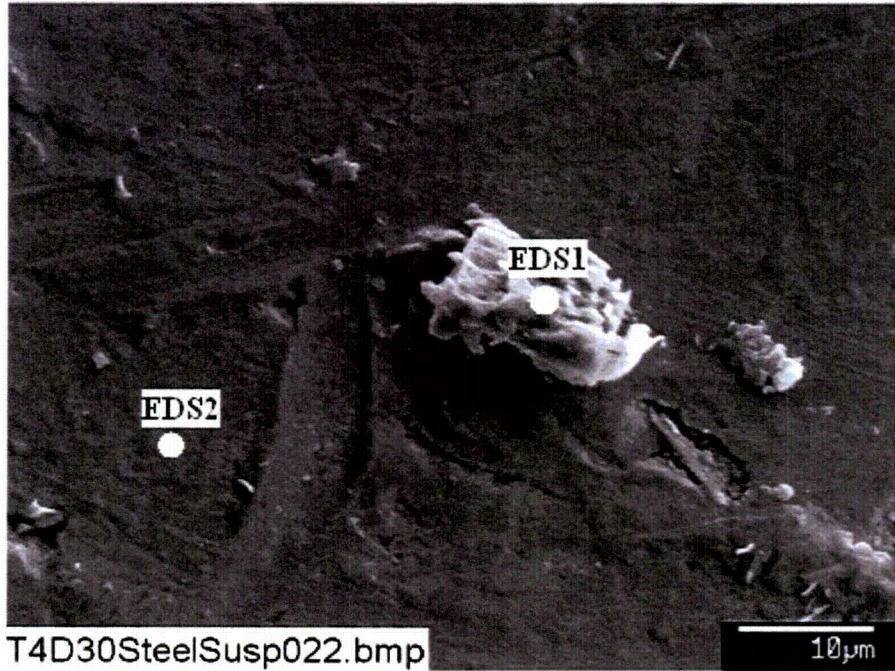
Figure F4-3. Annotated SEM image magnified 1800 times for a Test #4, Day-30 unsubmerged uncoated steel coupon sample. (T4D30SteelSusp022.bmp)

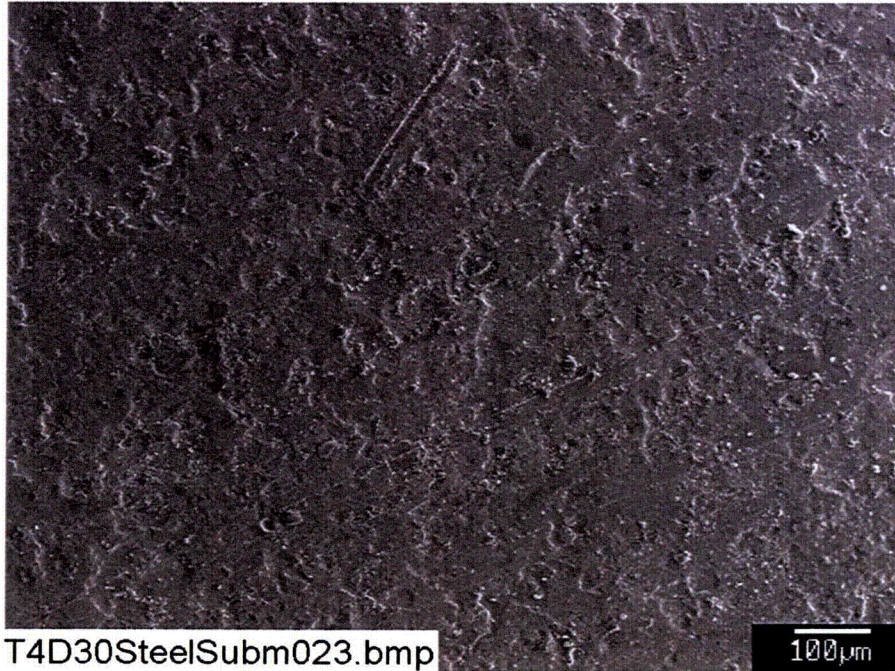
T4D30SteelSubm023.bmp

Figure F4-6. SEM image magnified 100 times for a Test #4, Day-30 submerged uncoated steel coupon sample. (T4D30SteelSubm023.bmp)

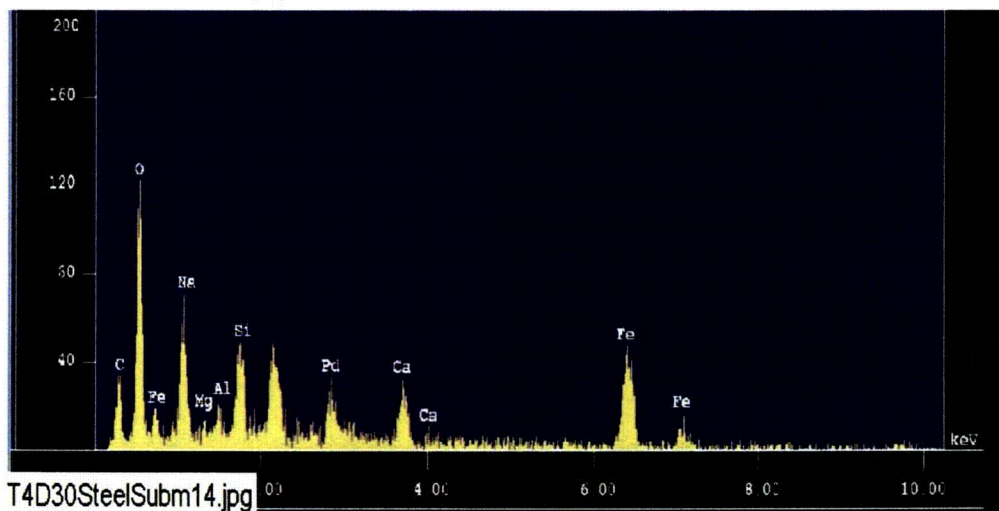
Figure F4-9. EDS counting spectrum for the deposit (EDS3) shown in Figure F4-8. (T4D30SteelSubm14.jpg)

Group : MRC
 Sample : T4D30 ID# : 14
 Comment : Particles on submerged steel
 Condition : Full Scale : 20KeV(10eV/ch,2Kch)
 Live Time : 60.000 sec Aperture # : 2
 Acc. Volt : 15.0 KV Probe Current : 1.063E-09 A
 Stage Point : X=12.785 Y=58.790 Z=10.786
 Acq. Date : Wed Jun 29 15:05:38 2005

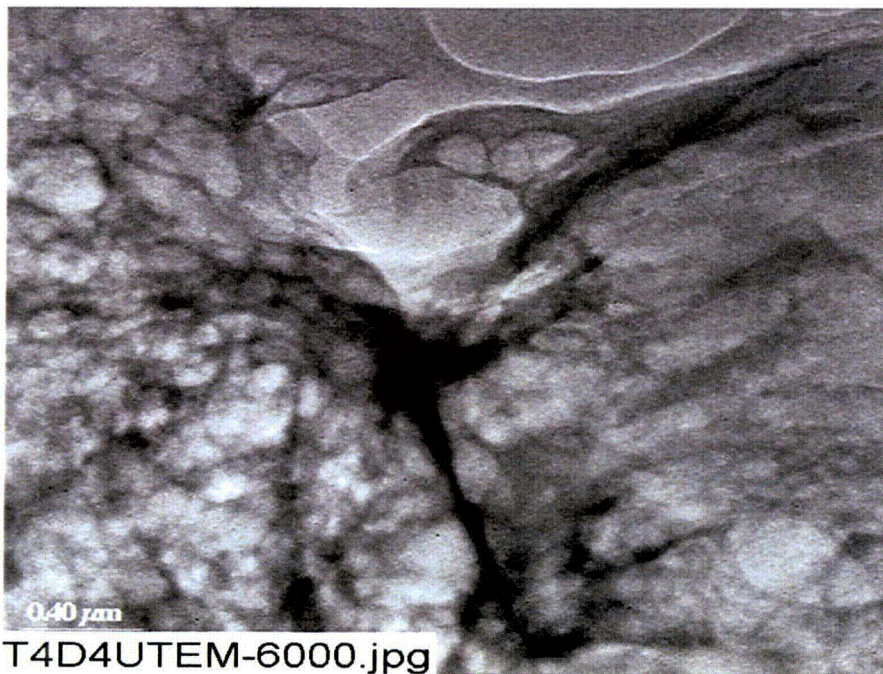
Figure H-2. TEM magnified 6000 times for one Test #4, Day-4 unfiltered sample location. (T4D4UTEM-6000.jpg)

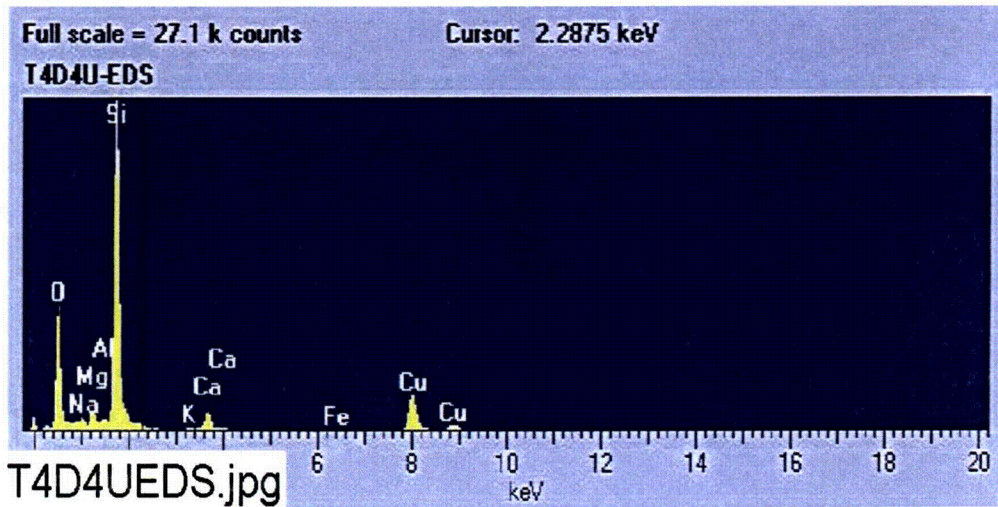
Figure H-3. TEM energy-dispersive x-ray spectrum for a Test #4 Day-4 unfiltered sample. The copper peak is likely from the copper sample holder for TEM analysis. (T4D4UEDS.jpg)

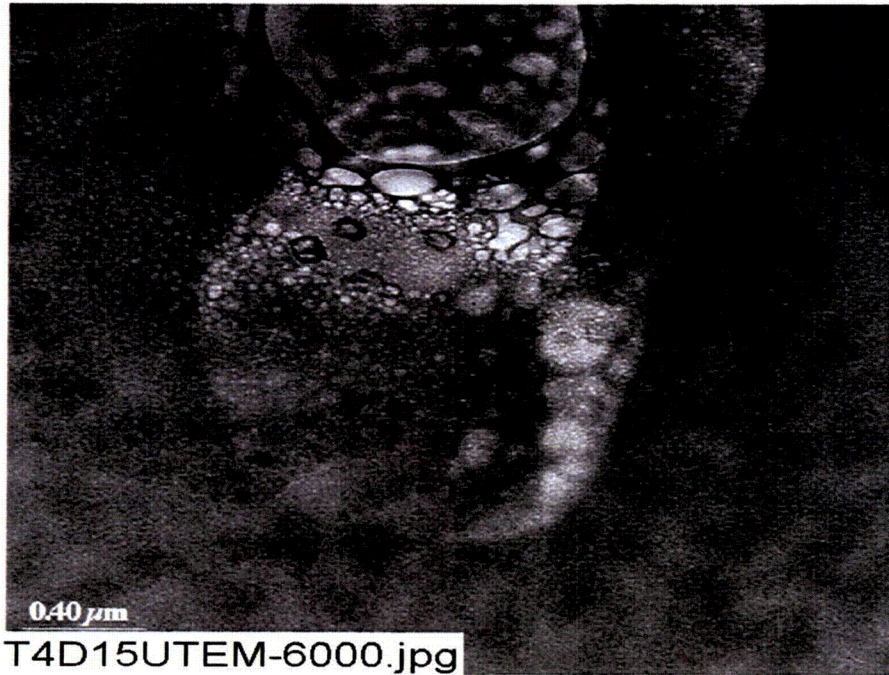
Figure H-5. TEM magnified 6000 times for one Test #4, Day-15 unfiltered sample location. (T4D15UTEM-6000.jpg)

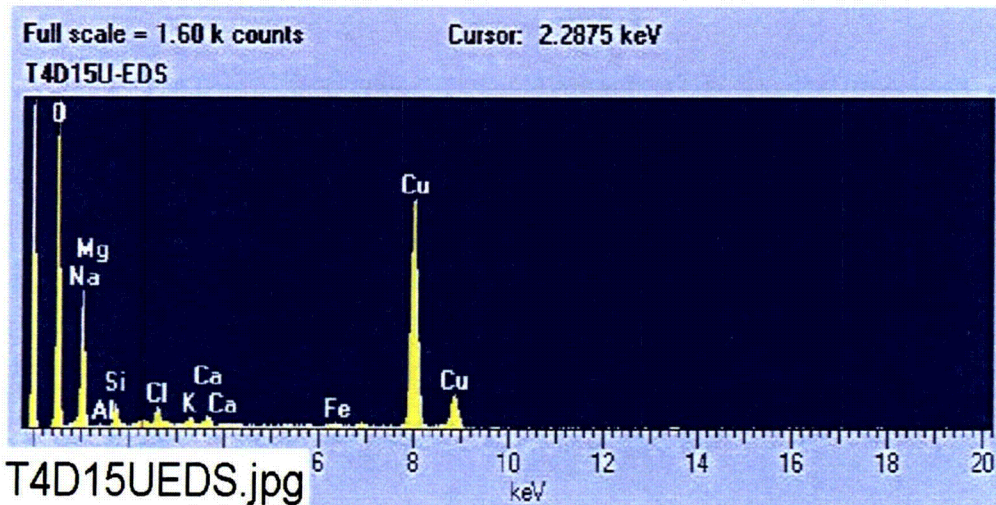
Figure H-6. TEM energy-dispersive x-ray spectrum for a Test #4 Day-15 unfiltered sample. The copper peak is likely from the copper sample holder for TEM analysis. (T4D15UEDS.jpg)

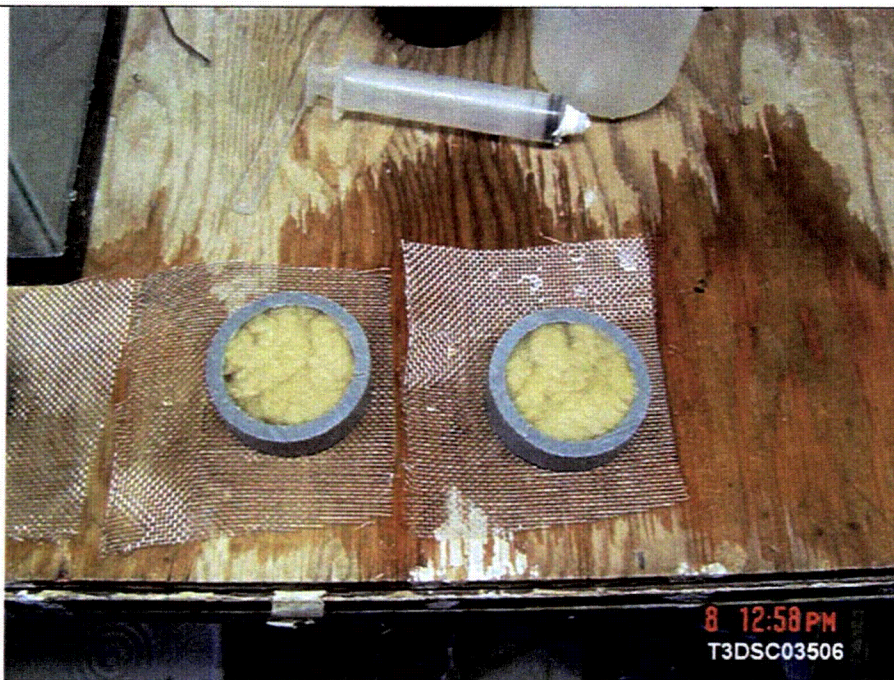
Figure 1. Example fiber pucks prepared for immersion in ICET test solution.

Between 3 and 5 fiberglass pucks will be prepared as shown in Figure 1 for jacketing in a stainless steel envelope and immersion in the Test #4 test solution after the water clarity has improved. Approximately 5-10 grams of dry fiberglass are required to fill the ½-inch thick, 2-in. diameter sample ring. The sample ring is cut from a 2-inch diameter CPVC pipe to provide a standard dimension for any flow testing that may be desired after the conclusion of Test #4 and to avoid the introduction of unapproved foreign materials in the test tank. Before introducing the fiberglass to the mold, it will first be agitated in a kitchen blender for at least 2 minutes in two batches, each batch containing approximately half the debris and approximately 2 quarts of water. The purpose of agitation is to separate fibers from the raw flocks of manufactured insulation. The batches will be sequential poured into the mold placed across a mesh screen. Gentle manual tamping may be required to ensure uniformity of the bed.
