PLATE 1

U.S. DEPARTMENT OF ENERGY GRAND JUNCTION, COLORADO	Work Performed by S.M. Stoller Corporation Under DOE Contract No. DE-AC01-02GJ79491
---	--

Aerial Photography Interpretation
for Crescent Junction Withdrawal Area
and Nearby Surrounding Area

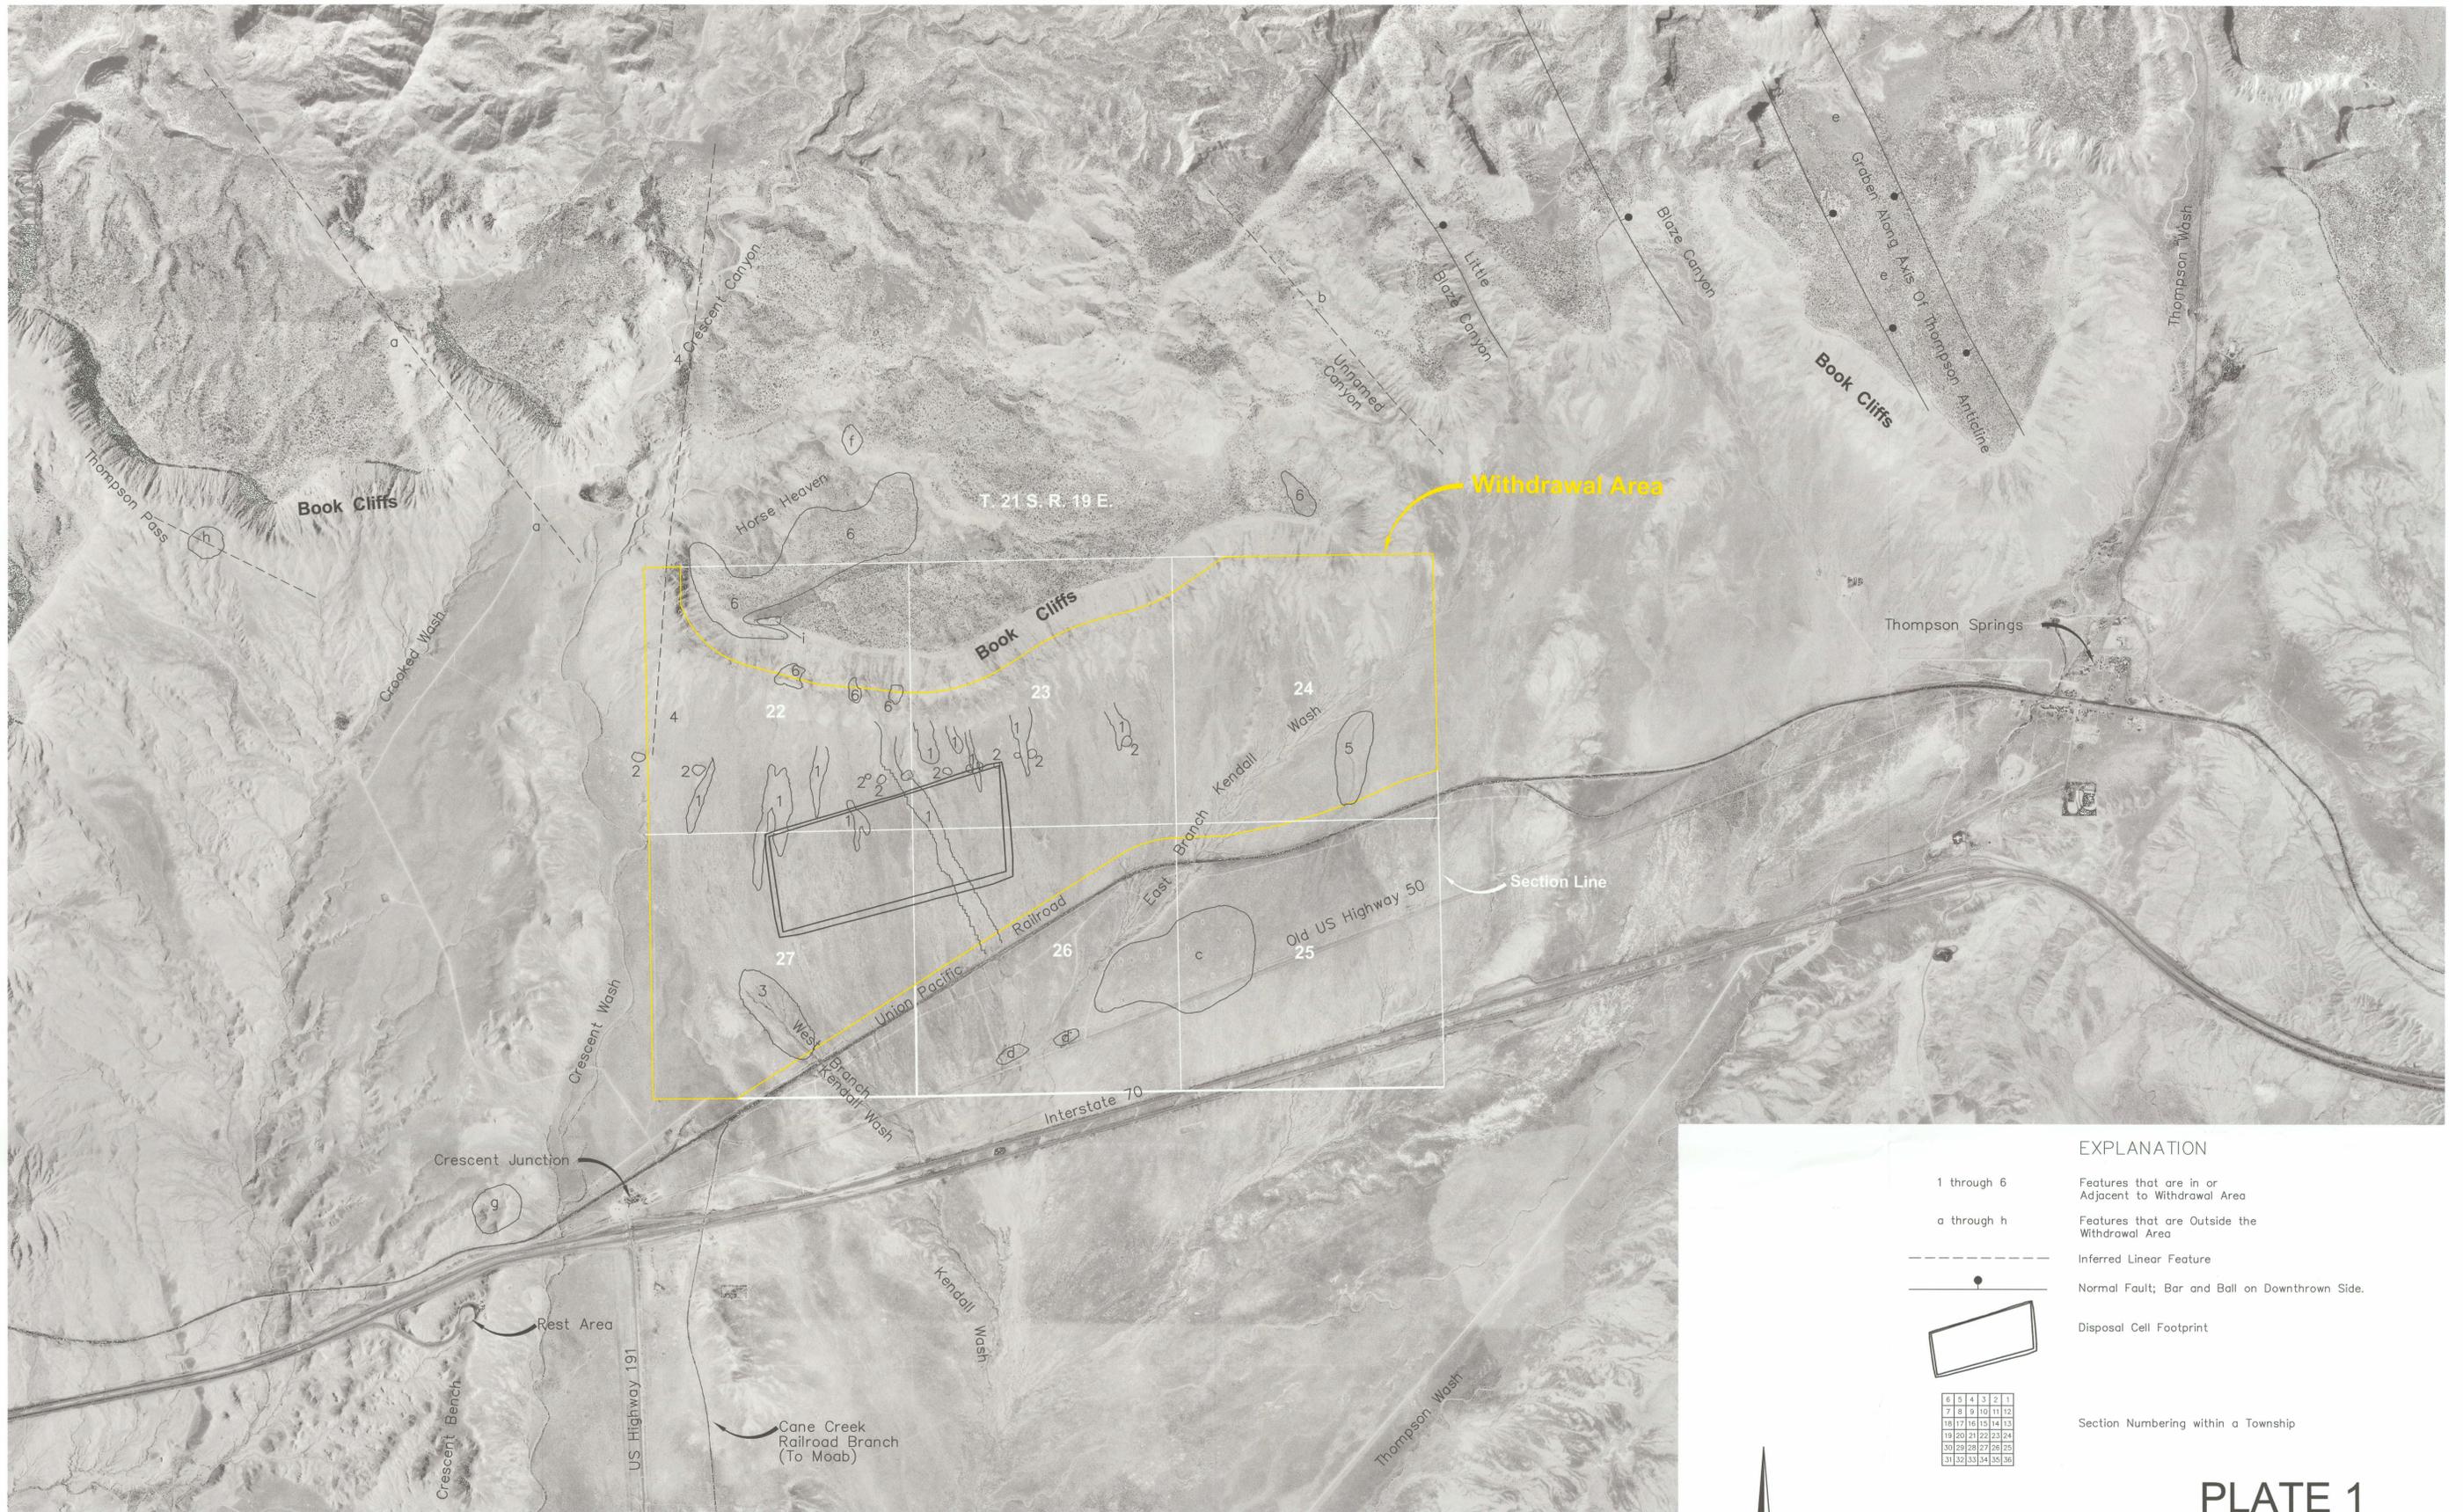
1998 Aerial Photograph

- EXPLANATION**
- 1 through 6 Features that are in or Adjacent to Withdrawal Area
 - a through h Features that are Outside the Withdrawal Area
 - - - - - Inferred Linear Feature
