Appendix C

SEM/EDS Data for Test #1, Day-30 Fiberglass and Filtrate

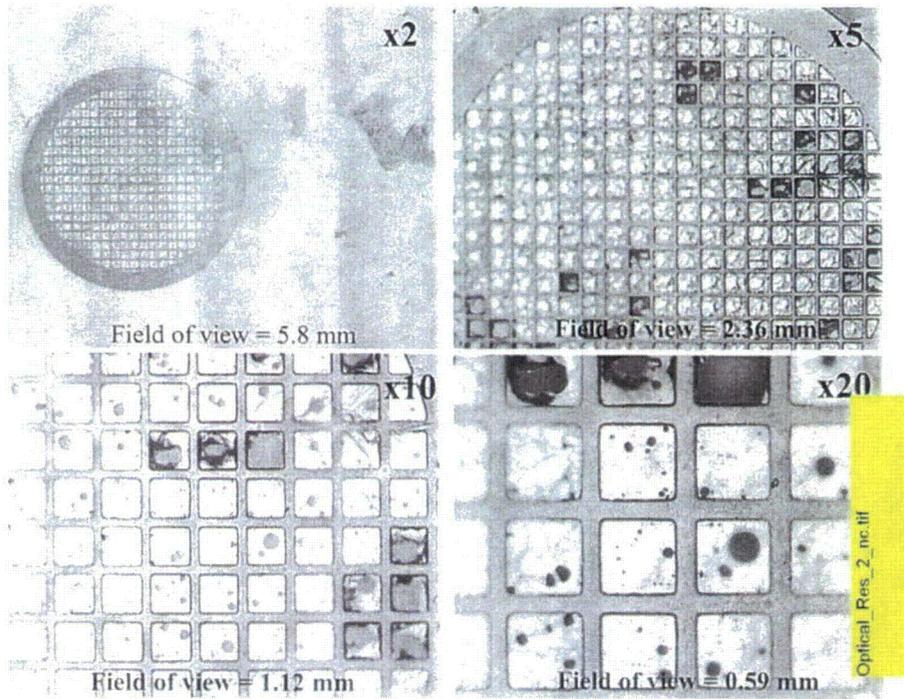
Figure C-1. Spatial resolution reference image for optical microscopy (1 of 2). Field of view refers to the length of the frame in the direction of the text label.

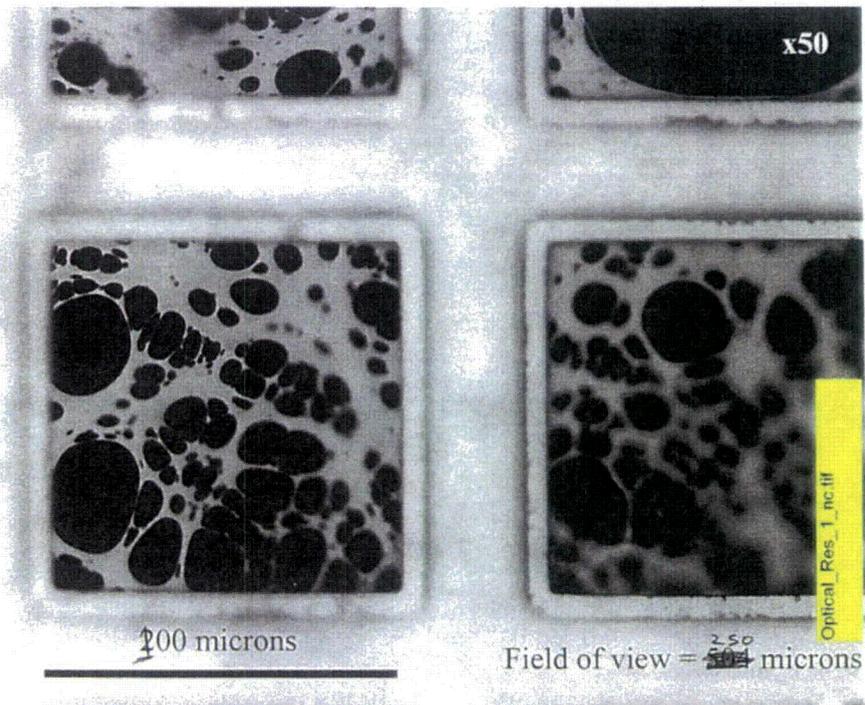
Figure C-2. Spatial resolution reference image (2 of 2). Field of view refers to the length of the respective quadrant in the direction of the text label.

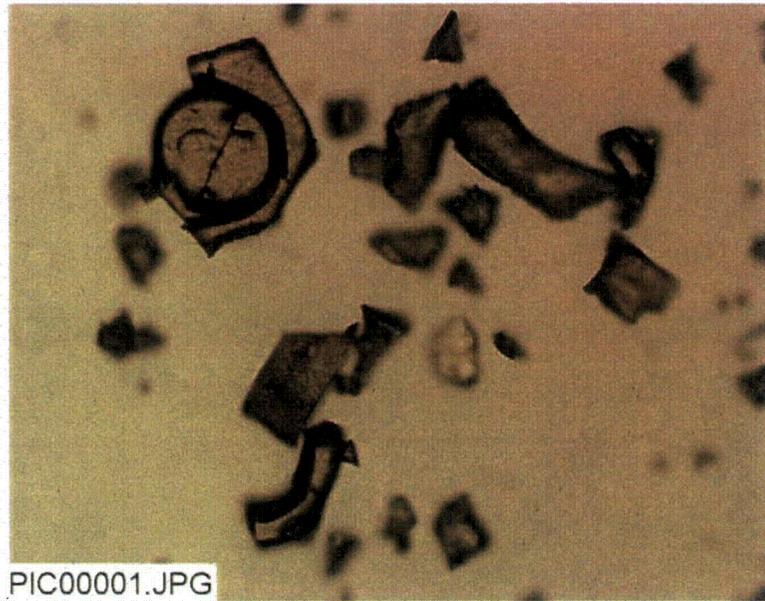
Figure C-3. Plane-polarized optical microscope photograph (PIC00001) for the Day-21 precipitation from the filtered water sample magnified 10 times on the scattered dry fragments.

Frame	I.D.	PIC	Mag	Description
1		PIC00001	× 10	scattered dry fragments
2		PIC00002	× 10	desiccated fragments
3		PIC00003	× 50	single fragment with contraction dome
4		PIC00004	× 50	similar fragment at adjacent area
5		PIC00005	× 10	general cracking pattern
6		PIC00006	× 50	edge of previous area as in PIC00005 larger cracks in the interior and finer cracks near the edge

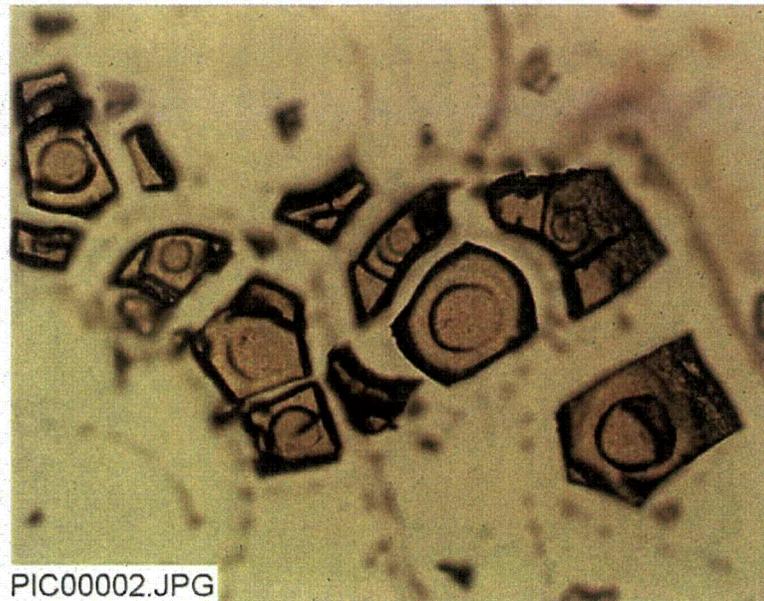
Figure C-4. Plane-polarized optical microscope photograph (PIC00002) for the Day-21 precipitation from the filtered water sample magnified 10 times on the desiccated fragments.

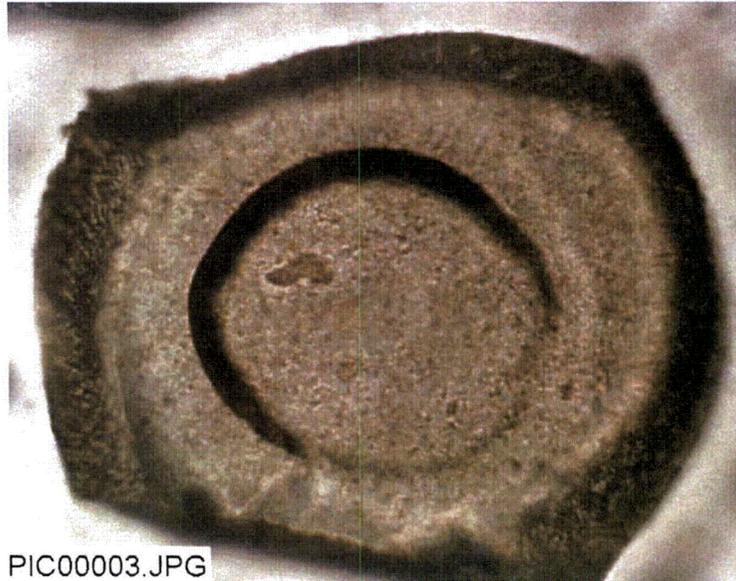
Figure C-5. Plane-polarized optical microscope photograph (PIC00003) for the Day-21 precipitation from the filtered water sample magnified 50 times on the single fragment with contraction dome, as shown in Figure C-4.

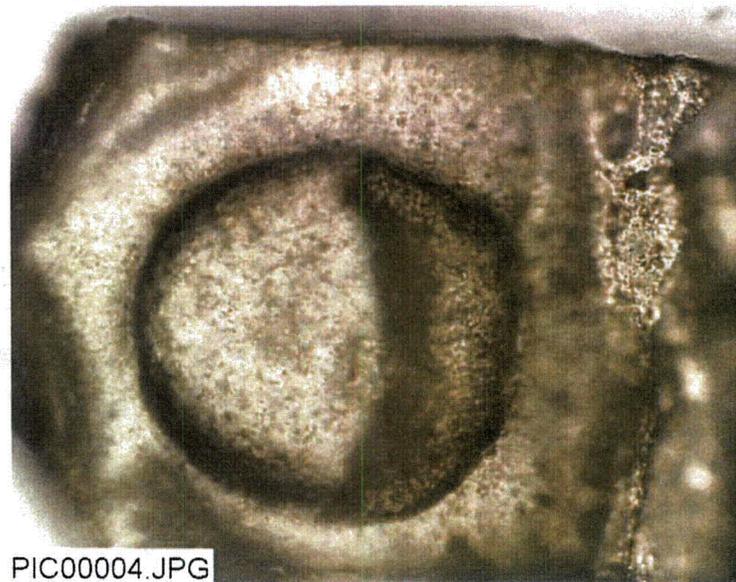
Figure C-6. Plane-polarized optical microscope photograph (PIC00004) for the Day-21 precipitation from the filtered water sample magnified 50 times on the similar adjacent single fragment, as shown in Figure C-4.

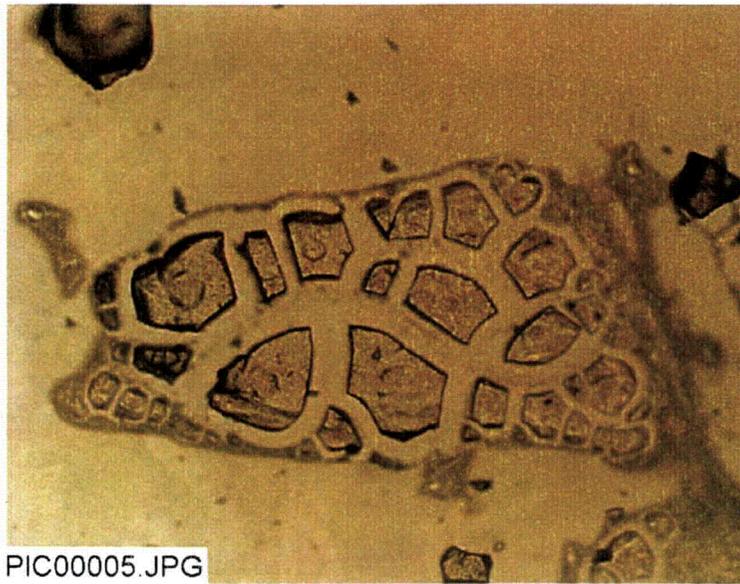
Figure C-7. Plane-polarized optical microscope photograph (PIC00005) for the Day-21 precipitation from the filtered water sample magnified 10 times on the dry fragments, showing the general cracking pattern.

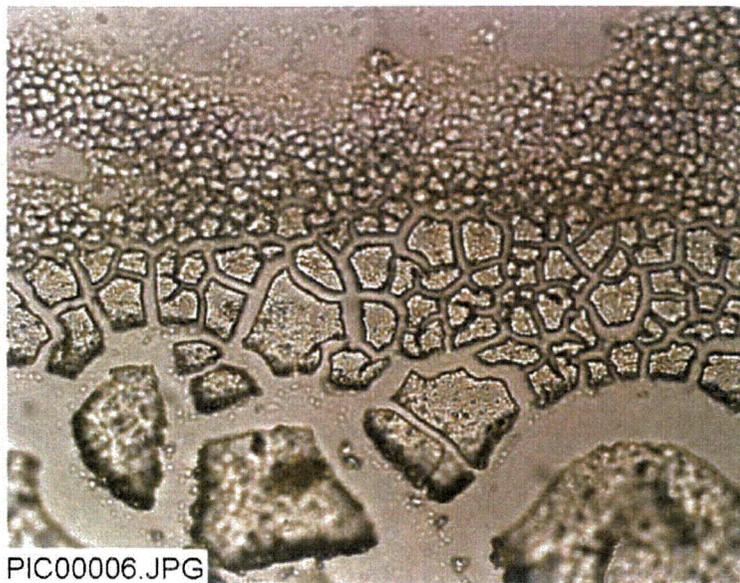
Figure C-8. Plane-polarized optical microscope photograph (PIC00006) for the Day-21 precipitation from the filtered water sample magnified 50 times on the desiccated fragments at the edge of the area in Figure C-7, showing larger cracks in the interior and finer cracks near the edge.

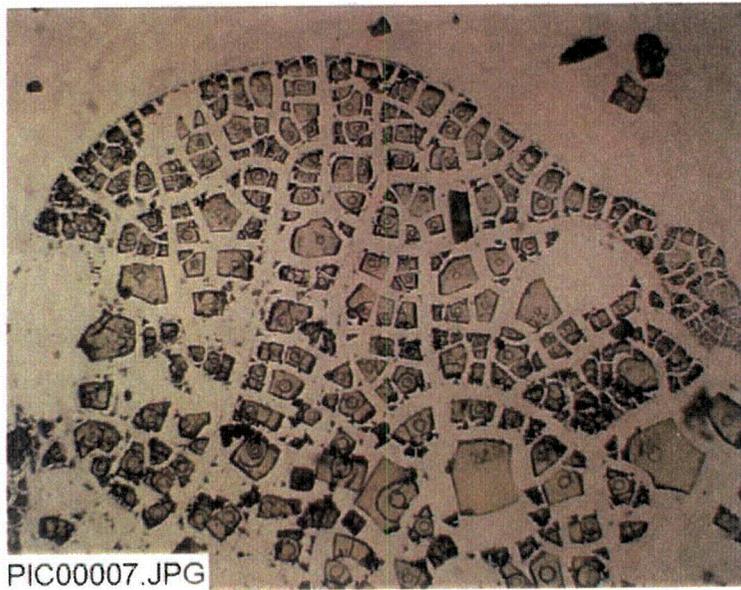
Figure C-9. Plane-polarized optical microscope photograph (PIC00007) for the Day-21 precipitation from the 46-ml high-volume filter magnified 2 times on the desiccated fragments.

Frame	I.D.	PIC	Mag	Description
7		PIC00007	× 2	general desiccated fragments
8		PIC00008	× 5	general desiccated fragments
9		PIC00009	× 5	same field with cross polarized filters showing some evidence of crystal highlights
10		PIC00010	× 5	same field with different exposure time
11		PIC00011	× 10	similar contraction bubbles on desiccated fragments
11b		PIC00012	× 50	zoom in on one of the contraction bubbles

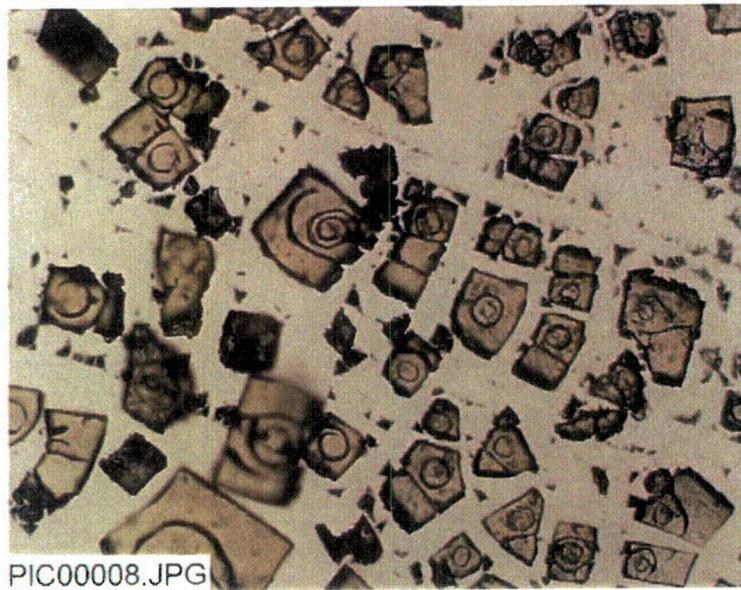
Figure C-10. Plane-polarized optical microscope photograph (PIC00008) for the Day-21 precipitation from the 46-ml high-volume filter magnified 5 times on the desiccated fragments.

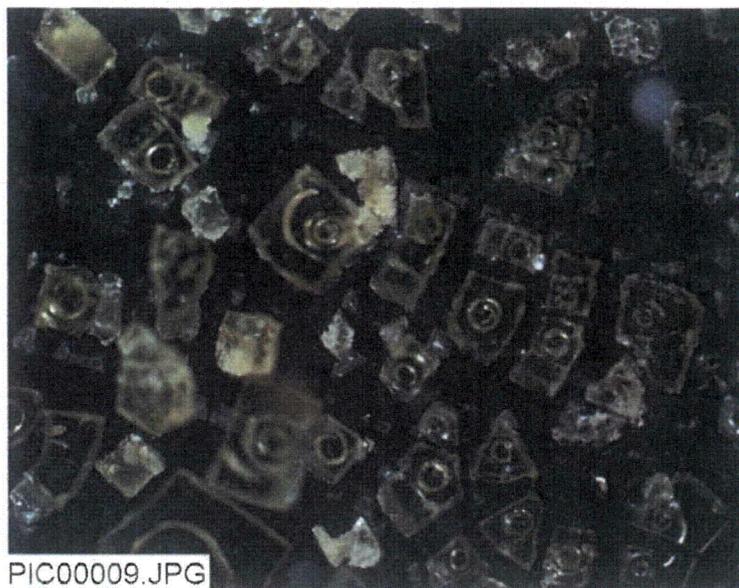
Figure C-11. Cross-polarized optical microscope photograph (PIC00009) of the same field shown in Figure C-10, showing some evidence of crystal highlights in the Day-21 precipitation from the 46-ml high-volume filter; magnified 5 times on the desiccated fragments.

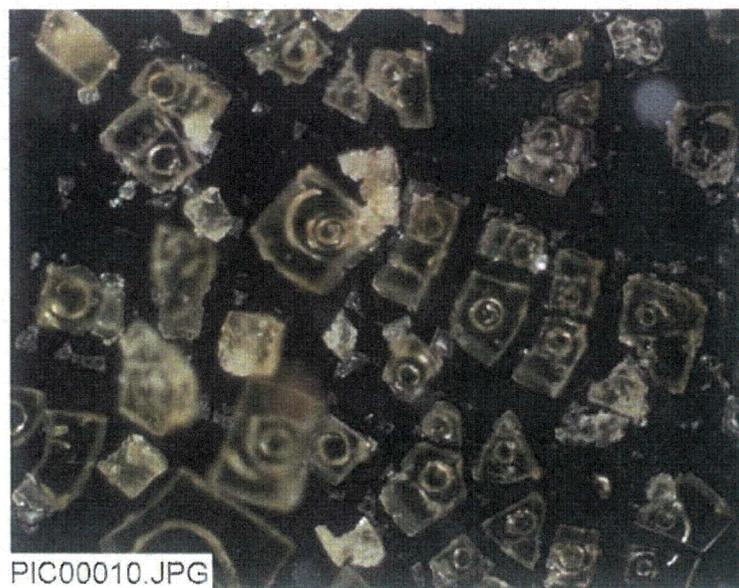
Figure C-12. Optical microscope photograph (PIC00010) with cross polar filters for the Day-21 precipitation from the 46-ml high-volume filter using a different exposure time from Figure C-11.

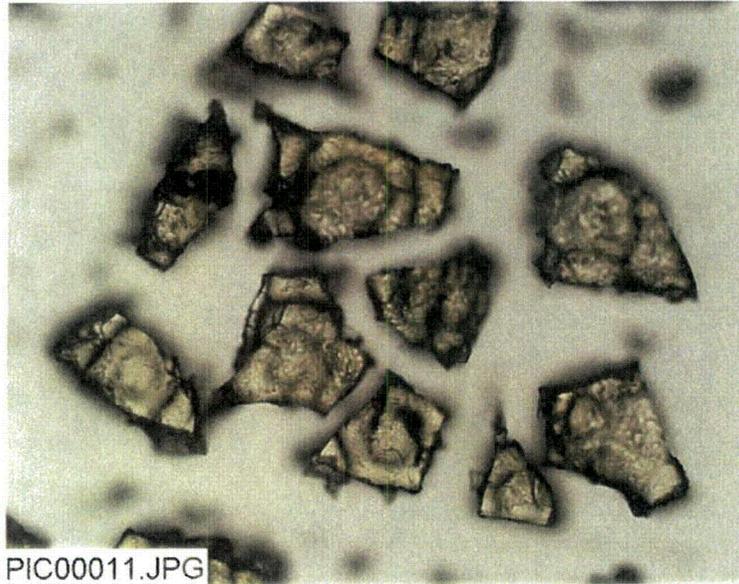
Figure C-13. Plane-polarized optical microscope photograph (PIC00011) for the Day-21 precipitation from the 46-ml high-volume filter magnified 10 times, showing contraction bubbles on the desiccated fragments.

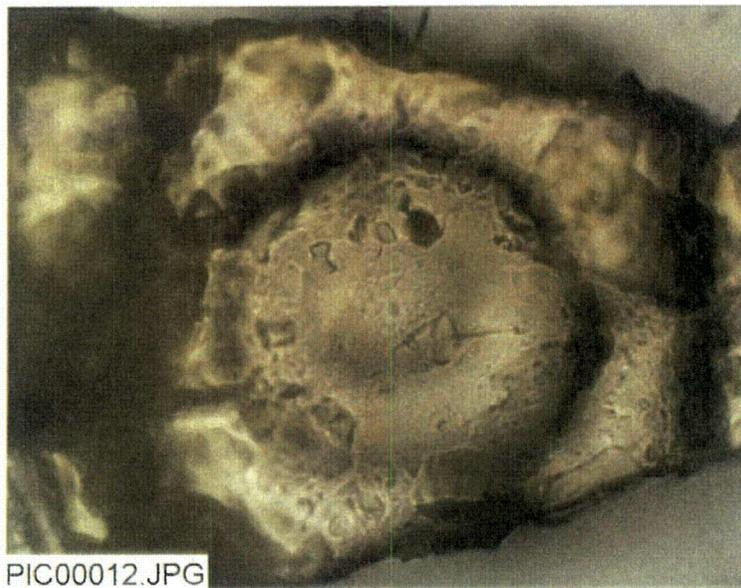
Figure C-14. Plane-polarized optical microscope photograph (PIC00012) for the Day-21 precipitation from the 46-ml high-volume filter magnified 50 times on a single desiccated fragment, showing contraction bubble.

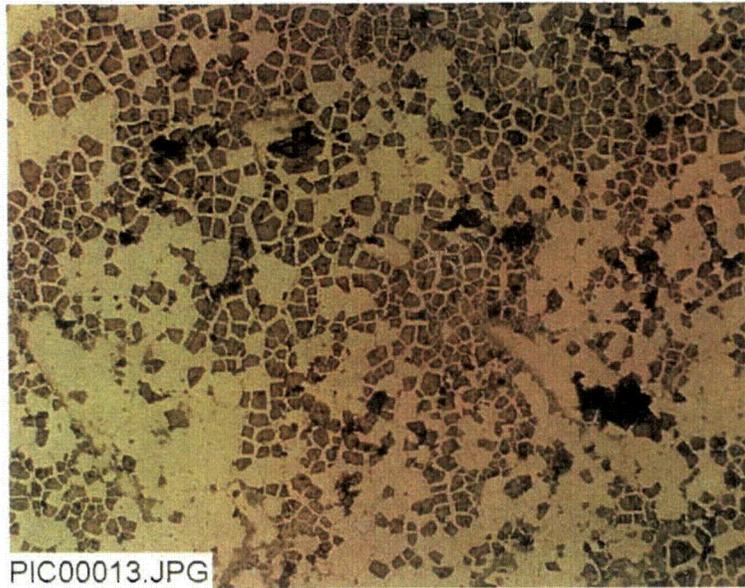
Figure C-15. Plane-polarized optical microscope photograph (PIC00013) for the Day-21 precipitation from the 1-l high-volume filter magnified 5 times on the desiccated fragments.

Frame	I.D.	PIC	Mag	Description
12		PIC00013	× 5	general desiccated fragments
13		PIC00014	× 10	same field as PIC00013 with higher resolution
14		PIC00015	× 50	same field as PIC00013 and PIC00014, some structure but no clear evidence of crystals
14a		PIC00016	× 50	cross polarized to see structure around edges of dry flakes
14b		PIC00017	× 50	cross polarized to see structure around edges of dry flakes with different exposure from PIC00016
15		PIC00018	× 5	anomalous dendrites with polarizers (not saved)
16		PIC00019	× 2	anomalous dendrites with polarizers (not saved)

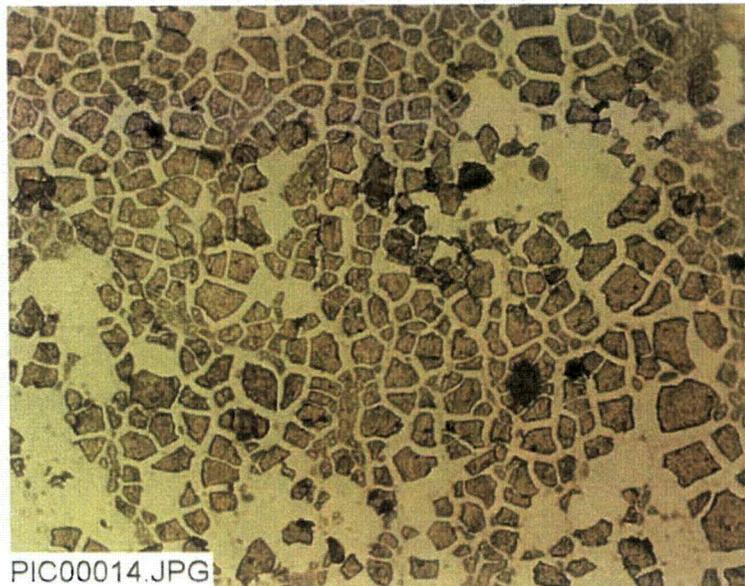
Figure C-16. Plane-polarized optical microscope photograph (PIC00014) for the Day-21 precipitation from the 1-l high-volume filter magnified 10 times on the same desiccated fragments as shown in Figure C-15.

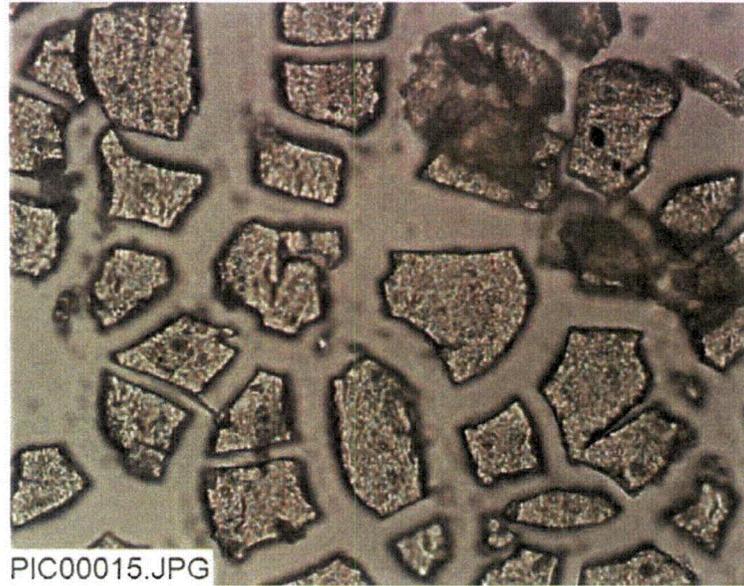
Figure C-17. Plane-polarized optical microscope photograph (PIC00015) for the Day-21 precipitation from the 1-l high-volume filter magnified 50 times on the desiccated fragments, as shown in Figure C-15.

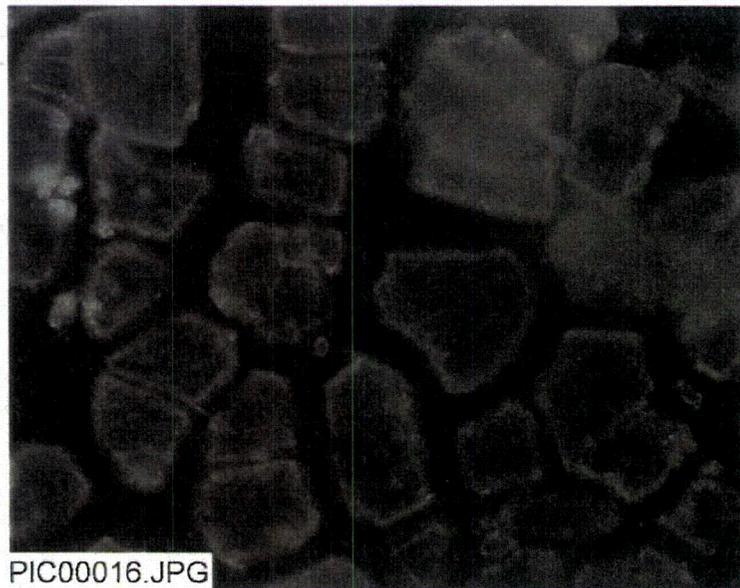
Figure C-18. Cross-polarized optical microscope photograph (PIC00016) for the Day-21 precipitation from the 1-l high-volume filter magnified 50 times to see structure on edges of the dry flakes.

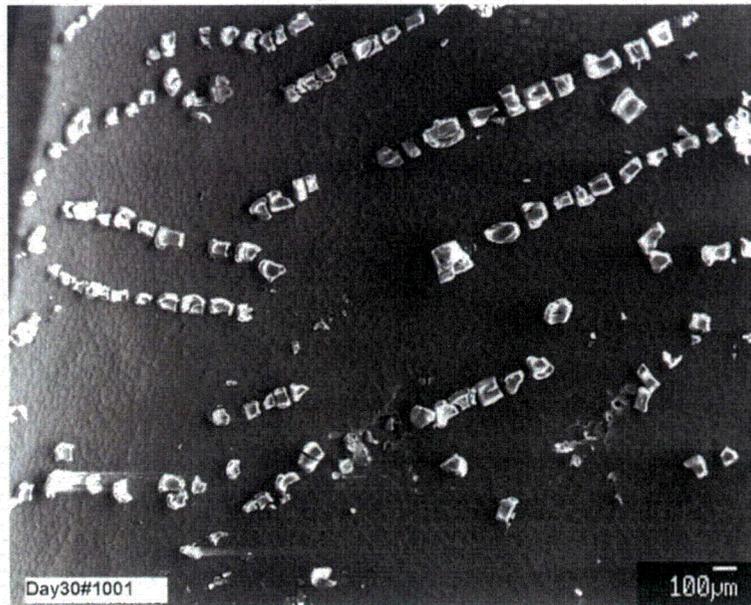
Figure C-20. Day-30, sample #1 SEM image (#1001) magnified 40 times on the string of blocky fragments.

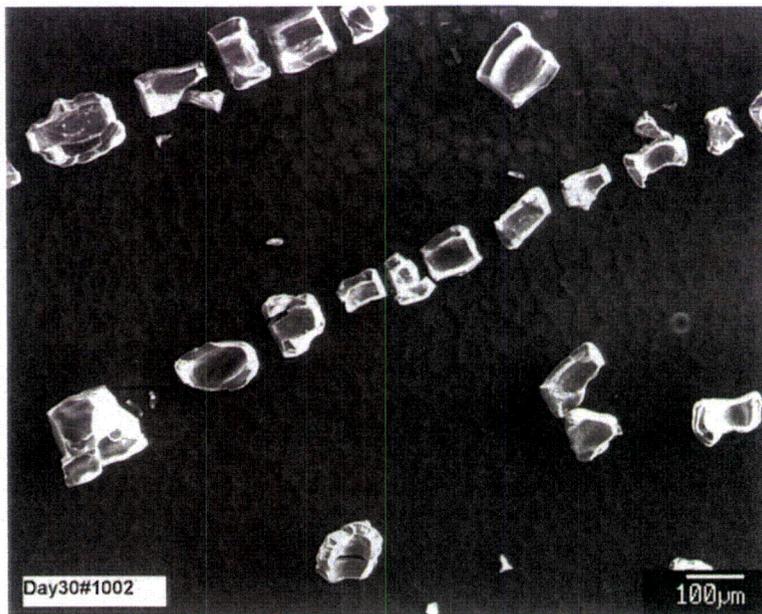
Figure C-21. Day-30, sample #1 SEM image (#1002) magnified 90 times on the string of blocky fragments.

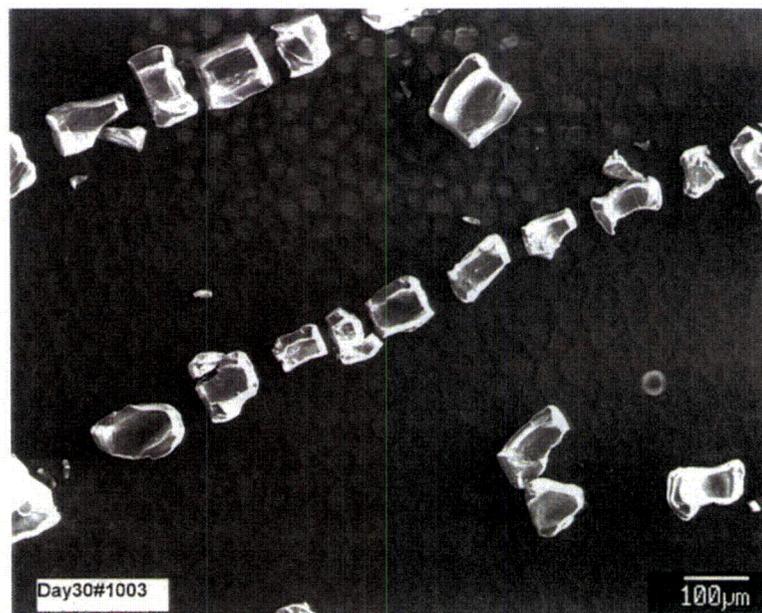
Figure C-22. Day-30, sample #1 SEM image (#1003) magnified 100 times on the string of blocky fragments.

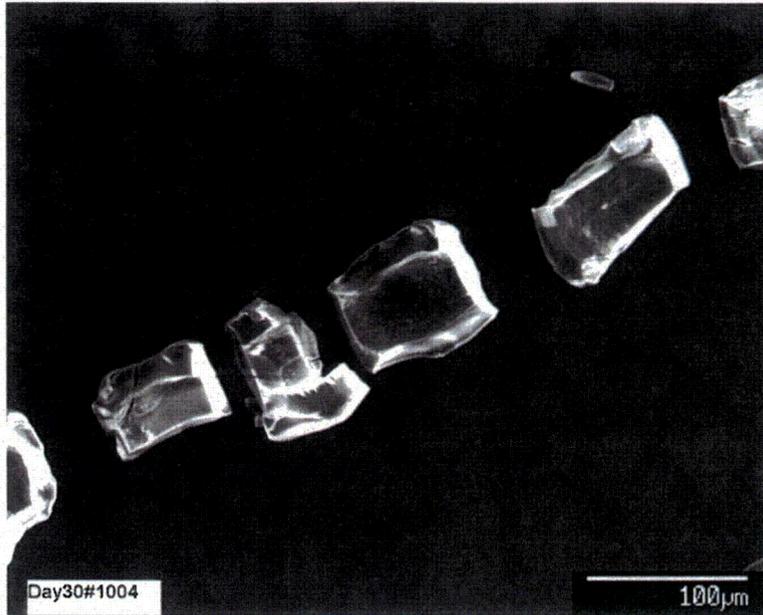
Figure C-23. Day-30, sample #1 SEM image (#1004) magnified 250 times; close-up of the fragments.

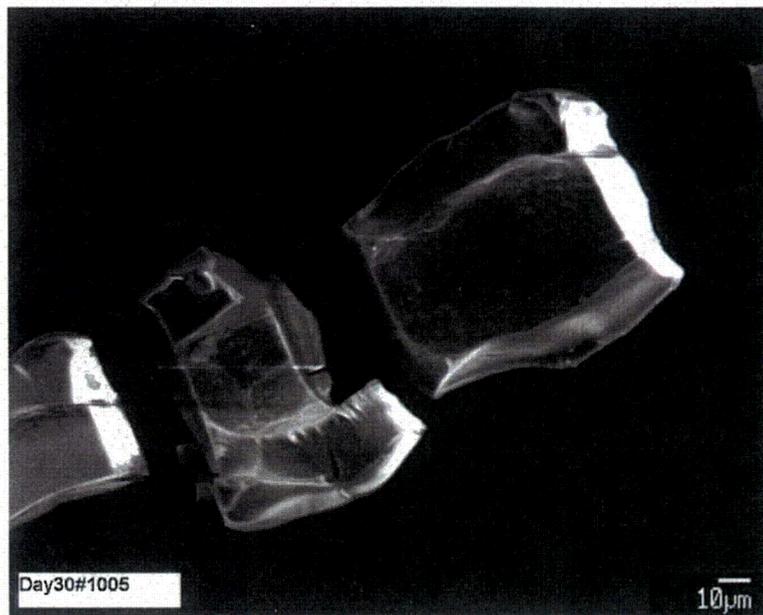
Figure C-24. Day-30, sample #1 SEM image (#1005) magnified 500 times; close-up of the fragments.

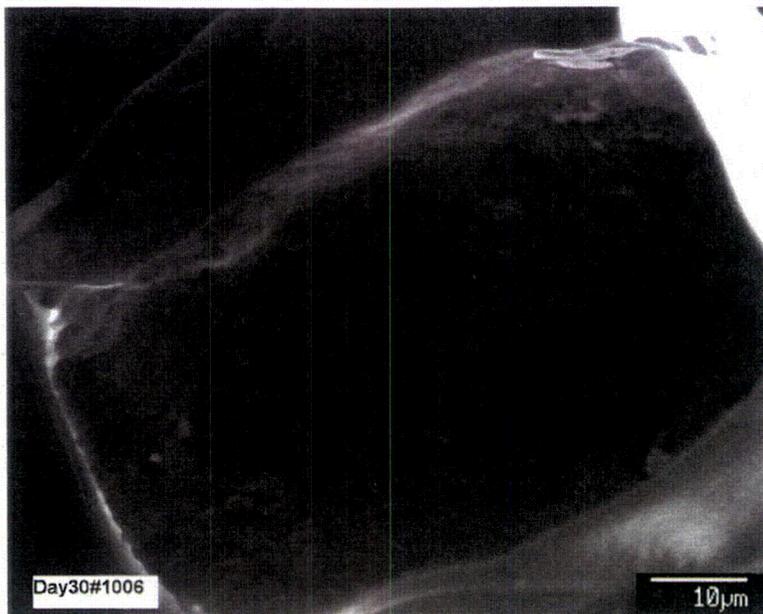
Figure C-25. Day-30, sample #1 SEM image (#1006) magnified 1500 times on the surface of a fragment.

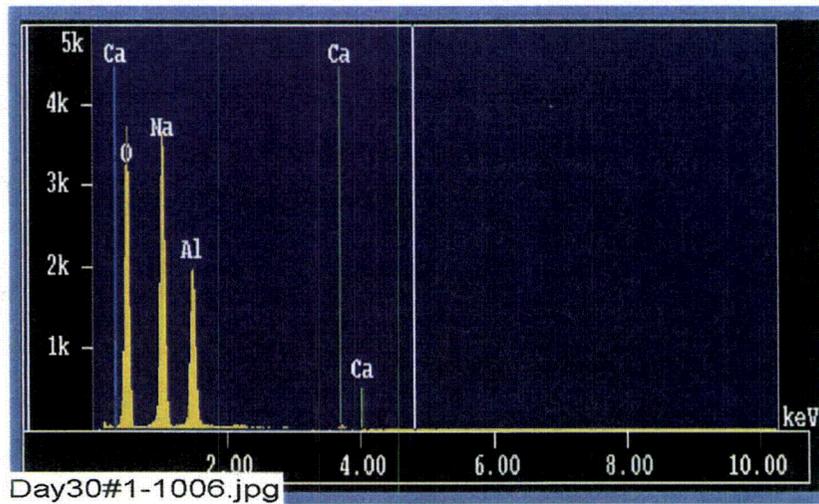
Figure C-26. Day-30, sample #1 counting spectrum (EDS 1-1006) for the fragment in Figure C-25 with a composition of Na, Al, O₂, and Ca.

Image:	Day-30 #1001	40 ×	on string of fragments
	Day-30 #1002	90 ×	string of blocky fragments
	Day-30 #1003	100 ×	string of blocky fragments
	Day-30 #1004	250 ×	close-up of fragments
	Day-30 #1005	500 ×	close-up of particles
	Day-30 #1006	1500 ×	surface of fragments
EDS:	1-1006		fragment in image 1006 showing Na, Al, O ₂ , Ca
	1-1006a		adjacent particles
	1-1006b		20-s exposure time—lower Na
	1-1006c		60-s scan for the same spot
Image:	Day-30 #1007	40 ×	filtrate on carbon-film substrate
	Day-30 #1008	100 ×	close-up of filtrate on carbon-film substrate
	Day-30 #1009	250 ×	close-up of filtrate on carbon-film substrate
EDS:	1-1009		carbon-film substrate in image 1009
Image:	Day-30 #1010	50 ×	area of filtrate
	Day-30 #1011	100 ×	area of filtrate
	Day-30 #1012	250 ×	area of filtrate
	Day-30 #1013	500 ×	area of filtrate
EDS:	1-1013		analysis of filtrate on carbon-film substrate
	1-1013a		analysis of filtrate on carbon-film substrate

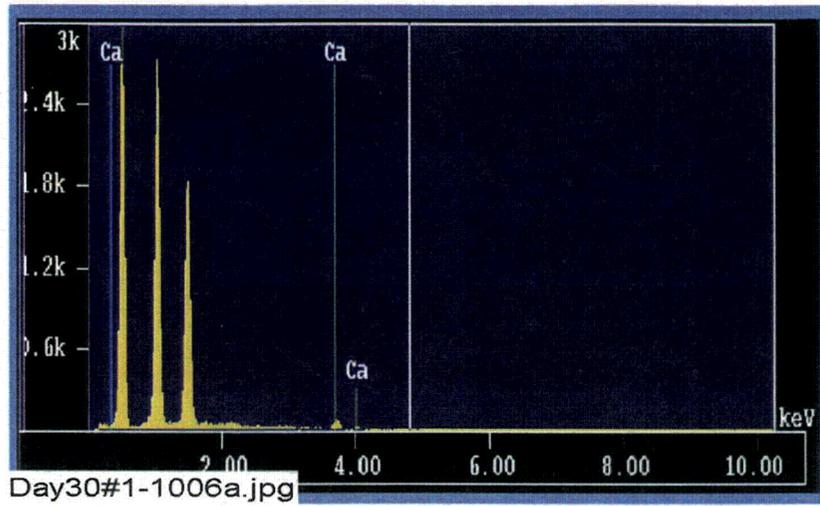
Figure C-27. Day-30, sample #1 counting spectrum (EDS 1-1006a) for the adjacent particles compared with that in Figure C-25 with a composition of Na, Al, O₂, and Ca.

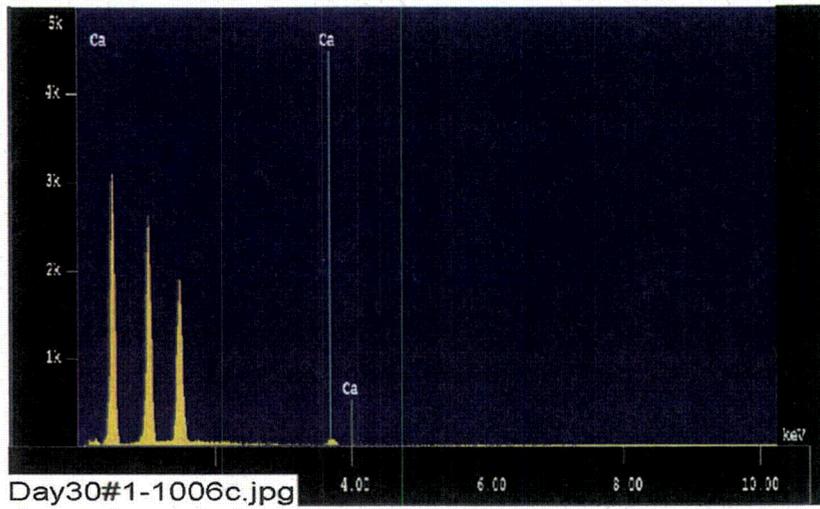
Figure C-29. Day-30, sample #1 counting spectrum (EDS 1-1006c).

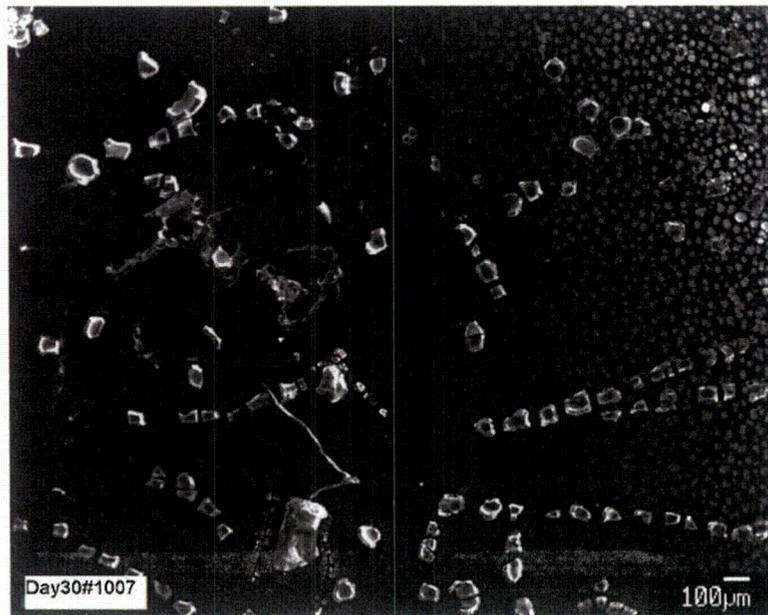
Figure C-30. Day-30, sample #1 SEM image (#1007) magnified 40 times of filtrate on carbon film substrate.

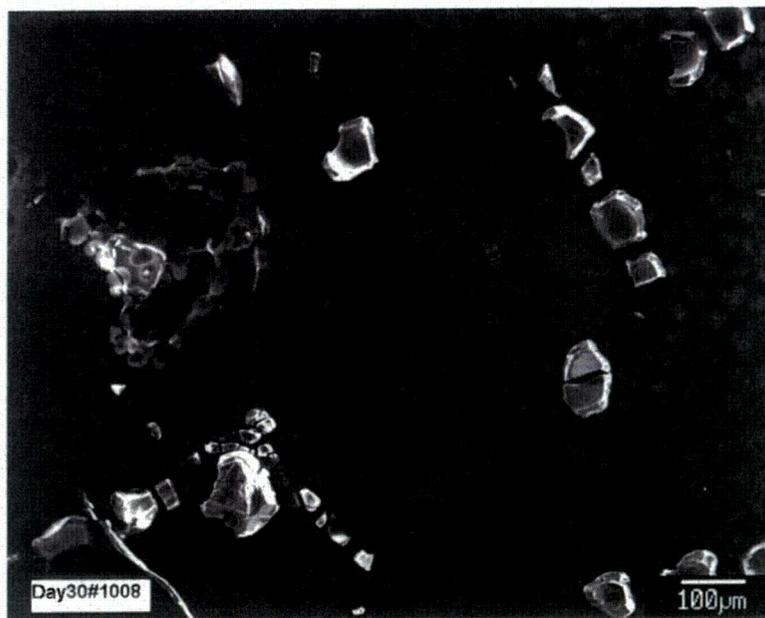
Figure C-31. Day-30, sample #1 SEM image (#1008) magnified 100 times; close-up of filtrate on carbon film substrate, as shown in Figure C-30.

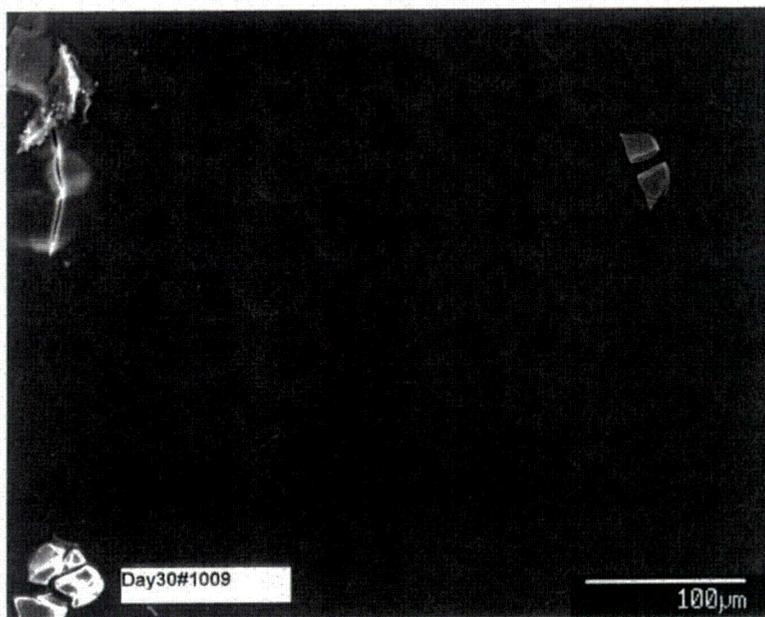
Figure C-32. Day-30, sample #1 SEM image (#1009) magnified 250 times; close-up of the carbon-film substrate, as shown in Figure C-31.

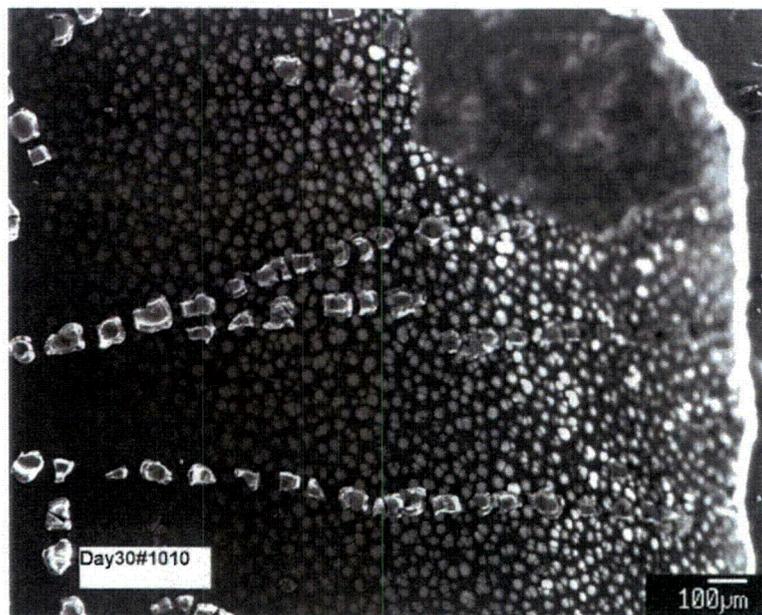
Figure C-34. Day-30, sample #1 SEM image (#1010) magnified 50 times on one area of the filtrate.

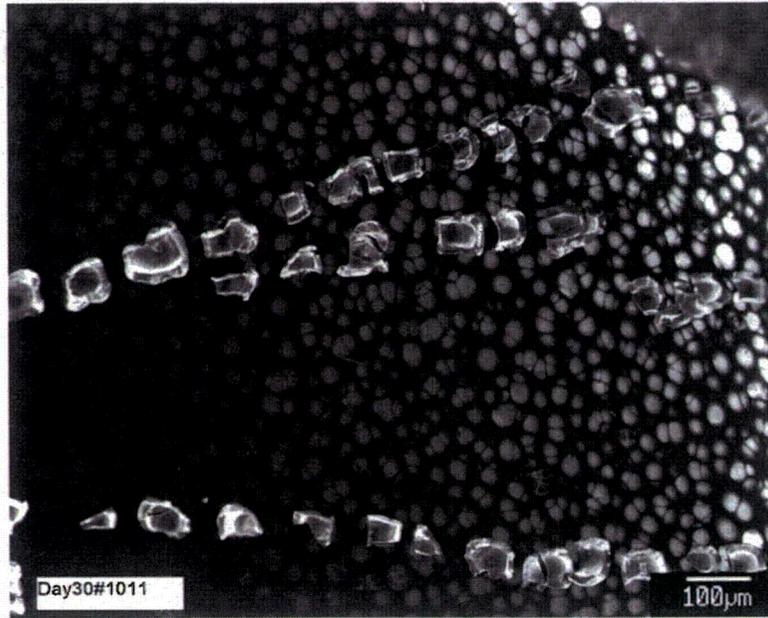
Figure C-35. Day-30, sample #1 SEM image (#1011) magnified 100 times on one area of the filtrate.

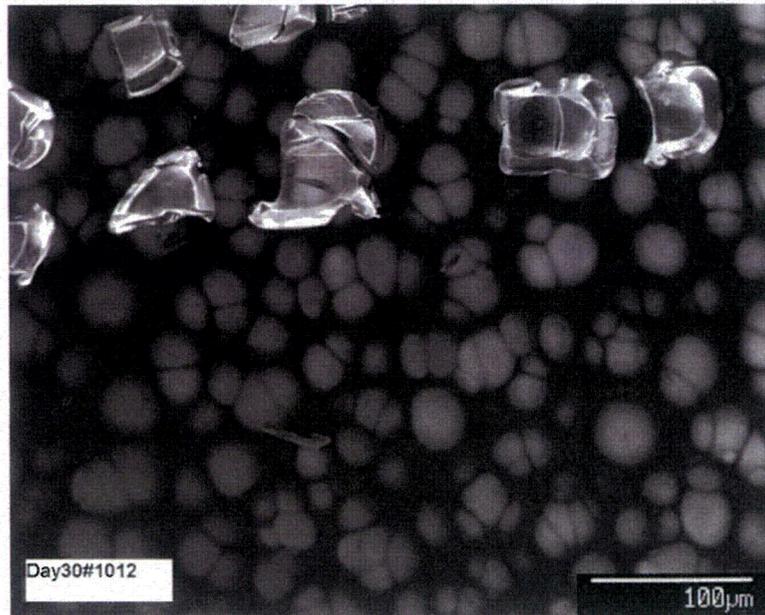
Figure C-36. Day-30, sample #1 SEM image (#1012) magnified 250 times on one area of the filtrate.

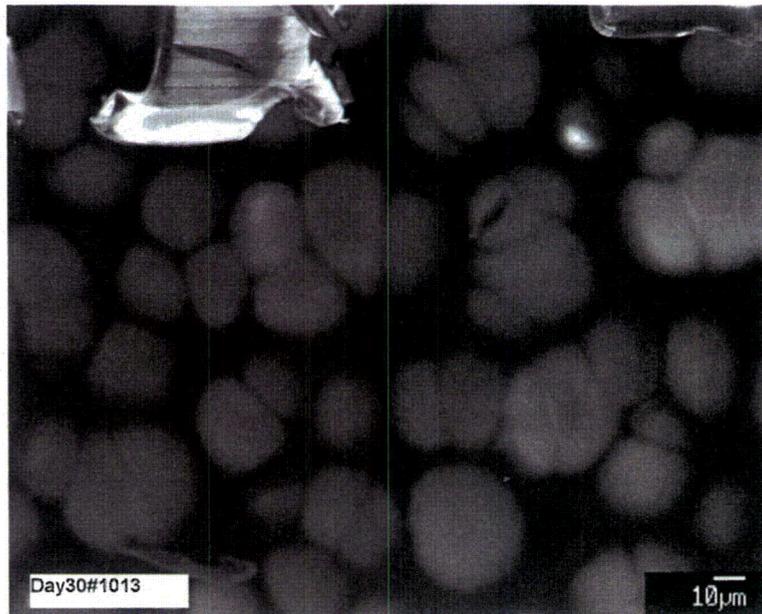
Figure C-37. Day-30, sample #1 SEM image (#1013) magnified 500 times on one area of the filtrate.

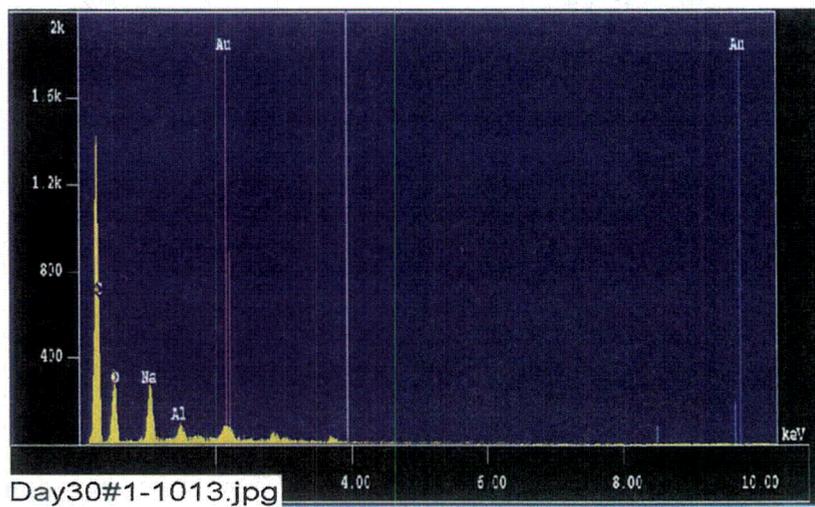
Figure C-38. Day-30, sample #1 counting spectrum (EDS 1-1013) for the filtrate on the carbon-film substrate, as shown in Figure C-37.

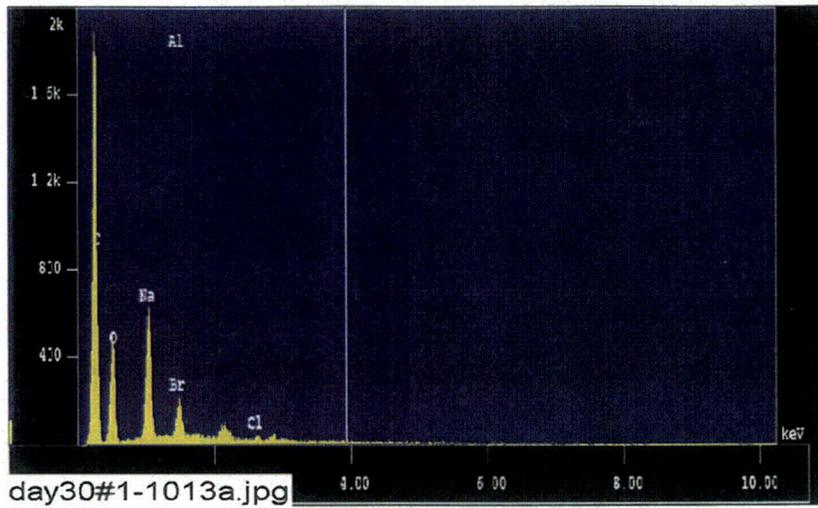
Figure C-39. Day-30, sample #1 counting spectrum (EDS 1-1013a) for the filtrate on the carbon-film substrate, as shown in Figure C-37.

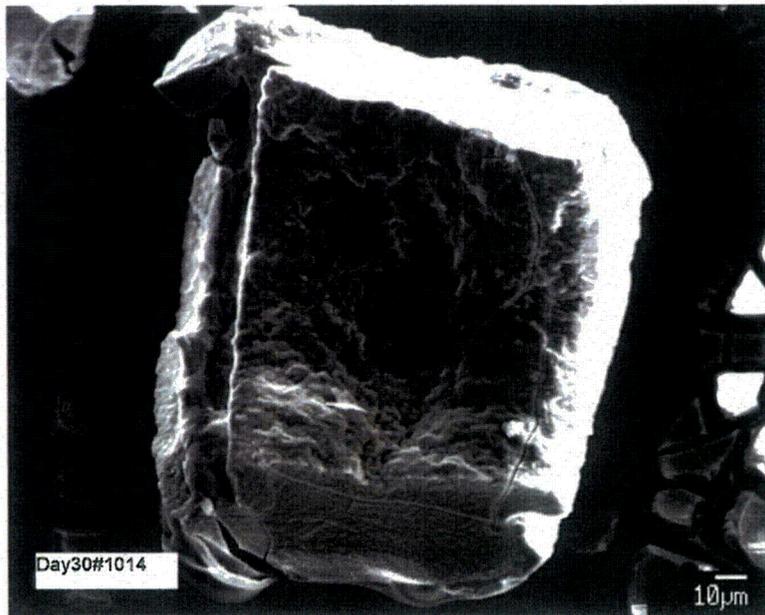
Figure C-40. Day-30, sample #1 SEM image (#1014) magnified 500 times on the block filtrate on the carbon-film substrate.

Image:	Day 30 #1014	500 ×	block fragment on carbon-film substrate
EDS:	1-1014		EDS on particulate
Image:	Day-30 #1015	2000 ×	close-up of fracture surface

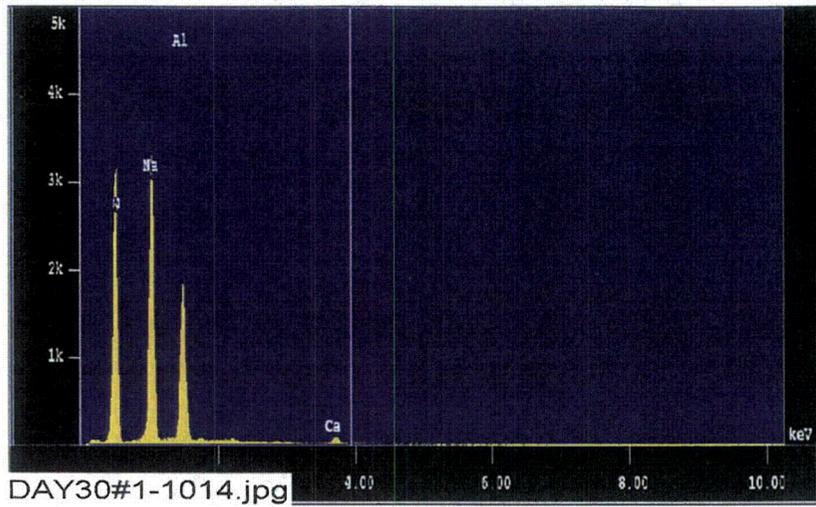
Figure C-41. Day-30, sample #1 counting spectrum (EDS 1-1014) on the particle, as shown in Figure C-40.

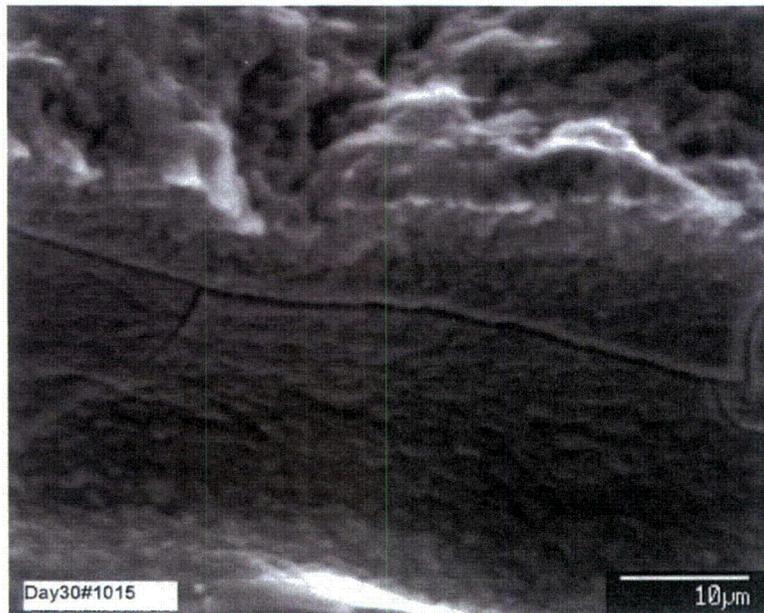
Figure C-42. Day-30, sample #1 SEM image (#1015) magnified 2000 times, close-up of the fracture surface, as shown in Figure C-40.

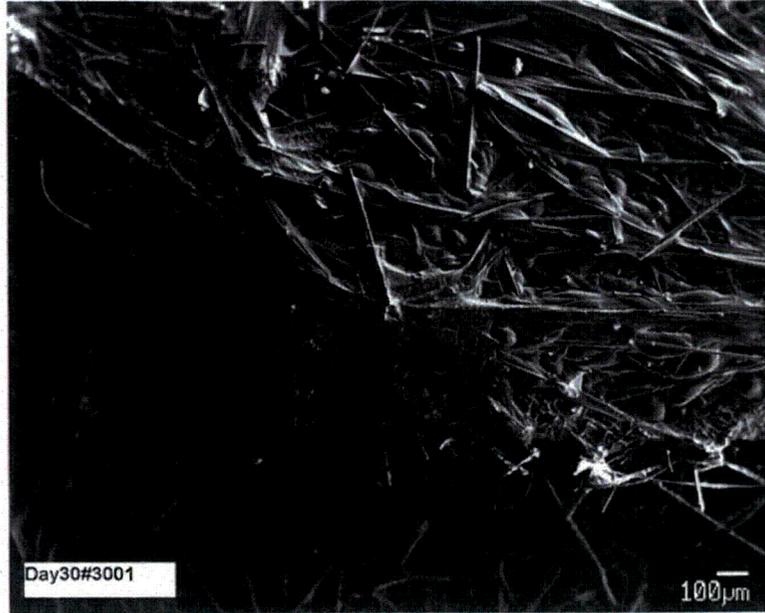
Figure C-43. Day-30, sample #3 SEM image (#3001) magnified 50 times on the fiberglass with surface coating.

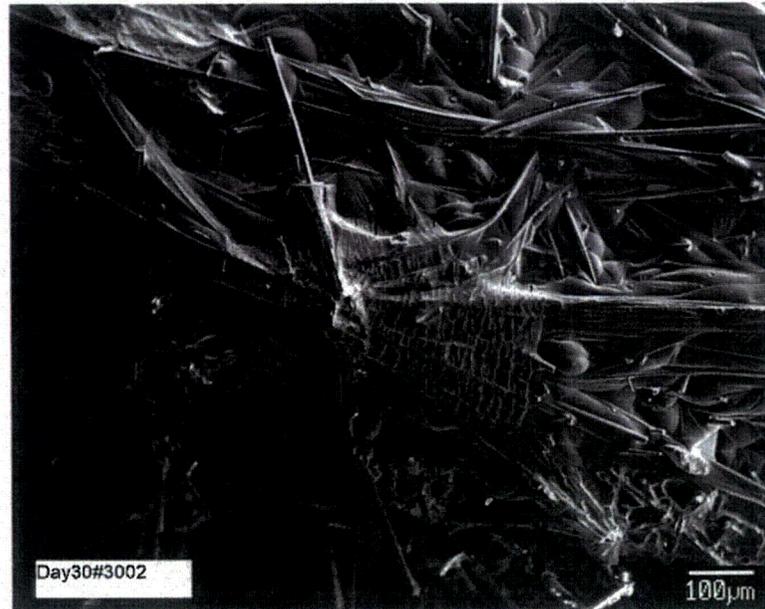
Figure C-44. Day-30, sample #3 SEM image (#3002) magnified 100 times on the fiberglass with surface coating.

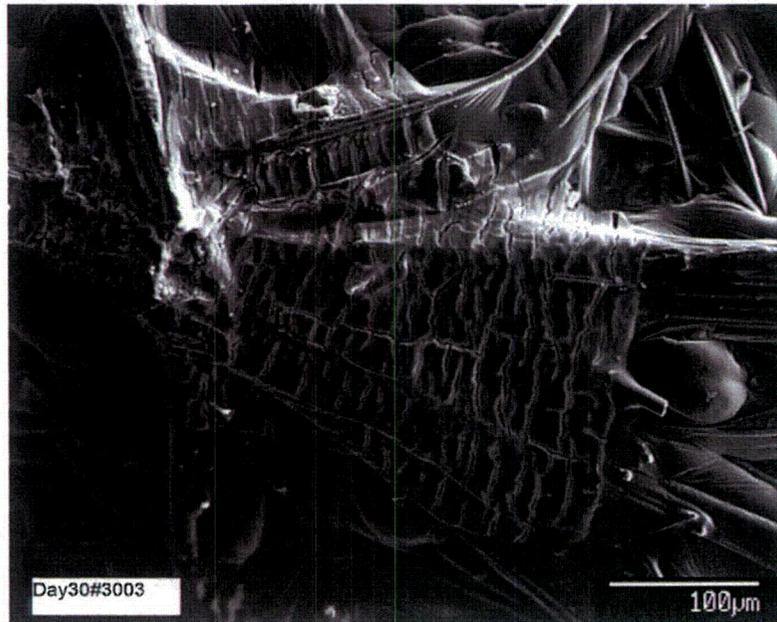
Figure C-45. Day-30, sample #3 SEM image (#3003) magnified 250 times on the fiberglass with surface coating.

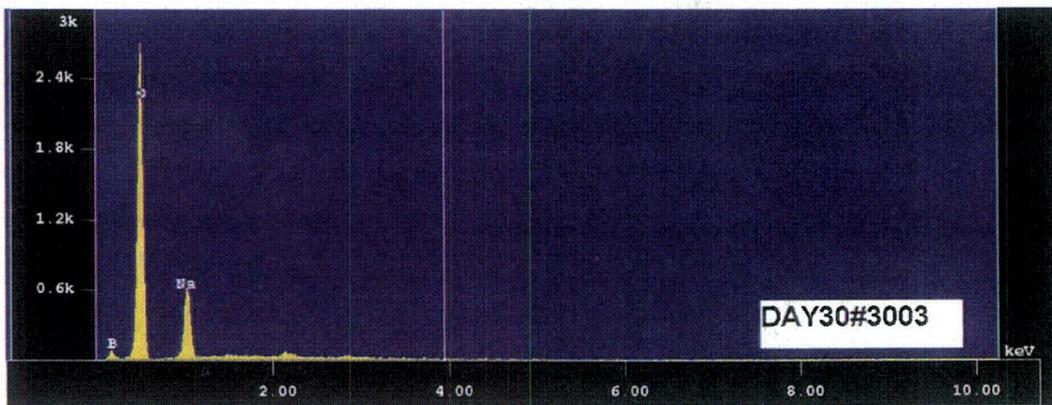
Figure C-46. Day-30, sample #3 counting spectrum (EDS #3003) of the fractured coating, as shown in Figure C-45.

Image:	Day-30 #3001	50 ×	fiberglass with surface coating
	Day-30 #3002	100 ×	fiberglass with surface coating
	Day-30 #3003	250 ×	close-up of surface coating
EDS:	3003		spectrum of fractured coating (Na, B, O)
Image:	Day-30 #3004	500 ×	close-up of fractured surface
	Day-30 #3005	100 ×	fiber with film
	Day-30 #3006	250 ×	films across fiber
	Day-30 #3007	500 ×	films across fiber
EDS:	3007a		analysis of film
Image:	Day-30 #3008	450 ×	particles on film
EDS:	3008a		analysis of particles
	3008b		analysis of fiber

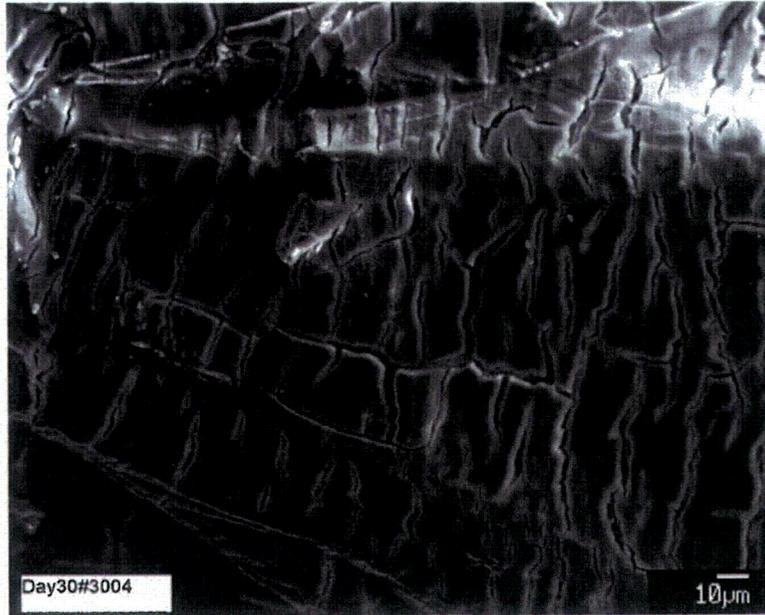
Figure C-47. Day-30, sample #3 SEM image (#3004) magnified 500 times; close-up of the fractured surface.
