Appendix C

SEM/EDS Data for Test #1, Day-30 Fiberglass and Filtrate

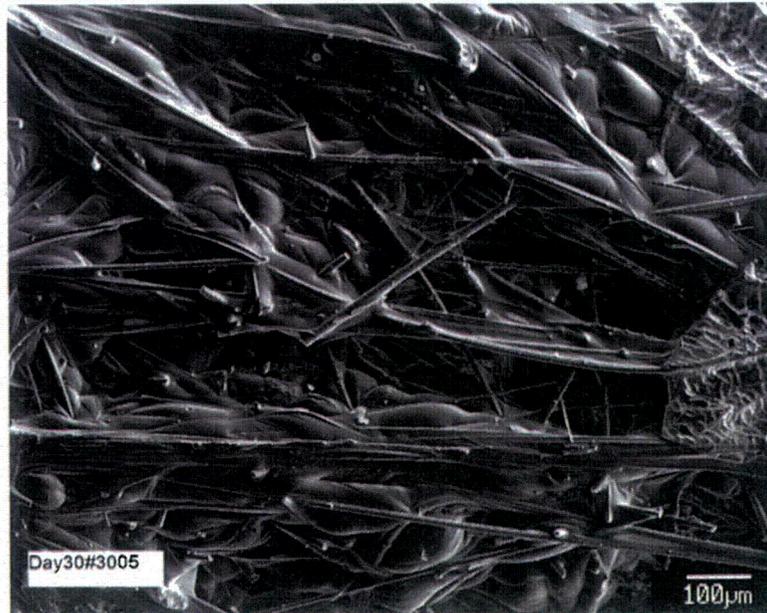
Figure C-48. Day-30, sample #3 SEM image (#3005) magnified 100 times on the fiber with film.

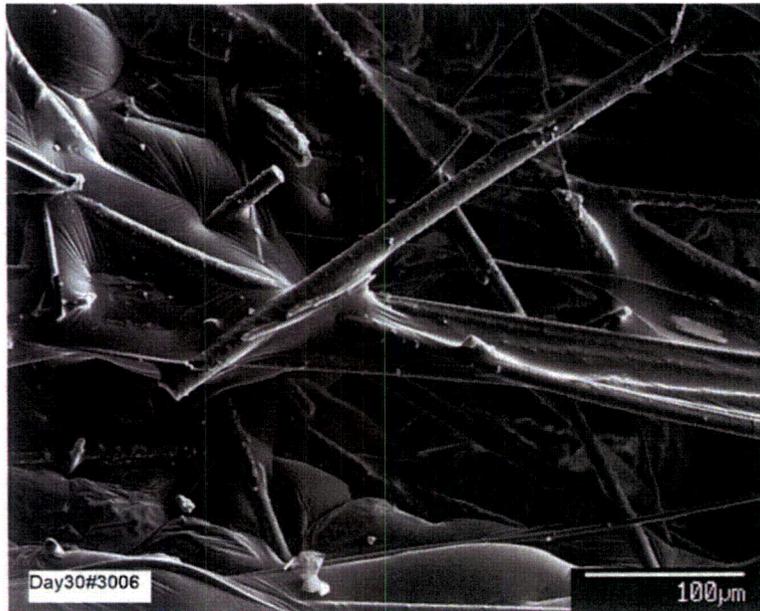
Figure C-49. Day-30, sample #3 SEM image (#3006) magnified 250 times on the film across the fibers.

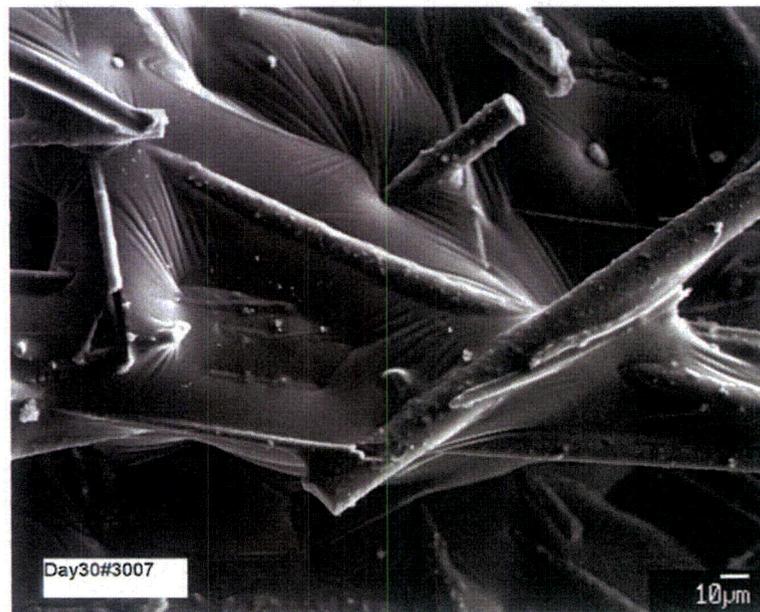
Figure C-50. Day-30, sample #3 SEM image (#3007) magnified 500 times on the film across the fibers.

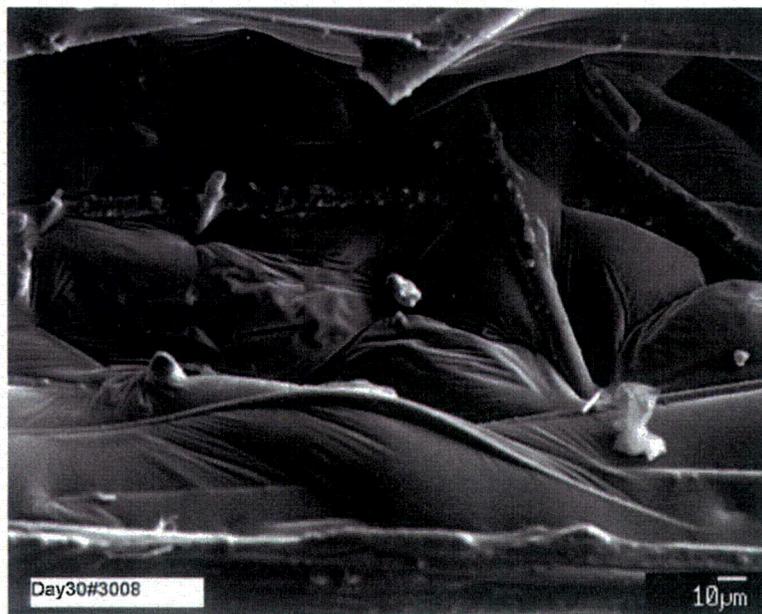
Figure C-52. Day-30, sample #3 SEM image (#3008) of particles on the film, magnified 450 times.

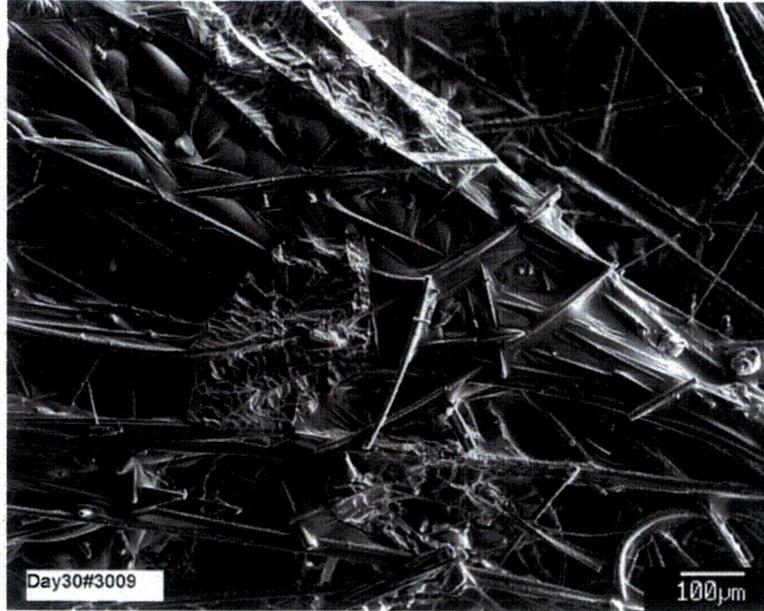
Figure C-55. Day-30, sample #3 SEM image (#3009) magnified 100 times on a group of fibers.

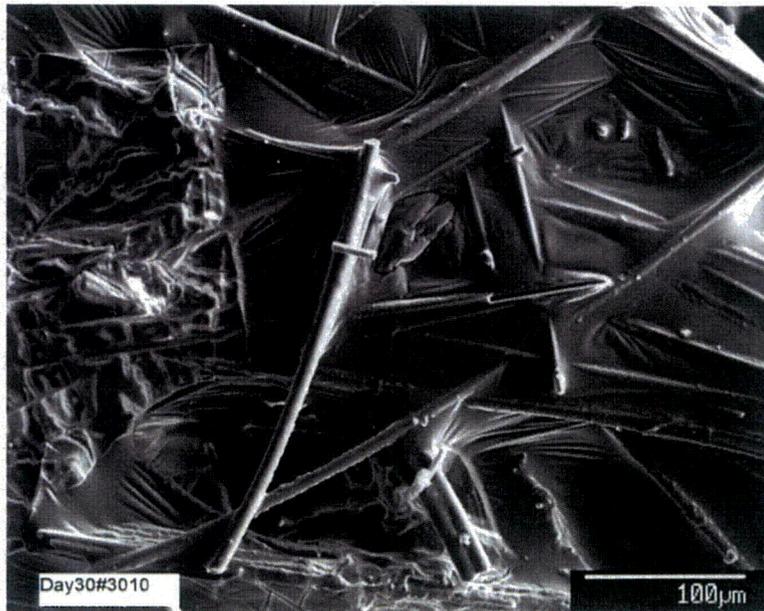
Figure C-56. Day-30, sample #3 SEM image (#3010) magnified 250 times; close-up of the film.

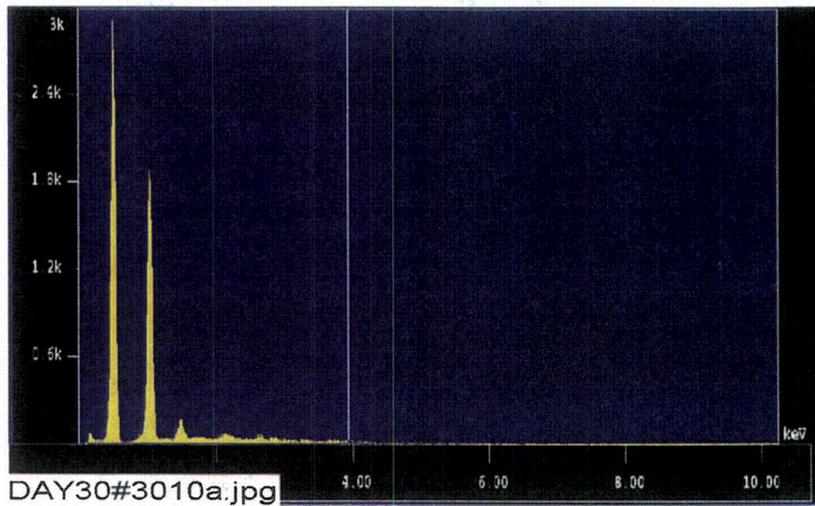
Figure C-57. Day-30, sample #3 counting spectrum (EDS #3010a) of precipitate on the film.

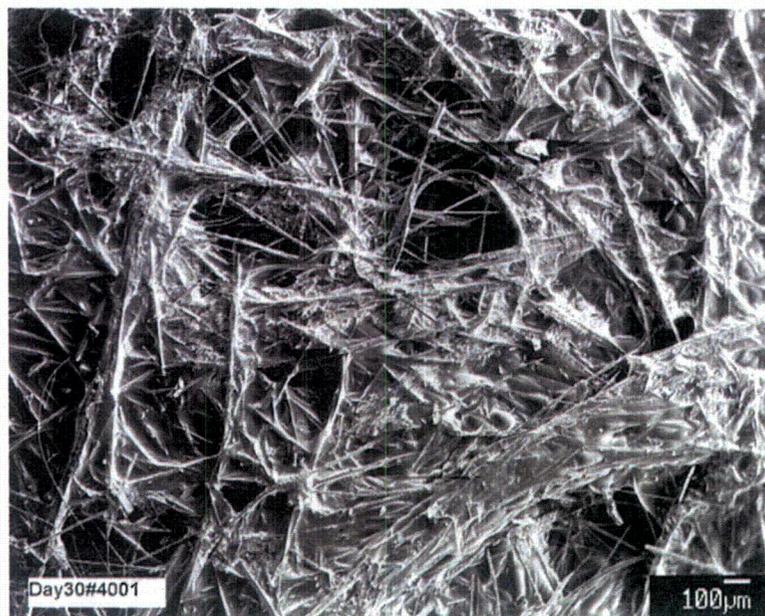
Figure C-58. Day-30, sample #4 SEM image (#4001) of fiber cluster with film, magnified 40 times.

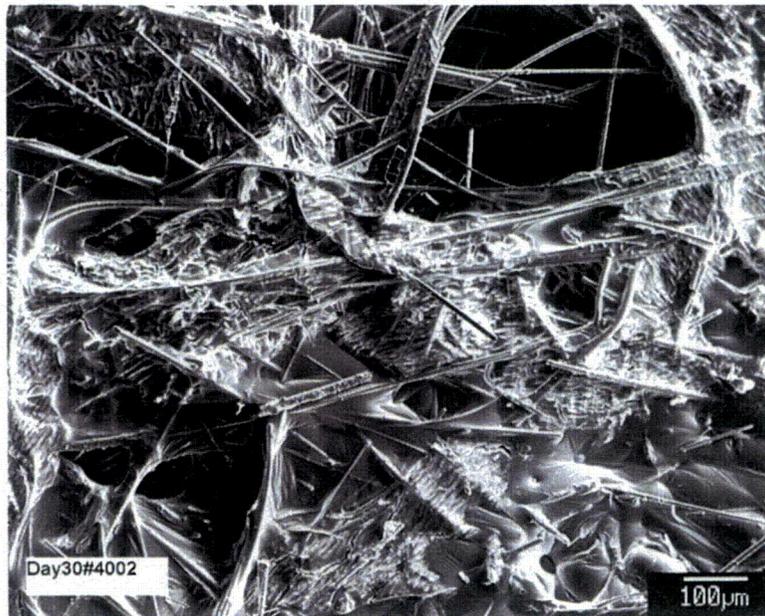
Figure C-59. Day-30, sample #4 SEM image (#4002) of fiber cluster with film, magnified 100 times.

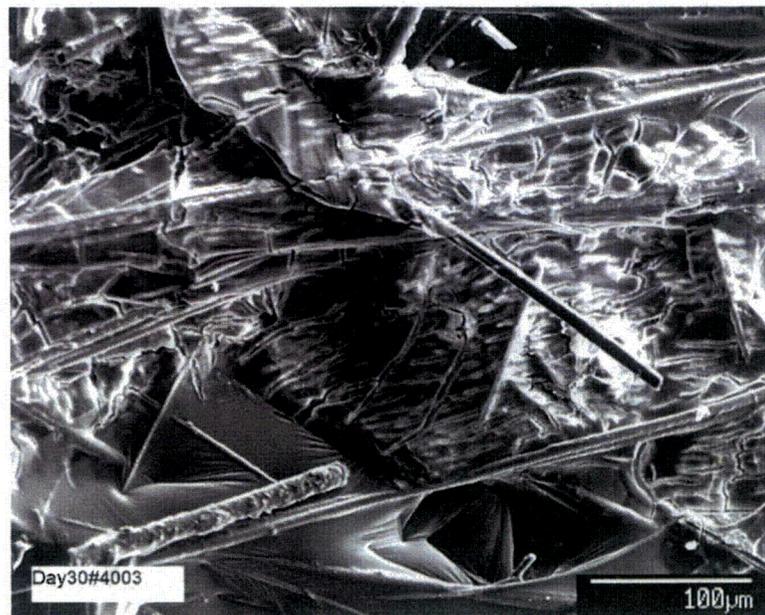
Figure C-60. Day-30, sample #4 SEM image (#4003) of fiber cluster with film, magnified 250 times.

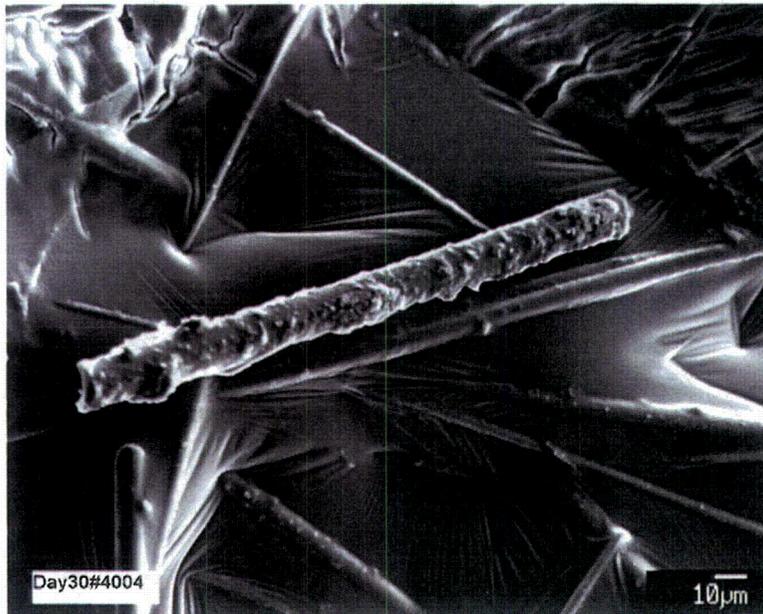
Figure C-61. Day-30, sample #4 SEM image (#4004) close-up of fiber with film, magnified 500 times.

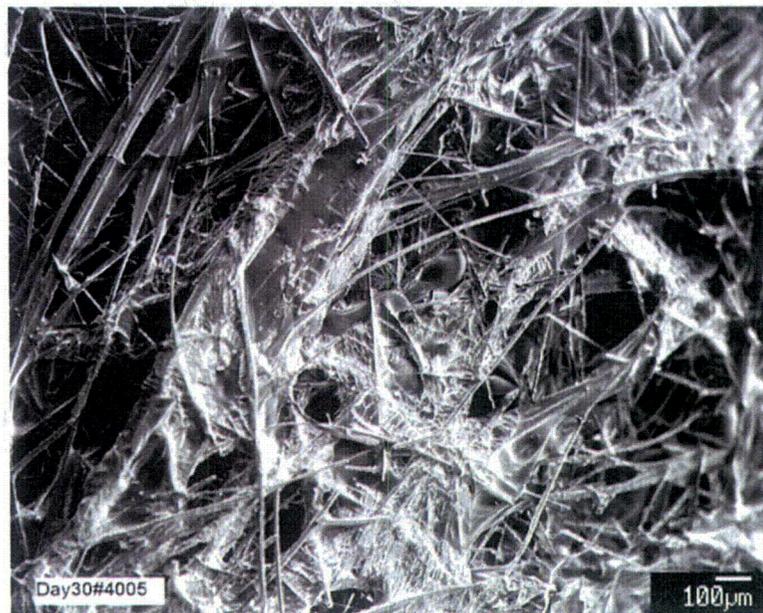
Figure C-62. Day-30, sample #4 SEM image (#4005) of a cluster of fiber, magnified 50 times.

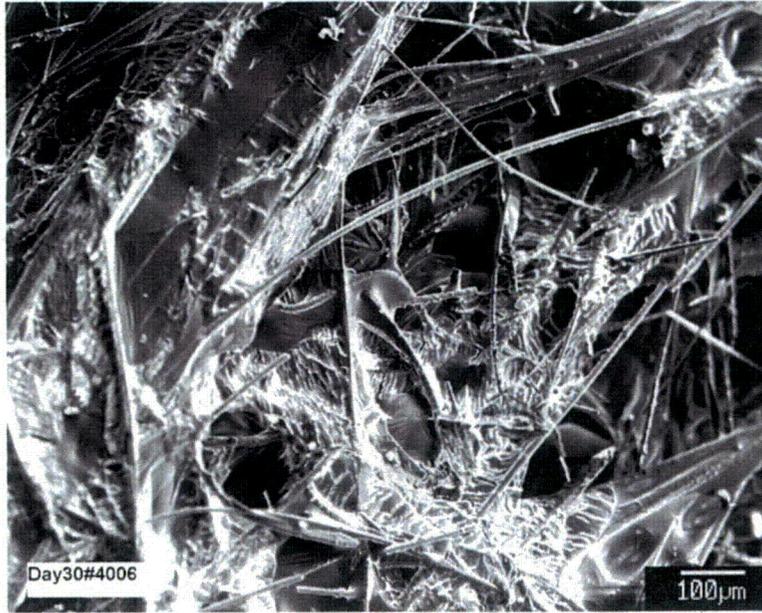
Figure C-63. Day-30, sample #4 SEM image (#4006) magnified 100 times on the cluster of fiber shown in Figure C-62.

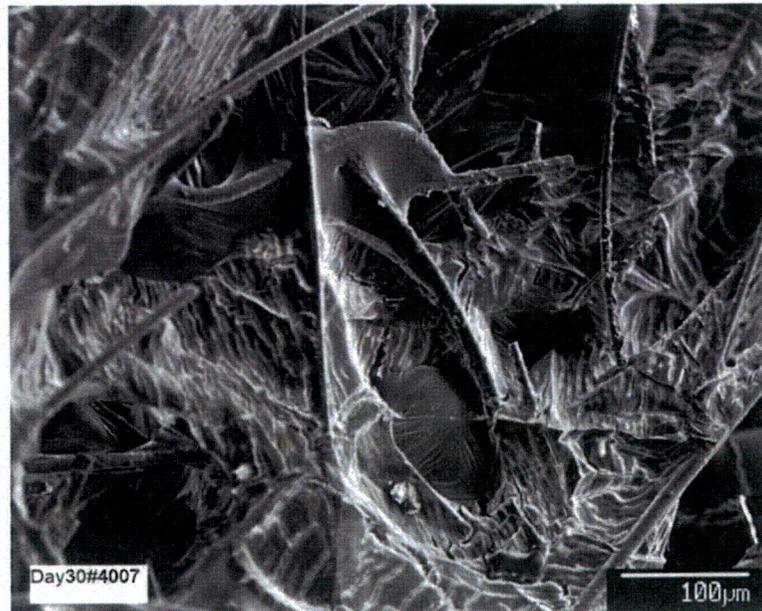
Figure C-64. Day-30, sample #4 SEM image (#4007) magnified 200 times on the surface precipitates shown in Figure C-62.

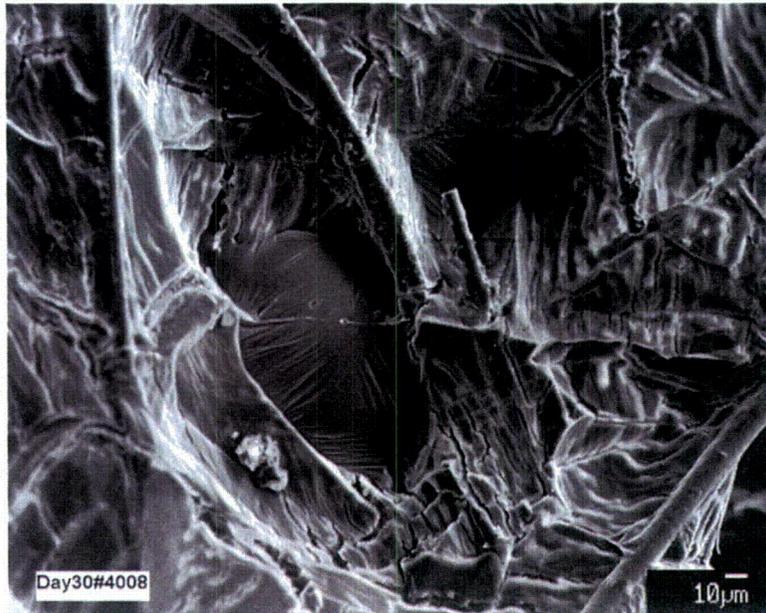
Figure C-65. Day-30, sample #4 SEM image (#4008) magnified 350 times on the surface precipitates shown in Figure C-62.

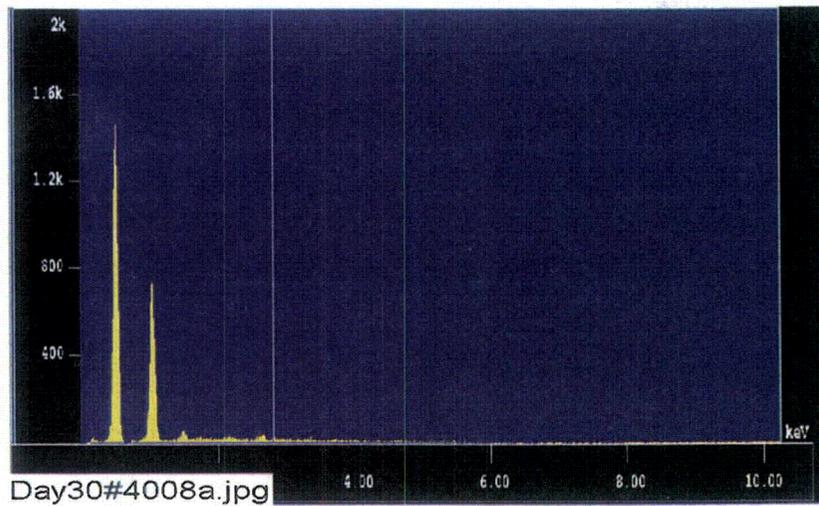
Figure C-66. Day-30, sample #4 counting spectrum (EDS #4008a) for the fractured precipitates.

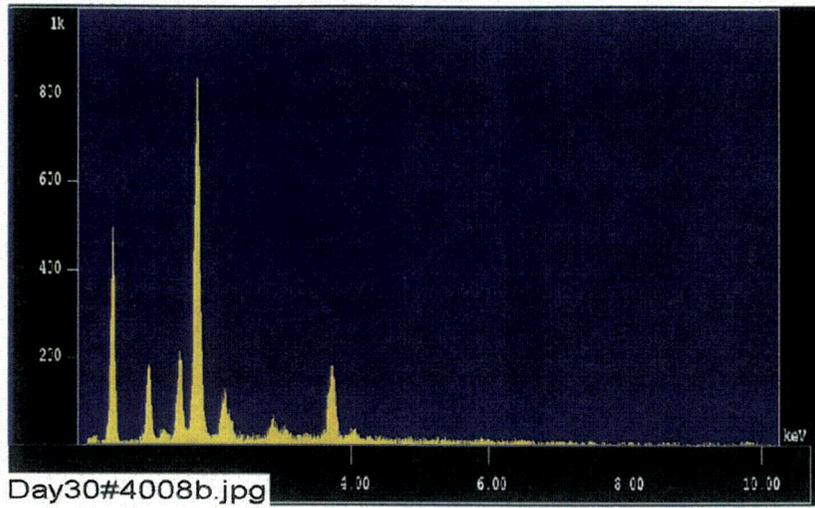
Figure C-67. Day-30, sample #4 counting spectrum (EDS #4008b) for the film between fibers.

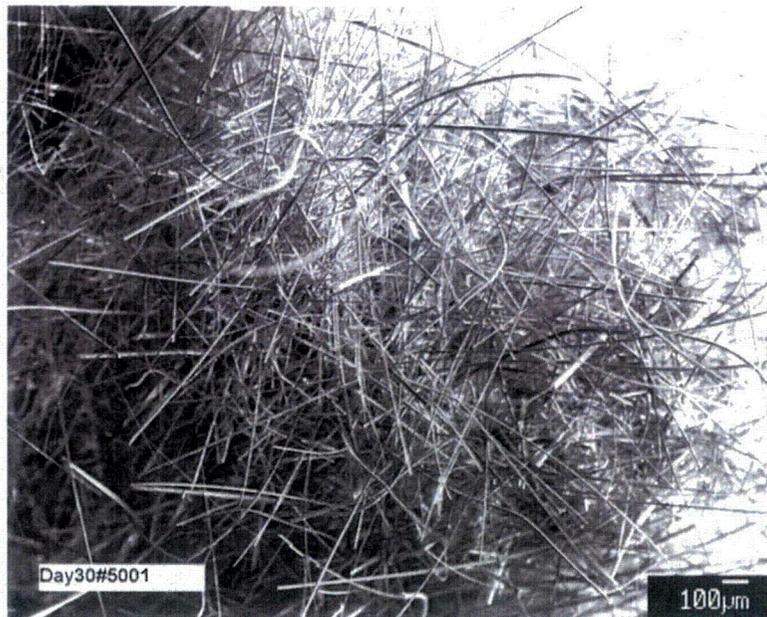
Figure C-68. Day-30, sample #5 SEM image (#5001) magnified 40 times on the fiberglass.

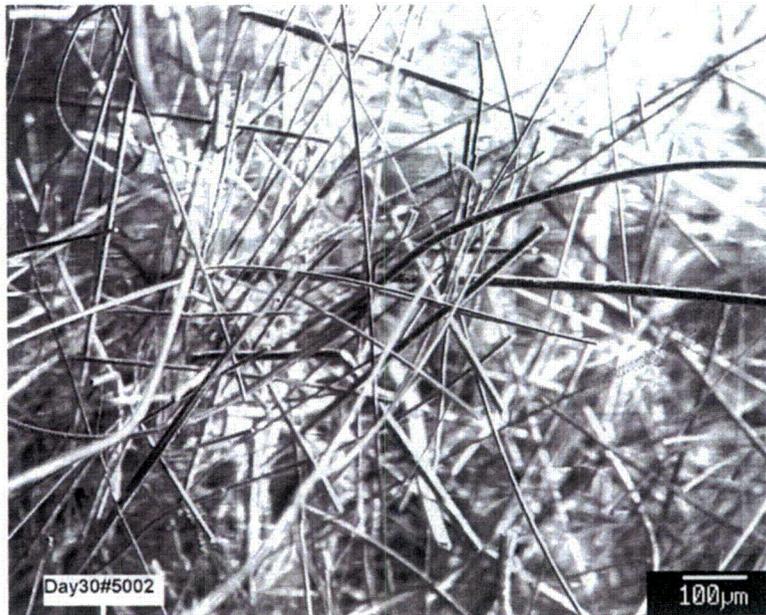
Figure C-69. Day-30, sample #5 SEM image (#5002) magnified 100 times; close-up of the fiberglass.

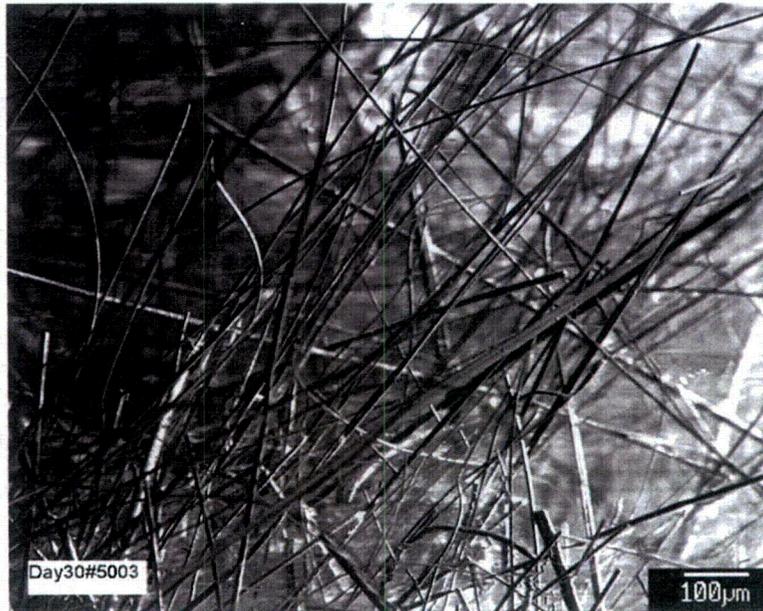
Figure C-70. Day-30, sample #5 SEM image (#5003) magnified 100 times; close-up of fibers.

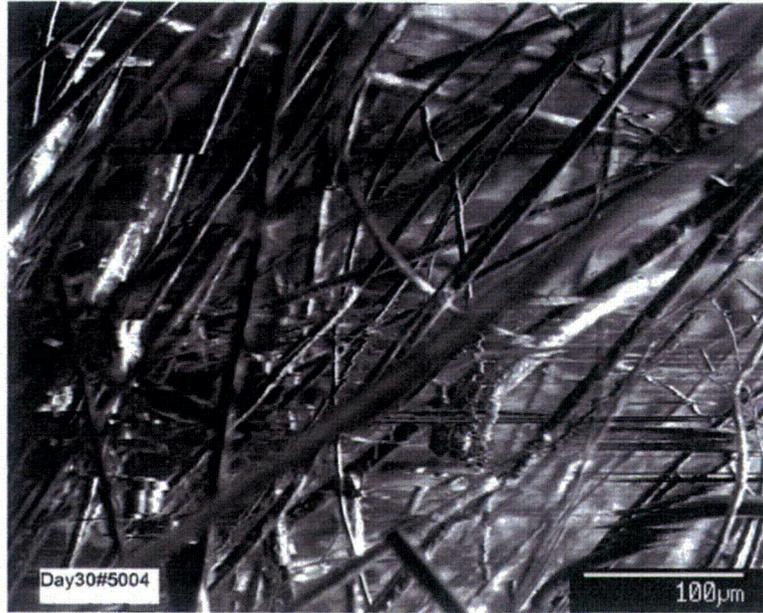
Figure C-71. Day-30, sample #5 SEM image (#5004) magnified 250 times on the fibers with precipitate on surface. Streaks show evidence of charge accumulation on the sample.

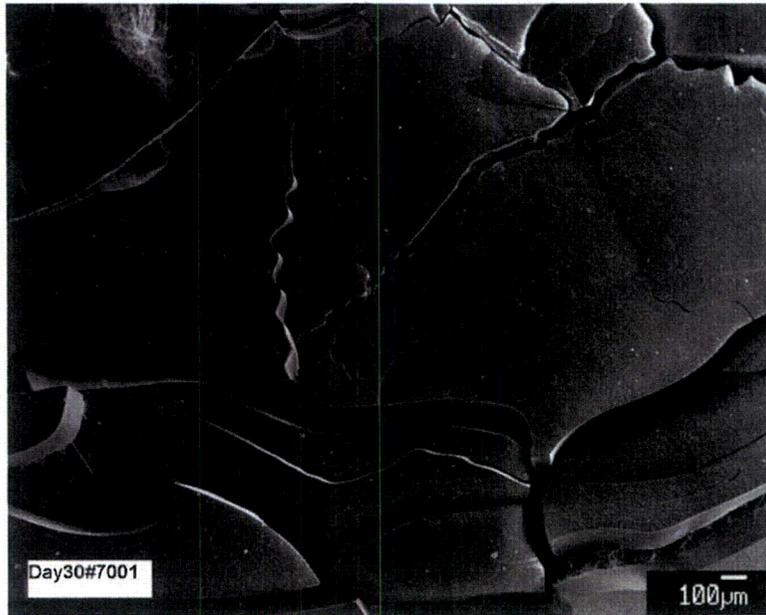
Figure C-73. Day-30, sample #7 SEM image (#7001), magnified 40 times; close-up of precipitate layer.

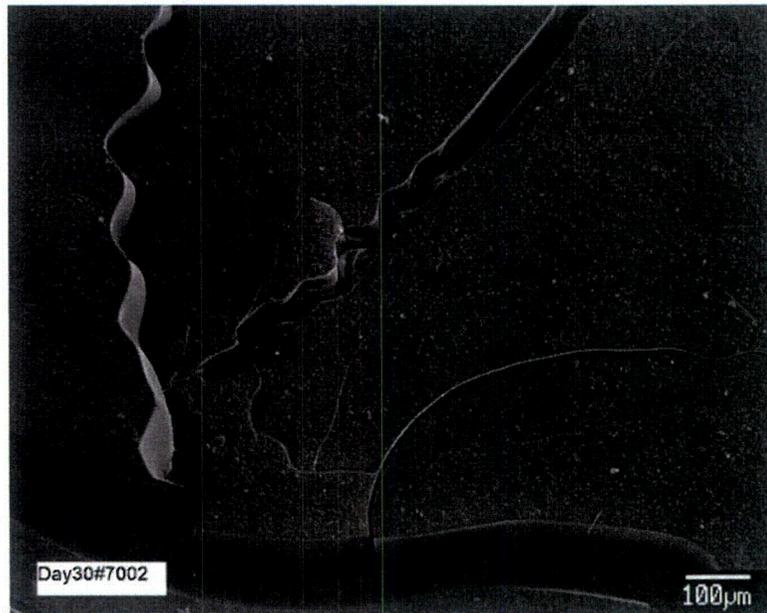
Figure C-74. Day 30, sample #7 SEM image (#7002), magnified 100 times; close-up of precipitate layer.

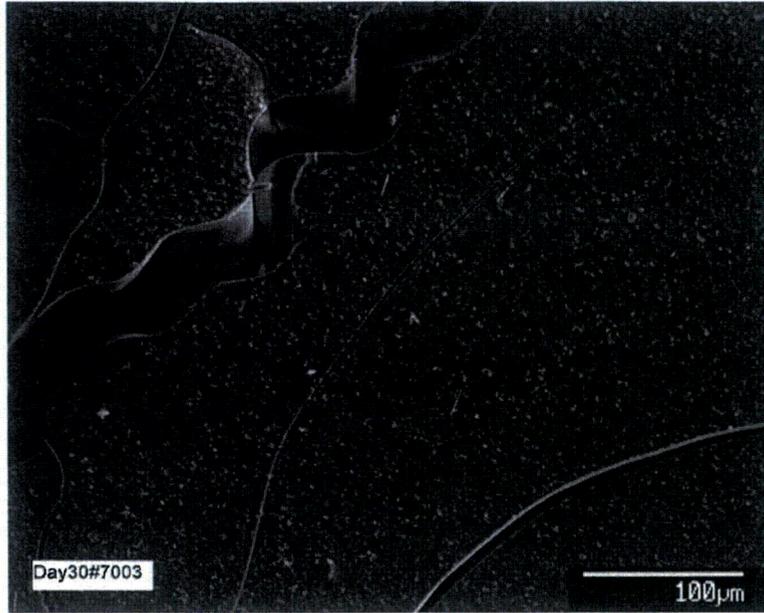
Figure C-75. Day-30, sample #7 SEM image (#7003) magnified 250 times; close-up of precipitate layer.

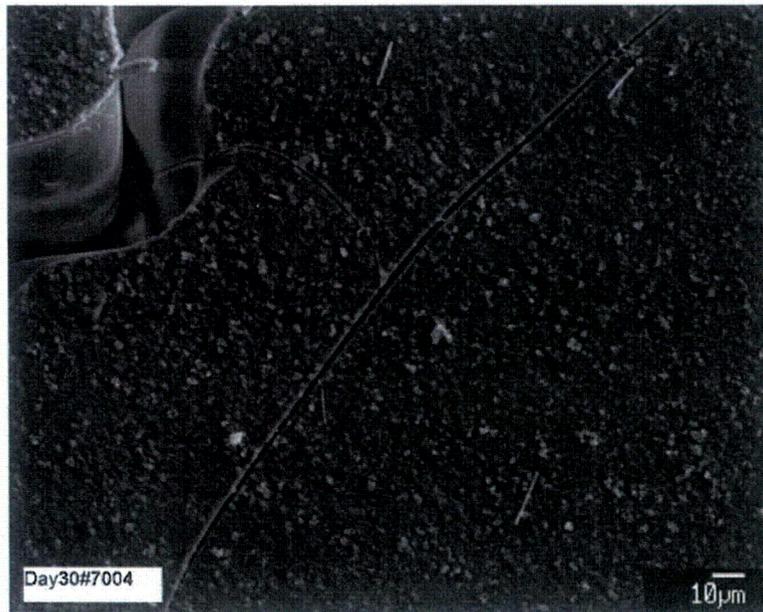
Figure C-76. Day 30, sample #7 SEM image (#7004) magnified 500 times on the crust on fiberglass; close-up of precipitate layer.
