Appendix C

SEM/EDS Data for Test #1, Day-30 Fiberglass and Filtrate

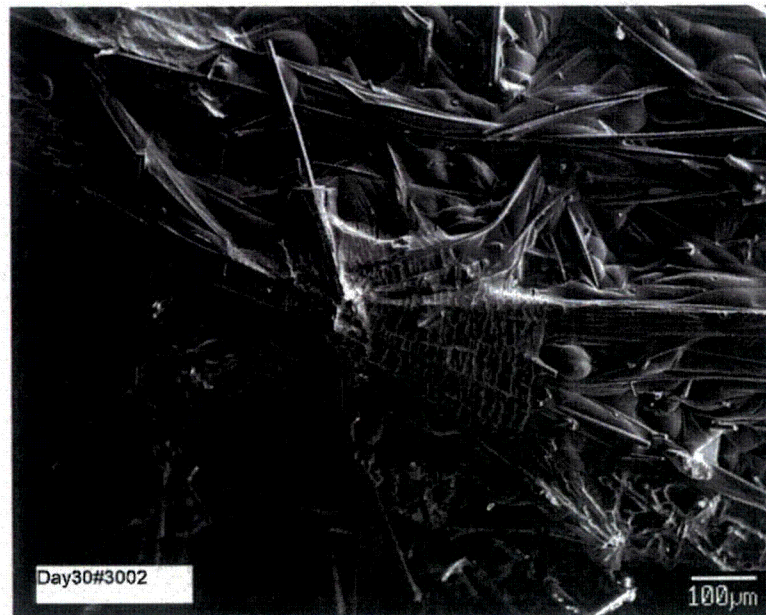
Figure C-44. Day-30, sample #3 SEM image (#3002) magnified 100 times on the fiberglass with surface coating.

Image:	Day-30 #3001	50 ×	fiberglass with surface coating
	Day-30 #3002	100 ×	fiberglass with surface coating
	Day-30 #3003	250 ×	close-up of surface coating
EDS:	3003		spectrum of fractured coating (Na, B, O)
Image:	Day-30 #3004	500 ×	close-up of fractured surface
	Day-30 #3005	100 ×	fiber with film
	Day-30 #3006	250 ×	films across fiber
	Day-30 #3007	500 ×	films across fiber
EDS:	3007a		analysis of film
Image:	Day-30 #3008	450 ×	particles on film
EDS:	3008a		analysis of particles
	3008b		analysis of fiber
