# **Integrated Chemical Effects Test Project: Test #2 Data Report**

**Los Alamos National Laboratory**

**U.S. Nuclear Regulatory Commission  
Office of Nuclear Regulatory Research  
Washington, DC 20555-0001**

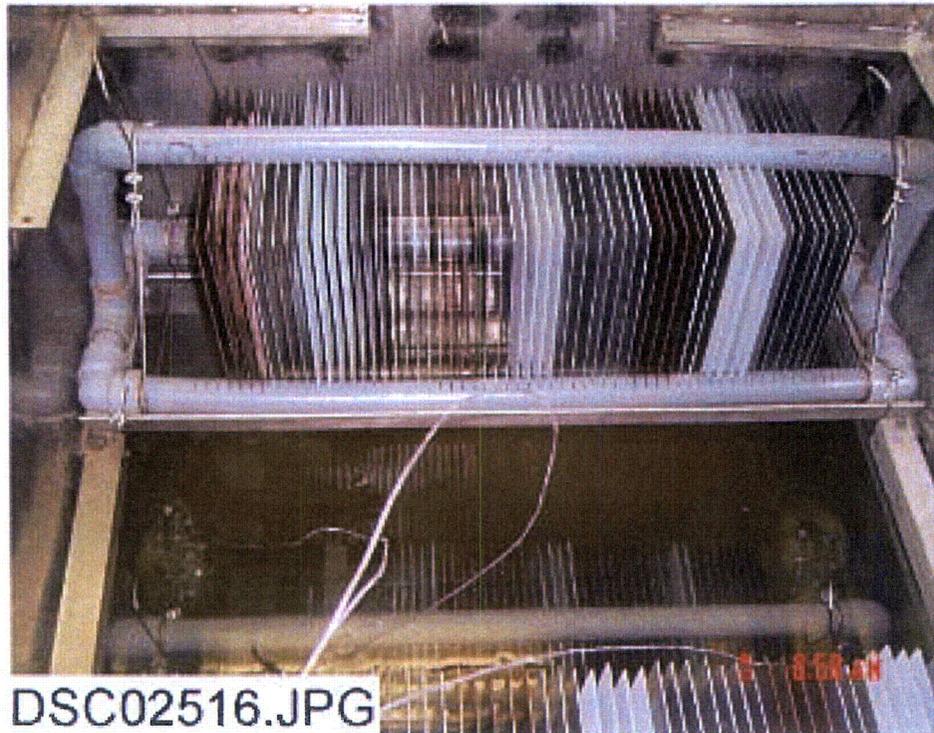
**Figure 3-3. Loaded coupon rack in the ICET tank.**

The configuration of an unsubmerged coupon rack loaded with metal coupons in the ICET tank is illustrated in Figure 3-3. The loading pattern of the racks was nearly identical, varying by only one or two coupons. Shown in the figure from left to right, the coupons are arranged as follows: 4 Cu, 4 Al, 4 IOZ, 7 GS, 4 Cu, 3 Al, 4 IOZ, 7 GS, 4 Cu, 3 Al, 4 IOZ, 7 GS.

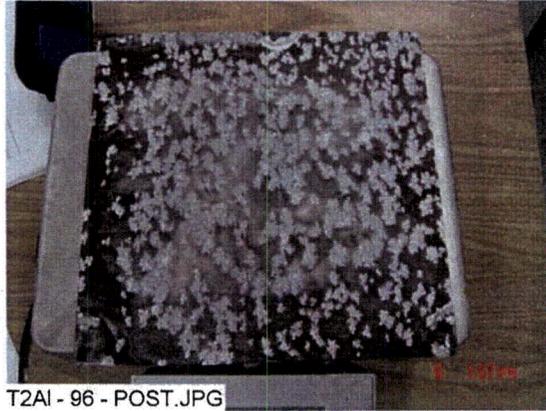
**Figure 4-3. AI-96 submerged, post-test.**

Figure 4-2 through Figure 4-7 display the pre-test and post-test pictures of the three submerged aluminum coupons. Each post-test aluminum coupon exhibits a similar pattern of white particle deposits. Also, each post-test coupon has a reddish-brown color, which is most attributable to the submerged copper coupons. The relative spatial location of these coupons, given in order from the west side of the tank to the east side of the tank, is as follows: Al-98, Al-97, and Al-96. It is evident that the concentration of white particles increases slightly from the westernmost coupon to the easternmost coupon.

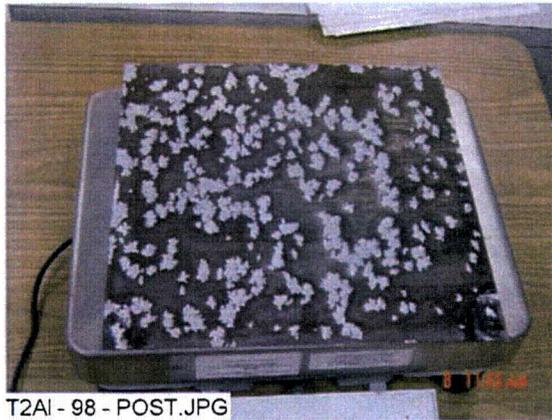
**Figure 4-7. AI-98 submerged, post-test.**

According to SEM/EDS results, the dominant corrosion products on the submerged aluminum coupons are likely aluminum hydroxide with other substances containing silicon, calcium, sodium, magnesium, phosphorus, carbon, and oxygen. In addition, evidence was found that some copper deposited on the submerged aluminum coupon surfaces. Comparing the redox potential ( $E^0$ ) of  $\text{Al}^{3+}$  and  $\text{Cu}^{2+}$ , which is  $-1.662$  and  $0.3419$  V (Ref. 6), respectively,  $\text{Cu}^{2+}$  in the solution may oxidize aluminum metal. As a result, aluminum metal may be oxidized into  $\text{Al}^{3+}$  and released to the solution. Correspondingly  $\text{Cu}^{2+}$  is reduced into metallic copper and subsequently deposits at the aluminum coupon surface.

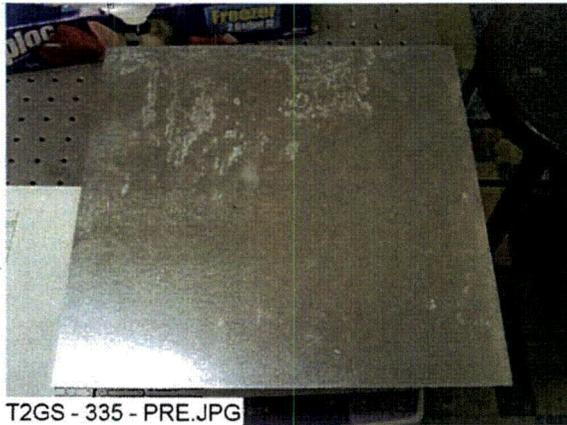
Figure 4-8. GS-335 submerged, pre-test.

Figure 4-8 through Figure 4-13 present the pre-test and post-test pictures of three submerged GS coupons. Each post-test GS coupon exhibits nearly identical patterns of dense gray particle deposits. The relative spatial location of these coupons, given in order from the west side of the tank to the east side of the tank, is as follows: GS-337, GS-338, and GS-335. There is no discernable relationship between the spatial location of the coupons and particle deposition patterns or density. For the submerged GS coupons, the possible corrosion products are phosphoric and carbonate compounds of zinc and calcium.

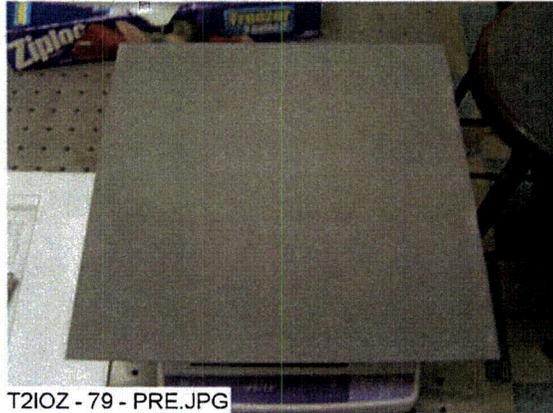
Figure 4-14. IOZ-79 submerged, pre-test.

Figure 4-14 through Figure 4-17 present pre-test and post-test pictures of two submerged IOZ CS coupons. Each post-test CS coupon exhibits similar patterns of white particle deposits. The IOZ-81 coupon is located on the west side of the tank in relation to the

IOZ-79 coupon. For each coupon, particle deposition appears to preferentially occur near the coupon rack contact points. With respect to the IOZ-81 coupon, the IOZ-79 coupon has more deposits near the top of the coupon and fewer deposits in the bottom corners of the coupon.

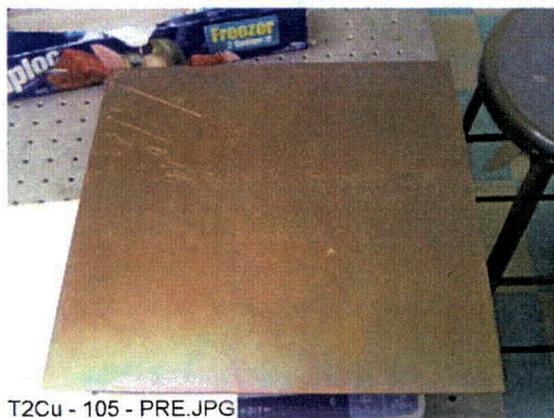
T2Cu - 105 - PRE.JPG

Figure 4-18 through Figure 4-21 present the pre-test and post-test pictures of two submerged copper coupons. Each post-test copper coupon exhibits similar patterns of white, streak-like deposits. The deposition streaks are almost perfectly horizontal and are more highly concentrated for coupon Cu-123. Different corrosion effects are visible at the contact points. The Cu-123 coupon is located on the west side of the tank in relation to the Cu-105 coupon. The Cu-105 coupon appears to have a greater distribution of these white, streak deposits. For submerged copper coupons, the possible corrosion products include  $\text{CuO}$ ,  $\text{Cu}_2(\text{CO}_3)(\text{OH})_2$ ,  $\text{Mg}_3(\text{PO}_4)_2$ , and substances containing magnesium, copper, sodium, aluminum, calcium, carbon, and oxygen.

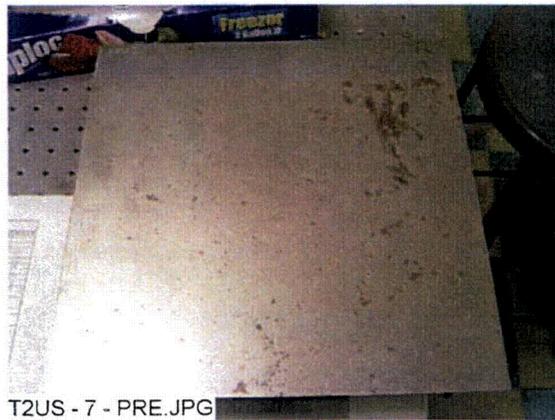
**Figure 4-22. US-7 submerged, pre-test.**

and significant corrosion around the edges. Different corrosion effects are visible at the contact points. This carbon steel coupon was adjacent to a copper coupon. For the submerged steel coupon, the possible corrosion products include phosphoric and carbonate compounds of iron and calcium and compounds composed by iron, aluminum, silicon, sodium, calcium, magnesium, phosphorus, and oxygen.

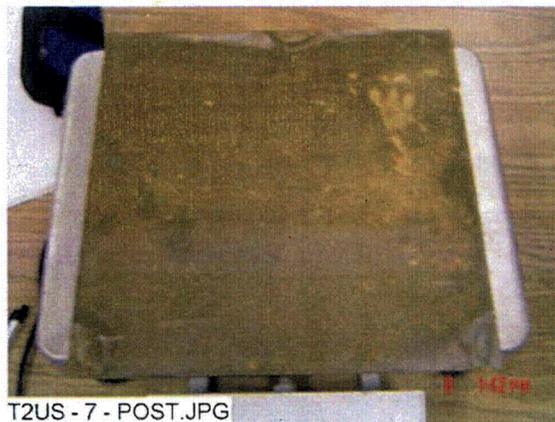
**Figure 4-23. US-7 submerged, post-test.**

Figure 4-22 and Figure 4-23 present the pre-test and post-test pictures of the submerged carbon steel coupon. The post-test carbon steel coupon exhibits a reddish-brown color

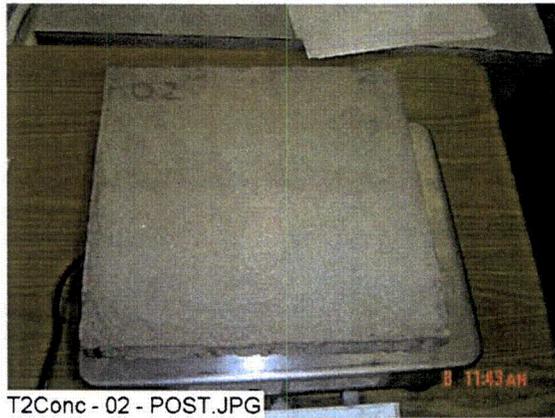
**Figure 4-25. Conc-02 submerged, post-test.**

Figure 4-24 and Figure 4-25 present the pre-test and post-test pictures of the submerged concrete coupon. The post-test concrete coupon exhibits an enhanced gray color as compared with the pre-test coupon.

Table 4-1 presents the pre-test and post-test weight data for each representative submerged coupon shown in Figures 4-2 through 4-25, and the average weight changes for each test material are summarized in Table 4-2.

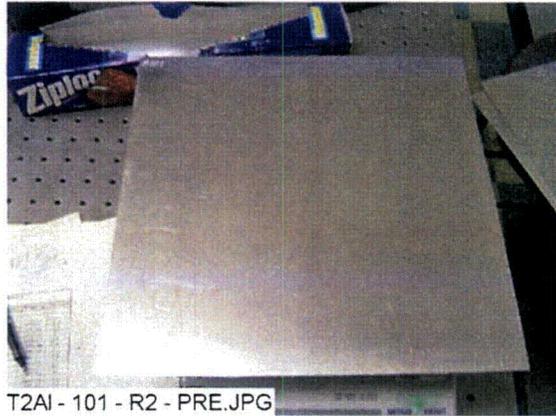
T2AI - 101 - R2 - PRE.JPG

The physical and chemical changes that the unsubmerged coupons experienced during Test #2 are less significant than the submerged coupons. Figure 4-26 through Figure 4-29 demonstrate the pre-test and post-test pictures of two unsubmerged aluminum coupons. Each post-test aluminum coupon exhibits similar deposits. Also, the texture of each coupon is coarser and the surface is less lustrous than its pre-test appearance. The reddish-brown color that was observed on the submerged coupons is absent on the unsubmerged coupons. The Al-101 coupon was loaded into Rack 2, which was located in the southern position on the tank's middle tier (see Figure 3-2). The Al-132 coupon was loaded into Rack 5, which was located in the southern position of the tank's top tier. The Al-101 specimen exhibits a greater concentration of these deposits.

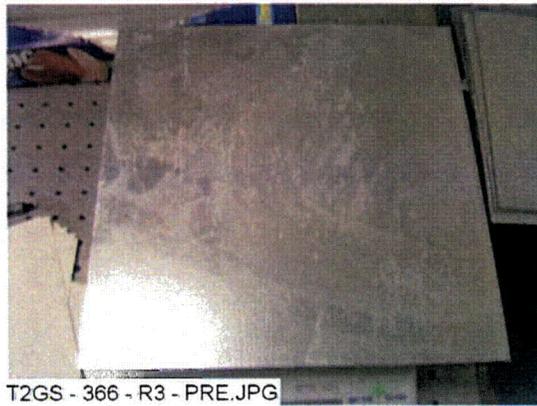
**Figure 4-30. GS-366 unsubmerged, pre-test.**

Figure 4-30 through Figure 4-33 show the pre-test and post-test pictures of two unsubmerged GS coupons. Each post-test GS coupon exhibits similar types of deposits. This deposition is visibly different and much less concentrated than that of the submerged coupons. The GS-366 coupon was loaded in Rack 3, which was located in the center position of the tank's middle tier. The GS-416 coupon was loaded in Rack 5, which was located in the southern position of the tank's top tier. The GS-366 coupon exhibits more of these deposits.

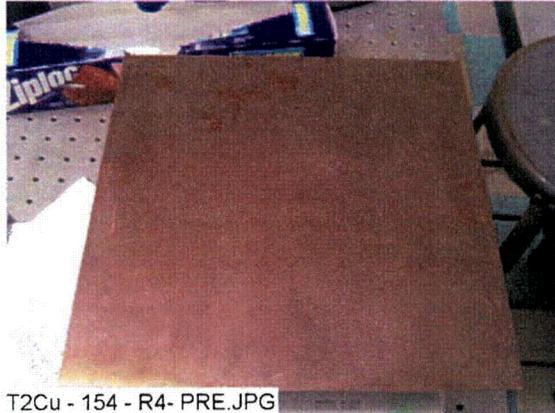
**Figure 4-34. Cu-154 unsubmerged, pre-test.**

Figure 4-34 through Figure 4-37 present the pre-test and post-test pictures of two unsubmerged copper coupons. Each post-test copper coupon exhibits similar types of

deposits. Unlike on the submerged coupons, the deposition patterns are vertical and less uniform. The Cu-154 coupon was loaded in Rack 4, which was located in the northern position of the tank's middle tier. The Cu-196 coupon was loaded in Rack 7, which was located in the northern position of the tank's top tier. The Cu-196 coupon exhibits a greater density of these white deposits.

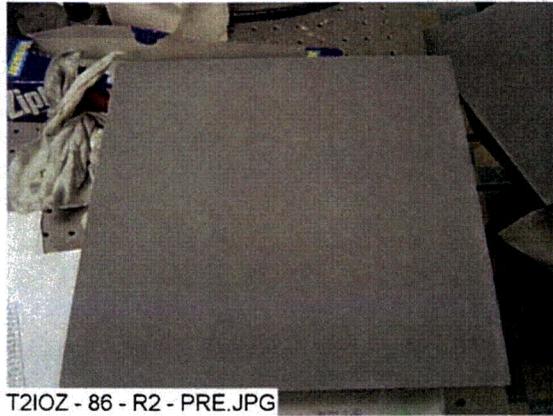
**Figure 4-38. IOZ-86 unsubmerged, pre-test.**

Figure 4-38 through Figure 4-41 present the pre-test and post-test pictures of two unsubmerged IOZ CS coupons. Each post-test CS coupon exhibits similar types of deposits. These deposits are much less concentrated than the deposits on the submerged coupons. The IOZ-86 coupon was loaded in Rack 2, which was located in the southern position of the tank's middle tier. The IOZ-135 coupon was loaded in Rack 6, which was located in the center position of the tank's top tier. There are no apparent differences in the IOZ coupons as a function of coupon location.

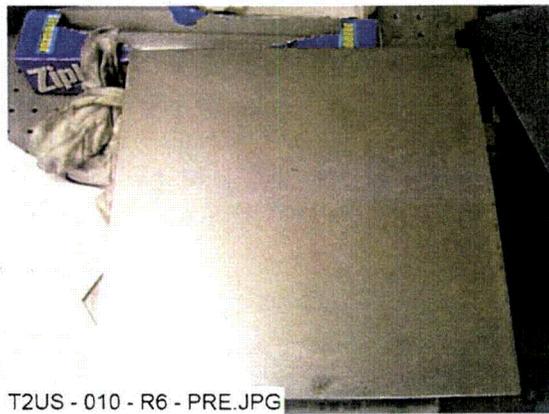
**Figure 4-42. US-10 unsubmerged, pre-test.**

Figure 4-42 and Figure 4-43 present the pre-test and post-test pictures of one unsubmerged carbon steel coupon. The post-test carbon steel coupon exhibits a reddish-brown color and significant corrosion around the edges. The color is similar to that of the submerged carbon steel coupon, although the corrosion does not appear to be as severe as on the submerged coupon. The US-10 coupon was loaded in Rack 6, which was in the center position of the tank's top tier.

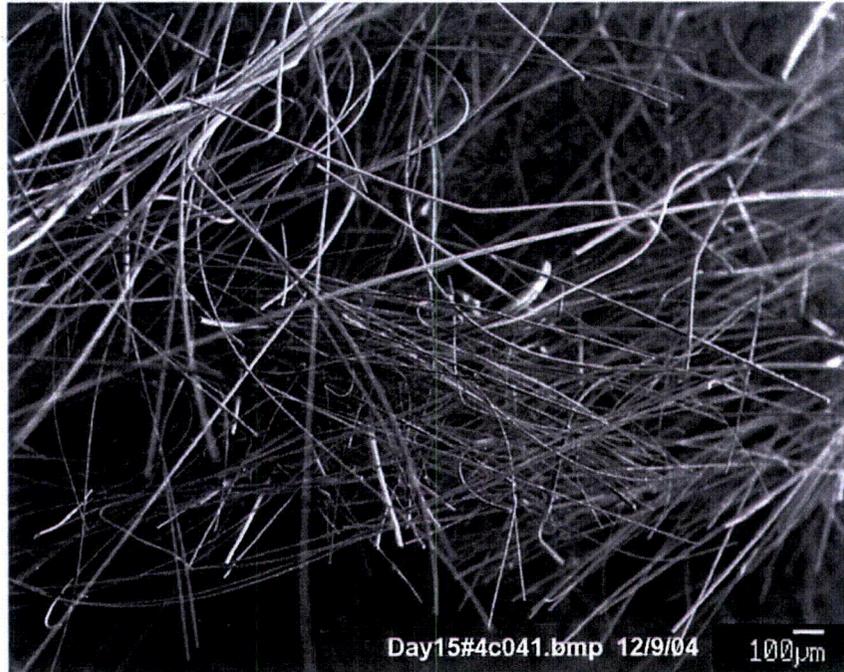
Figure 4-44 illustrates the clean fiberglass as it appears before the test. This visual baseline is used to compare with images from samples taken after the test began. As can be seen, there are no deposits on the clean fiberglass.

Figure 4-44. Clean fiberglass before exposure to test chemicals.

Figure 4-44 illustrates the appearance of clean fiberglass before exposure to the chemical environment. After the fiberglass was exposed to the tank solution for some time, deposits formed throughout the fiber matrix and appear to be chemically originated and/or physically retained or attached. Because there was no direct water flow through the fiber, particle migration into the fiberglass interior is likely not the source of these deposits. Therefore, the deposits found in the interior of the fiberglass samples are likely chemically originated, i.e., through precipitation. However, particulate deposits may be physically retained or attached on the fiberglass exterior. Thus, the particulate deposits are more likely on the exterior of the fiberglass samples than on the interior.

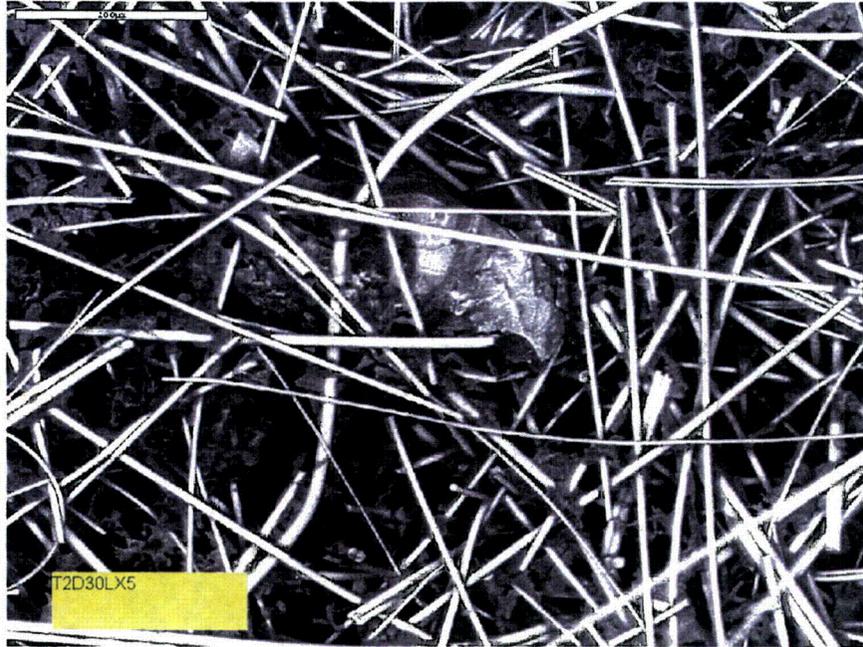
Comparing the two samples revealed slightly more deposits on the Day-30 interior low-flow fiberglass sample than on the Day-16 sample. Comparing the exterior and the interior of Day-30 low-flow fiberglass samples revealed more particulate deposits on the exterior sample.

Figure 4-49. ESEM image for a Test #2, Day-30 low-flow exterior fiberglass sample.

Figure 4-50. Higher-magnification ESEM image of a Test #2, Day-30 low-flow exterior fiberglass sample.

Figure 4-51. ESEM image of a Test #2, Day-30 low-flow interior fiberglass sample.

Figure 4-52. Higher-magnification ESEM image of a Test #2, Day-30 low-flow interior fiberglass sample.

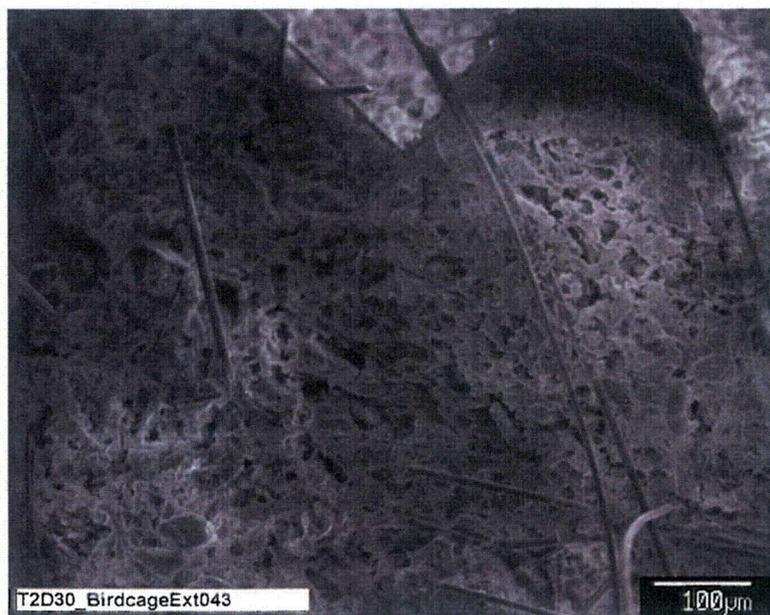
Figure 4-57. SEM image of a Test #2, Day-30 exterior fiberglass sample within the birdcage.

For the Day-30 fiberglass sample within the birdcage, Figure 4-57 indicates a coating over the exterior of the fiberglass. It shows the development of a continuous coating, which includes particles that were likely physically deposited or attached. In addition, Figure 4-58 shows the presence of lathlike crystals in the exterior of the fiberglass sample. The crystals may have been physically deposited or originated from chemical precipitation. The EDS result (Figure 4-59) shows that the crystal is composed of carbon, oxygen, sodium, magnesium, phosphorus, and calcium.

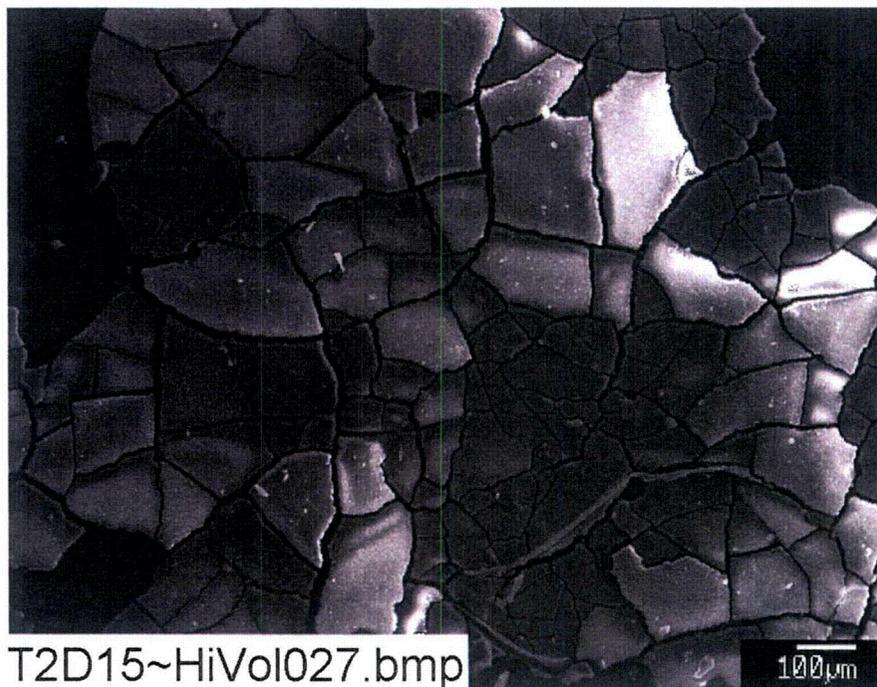
Figure A-1. SEM image at 120× magnification for a Test #2, Day-15 sample of particles on the high-volume filter. (T2D15\_HiVol027)

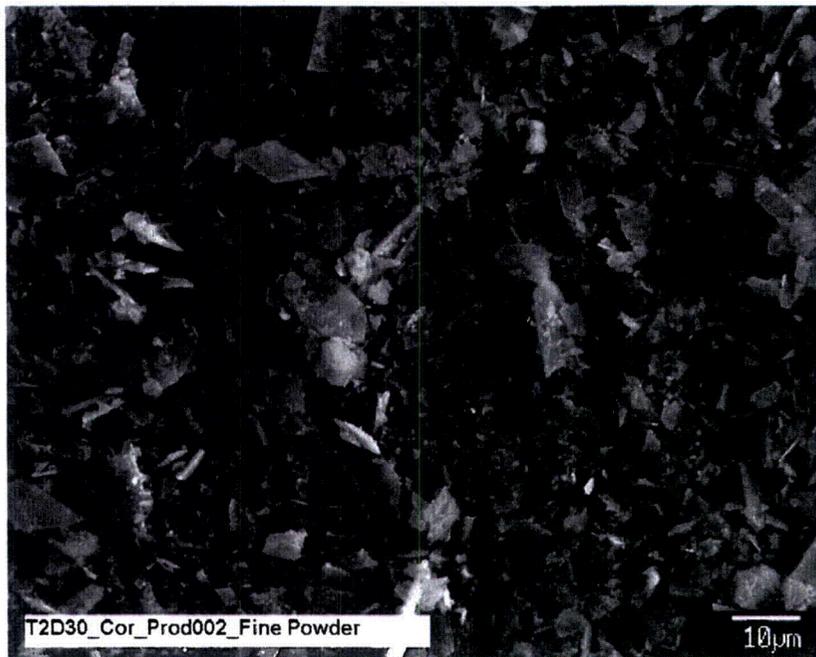
**Figure B-2.** SEM image at 1000× magnification for a Test #2, Day-30 sample of fine powder on a vertical piece of the submerged PVC rack. (T2D30\_Cor\_Prod002\_Fine Powder)

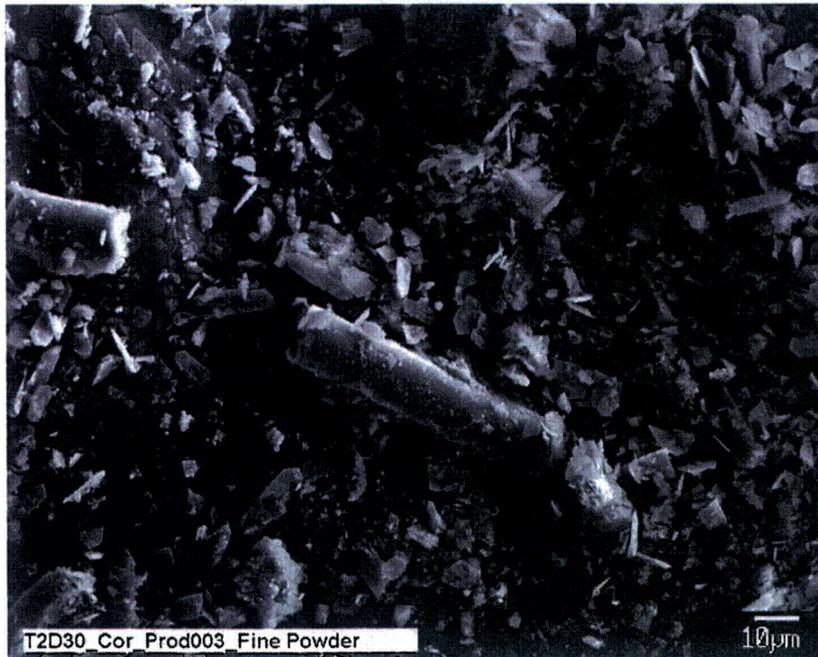
Figure B-4. Another SEM image at 650× magnification for a Test #2, Day-30 sample of fine powder on a vertical piece of the submerged PVC rack. The cylinder-shaped debris is likely to be fiberglass. (T2D30\_Cor\_Prod003\_Fine Powder)

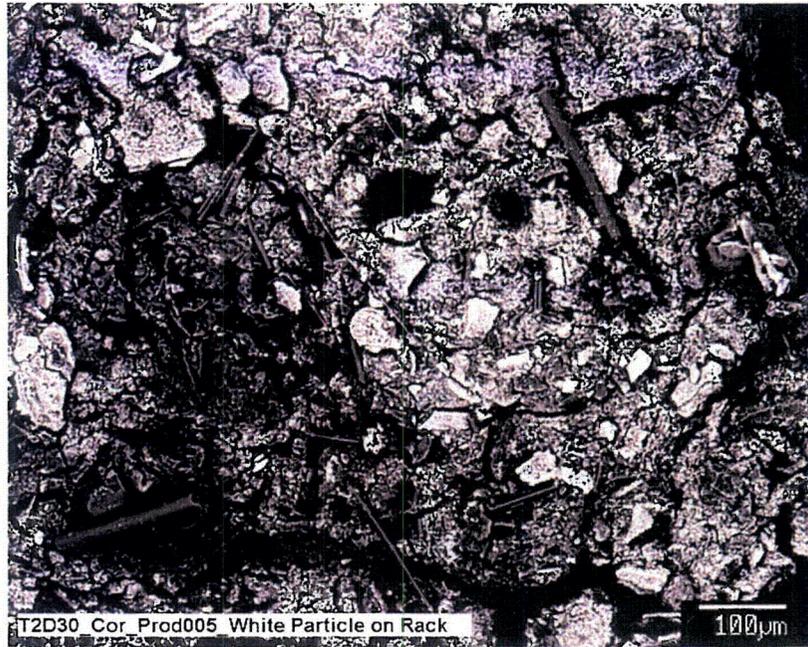
Figure B-7. Backscattered SEM image at 130× magnification for a Test #2, Day-30 sample of white residue on a horizontal piece of the submerged PVC rack. (T2D30\_Cor\_Prod005\_White Particle on Rack)

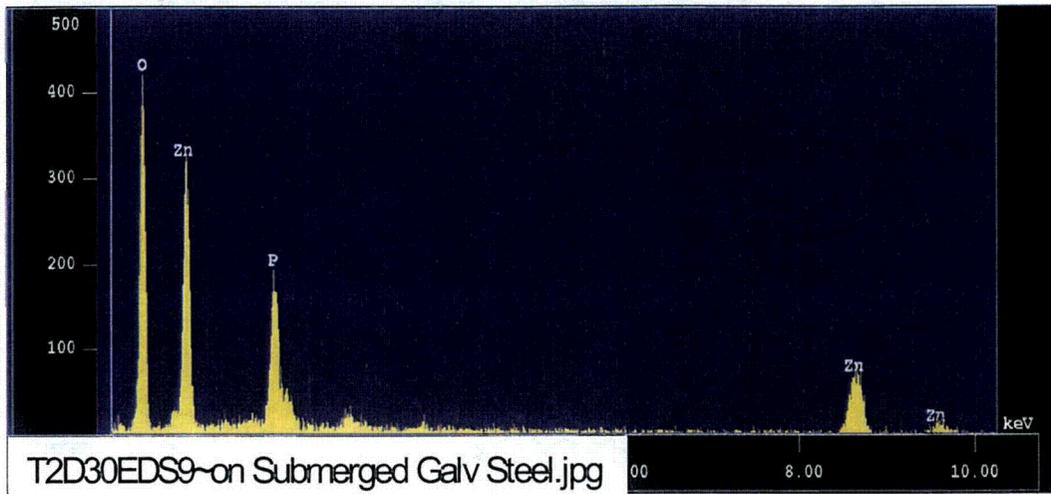
Figure B-18. EDS counting spectrum collected from the spot EDS9 indicated in Figure B-17. (T2D30EDS9~on Submerged Galv Steel)

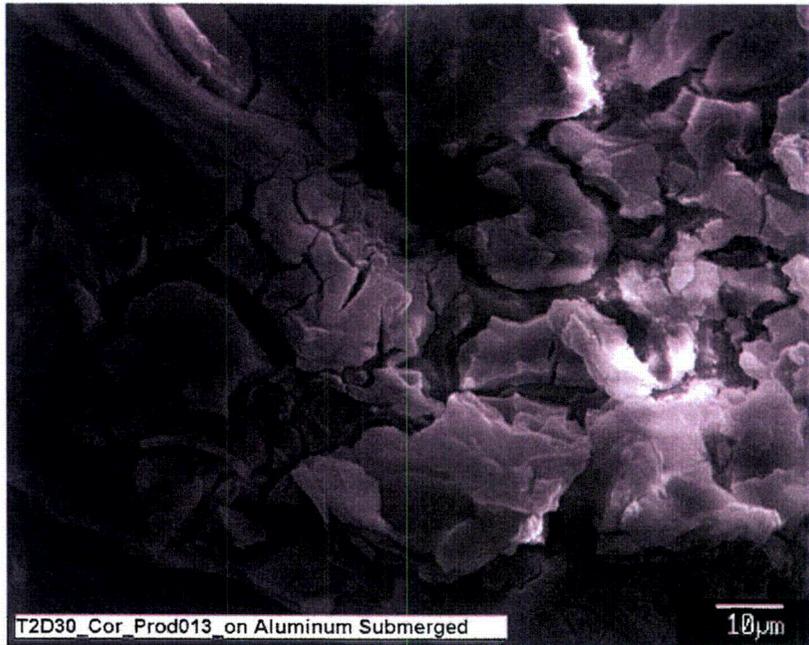
Figure B-23. SEM image at 1000× magnification of a Test #2, Day-30 sample of corrosion products on a submerged aluminum coupon. (T2D30\_Cor\_Prod013\_on Aluminum Submerged)
