## Appendix E1

### SEM/EDS Data for Test #3, Day-30 Aluminum Coupons

This appendix presents SEM/EDS results for metal aluminum coupons described by two different exposure categories: (1) suspended and (2) submerged. *Suspended* refers to the coupons located above the water level of the solution during the ICET tests. Suspended coupons were contacted by the solution only during the 4-hour spray period at initiation of the test. In addition, the surface of the suspended coupons may be affected by moisture in the test chamber vapor space. *Submerged* refers to coupons that were immersed in the solution for the duration of the test.

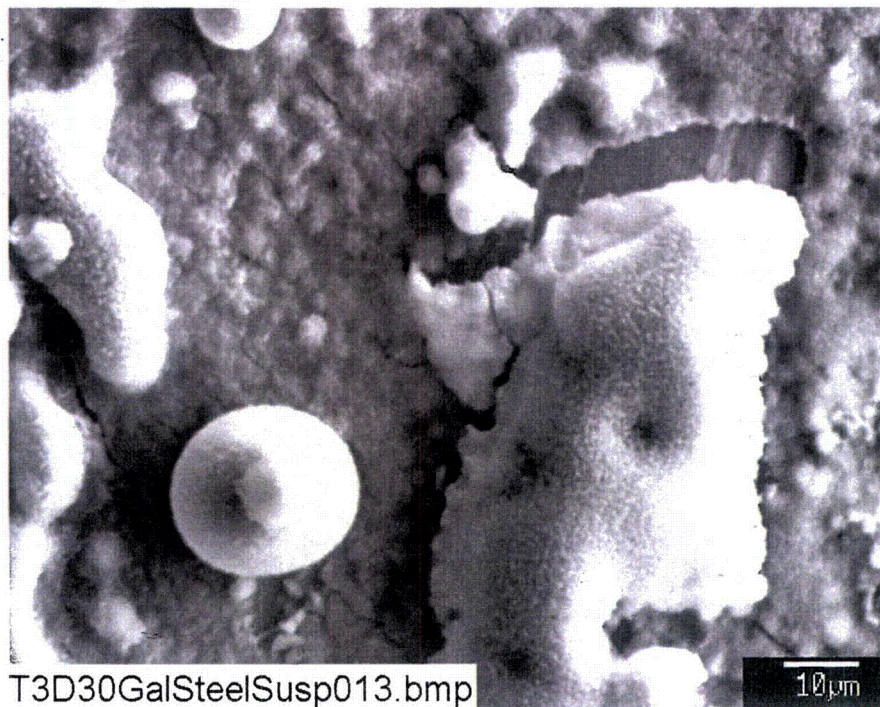
Figure E3-2. SEM image magnified 1000 times for a Test #3, Day-30 suspended galvanized steel coupon. (T3D30GalSteelSusp013)

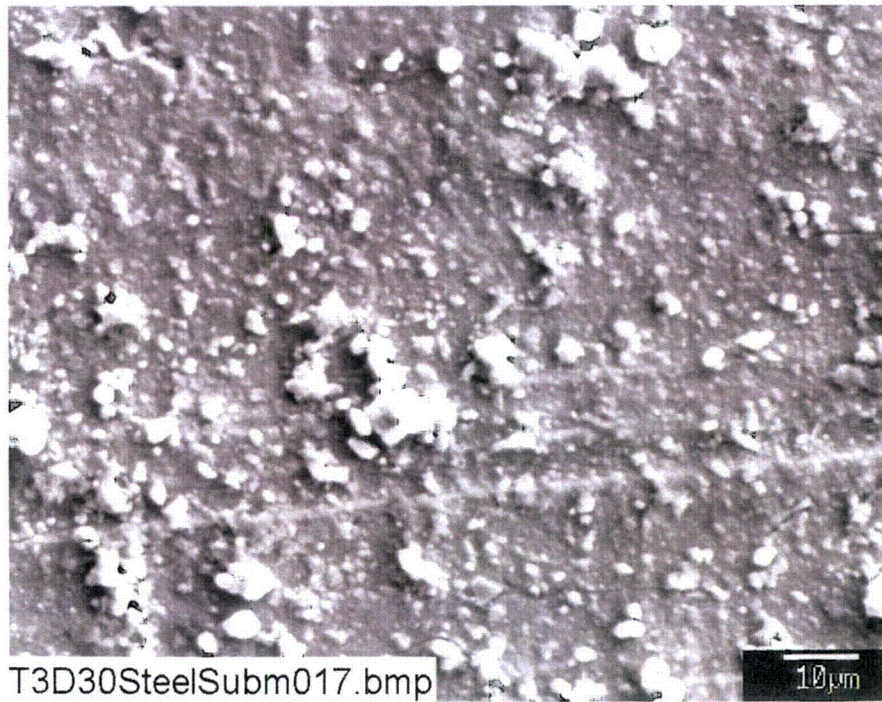
Figure E4-14. SEM image magnified 1000 times for a Test #3, Day-30 submerged carbon steel coupon. (T3D30SteelSubm017)

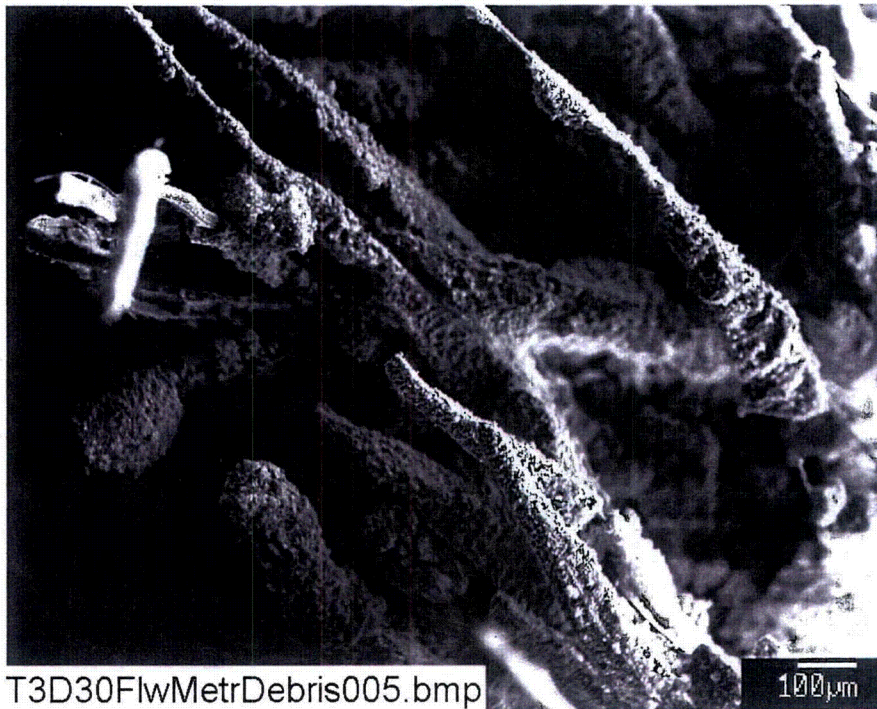
Figure F-1. SEM image magnified 80 times for Test #3, Day-30 debris within the flow meter. (T3D30FlwMetrDebris005)

In ICET Test #3, significant amounts of debris and precipitates were found within the flow meter. SEM/EDS analysis was performed to examine the composition of the debris trapped in the flow meter, as well as the white precipitates deposited on the inner wall of the flow meter. The debris and the precipitates were collected on May 5, 2005, the date Test #3 was shut down. The samples were dried in air before being coated with Au/Pd for SEM examination. Available logbook entries for this laboratory session are included in this appendix as transcribed notes.

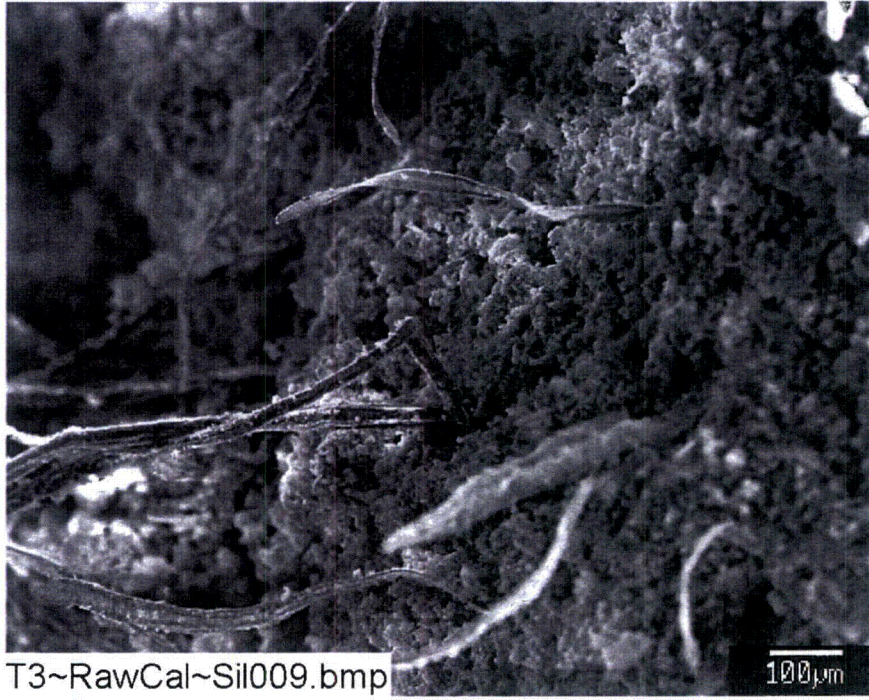
Figure H-7. SEM image magnified 100 times for a raw cal-sil sample. (T3~RawCal~Sil009)

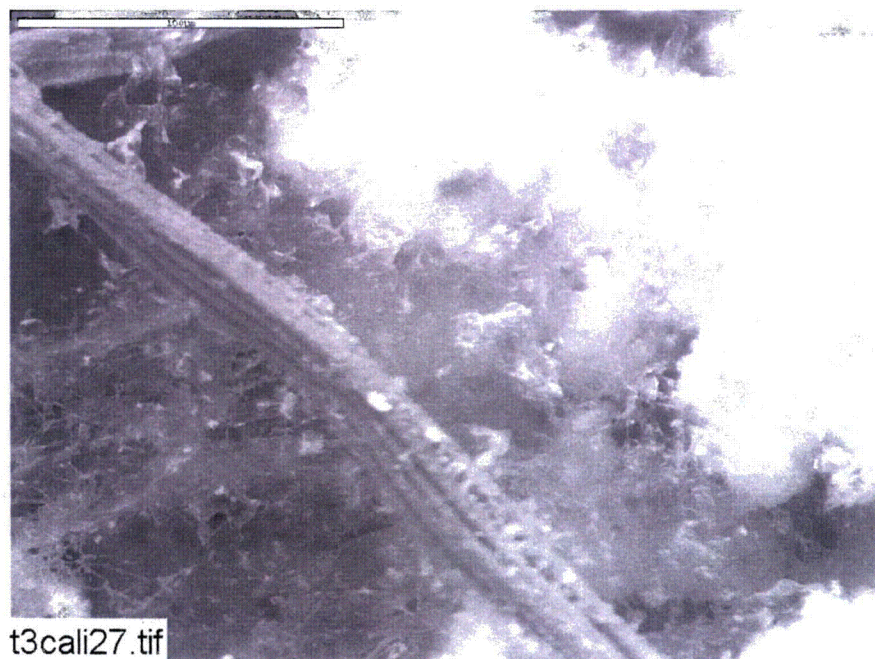
Figure H-19. ESEM image magnified 500 times for the interior of a Test#3, Day-30 raw cal-sil sample submerged in the birdcage. (T3Call27)
