GE Hitachi Nuclear Energy Americas Diablo Canyon Power Plant

Head Loss and Chemical Effects Testing Program

Overview

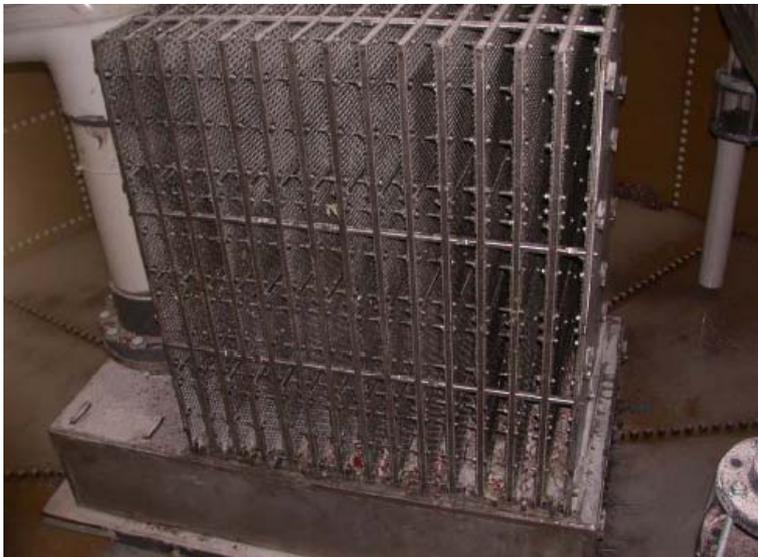
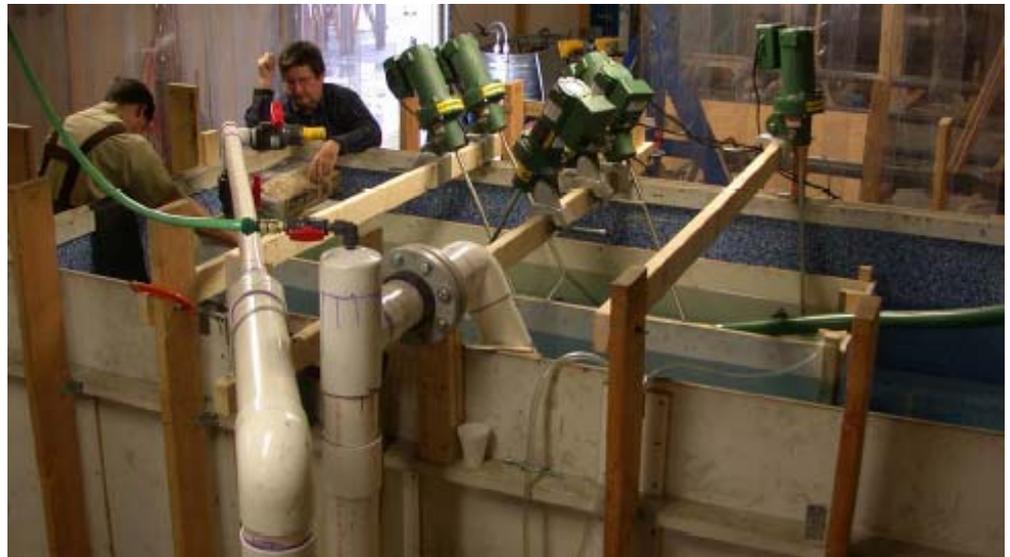
- Chemical effects testing conducted for Diablo Canyon Power Plant (DCPP)
- Plenum style strainer with ~ 3300 ft² of perforated area allows open area for chemical effect bypass
- Sector and module testing with WCAP-16530-NP chemical precipitant surrogates

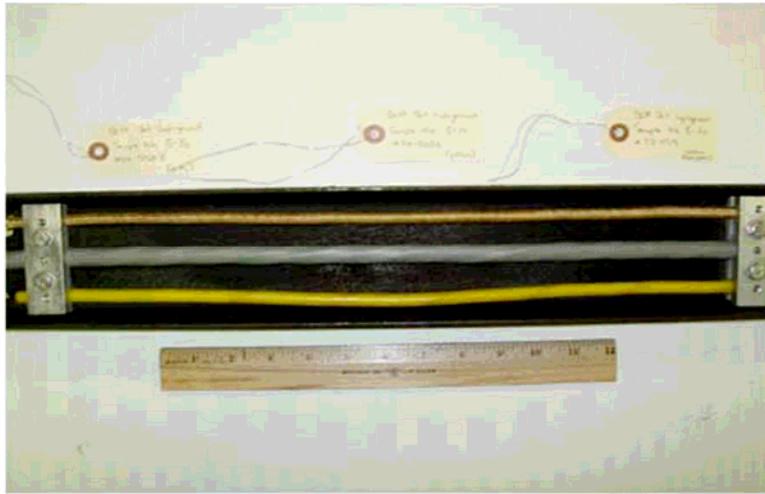
Pre-Test

Jet Test – Cables 5D

- Pressurizer heater cable: #4 copper, fiberglass and mica insulated
- Power cable: 4conductor #10 AWG copper, cross-linked polyethylene (XLPE) with a cross-linked polyethylene jacket
- Instrumentation cable: 2-#16, silicone rubber with a silicone rubber jacket

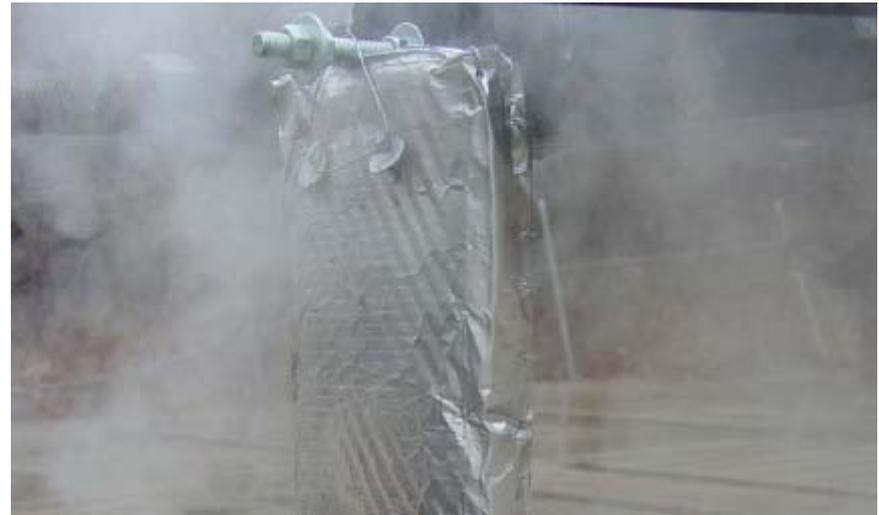
Post Test

Hog Tied Temp Mat with wire mesh – 3.7D ZOI

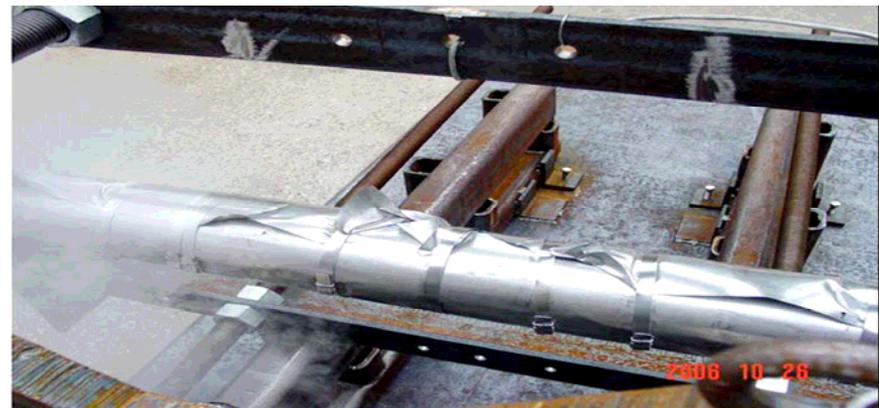
Post Test

Calcium silicate with single jacket and bands on 3 inch centers – 3D ZOI

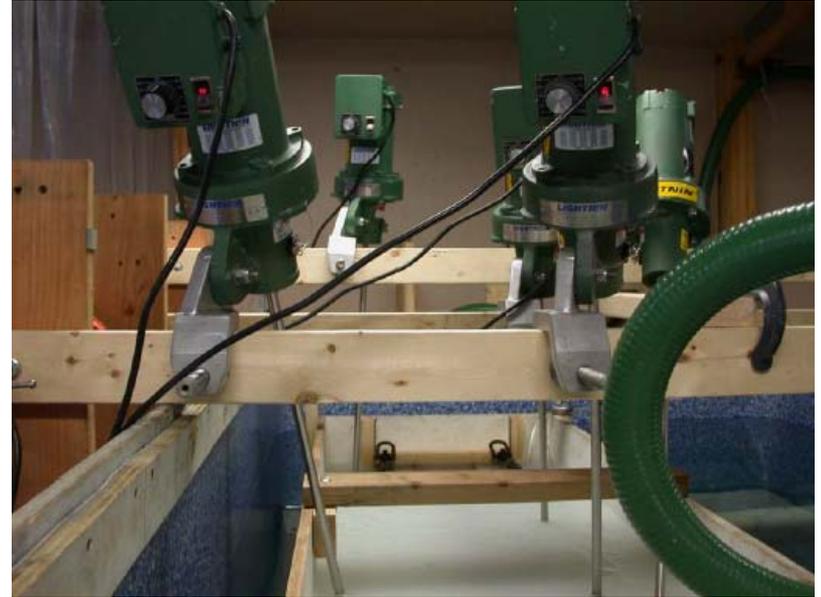
- Head loss tests were performed in fully agitated closed loop pools.
- Settling was prevented by using mechanical agitators.
- Testing duration was at least 50 pool turnovers; tests were terminated after measuring less than or equal to a 1% or 0.1 inch of water increase in head loss over a 30 minute period or 5 turnover times, whichever was longer.

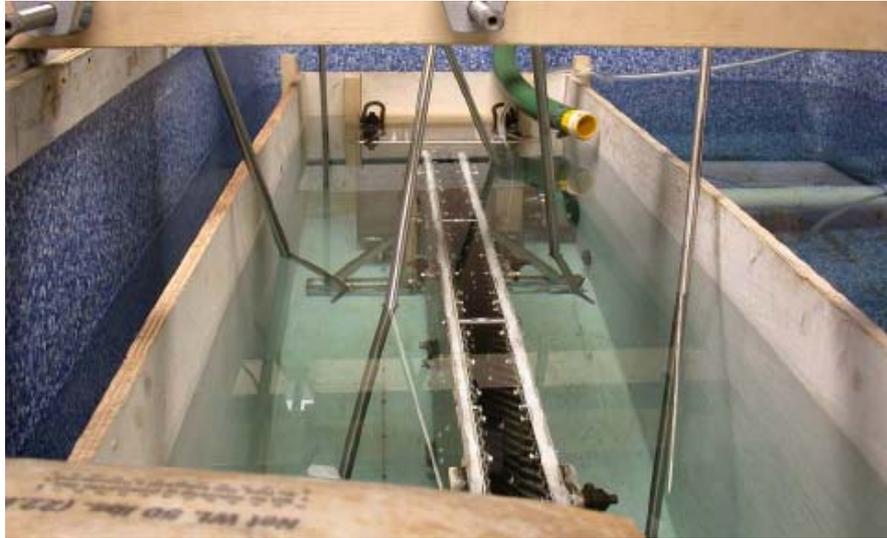
- Chemical precipitates were introduced after particulate and fiber to be representative of the expected debris sequence.
- An investigatory test was performed with chemical precipitates introduced before particulate and fiber. The resulting head loss was bounded by subsequent tests using the expected debris sequence.

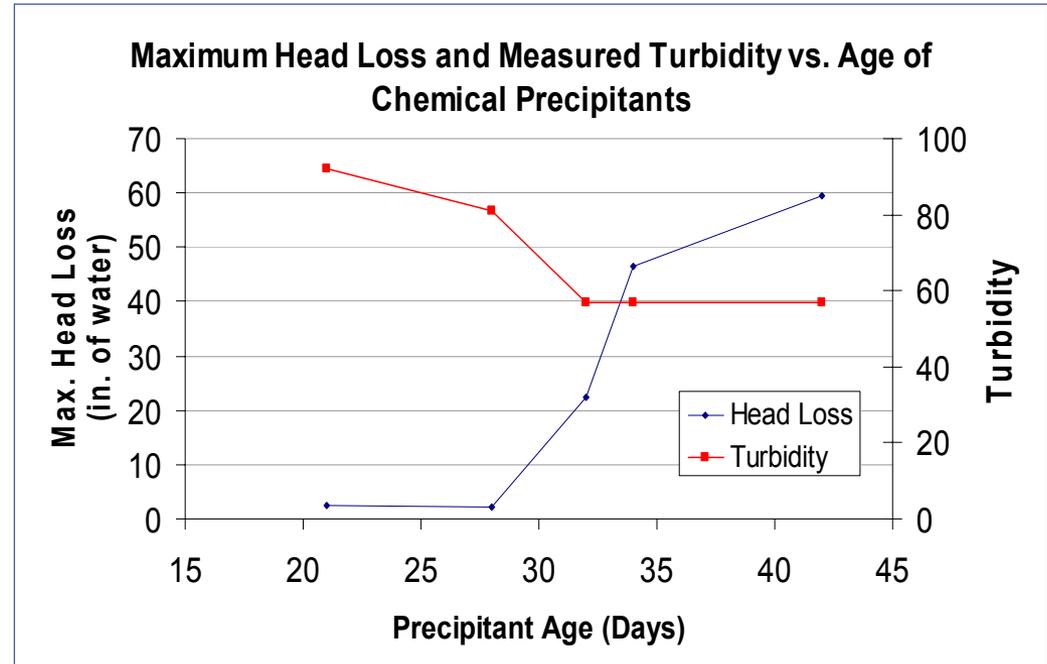
- Over a series of repeatability tests, head loss was observed to increase over time. The debris load and test conditions were unchanged.
- Inspection of test article indicated a trend of decreasing open area over several tests, and some holes were plugged only with chemical precipitants.

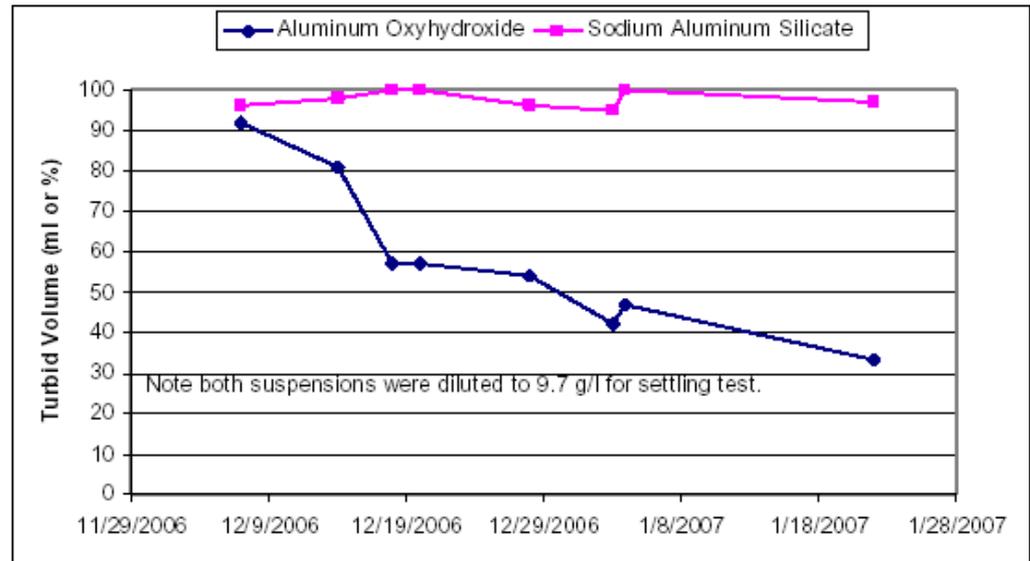
- Additional tests were performed on the chemical precipitants. Based on the results of microscopic analysis, gravity head loss tests, and turbidity tests, it was concluded that the physical properties of the aluminum oxyhydroxide changed with time and affected the test results.

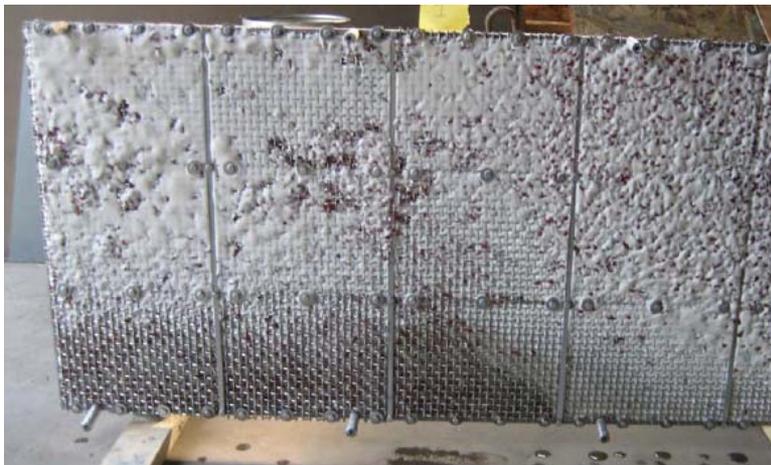
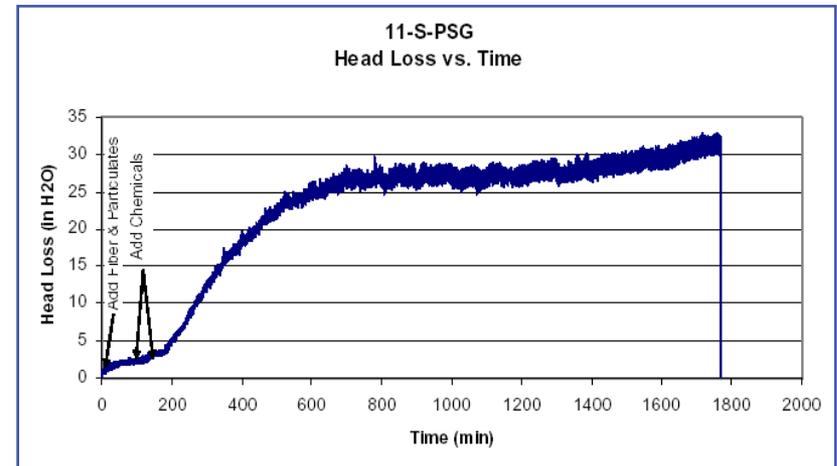
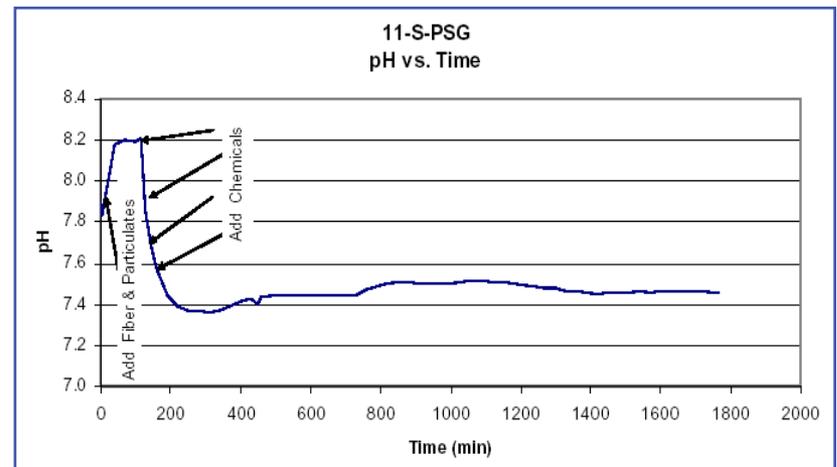
- Design basis sector test result
- Fully agitated
- Evidence of channeling, therefore test head loss is not scaled by kinematic viscosity ratio for plant head loss
- Test run for 270 turnovers.

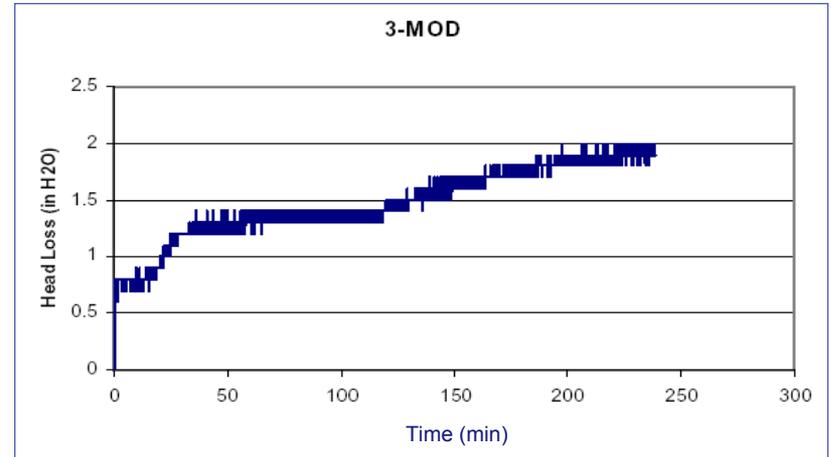
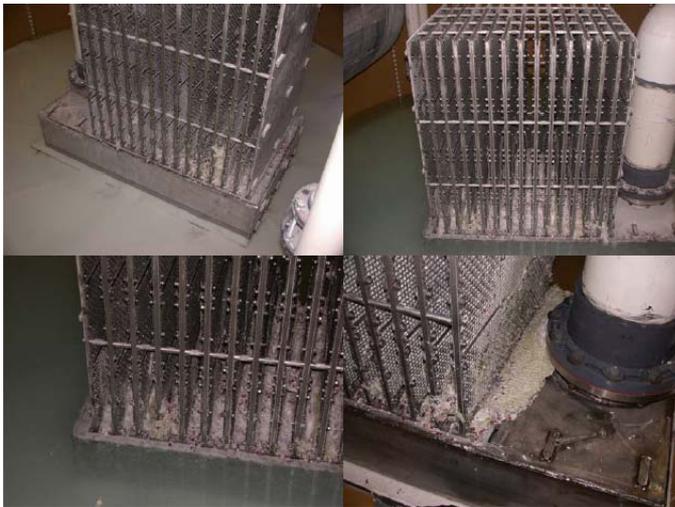
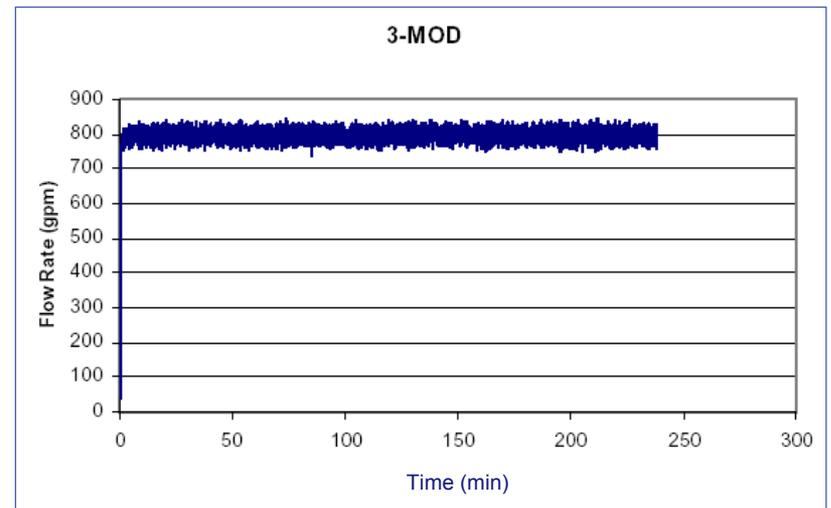
- Module test result not used as design basis - bounded by design basis sector test
- Fully agitated
- Rear strainer module
- Test run until <0.1 inch of head loss increase for 5 turnovers.

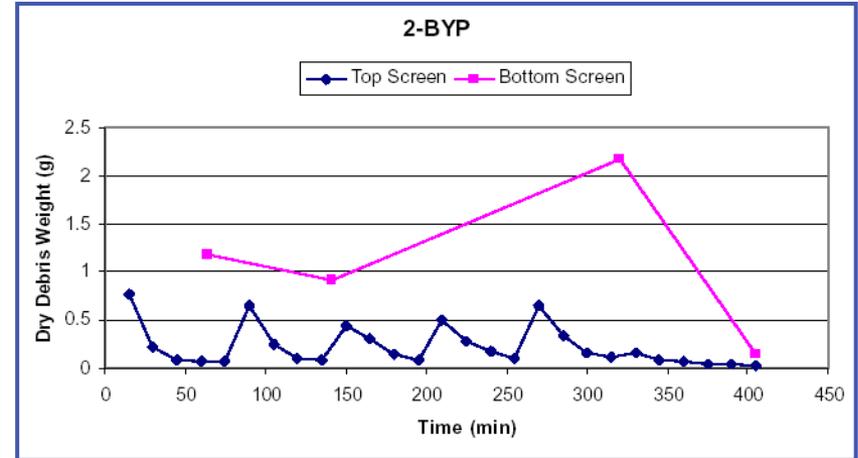
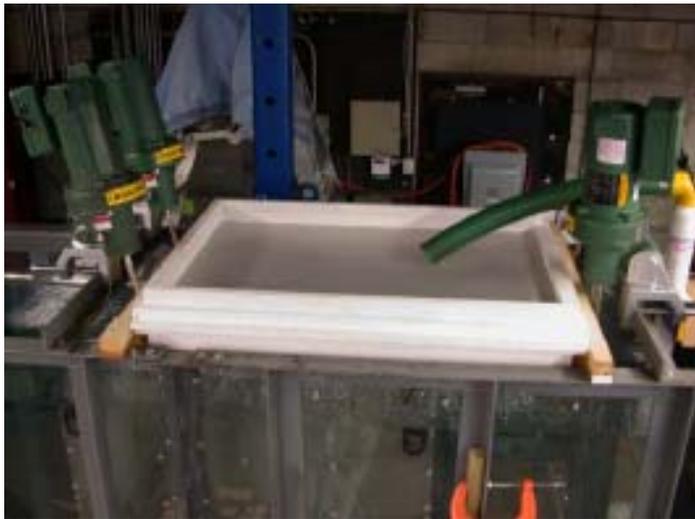
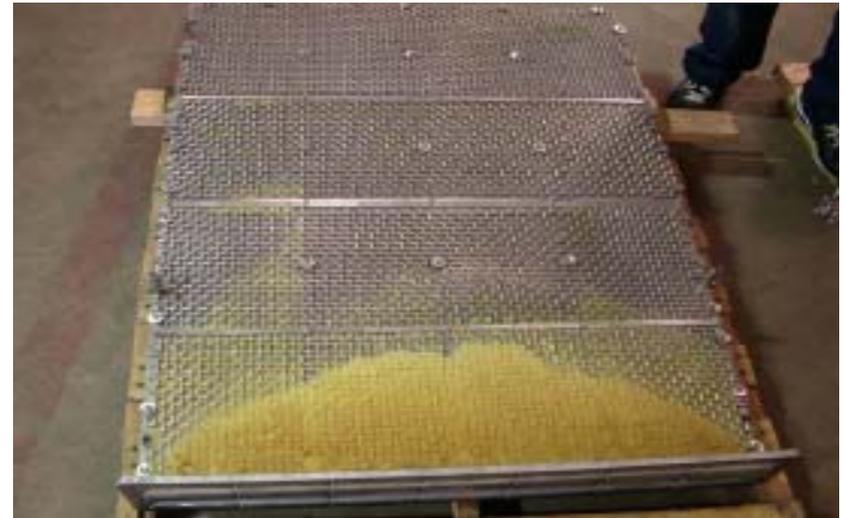
- Test sector with greatest open area used for conservatism
- Fiber added stepwise
- Four tests were run, highest measured bypass was scaled to plant strainer.
- Total fiber bypass for plant strainer is 2.16 ft³

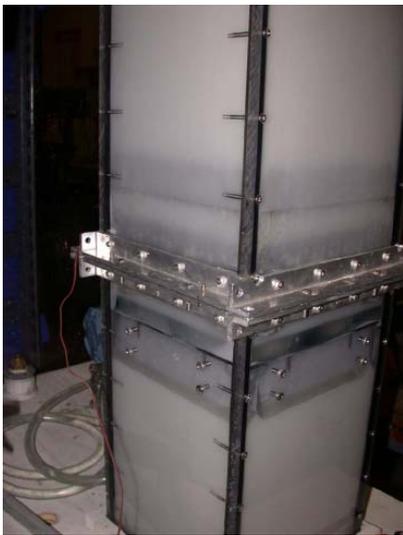
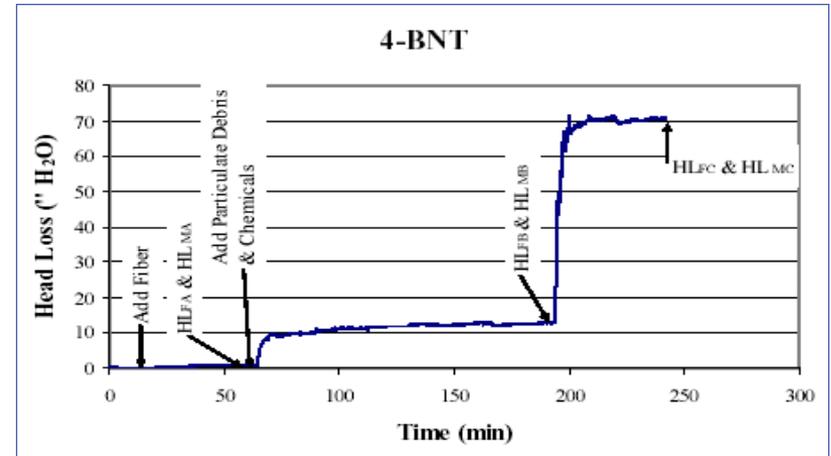
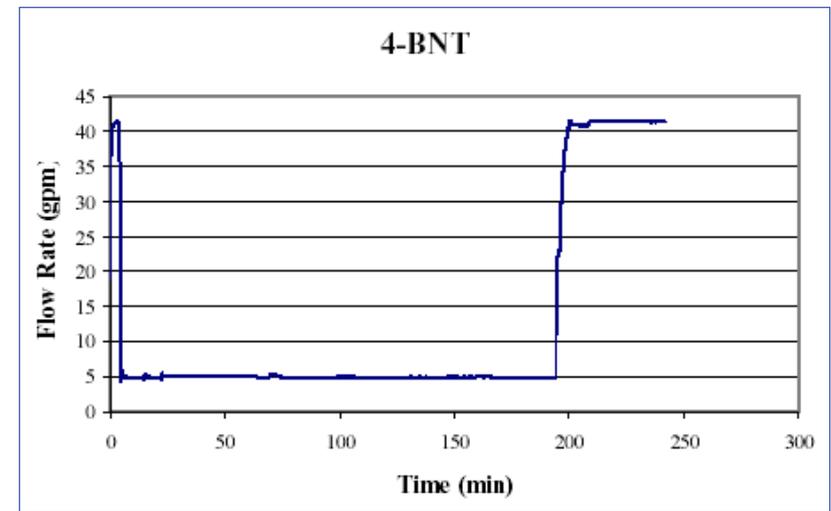
- Design basis fuel grid test result
- Fiber quantity was based on scaled limiting result from bypass tests.
- Flow run at 5 gpm to allow bed to accumulate, then increased to 41 gpm to find max. head loss.
- Flow was maintained through bottom nozzle and fuel grid during all tests

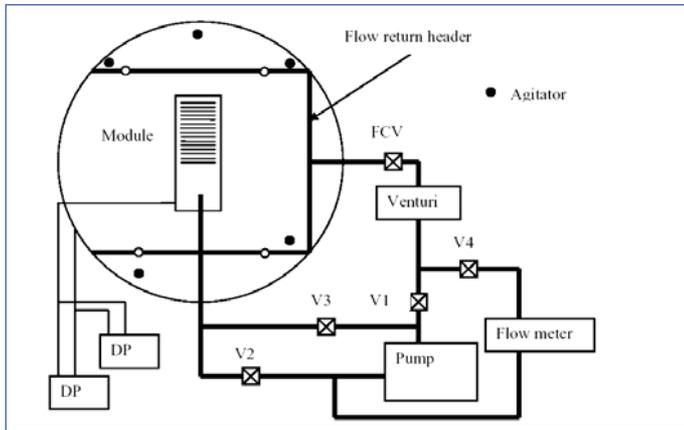
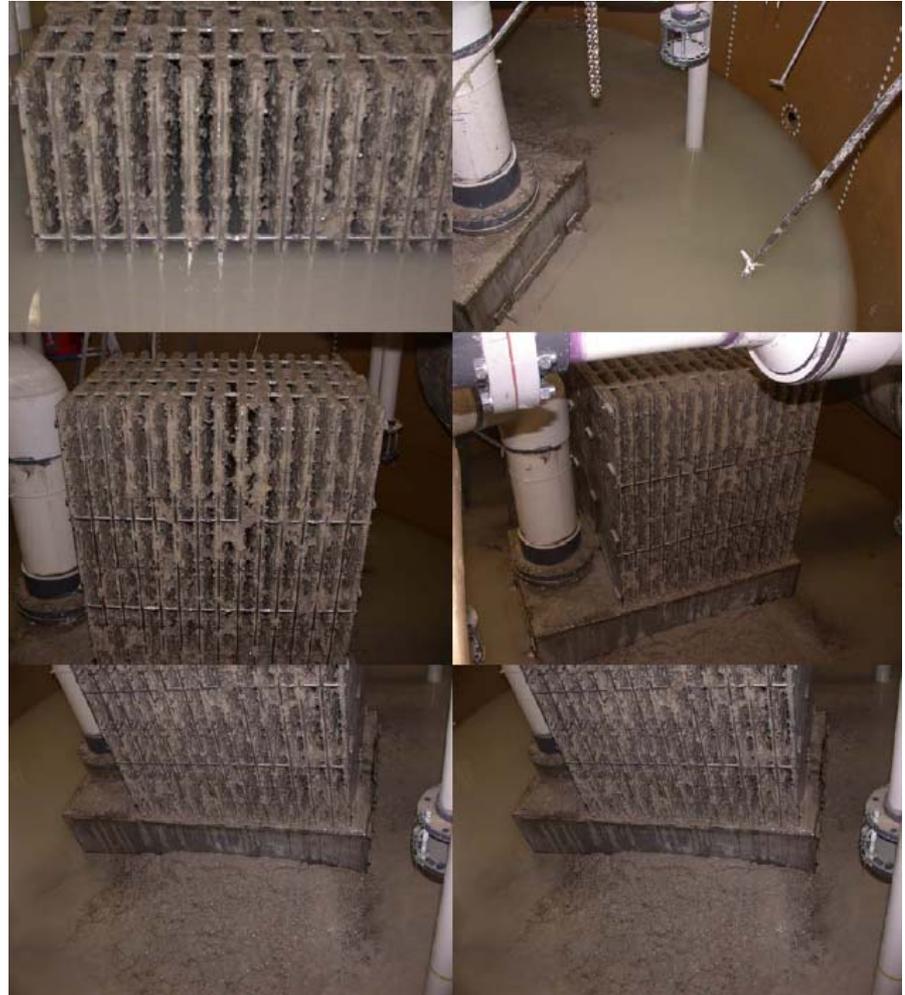
- Plant Simulator confirmed multiple alignments for back flush are achievable
 - > 900 gpm flow rate
 - > 20 min for back flush alignment
 - > Base Case (Large Break) debris load
