Oyster Creek License Renewal Presentation to ACRS Subcommittee

Drywell Shell Corrosion Cause and Corrective Actions

Drywell Thickness Analysis

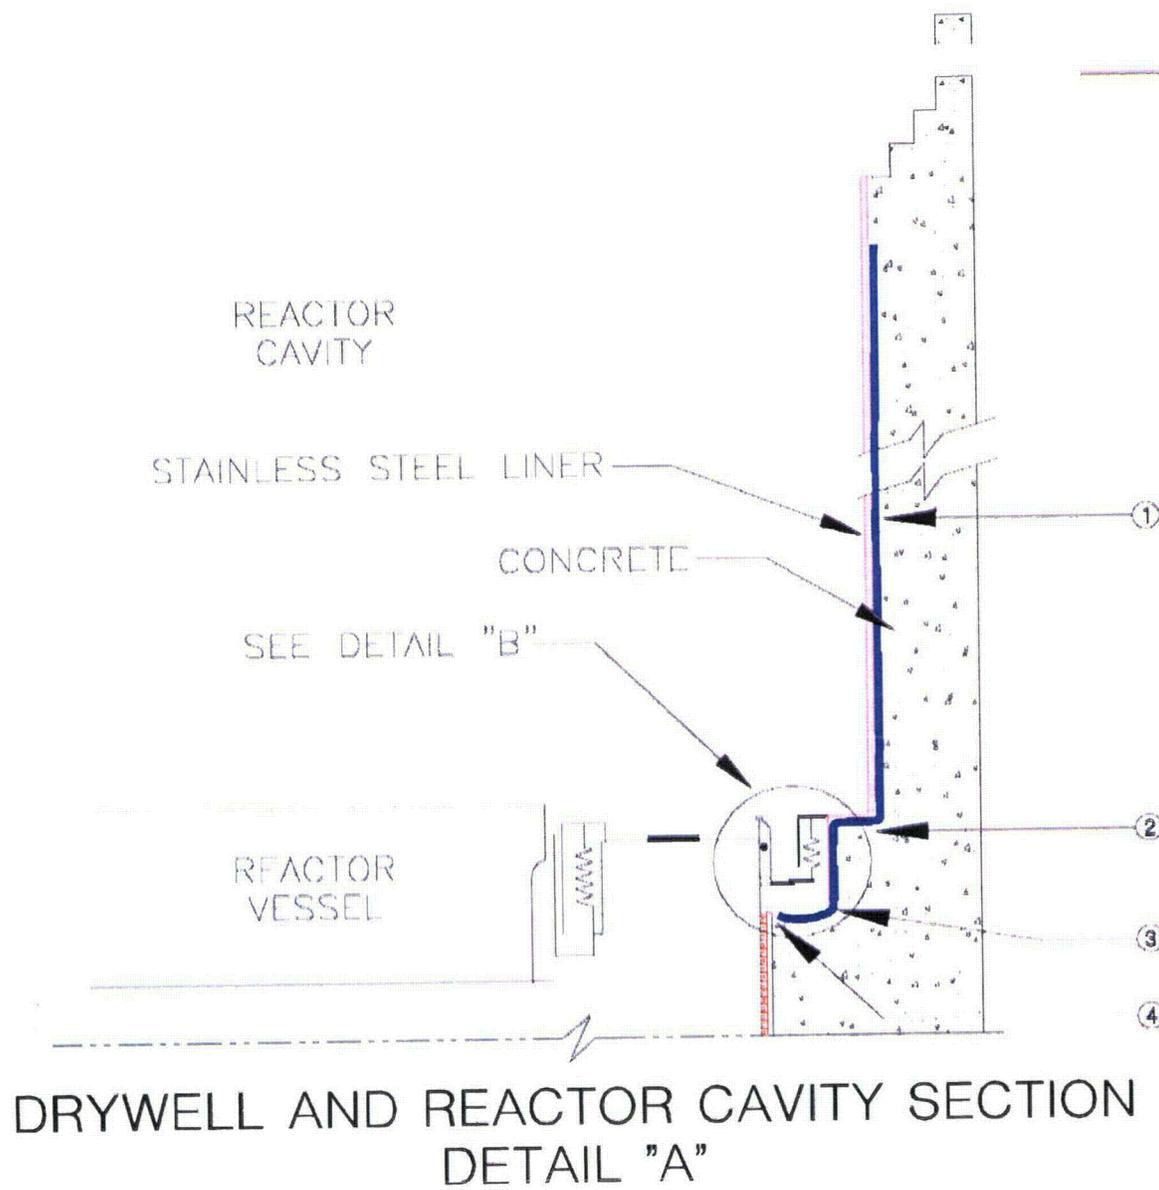
DRYWELL TO REACTOR CAVITY SEAL DETAIL 'B'

OBSERVED DAMAGE AT LIP OF TROUGH
CORRECTED IN 1988

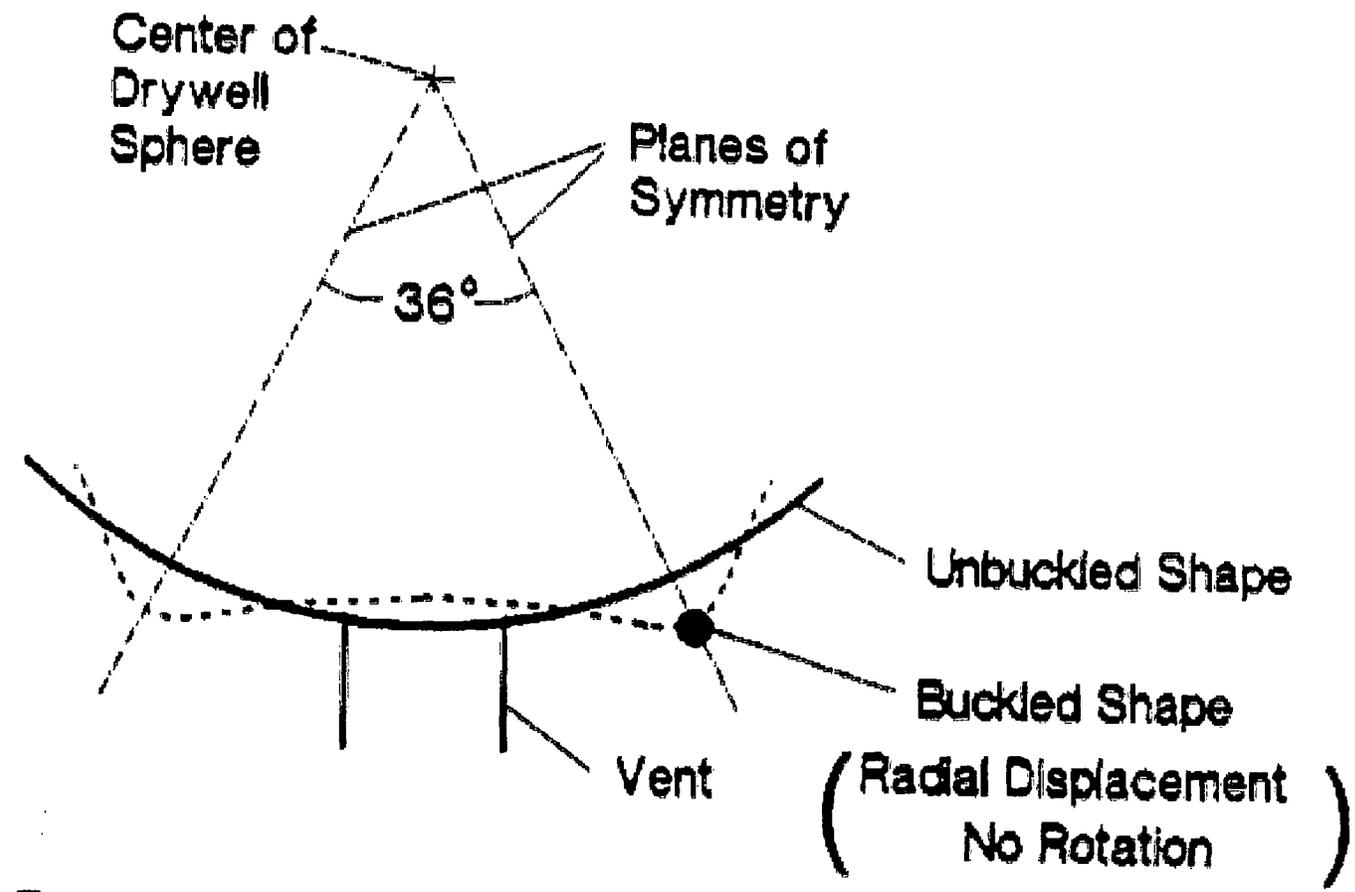
Symmetric Buckling of Drywell

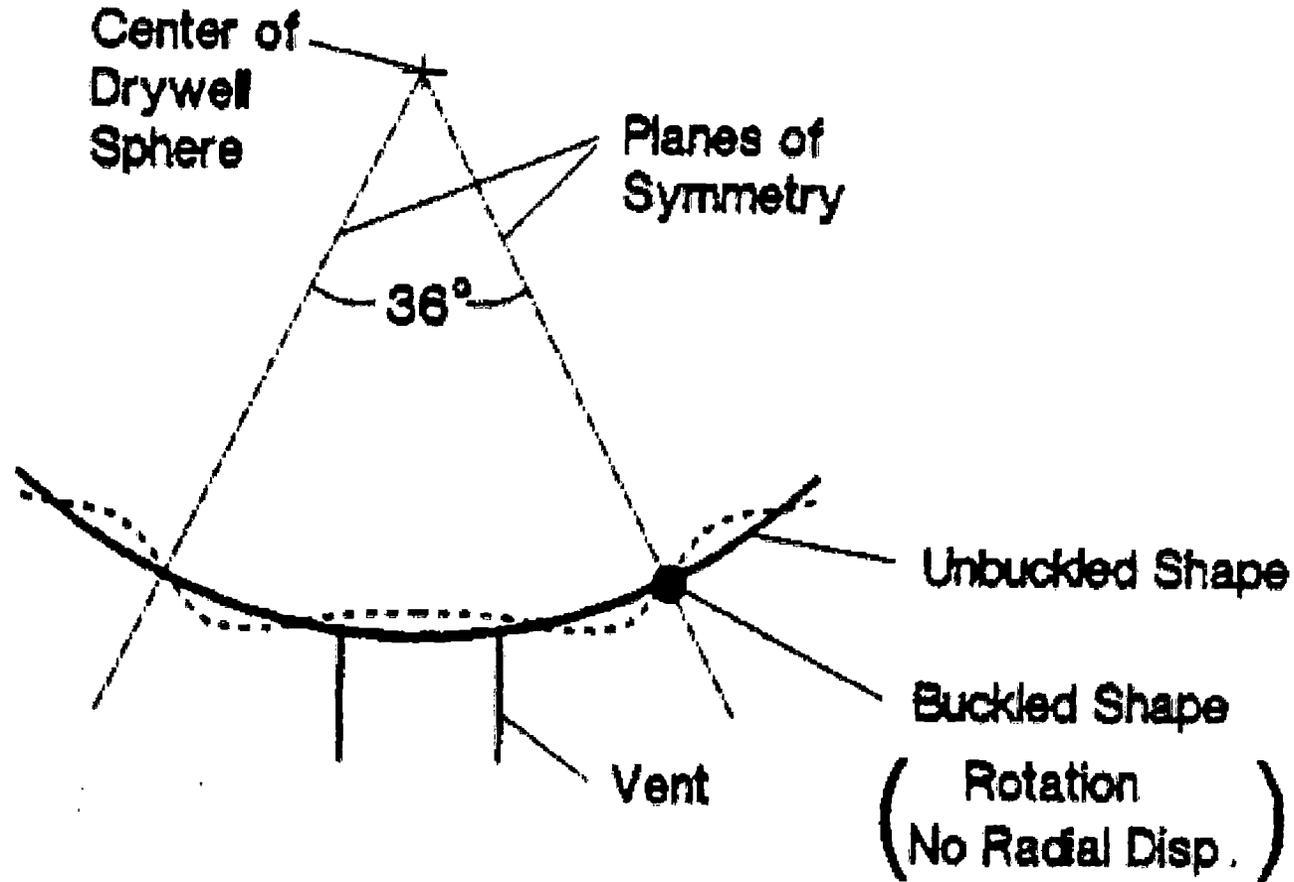
Asymmetric Buckling of Drywell

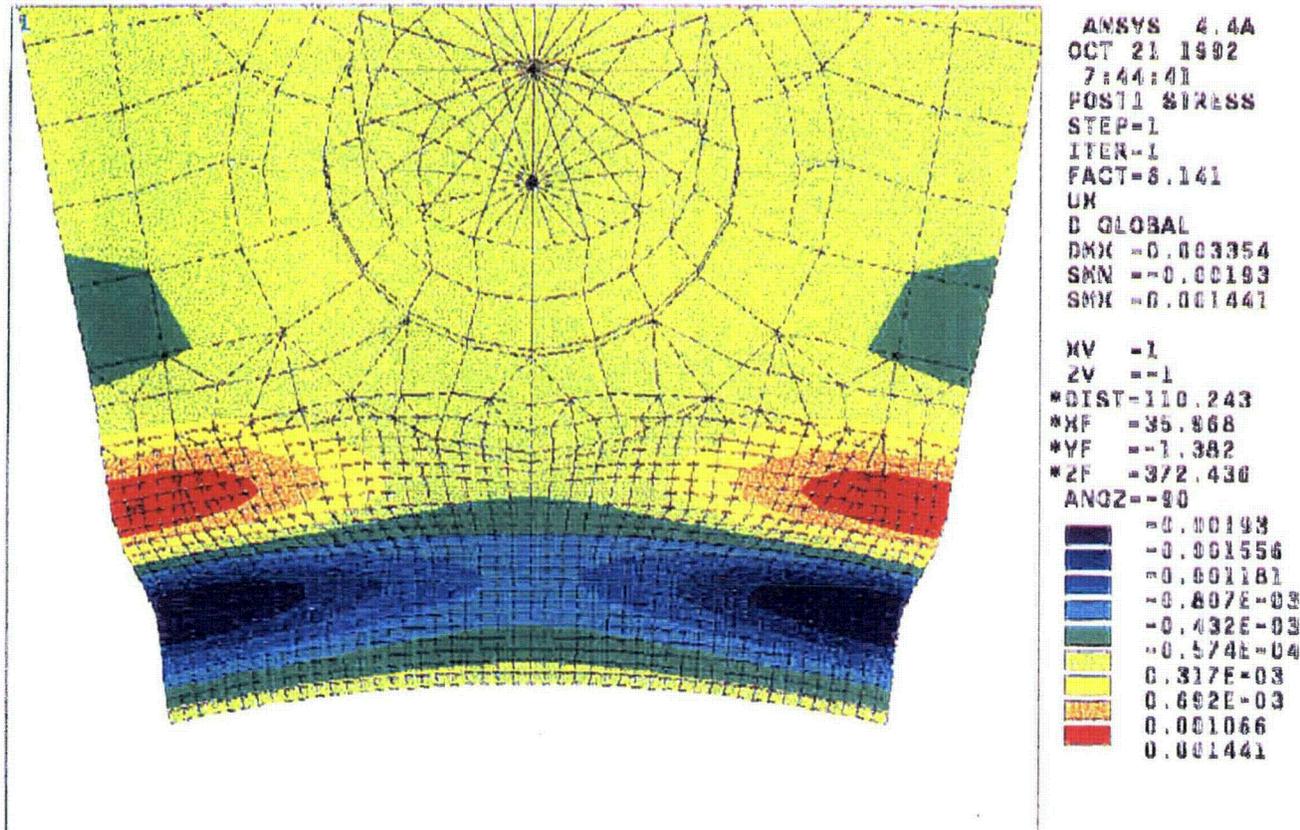
Figure 3-18 Sym-Sym Buckling Mode Shape - Refueling Case

OYSTER CREEK DRYWELL ANALYSIS - OCRFREF SYM-SYM (NO SAND, REFUELING)

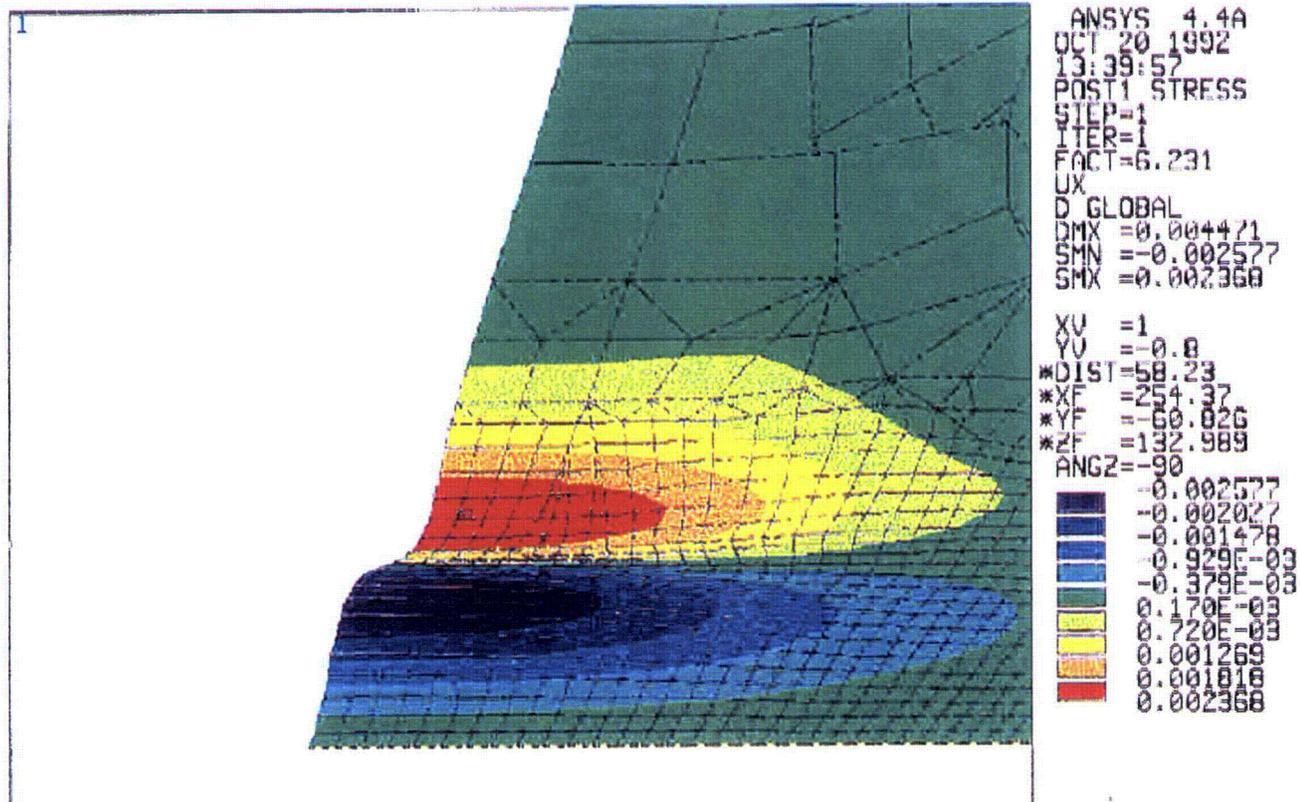
Figure 3-19 Sym-Asym Buckling Mode Shape - Refueling Case

OYSTER CREEK DRYWELL - ASYM - SYM , NO SAND, REFUELING

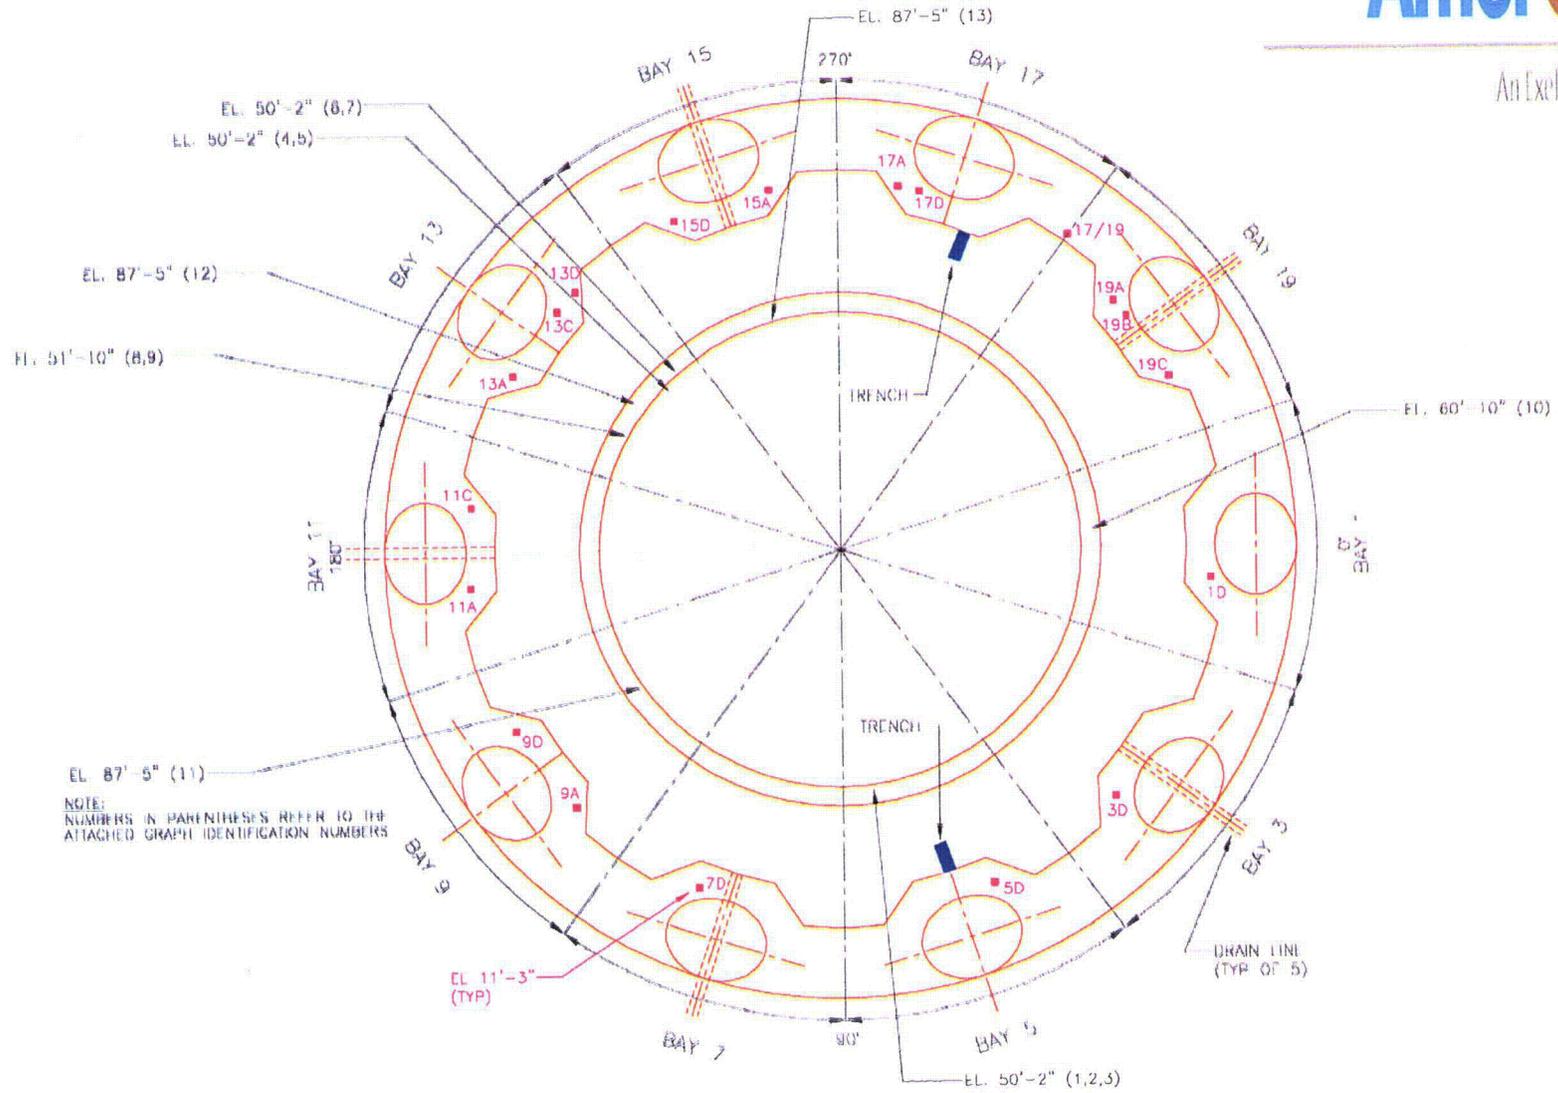
VIEW FROM INSIDE DRYWELL

- 1983 to 1986 corrosion data 360° at elev. 11'3"
 - When thin locations were identified, UT measurements were taken horizontally and vertically to locate the thinnest locations
 - UT grid measurements were taken at the thinnest locations
 - 19 locations were selected for corrosion monitoring based on over 500 initial data points measured
 - At least one grid is located in each of the 10 bays

NOTE:
NUMBERS IN PARENTHESES REFER TO THE
ATTACHED GRAPH IDENTIFICATION NUMBERS

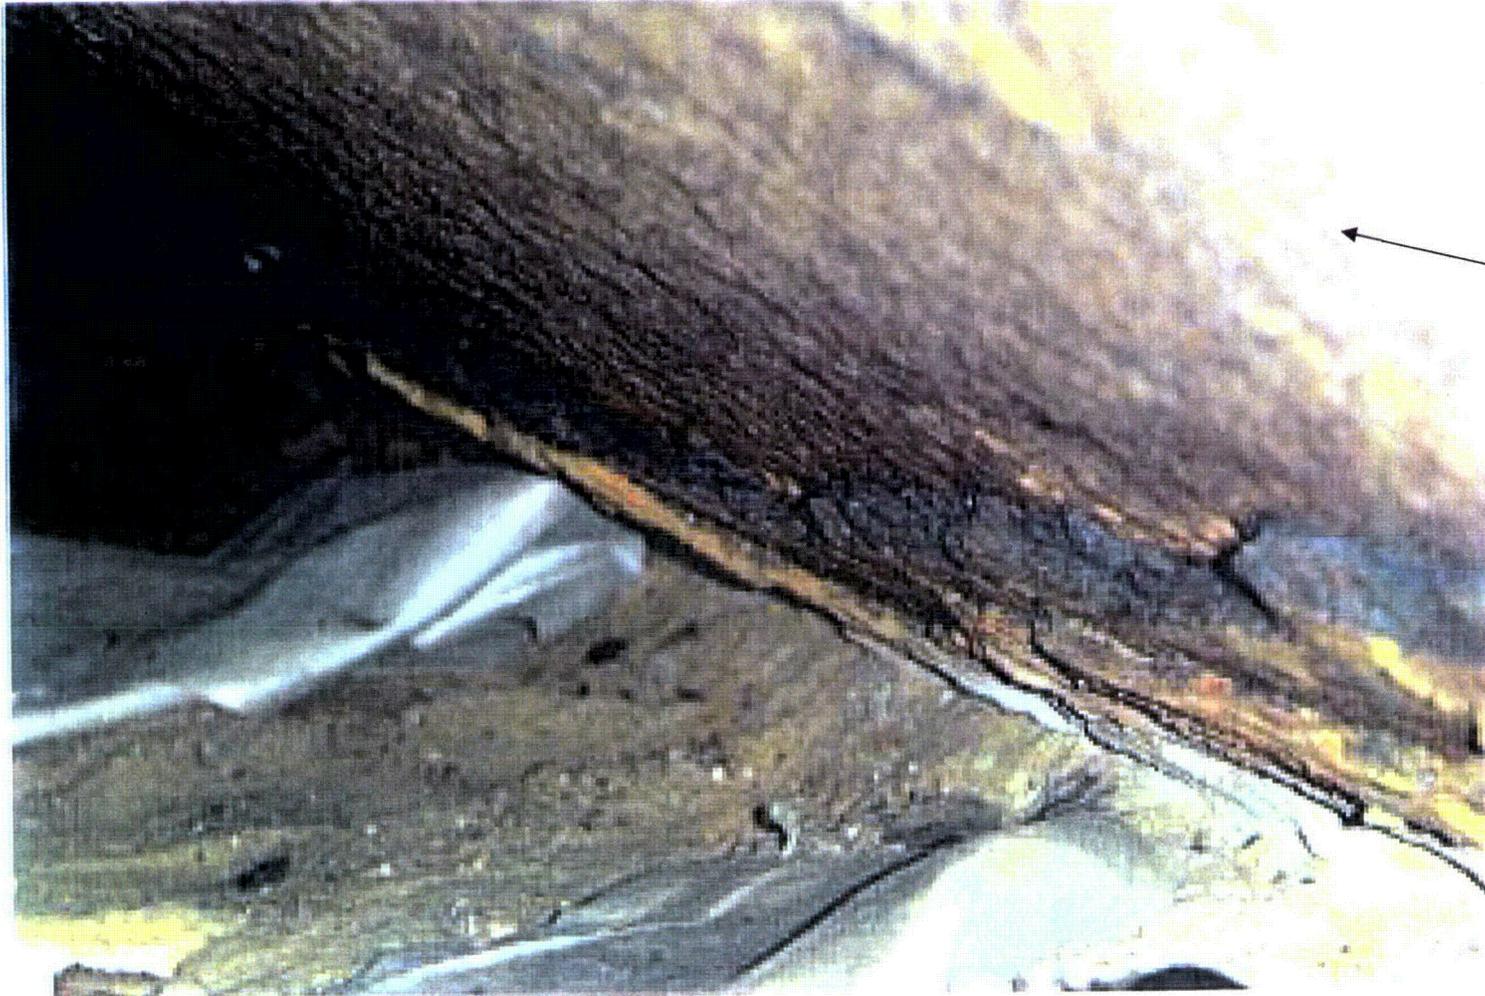
Sand Bed Region 1992

Drywell
Shell

Corrosion product on drywell vessel

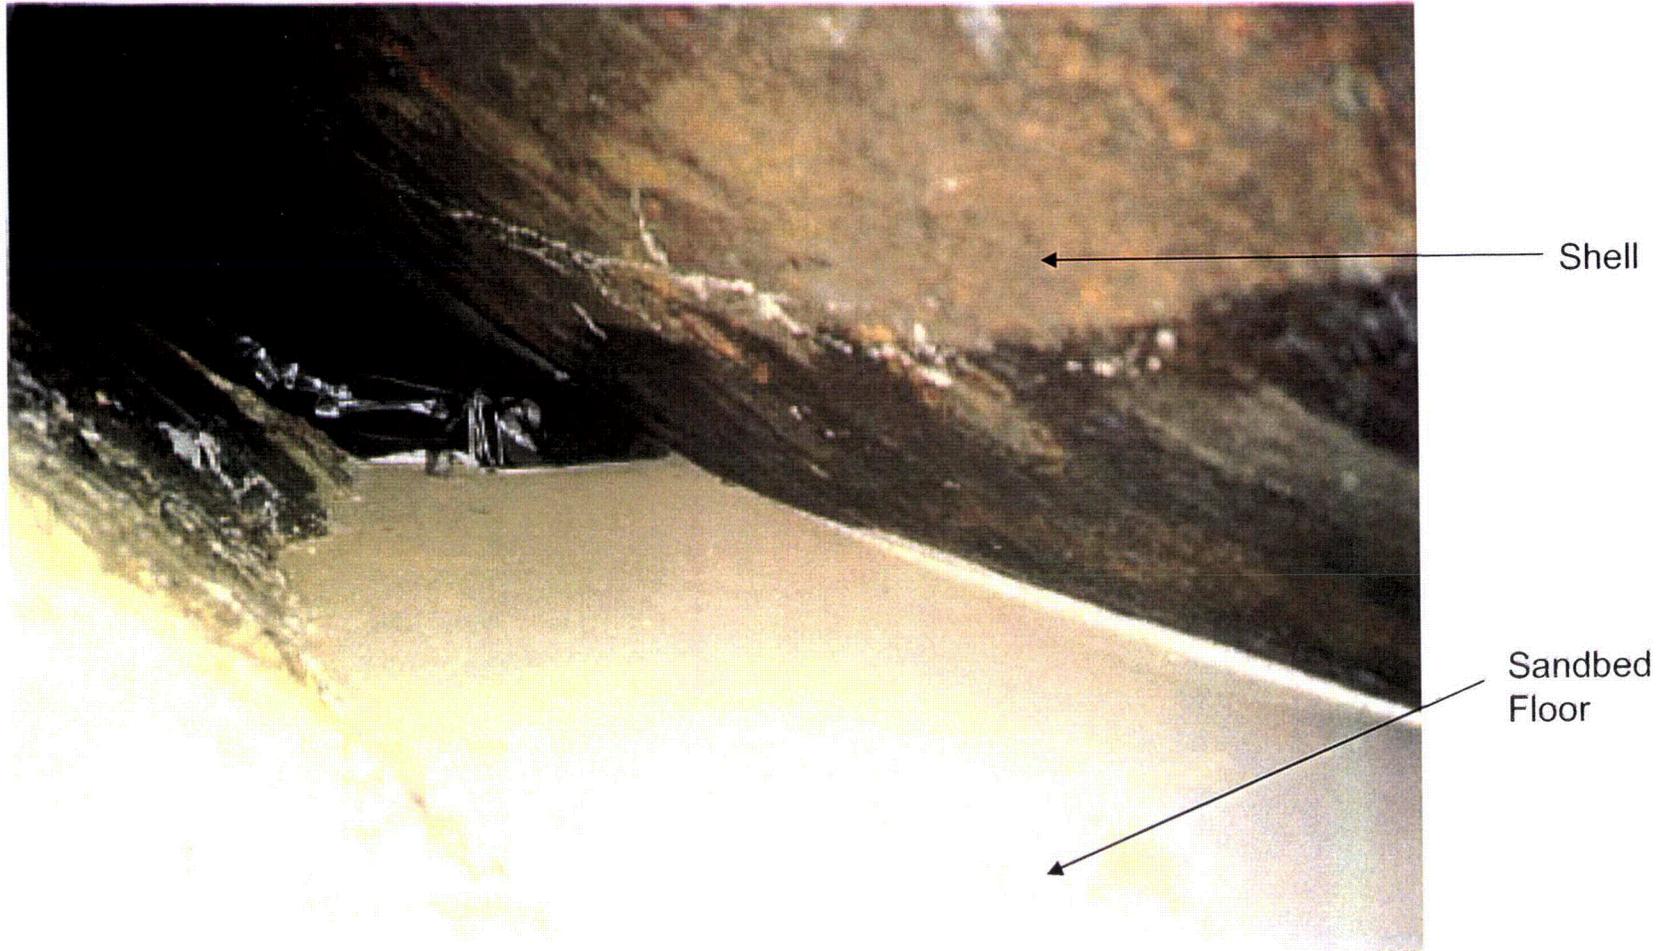
Sand Bed Region 1992

Bay 5 before shell coating

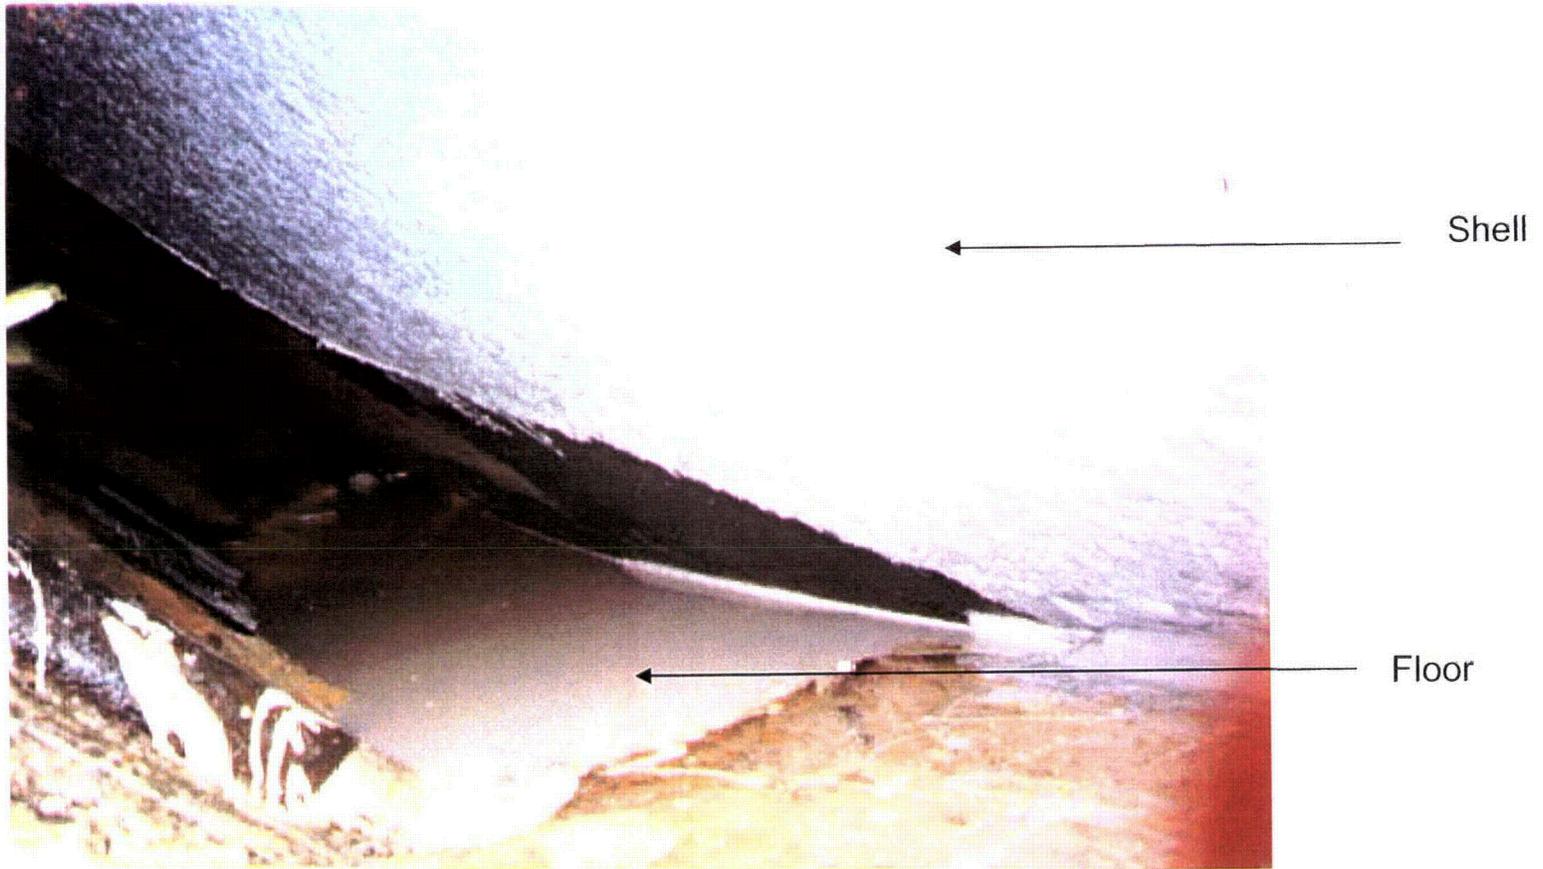
Sand Bed Region 1992

Shell and floor undergoing coating and repairs

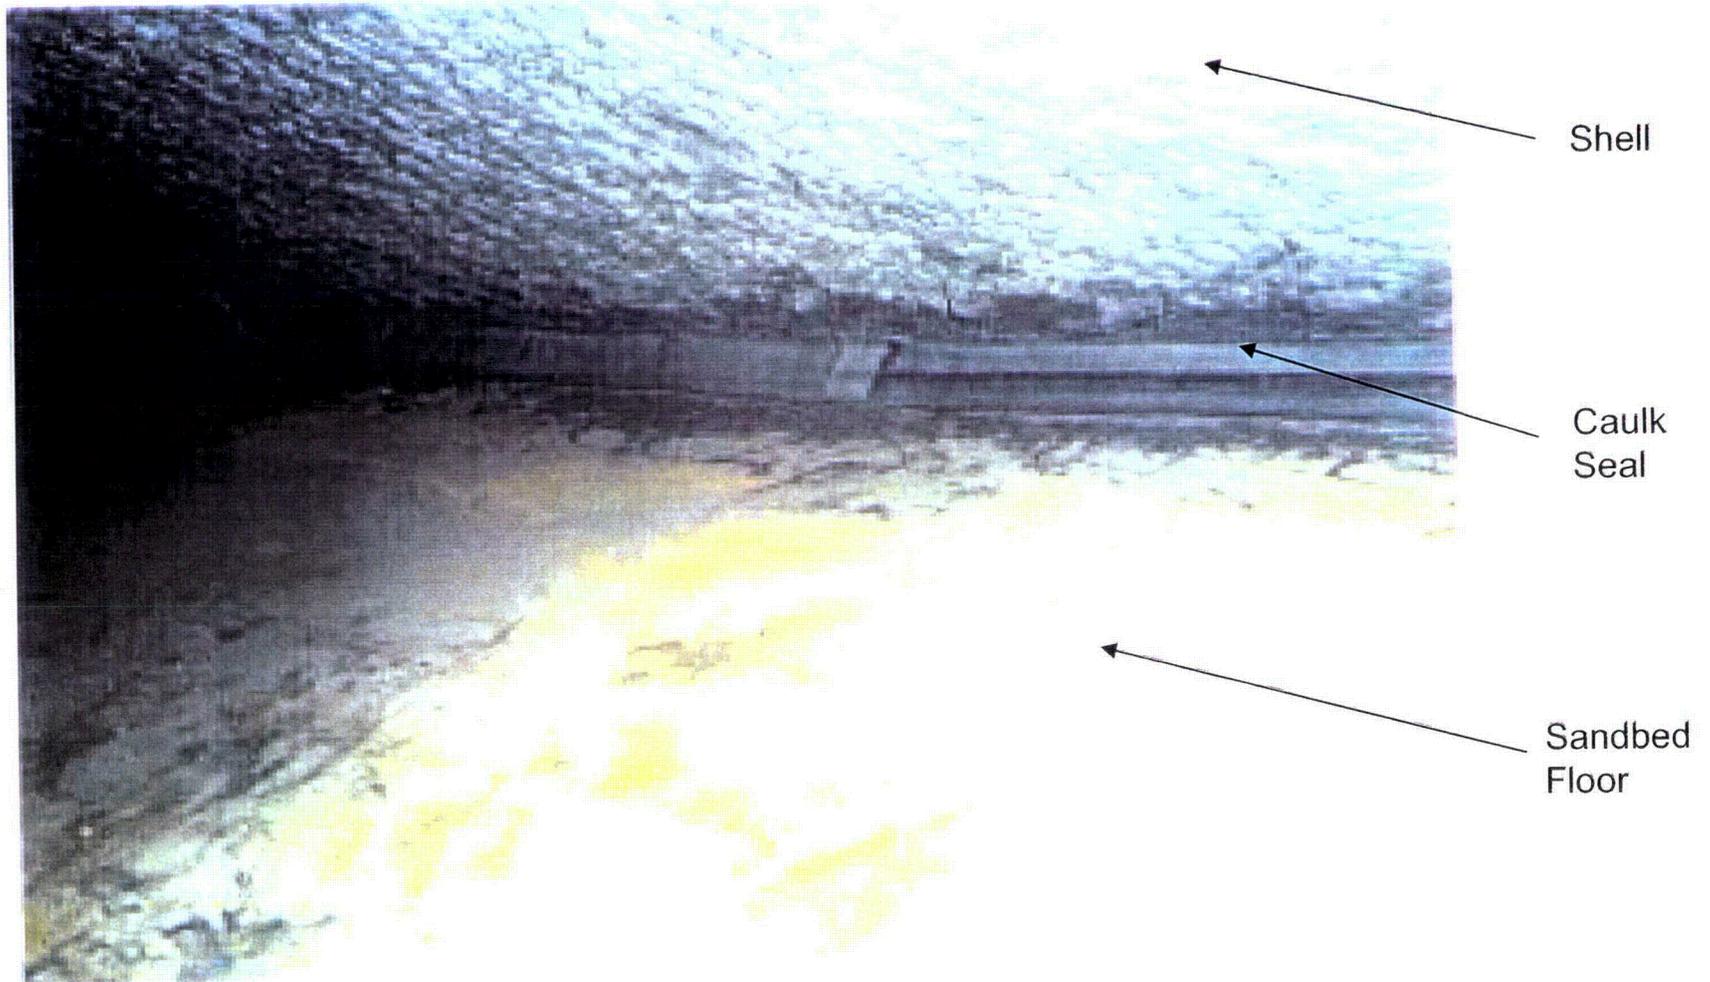
Sand Bed Region 1992

Finished floor, vessel with two top coats – caulking material applied

- DEVOE Epoxy coating system (3 part)
 - Designed for application on corroded surfaces
 - One coat DEVOE 167 Rust Penetrating Sealer
 - Penetrates rusty surfaces
 - Reinforces rusty steel substrates
 - Ensures adhesion of Devran 184 epoxy coating

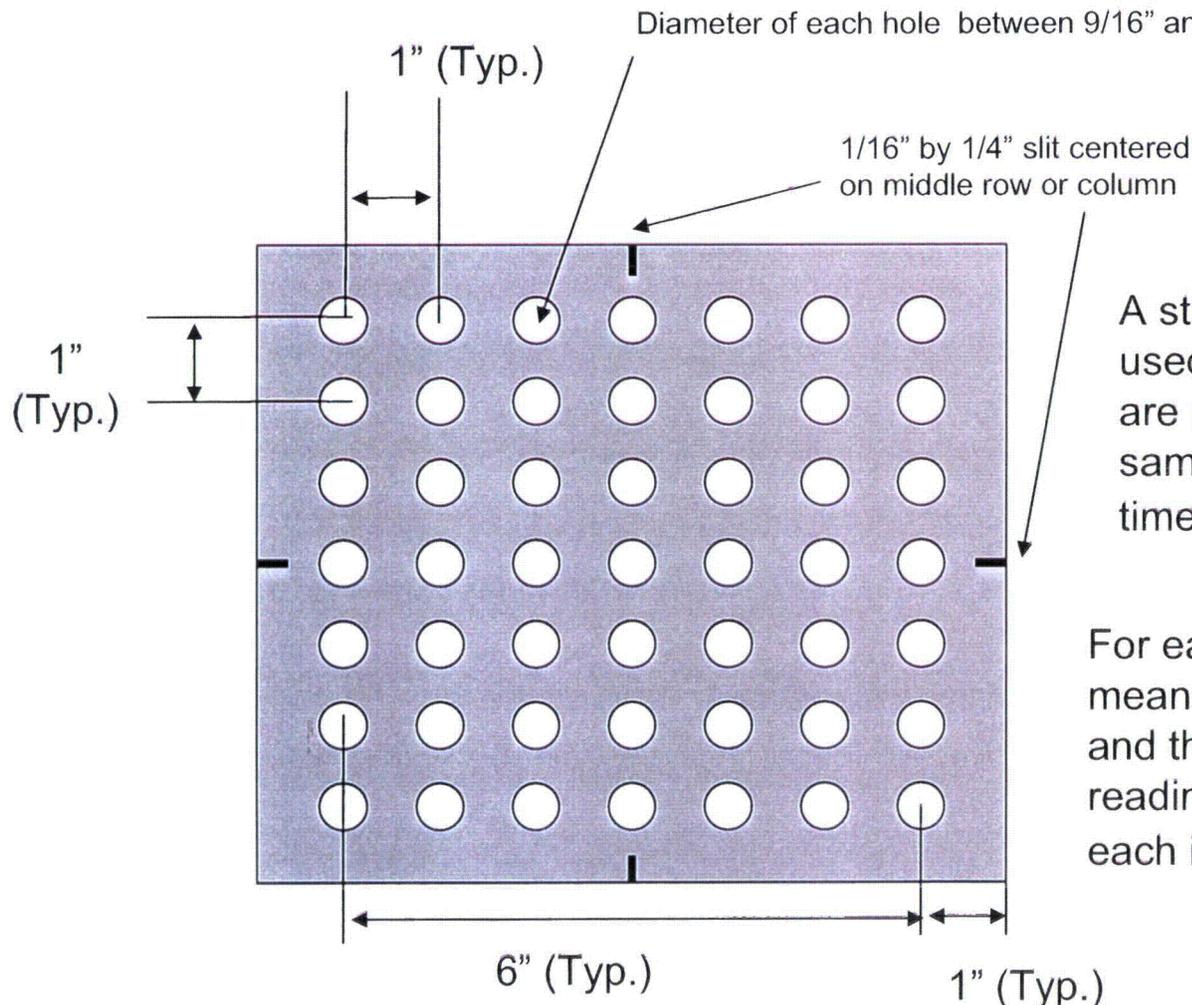
49 UT readings are recorded over a 6" by 6" area.

A stainless steel template is used to ensure that the readings are recorded consistently and in same location (+/- 1/16") every time.

For each location, the mean and standard error and the thinnest of the 49 readings are calculated after each inspection.

- Measurement locations are marked on the inside of the drywell shell
- Use a stainless steel template with 49 holes to align the UT probe
- UT probe placed perpendicular to the surface to consistently obtain lowest reading
- A protective grease is applied to the 6"x6" grid during operation, and removed to take UT measurements

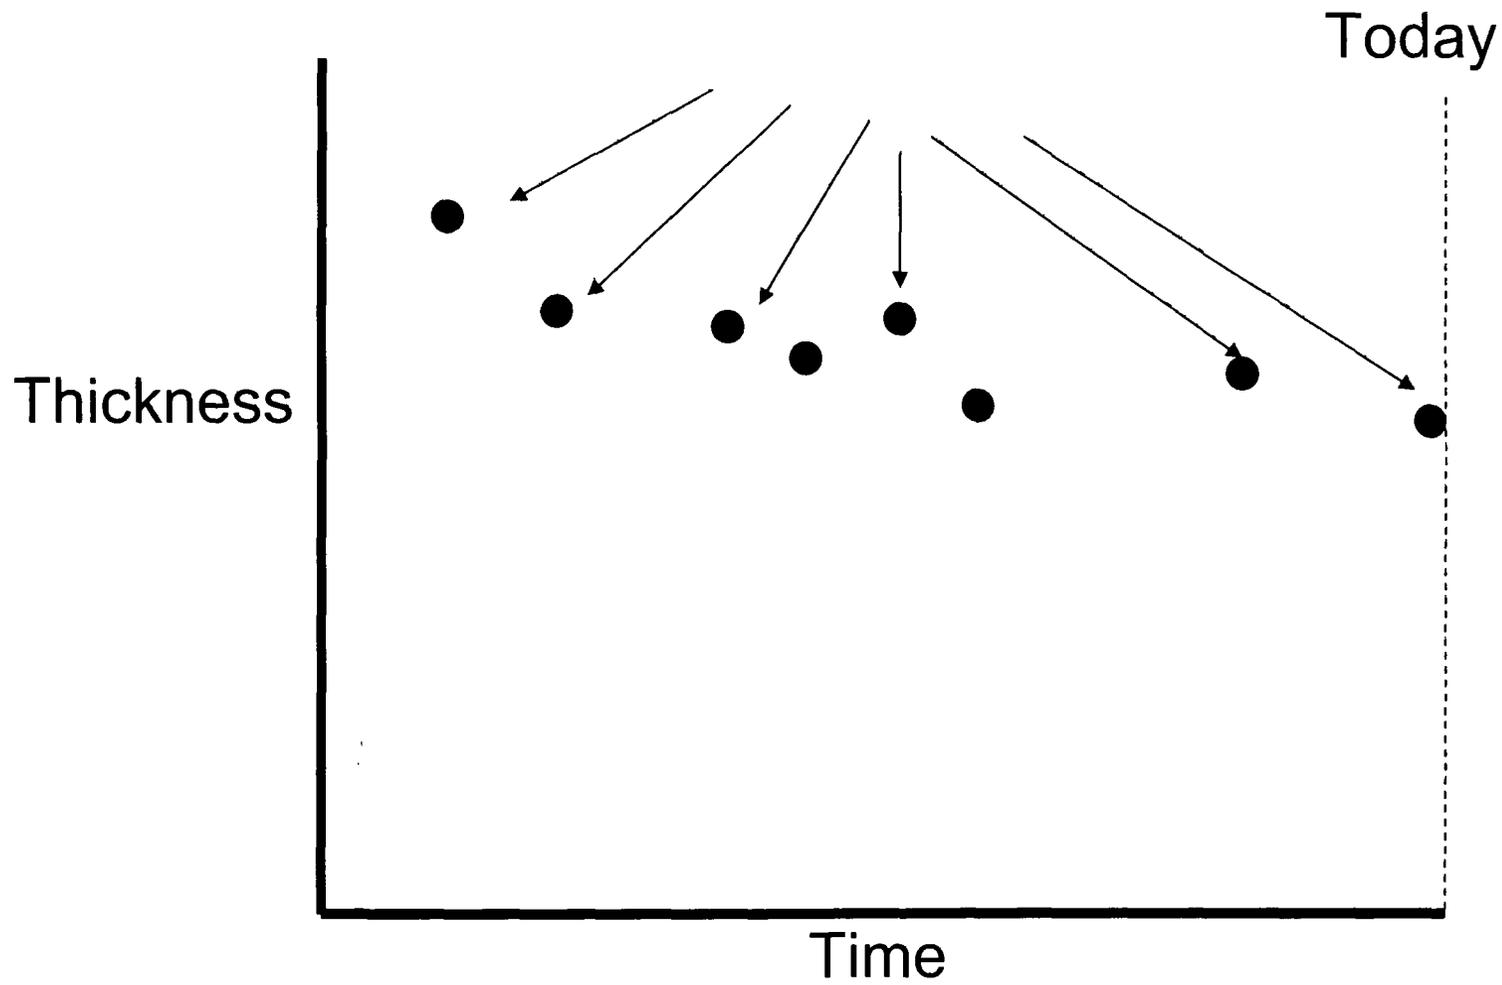
For each location the means and thinnest points are trended over time

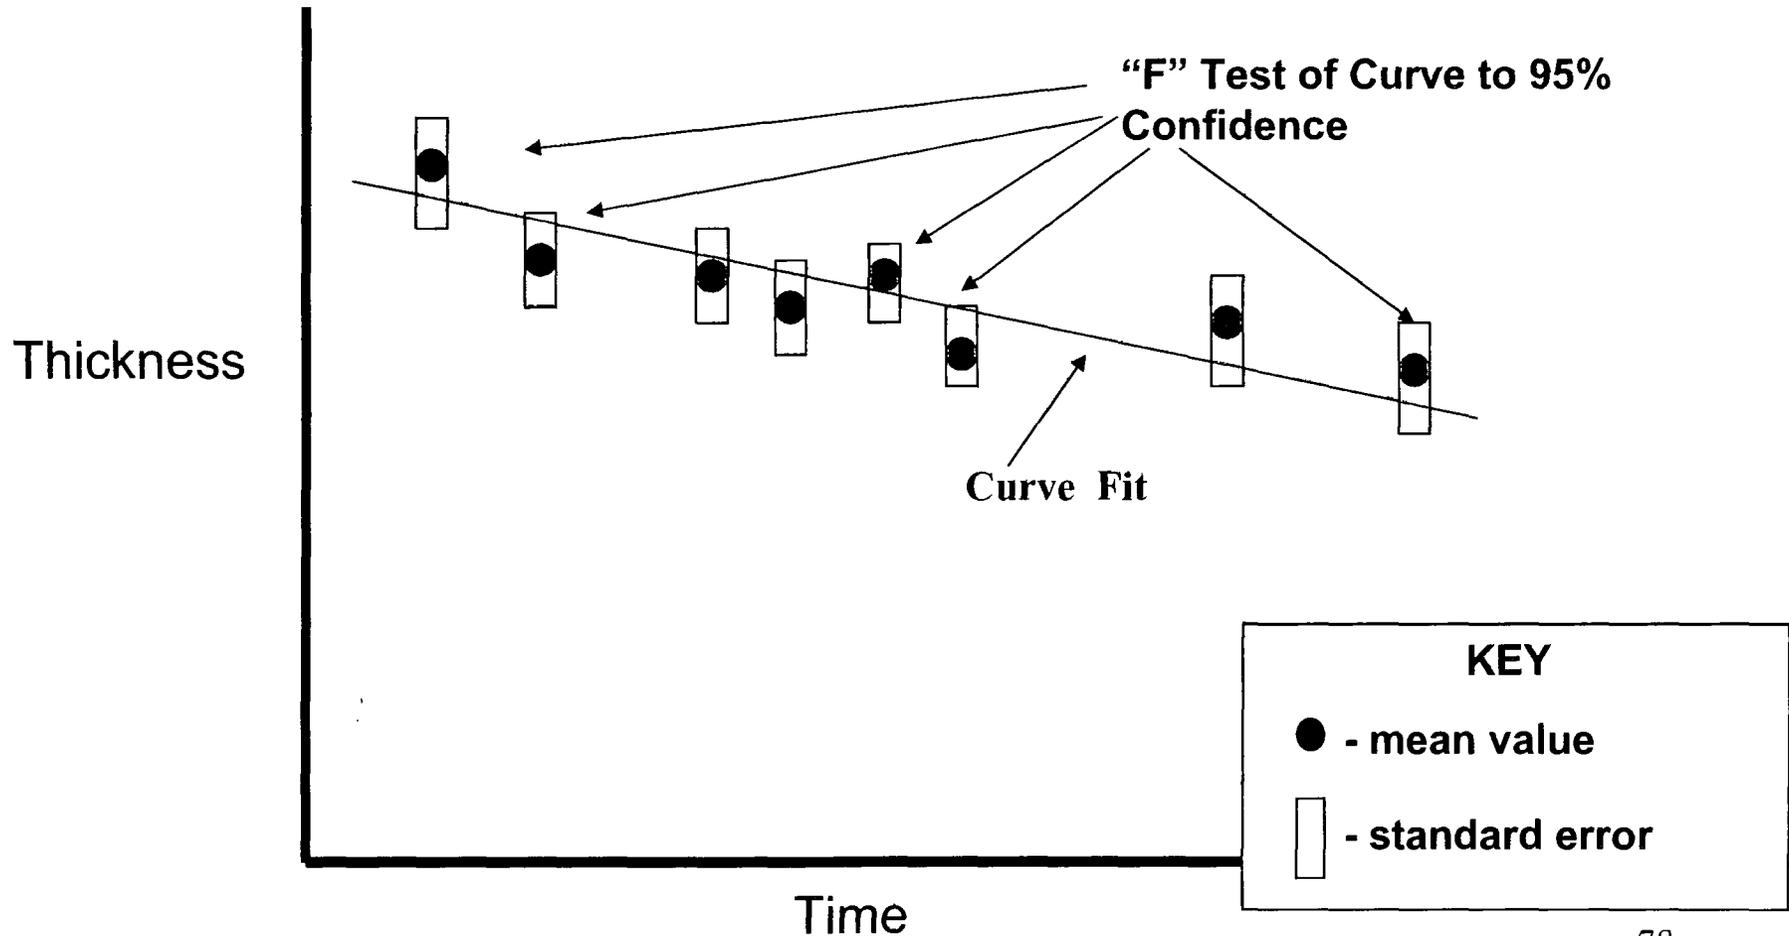
1) A curve fit based on the regression model is then developed.

2) The Corrosion “F” Test is performed to determine if the data meet the curve fit with 95% confidence.

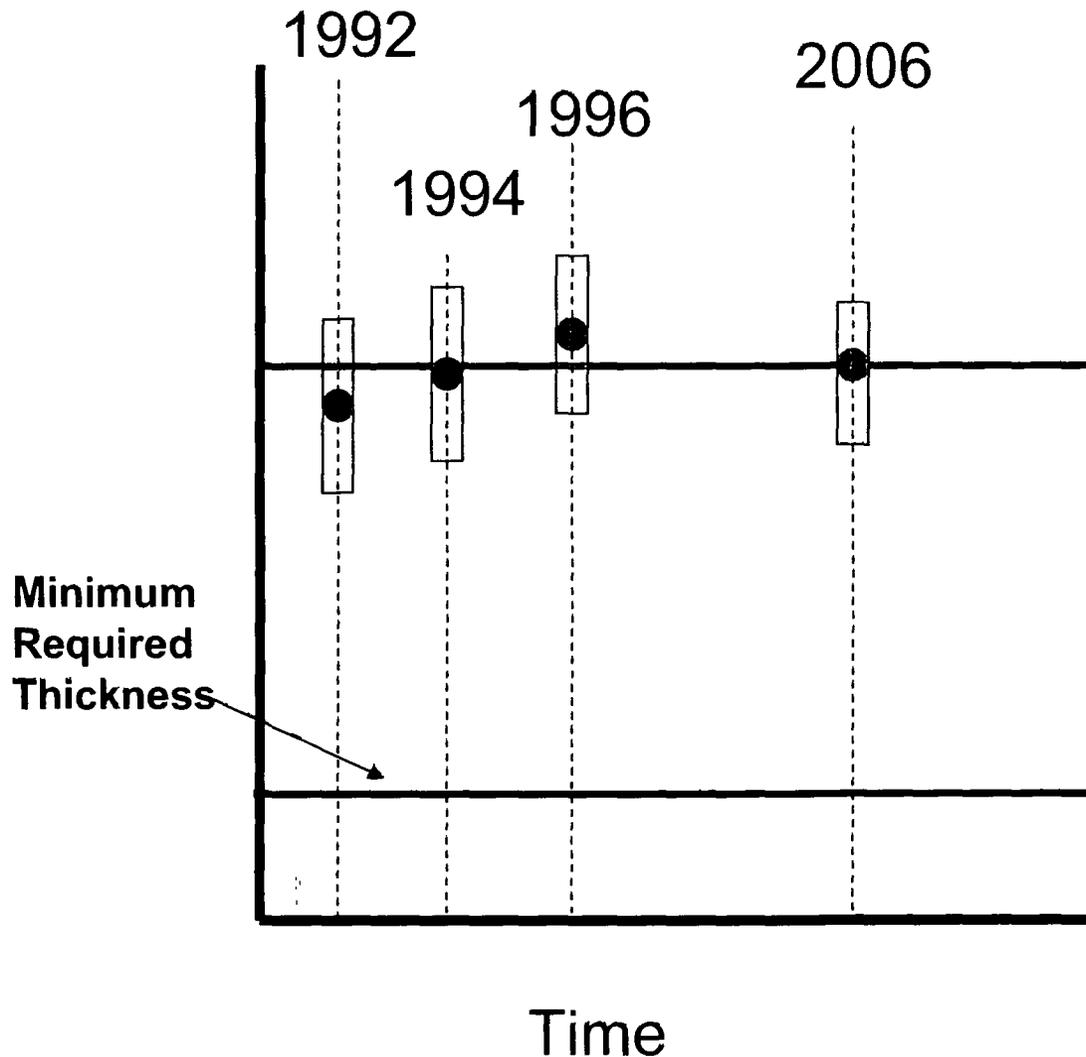
2006 Sand Bed Data Summary

In the case of the 2006 sand bed inspections, there are only 4 inspections per location with most standard errors between +/- 8 and +/-16 mils

There are not enough inspections to satisfy the Corrosion Test F test with 95% confidence.

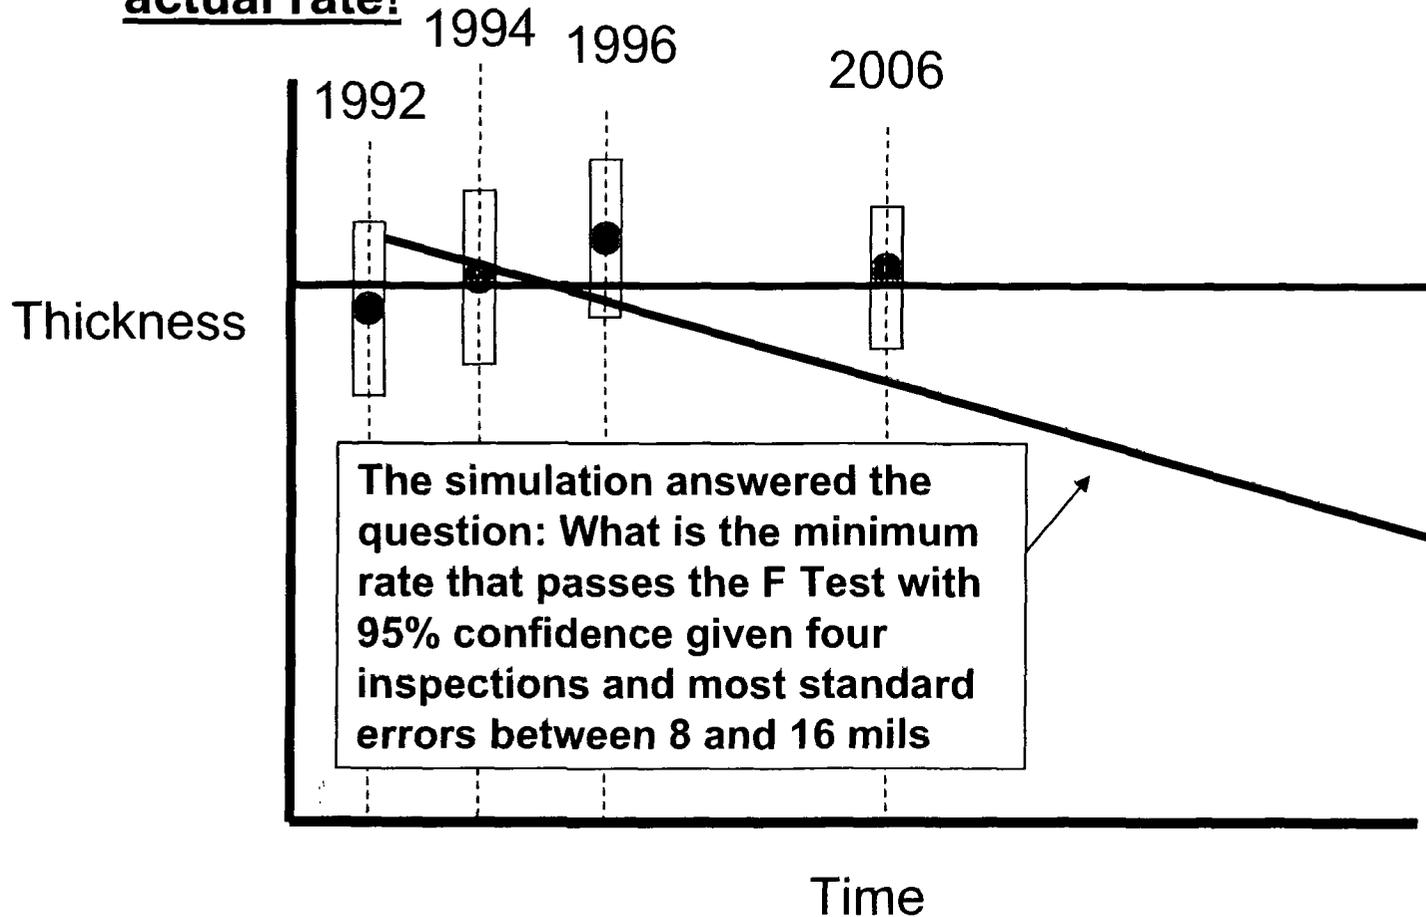
Given only 4 inspections and the standard errors, simulation was required to determine the minimum observable rate with 95% confidence. This is not an actual rate!

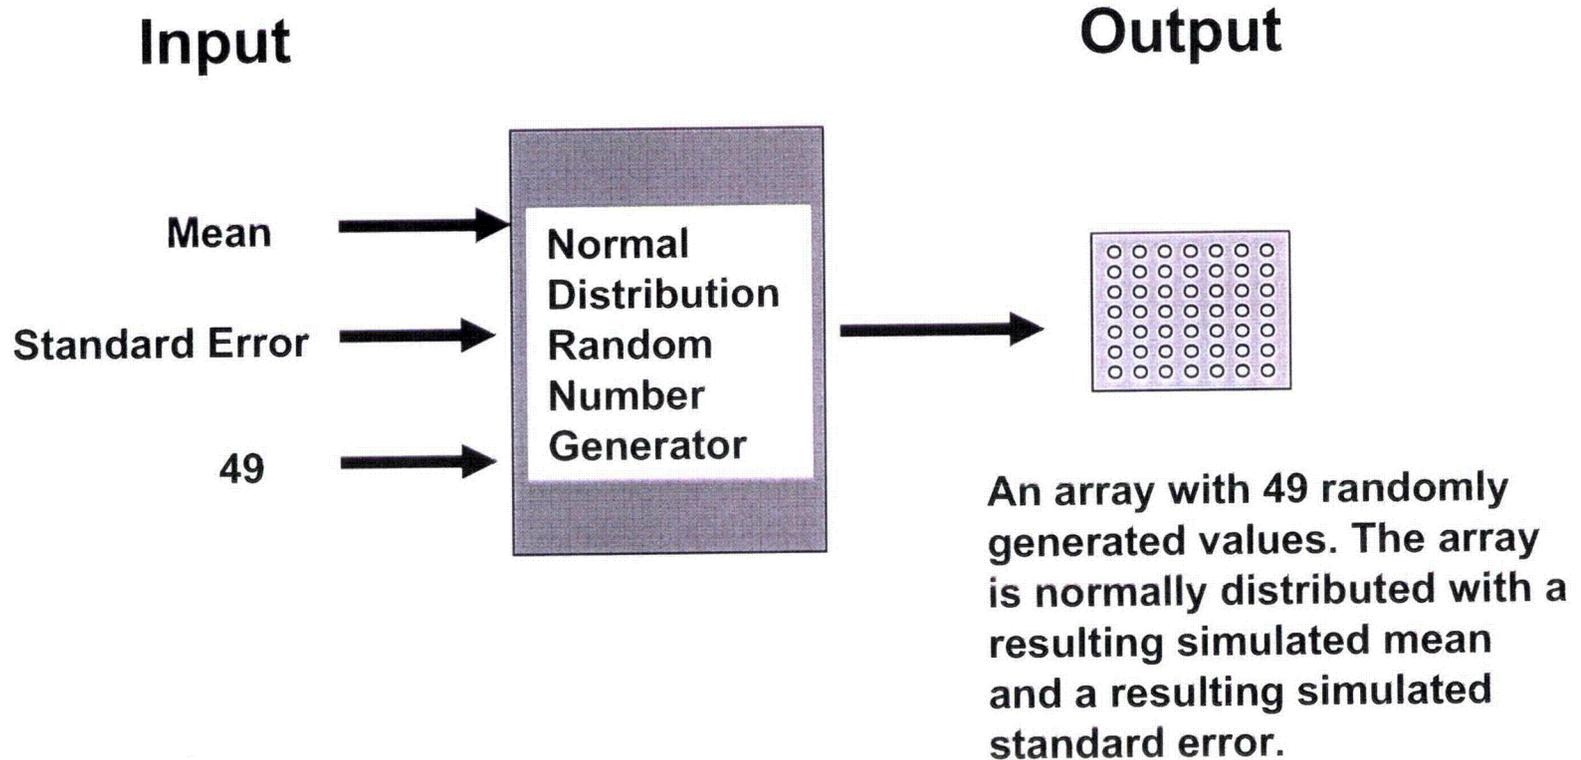
The simulation used a random number generator based on the normal distribution
