Oyster Creek License Renewal Presentation to ACRS Subcommittee

Drywell Shell Corrosion Cause and Corrective Actions

Drywell Thickness Analysis

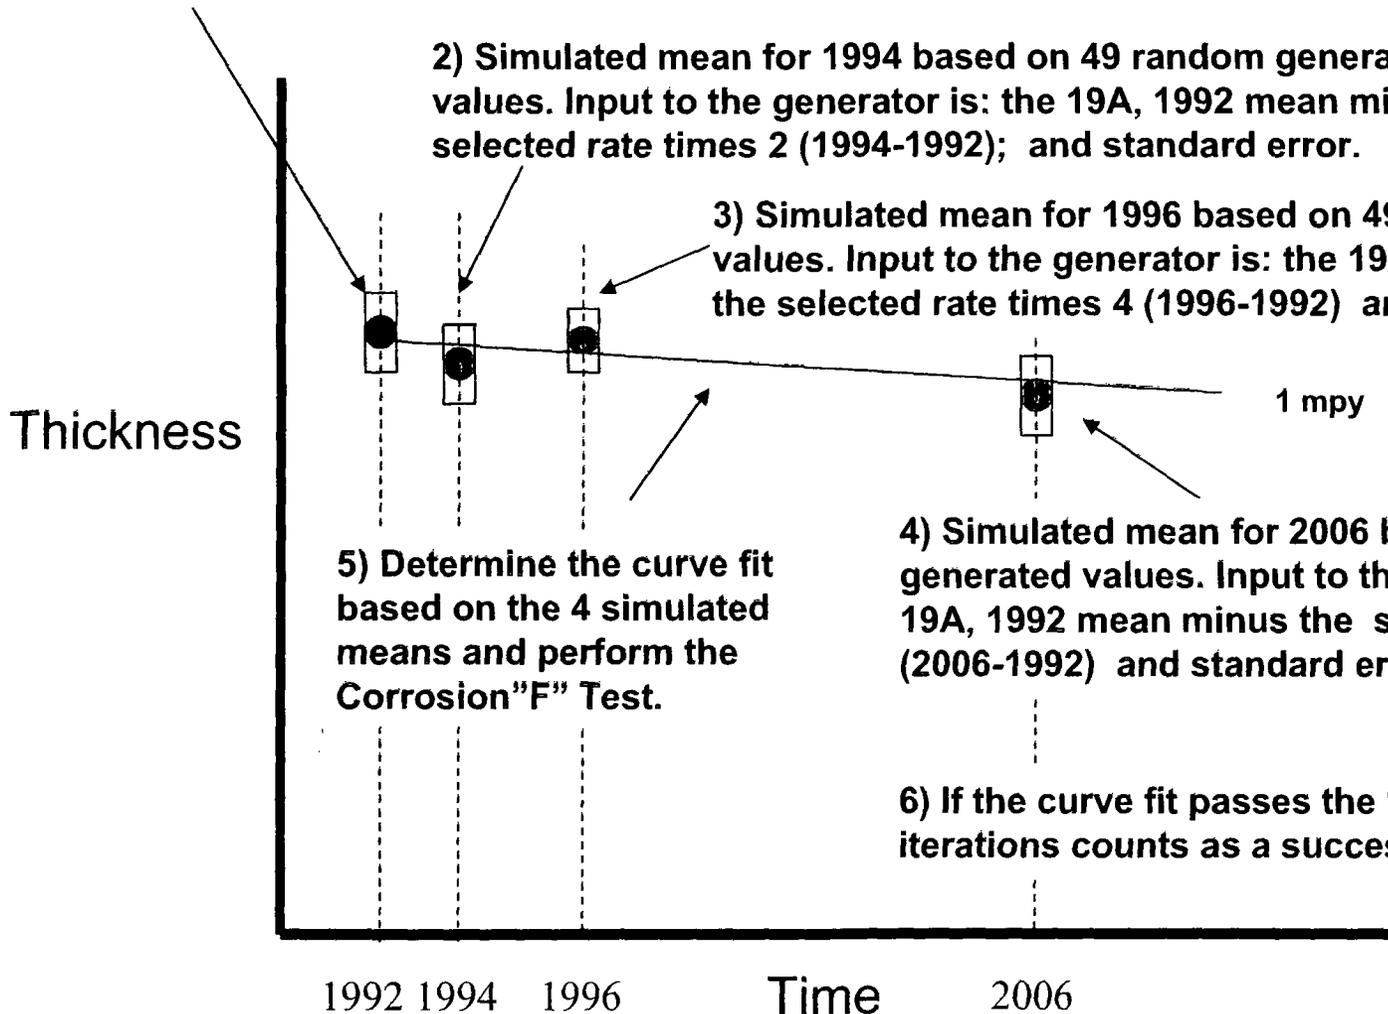
5) Determine the curve fit based on the 4 simulated means and perform the Corrosion "F" Test.

6) If the curve fit passes the "F" test than this iterations counts as a successful iterations.

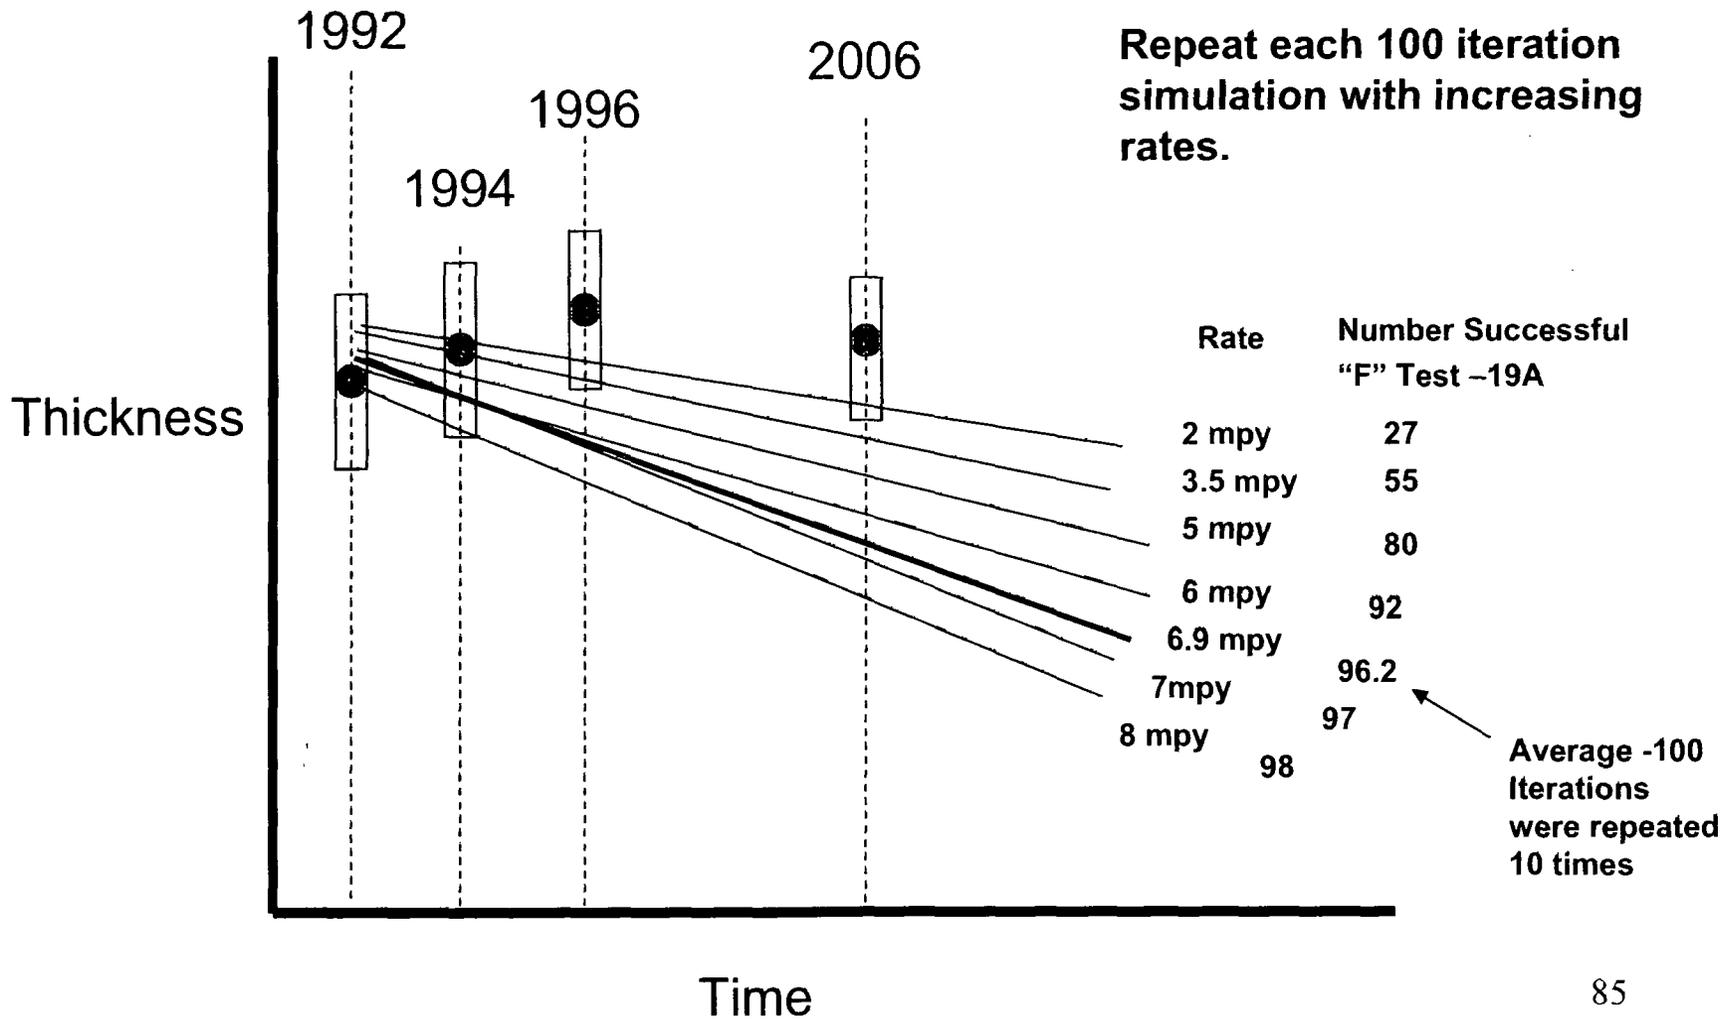
The minimum rate which consistently passes the Corrosion “F” Tests 95 out of 100 times is the Minimum Observable Corrosion Rate.

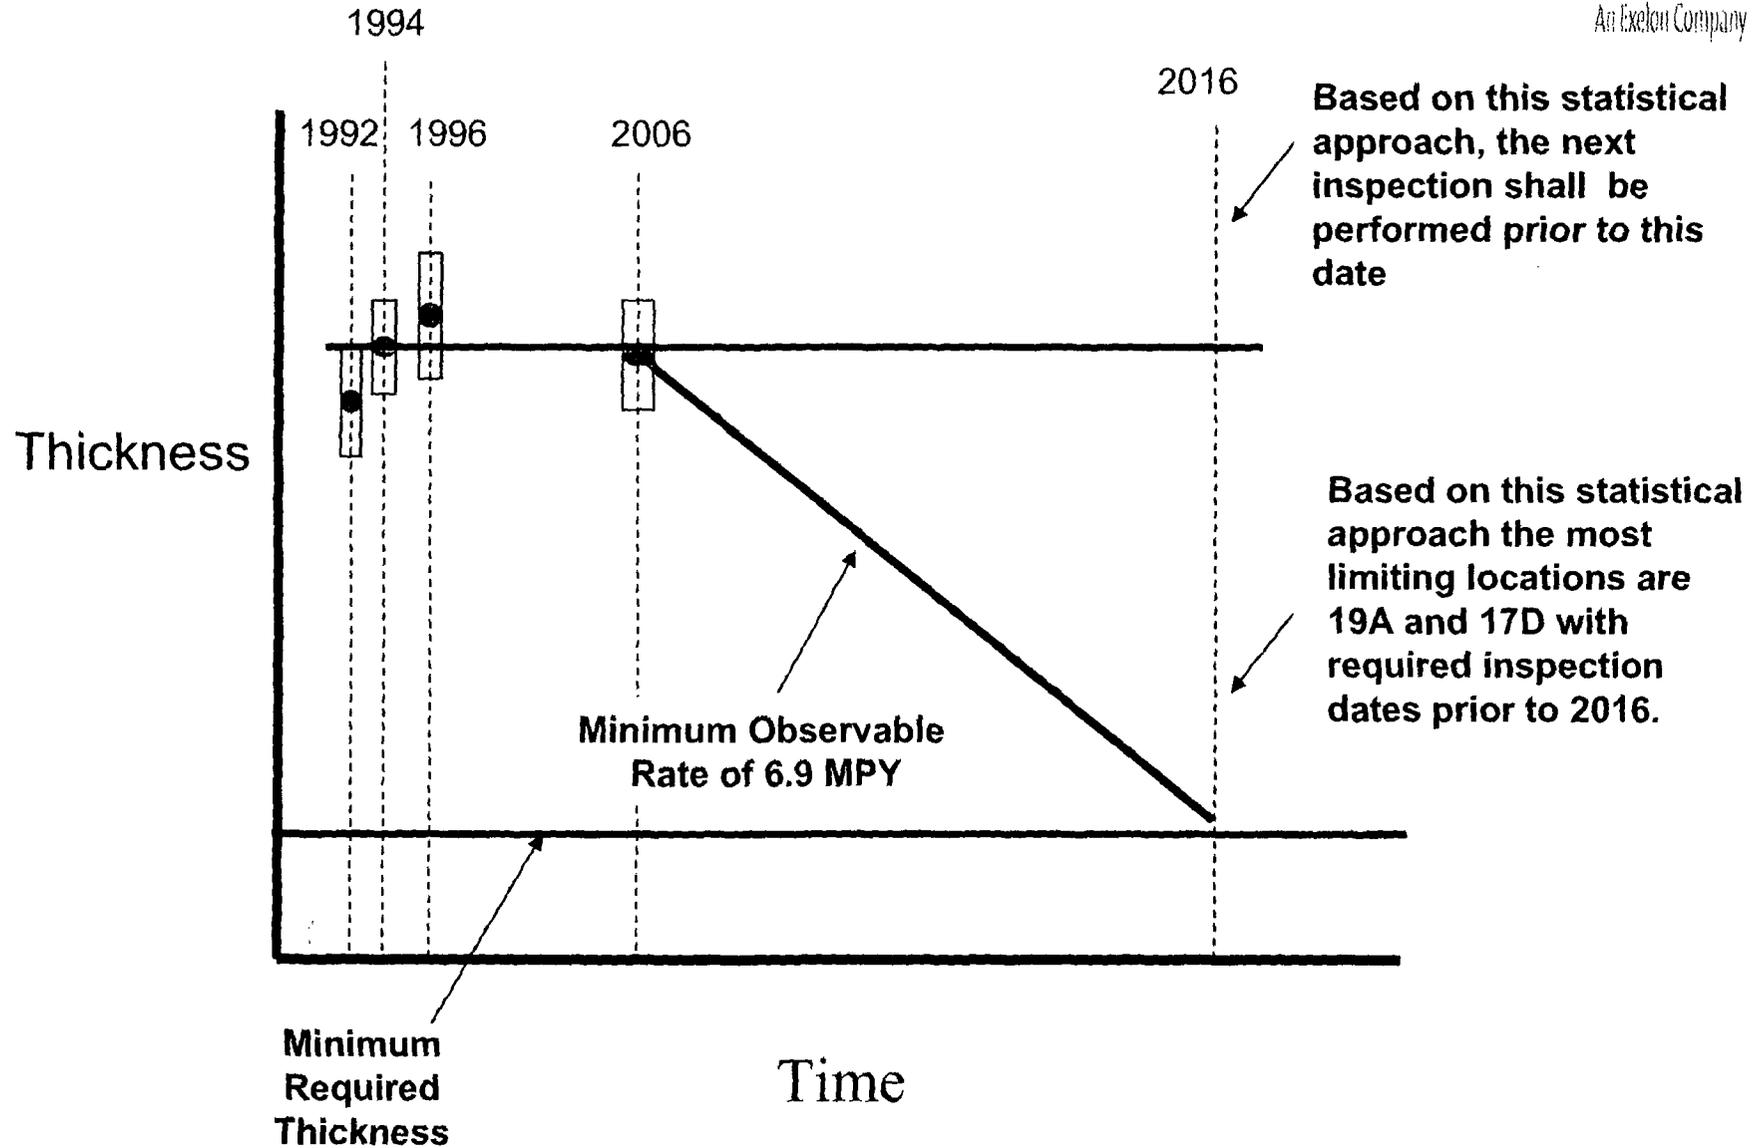
Next Required Inspection Based on the Minimum Observable Rate

- The most limiting locations are 19A and 17D, with required inspections prior to 2016
- Therefore, the next inspection scheduled for 2010 is appropriate
- Analysis after future inspections will be used to determine the appropriate inspection frequency

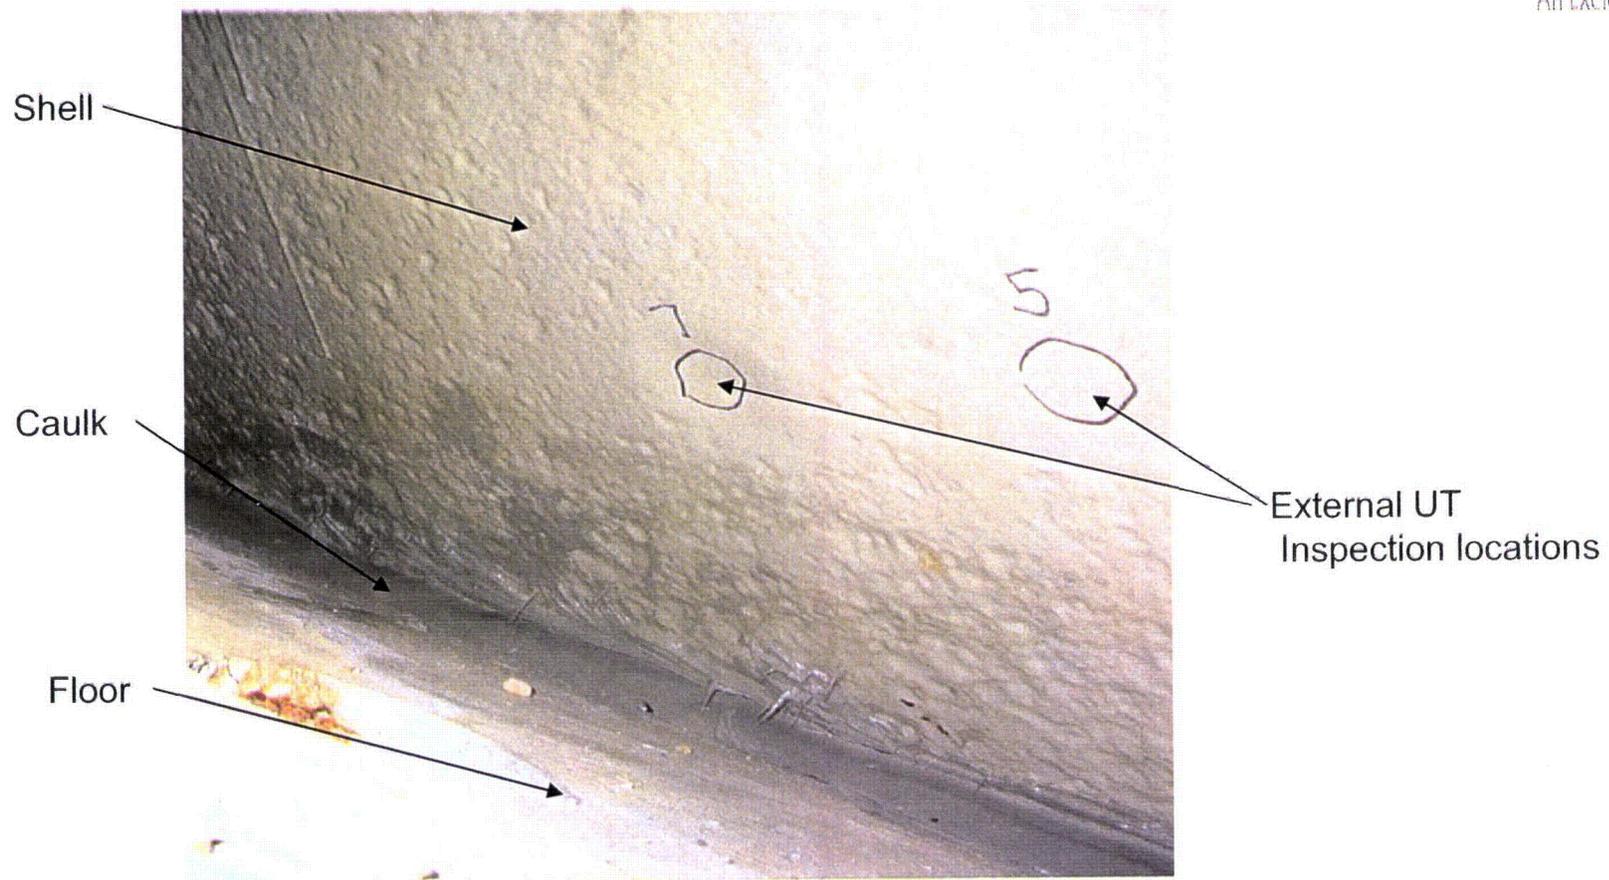
Sand Bed Region 2006

- Visual inspection of External Shell Coating – no degradation

Bay 7 – Drywell shell, caulking, sand bed floor

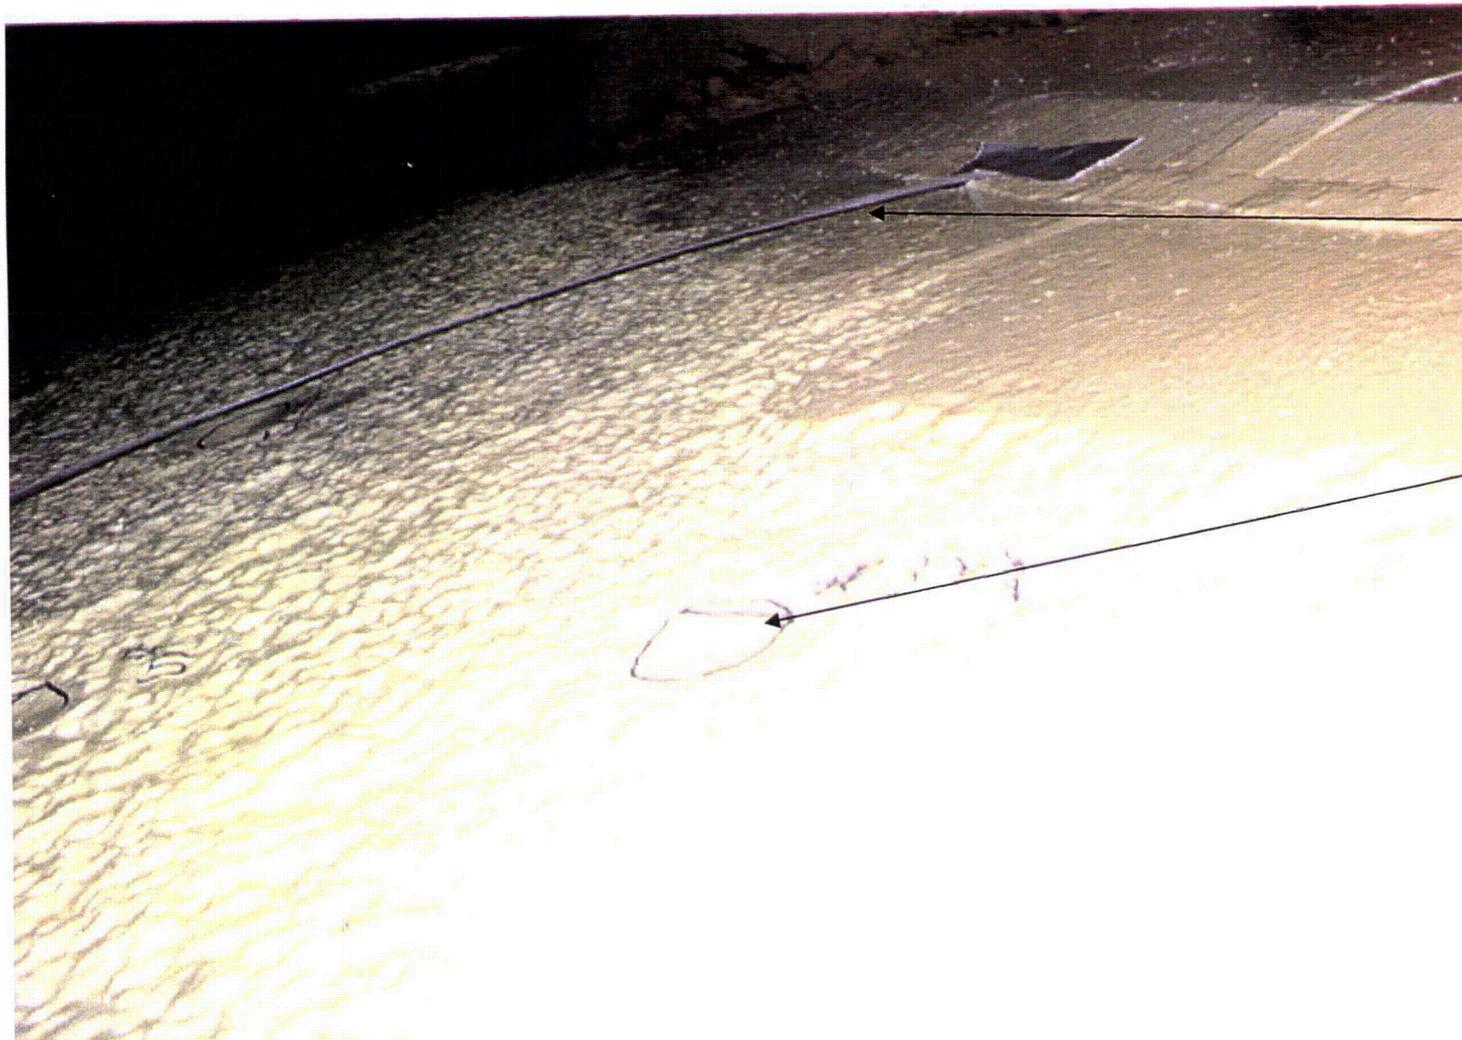
Sand Bed Region 2006

Reference for
locating inspection
points

External UT
Inspection
location

Bay 13 Drywell shell

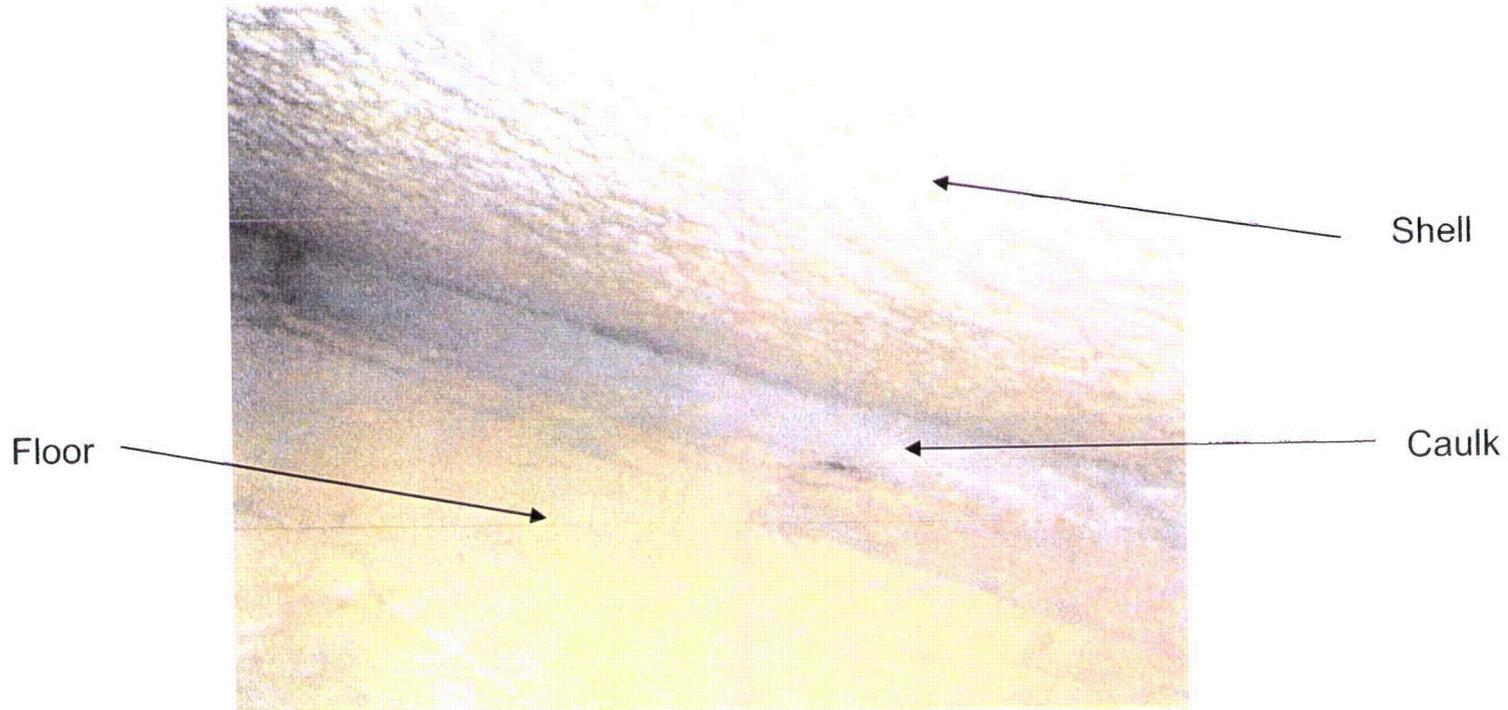
Sand Bed Region 2006

Bay 19 caulking

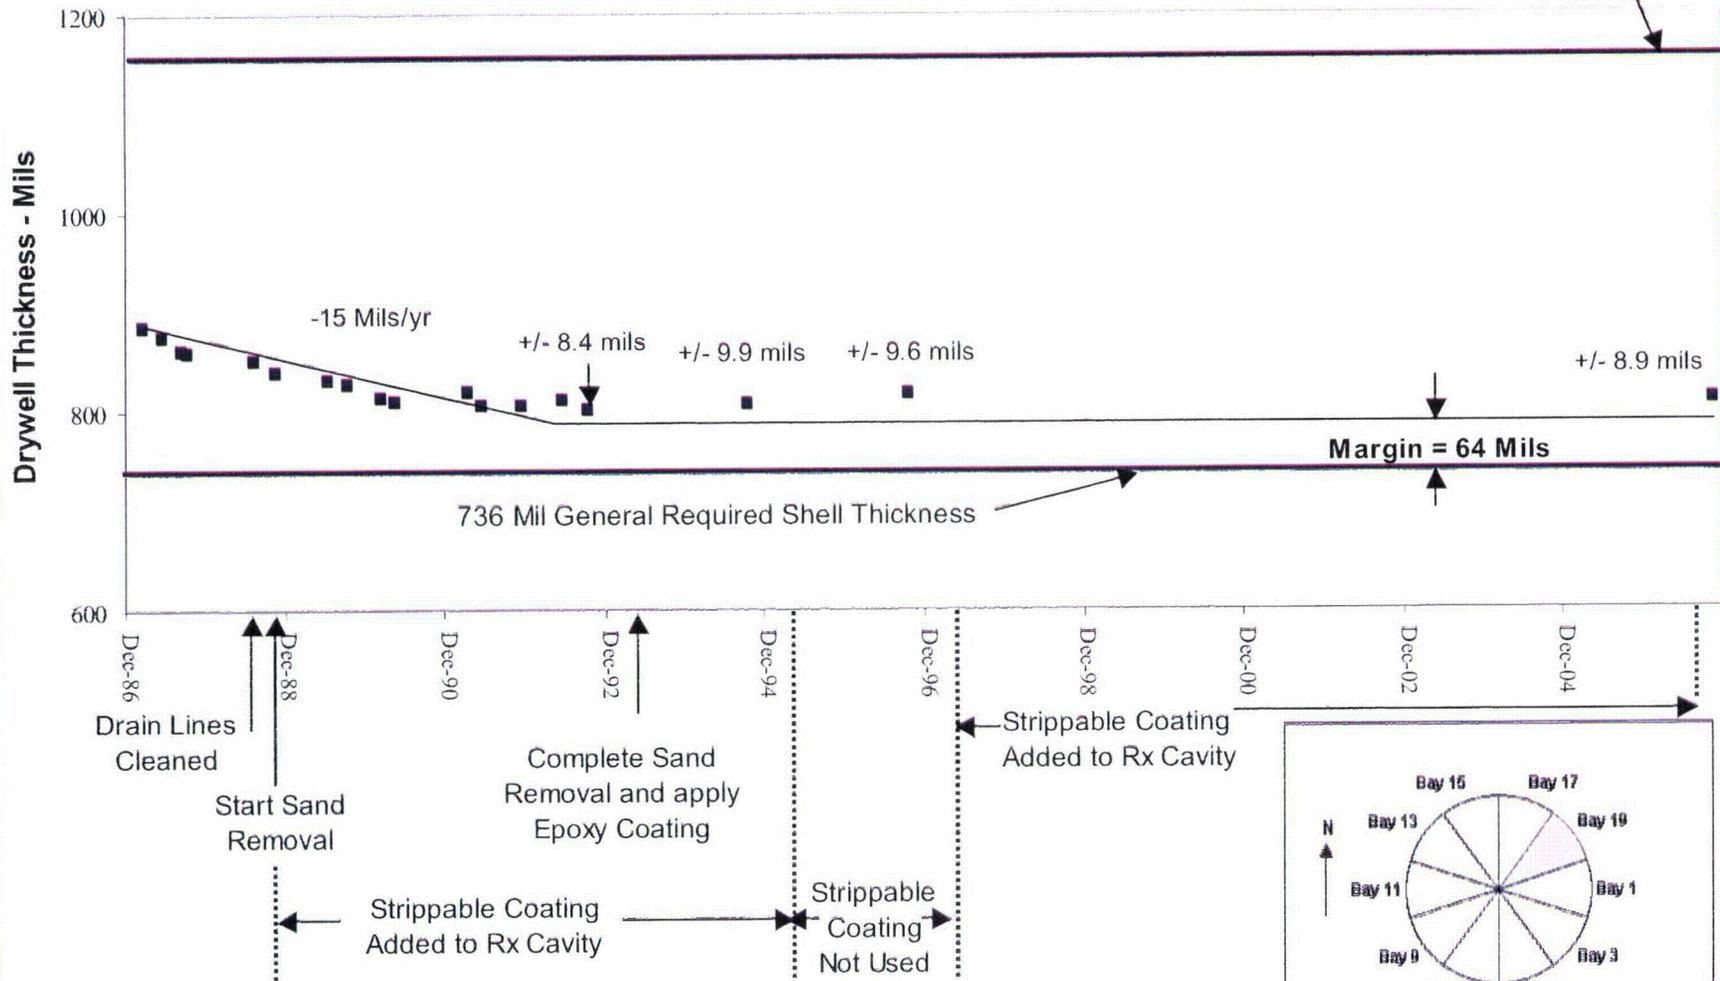
Figure 21 Sandbed Bay # 19A

1154 Mil Nominal Shell Plate Thickness

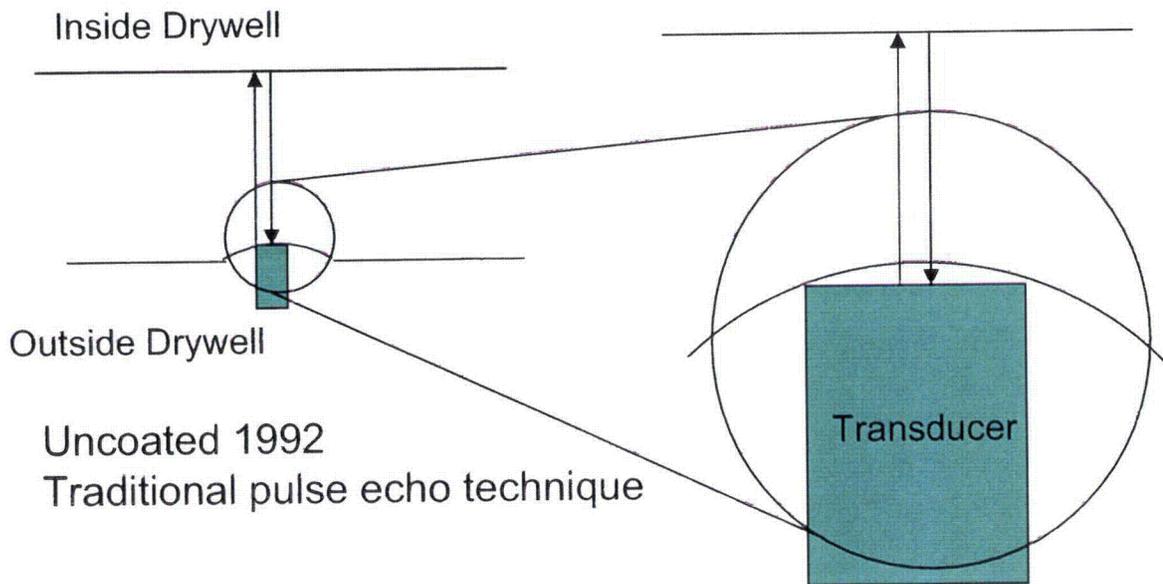
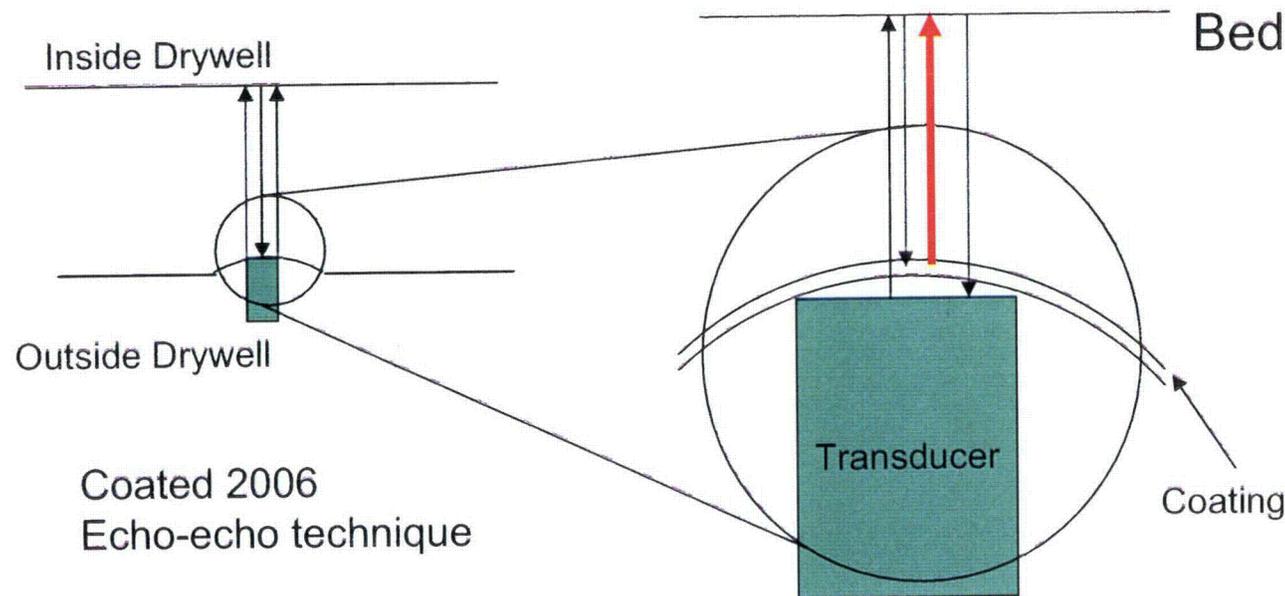
- 106 individual UT measurements were taken externally in the sand bed region
- It was verified that all 106 measurements meet the local thickness requirements (both buckling and membrane stresses)
- The 2006 measurements are not directly comparable to the 1992 results because of differences in measurement techniques

Concave Curvature Effects
1992 vs. 2006 External
UT Data (106) Sand
Bed Readings

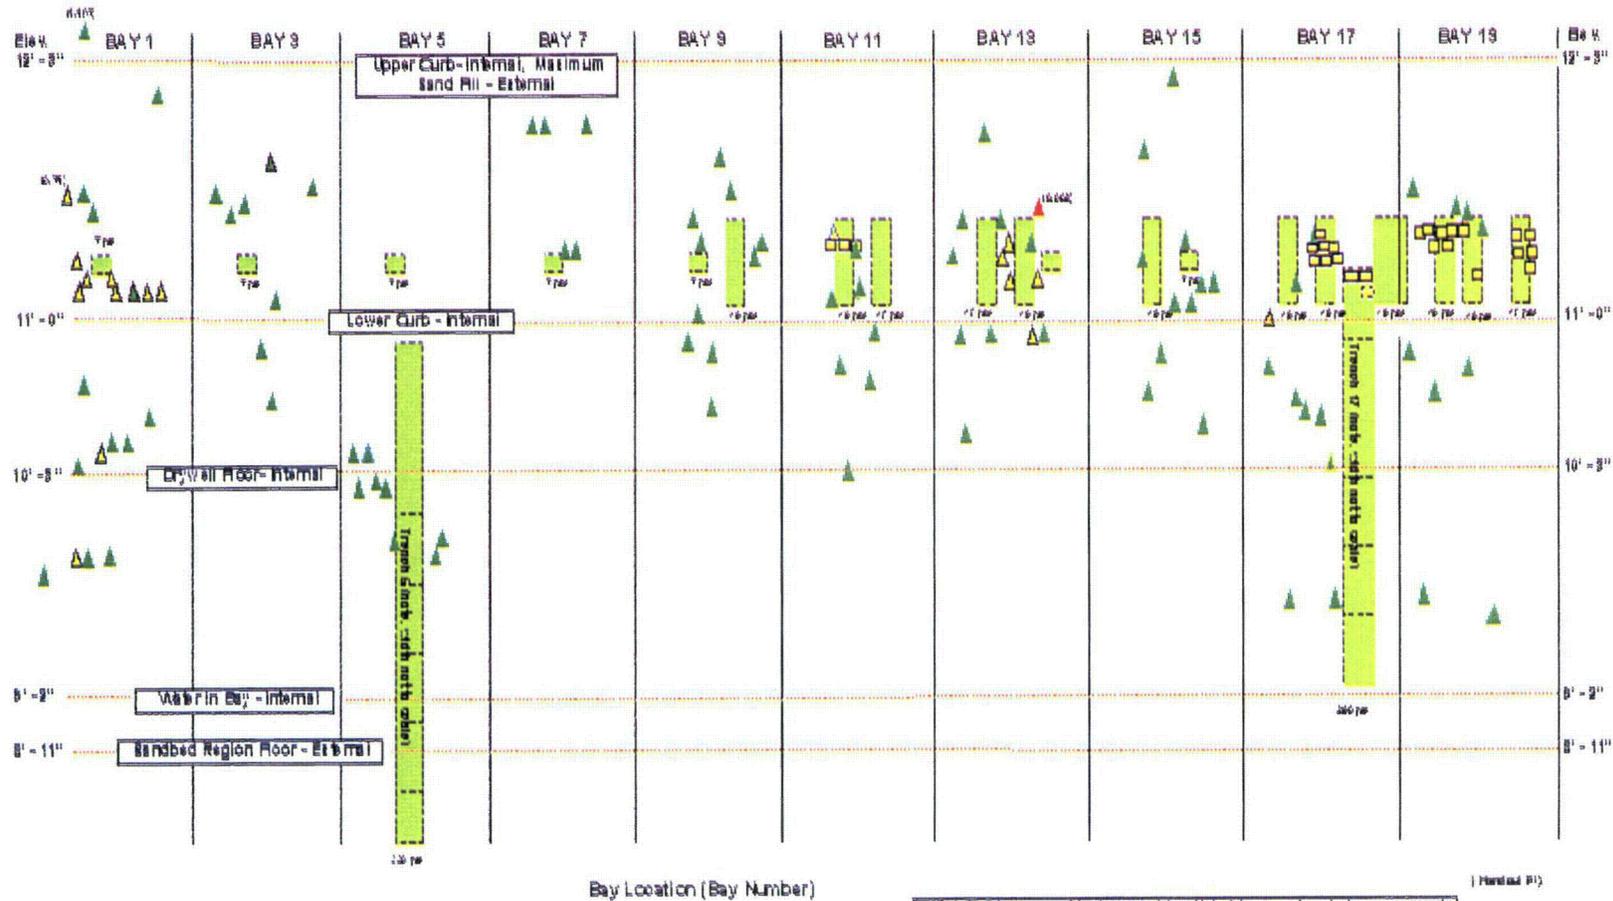
Location / Type of UT Measurement

- △ External Point UT Measurements
- Internal Grid UT Measurements
- Internal Point UT Measurements

For additional information, please refer to the data sheets for each bay. The total of measurements in each bay is always 9 measurements. The number of measurements in each bay is shown in the table below. Please refer to the data sheets for more information on the individual bays.

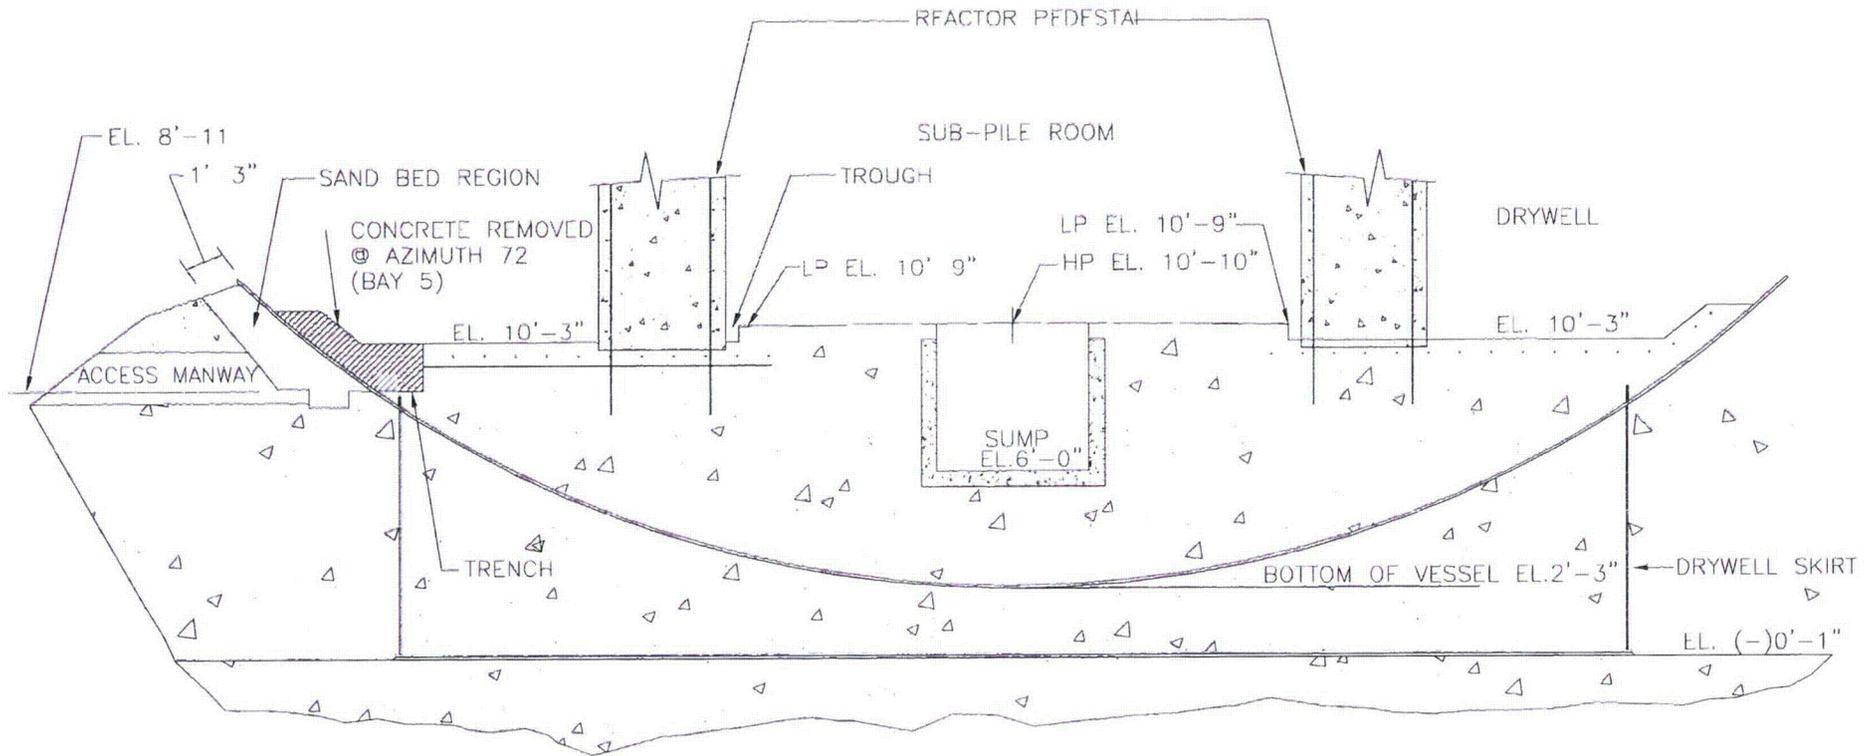
LOWER DRYWELL- SANDBED, TRENCH & SUMP

ELEVATION LOOKING WEST

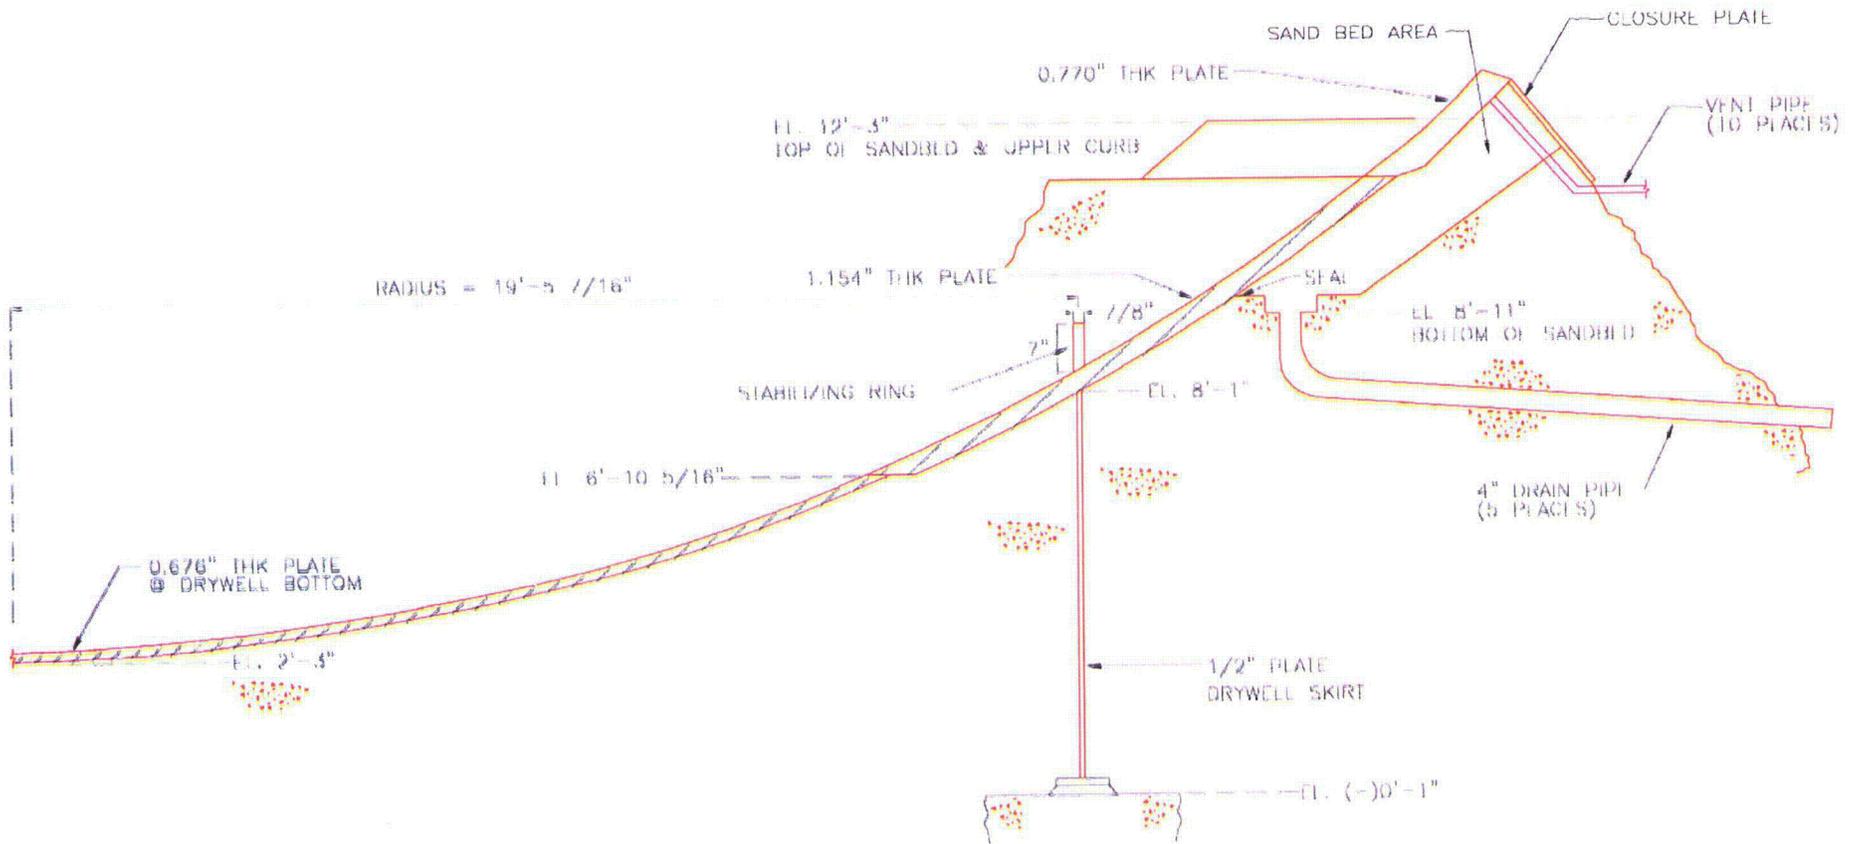
SECTIONAL VIEW OF SAND BED AREA AT VENT PIPE

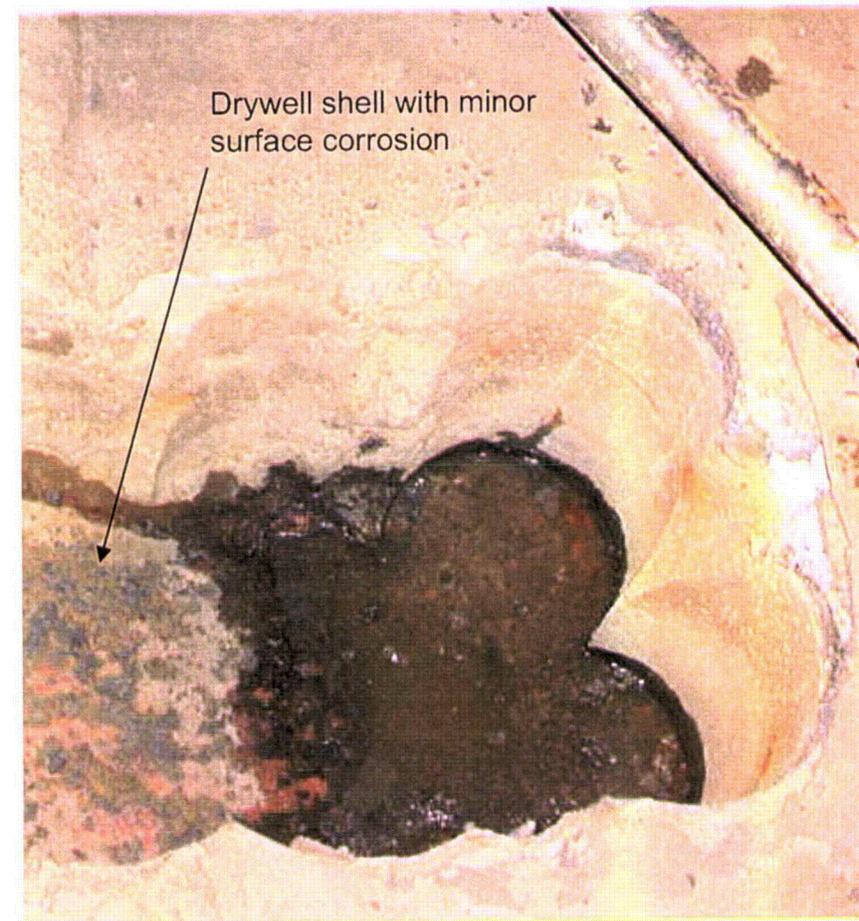
- Trench #5 water's high Ca indicates that the water slowly migrated through the alkaline concrete
- Any subsequent water ingress into the concrete floor will also become high pH concrete pore water

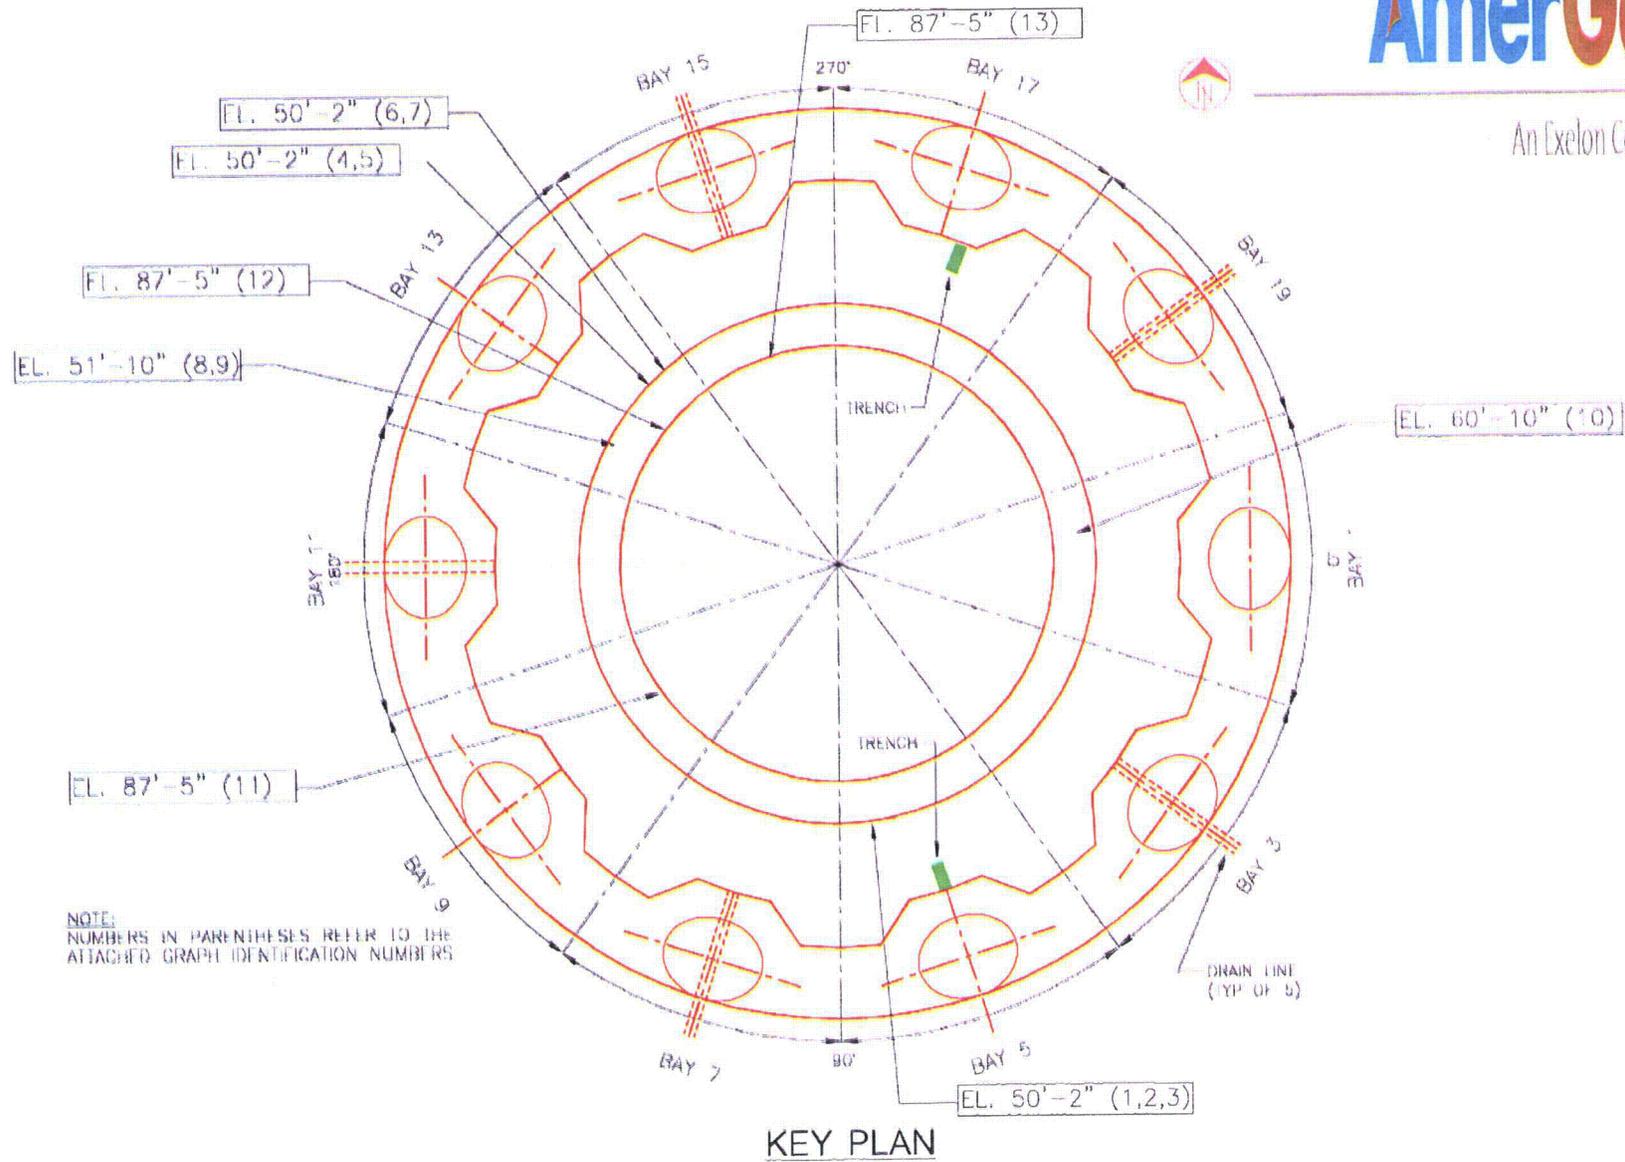
- Starting in 1983, over 1,000 UT measurements were taken to locate areas of corrosion on the exterior surface of the drywell shell
- 13 grid locations have been selected for monitoring
- These locations are measured every other refueling outage

- 12 of the 13 locations show no statistically observable corrosion
- The location with the minimum margin (137 mils) has no ongoing corrosion
- 1 location shows a corrosion rate of 0.66 mils/year
 - Projected thickness in 2029 is 720 mils, compared to a minimum required thickness of 541 mils
