U.S. NUCLEAR REGULATORY COMMISSION
 In the Matter of AmerGen Energy Co., LLC
 Docket No. 50-0219-12 Official Exhibit No. Citizens Exhibits
 OFFERED by: Applicant/Licensee Intervenor
 NRC Staff _____ Other _____
 IDENTIFIED on 9/20/07 Witness/Panel N/A
 Action Taken: ADMITTED REJECTED WITHDRAWN
 Reporter/Clerk _____

Memorandum

**Subject: Review of Fitness for Service Assessment of Oyster Creek Dry Well
on the Basis of Extended Data Analysis**

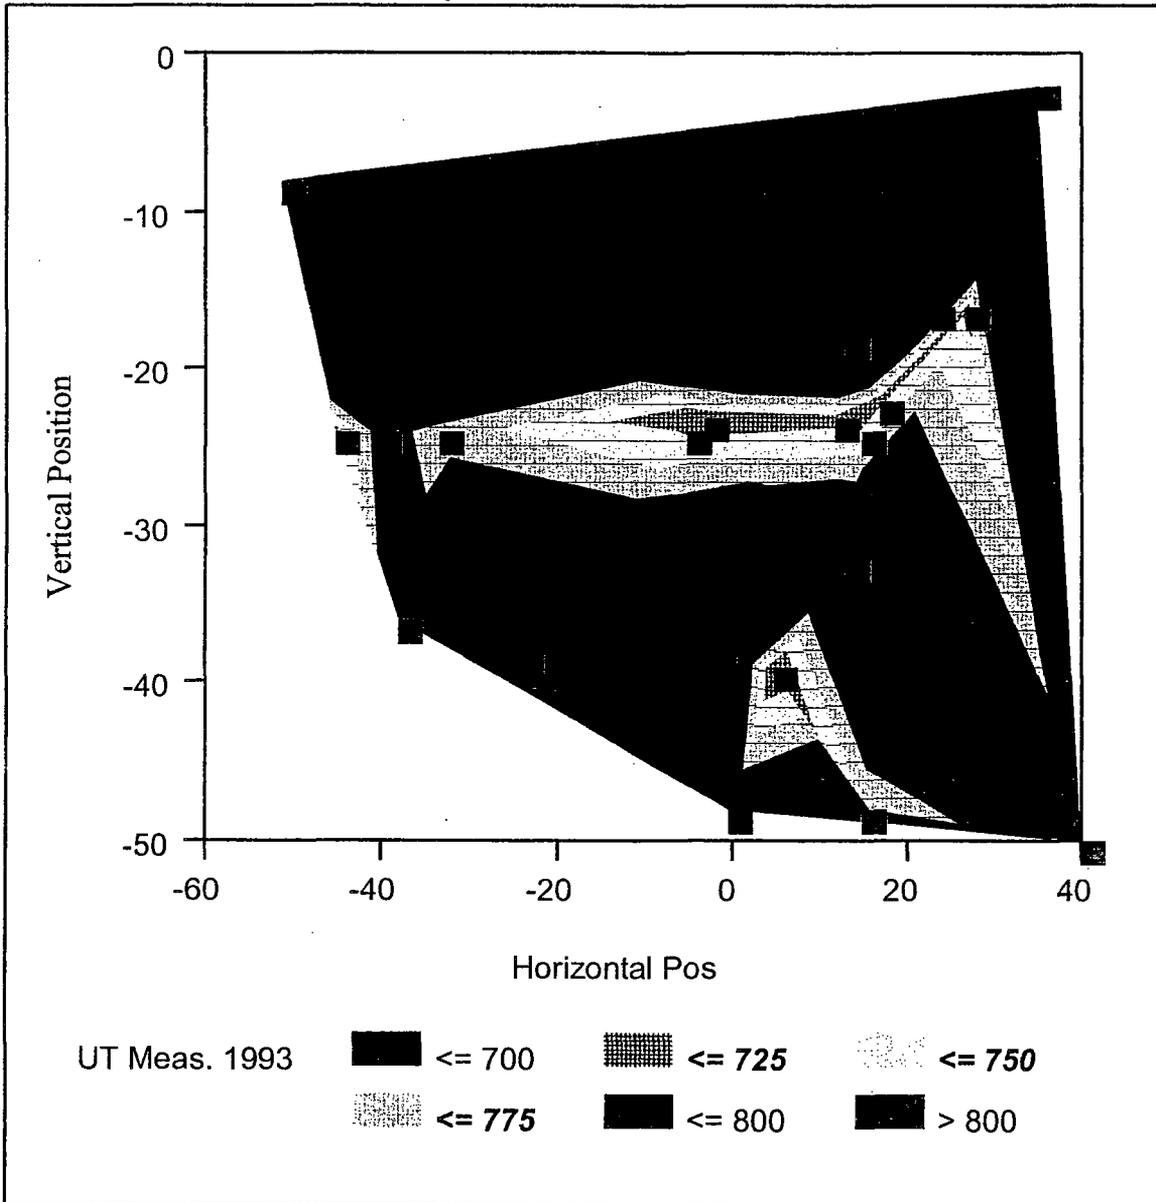
Figure 2
Bay 1 Remaining Wall thickness
External UT Measurements 1992/1993

The data used for the analysis are contained in Tables 1 and 2 for Bays 1 and 13 as extracted from AmerGen documents. Presumably, these were the most corroded Bays. Figure 2 shows a contour plot for Bay 1 obtained with the data from 1992. The dimensions of the points in the plot are 2.5 by 2.5 inches. Again, one needs to remember that the specific shape of the contours depends not only on the residual wall thickness measured at the locations indicated, but on the density of measurements as well. (For instance, an additional measurement at coordinates h (-20) v (-25) could completely alter the contours and in all likelihood extend the area of wall thickness below -750 mils ⁴⁾).

Nevertheless, it appears in Figure 2 that in the so called “bathtub ring” an extensive area exists with wall thicknesses between 700 and 750 mils (0.75 inches). This area extends well over 52 inches (4+ feet) and is about 5 inches wide. In view of the fact that UT measurements are at best accurate with a standard deviation of about 45 mils, (95% confidence limits +/-90 mils), this area could well be more extensive.

Contour Plot For Bay 1: 1992/1993 External UT Measurements

AmerGen discusses the bathtub ring in Bay 1 (See also Figure 2) as one single area using 1992 and 2006 data for which the *evaluation thicknesses* had been determined (See discussion of evaluation thicknesses above). AmerGen finds that in this area the average of 11 data points, which is around 4 square feet in area, is 0.766 inches and 0.765 inches for the 1992 and 2006 measurements, respectively. Considering the uncertainty of the measurements, +/- 27 mils, there is at least a 5% probability that the remaining margin is of the order of 2 to 3 mils, assuming that areas larger than one square foot in extent must average 0.736 inches or more.

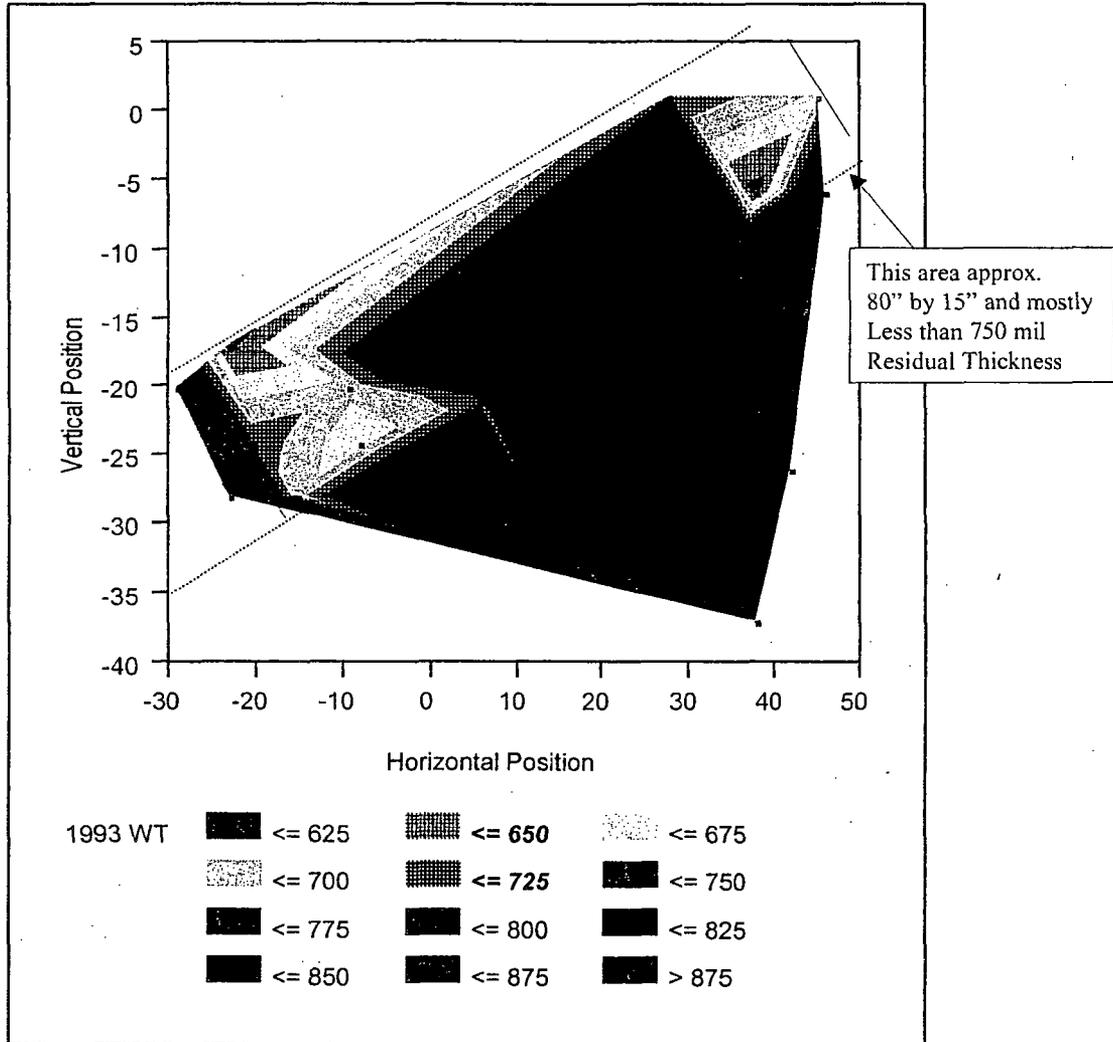
Figure 4

Figures 4 and 5 show the contours for Bay 13, 1992 and 2006 data, respectively. Here large areas exist with wall thicknesses below 700 mils and at least two seemingly unconnected areas where the residual wall thickness is less than 650 mils. It could be argued that those heavily corroded areas are less than 1 square foot and therefore are still acceptable according to the 636 mil criterion. However, the heavily corroded area on the left hand side (-20, -20) has not been further explored. One therefore does not know whether it might extend further. Similarly, the area on the right ((40, -7), clearly showing a fairly deep pit, was not further explored and was not even measured in 2006. While in Bay 1 the bathtub ring was at elevation -20 to -25 (from the reference point) in Bay 13 there is no clearly prominent bathtub ring. This may be because it was not there, but it may also be because the measurements were not extended toward elevation -15 and -10. We are therefore left with a great uncertainty as to the true extension of the damage in this Bay.

Bay 13 Remaining Wall Thickness
External UT Measurements 1992/1993

Contour Plot for Bay 13 1992/1993 External UT Data

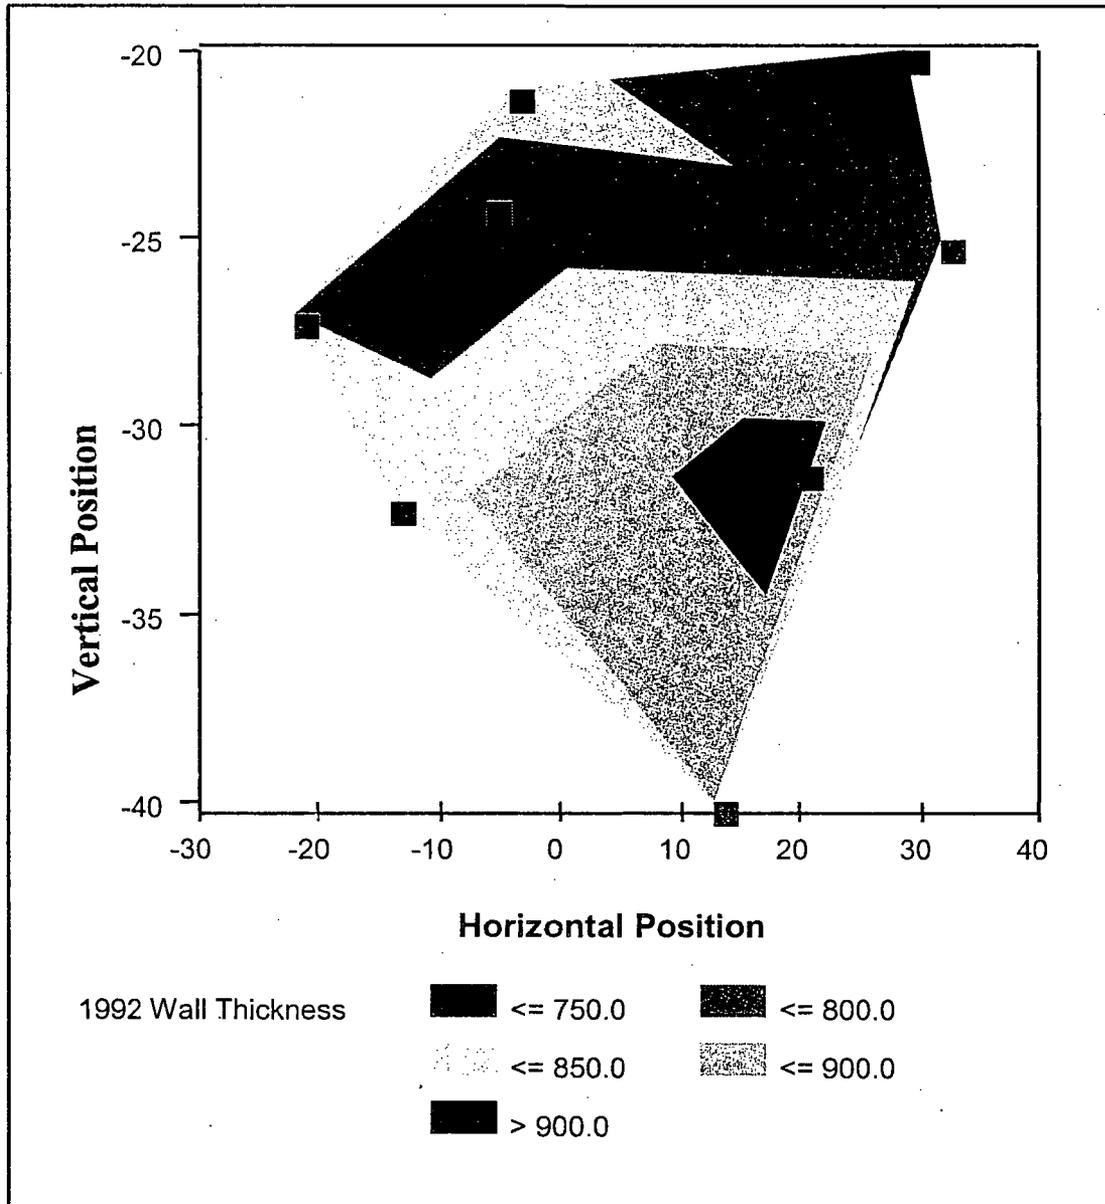
Figure 7 shows the contours for Bay 11. Again there is a suggestion of severe corrosion at elevation -20 and no further exploration into the bathtub ring area. Once again, the extent of this area is highly uncertain because it was not further defined by additional UT measurements.

Figure 7
Contour Plot for External UT 1992 Data Bay 11

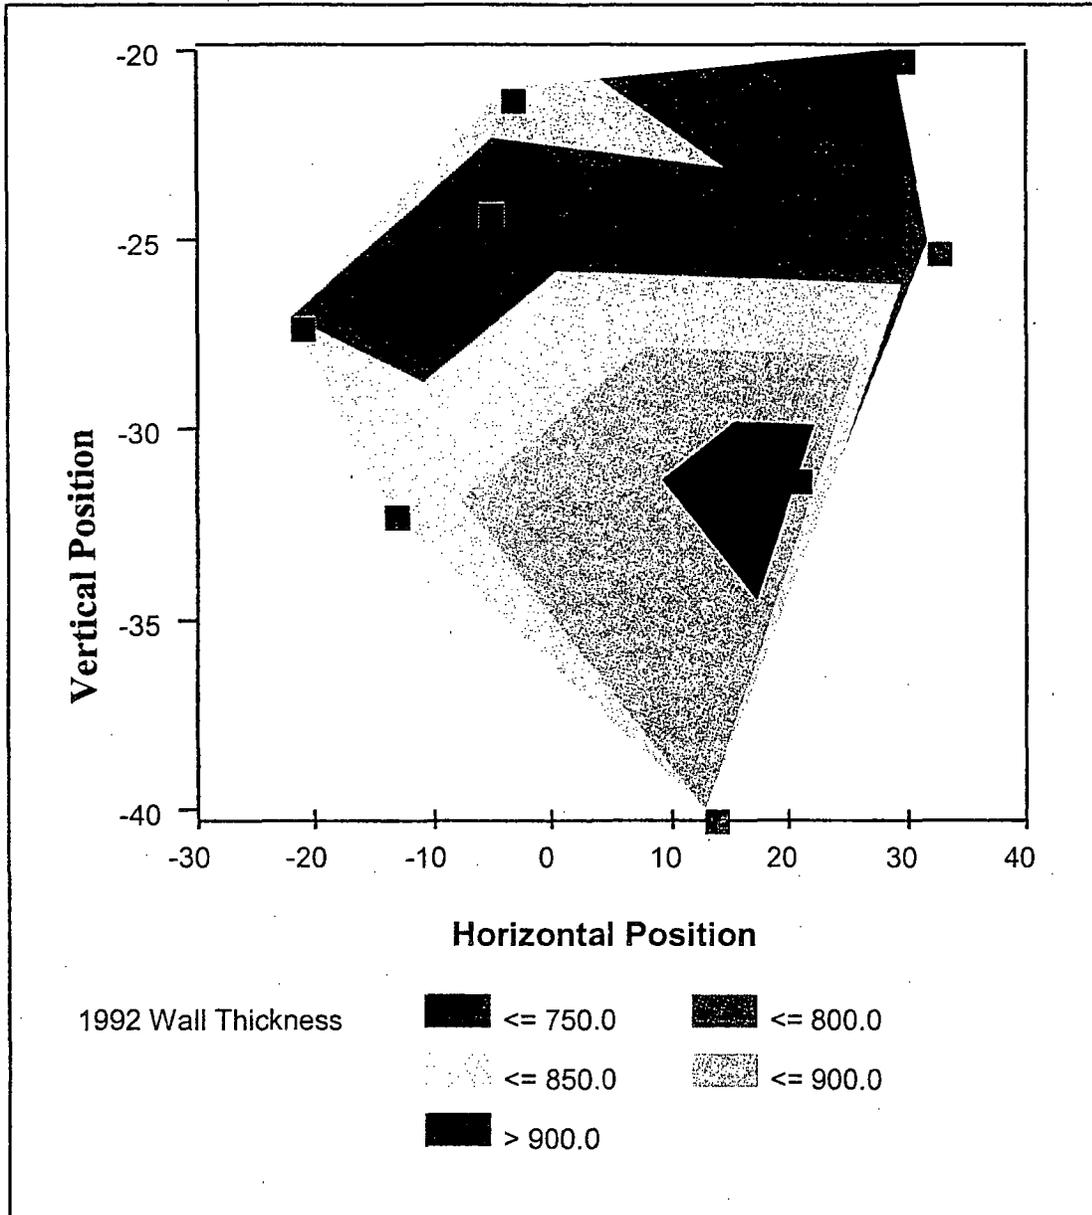
Figure 7
Contour Plot for External UT 1992 Data Bay 11
