Rancho Seco  
Final Status Survey Summary Report  
October 30, 2007  
Training and Records Building  
(exterior)  
Survey Unit F8140002

## FINAL STATUS SURVEY SUMMARY REPORT

F8140002, Training and Records Building (exterior)

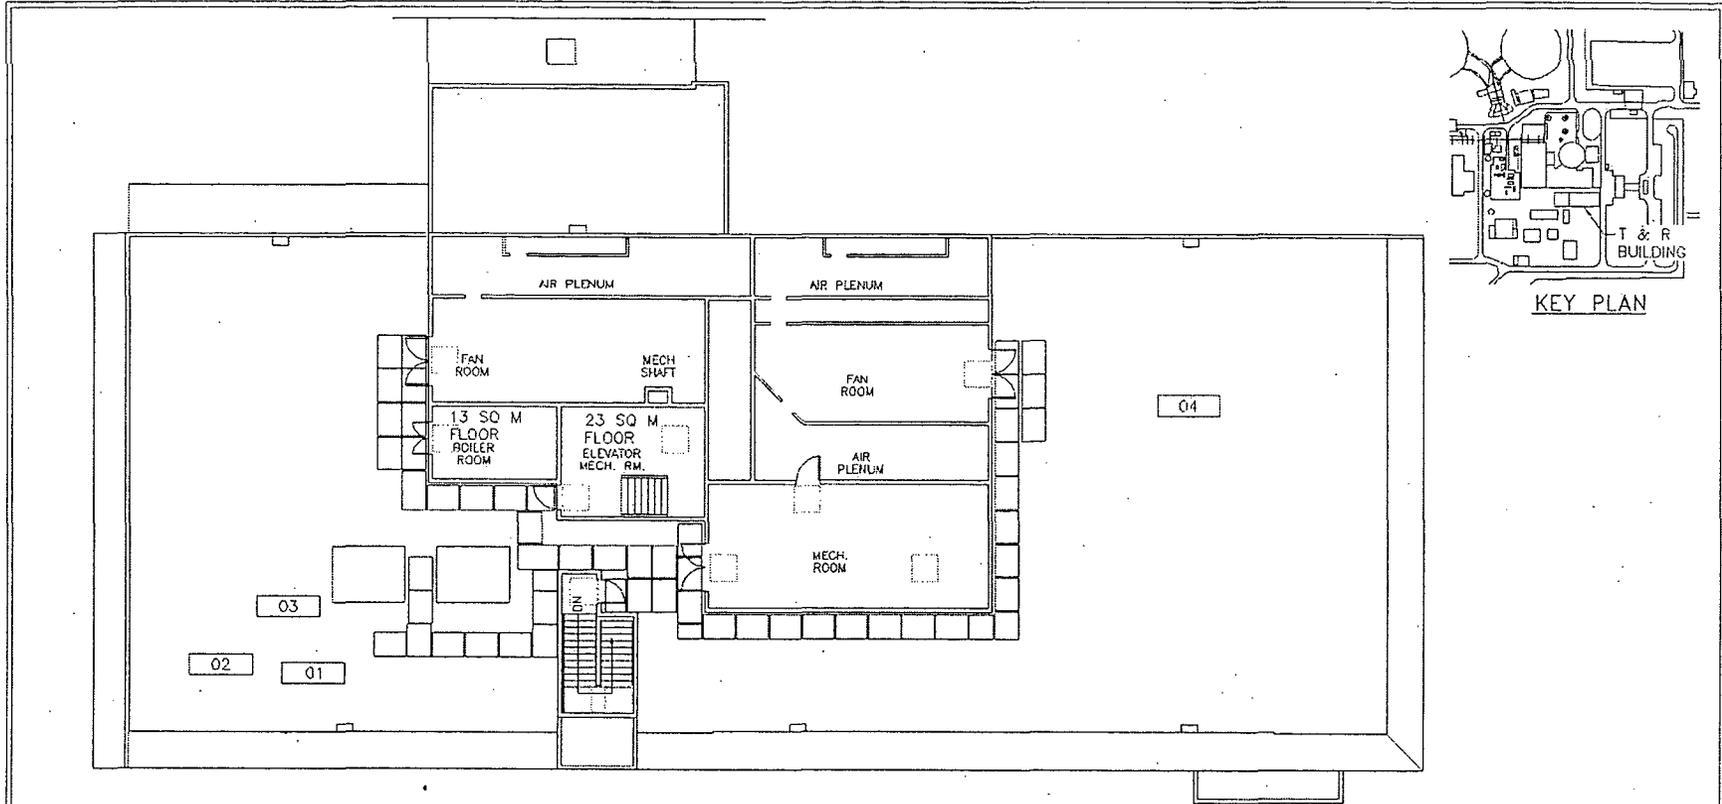
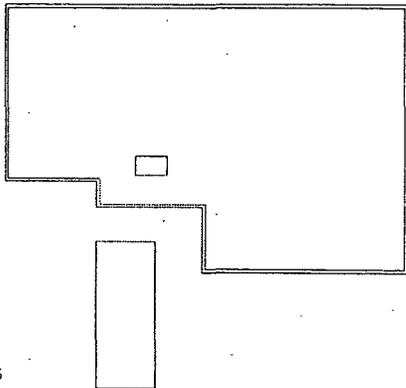
T&R BLDG PENTHOUSE & ROOF PLANS  
BETA DIRECT-LOOSE SURFACE  
ACTIVITY MEASUREMENTS  
8140002-M5

PENTHOUSE & LOWER ROOF PLAN

UPPER ROOF PLAN
