Rancho Seco

Final Status Survey Summary Report

Aux. Bldg (-) 20' El., Rm 43, "B" HPI Pump Room, Upper Walls & Ceiling

Survey Unit F8130611

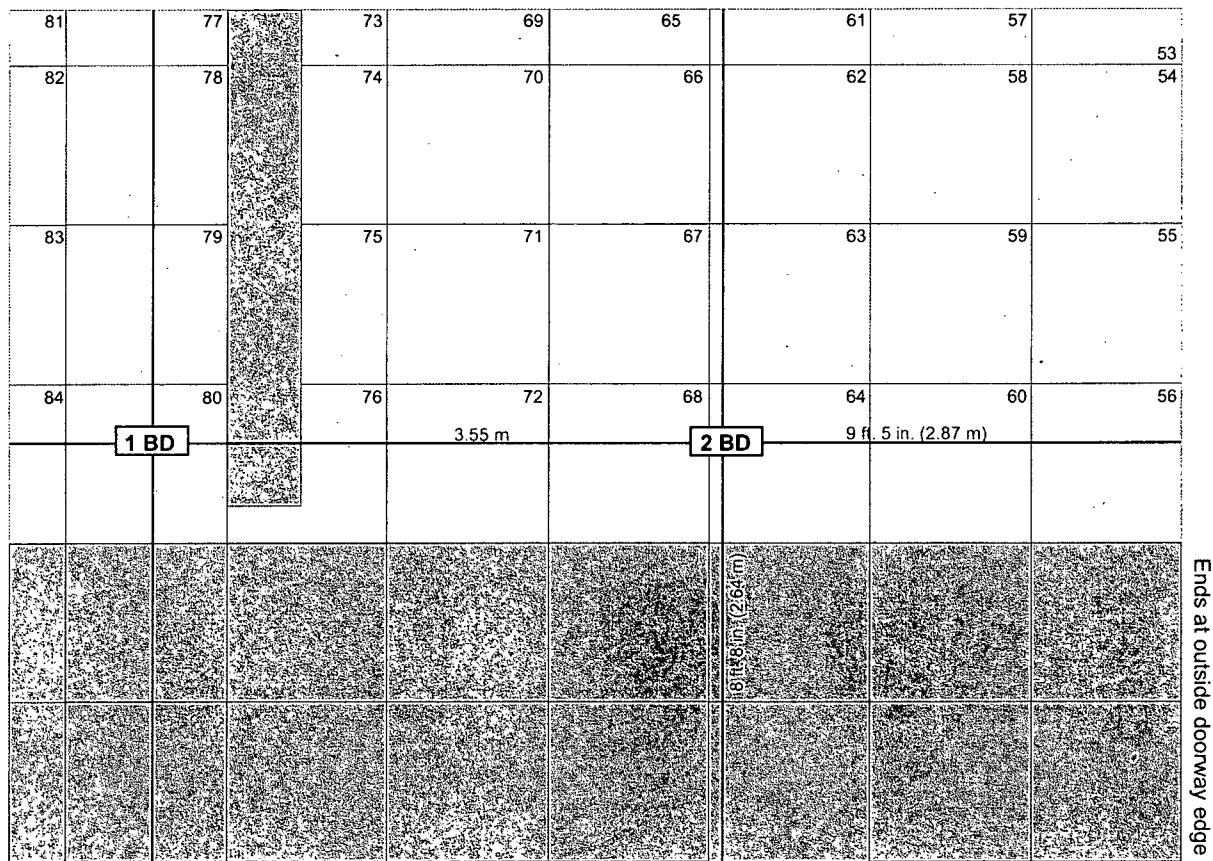
Rm 43, South Wall

Map F8130611-6, Auxiliary Building -20' EI
 Rm 43, "B" HPI Pump Room (3.55 m grid spacing)
 South Wall Beta Direct Measurements
 F8130601C0001BD to F8130601C0002BD

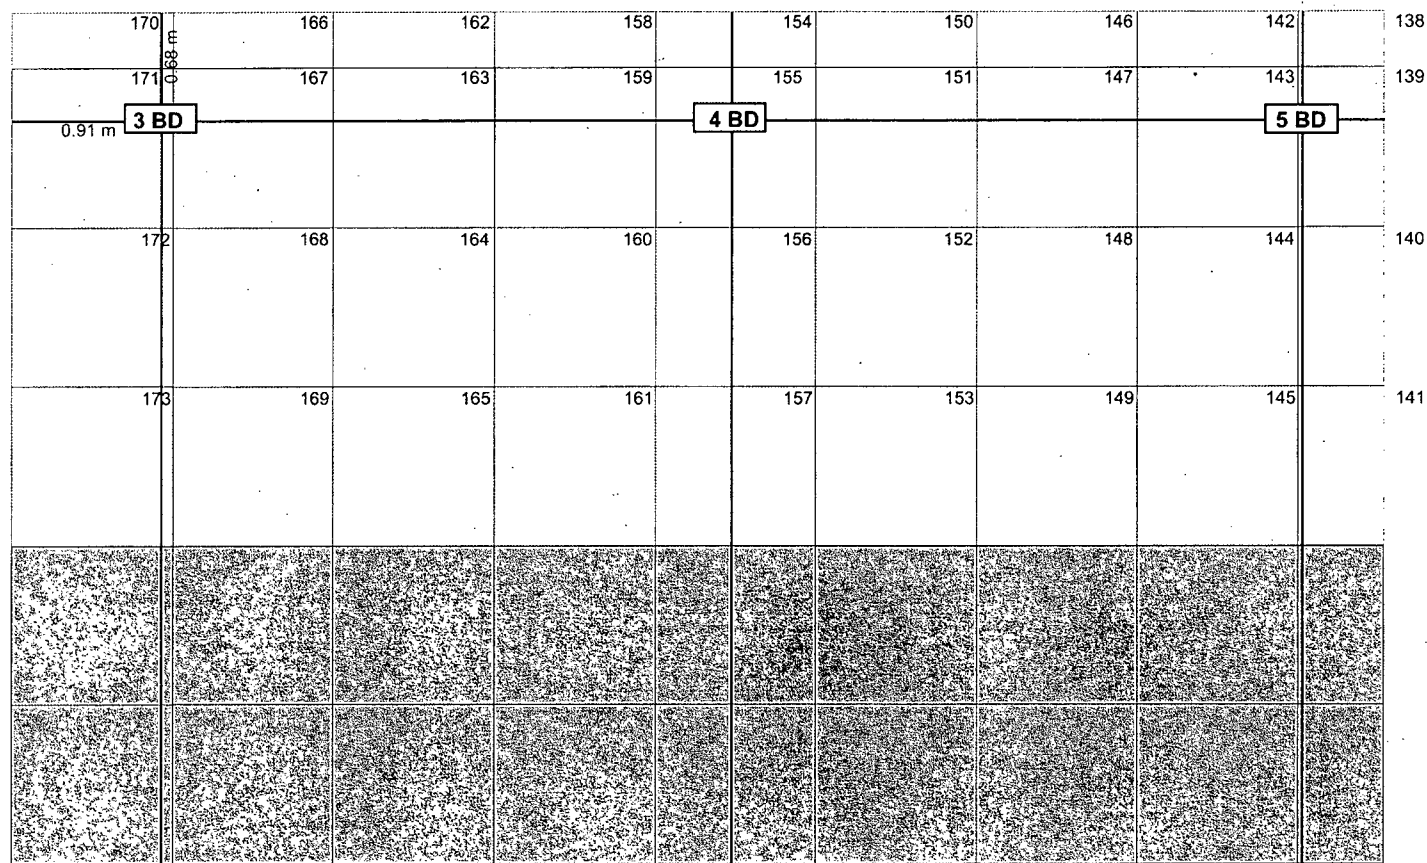
Rm 43, West Wall

Map F8130611-7, Auxiliary Building -20' EI
 Rm 43, "B" HPI Pump Room (3.55 m grid spacing)
 West Wall Beta Direct Measurements
 F8130601C0003BD to F8130601C0005BD

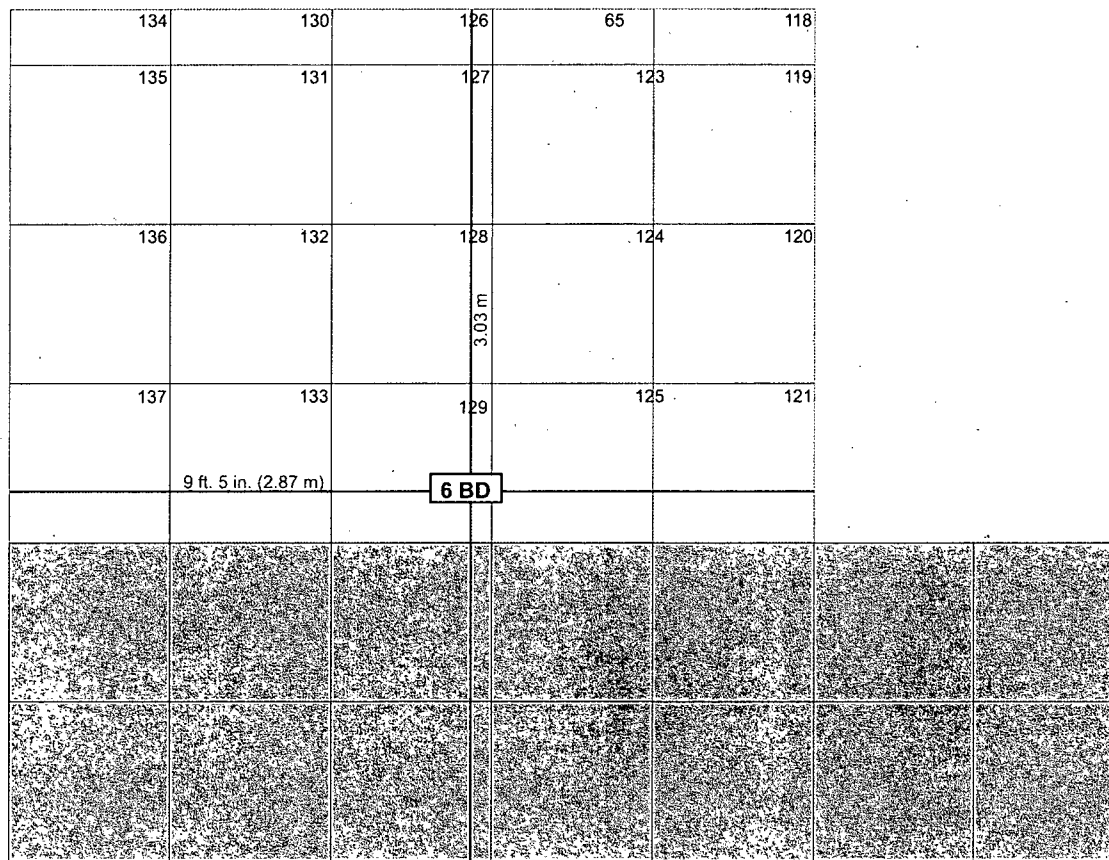
Rm 43, North Wall

Map F8130611-8, Auxiliary Building -20' EI
 Rm 43, "B" HPI Pump Room (3.55 m grid spacing)
 North Wall Beta Direct Measurement
 F8130601C0006BD

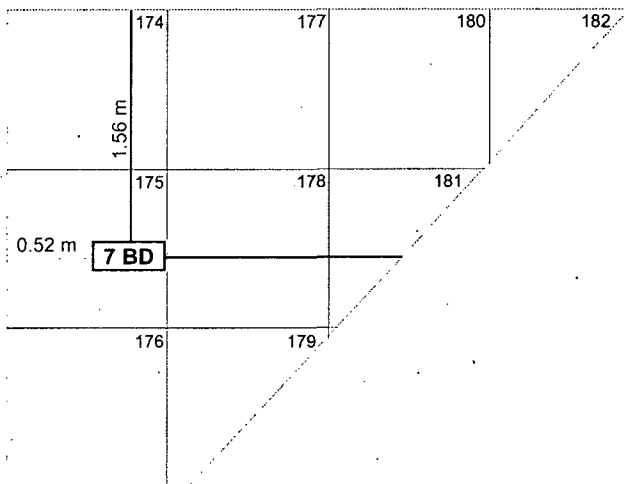
Rm 43, East Stairwell Wall

Map F8130611-9, Auxiliary Building -20' EI
 Rm 43, "B" HPI Pump Room (3.55 m grid spacing)
 East Stairwell Wall Beta Direct Measurement
 F8130601C0007BD

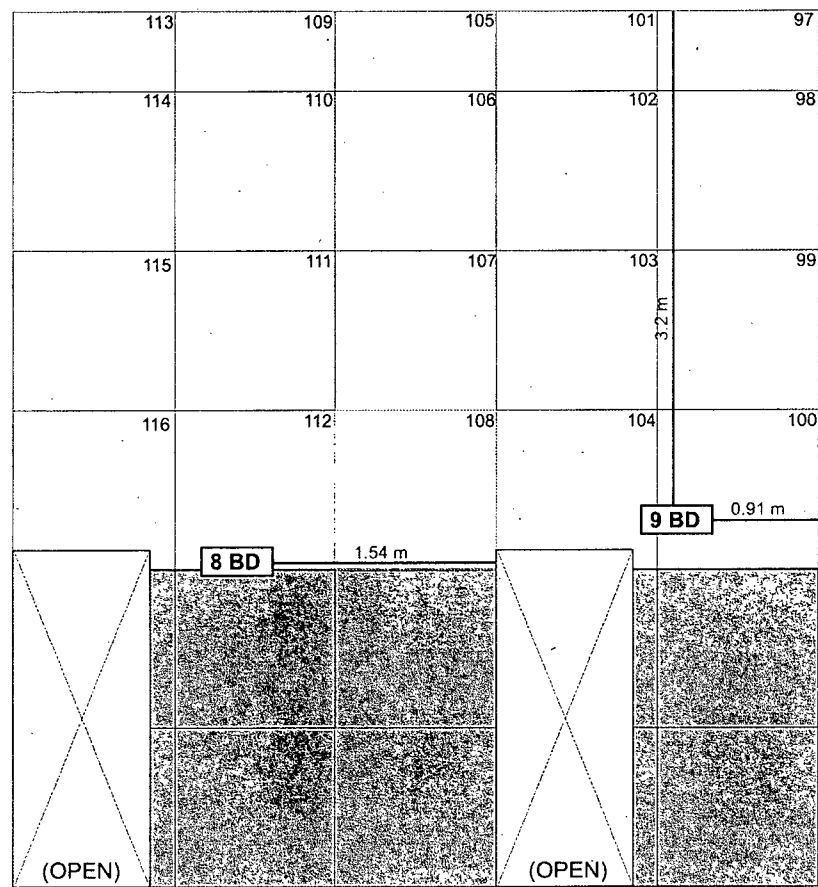
Rm 43, East Shield Wall (Exterior)

Map F8130611-10, Auxiliary Building -20' EI
Rm 43, "B" HPI Pump Room (3.55 m grid spacing)
Exterior and Interior Shield Wall Beta Direct Measurements
F8130601C0008BD to F8130601C0009BD

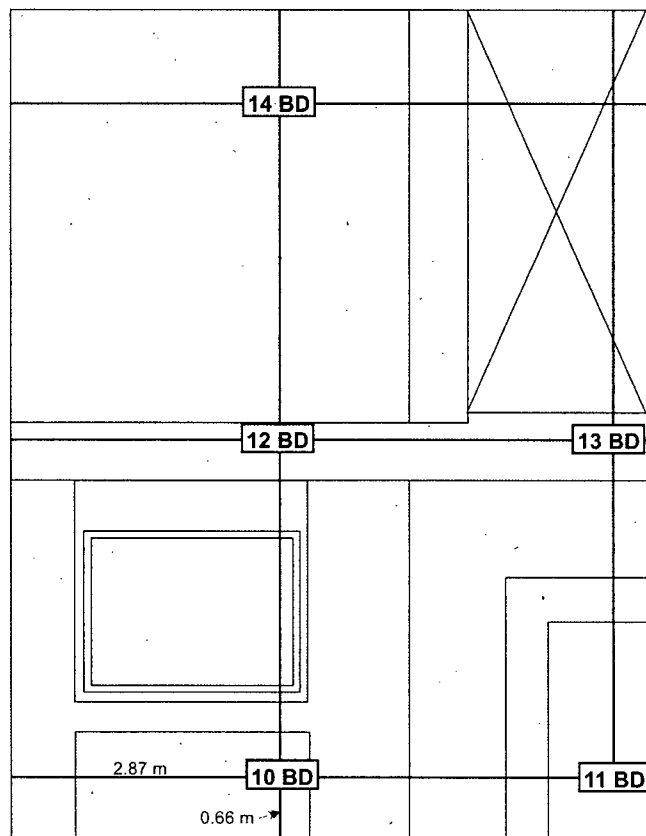
Rm 43, Ceiling

Map F8130611-11, Auxiliary Building -20' EI
 Rm 43, "B" HPI Pump Room (3.55 m grid spacing)
 Ceiling Beta Direct Measurements
 F8130601C0010BD to F8130601C0014BD

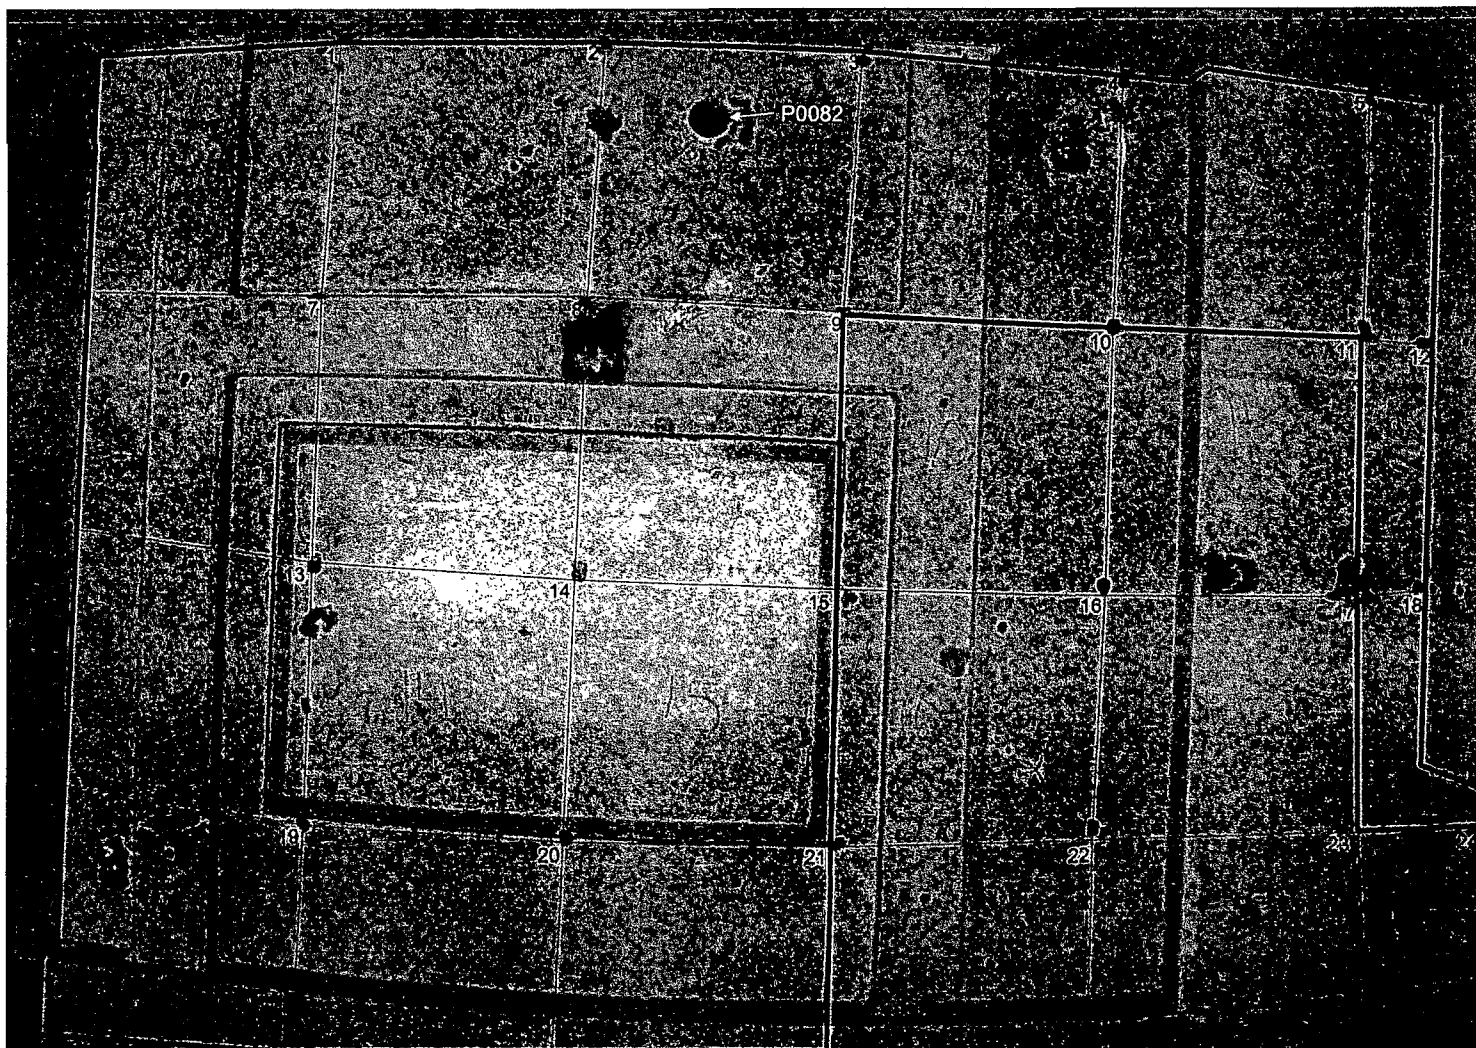
Map F8130611-12, Aux Bldg. -20' El.,
Rm 43, "B" HPI Pump Room
Upper Walls and Ceiling, Class 2
South Ceiling Beta Scan Measurements

F8130611C0012BS to F8130611C0015BS,
F8130611C0018BS to F8130611C0021BS
Penetration Scan F8130611P0082BS
Total Scan Area: ~14.5 sq. meters

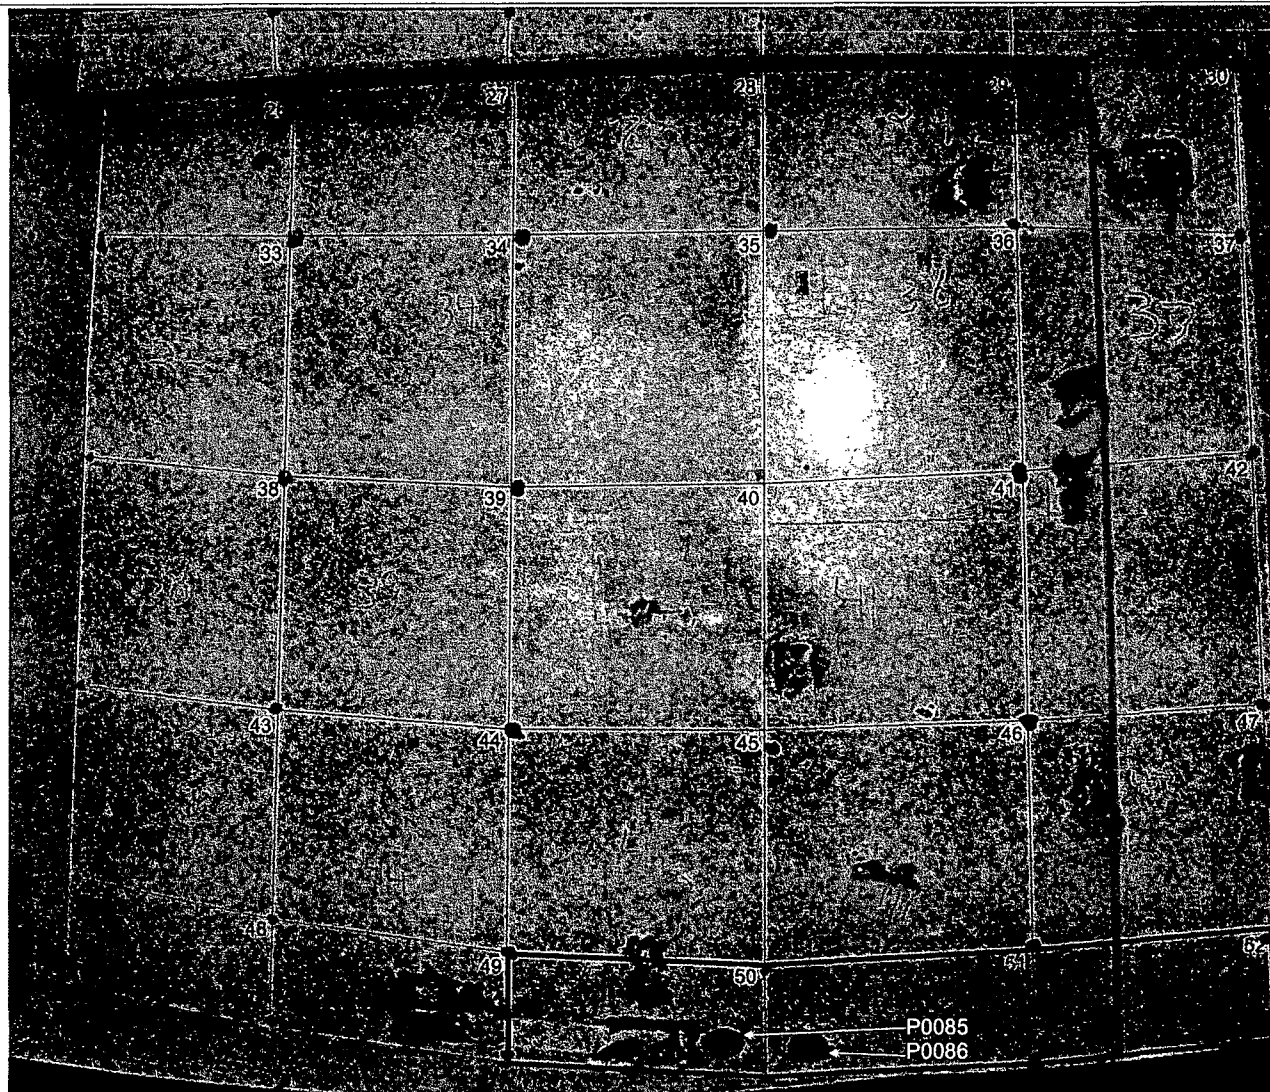
Map F8130611-13, Aux Bldg. -20' El.,
Rm 43, "B" HPI Pump Room
Upper Walls and Ceiling, Class 2

North Ceiling Beta Scan Measurements
F8130611C0050BS to F8130611C0052BS
Penetration Scans F8130611P0085BS to F8130611P0086BS
Total Scan Area: ~1.0 sq. meter

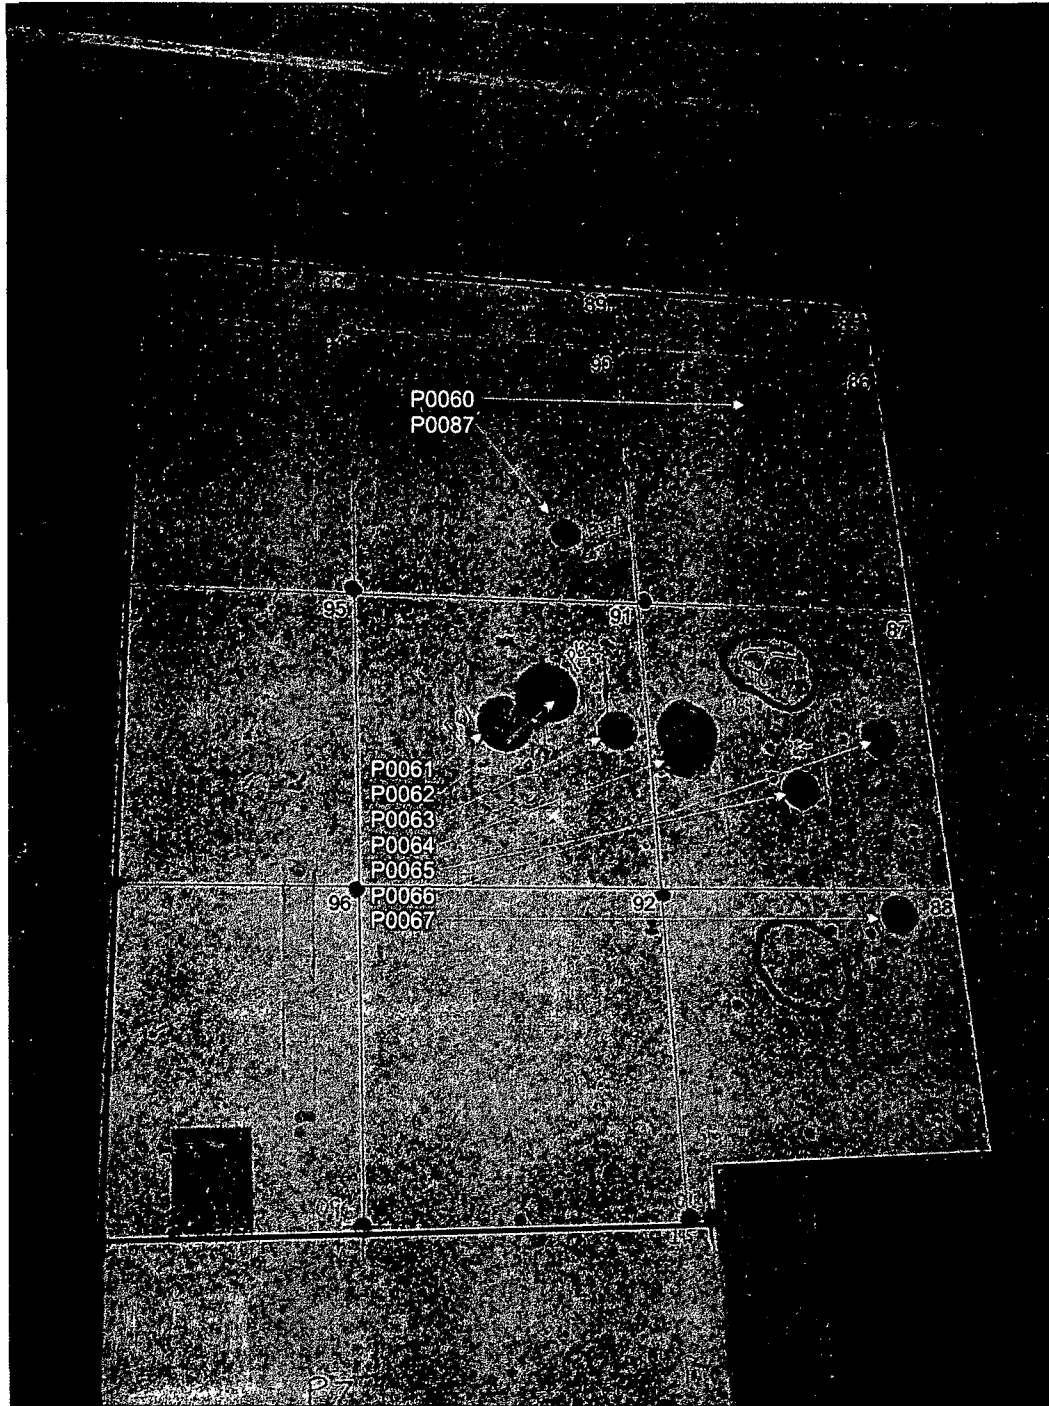
Map F8130611-15, Aux Bldg. -20' El., Rm 43, "B" HPI Pump Room
 Upper Walls and Ceiling, Class 2
 East Wall Beta Scan Measurements
 F8130611C0085BS to F8130611C0096BS
 Penetration Scans F8130611P0060BS to F8130611P0067BS
 and F8130611P0087BS
 Total Scan Area: ~8 sq. meters

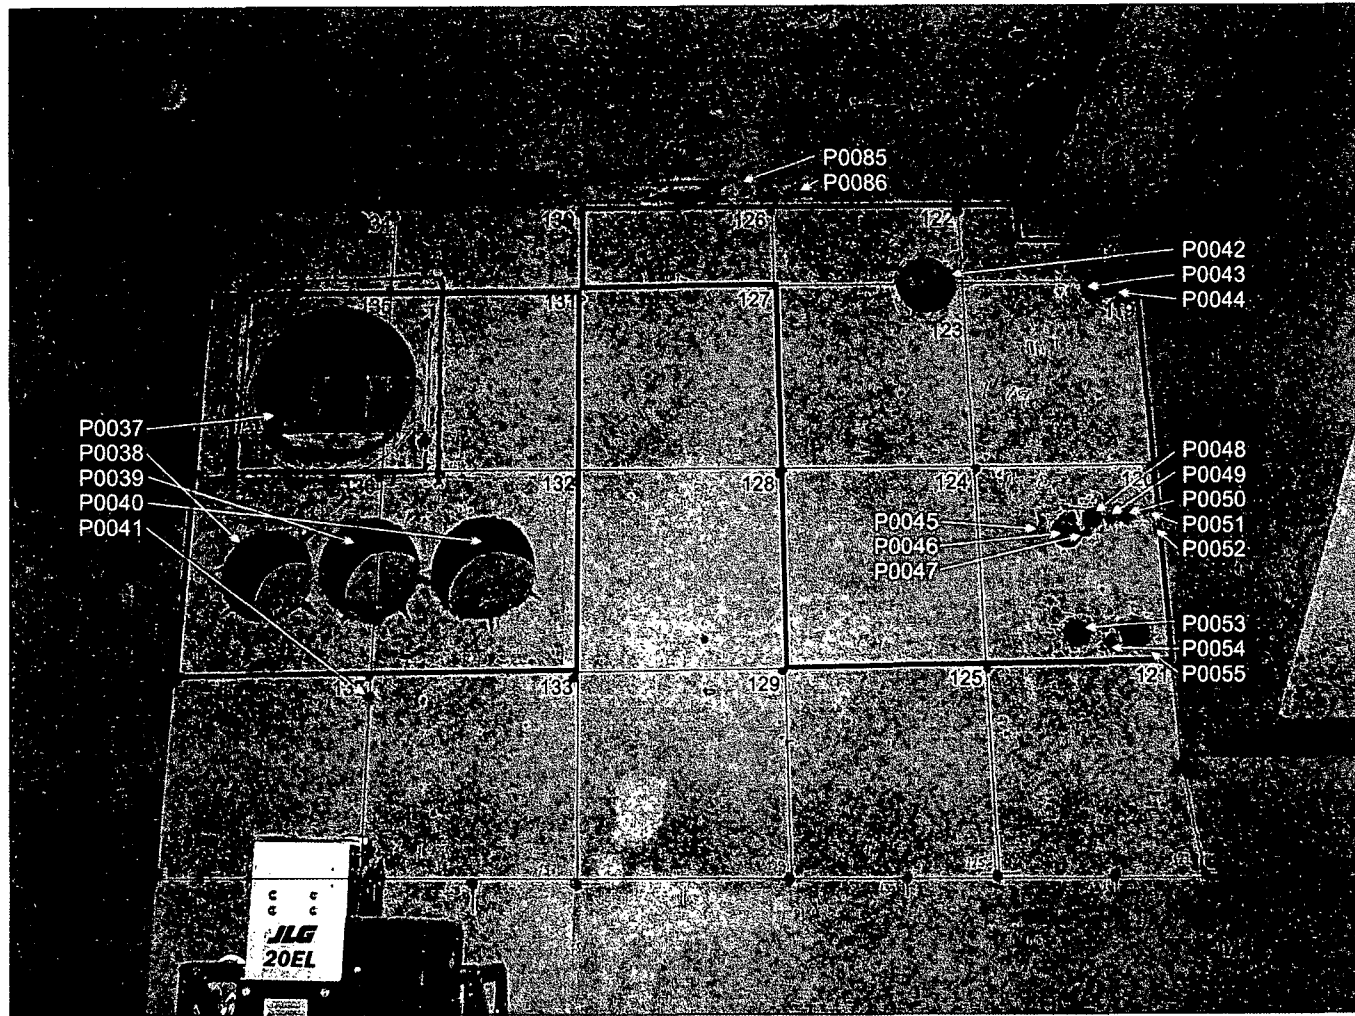
Map F8130611-16, Aux Bldg. -20' El., Rm 43, "B" HPI Pump Room
Upper Walls and Ceiling, Class 2
North Wall Beta Scan Measurements
F8130611C0118BS to F8130611C0120BS,
F8130611C0122BS to F8130611C0124BS,

F8130611C0126BS,
F8130611C0131BS to F8130611C0132BS, and
F8130611C0135BS to F8130611C0136BS
Penetration Scans F8130611P0037BS to F8130611P0055BS
and F8130611P0085BS to F8130611P0086BS
Total Scan Area: ~8.5 sq. meters

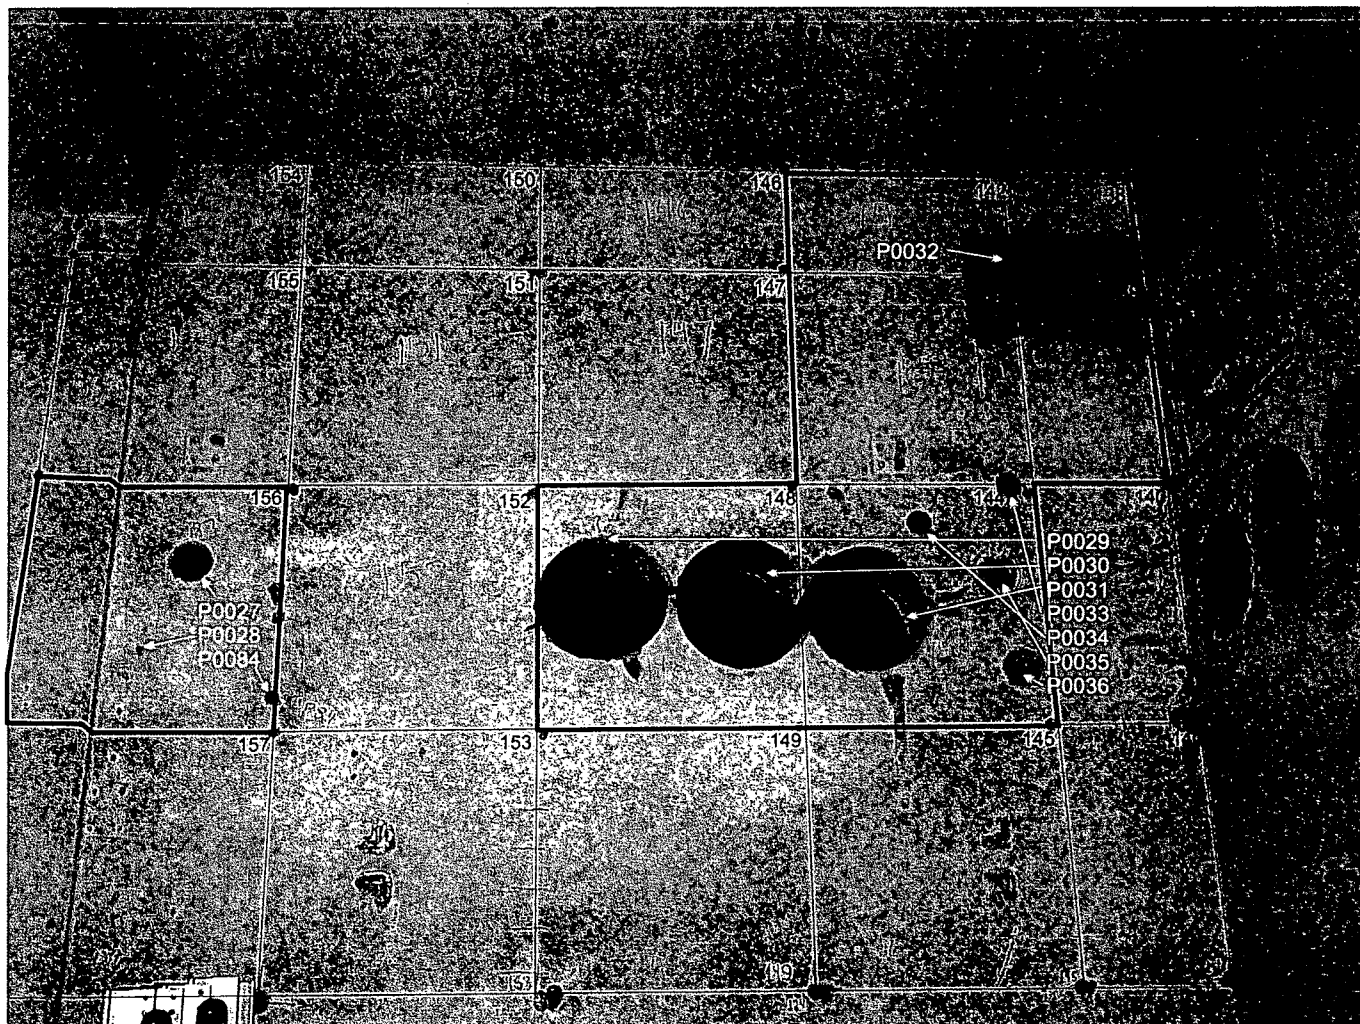
Map F8130611-17, Aux Bldg. -20' El.,
Rm 43, "B" HPI Pump Room
Upper Walls and Ceiling, Class 2
West Wall Beta Scan Measurements
F8130611C0138BS to F8130611C0139BS,

F8130611C0142BS to F8130611C0144BS,
F8130611C0148BS and F8130611C0156BS,
Penetration Scans F8130611P0027BS to F8130611P0036BS
and F8130611P0084BS
Total Scan Area: ~ 4.5 sq. meters

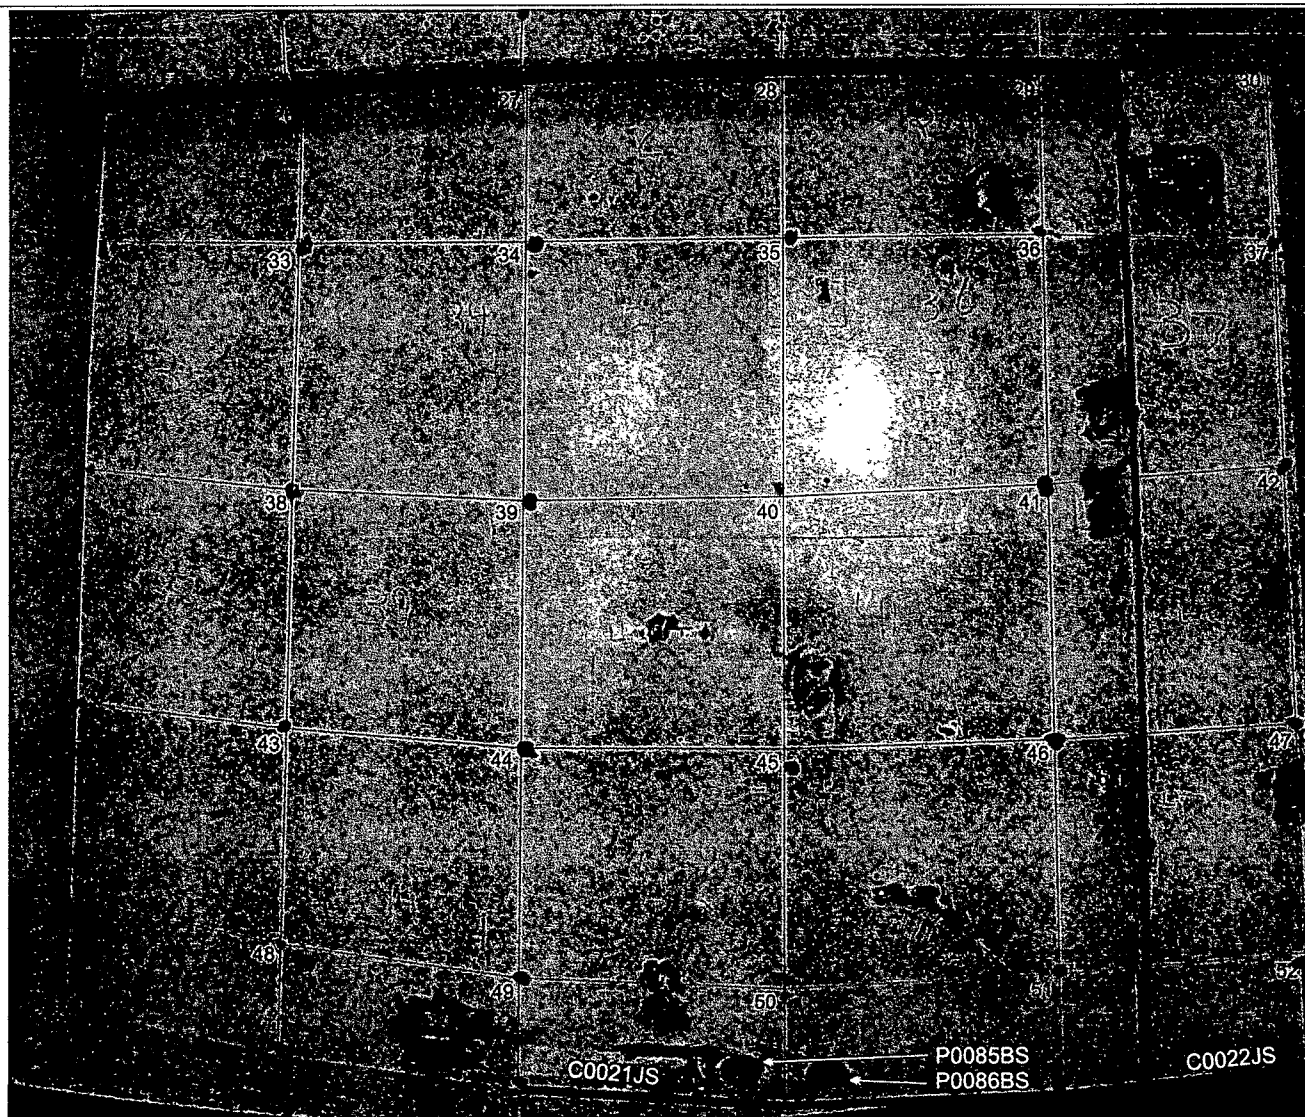
Map F8130611-21, Aux Bldg. -20' El., Rm 43, "B" HPI Pump Room
 Upper Walls and Ceiling, Class 2
 North Ceiling Juncture Scan Measurements
 F8130611C0021JS to F8130611C0022JS

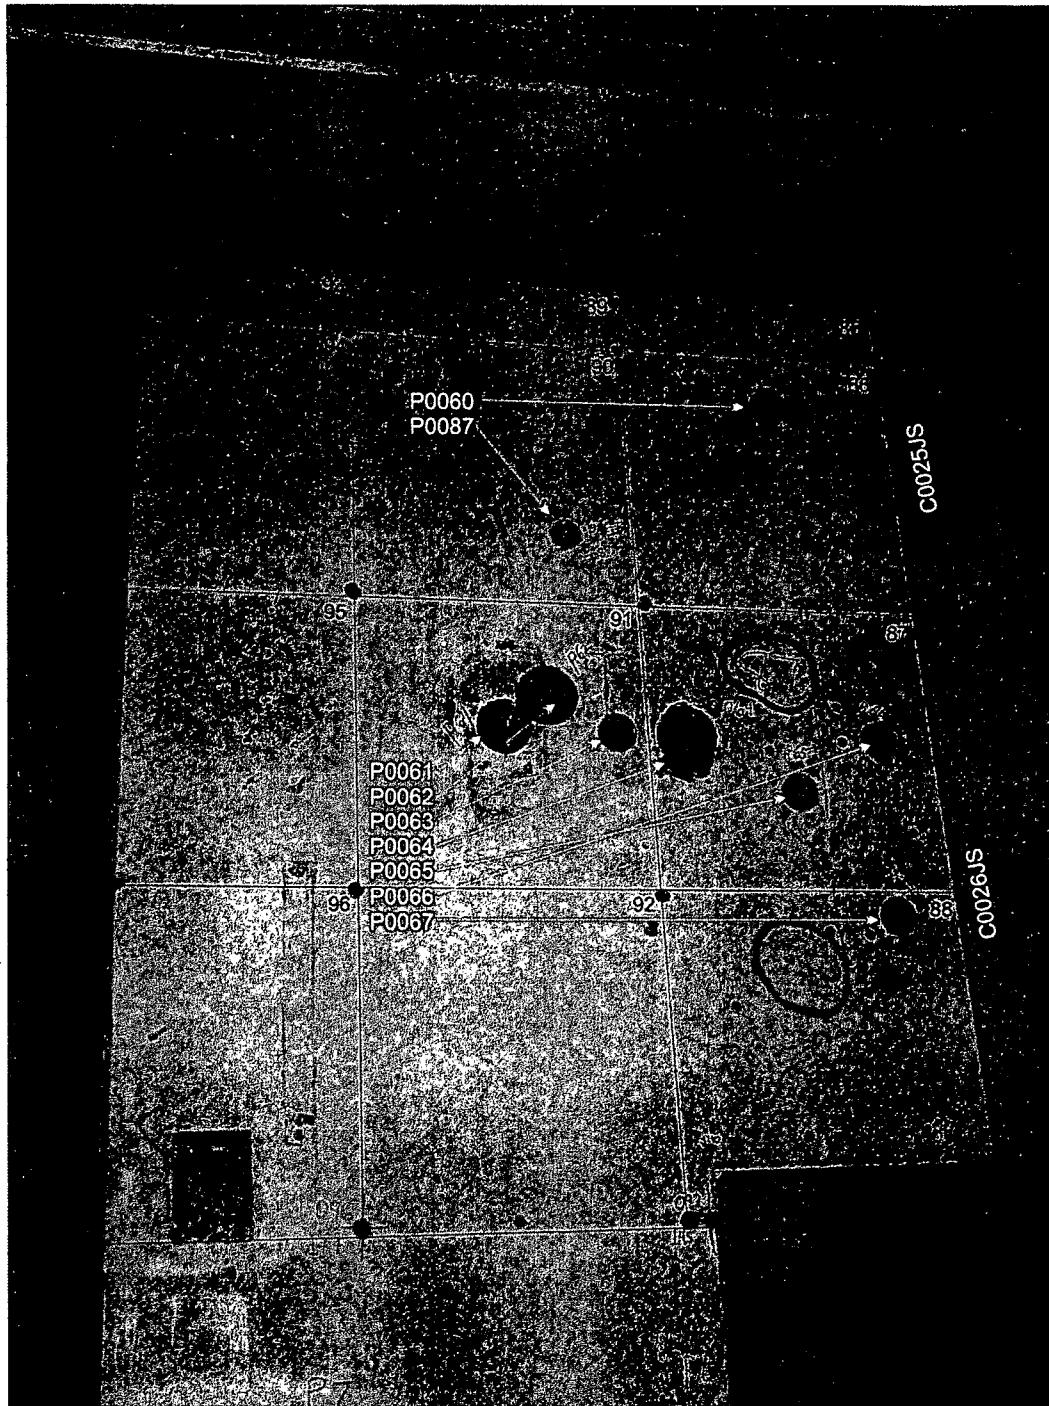
Map F8130611-23, Aux Bldg. -20' El., Rm 43, "B" HPI Pump Room
 Upper Walls and Ceiling, Class 2
 East Wall Juncture Scan Measurements
 F8130611C0025JS to F8130611C0026JS

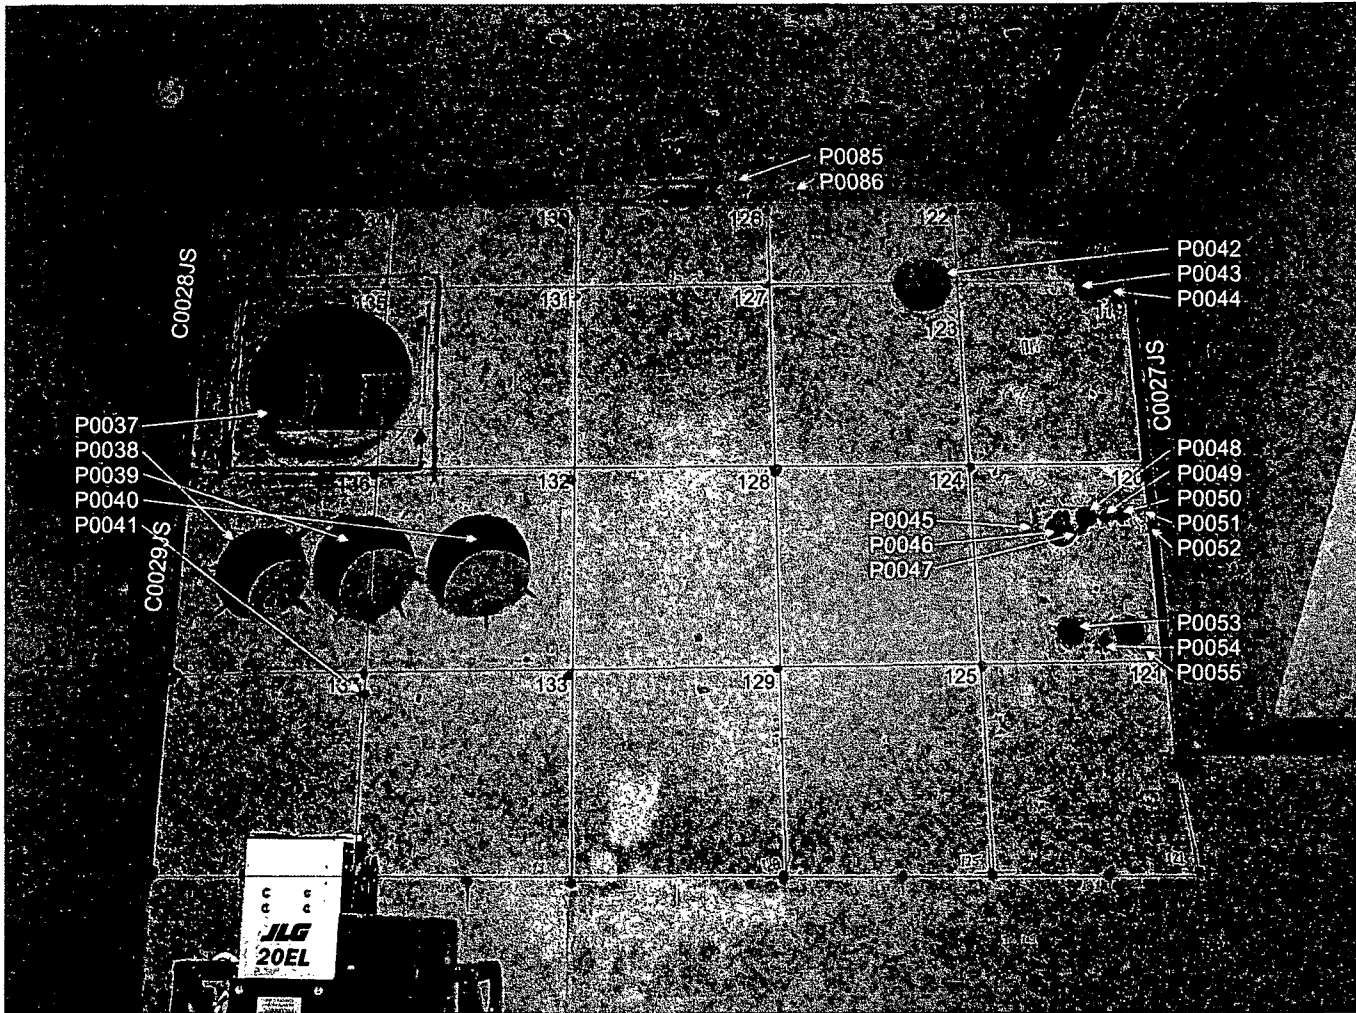
Map F8130611-24, Aux Bldg. -20' El., Rm 43, "B" HPI Pump Room
 Upper Walls and Ceiling, Class 2
 North Wall Juncture Scan Measurements
 F8130611C0027JS to F8130611C0029JS

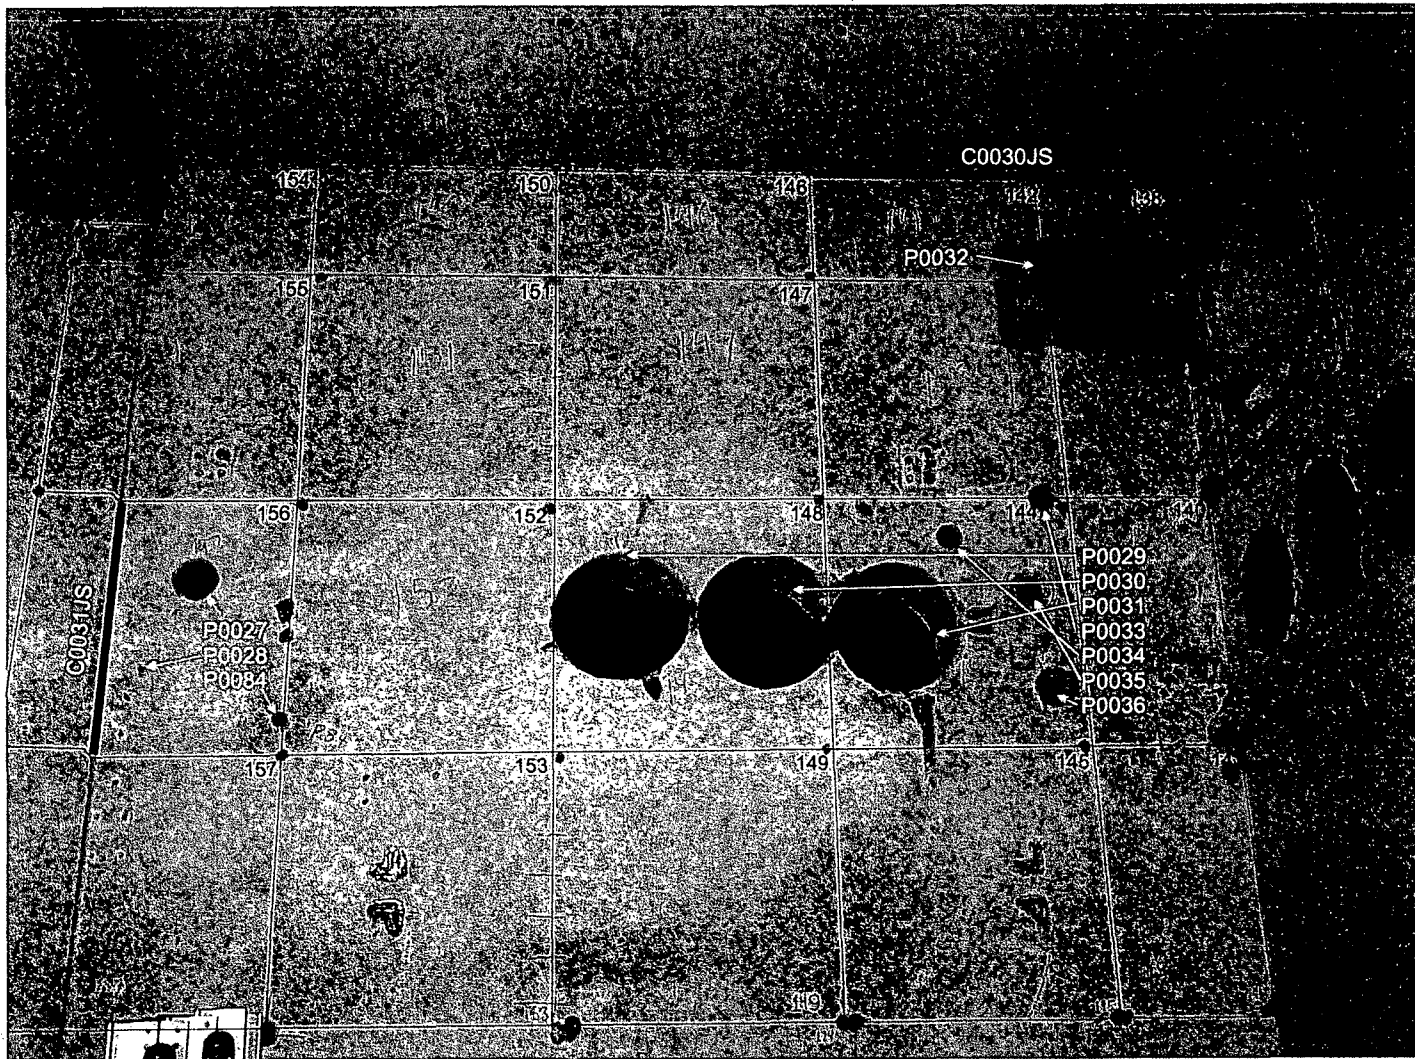
Map F8130611-25, Aux Bldg. -20' El., Rm 43, "B" HPI Pump Room
Upper Walls and Ceiling, Class 2
West Wall Juncture Scan Measurements
F8130611C0030JS to F8130611C0031JS

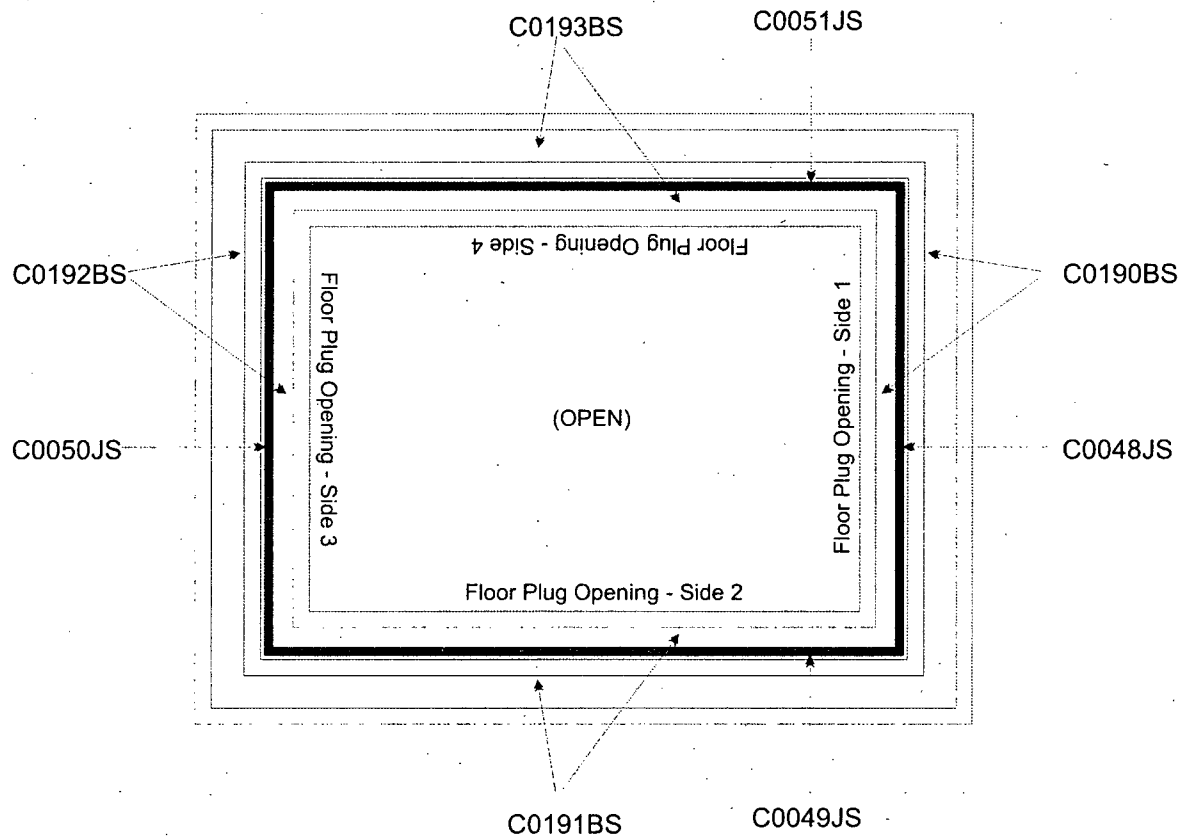
Map F8130611-27, Aux Bldg. -20' El., Rm 43, "B" HPI Pump Room
 Upper Walls and Ceiling, Class 2
 Floor Plug Opening Beta Scan Measurements
 F8130611C0190BS to F8130611C0193BS
 Juncture Scan Measurements
 F8130611C0048JS to F8130611C0051JS
 Total Scan Area: ~6 sq. meters
