Rancho Seco

Final Status Survey Summary Report

Misc. Waste Gas Condensate Tank Room Upper Walls and Ceiling
(Room 021)

Survey Unit F8130271

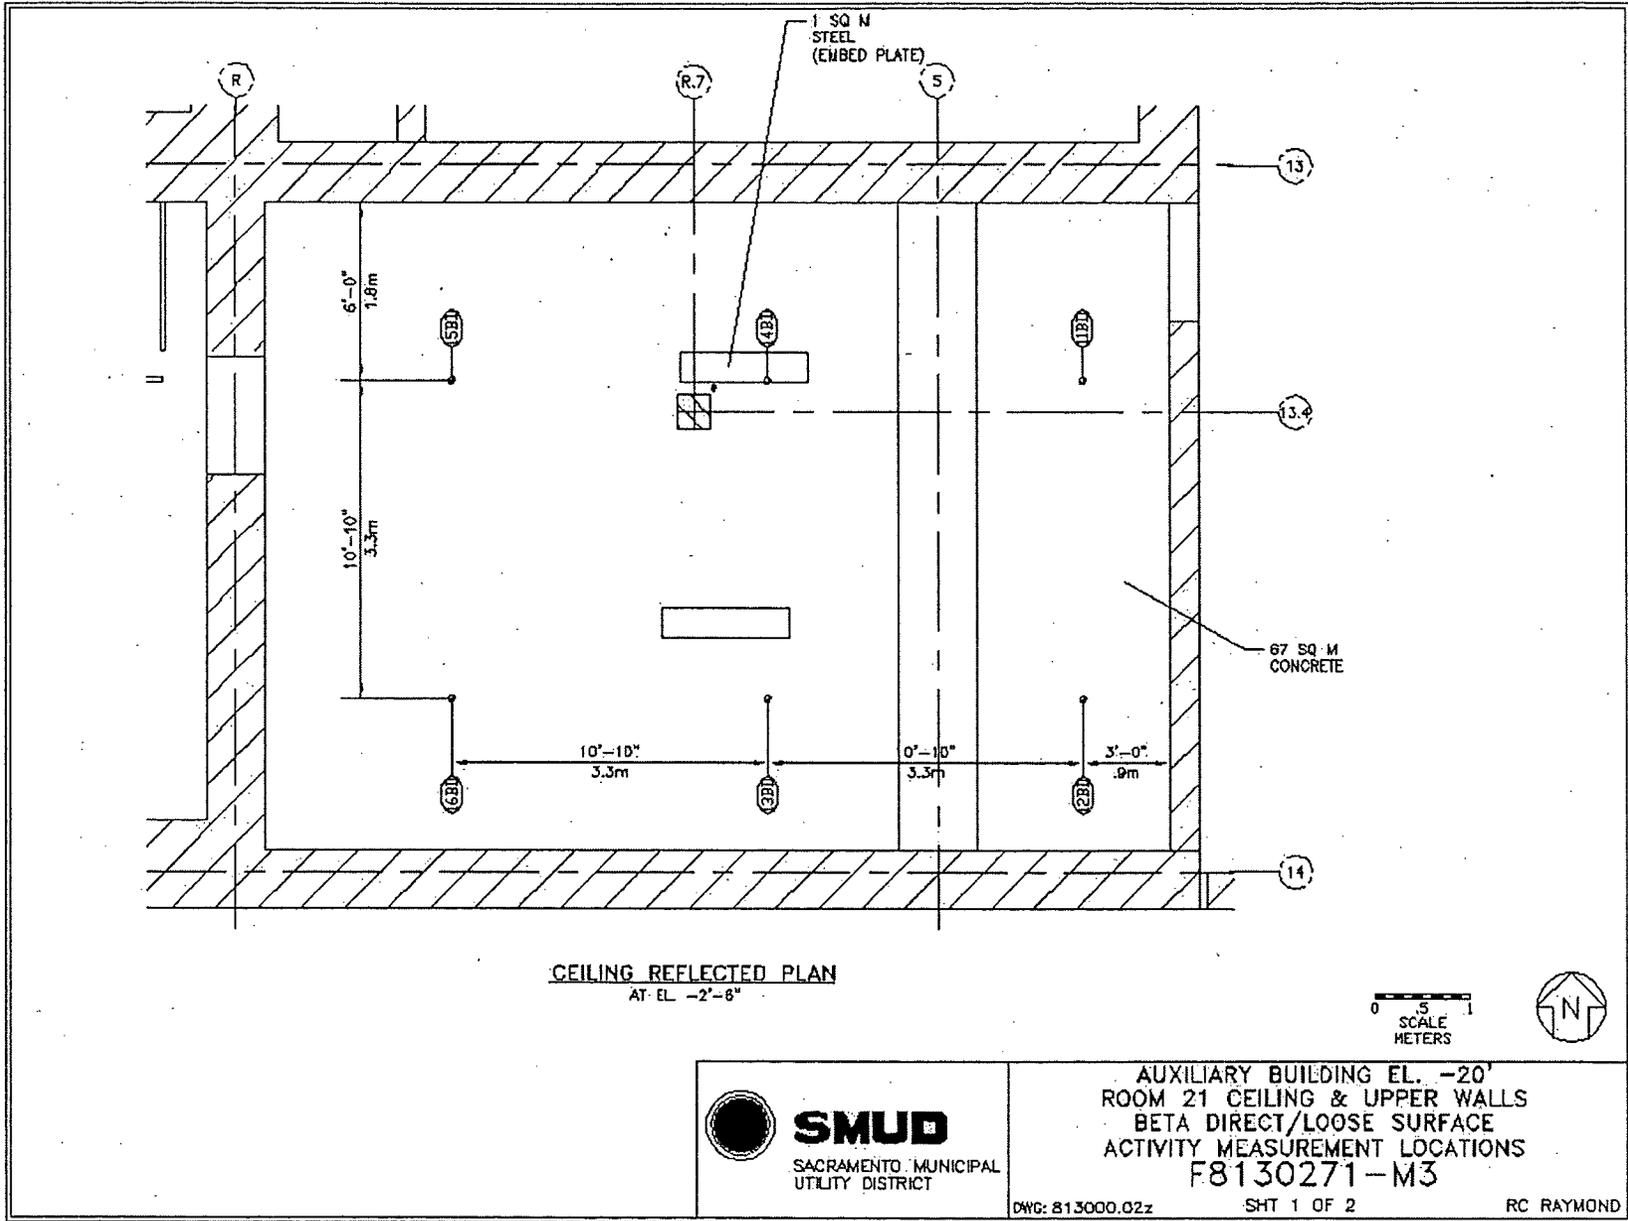
<p>SMUD SACRAMENTO MUNICIPAL UTILITY DISTRICT</p>	<p>AUXILIARY BUILDING EL. -20' ROOM 21 CEILING & UPPER WALLS BETA DIRECT/LOOSE SURFACE ACTIVITY MEASUREMENT LOCATIONS F8130271-M3</p>
	<p>DWG: 813000.02z SHT 1 OF 2 RC RAYMOND</p>

The Survey Unit Design Parameters are presented in Table 1 below. The survey unit and measurement locations are depicted on the maps in Attachment 1. Direct measurement locations were determined using a random-start, fixed grid pattern and 64 m² were scanned for approximately 35% coverage. Samples of removable contamination were collected at each direct measurement location. The instrumentation used for the survey along with the MDC values are listed in Tables 2-1 and 2-2 in Attachment 2.

CEILING REFLECTED PLAN
AT EL. -2'-8"

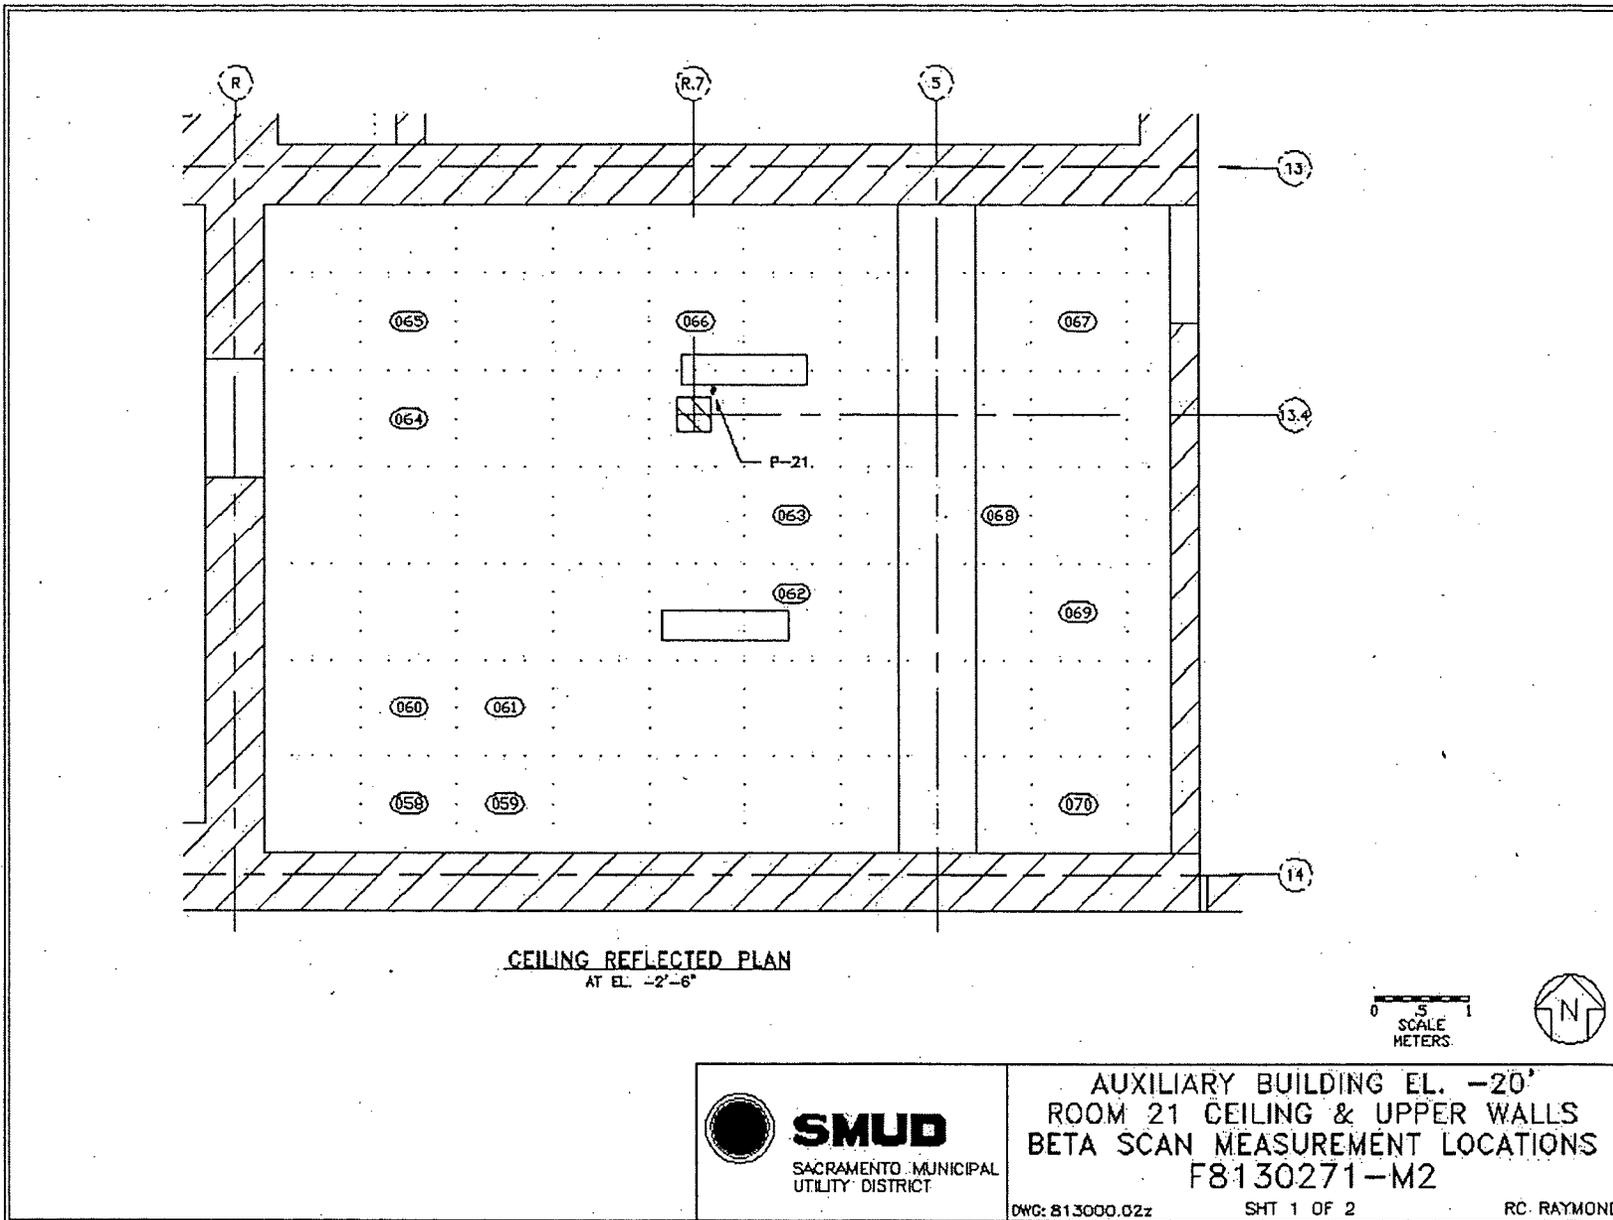
AUXILIARY BUILDING EL. -20'
ROOM 21 CEILING & UPPER WALLS
BETA SCAN MEASUREMENT LOCATIONS
F8130271-M2
DWG: 813000.02z SHT 1 OF 2 RC. RAYMOND

CEILING REFLECTED PLAN
AT EL. -2'-6"
