# Rancho Seco

# Final Status Survey Summary Report

"A" High Pressure Injection Pump Room Upper Walls and Ceiling (Room 053)

Survey Unit F8130782

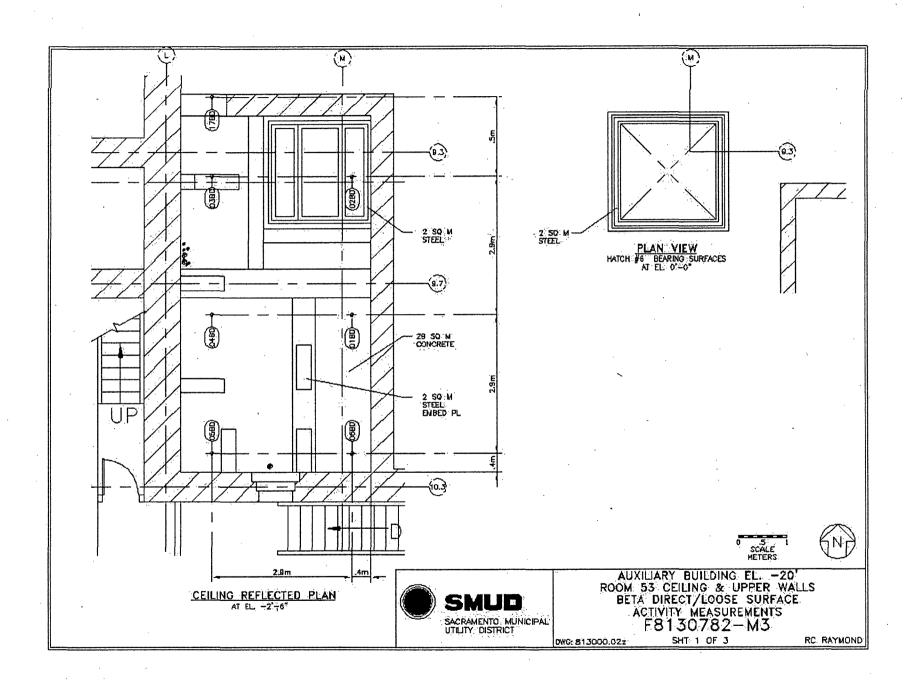
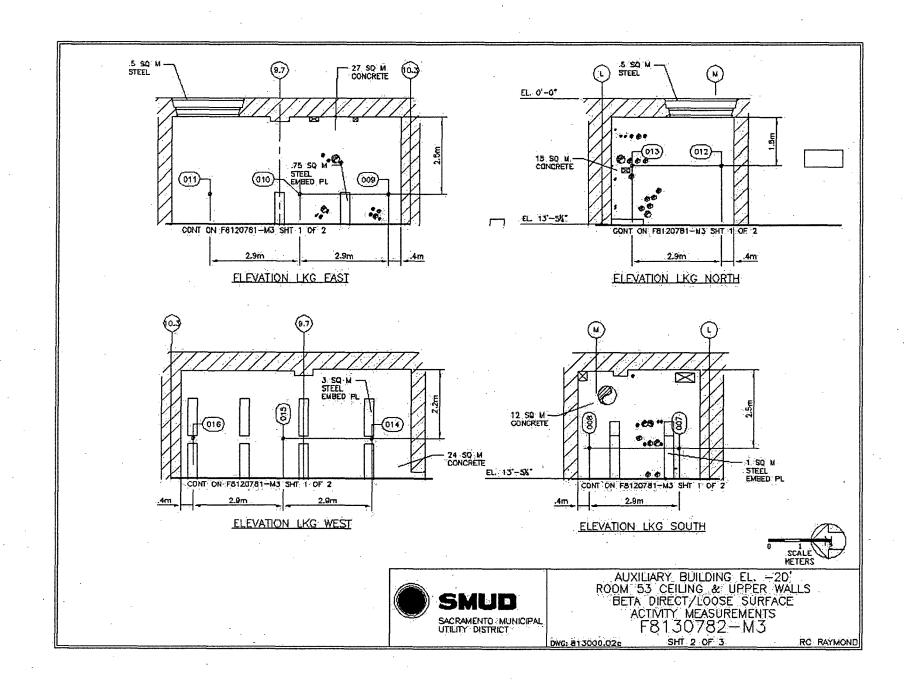
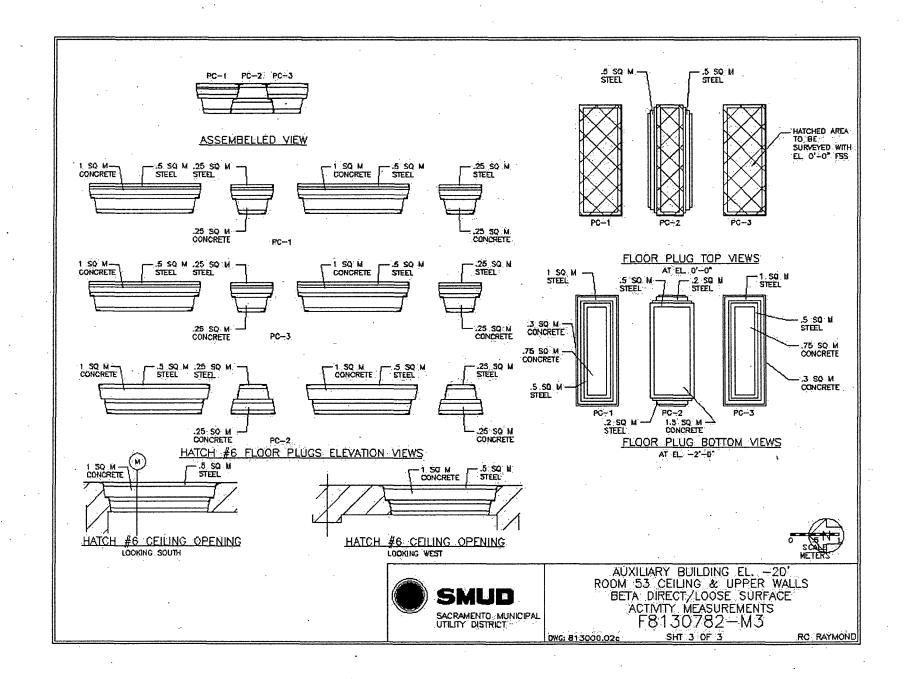
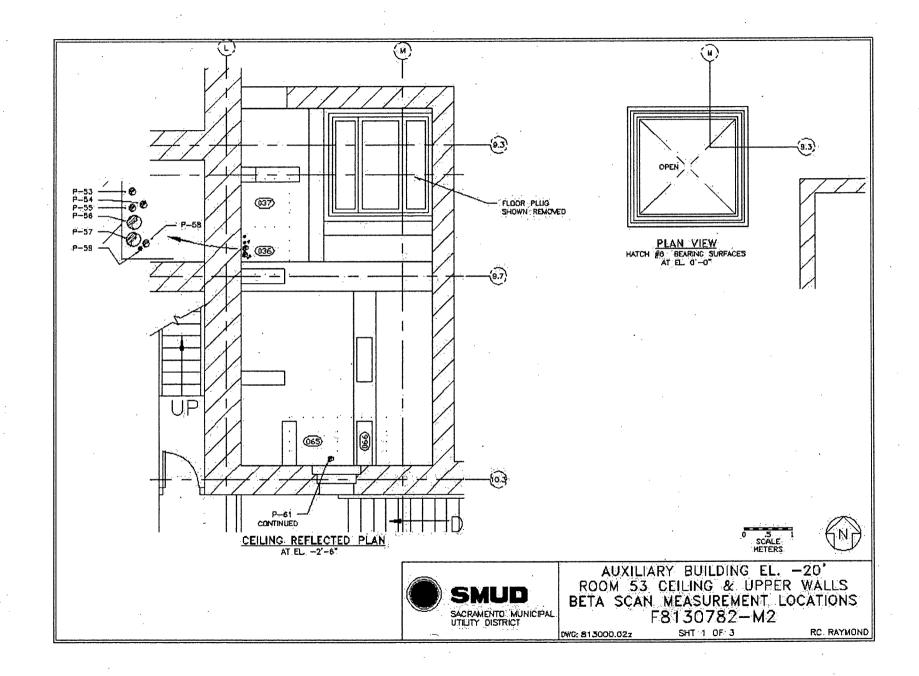
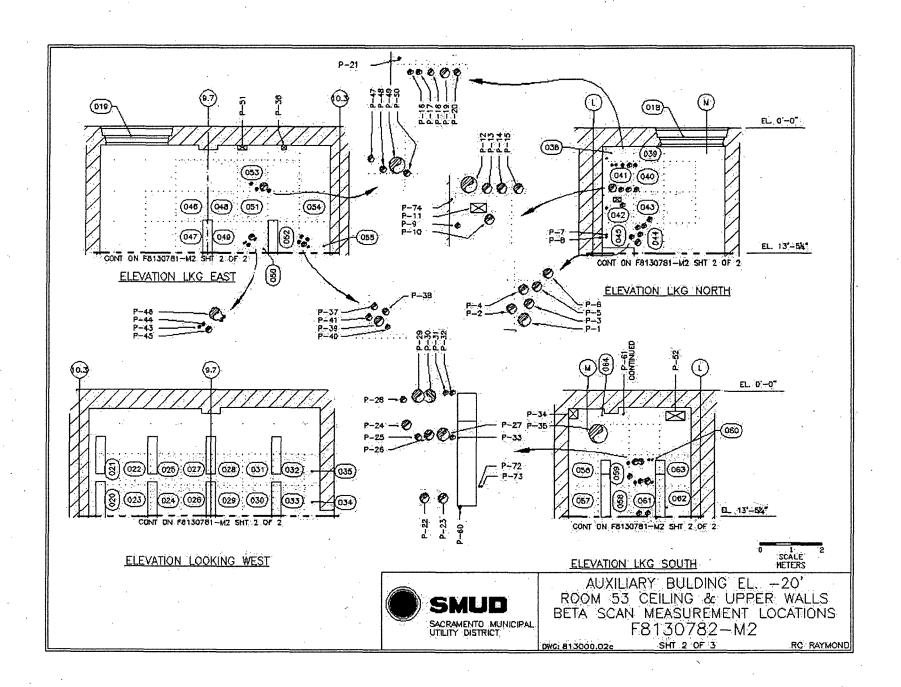
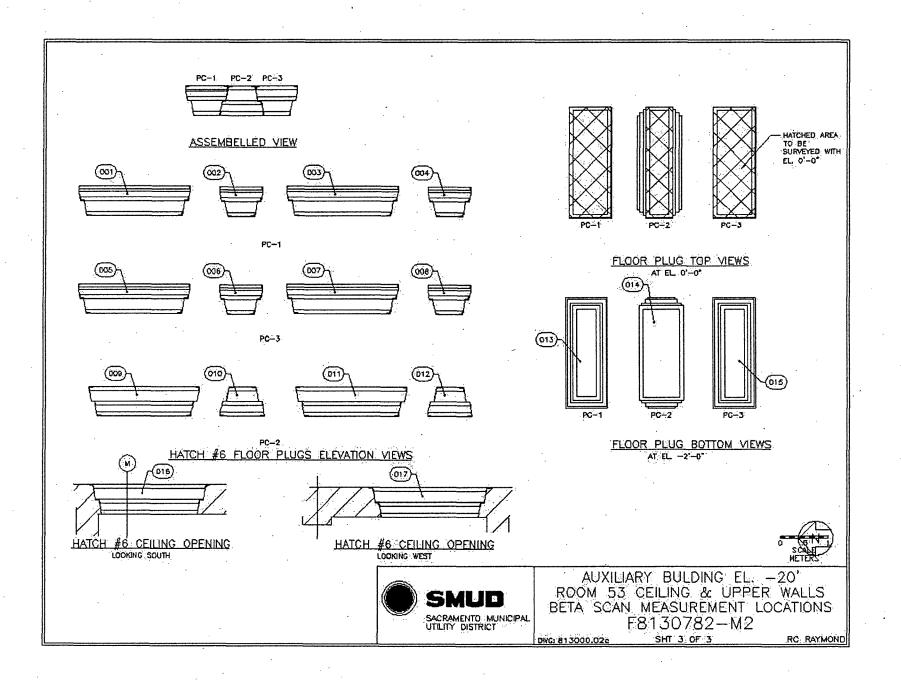
# Attachment 1 Maps

The Survey Unit Design Parameters are presented in Table 1 below. The survey unit and measurement locations are depicted on the maps in Attachment 1. Direct measurement locations were determined using a random-start, fixed grid pattern and 50 m² were scanned for approximately 35% coverage. Samples of removable contamination were collected at each direct measurement location. The instrumentation used for the survey along with the MDC values are listed in Tables 2-1 and 2-2 in Attachment 2.

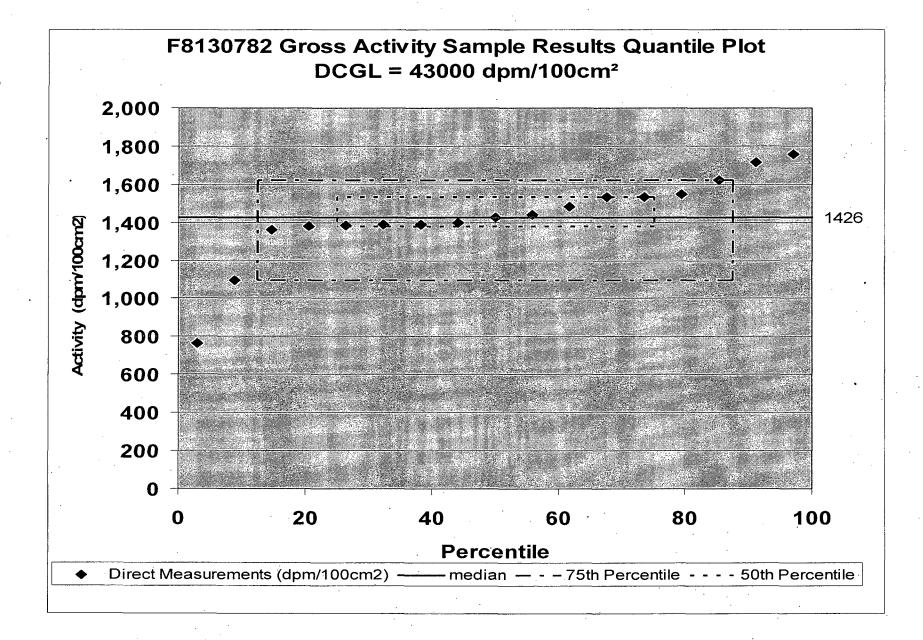
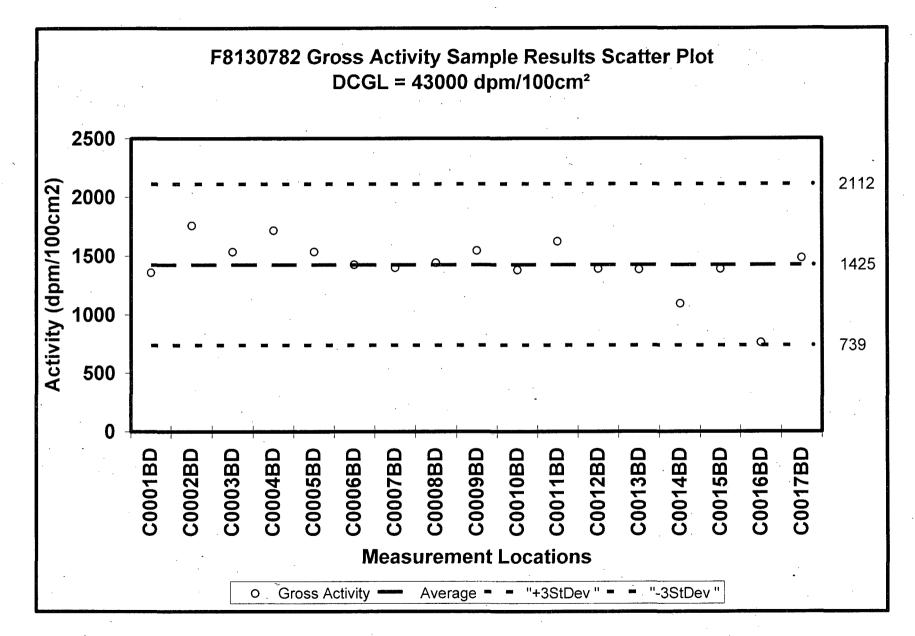
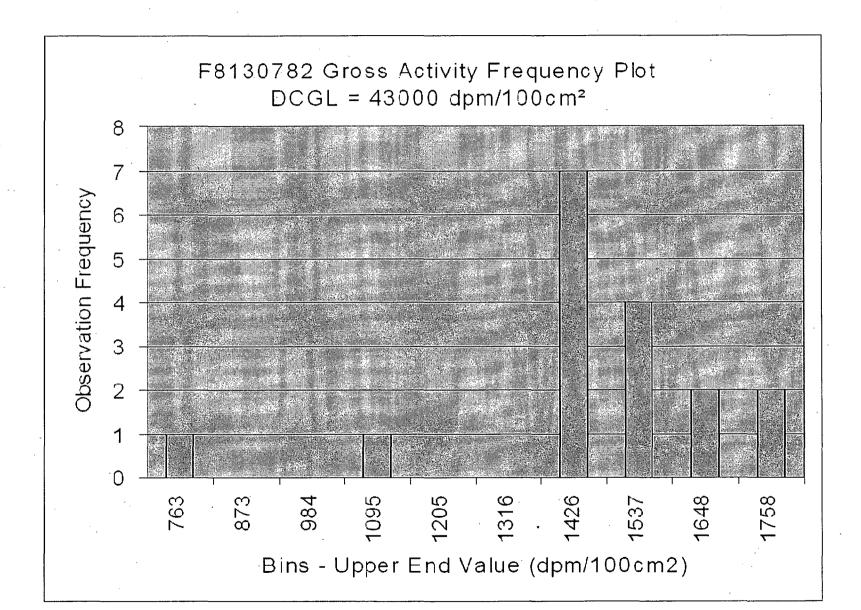
Attachment 4

The survey design required 17 direct measurements for the Sign Test. The critical value and the results of the Sign Test are presented in Table 4. The sample mean and median values were less than the DCGL. The sample standard deviation was less than the design standard deviation so no additional samples were required.
