**Rancho Seco**  
**Final Status Survey Summary Report**  
**October 31, 2007**  
**"A" Warehouse (interior)**  
**Survey Unit F8400001**

F8400001, "A" Warehouse (interior)

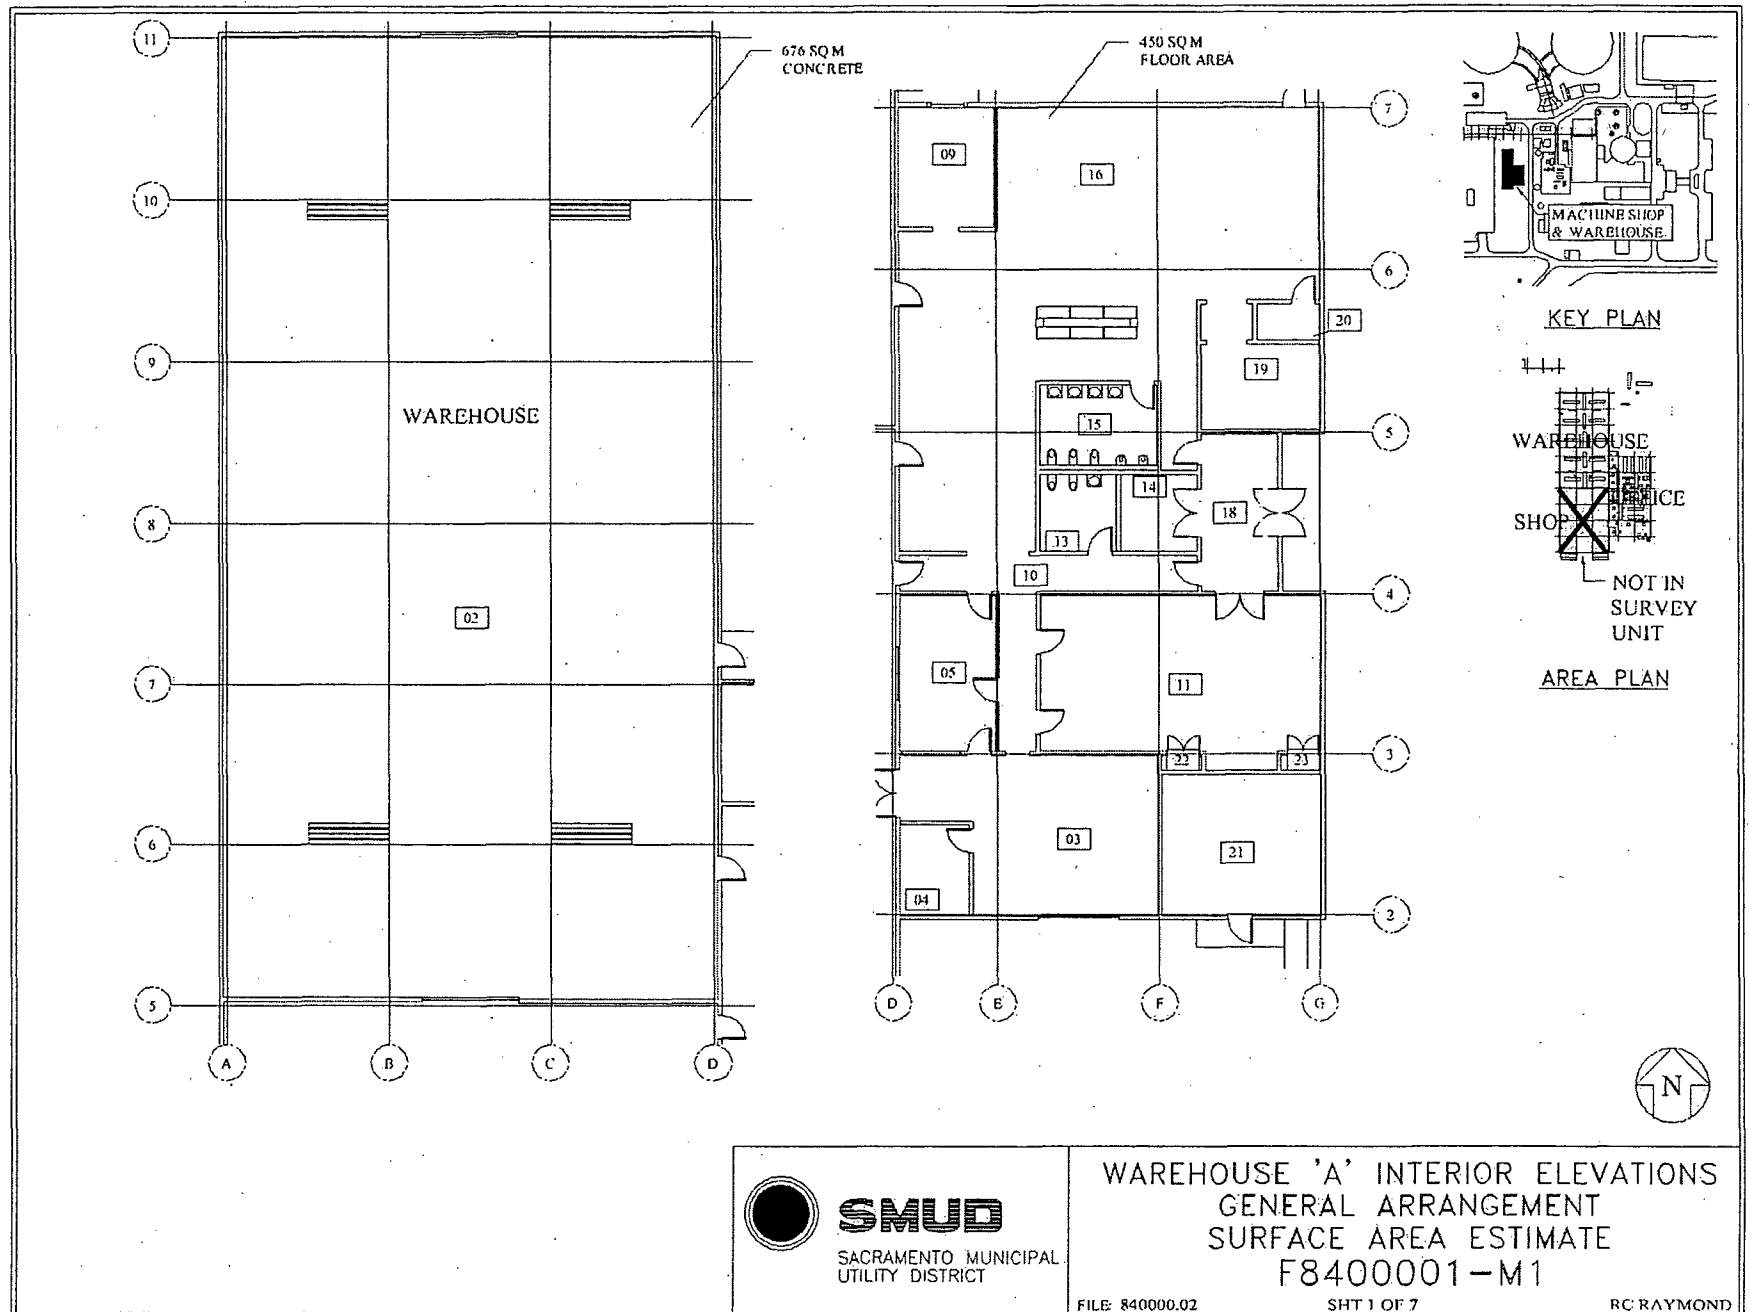
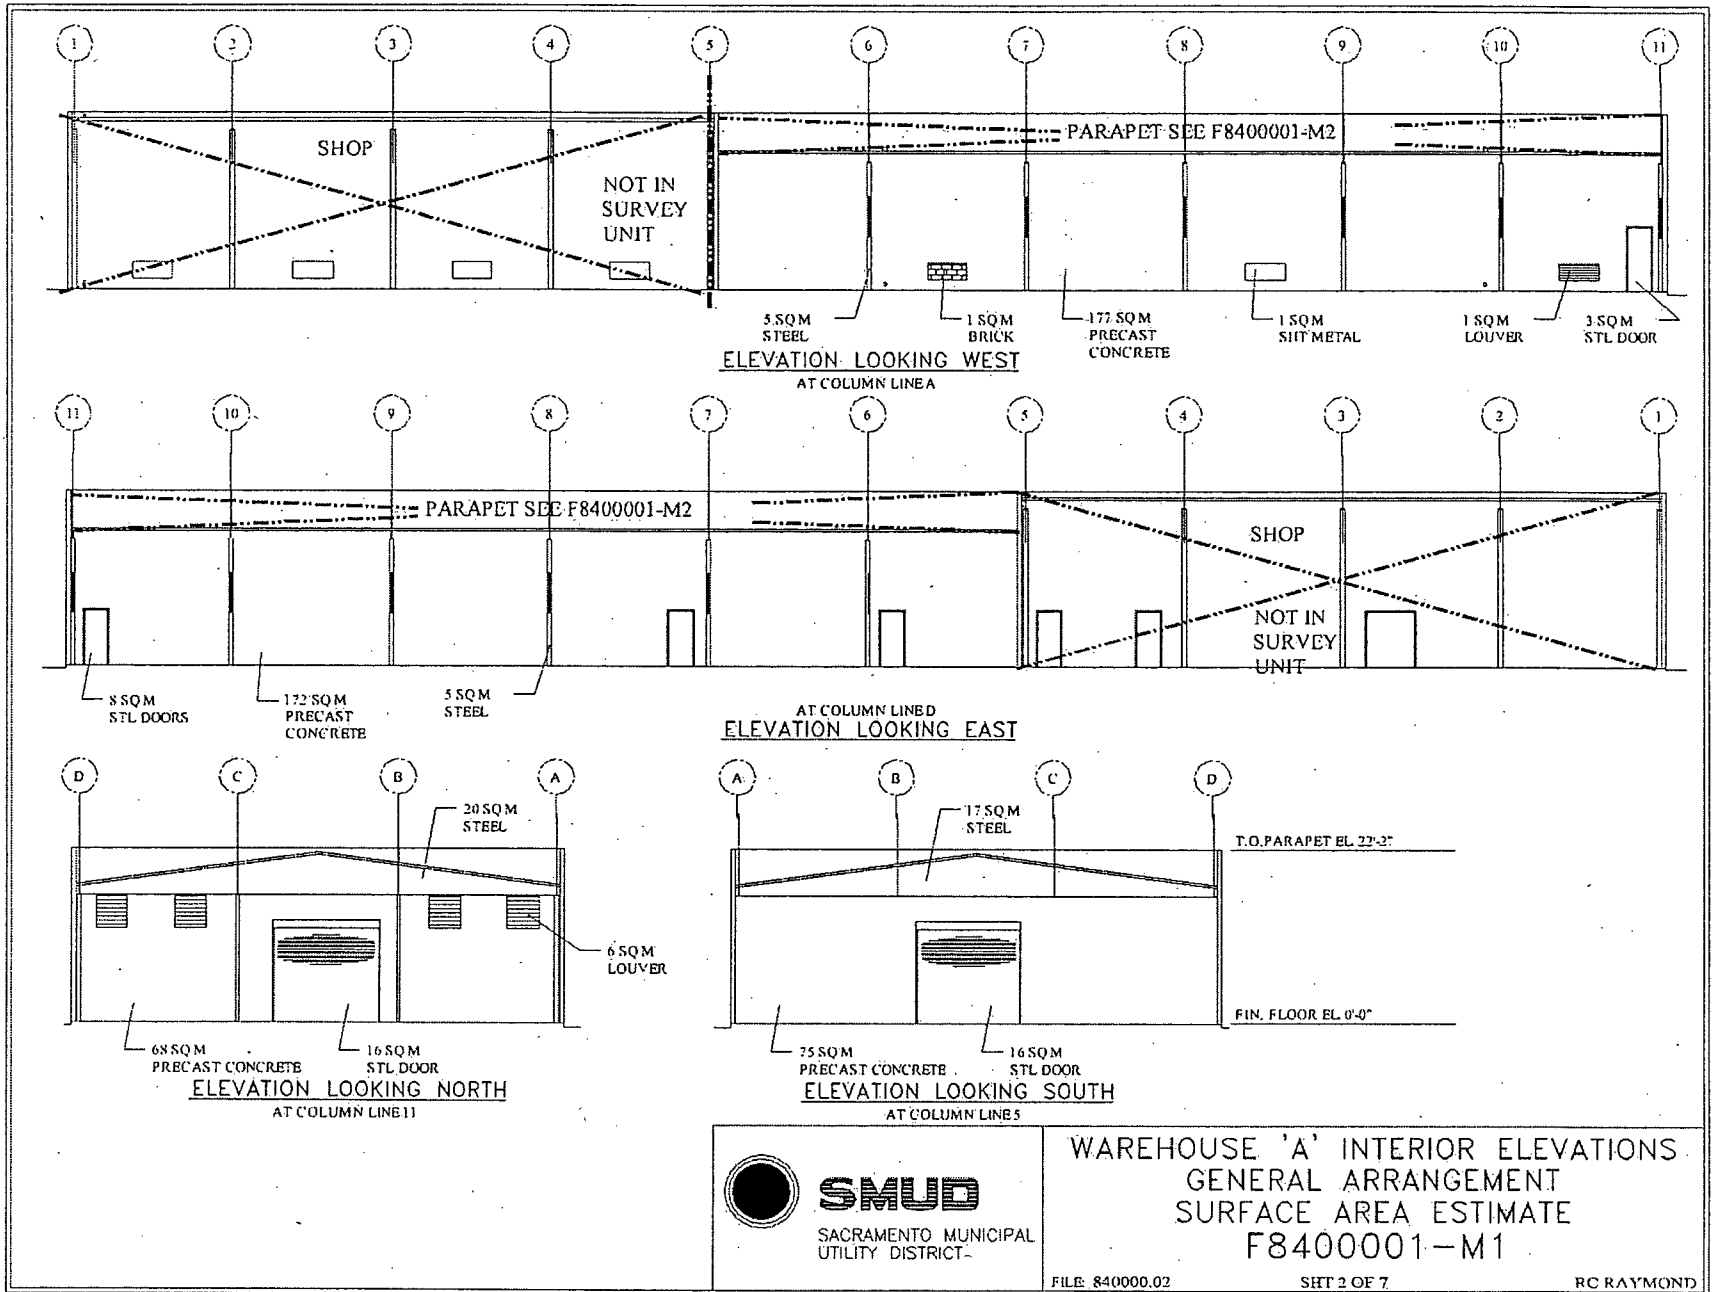
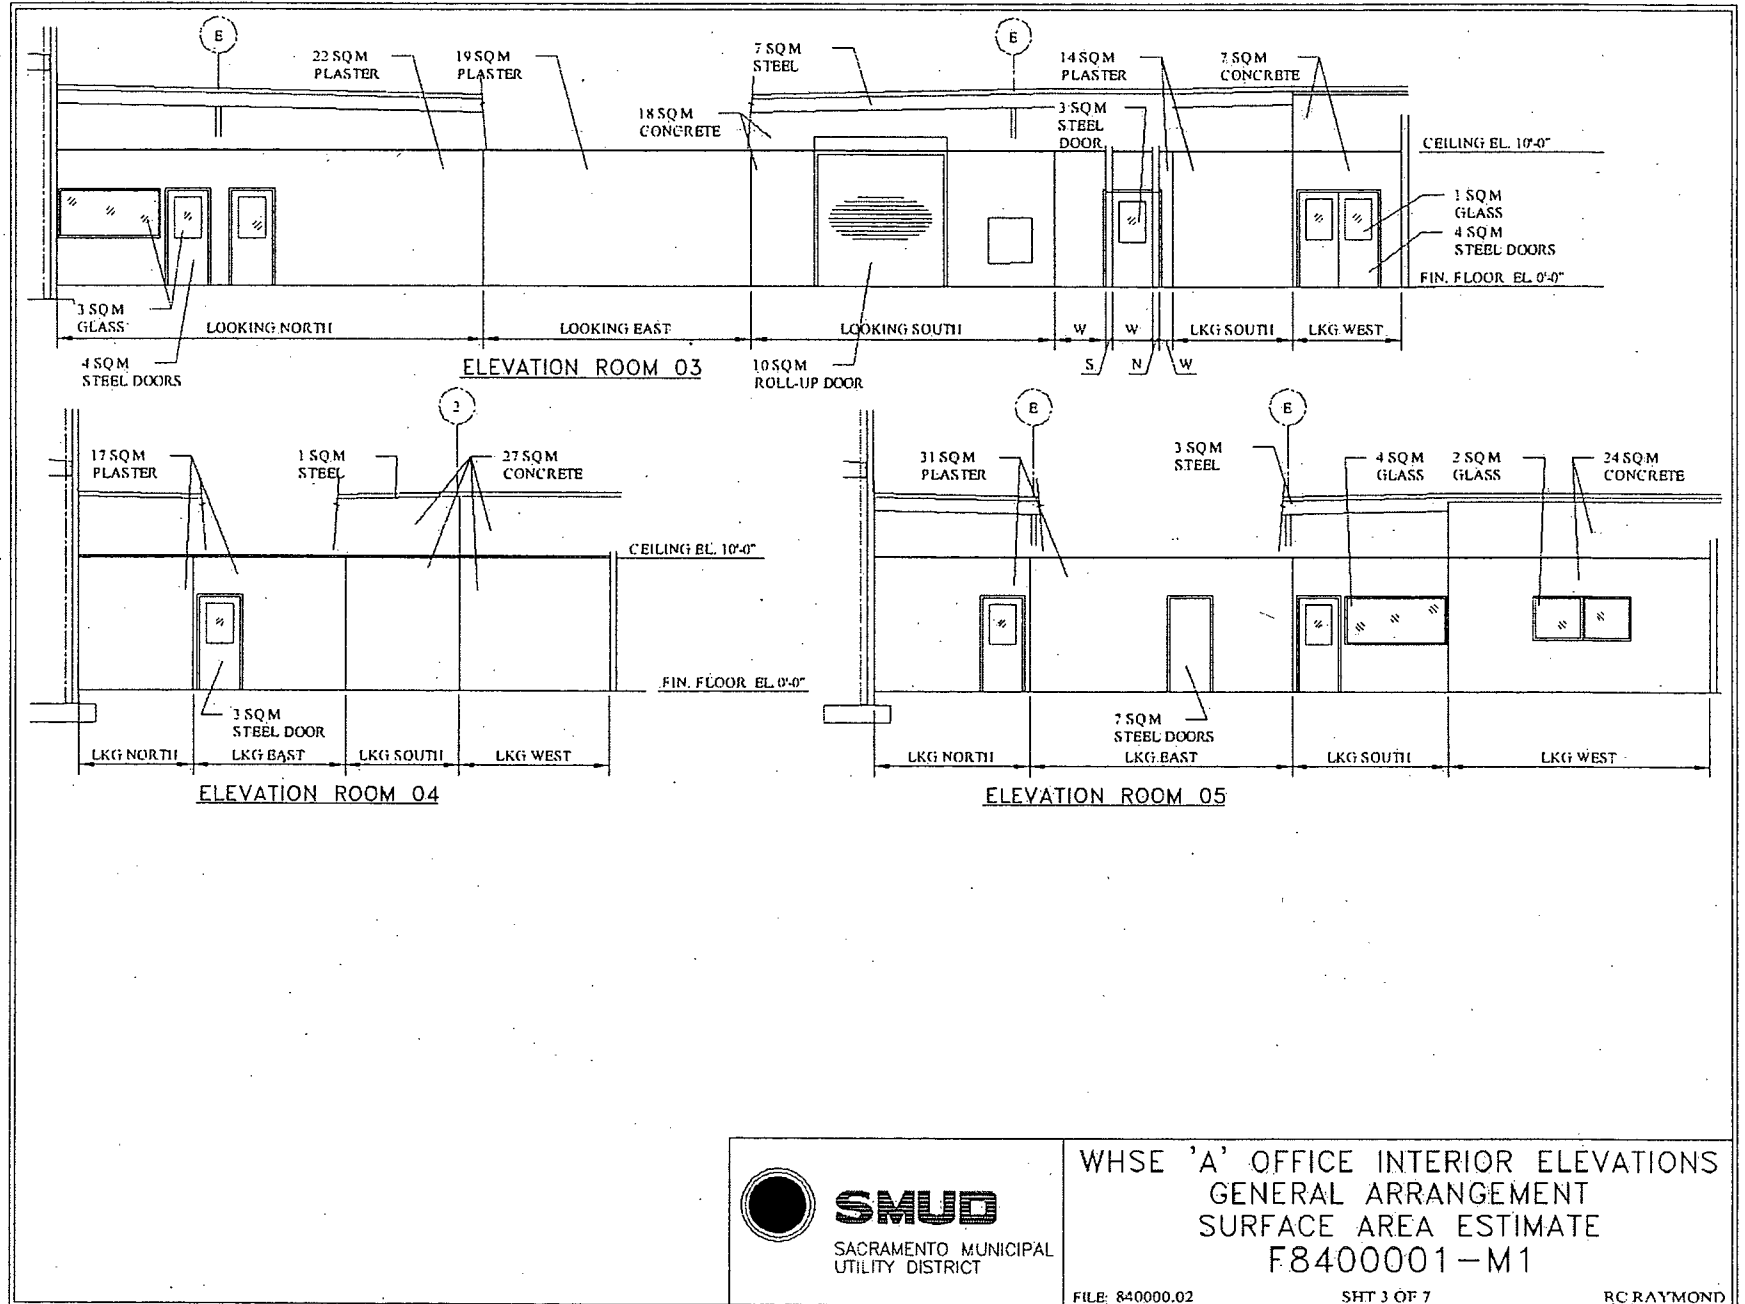
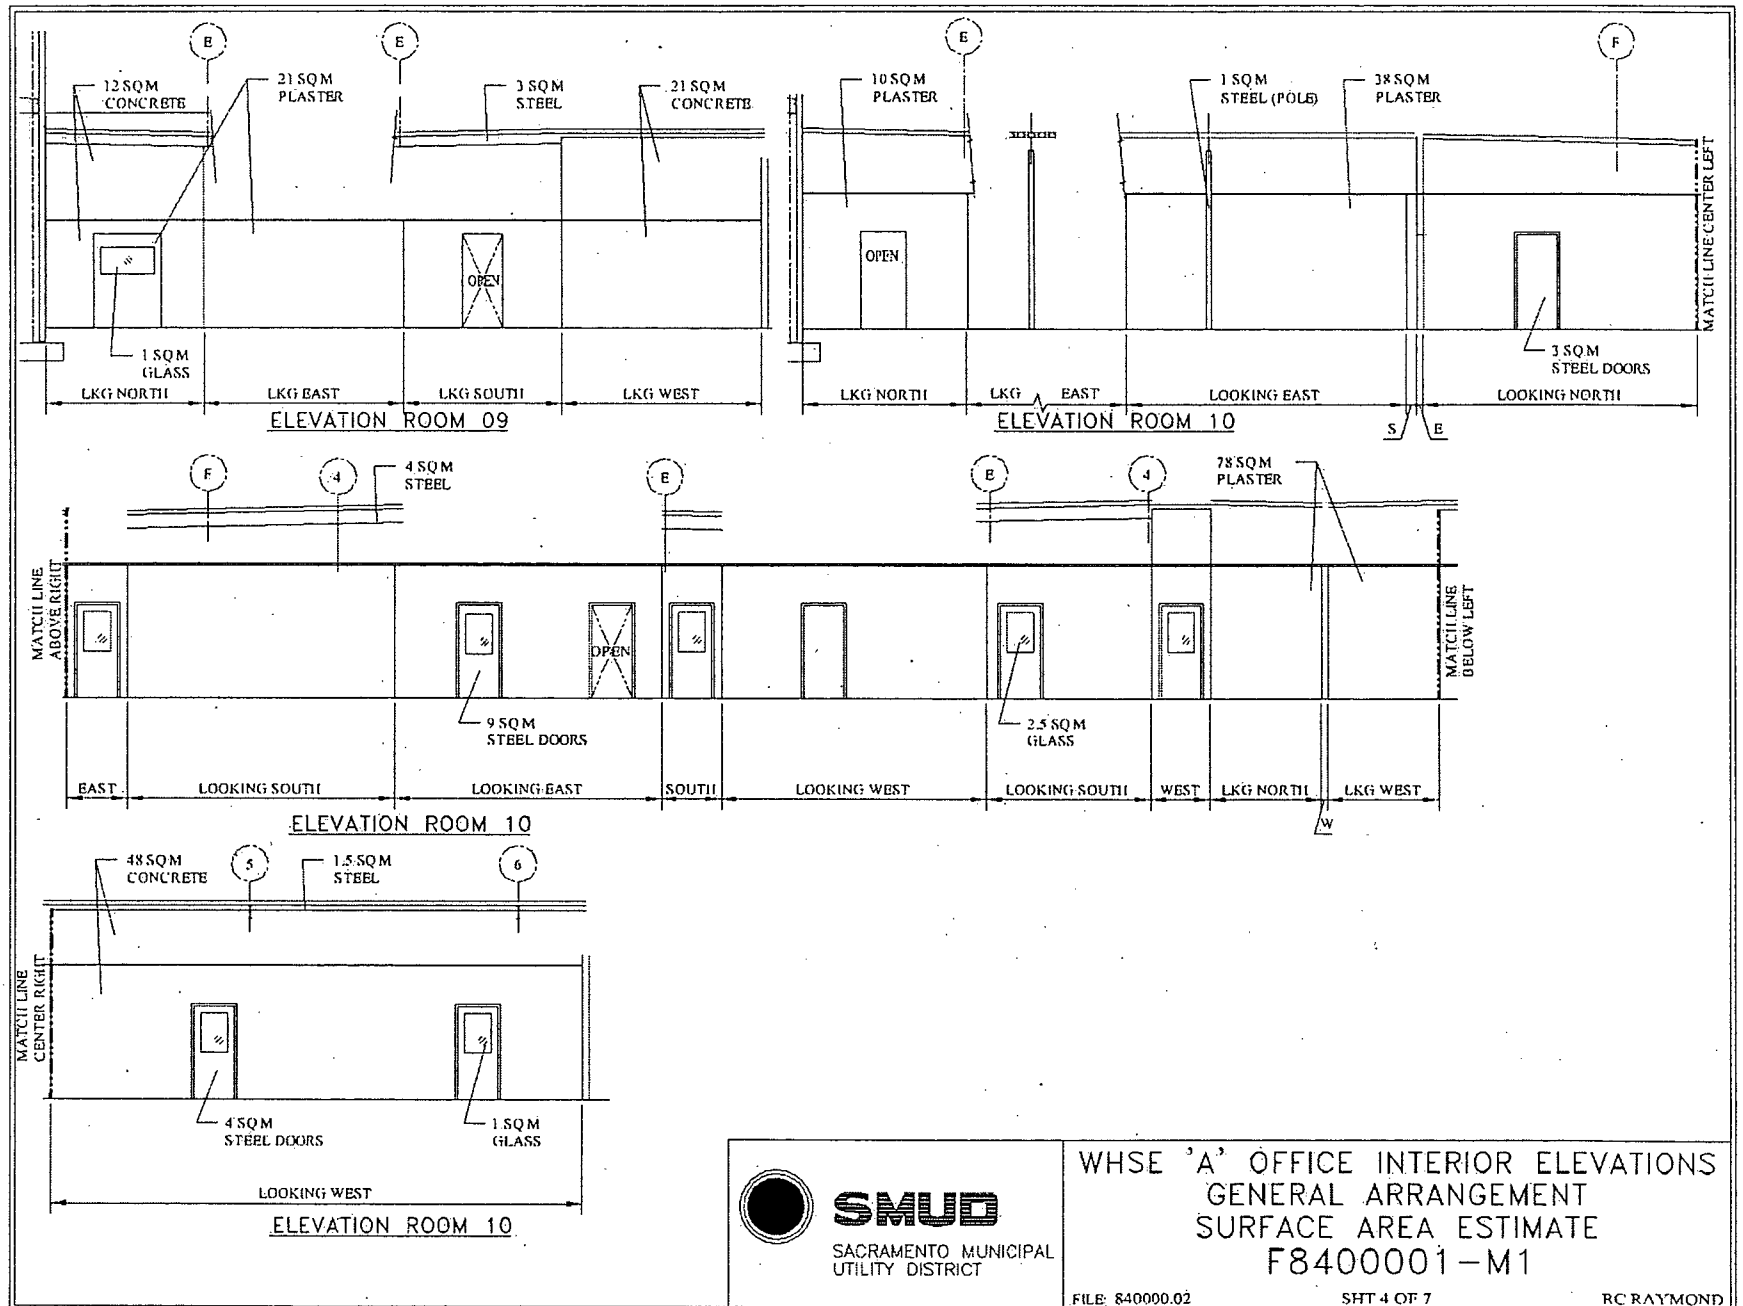
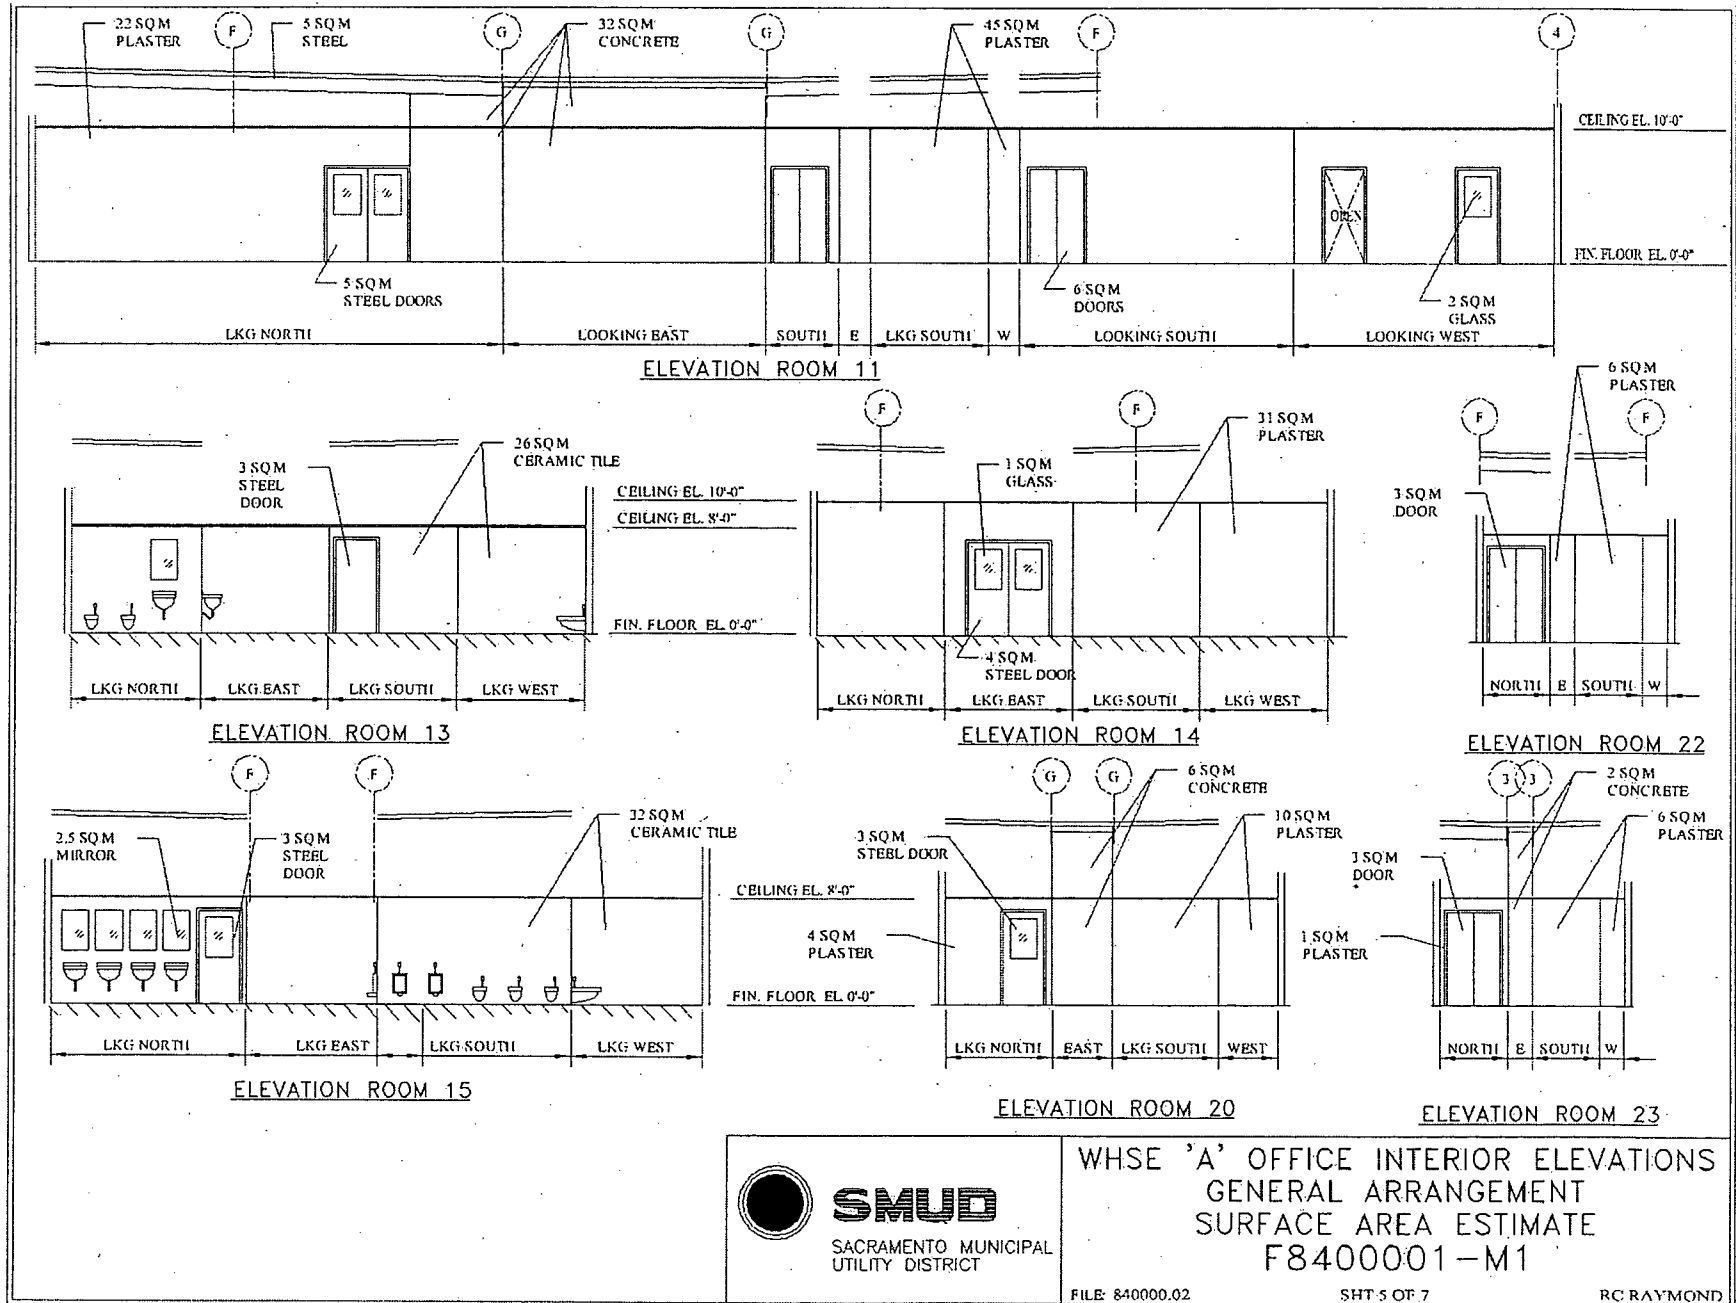
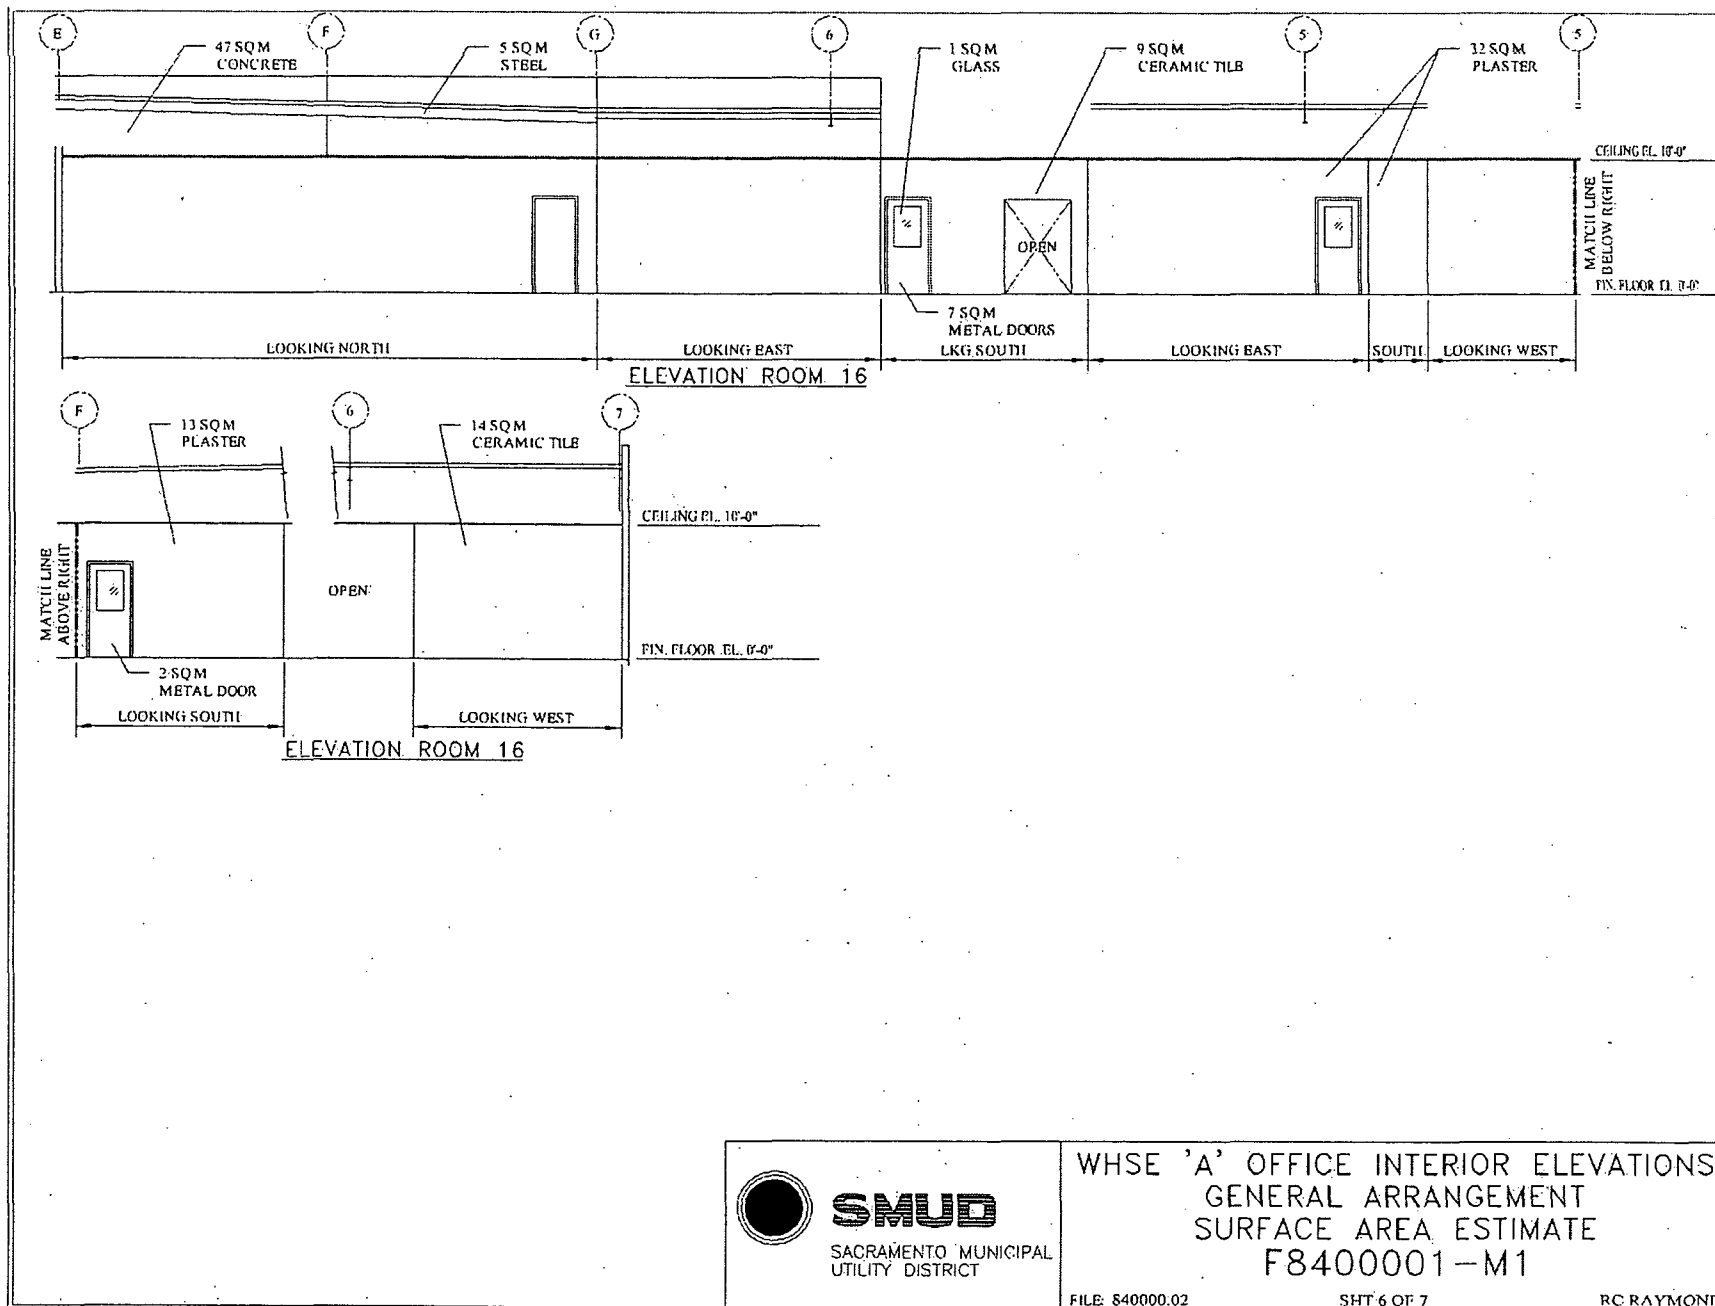
WHSE 'A' OFFICE INTERIOR ELEVATIONS  
GENERAL ARRANGEMENT  
SURFACE AREA ESTIMATE  
F8400001-M1

The Survey Unit Design Parameters are presented in Table 1 below. The survey unit and measurement locations are depicted on the maps in Attachment 1. Direct measurement locations were randomly determined and 234 m<sup>2</sup> were scanned for approximately 5% coverage. Samples of removable contamination were collected at each direct measurement location. The instrumentation used for the survey along with the MDC values are listed in Tables 2-1 and 2-2 in Attachment 2.
