**Rancho Seco**  
**Final Status Survey Summary Report**  
**October 31, 2007**  
**"A" Warehouse (interior)**  
**Survey Unit F8400001**

F8400001, "A" Warehouse (interior)

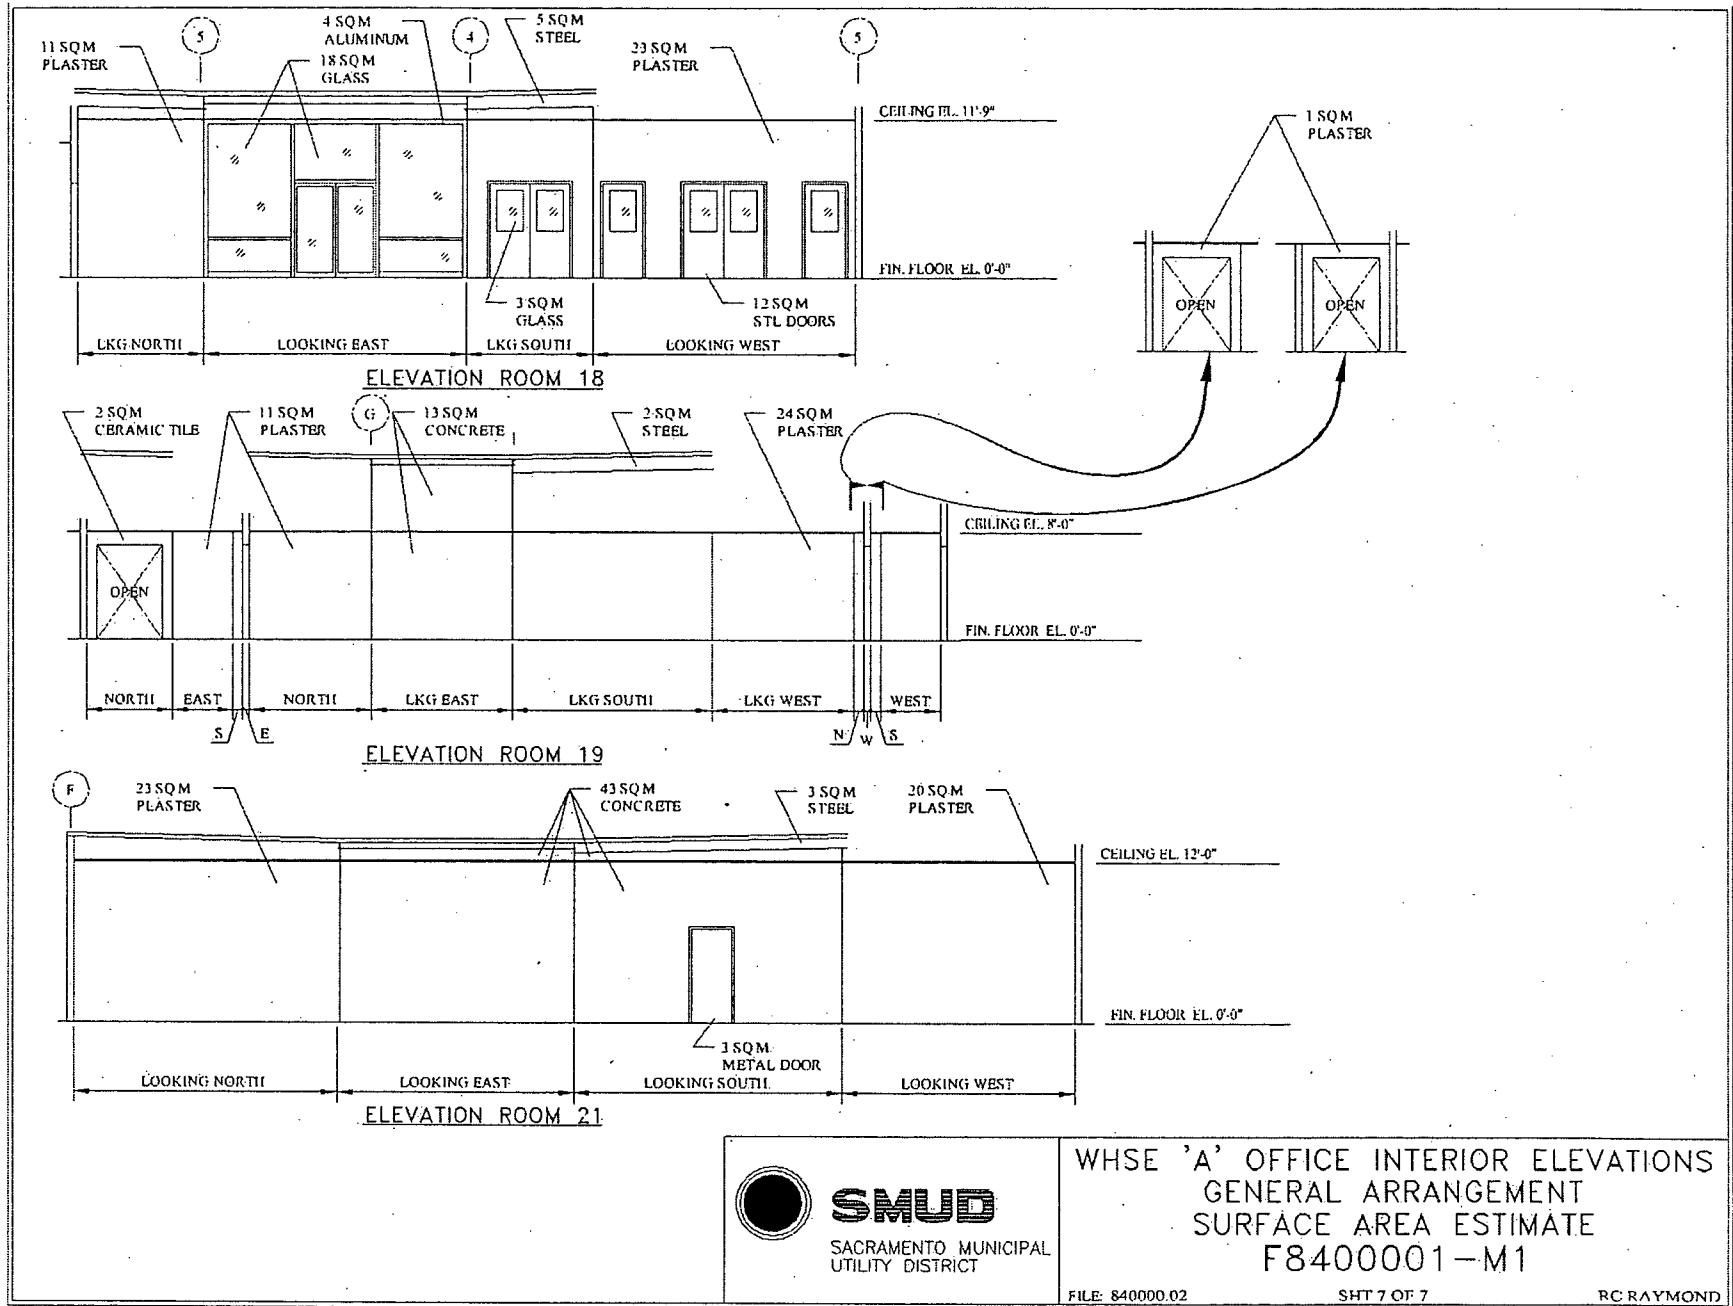
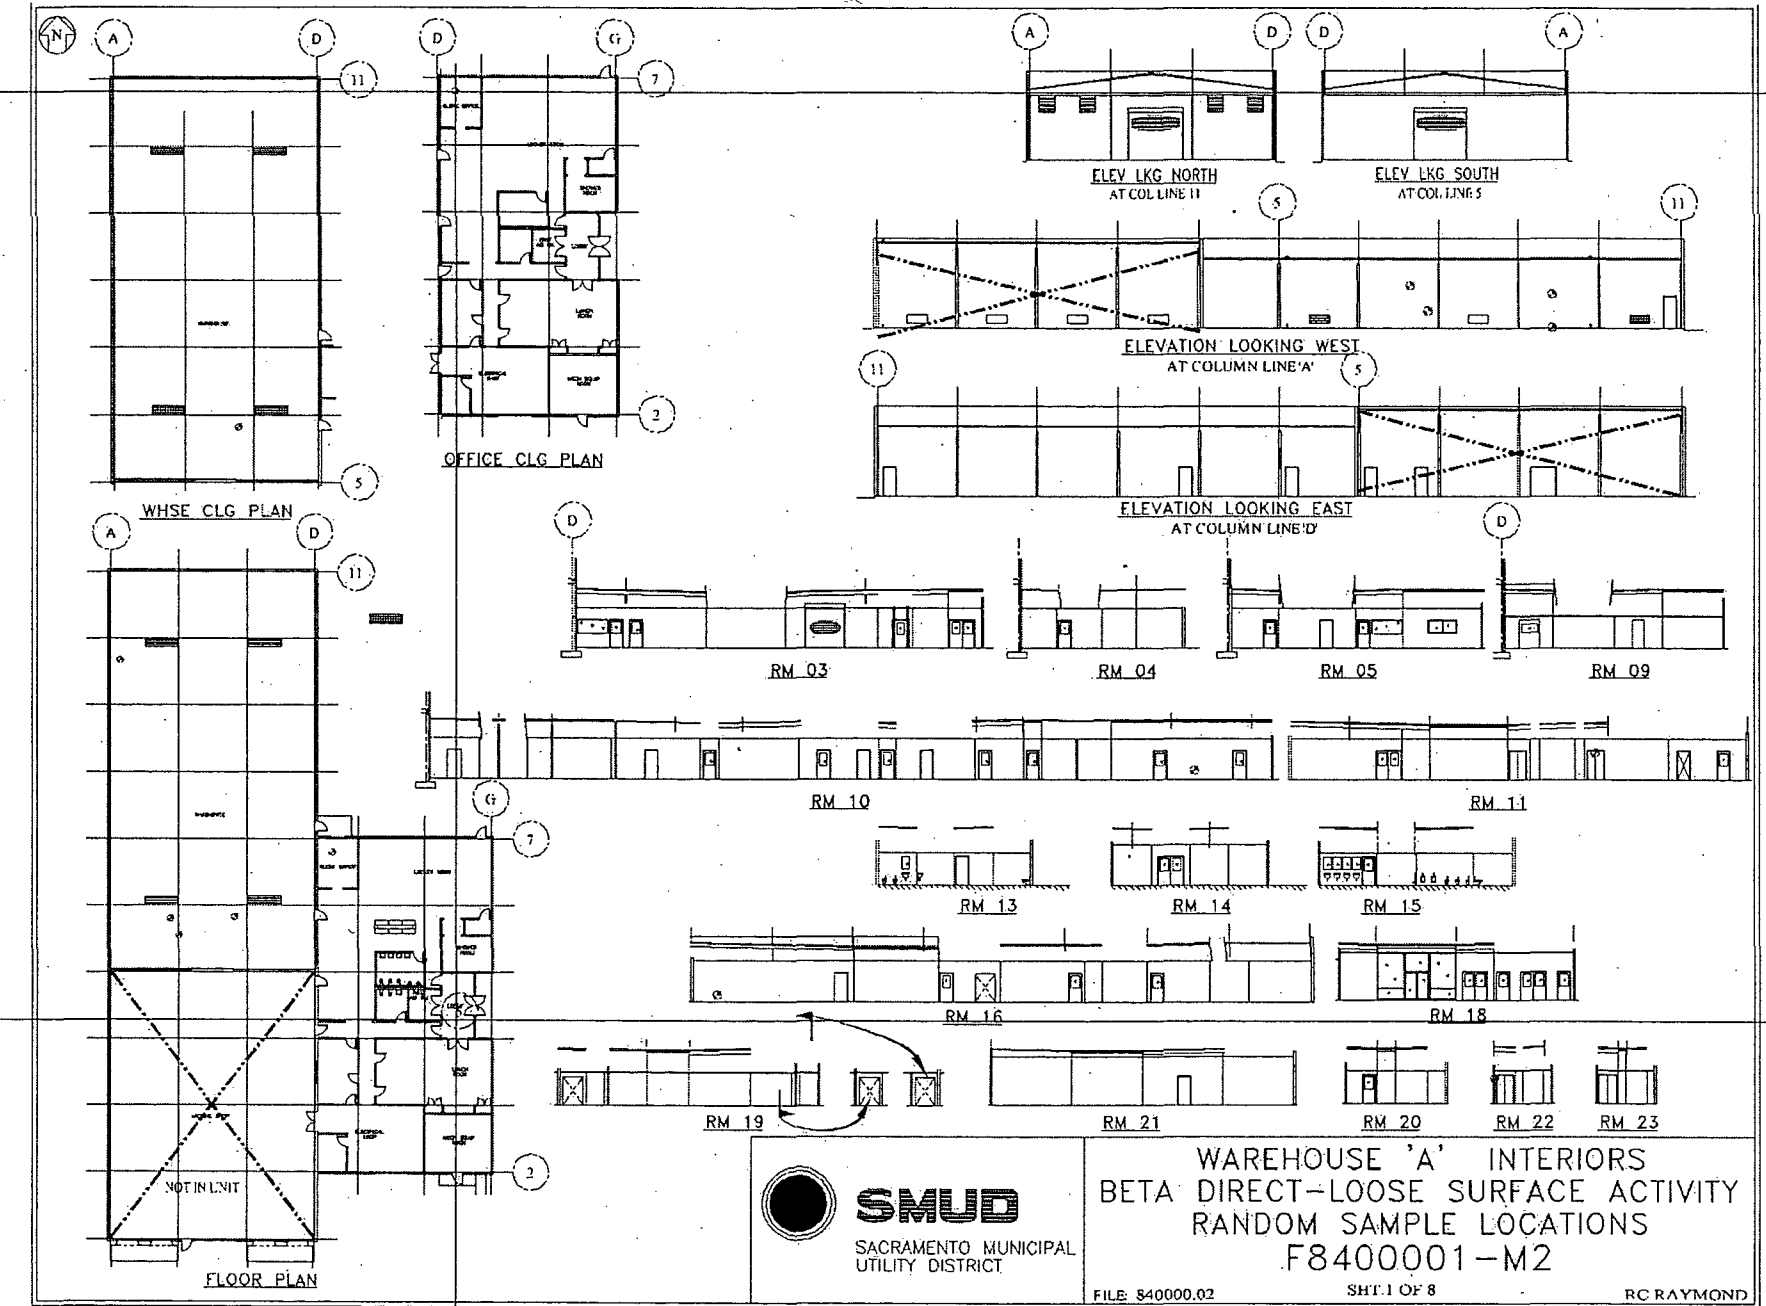
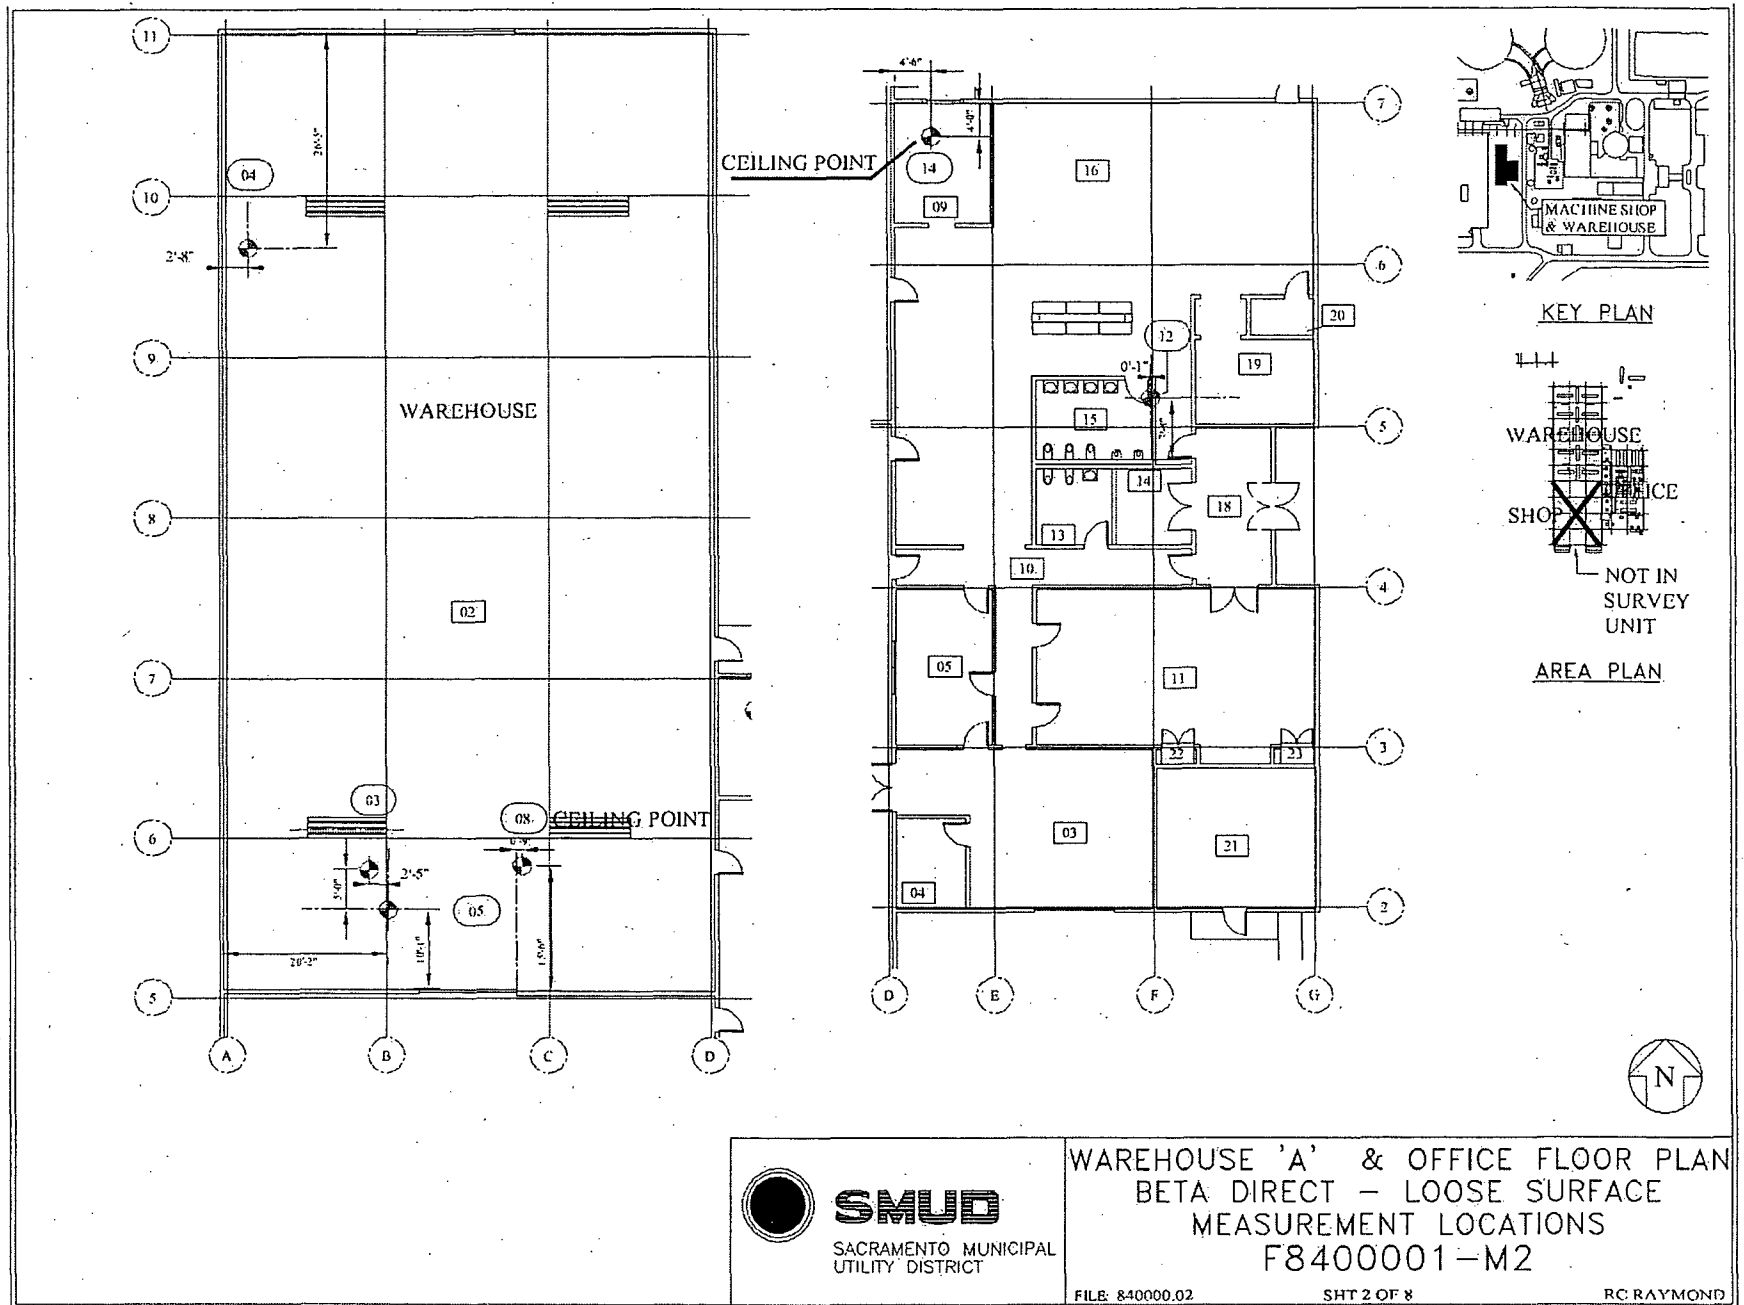
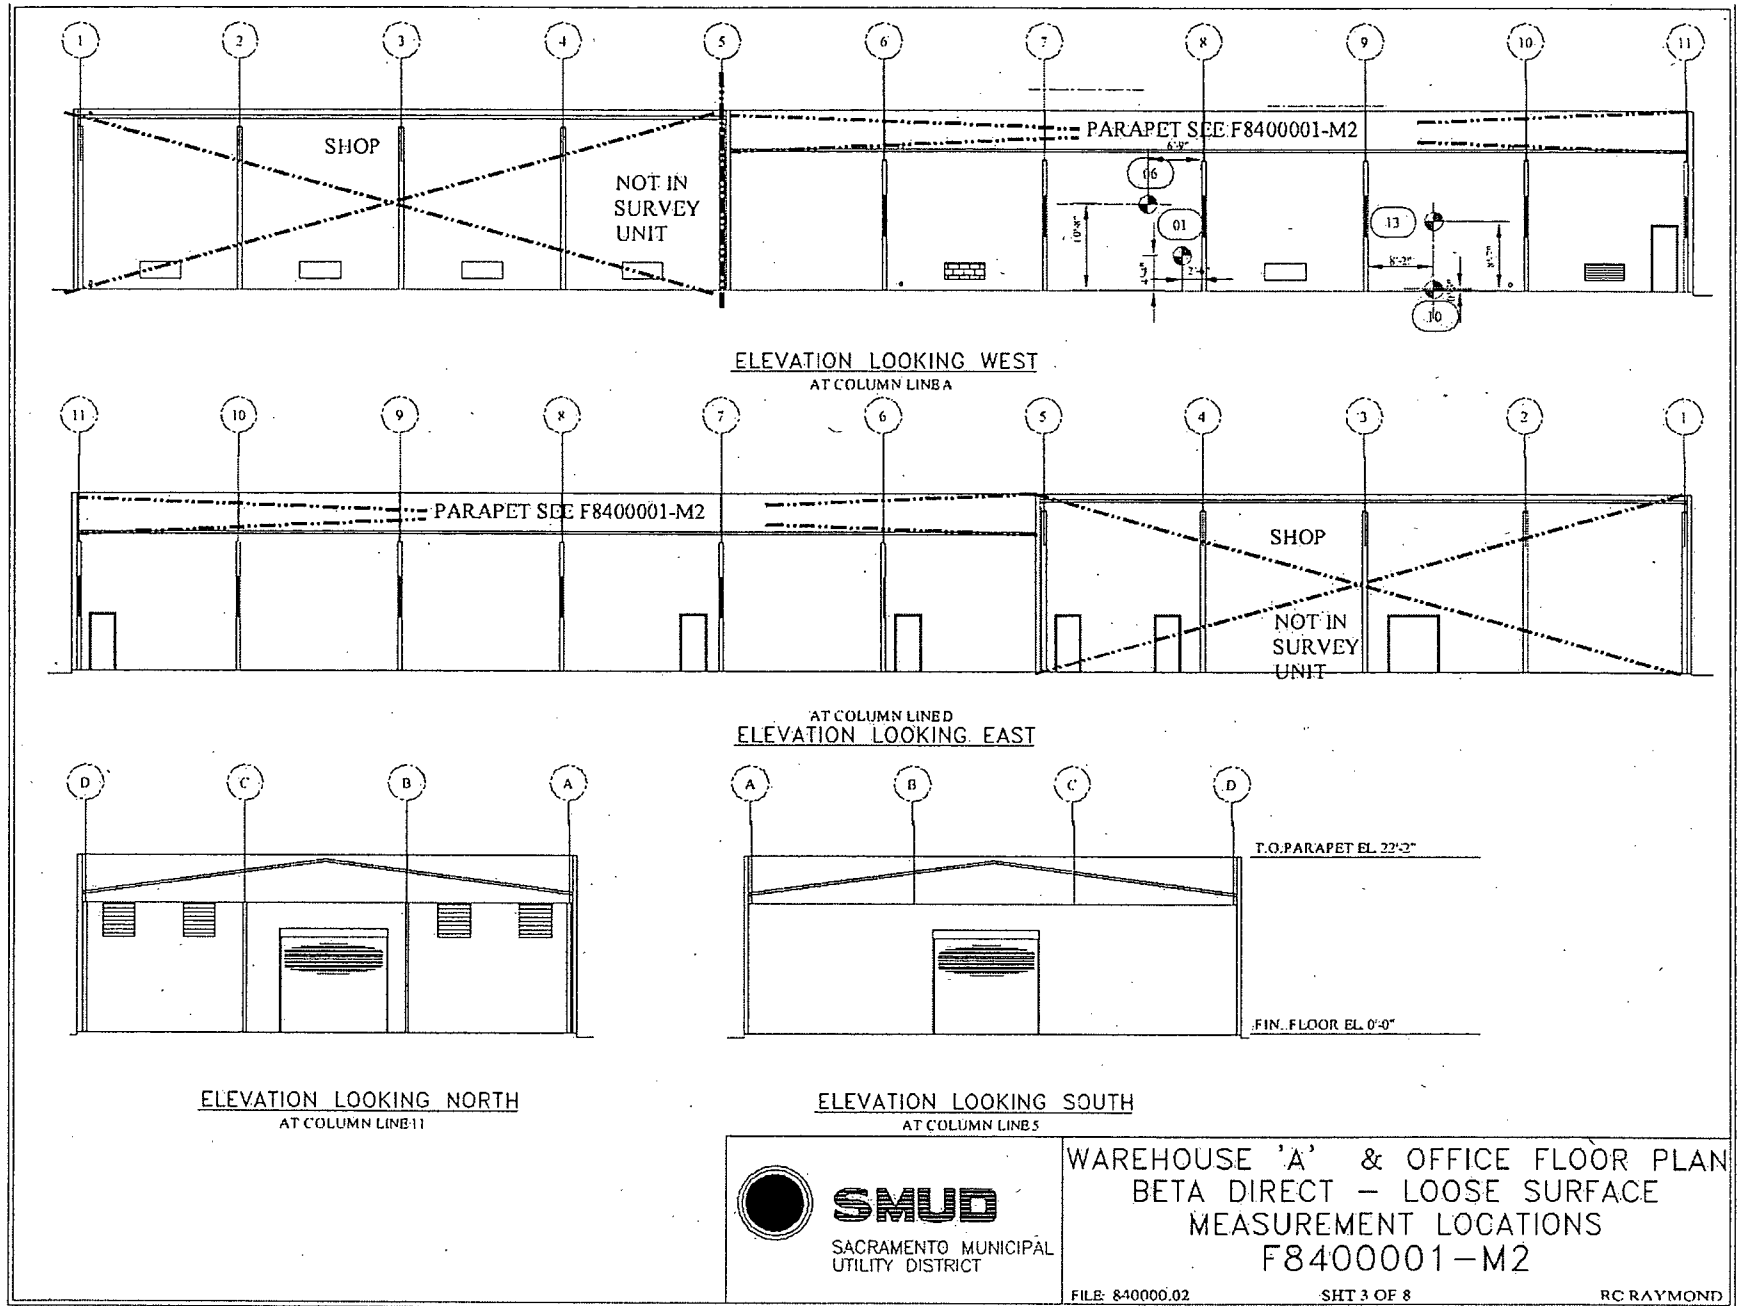
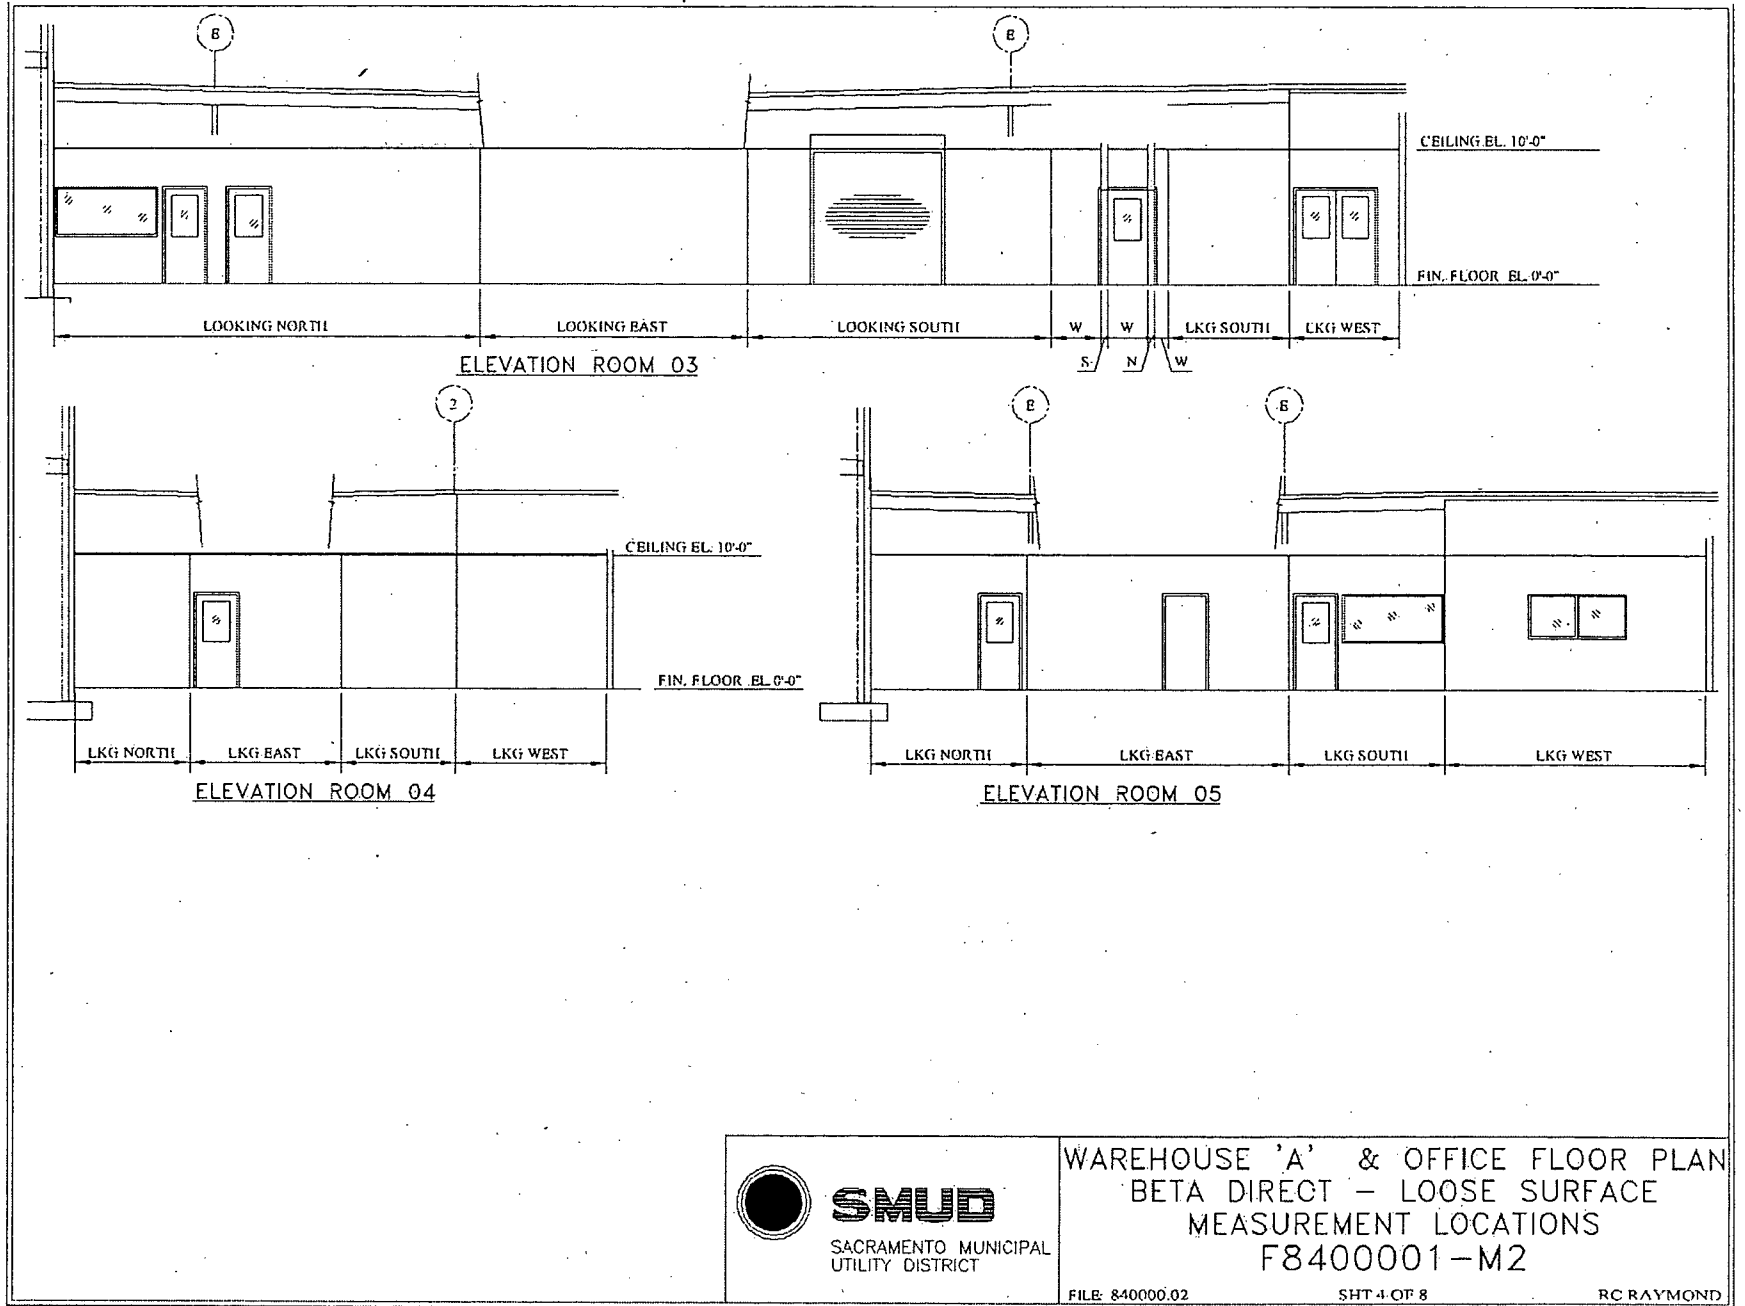
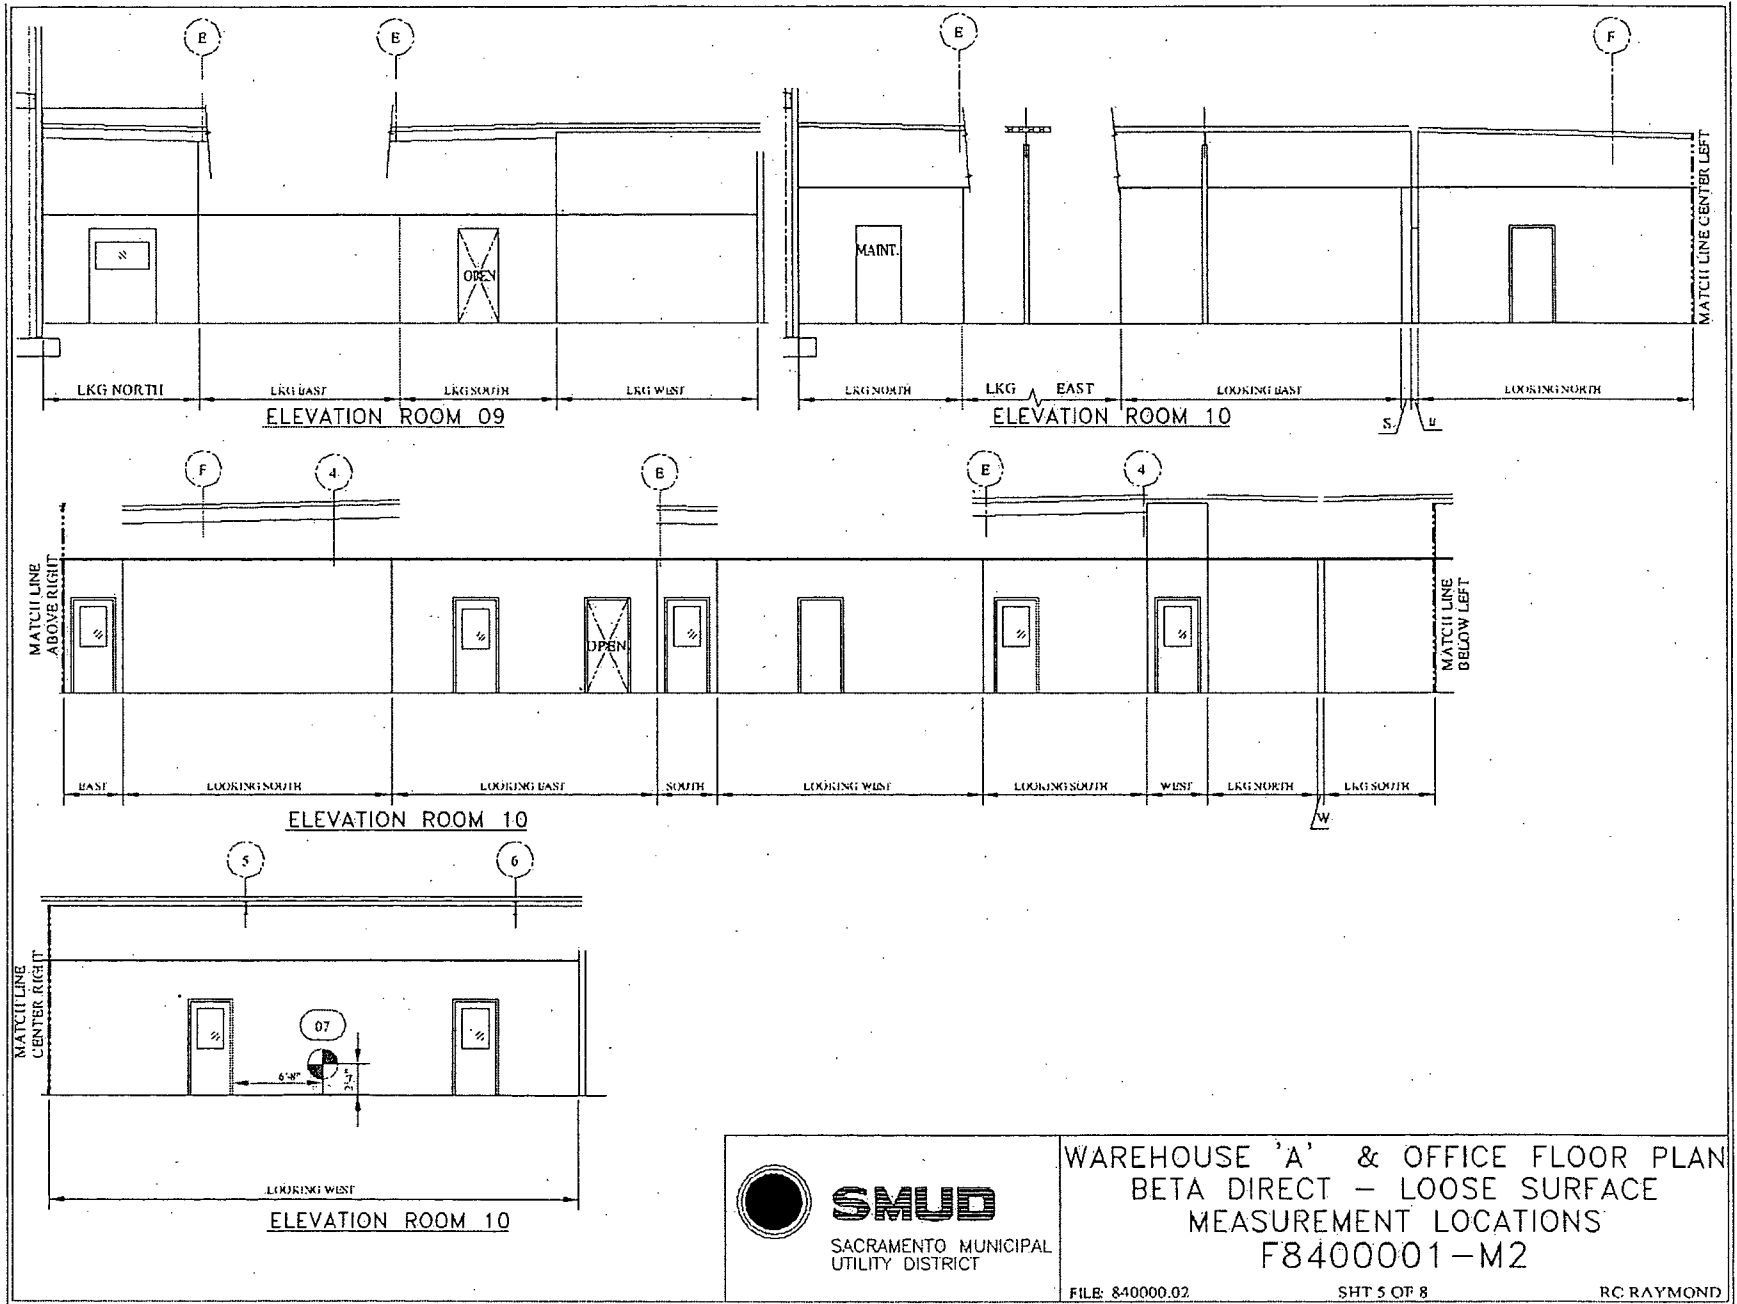
WHSE 'A' OFFICE INTERIOR ELEVATIONS  
BETA SCAN  
MEASUREMENT LOCATIONS  
F8400001-M3

A total of 14 direct measurements were made in F8400001. The results including mean, median, standard deviation and range are shown in Table 2. All direct measurements were less than the DCGL. None of the scan measurements indicated areas of elevated activity. Scan activity ranged from 2,123 to 6,573 dpm/100 cm<sup>2</sup>, based on a surveyor efficiency of 0.5 and no background subtracted. Samples for removable surface activity were all less than 10% of the DCGL as shown in Table 3. Removable surface activity samples were counted for alpha activity and none was detected at the MDC shown in Table 2-1 of Attachment 2.

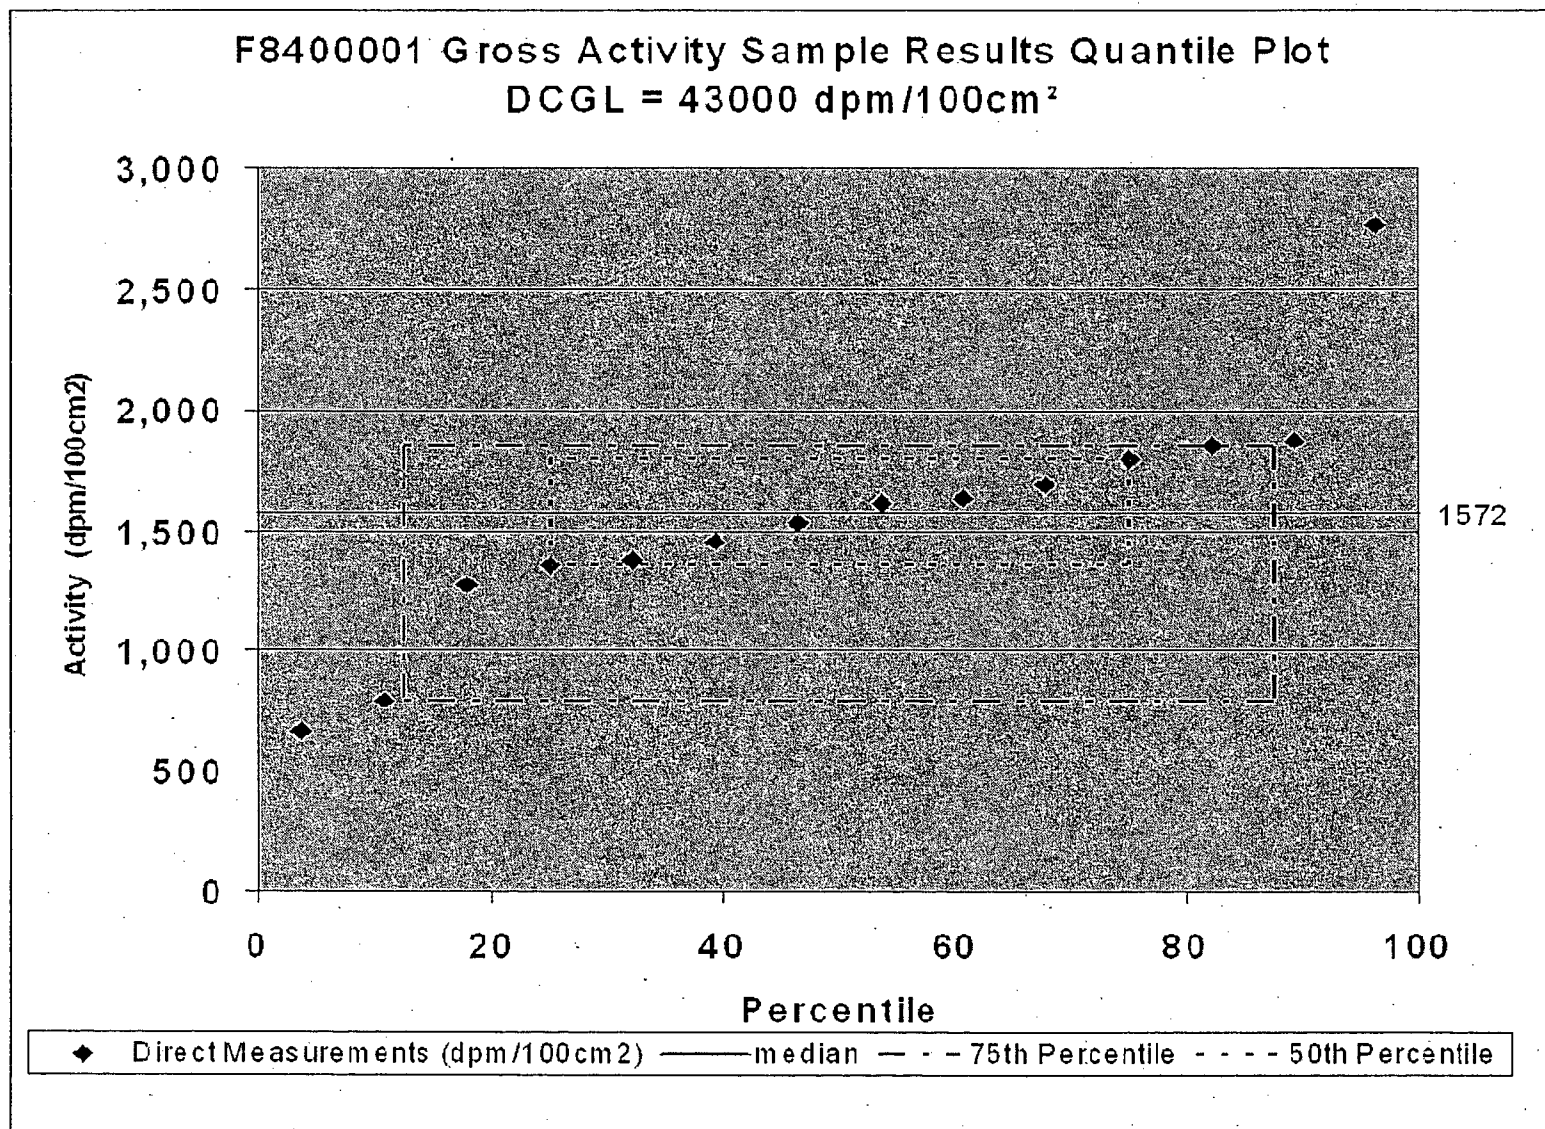
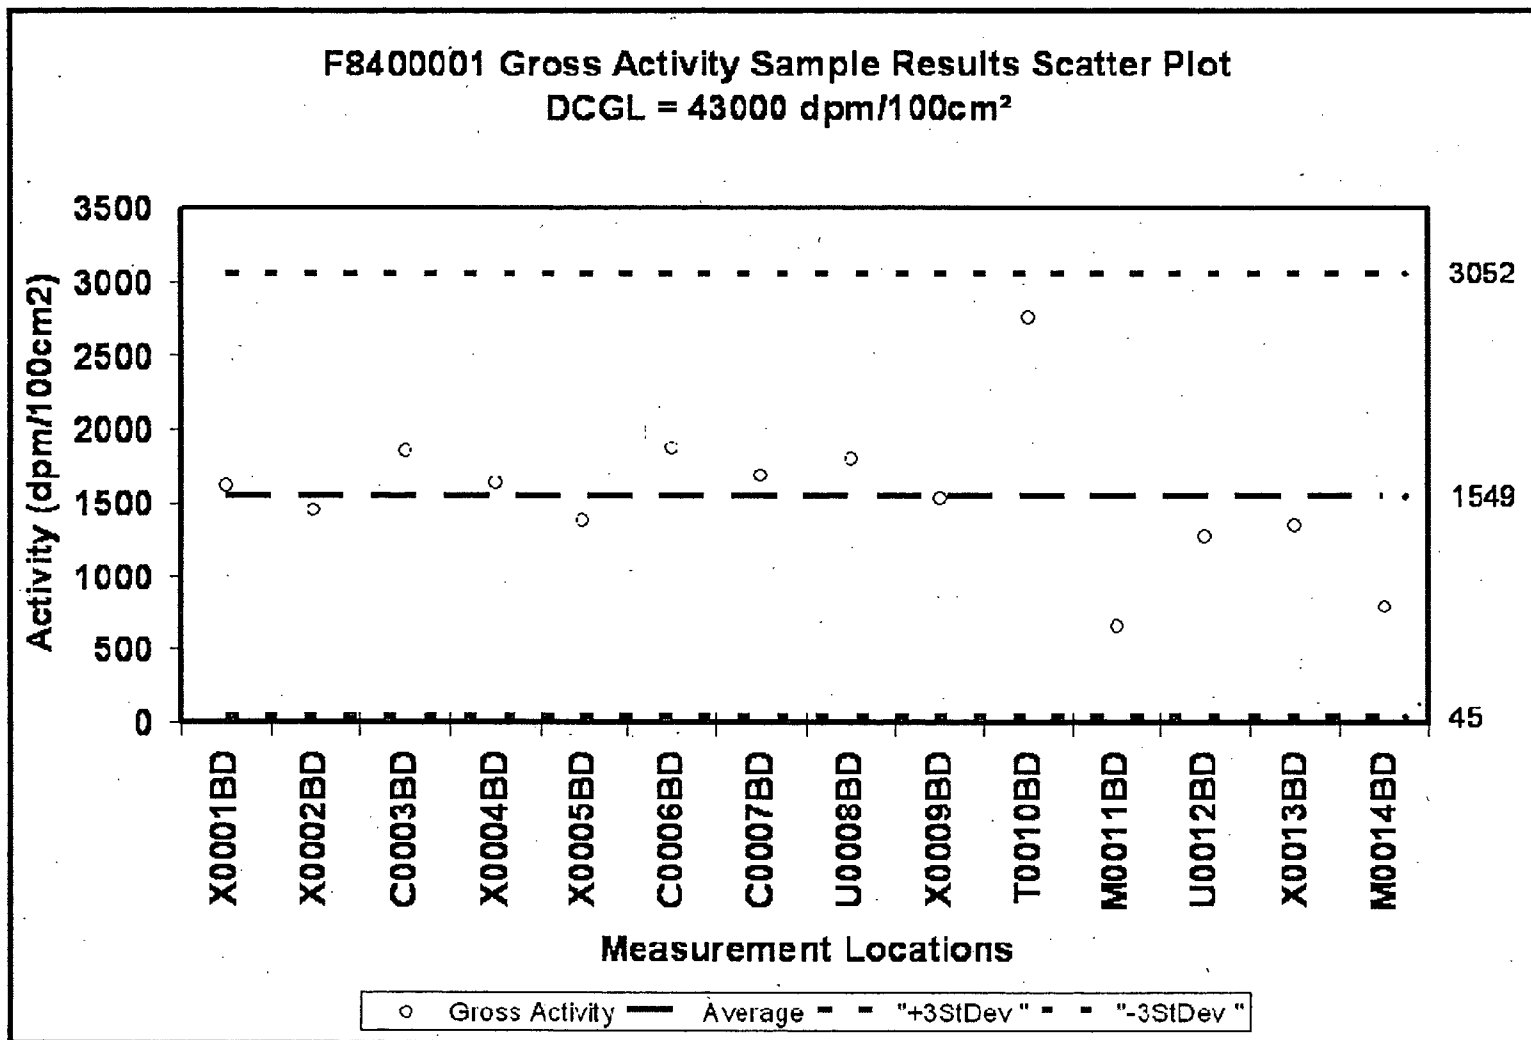
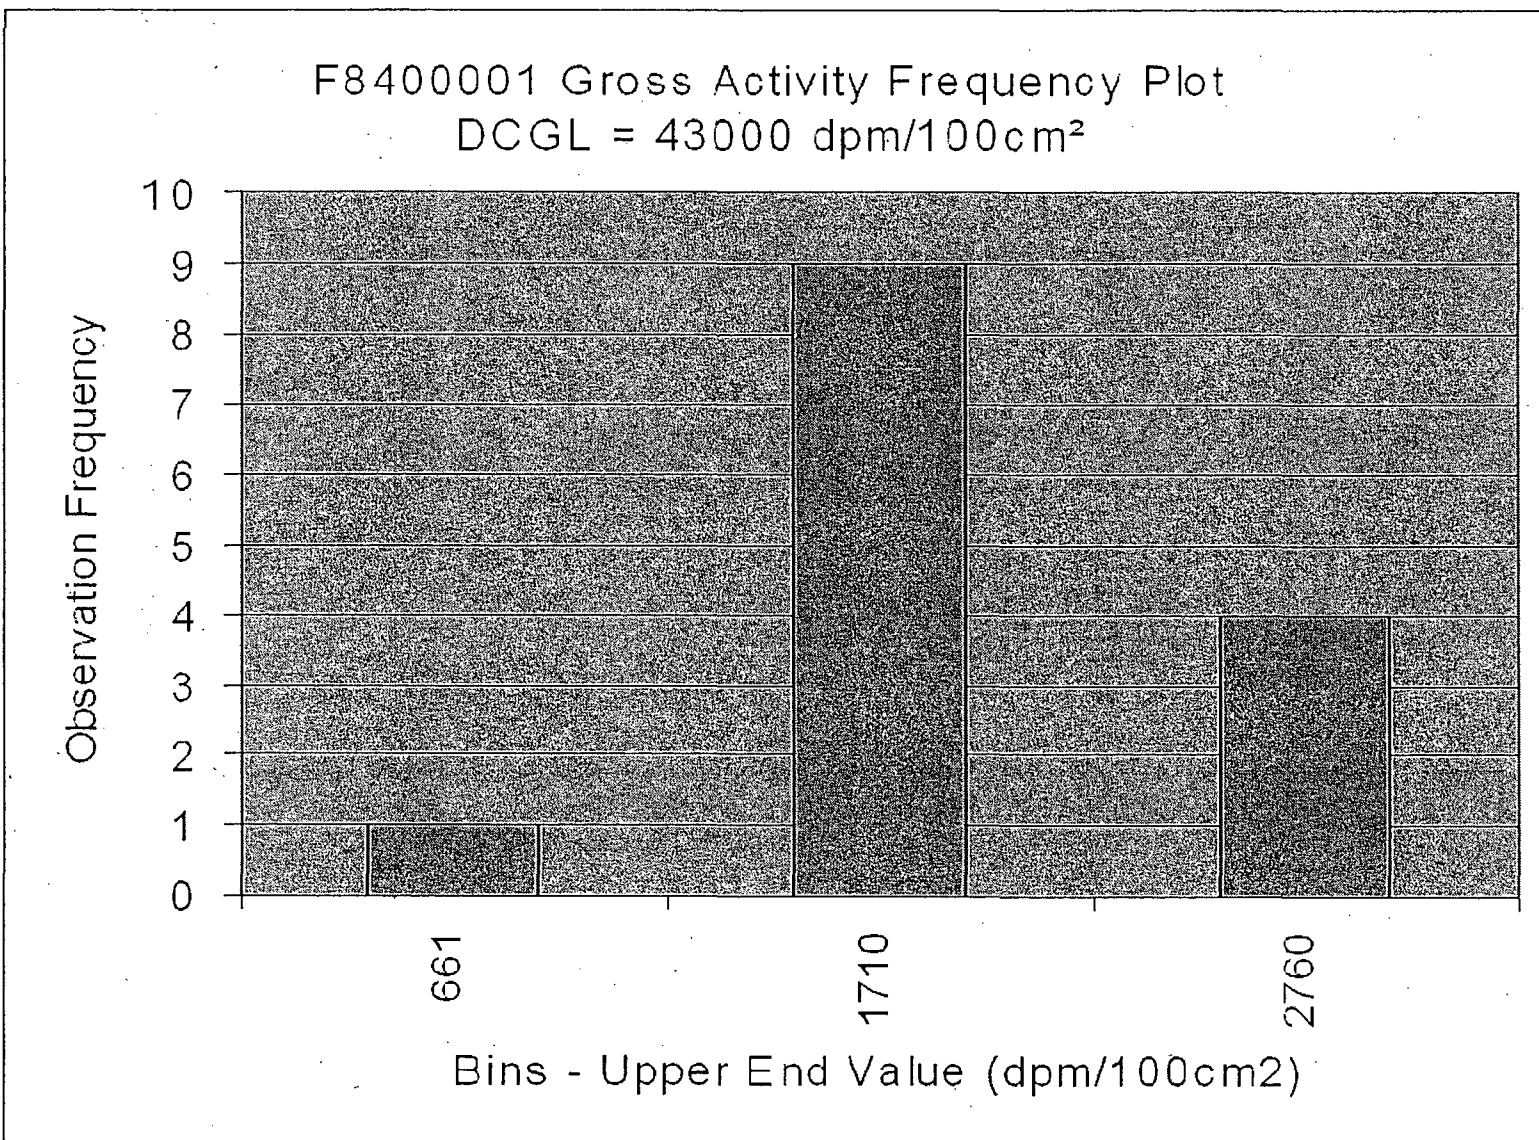
**Survey Unit F8400001**

The Survey Unit Design Parameters are presented in Table 1 below. The survey unit and measurement locations are depicted on the maps in Attachment 1. Direct measurement locations were randomly determined and 234 m<sup>2</sup> were scanned for approximately 5% coverage. Samples of removable contamination were collected at each direct measurement location. The instrumentation used for the survey along with the MDC values are listed in Tables 2-1 and 2-2 in Attachment 2.
