**Rancho Seco**  
**Final Status Survey Summary Report**  
**November 7, 2007**  
**Machine Shop (interior)**  
**Survey Unit F8520001**

F8520001, Machine Shop (interior)

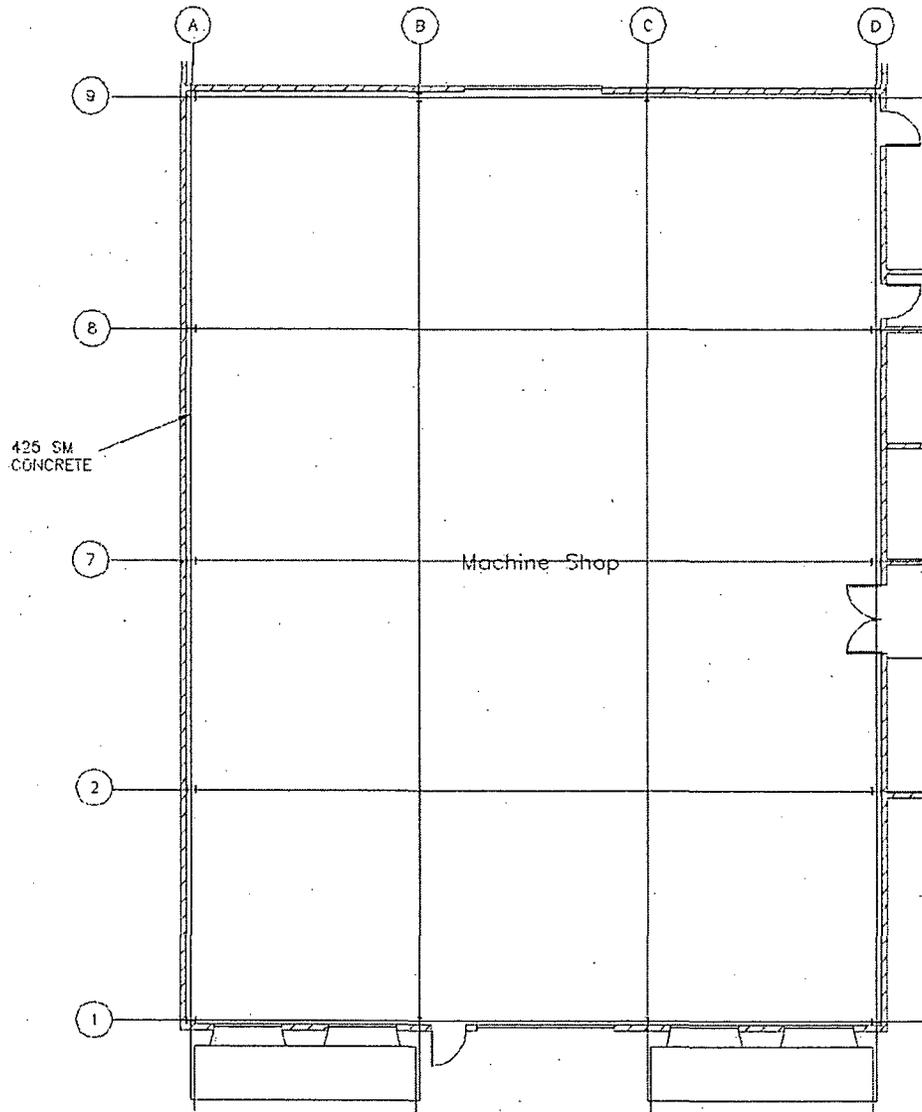
MACHINE SHOP FLOOR PLAN  
 BETA DIRECT/LOOSE SURFACE  
 ACTIVITY MEASUREMENT LOCATIONS  
 F8520001-M1

The Survey Unit Design Parameters are presented in Table 1 below. The survey unit and measurement locations are depicted on the maps in Attachment 1. Direct measurement locations were randomly determined and 141.1 m<sup>2</sup> were scanned for approximately 10% coverage. Samples of removable contamination were collected at each direct measurement location. The instrumentation used for the survey along with the MDC values are listed in Tables 2-1 and 2-2 in Attachment 2.

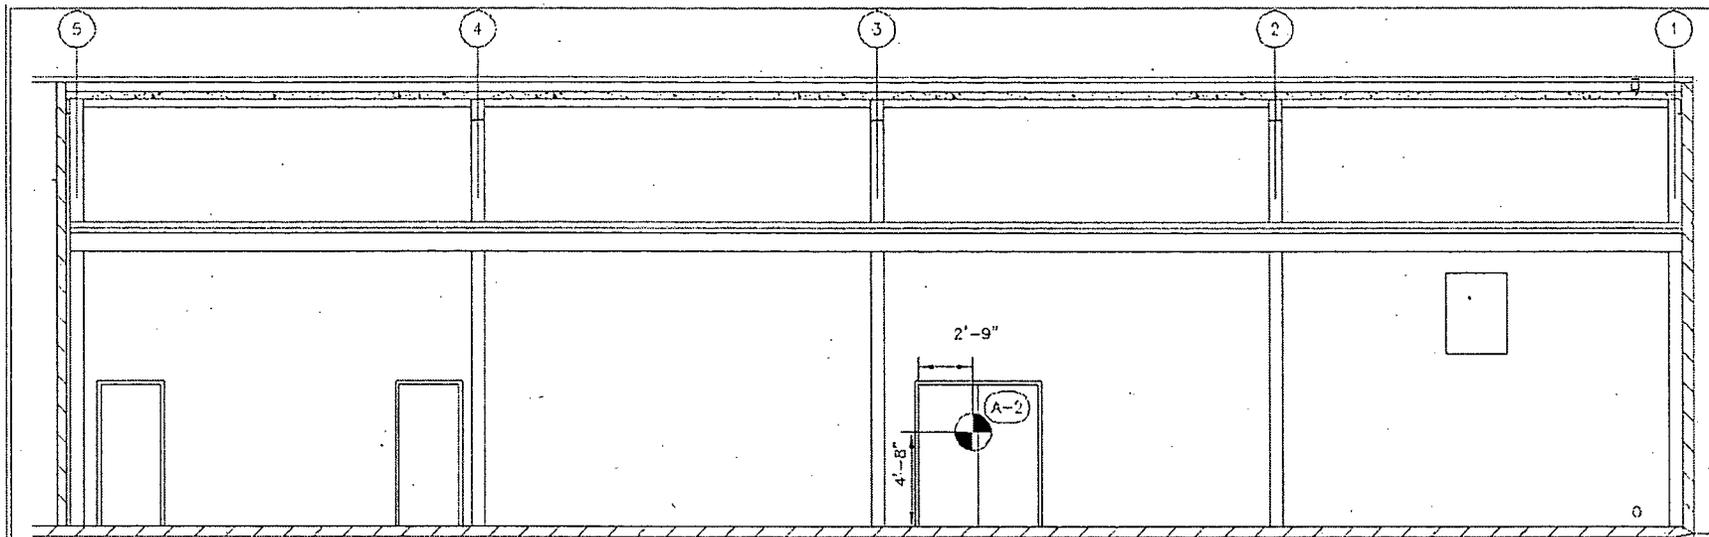
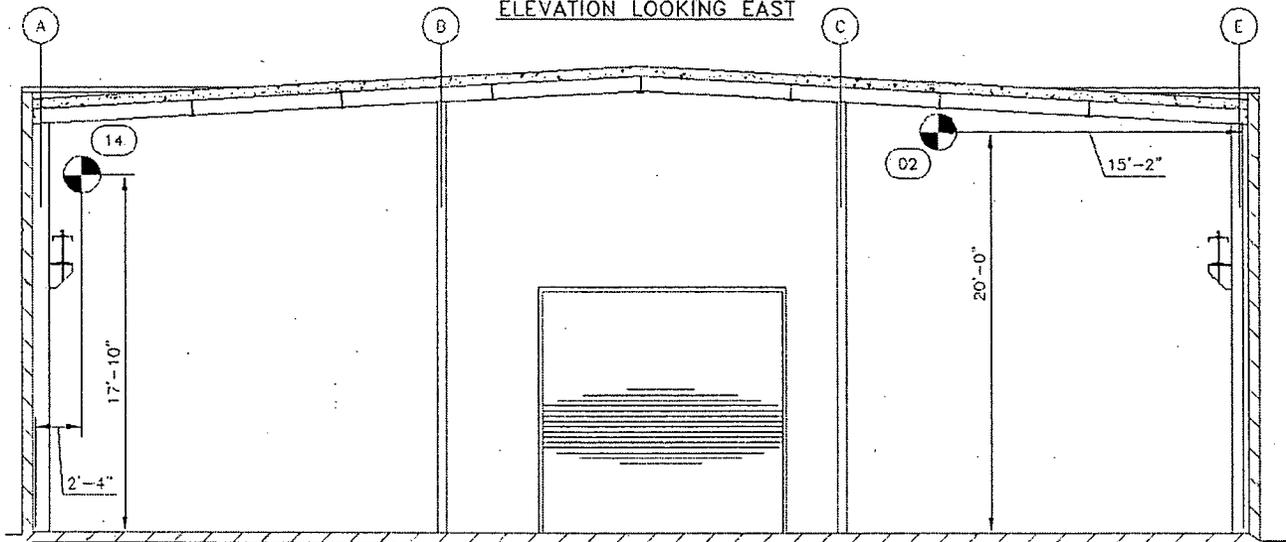
MACHINE SHOP FLOOR PLAN  
BETA DIRECT/LOOSE SURFACE  
ACTIVITY MEASUREMENT LOCATIONS  
F8520001-M2

ELEVATION LOOKING EAST

ELEVATION LOOKING NORTH

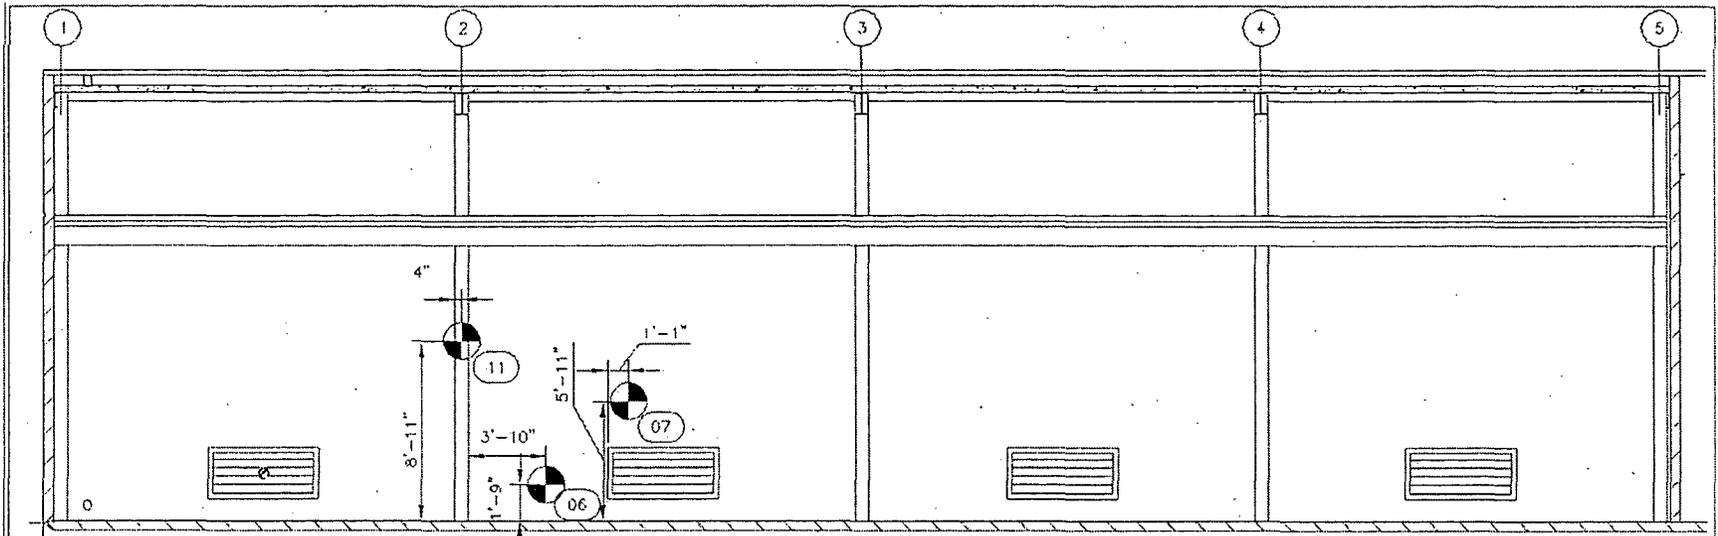
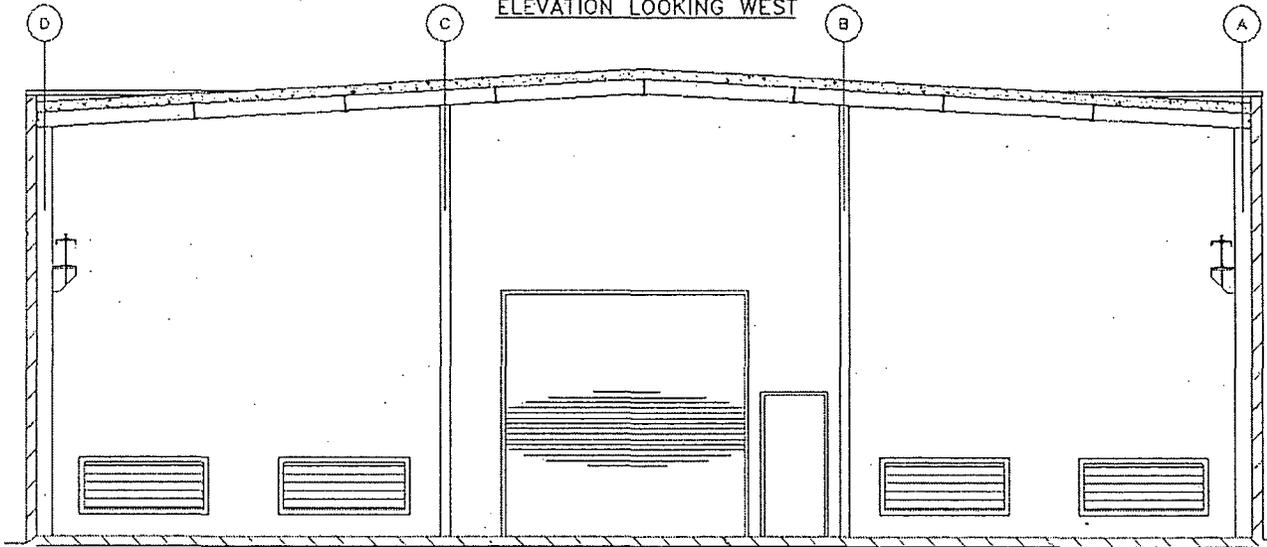
MACHINE SHOP FLOOR PLAN  
 BETA DIRECT/LOOSE SURFACE  
 ACTIVITY MEASUREMENT LOCATIONS  
 F8520001-M2

ELEVATION LOOKING WEST

ELEVATION LOOKING SOUTH

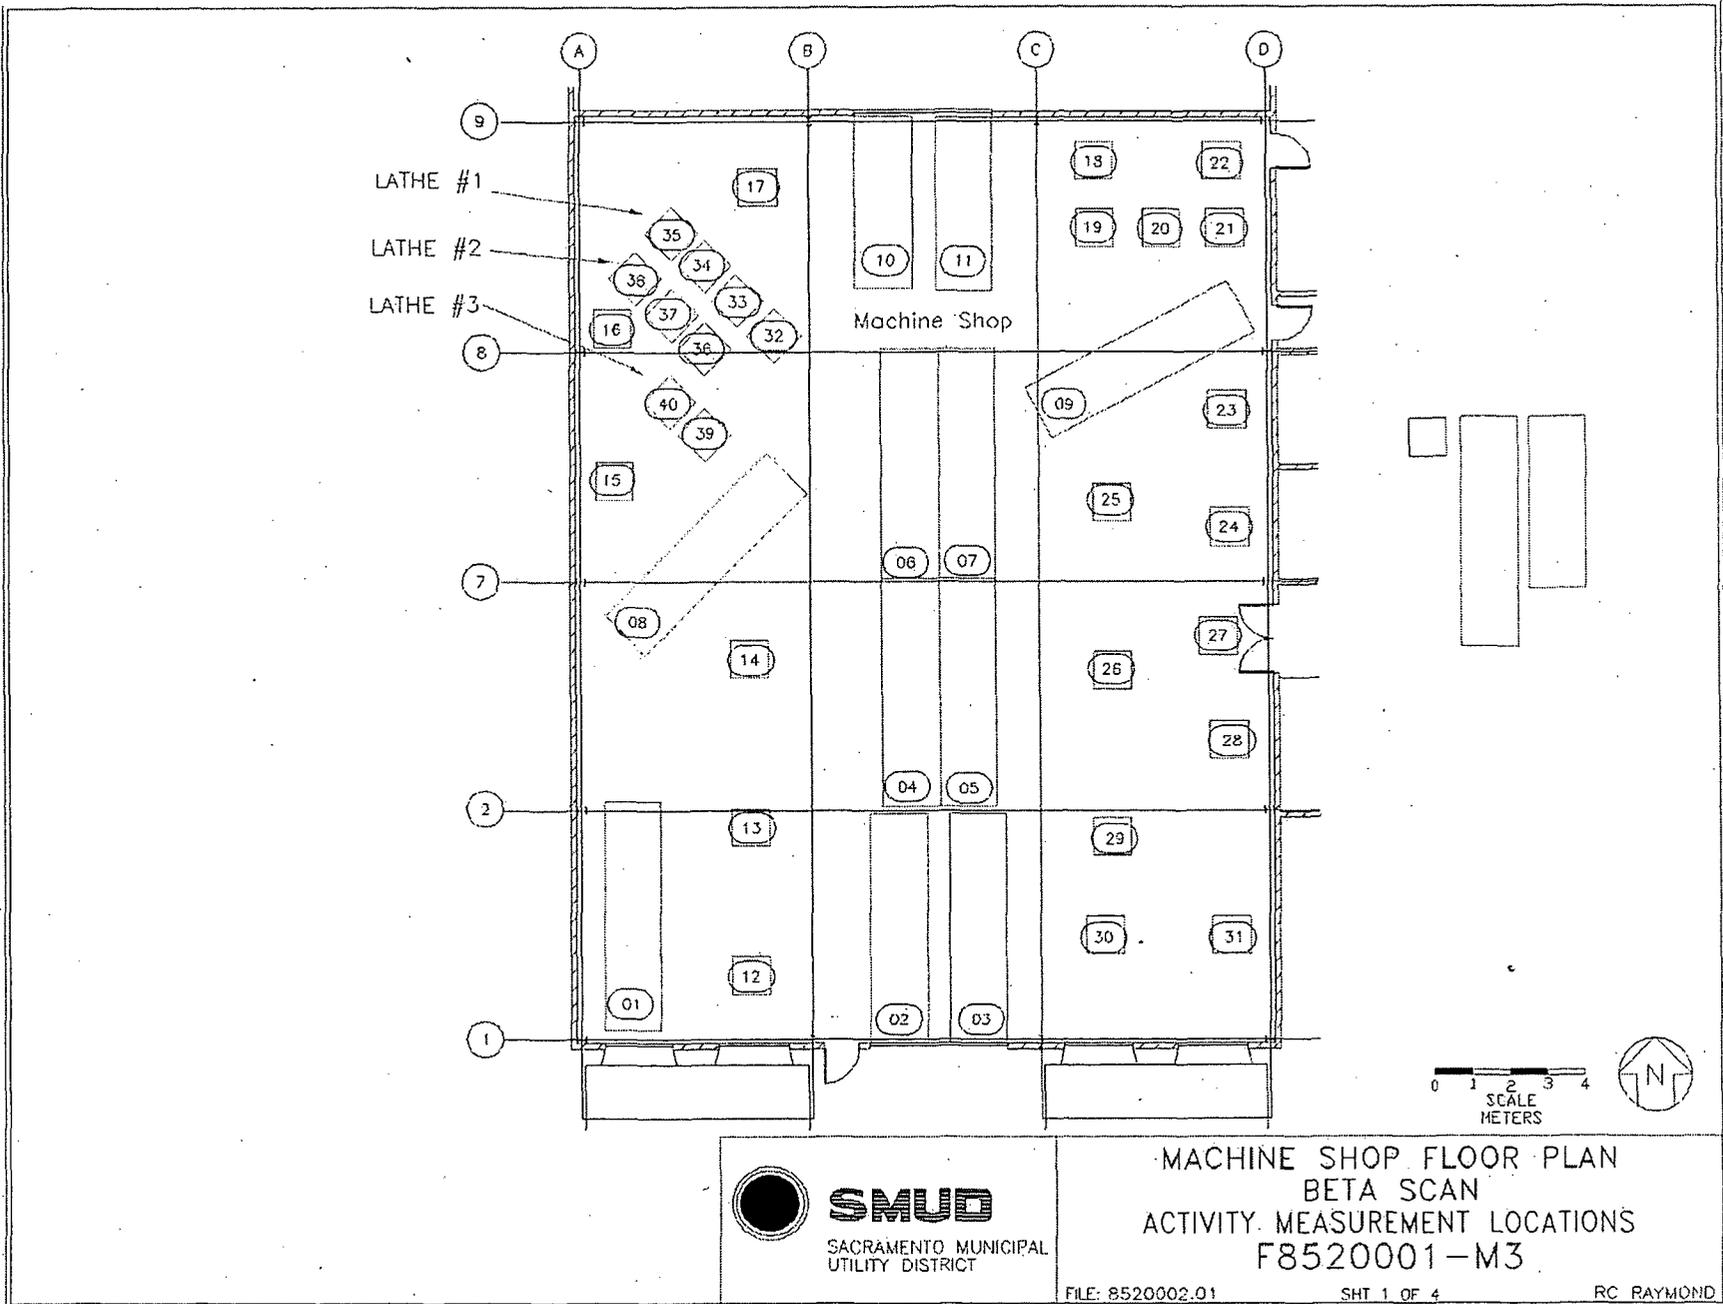
MACHINE SHOP FLOOR PLAN  
BETA SCAN  
ACTIVITY MEASUREMENT LOCATIONS  
F8520001-M3

A total of 14 direct measurements were made in F8520001. The results including mean, median, standard deviation and range are shown in Table 2. All direct measurements were less than the DCGL. None of the scan measurements indicated areas of elevated activity. Scan activity ranged from 1992 to 7285 dpm/100 cm<sup>2</sup>, based on a surveyor efficiency of 0.5 and no background subtracted. Samples for removable surface activity were all less than 10% of the DCGL as shown in Table 3. Removable surface activity samples were counted for alpha activity and none was detected at the MDC shown in Table 2-1 of Attachment 2.

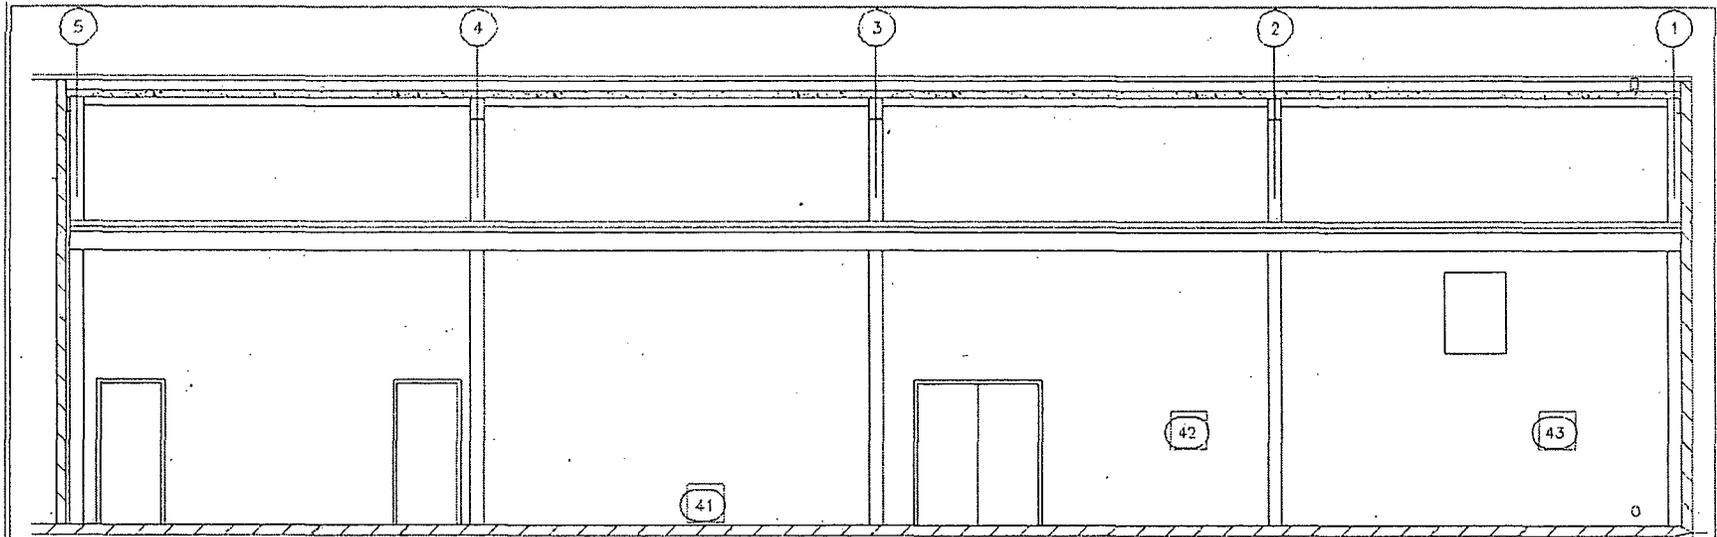
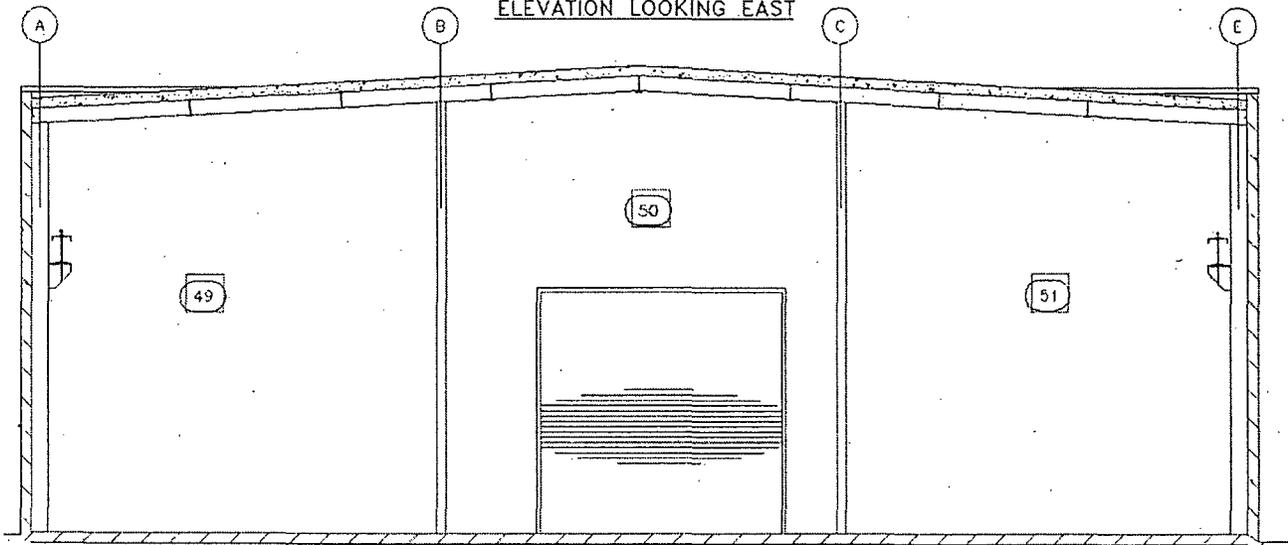
MACHINE SHOP INTERIOR WALL ELEV.S  
 BETA SCAN  
 MEASUREMENT LOCATIONS  
 F8520001-M3

ELEVATION LOOKING EAST

ELEVATION LOOKING NORTH
