Rancho Seco

Final Status Survey Summary Report

Aux. Bldg (-) 20' El., Rm 47, Spent Resin Tank Room

Survey Unit F8130651

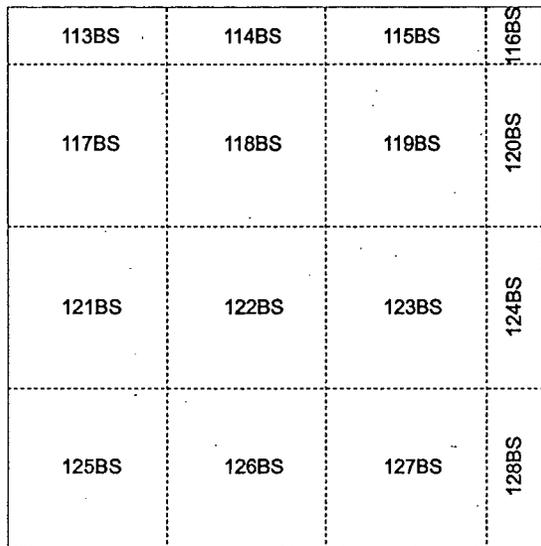
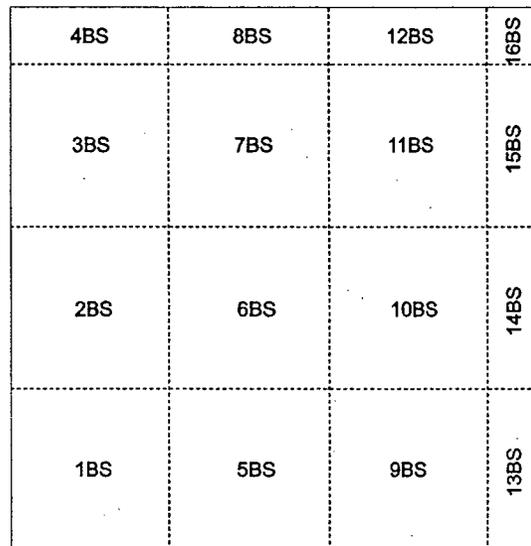
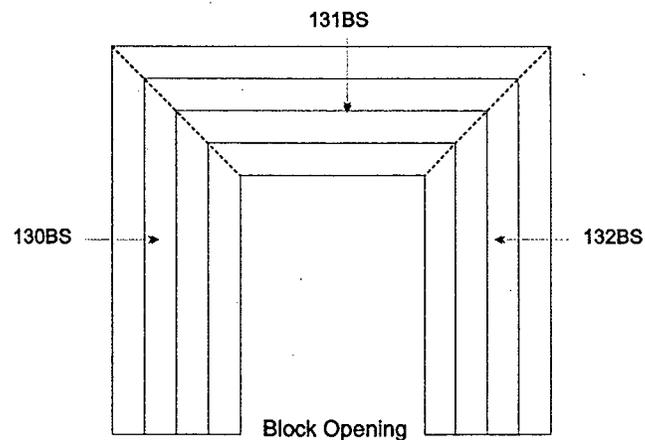
Map F8130651-8, Auxiliary Building -20' El.
Rm 47, Spent Resin Tank Room Floor and Ceiling
Beta Scan Measurements
F8130651M0001BS to F8130651M0016BS and
F8130651C0113BS to F8130651C0132BS

Floor

Ceiling
