Rancho Seco

Final Status Survey Summary Report

Aux. Bldg (-) 20' El., Rm 48, Crud Tank Room

Survey Unit F8130661

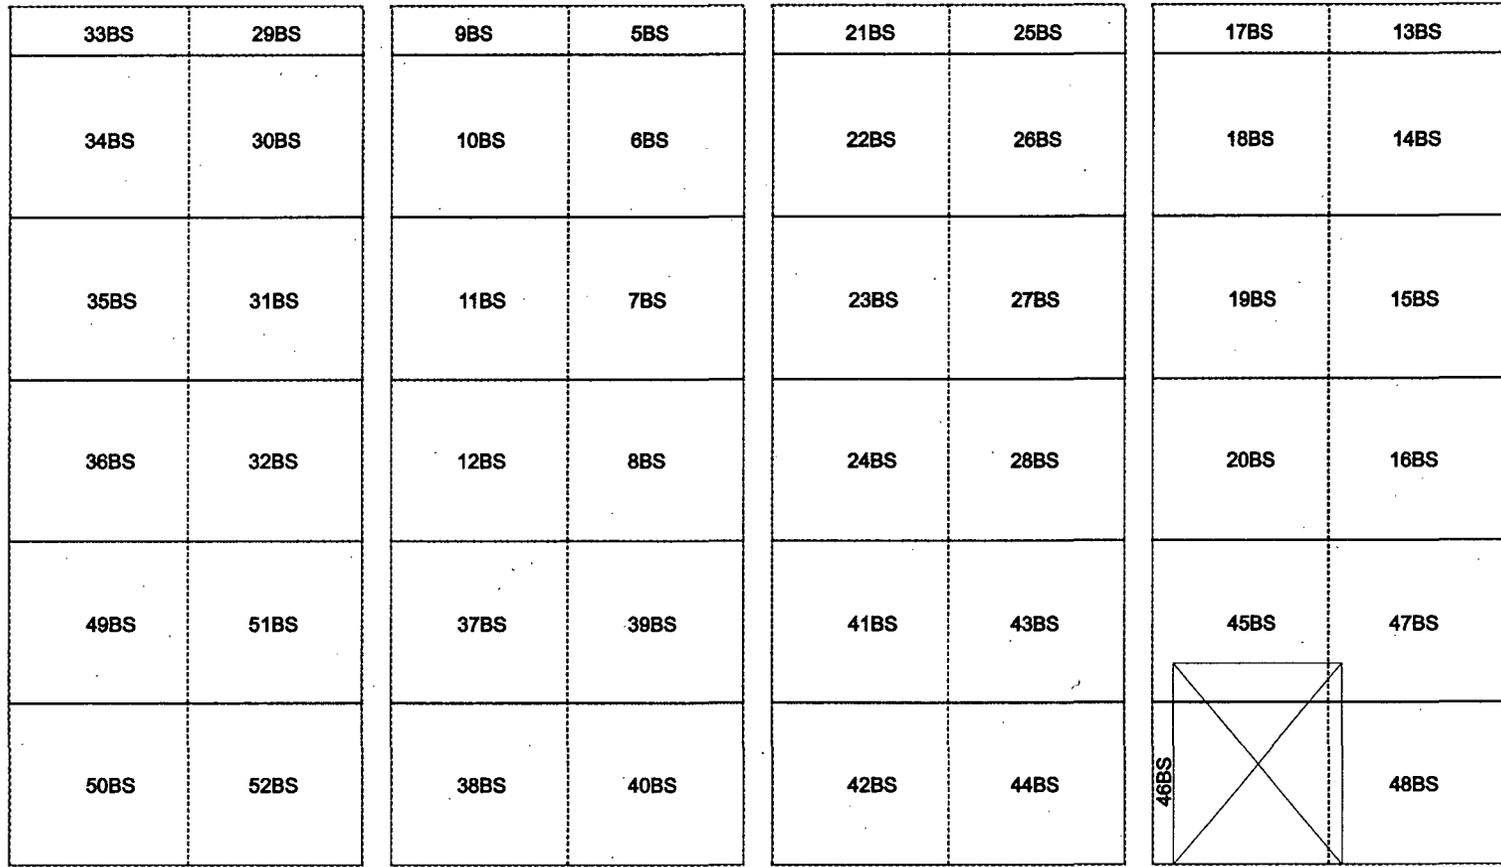
Map F8130661-9, Auxiliary Building -20' El.
Rm 48, Crud Tank Room All Walls
Beta Scan Measurements
F8130661C0005BS to F8130661C0052BS

North Wall

East Wall

South Wall

West Wall
