Rancho Seco  
Final Status Survey Summary Report  
November 4, 2007  
Aux. Bldg (-) 20' El, Rm 45, NE Corridor  
Survey Unit F8130631

## FINAL STATUS SURVEY SUMMARY REPORT

F8130631, Aux. Bldg (-) 20' El, Rm 45, NE Corridor

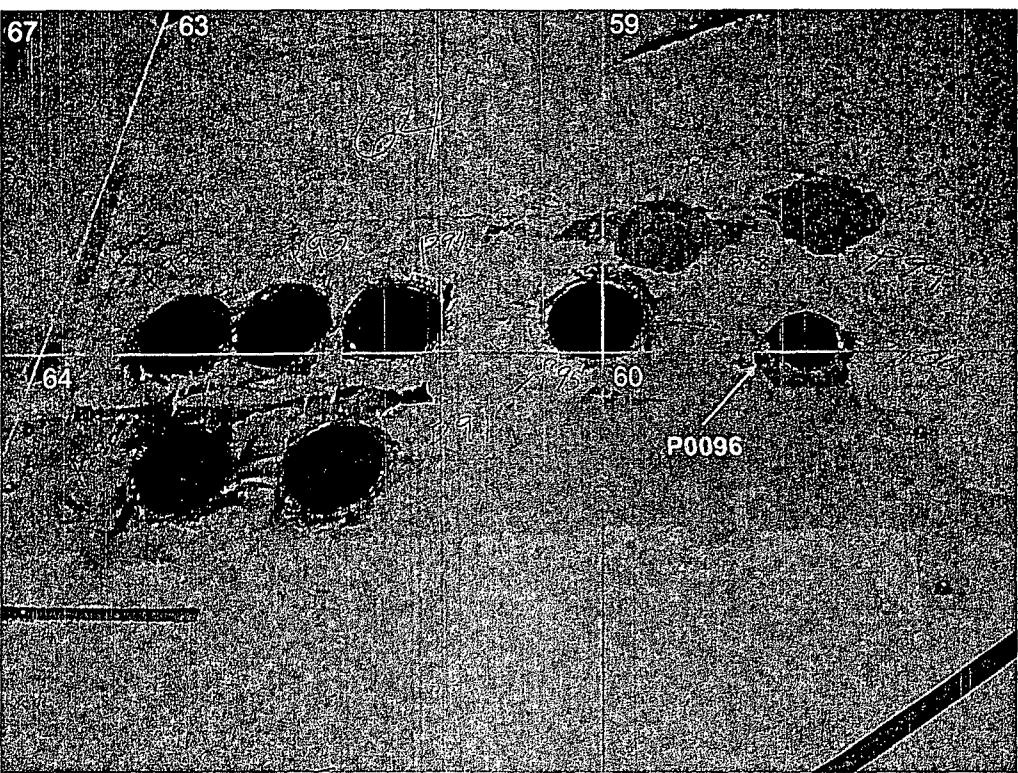
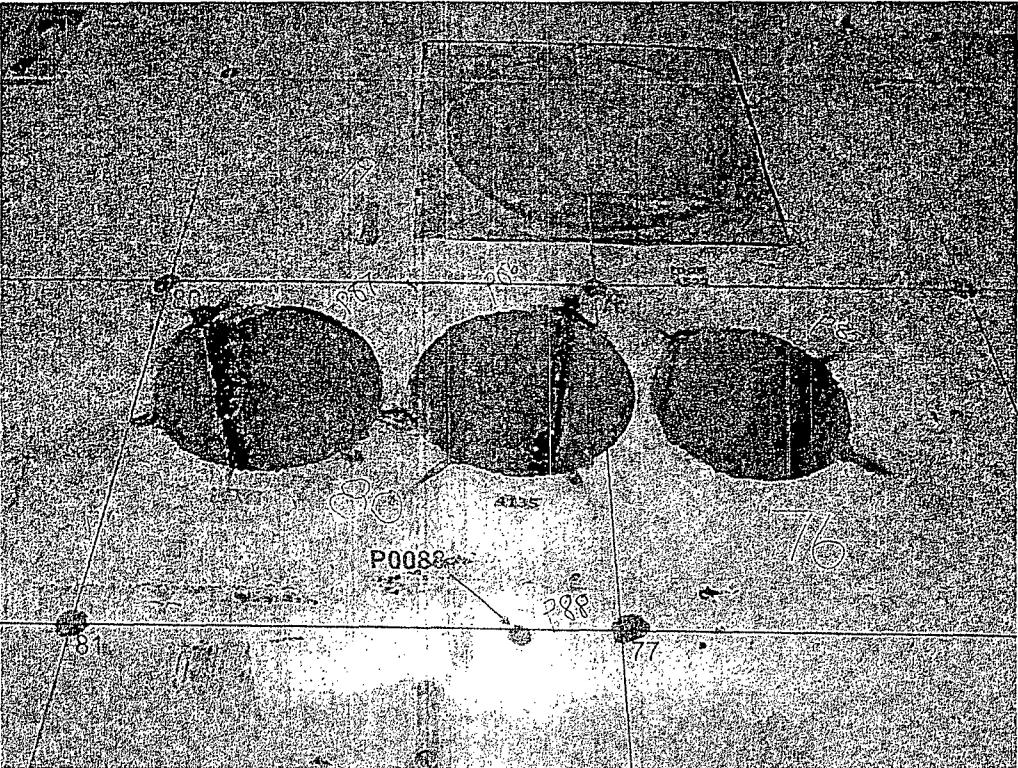
Aux. Bldg -20' El, Rm 43, NE Corridor  
Penetrations-1

Six investigations (penetrations P0061, P0062, P0063, P0064, P0076 and P0068) were required for the scan measurements and the results are reported in Attachment 3. The EMC unity rule was not exceeded as shown in Table 3-1.

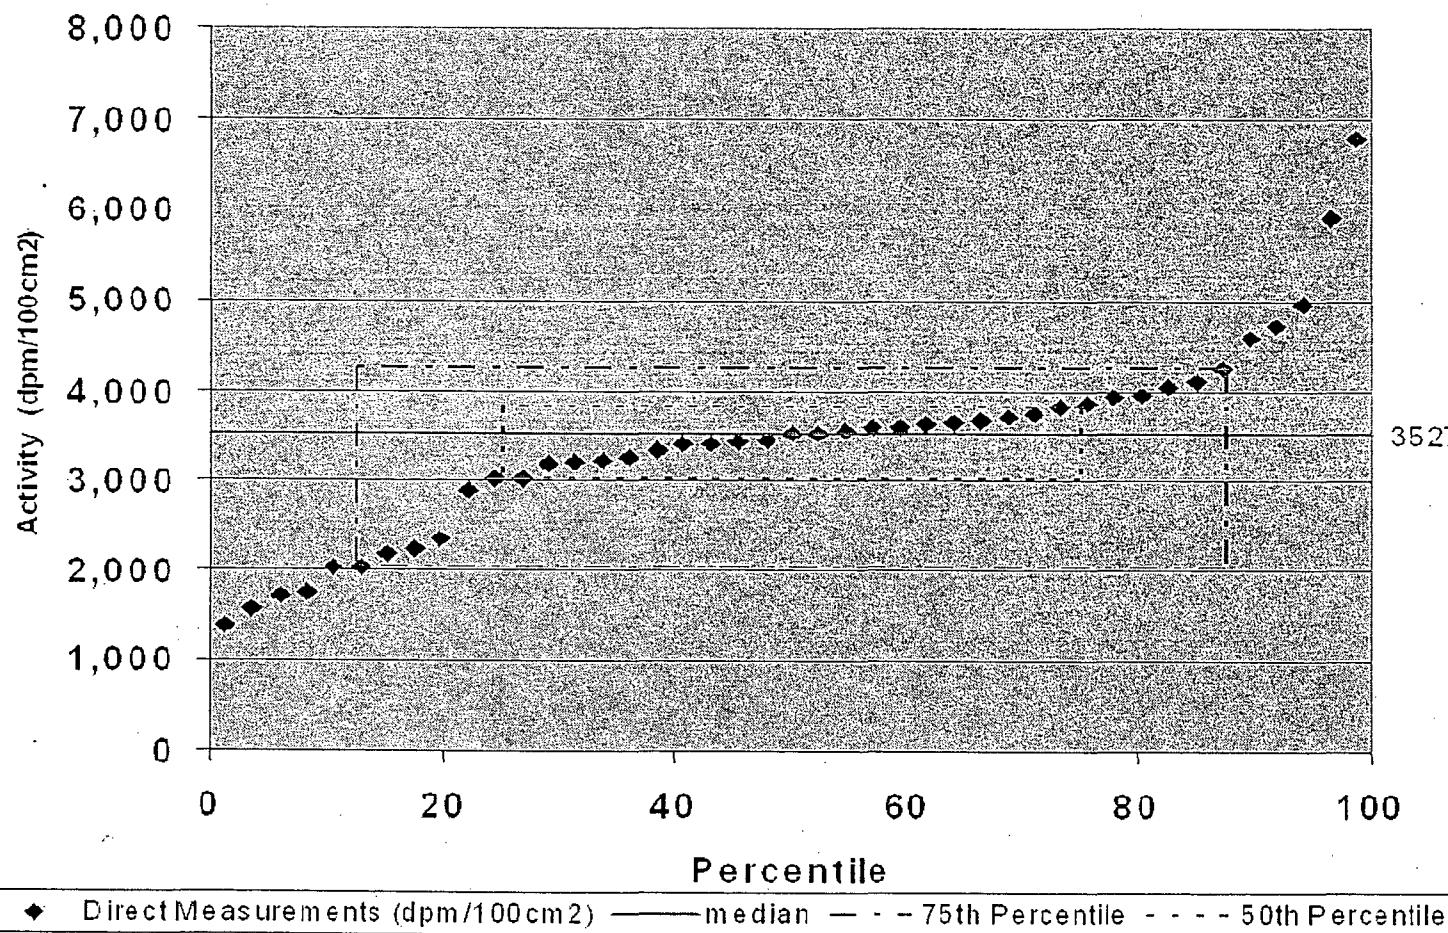
F8130631 Gross Activity Sample Results Quantile Plot  
DCGL = 43000 dpm/100cm<sup>2</sup>

The survey design required 43 direct measurements for the Sign Test. The critical value and the results of the Sign Test are presented in Table 4. The sample mean and median values were less than the DCGL. The sample standard deviation was less than the design standard deviation so no additional samples were required.
