Rancho Seco

Final Status Survey Summary Report

Aux. Bldg (-) 20' El., Rm 50, Radwaste Air Supply Fan Room, Upper Walls & Ceiling

Survey Unit F8130682

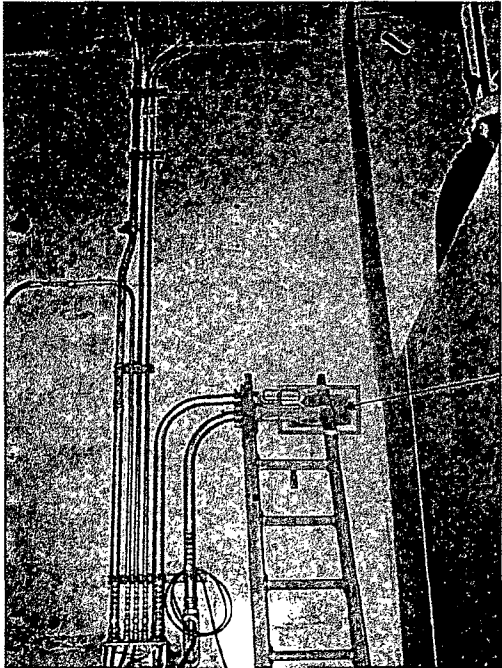
Rm 50, Radwaste Air Supply Fan Room,  
South Wall Penetration P0001

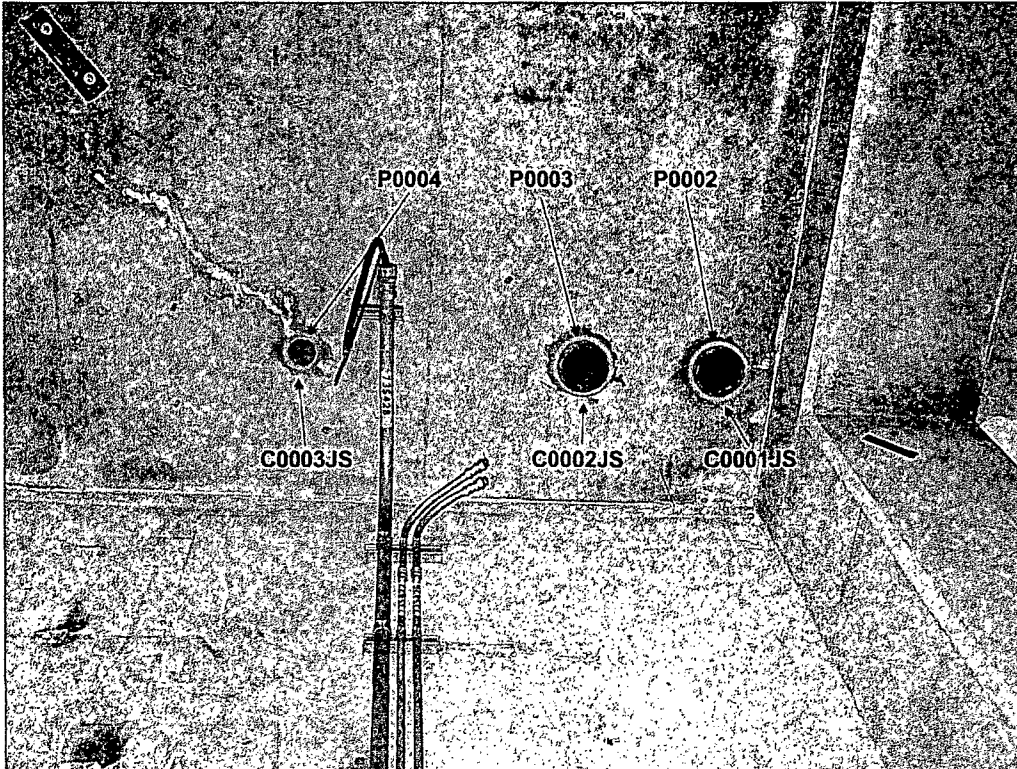
Rm 50, Radwaste Air Supply Fan Room  
Ceiling Penetration P0001 to P0003  
Juncture Scans F8130682C0001JS to F8130682C0003JS
