Rancho Seco

Final Status Survey Summary Report

Aux. Bldg (-) 20' El., Rm 50, Radwaste Air Supply Fan Room, Floor & Lower Walls

Survey Unit F8130681

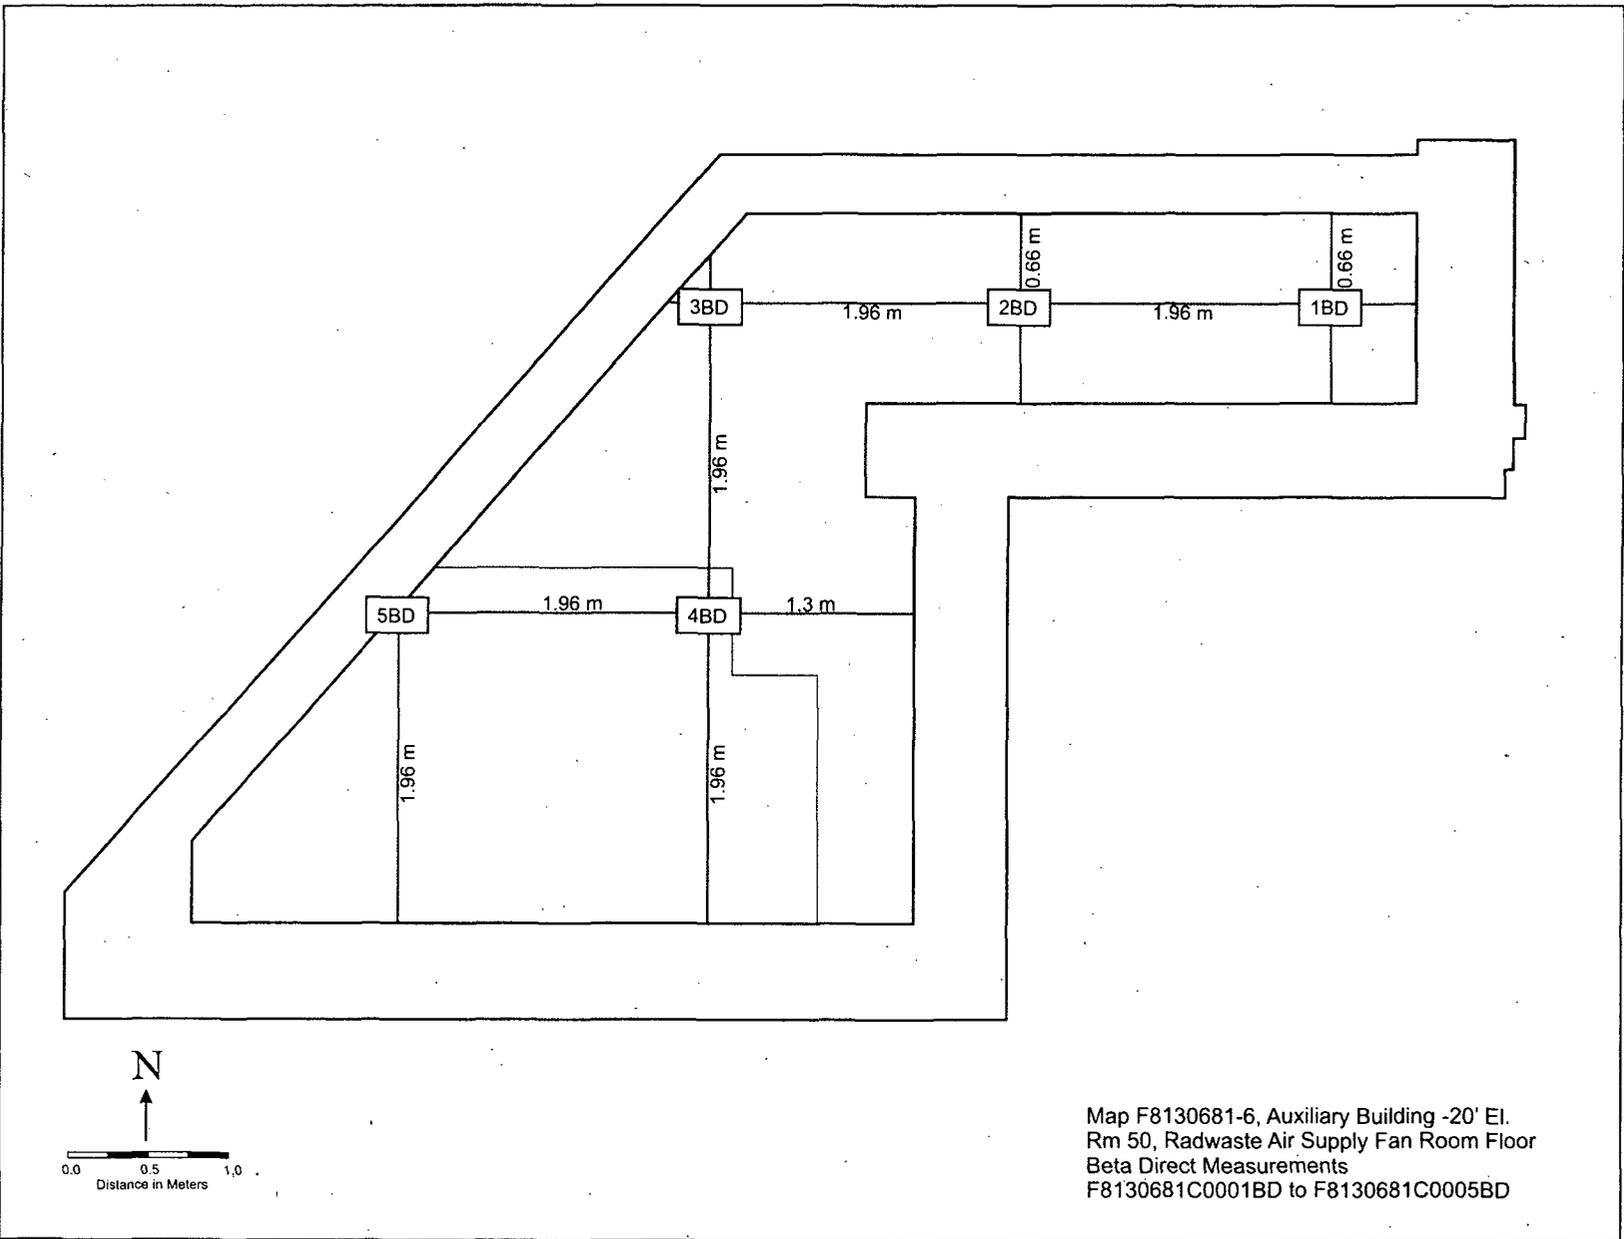
Map F8130681-6, Auxiliary Building -20' El.
Rm 50, Radwaste Air Supply Fan Room Floor
Beta Direct Measurements
F8130681C0001BD to F8130681C0005BD

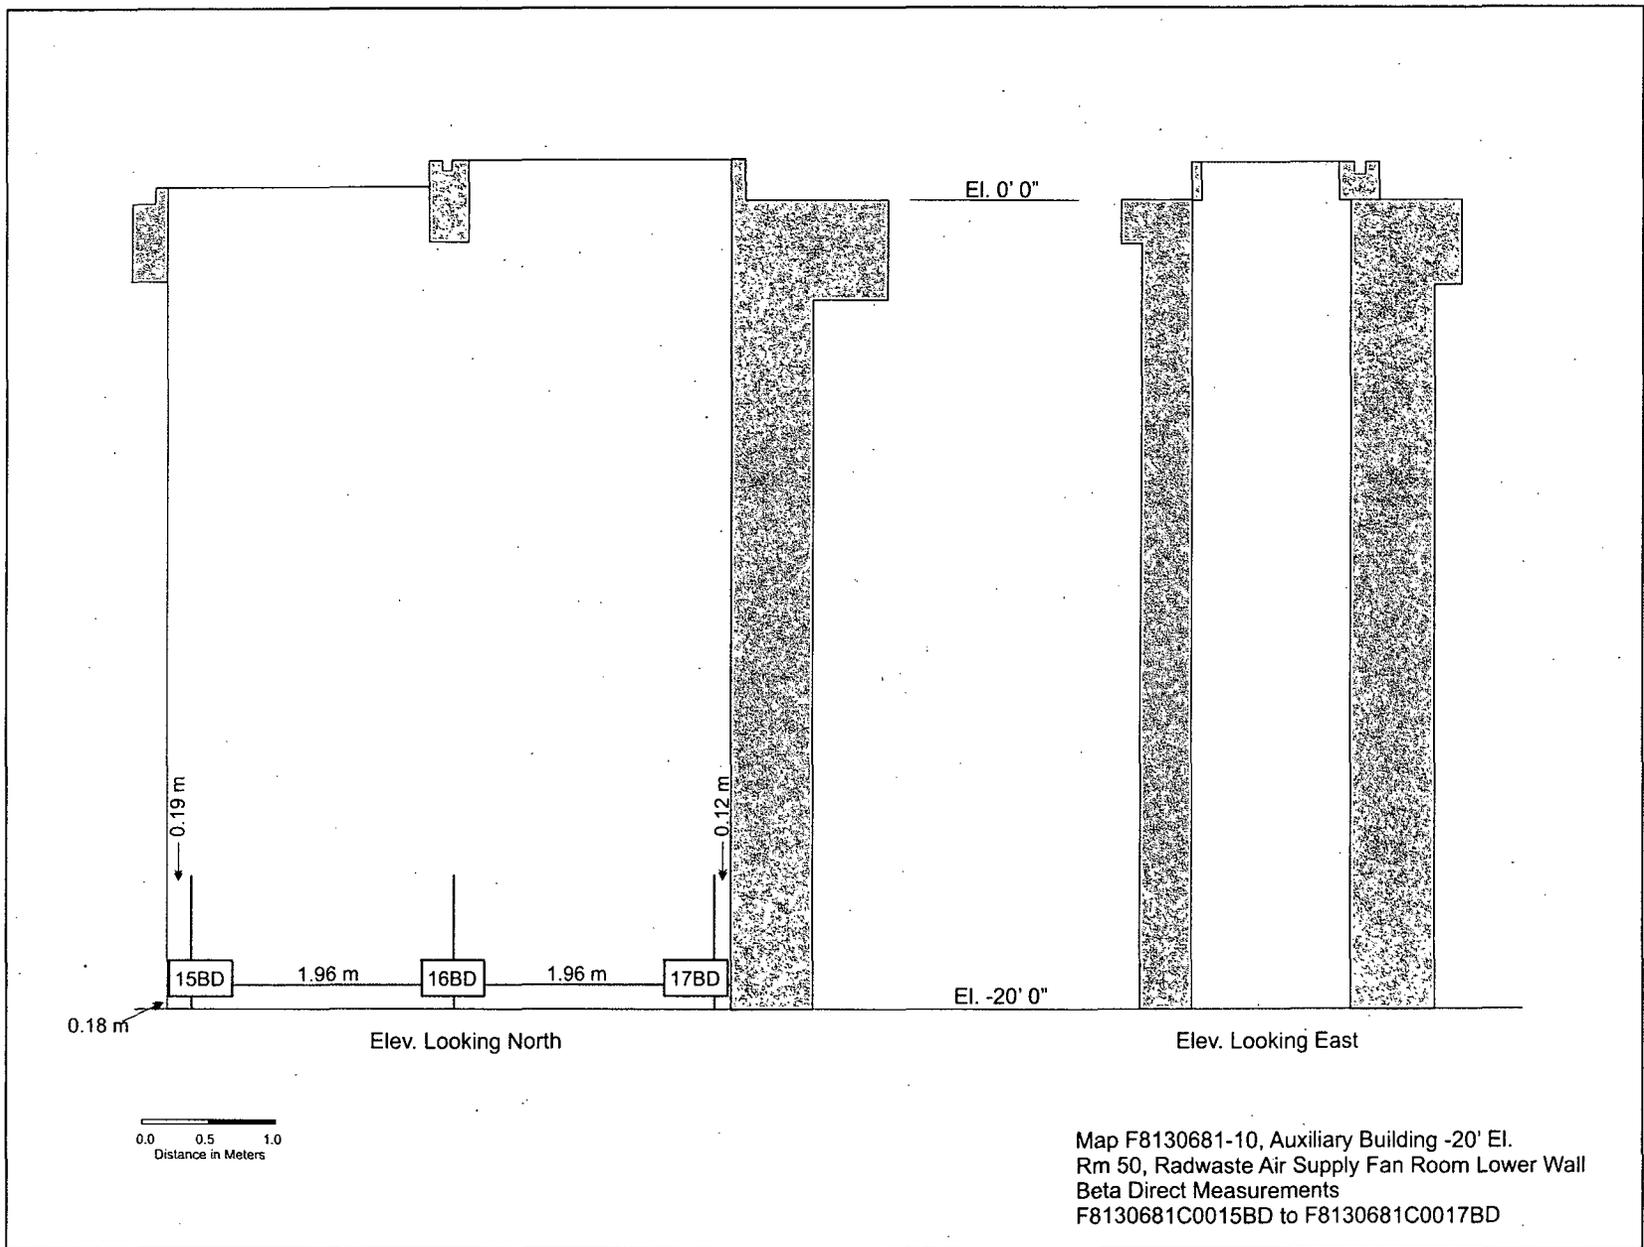
Map F8130681-10, Auxiliary Building -20' El.
Rm 50, Radwaste Air Supply Fan Room Lower Wall
Beta Direct Measurements
F8130681C0015BD to F8130681C0017BD

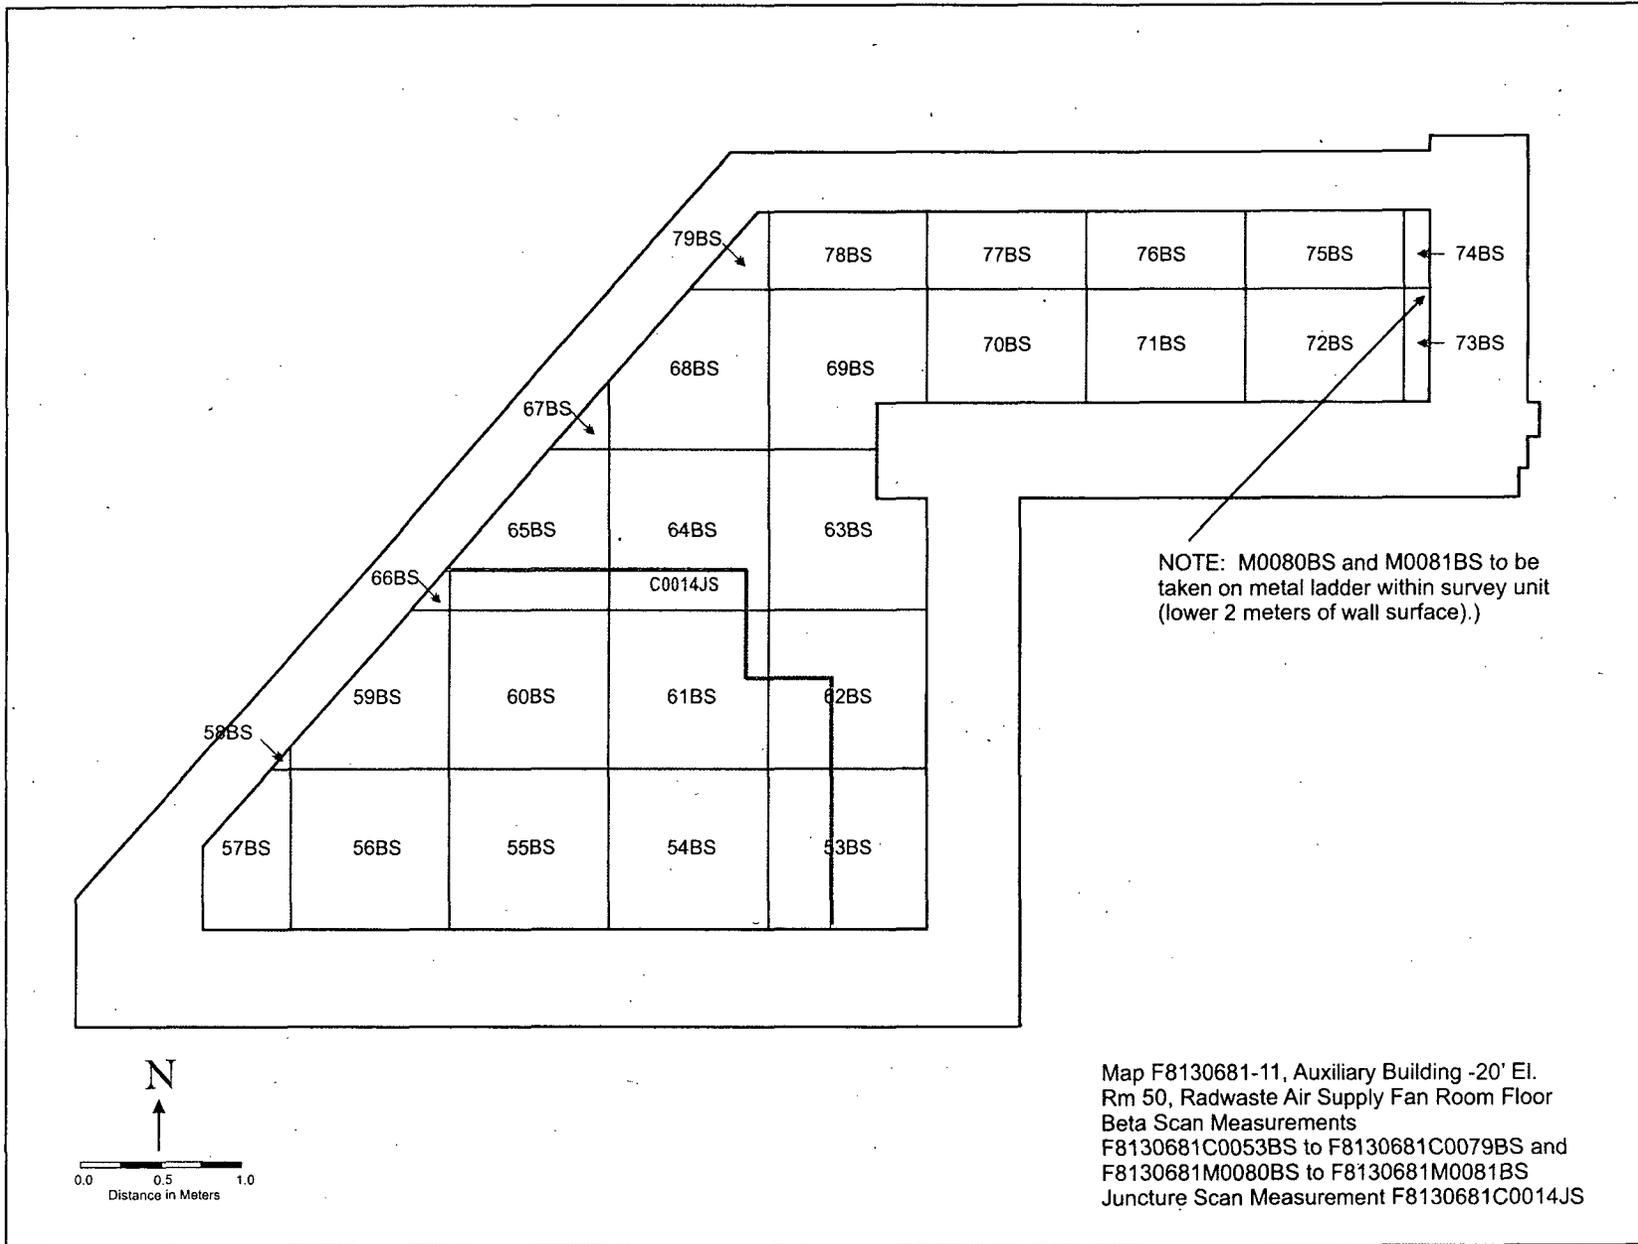
NOTE: M0080BS and M0081BS to be taken on metal ladder within survey unit (lower 2 meters of wall surface.)

Map F8130681-11, Auxiliary Building -20' El.
Rm 50, Radwaste Air Supply Fan Room Floor
Beta Scan Measurements
F8130681C0053BS to F8130681C0079BS and
F8130681M0080BS to F8130681M0081BS
Juncture Scan Measurement F8130681C0014JS
