McGuire Nuclear Station Regulatory Conference

Foreign Material Found in the Unit 2 ECCS Sump

*NRC Region II Office
Atlanta, Georgia
25 Oct 2007*

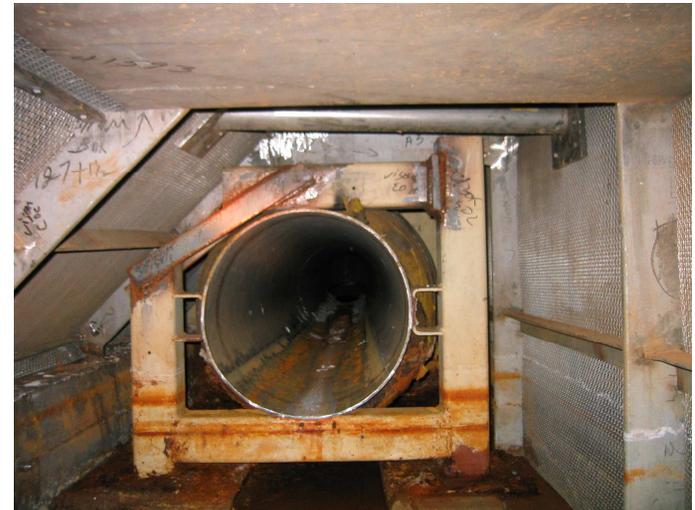
Duct Tape as-found Location

- Tape presence was obscured by a piping support, poor lighting, and was located in relatively inaccessible area. Inspection “tunnel vision,” focus was on loose floor debris, boron and corrosion.
- Inspection procedure lacked formal requirement to inspect inaccessible area behind the pipe support.
- A performance deficiency did exist due to the failure to previously identify and remove the duct tape in prior inspections

- Note the photo above is a typical piping configuration, but not typical of the lighting or visibility in the area (pipe diameter 18”)

- Tape was visibly aged in appearance.
- The as-found duct tape was removed from the ECCS pipe.
 - The outer polyethylene coating was brittle and friable. Portions of outer edges exhibited some de-lamination of the outer polyethylene coating.
 - The inner layer and adhesive was tightly adhered to the piping.
 - Solvent and mechanical force was used to remove the adhesive from the piping

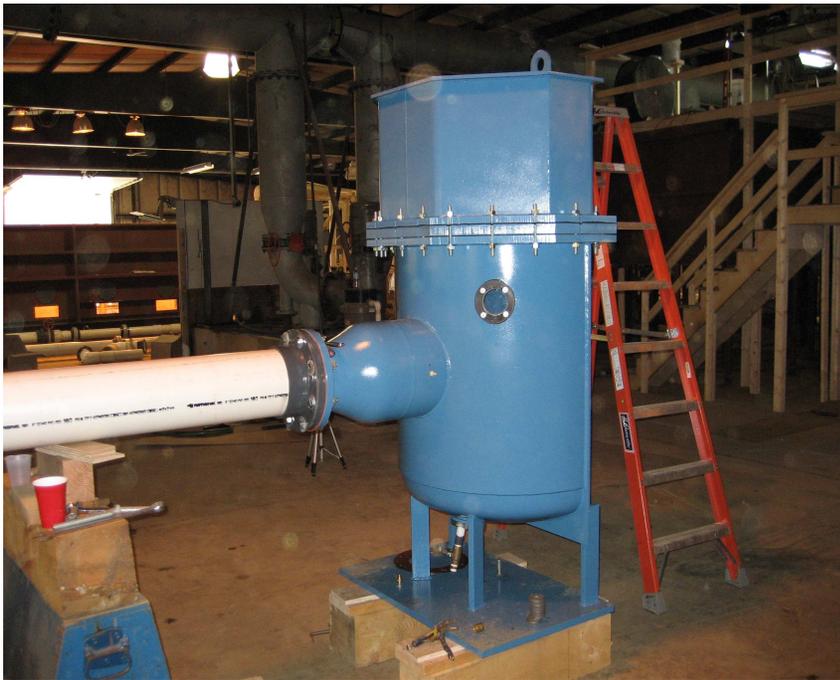
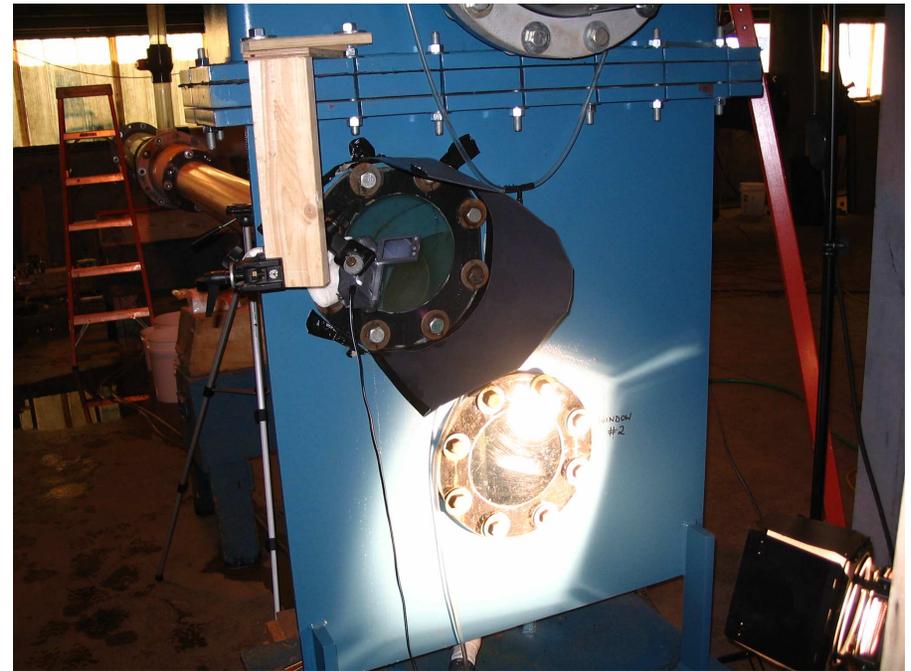
RHR Heat-Exchanger Test Loop Model

Purpose of test was to demonstrate duct tape transport behavior thru the heat-exchanger, and maximum size which could transport to downstream throttles.

- Test demonstrated that the RHR HX tube-sheet captured a significant amount of the duct tape.
- No duct tape greater than 2"x2" passed through heat-exchanger for 1700/2100 gpm flow rates.
- No duct tape greater than 2"x4" passed through.
- Margin exists for HX performance

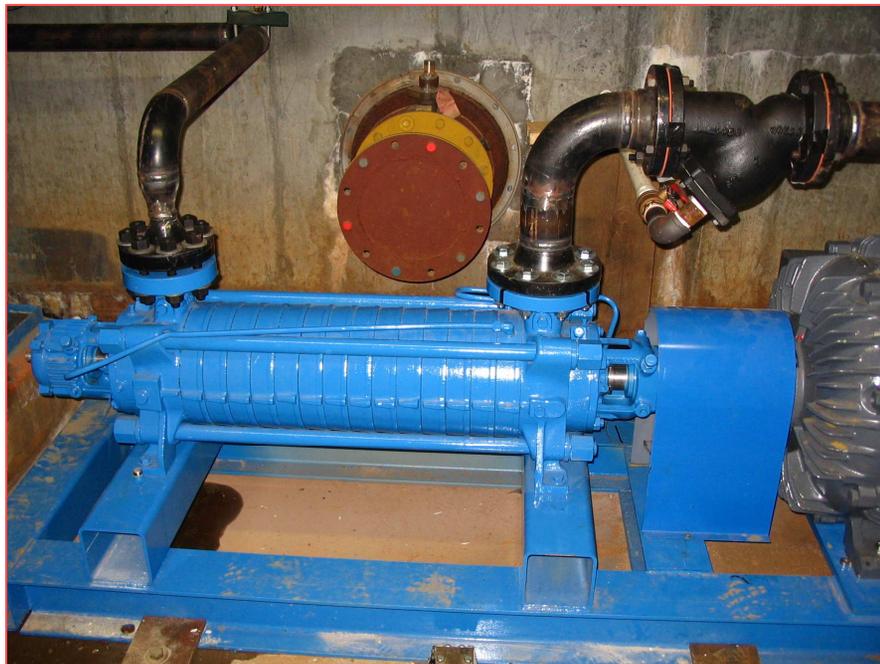
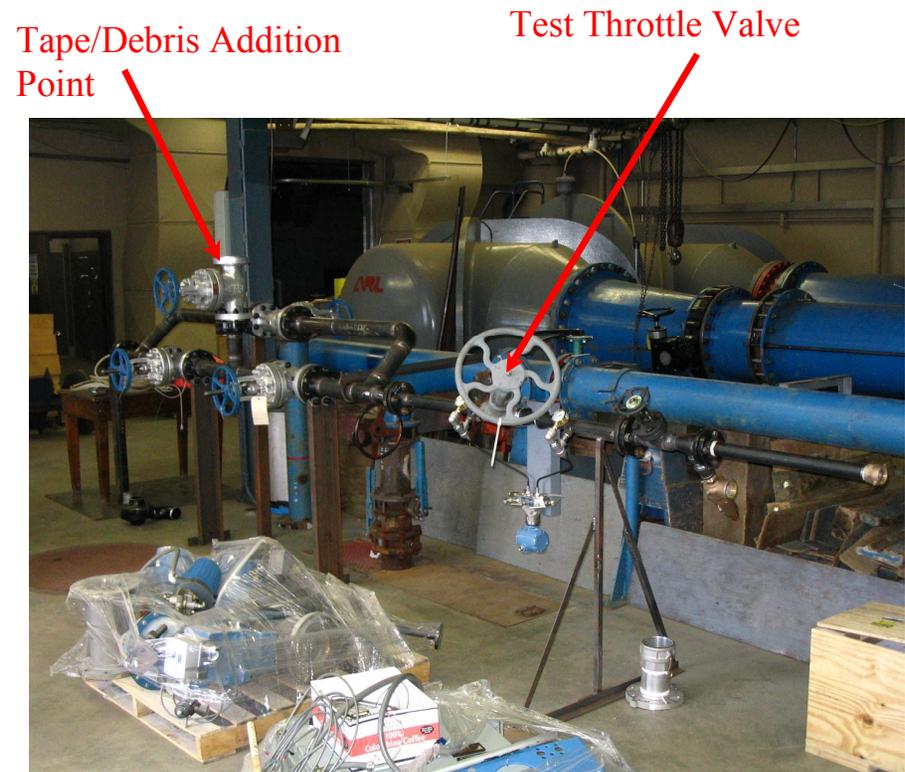
Throttle Valve Testing

Purpose of test was to demonstrate the effects of duct tape on ECCS throttle valve performance.

- Tests largely performed at minimum expected loop flow and throttle valve differential pressure representative for small break LOCAs.
- 27 tests were run, with varying sequence of duct tape addition.
 - ❖ Tape sizes (1/2" x 1/2" up to 2" x 6").
 - ❖ Tests performed with varying number of duct-tape specimens, up to 230 pieces in a single test.
- 10 tests included a very large quantity of duct tape ~110" linear inches thru a single throttle valve (conservatively simulates transport of all tape, distributed equally to each of the 8 throttle valves).
- Over 3000 pieces of various sized duct-tape readily passed through the test valve.

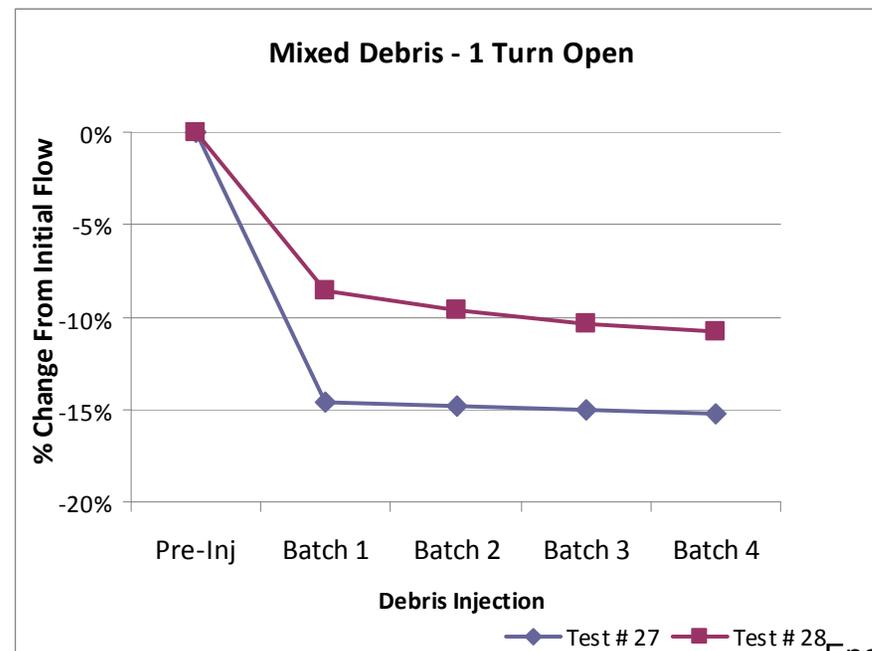
Throttle Valve Test Observations

- ECCS Throttle valve performance not significantly affected by small tape fragments in the size range and quantity that could pass through the RHR heat exchanger.
- NO flow reduction for 2.75 turn open position (2 high head valves)
- <17% flow reduction for 1 turn open position (vs. the 50% allowed by analysis)
- The flow reduction that was observed for 1 turn open position, did not continue to appreciably increase as more tape was added.

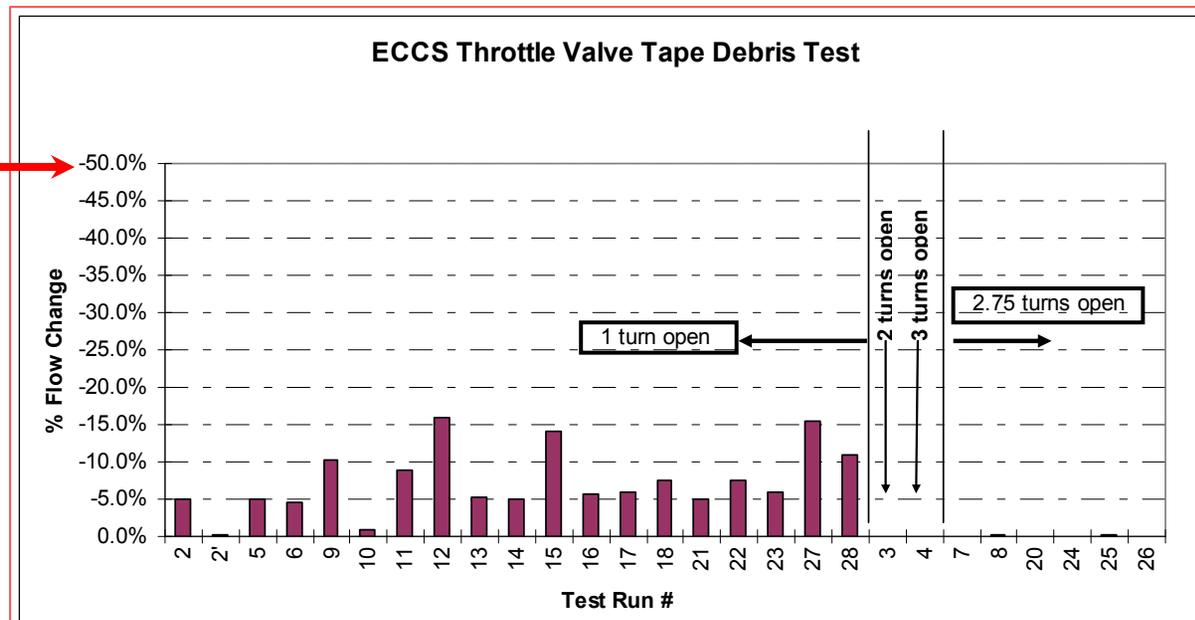
Throttle Valve Testing- Results

- Maximum throttle valve flow reduction < 17% for 1 turn open position. No reduction for 2 further open high head valves.
- Analysis indicates that with only 50% of a single pump available there is sufficient flow to prevent core damage during the ECCS recirculation phase.

allowed by analysis

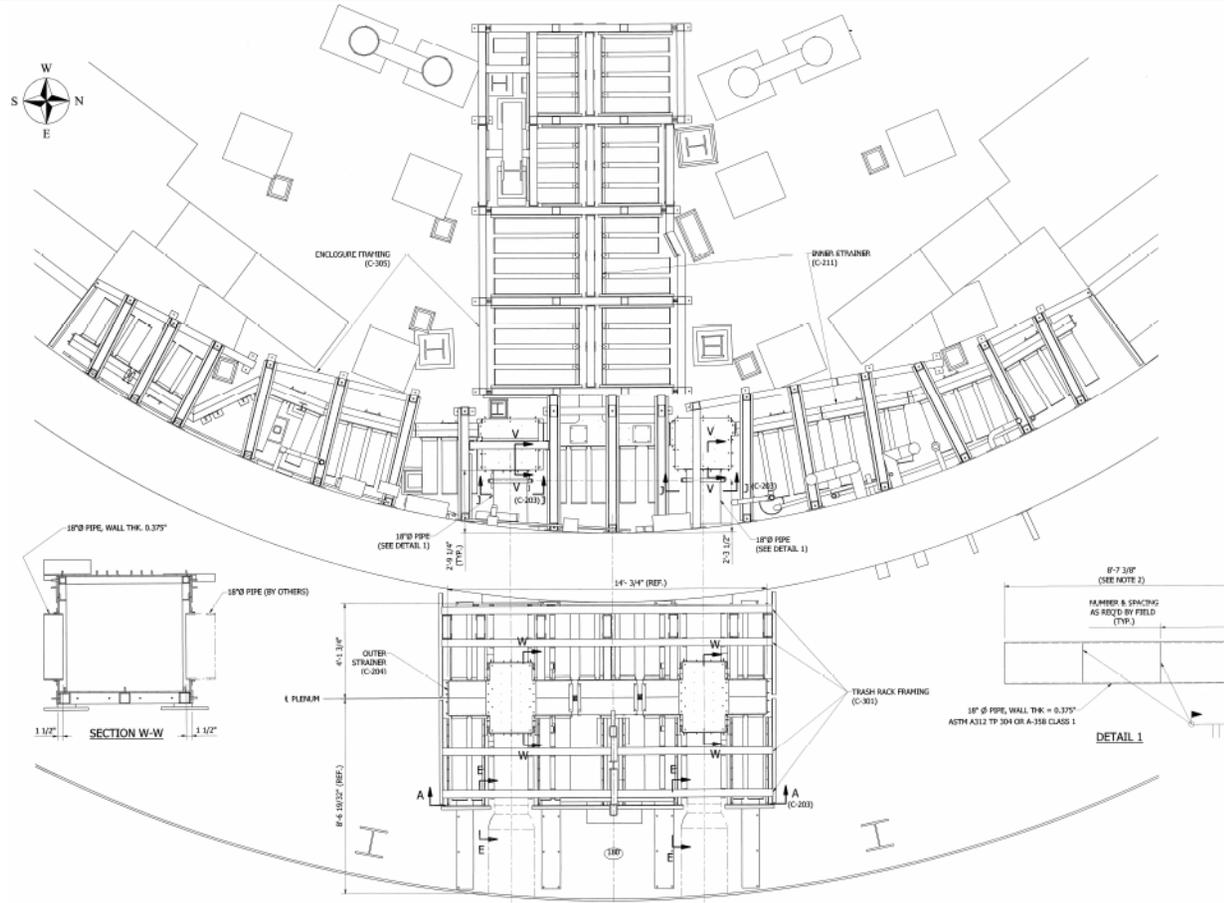
Modified ECCS Sump Arrangement

- McGuire implemented a rigorous foreign material exclusion (FME) process for installation of the new ECCS Sump.
- The strainer received thorough inspections to ensure no debris was internally introduced during fabrication and assembly.
- Video inspections performed inside the previously existing sump piping to ensure no foreign material was present.
- The replacement ECCS sump strainer is a self-contained “closed system,” which provides protection against exterior foreign material intrusion.
