Subject: Draft Decommissioning Plan Completion Report for the Reading Slag Pile Site
License No. SMC-1562
Docket Number 40-9027

**READING SLAG PILE SITE
DECOMMISSIONING PLAN COMPLETION REPORT
SOURCE MATERIAL LICENSE SMC-1562**

**ST Environmental Professionals, Inc.
GeoSystems, Inc.
de maximis, inc.
Austin Masters, Inc**

Cabot Corporation

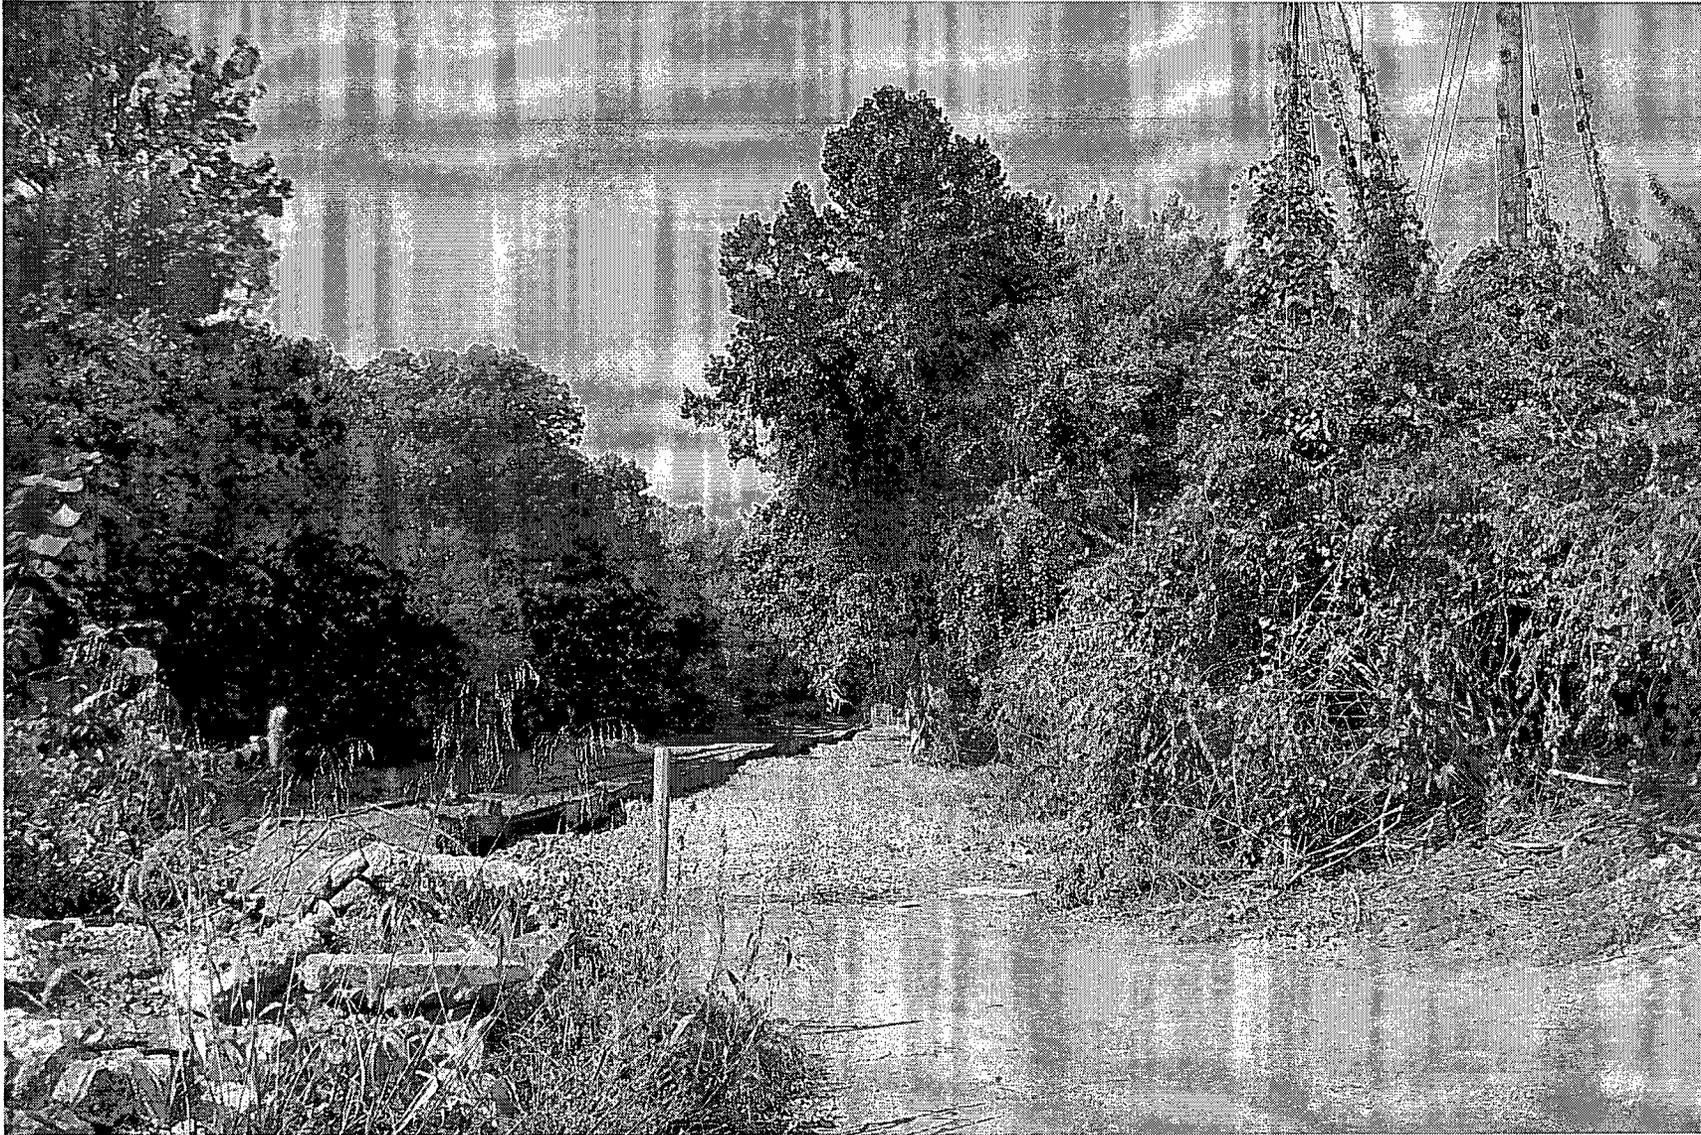
Construction of the temporary access road began on August 20, 2007 and was completed on August 24, 2007. Photo 3-1 shows the completed site access road and the silt fence.

PHOTO 3-1 COMPLETED ACCESS ROAD & SILT FENCE

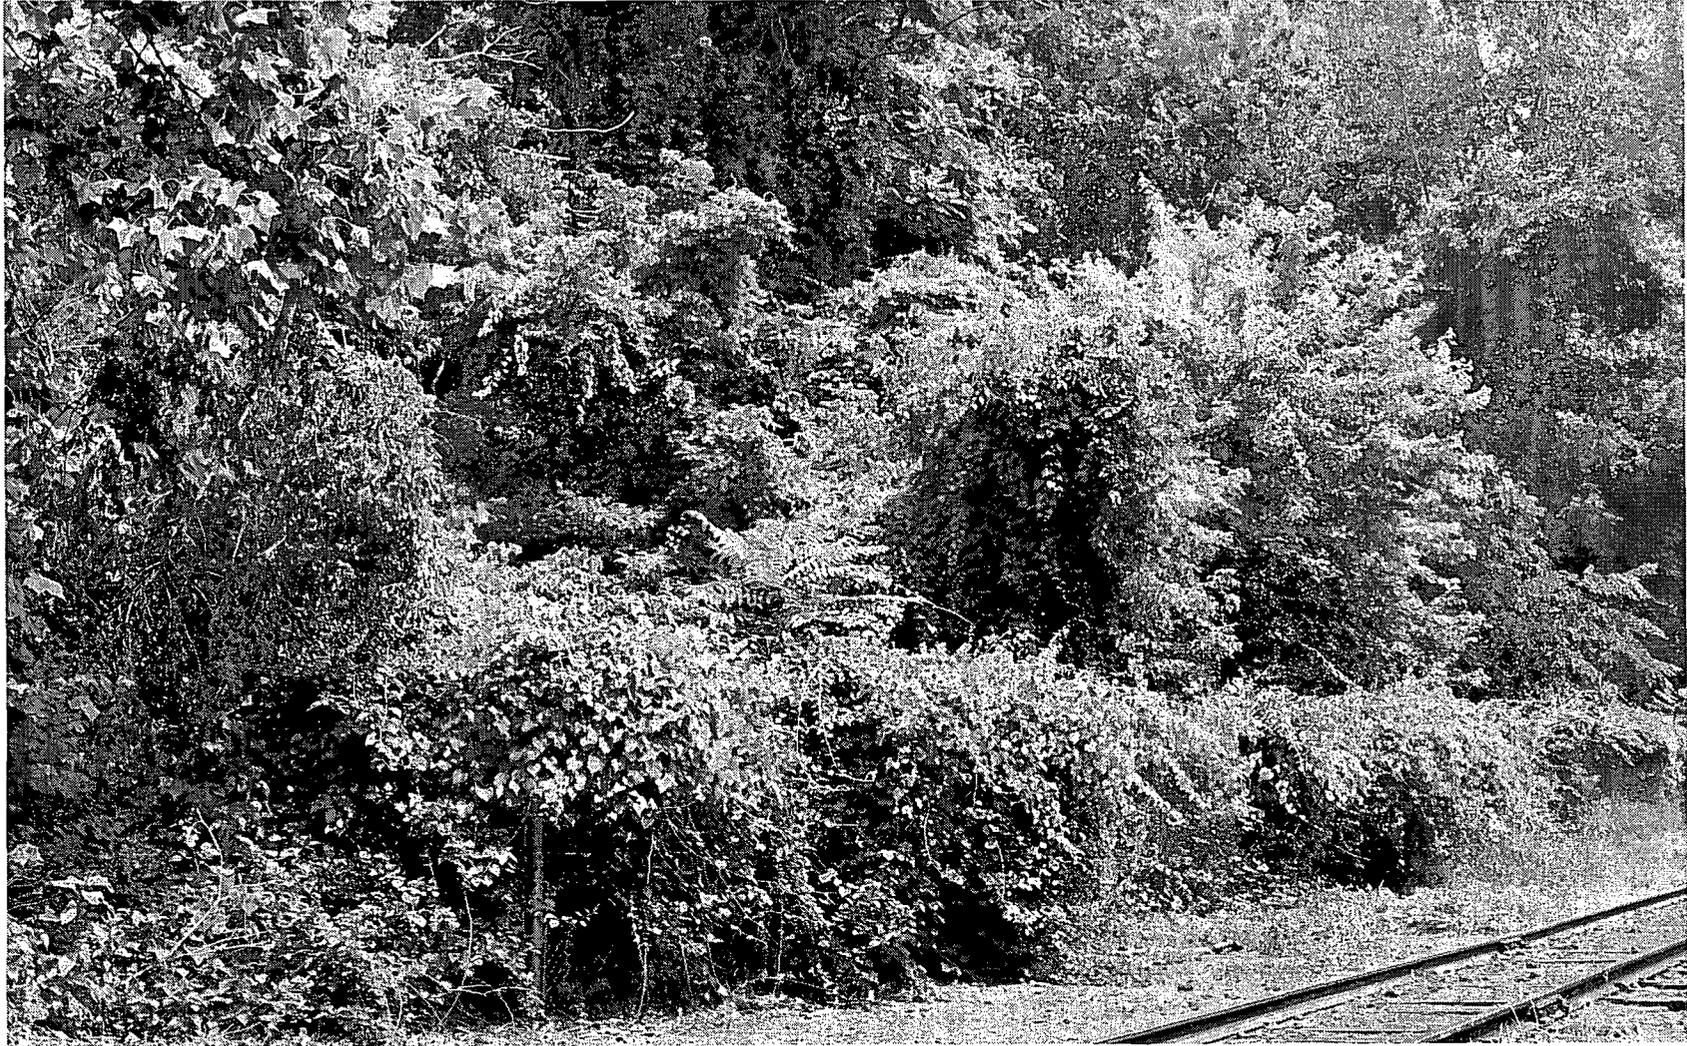
To construct the cover, vegetation and surface debris had to be cleared from slag pile area. Since above-grade vegetation would not have been impacted by the slag material and the removal of trees and shrubs did not involve any significant disturbance of the slag material, clearing was performed with concurrence of the NRC, before the Decommissioning Plan was approved. Photos 3-2 and 3-3 show the vegetation at the Site prior to clearing.

PHOTO 3-2 SOUTHWEST CORNER OF SITE PRIOR TO CLEARING

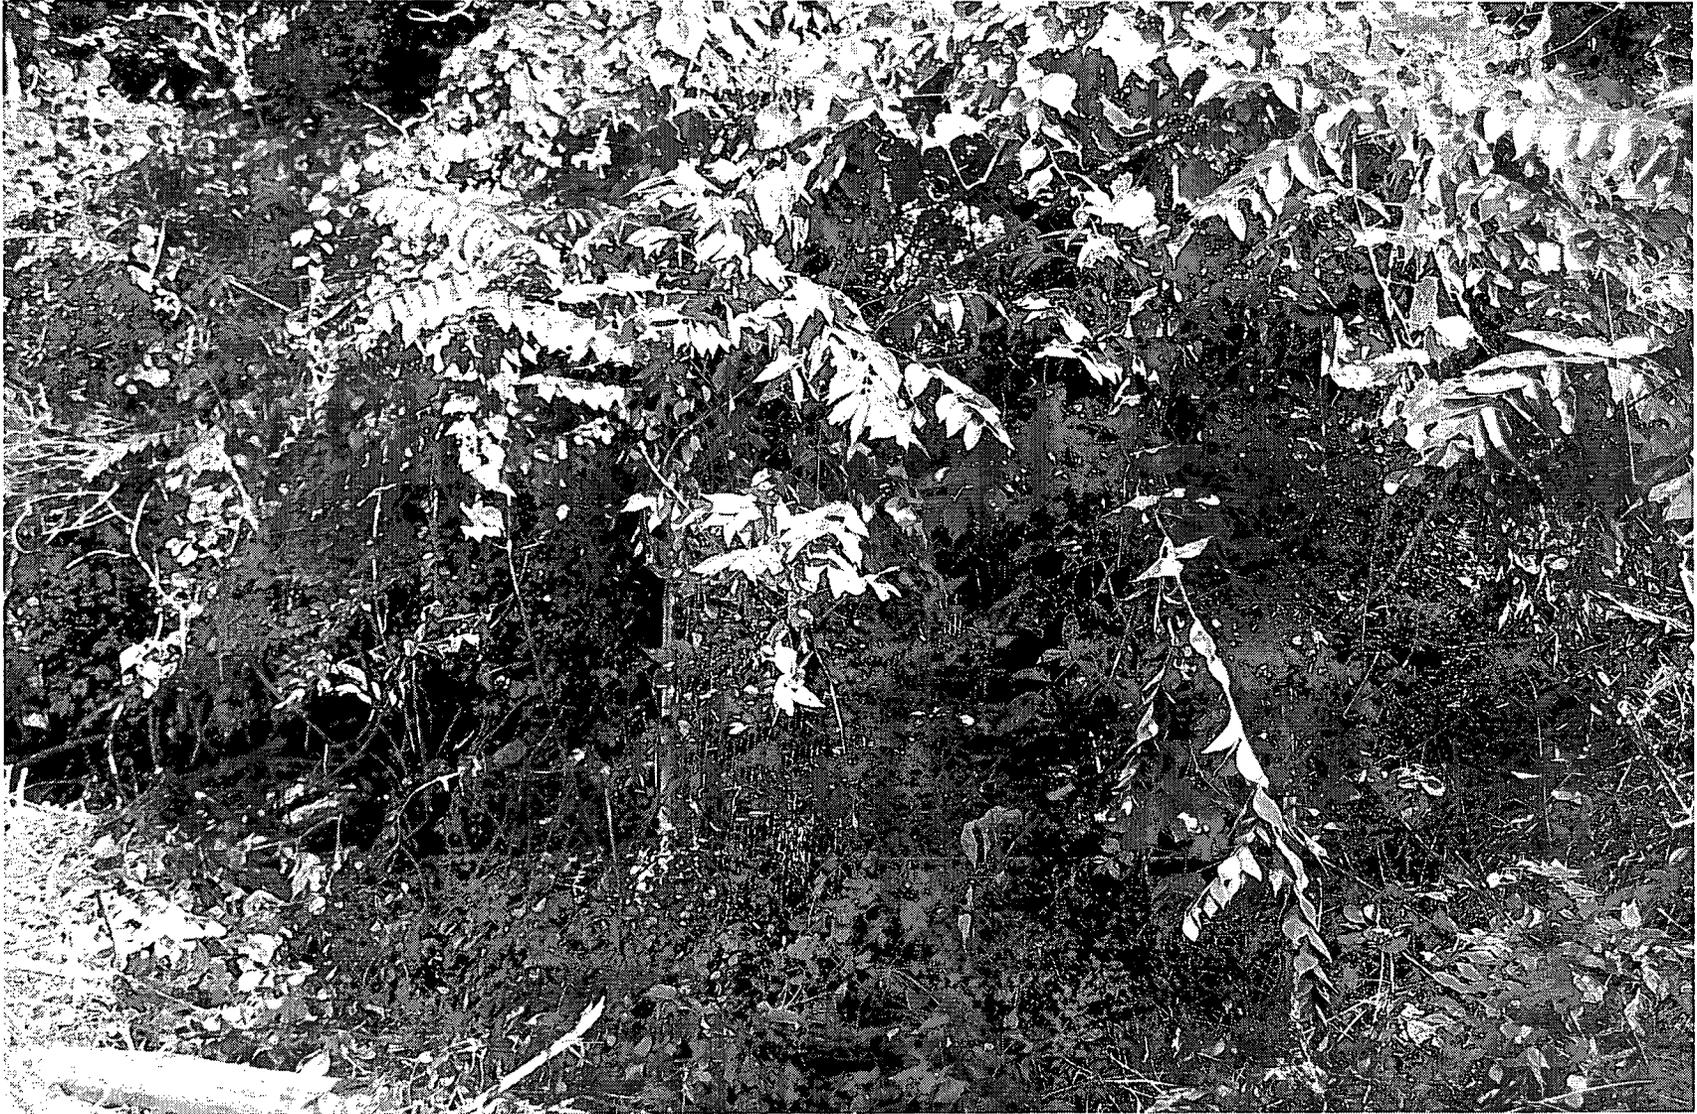
PHOTO 3-3 SOUTHEAST CORNER OF SITE PRIOR TO CLEARING

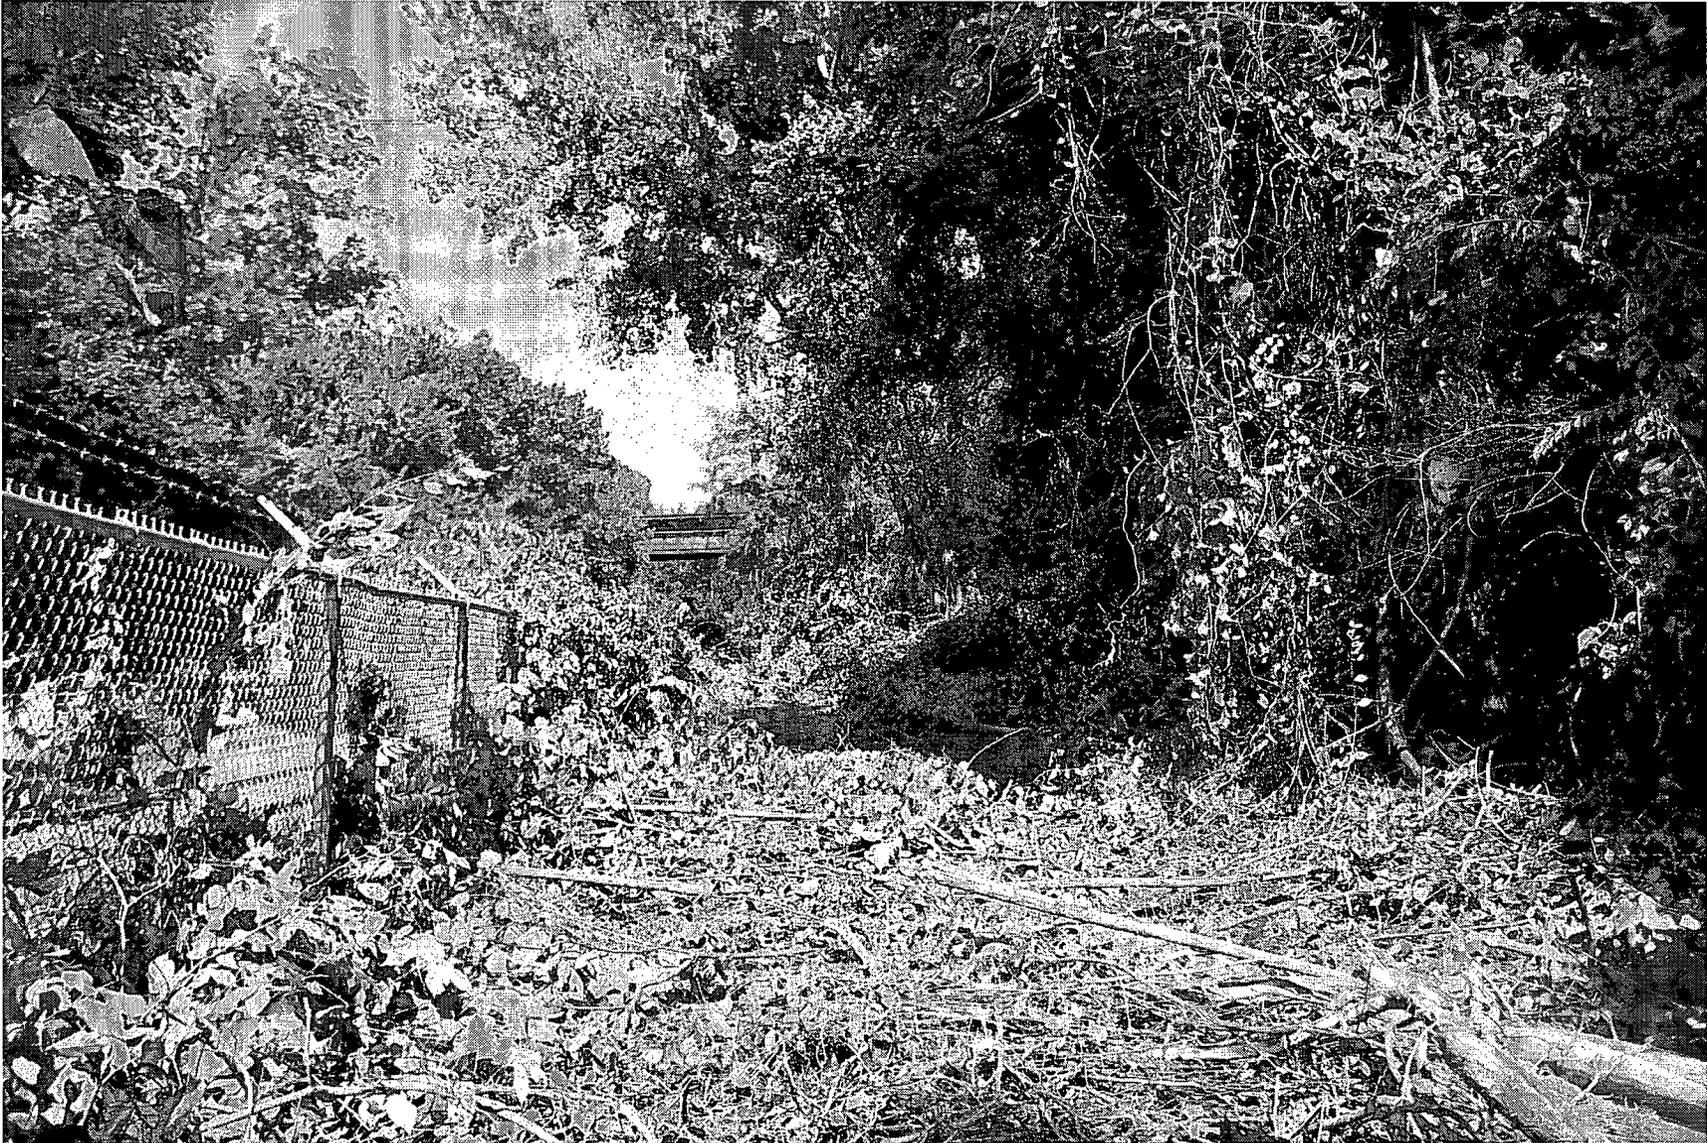
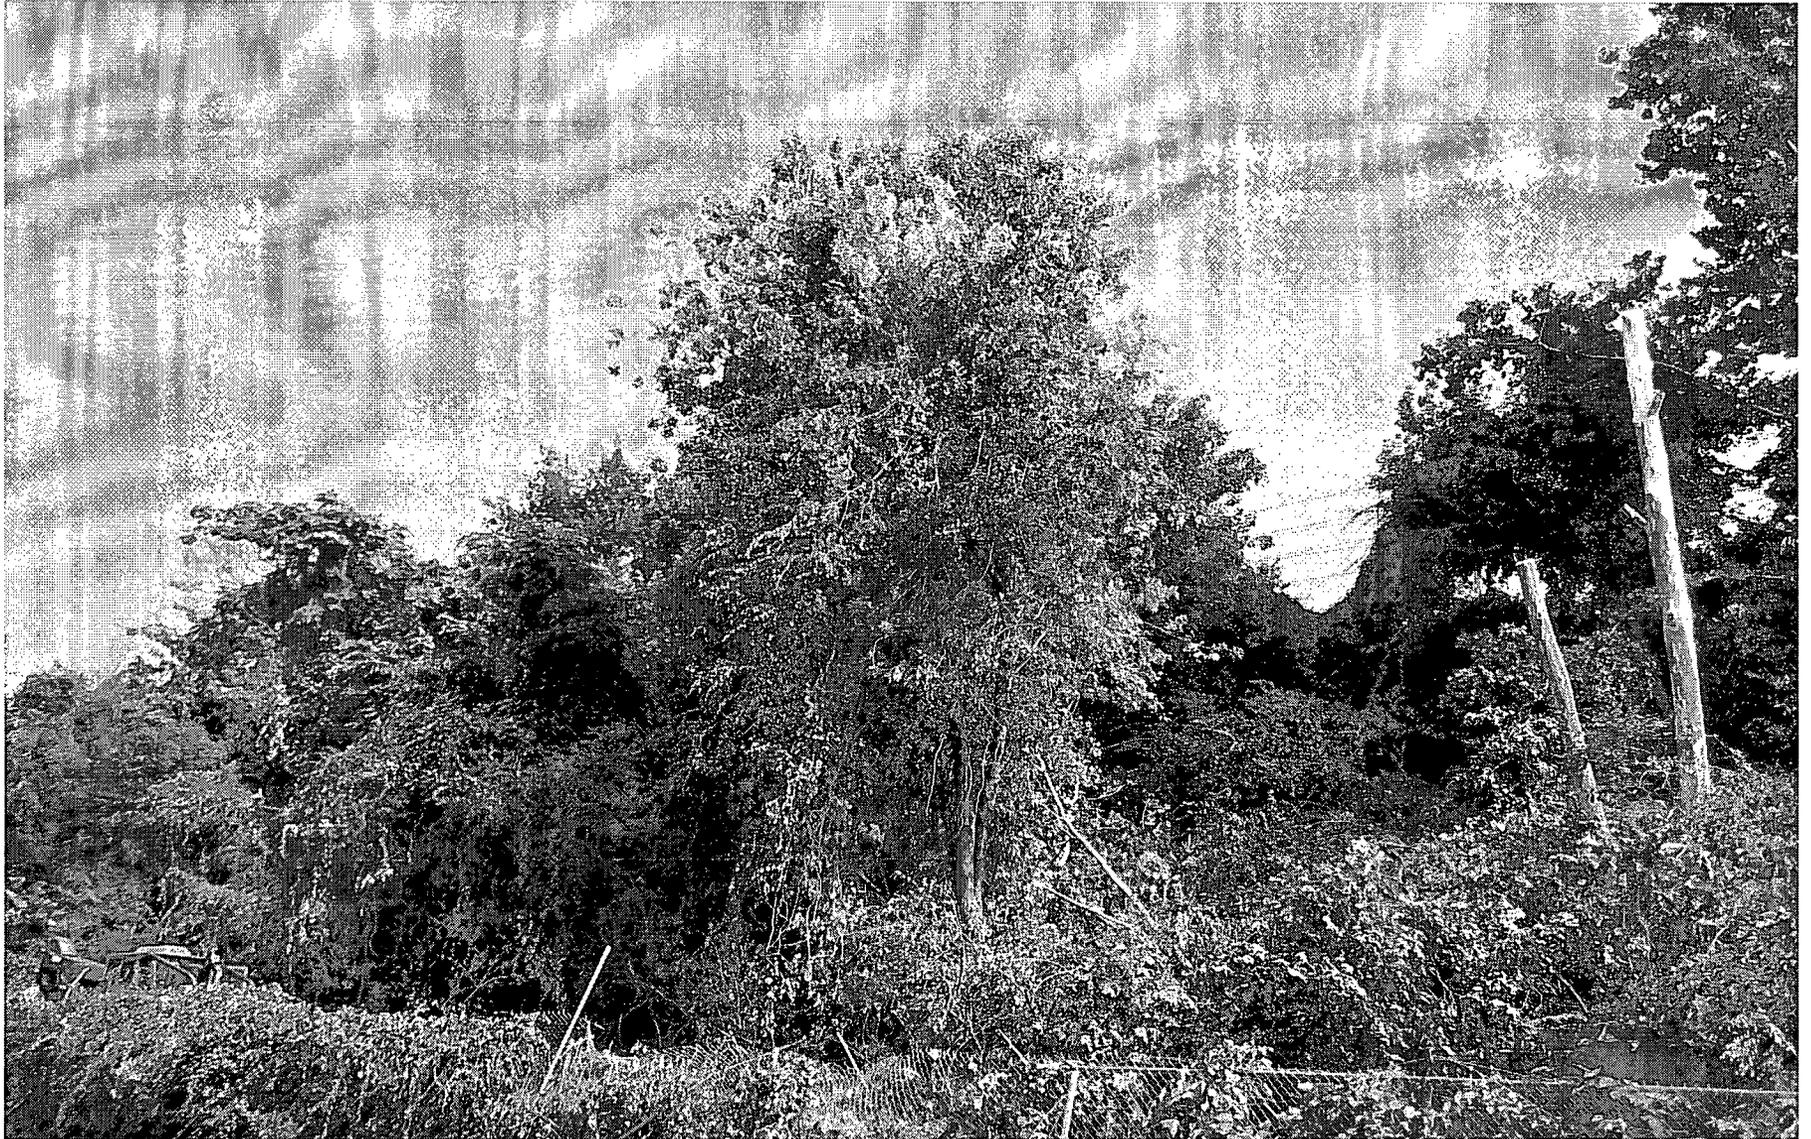
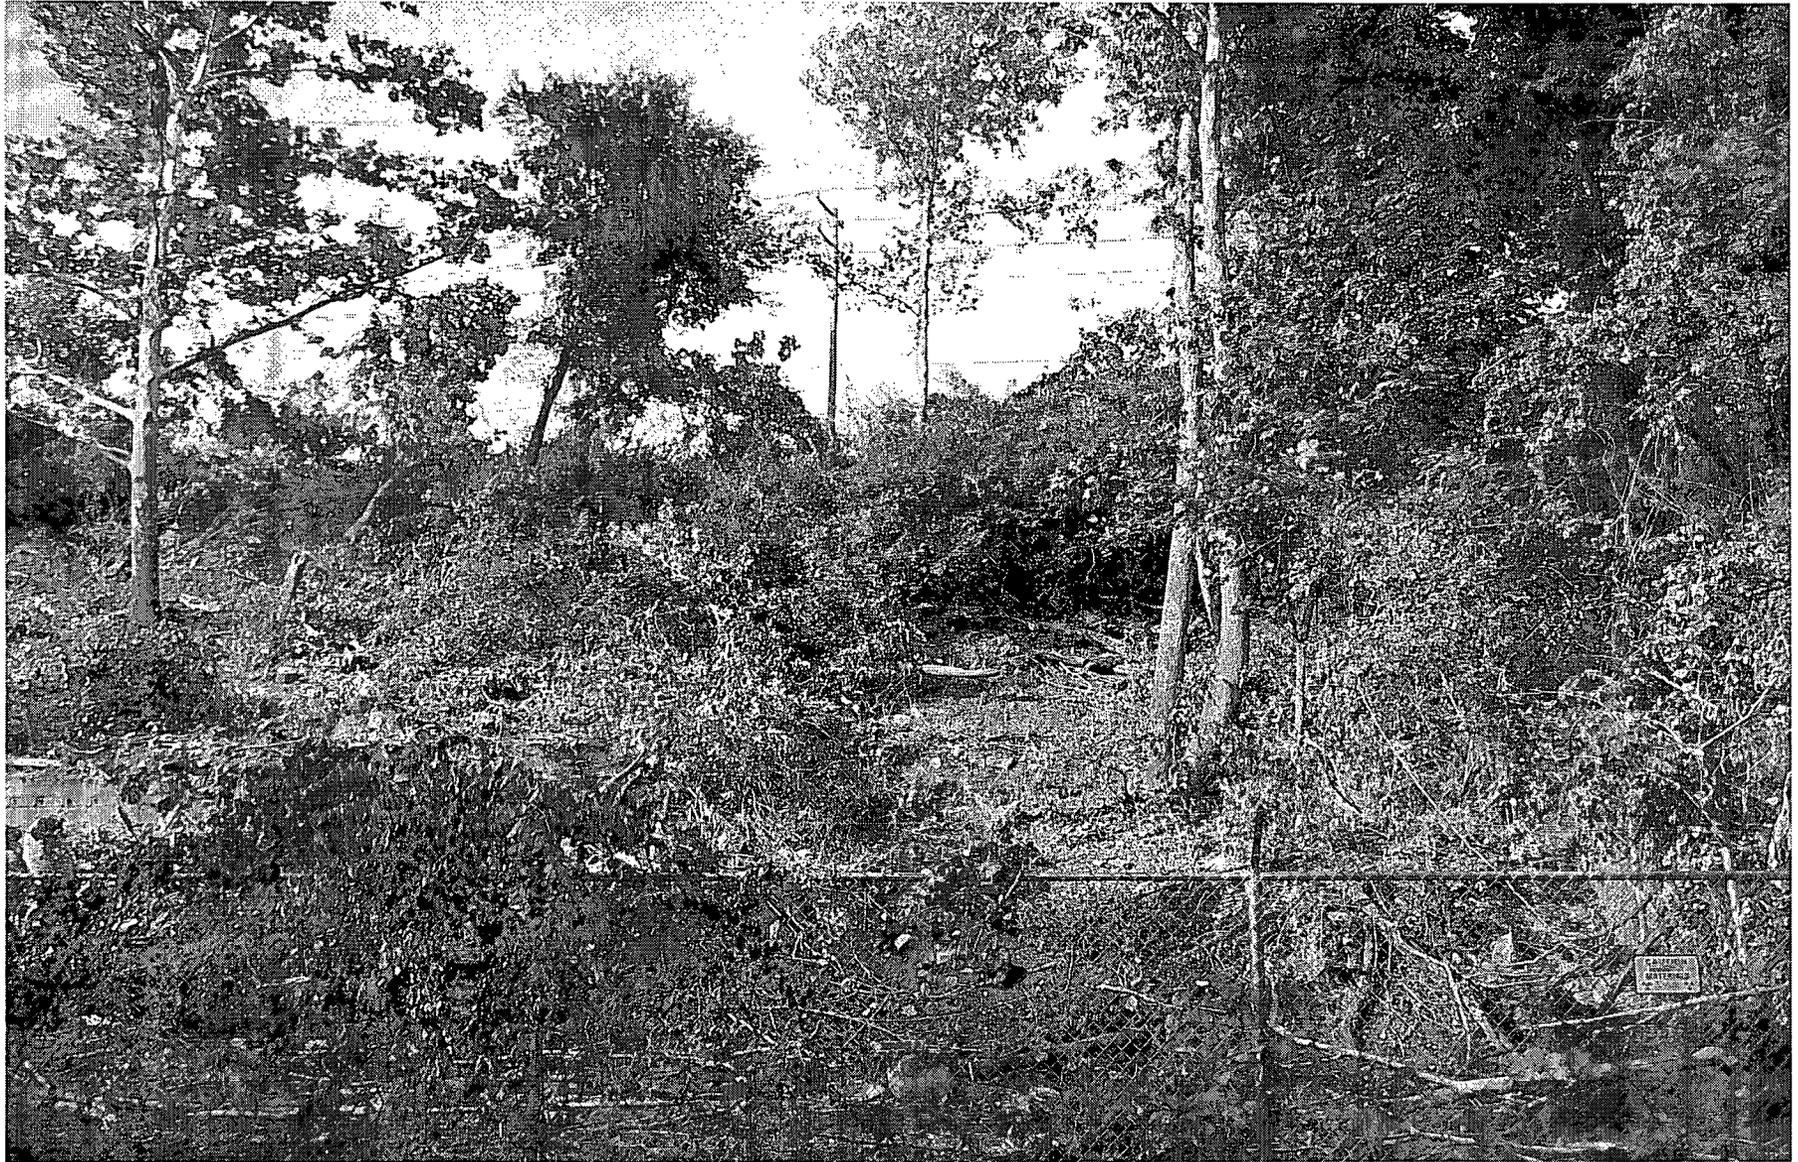
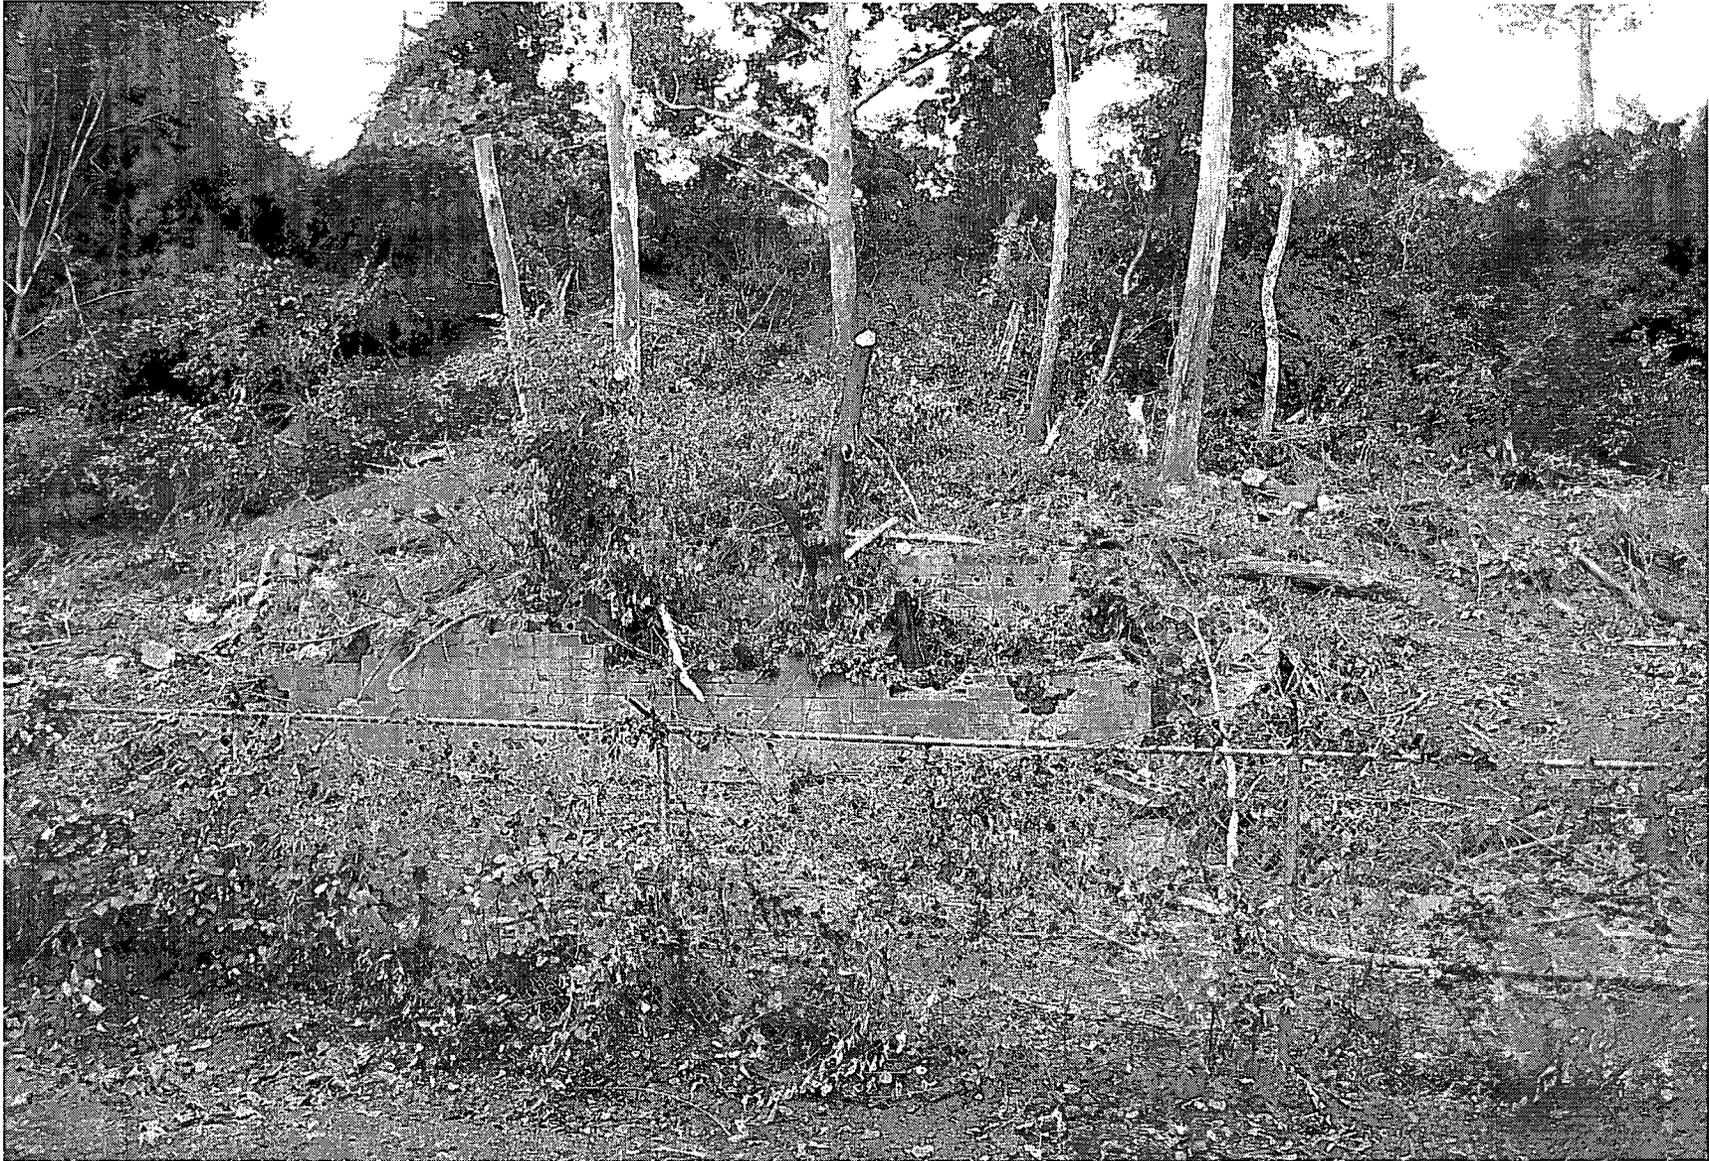
The underbrush and smaller trees were removed using a hydraulic axe. The larger trees were then cut as close to grade as possible using chain saws. Using a mechanical log carrier and track hoe (equipped with a thumb), the cut trees and underbrush were removed from the slag pile area and chipped into an onsite tractor-trailer. The chips were then taken to a local wood recycling facility. The stumps were removed only after NRC approved the Decommissioning Plan and prior to the construction of the cover (see below). As discussed in Section 6, periodic radiological monitoring was conducted by the on site radiological control technician during all clearing activities. Photos 3-4 through 3-8 show the Site during and after clearing of the above-grade vegetation.

PHOTO 3-4 SITE CLEARING

PHOTO 3-5 SITE CLEARING

PHOTO 3-6 SITE CLEARING

PHOTO 3-7 SITE CLEARING

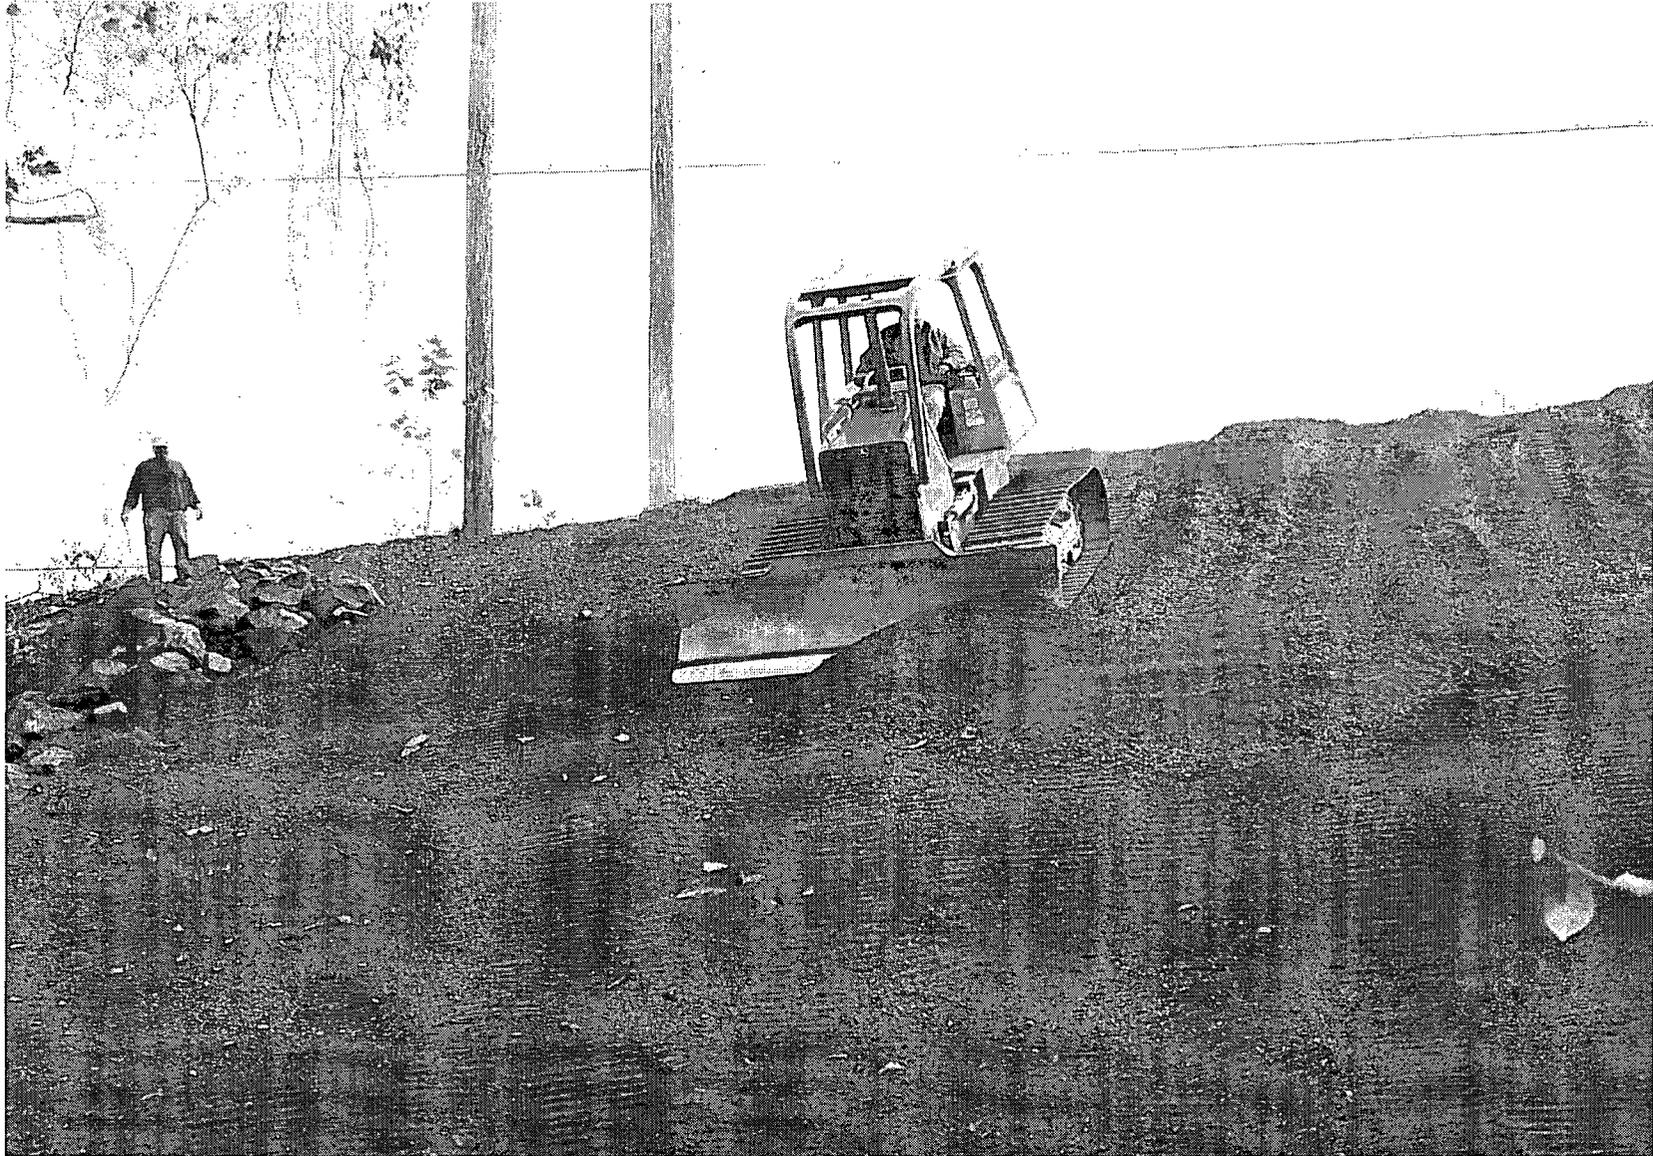
After clearing, but prior to stump removal, Cabot requested and received approval from the NCR to place a minimum of six (6) inches of FS-2 across the slag pile as an interim erosion protection measure. FS-2 rock was placed across the entire slag pile area by placing the material at the top of the slope and pushing it down-slope with a small dozer (see Photos 3-9 and 3-10). Tree stumps were not covered during this phase of work because the Decommission Plan was not approved and the stumps needed to be removed.

PHOTO 3-9 SUBGRADE MAINTENANCE

PHOTO 3-10 SUBGRADE MAINTENANCE
