Subject: Draft Decommissioning Plan Completion Report for the Reading Slag Pile Site
License No. SMC-1562
Docket Number 40-9027

**READING SLAG PILE SITE
DECOMMISSIONING PLAN COMPLETION REPORT
SOURCE MATERIAL LICENSE SMC-1562**

**ST Environmental Professionals, Inc.
GeoSystems, Inc.
de maximis, inc.
Austin Masters, Inc**

Cabot Corporation

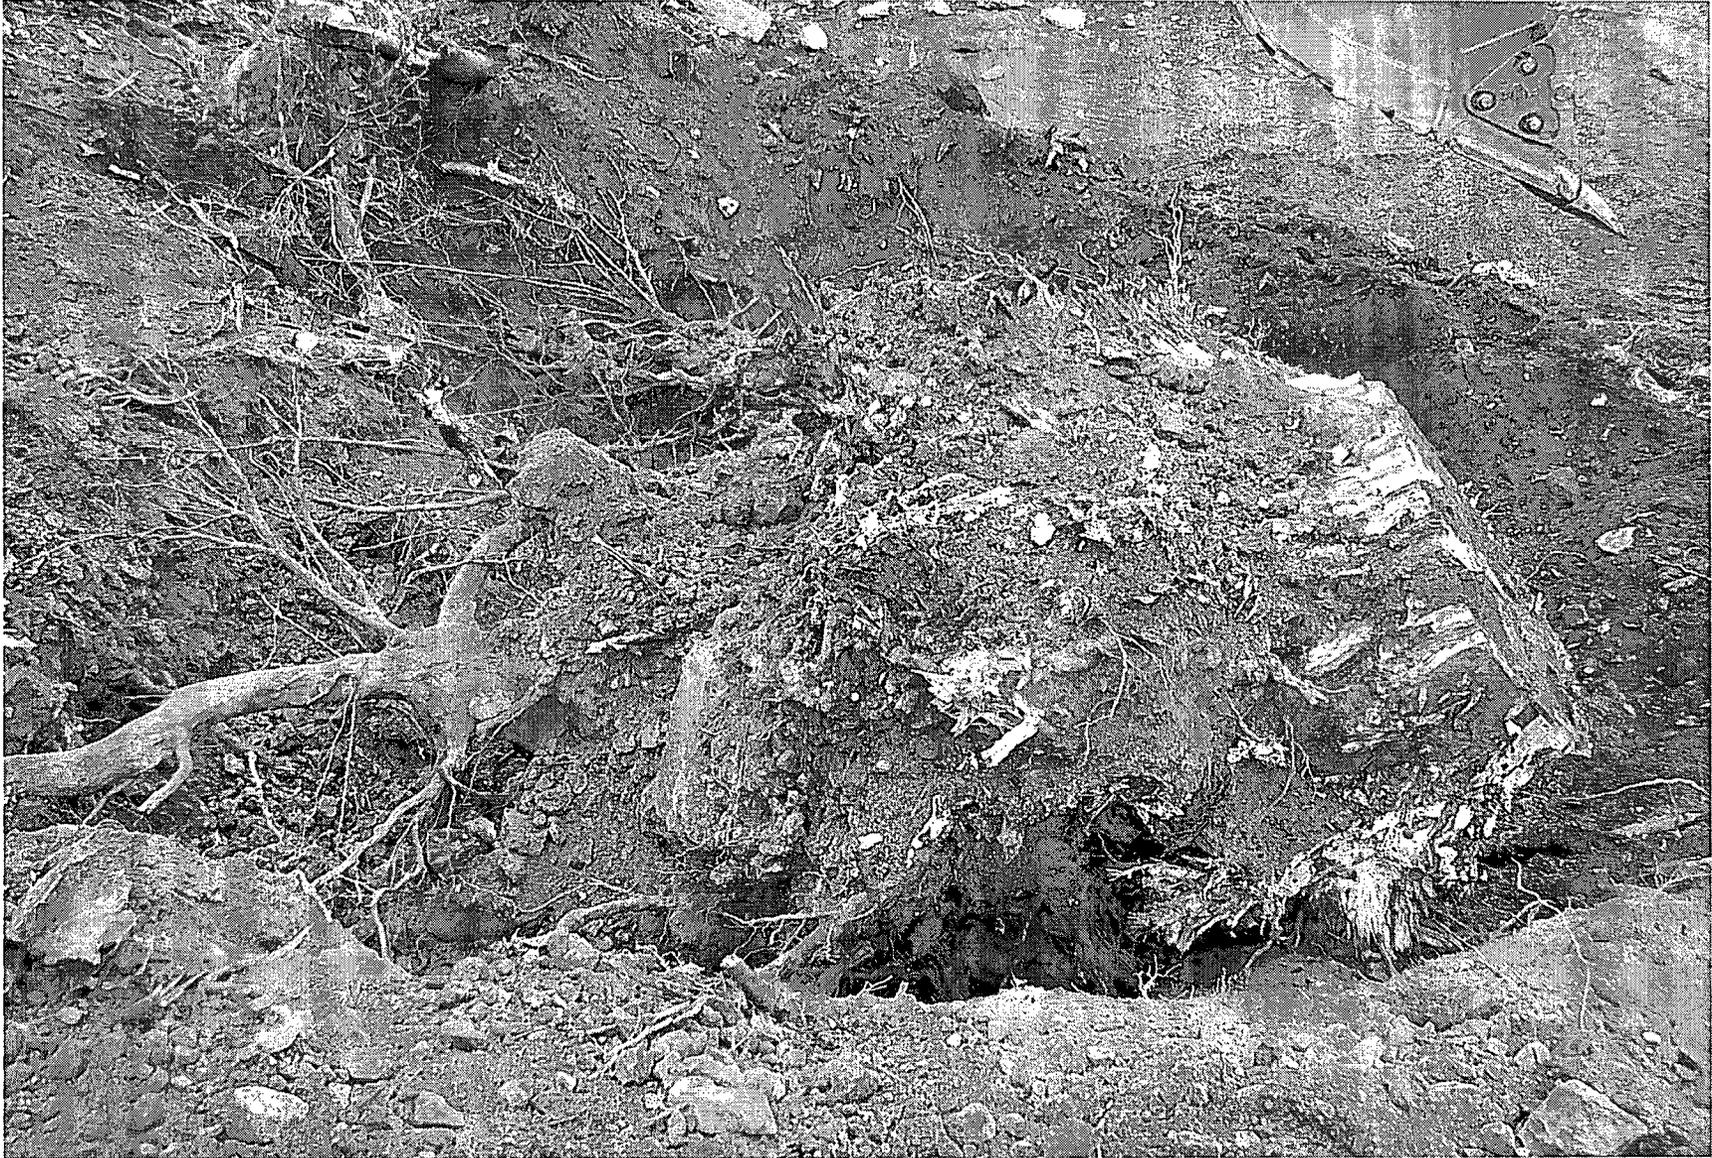
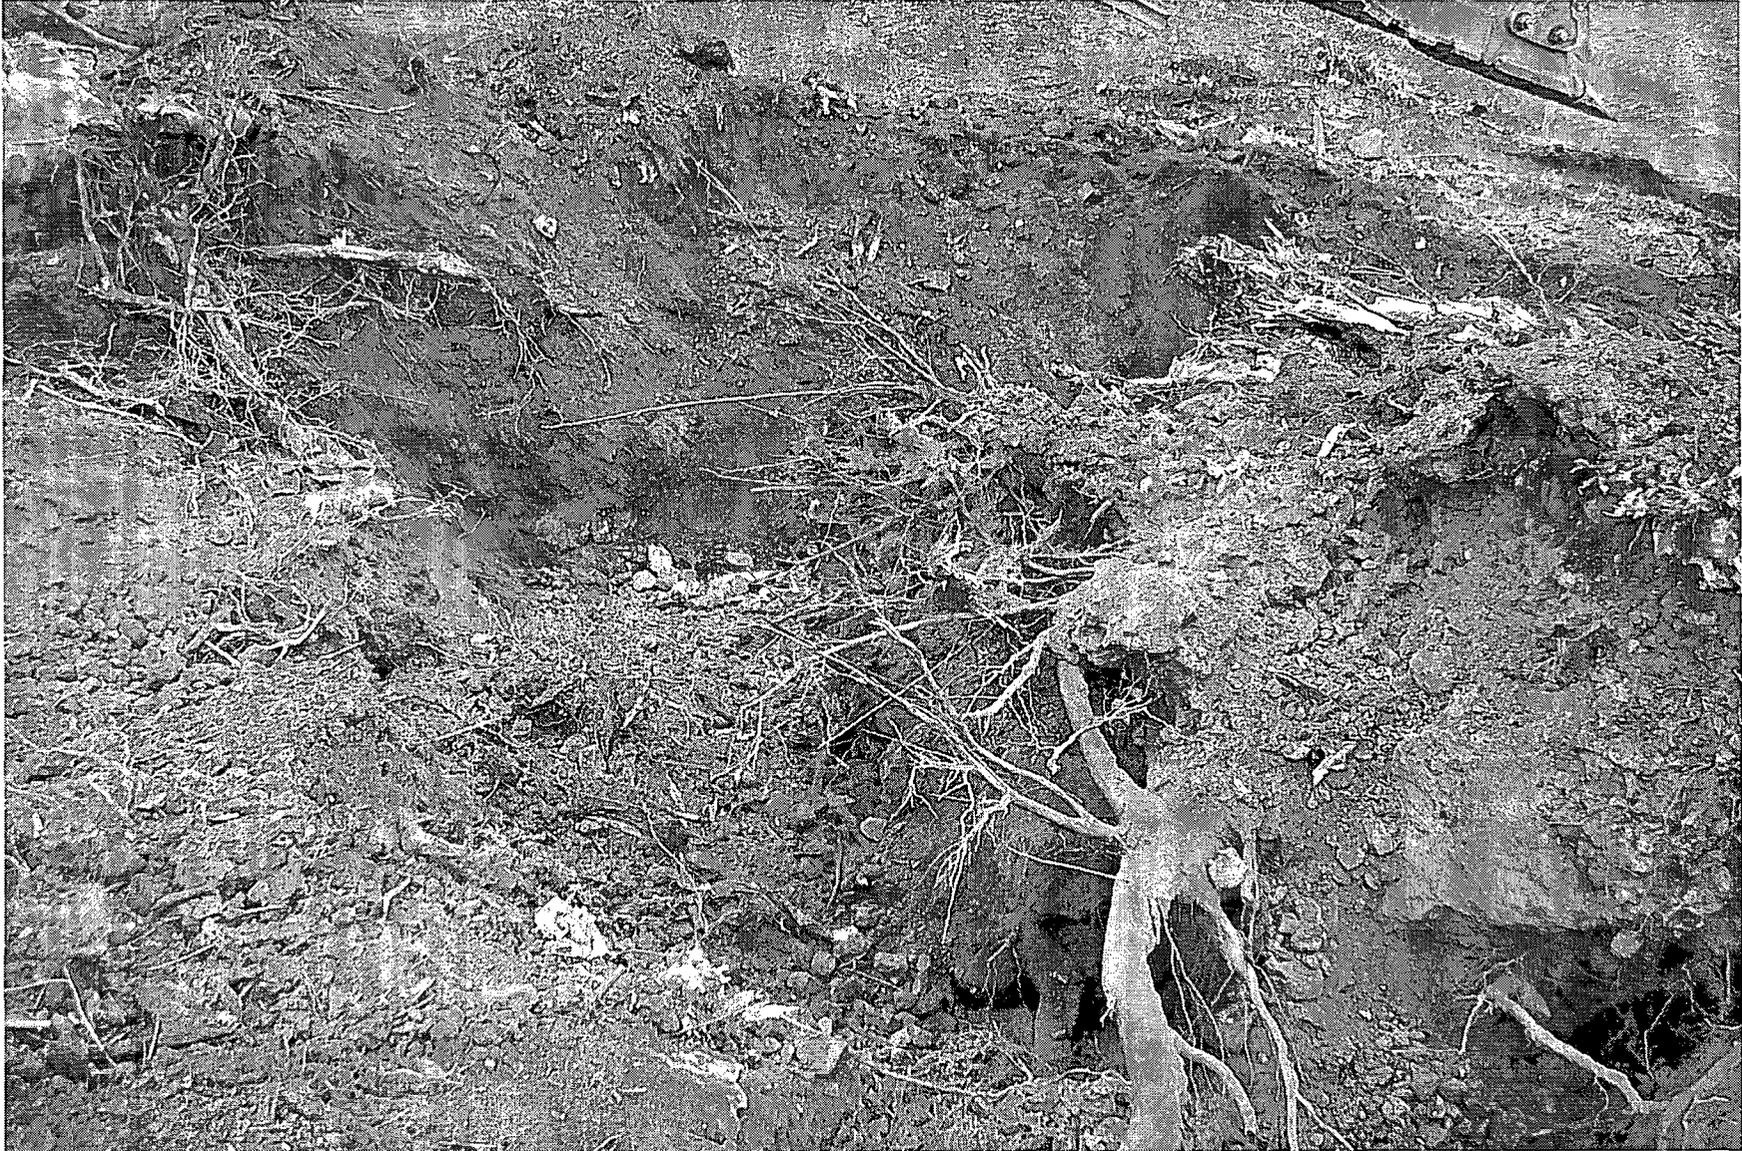
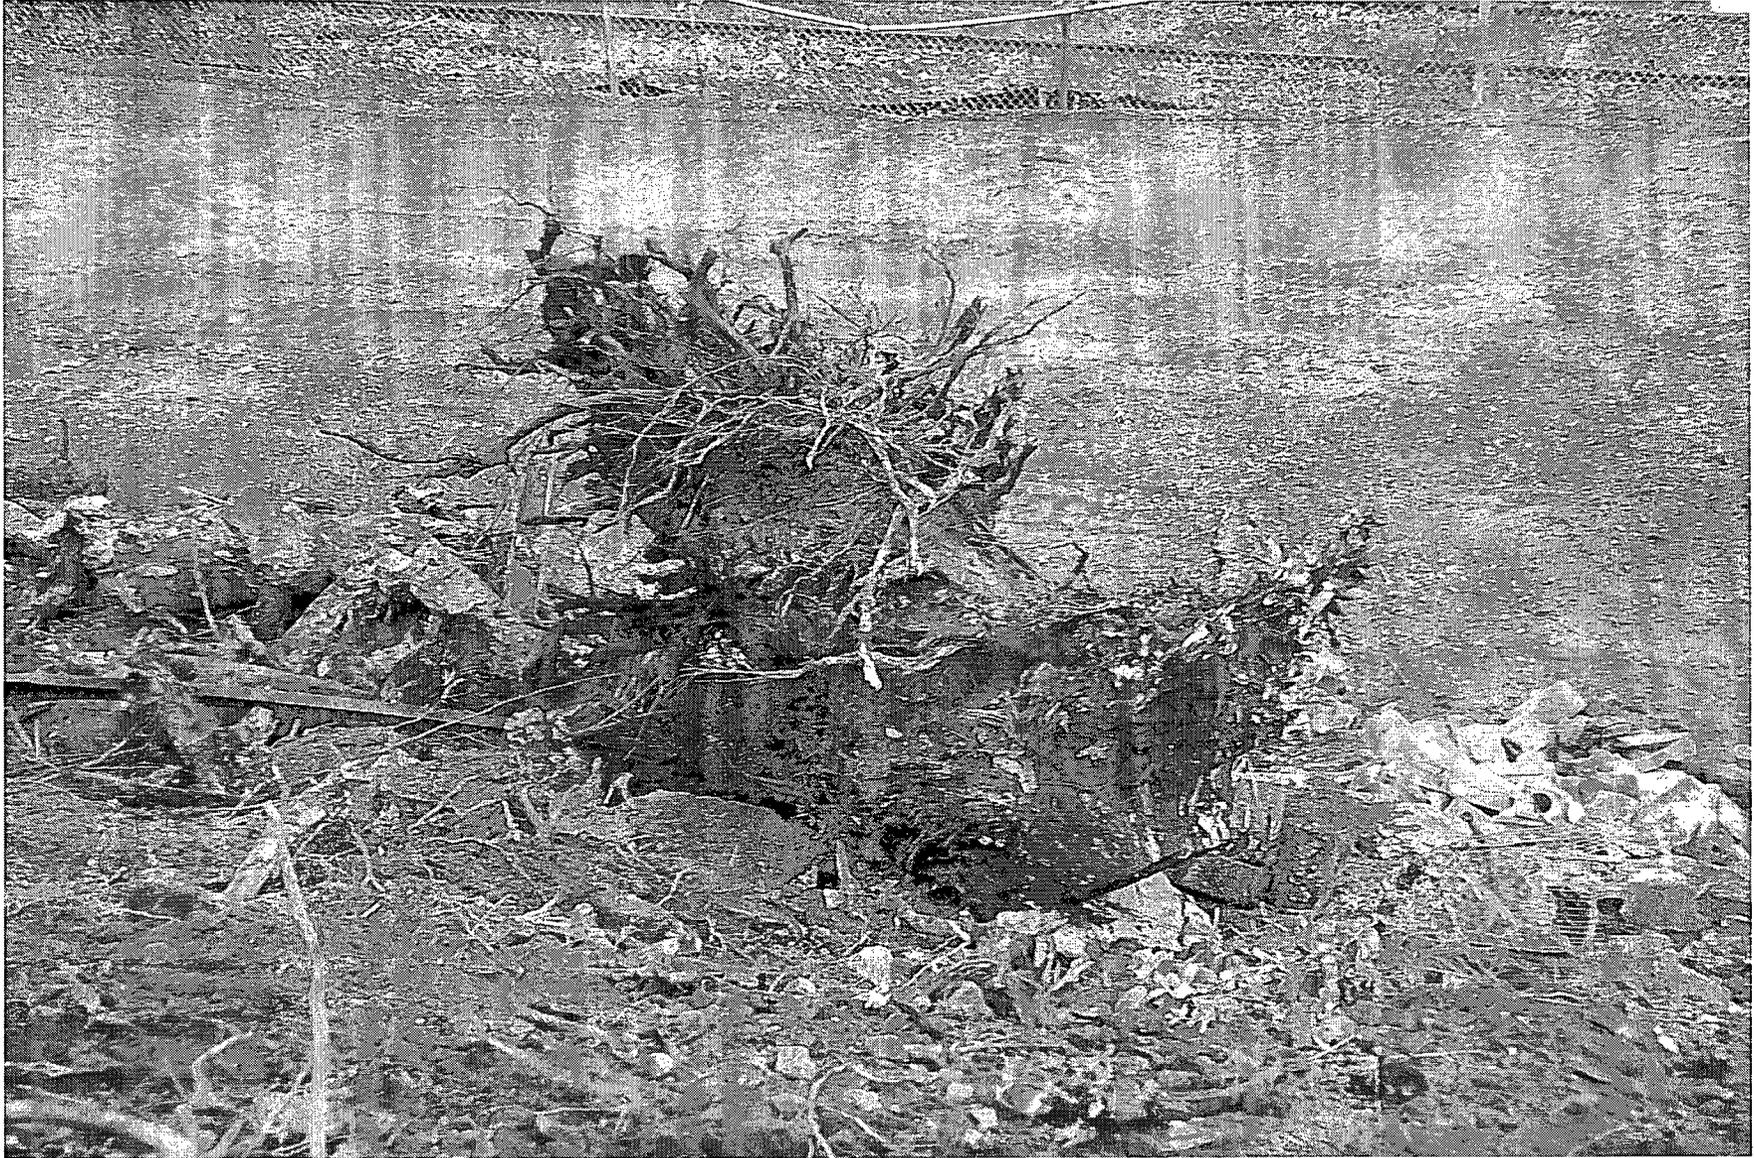
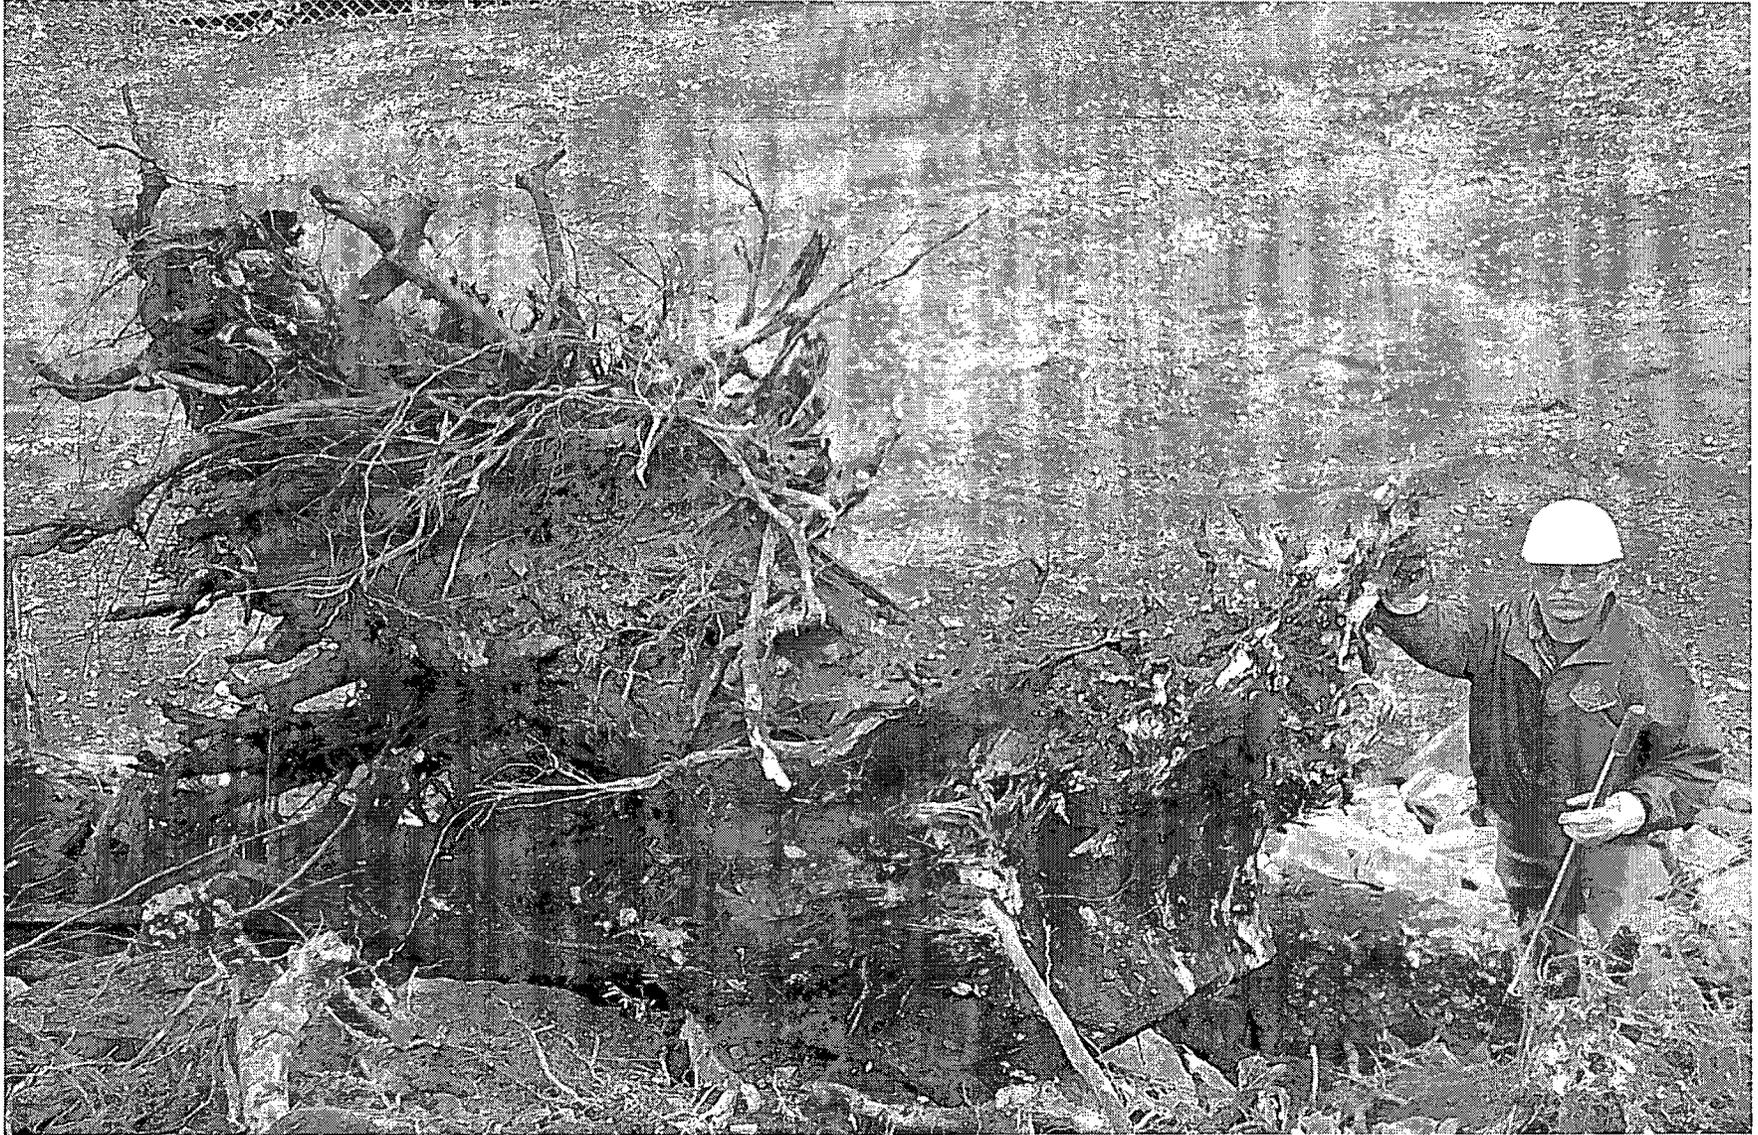
Removal of the tree stumps from the slag pile area occurred after NRC approval of the Decommissioning Plan in October 2007. The qualified radiological control technician performed radiological surveys of the ground surface surrounding each stump and the stump after it was removed. The technician also performed a visual inspection for slag material on each stump. After each stump was removed, the resulting hole was backfilled with FS-2.

The radiological control technician also surveyed and inspected each 30-yard roll-off prior to being filled with stumps and debris. Once cleared by the radiological control technician, the stumps and debris were placed in the roll-off for off-site disposal at a municipal waste landfill. All survey/inspection results for the stumps and roll-offs were documented in the radiological control technician's daily field book. A total of four (4) roll-off containers of debris and tree stumps were removed from the Site. Removal of the stumps began on October 25, 2007 and was completed on November 2, 2007. Photos 3-11 through 3-14 show examples of the stumps removed from the Site.

PHOTO 3-11 STUMP REMOVAL

PHOTO 3-12 STUMP REMOVAL.

PHOTO 3-13 STUMP REMOVAL

PHOTO 3-14 STUMP REMOVAL

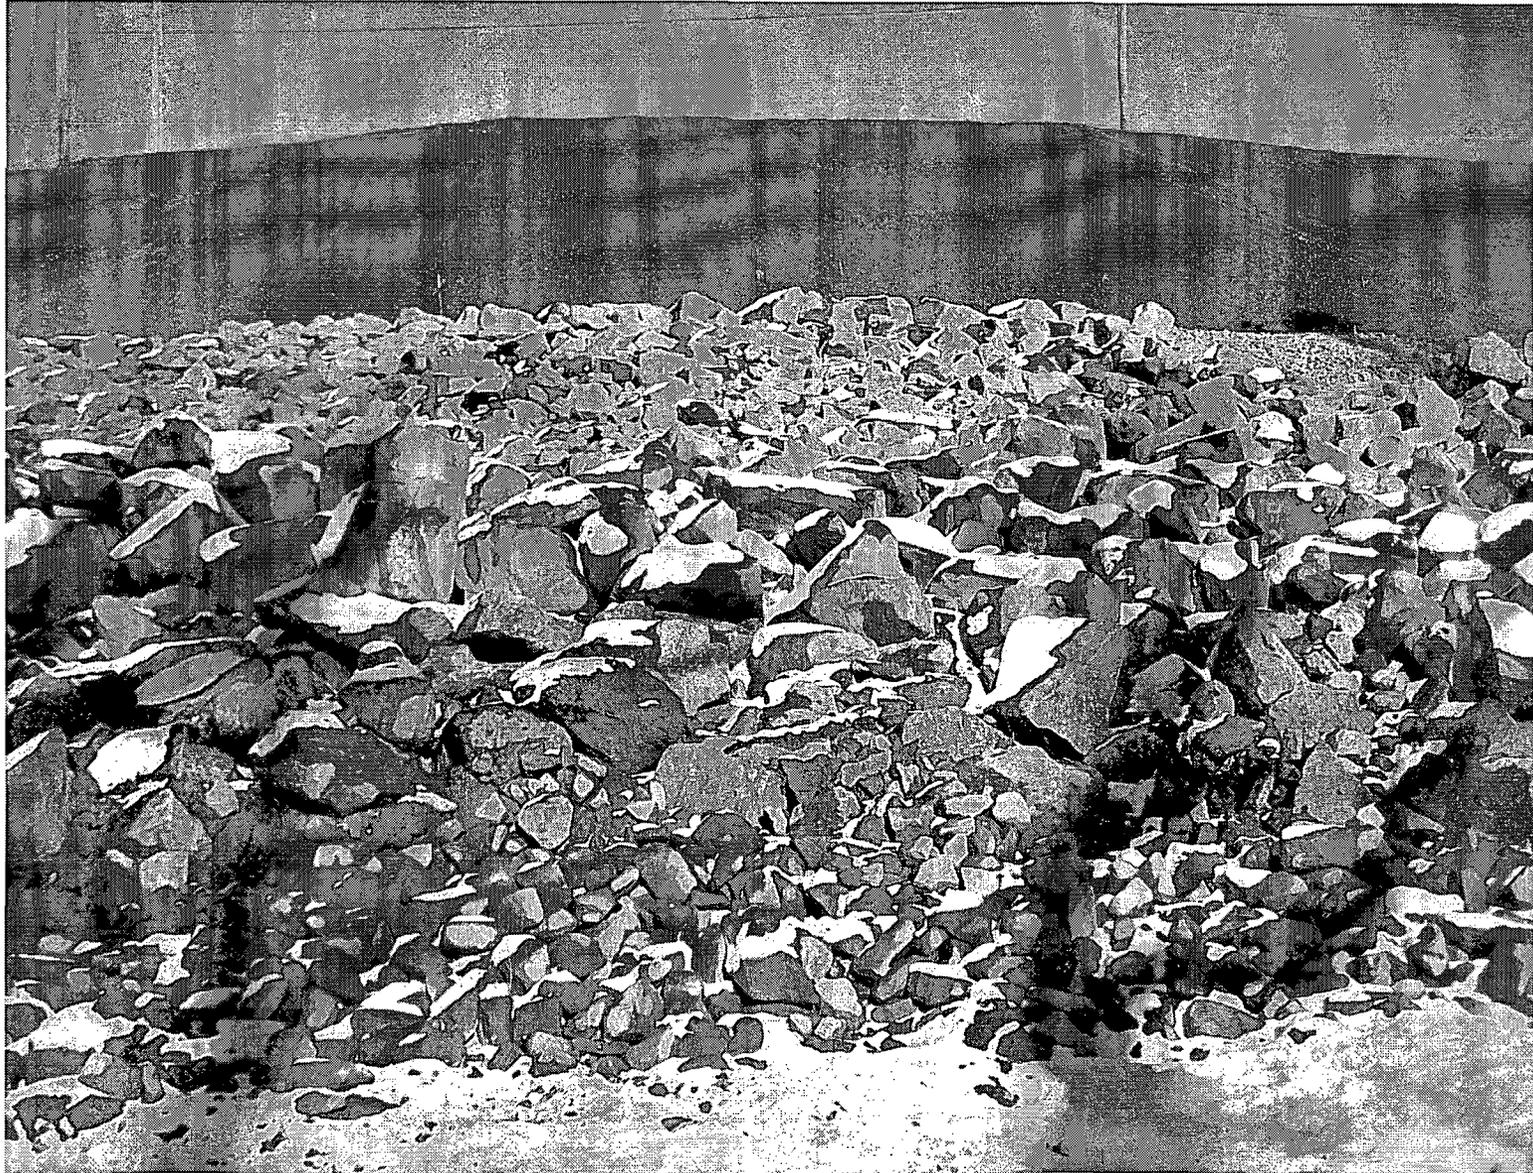
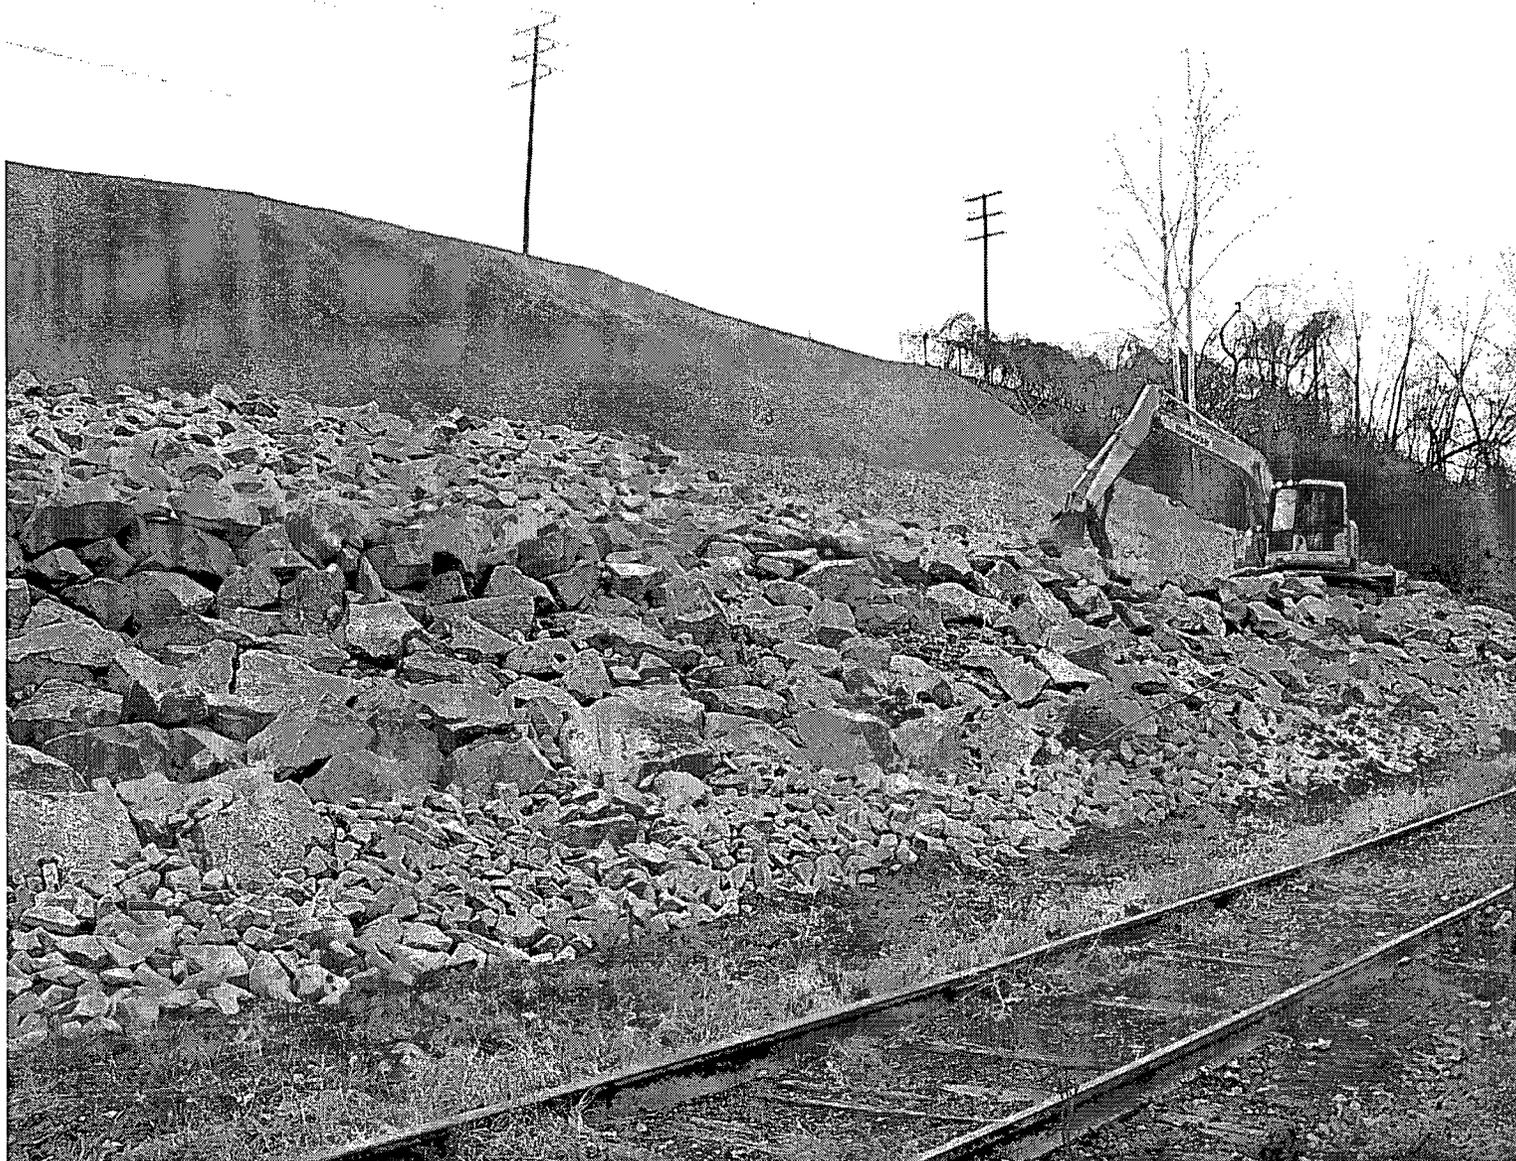
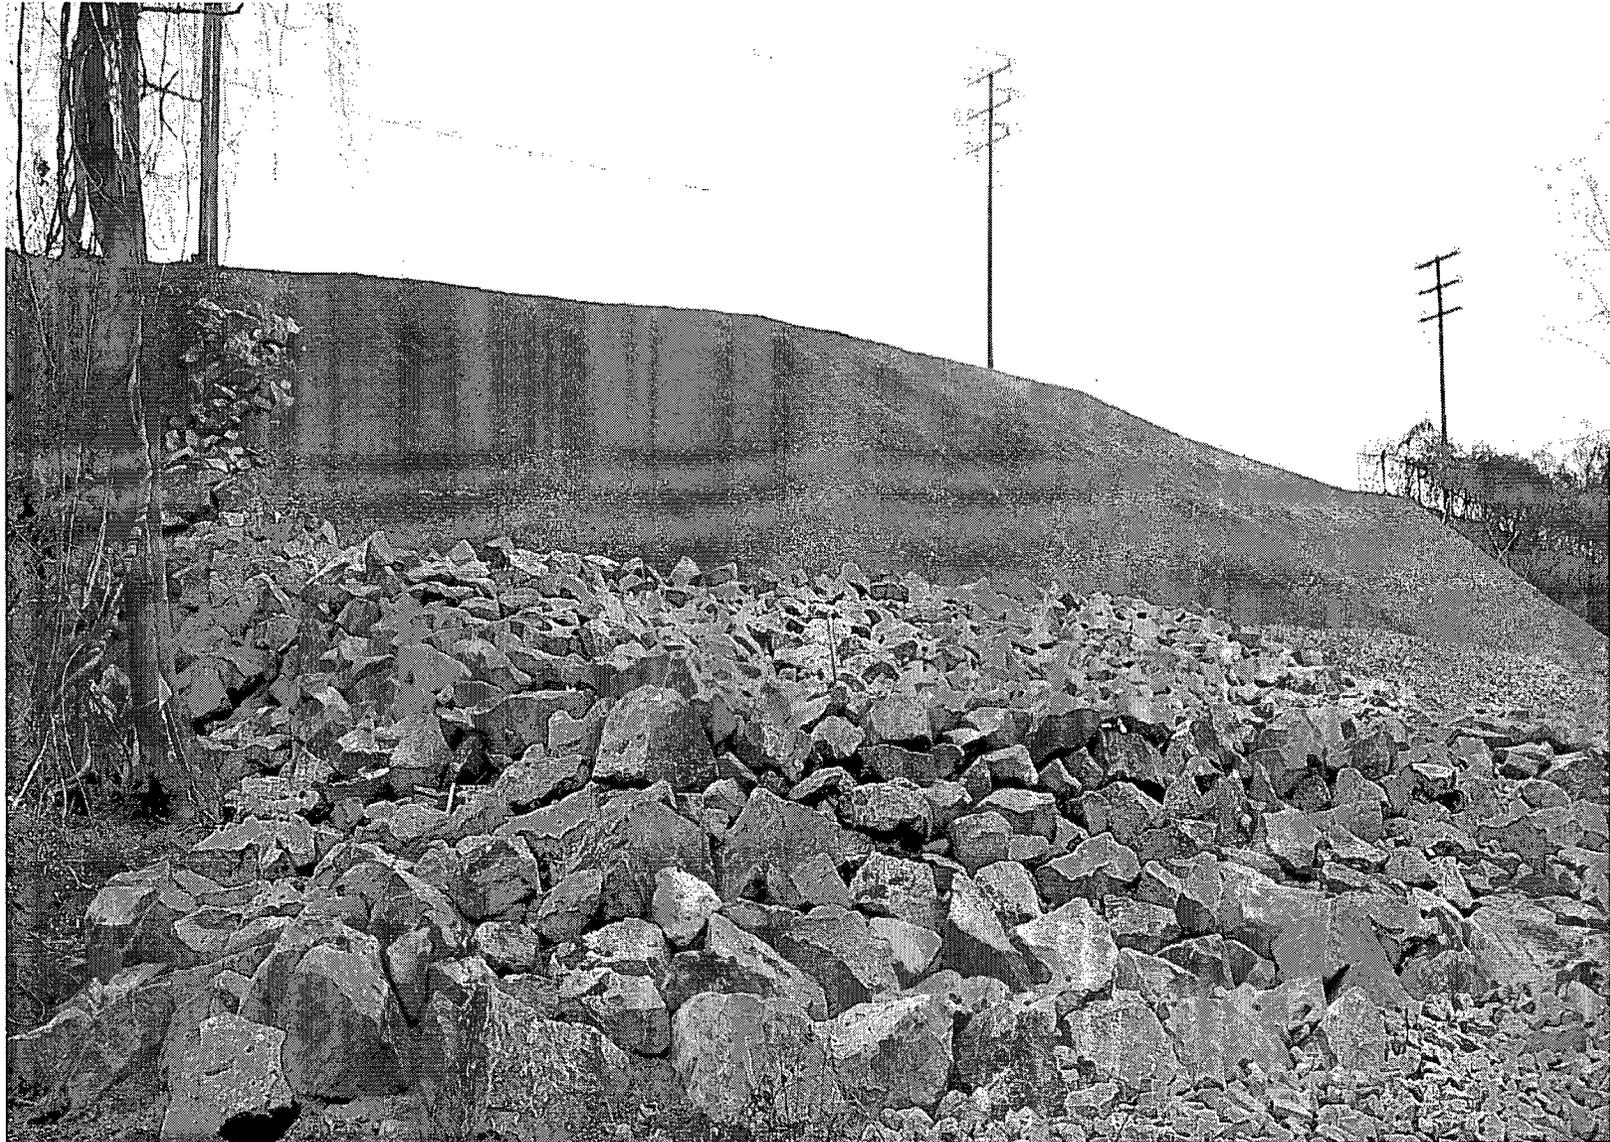
After stump removal and backfilling with FS-2, between 1 and 6 feet of additional FS-2 material needed to be placed across the slag pile to create a relatively uniform subgrade surface on which to construct the rip-rap cover. The dozer tracked up, down and across (to the extent possible) the slope to compact the subgrade material. The subgrade was completed on November 21, 2007 and is shown in Photos 3-15 through 3-17. The subgrade surface was then surveyed and confirmed that slopes were relatively uniform and were not greater than 1.5H:1V.

PHOTO 3-15 COMPLETED SUBGRADE

PHOTO 3-16 COMPLETED SUBGRADE

PHOTO 3-17 COMPLETED SUBGRADE

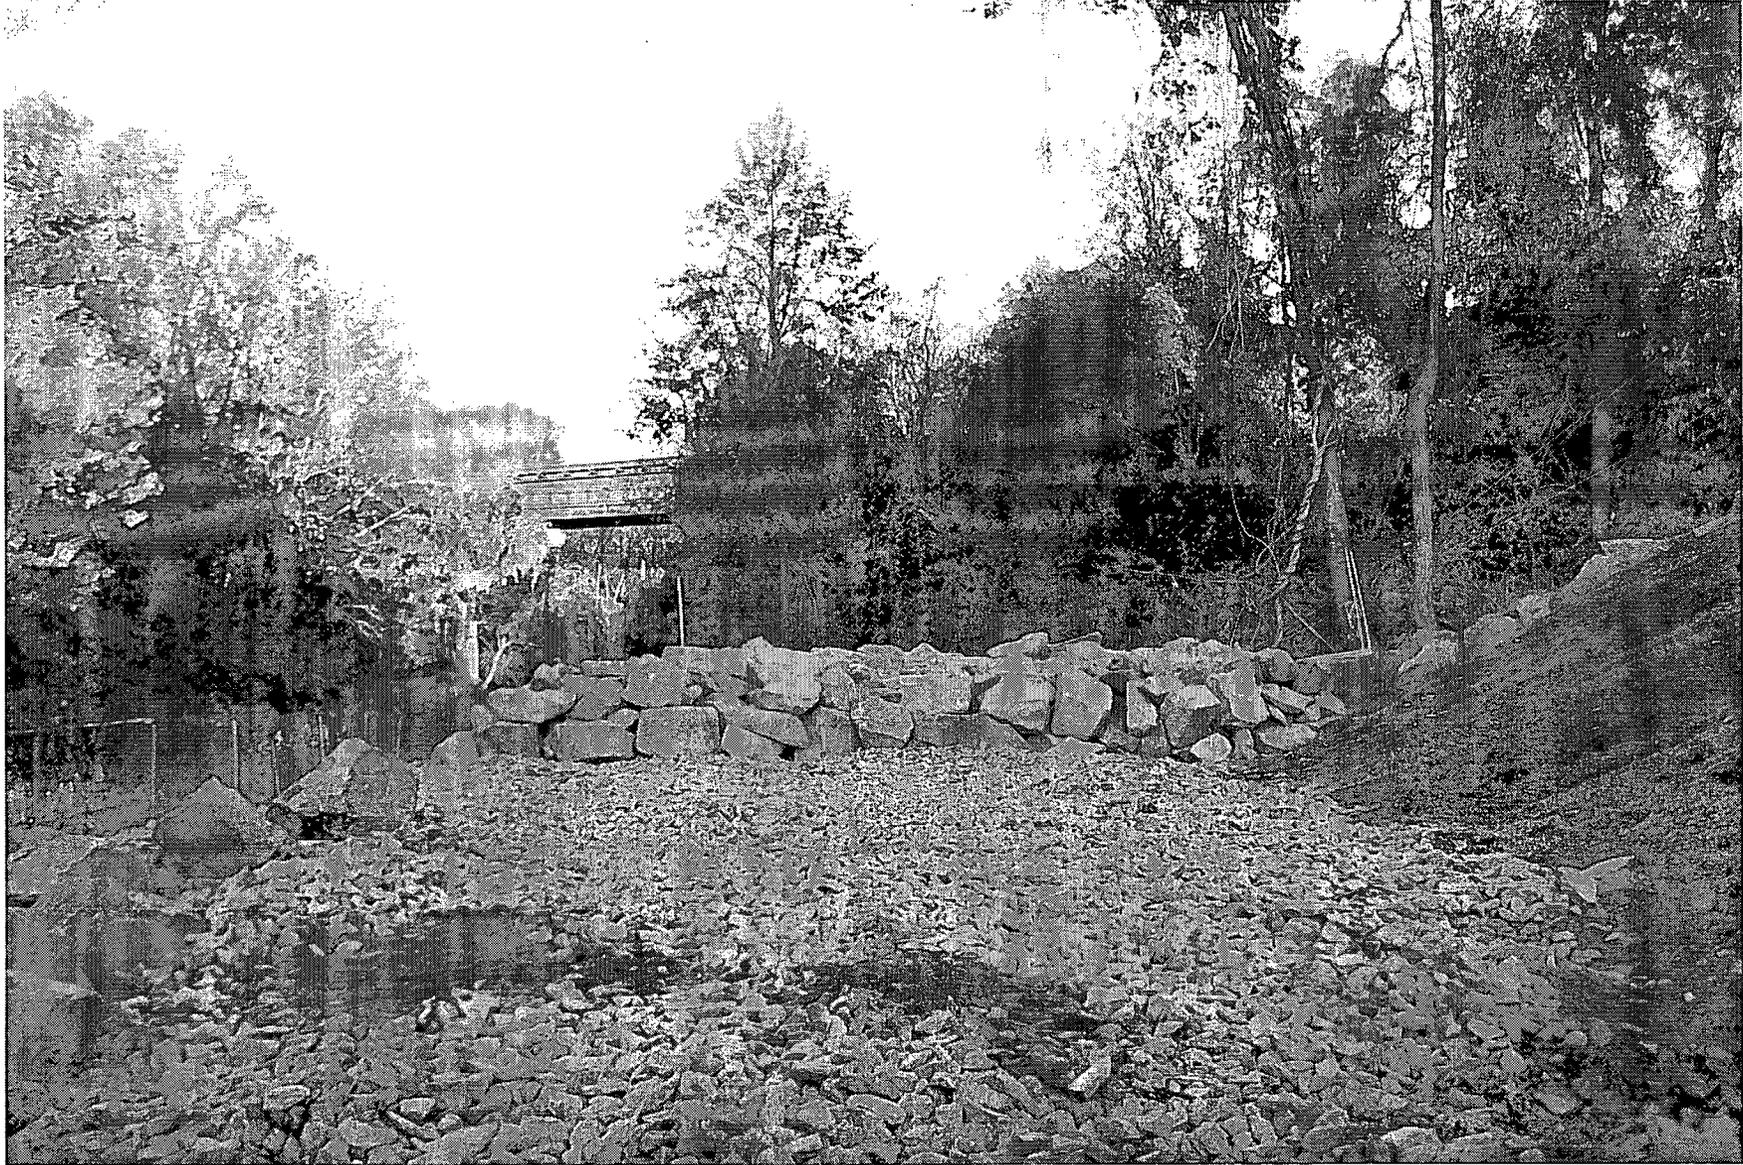
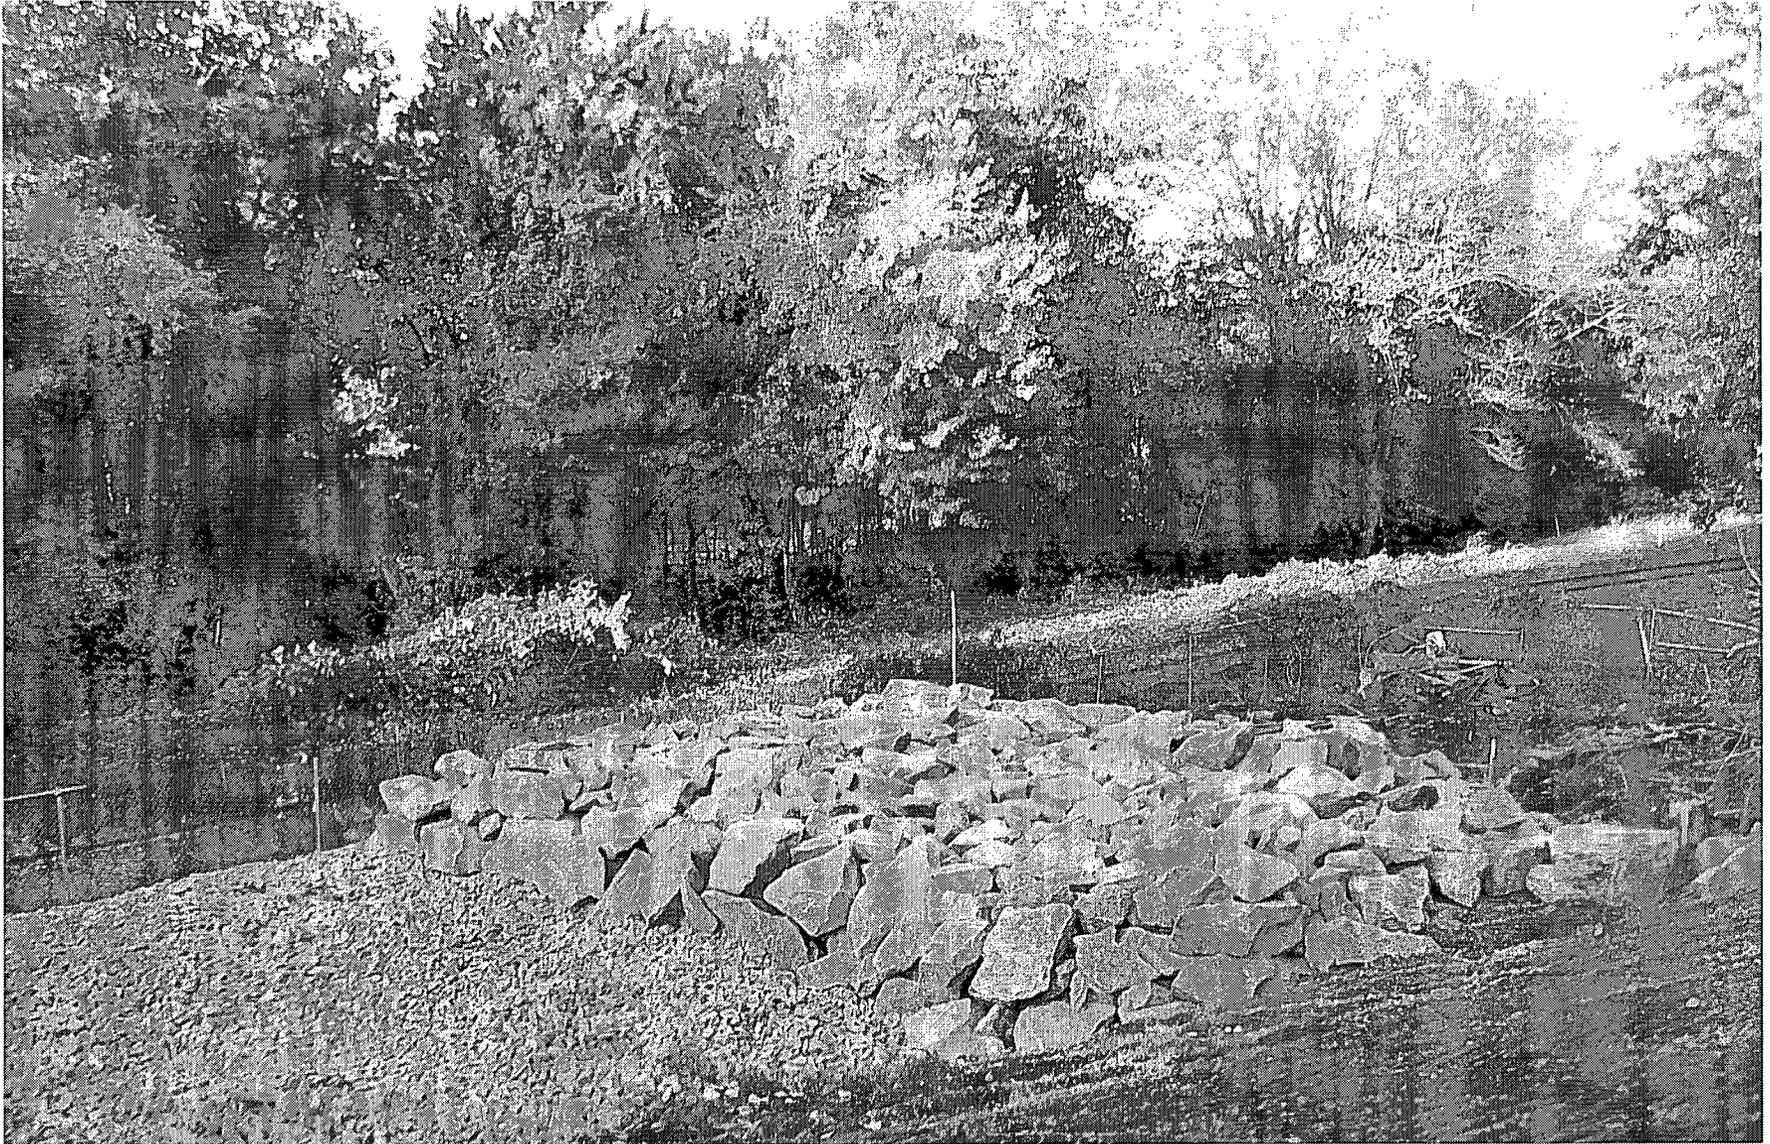
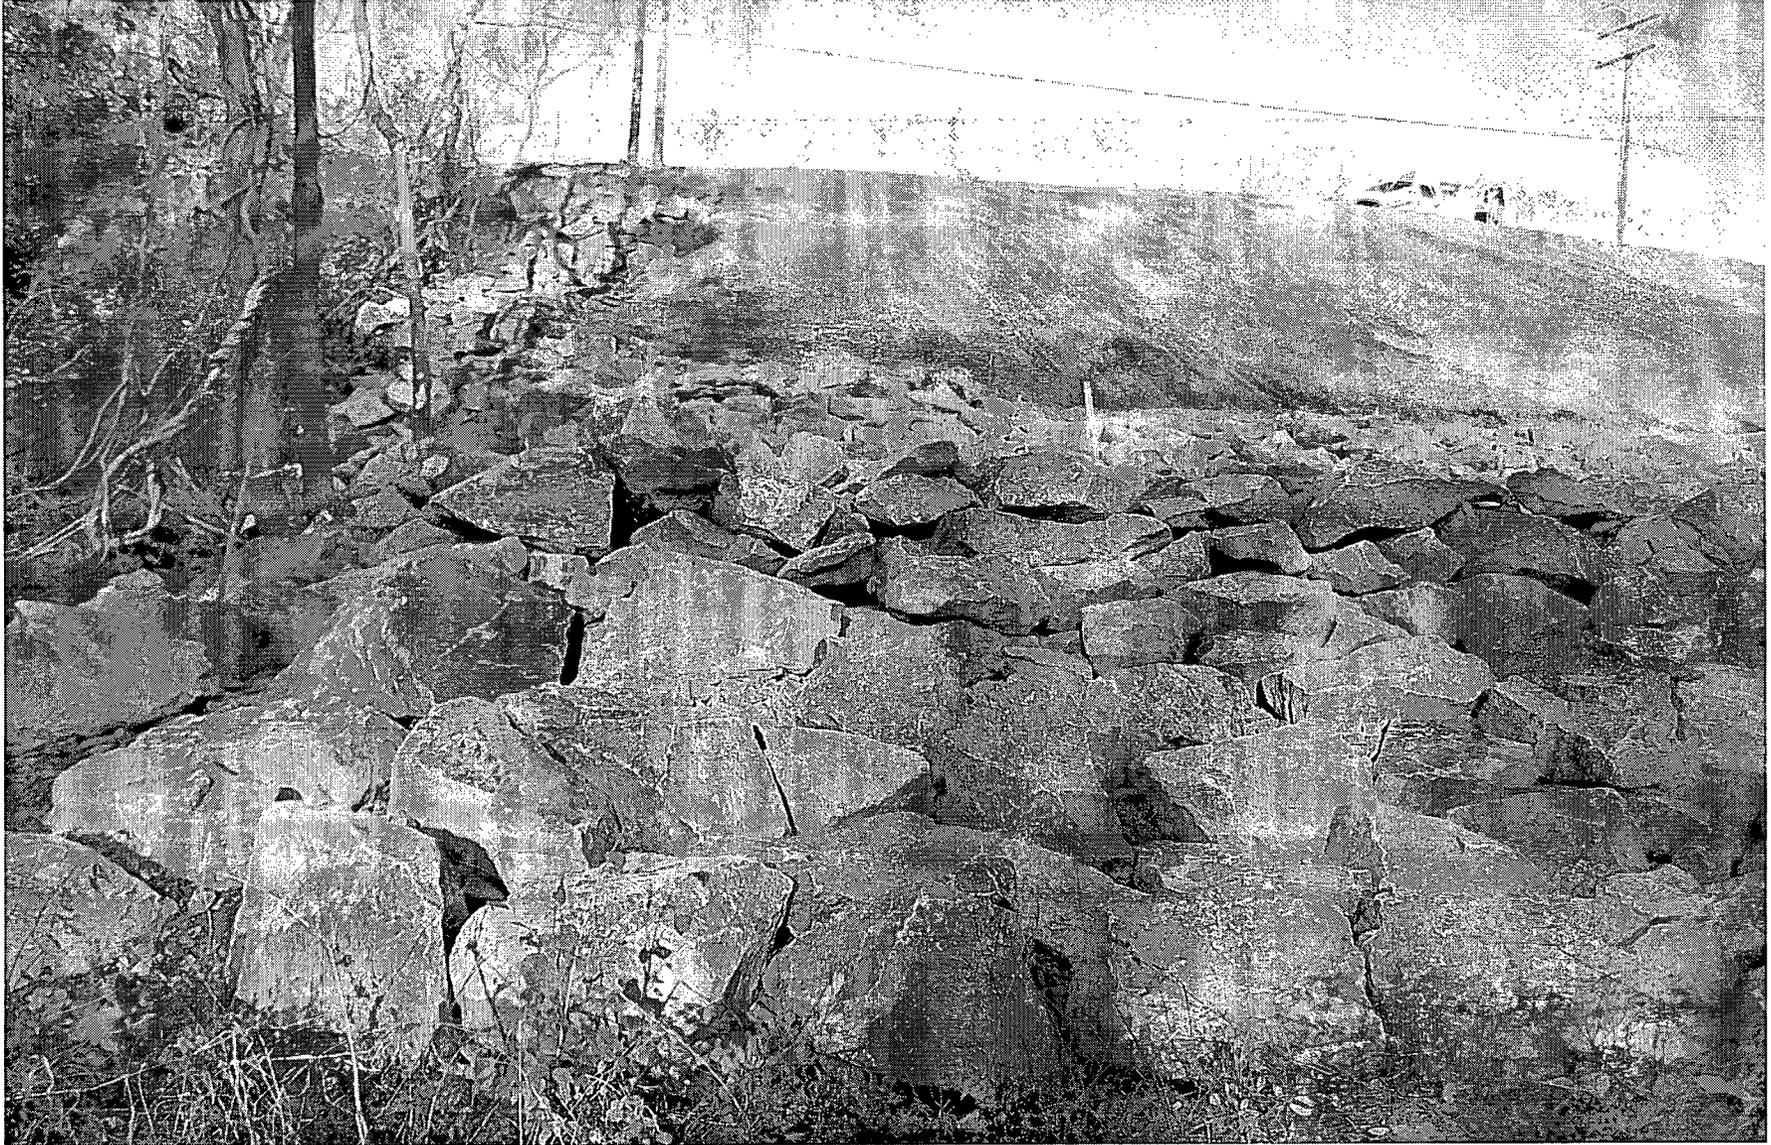
Prior to initiating full-scale cover construction, test pads for each size of the rip-rap (R-4, R-6, and R-7) were constructed for NRC inspection to establish and confirm acceptable construction methods. Due to site area limitations and to avoid the need to dismantle the test pads after inspection, the test pads were constructed in the upstream portion of the cover area and subsequently incorporated into the rest of the cover. The R-7 test pad was approximately 25’ (W) x 25’ (L) x 4.5’ (H) (minimum thickness for R-7), the R-6 test pad was approximately 20’ (W) x 25’ (L) x 2’ (H) (minimum thickness for R-6) and the R-4 test pad was approximately 10’ (W) x 10’ (L) x 1’ (H) (minimum thickness for R-4).

The NRC inspected the test pads on November 13, 2007 to confirm that they met the requirements of the rock placement procedures. With one exception, the NRC agreed that construction was consistent with the procedures and also agreed that construction of the remainder of the cover could proceed. The NRC noted one area of the test pad where the layer of R-7 rock appeared to be less than the required thickness. It was agreed at this time that the thickness of any area of the cap could be confirmed by dismantling the area in question and confirming the in-place thickness or by providing documentation (i.e. field notes, photos) as evidence of compliance with the design. Verification of proper construction of this area of the test pad and other areas of the cover (during and post-construction) are presented in Section 6.

Photos 3-18 through 3-20 show the completed test pads. Full-scale construction of the rip-rap cover commenced immediately after the NRC inspection and approval to proceed.

PHOTO 3-18 R-7 TEST PAD

PHOTO 3-19 R-7 TEST PAD

PHOTO 3-20 R-4 & R-6 TEST PADS
