Subject: Draft Decommissioning Plan Completion Report for the Reading Slag Pile Site
License No. SMC-1562
Docket Number 40-9027

**READING SLAG PILE SITE
DECOMMISSIONING PLAN COMPLETION REPORT
SOURCE MATERIAL LICENSE SMC-1562**

**ST Environmental Professionals, Inc.
GeoSystems, Inc.
de maximis, inc.
Austin Masters, Inc**

Cabot Corporation

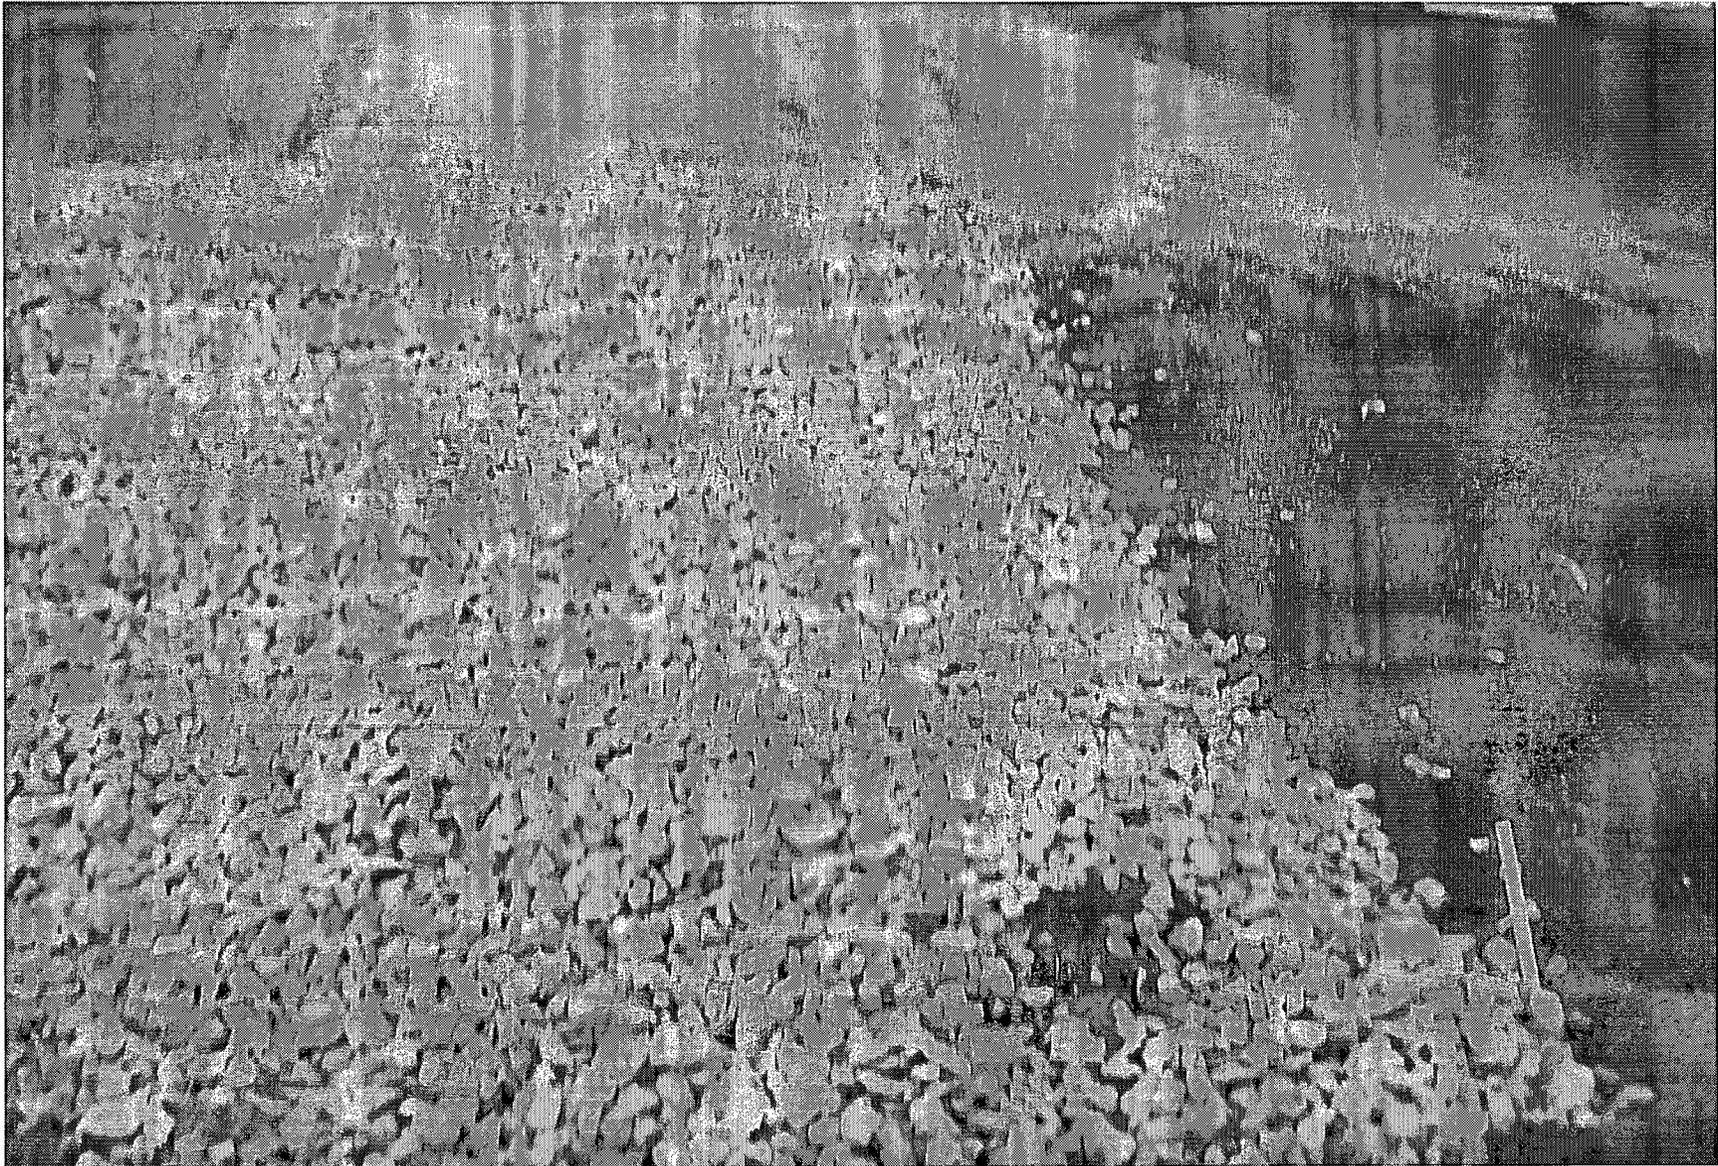
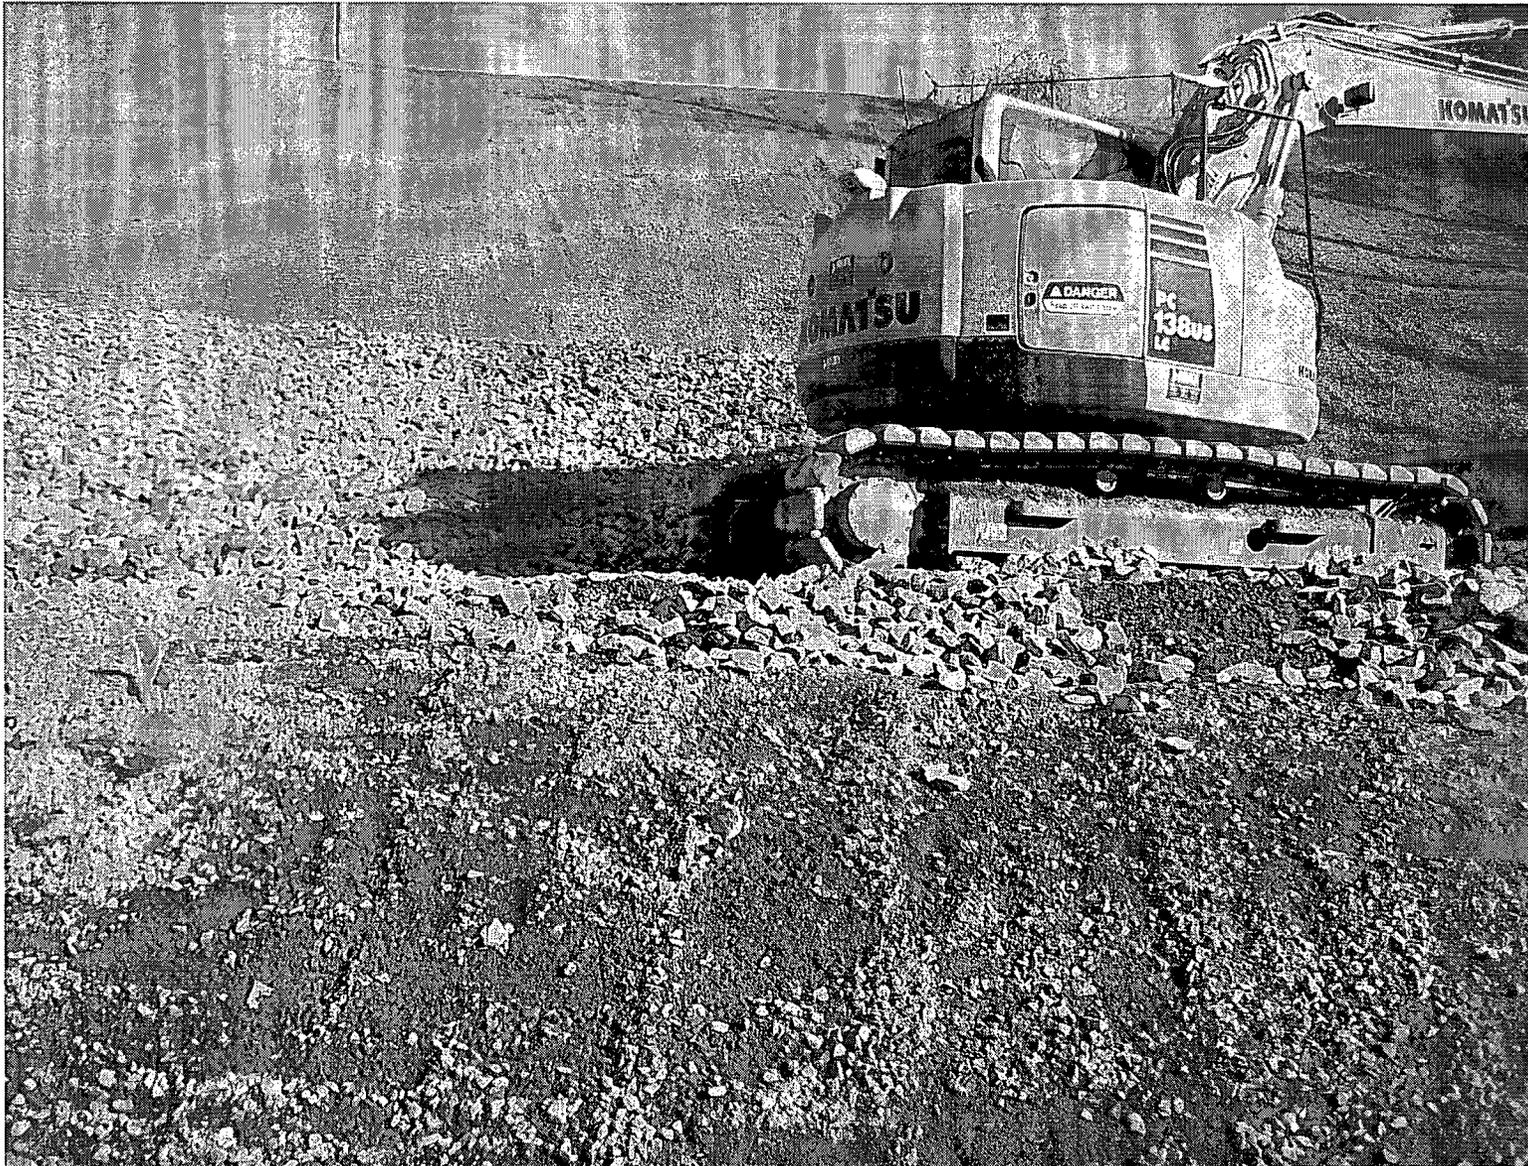
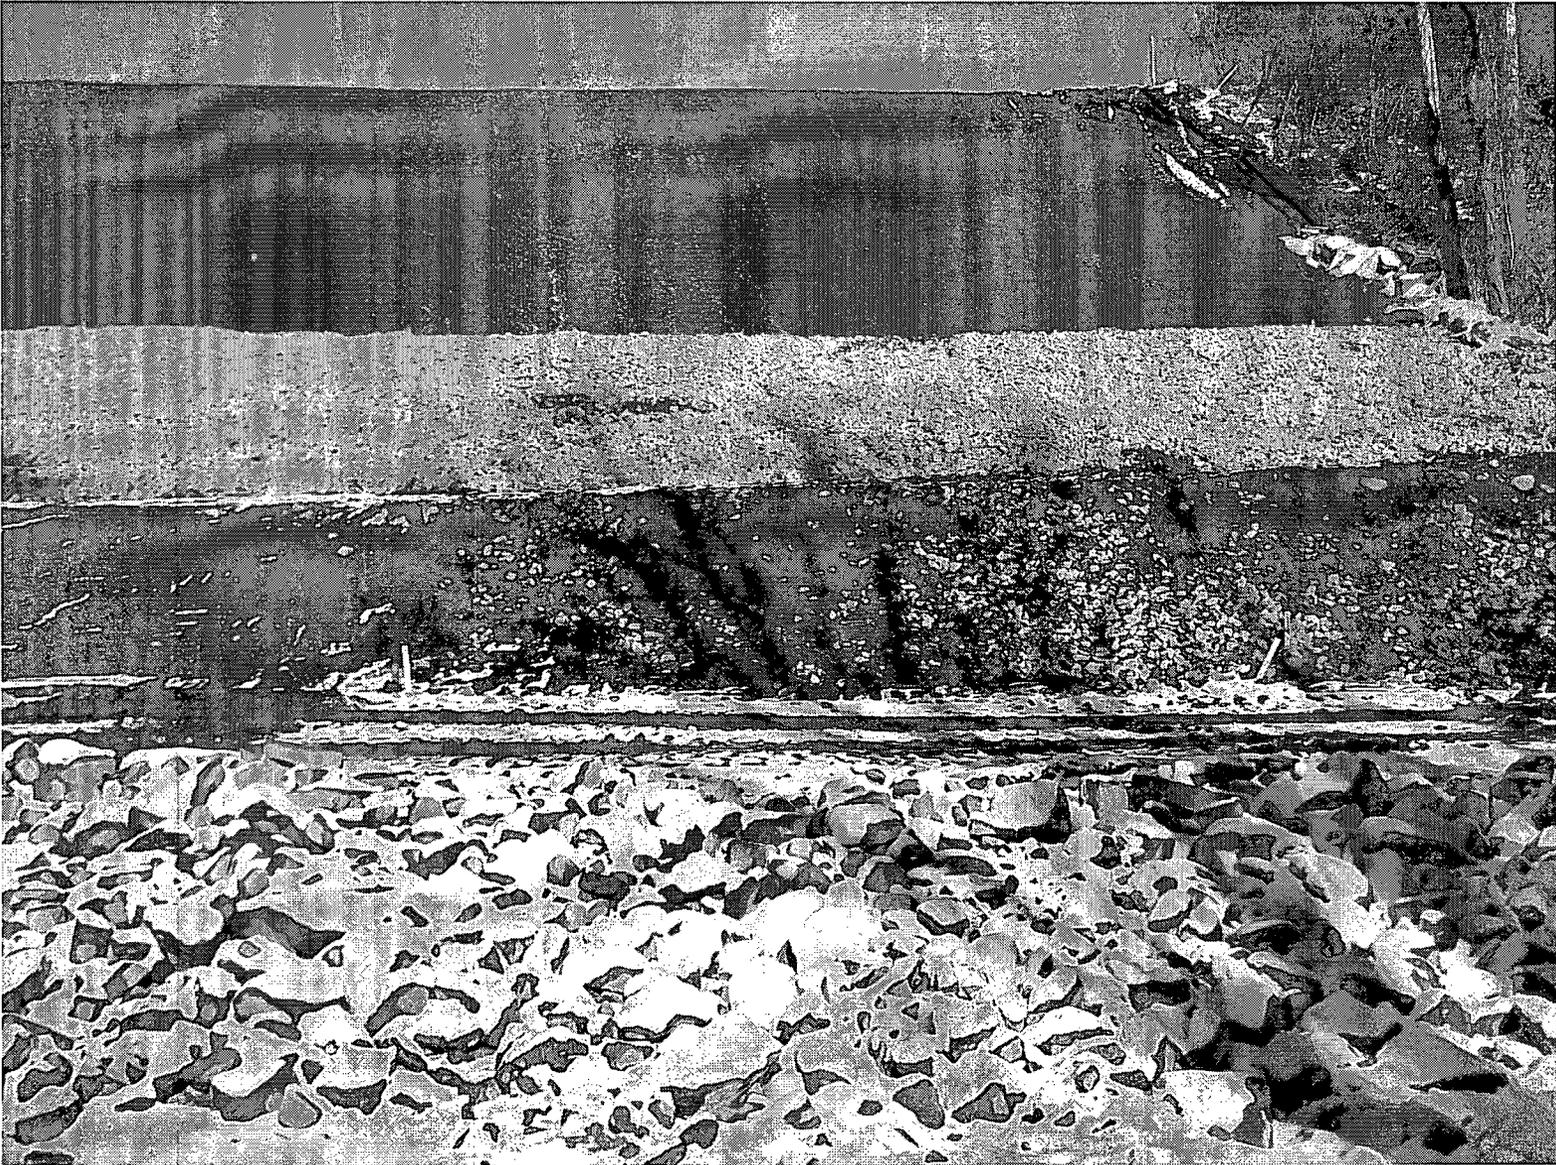
The Contractor placed field stakes and used string lines across the work area to guide the placement of one foot of FS-3 bedding layer in the R-7 section and eight inches of the FS-3 in the R-6 section. Due to site area limitations and slope constraints, the Contractor chose to construct the R-6 and R-7 sections of the cover in roughly 30 foot by 30 foot areas, moving from west to east. Therefore, instead of placing the bedding material across the entire R-6 and R-7 sections, the bedding layer was also placed in the 30 foot by 30 foot areas. This construction approach also reduced the potential for over-compaction or disturbance of the bedding layer had it been placed initially across the entire R-6 and R-7 area. Placement of the bedding layer in the R-7 and R-6 sections began on October 29, 2007 and was completed on January 9, 2008. Photos 3-21 through 3-24 show placement of the bedding layer.

PHOTO 3-21 BEDDING LAYER

PHOTO 3-22 BEDDING LAYER

PHOTO 3-24 BEDDING LAYER

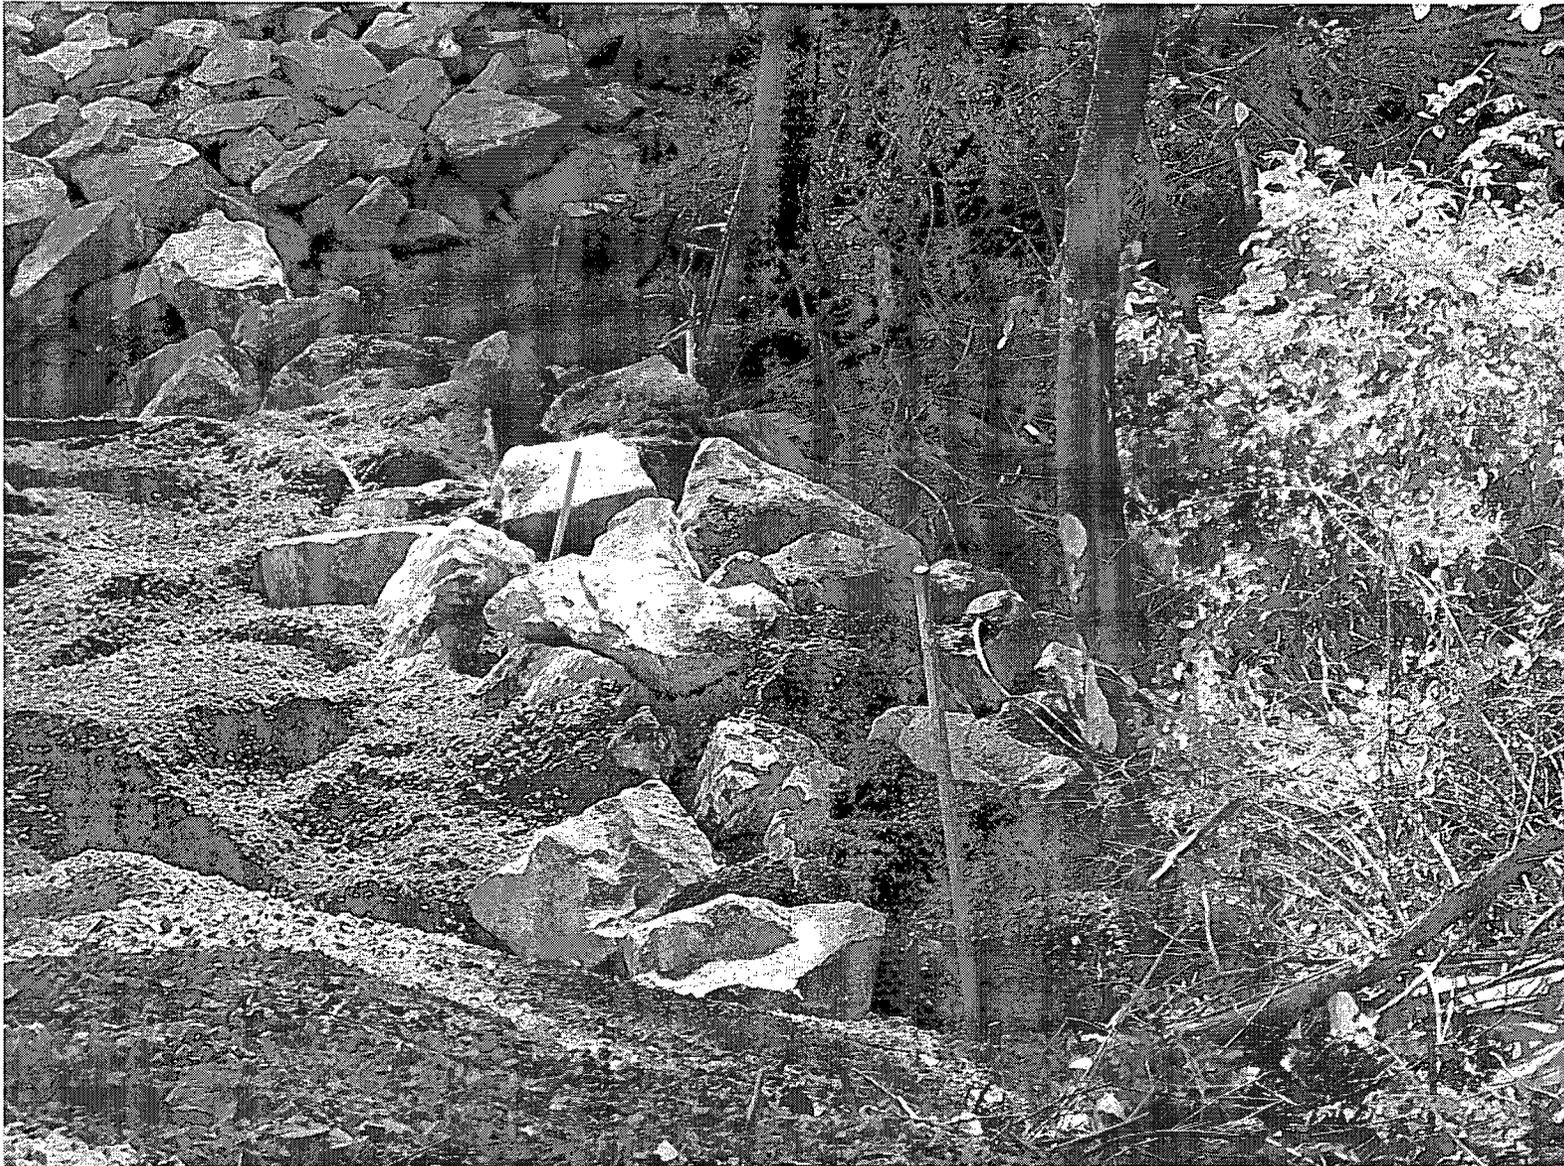
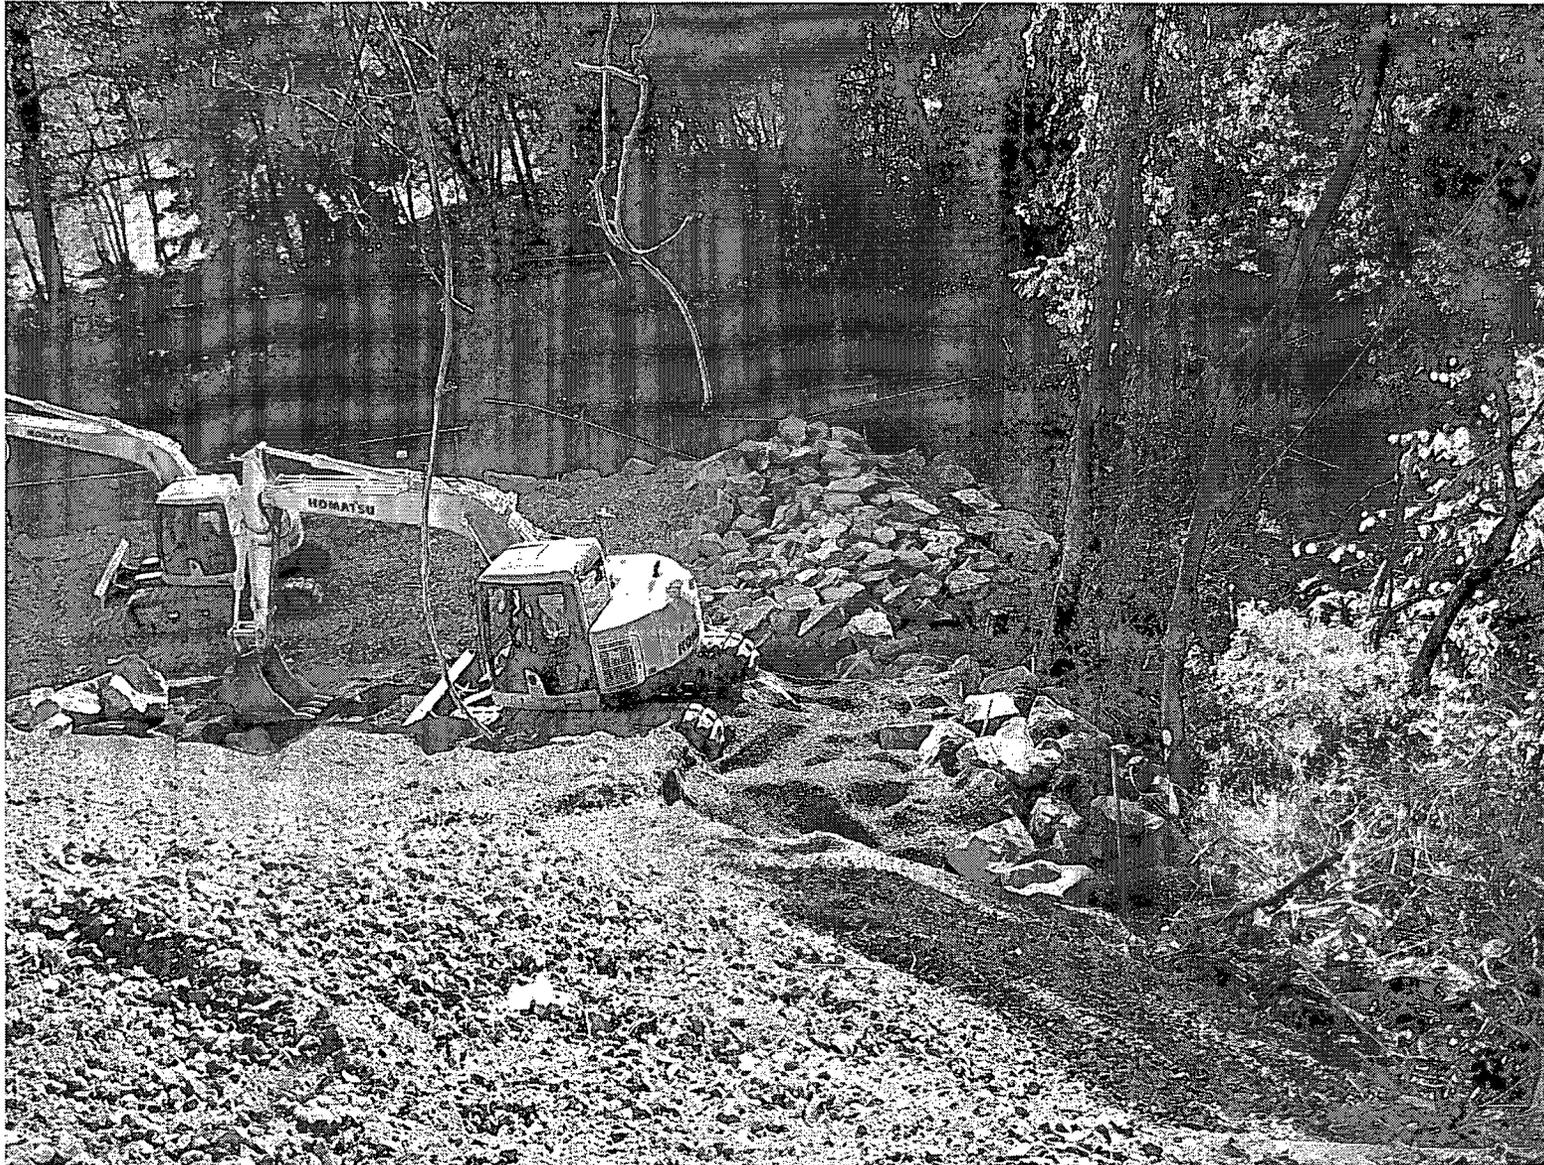
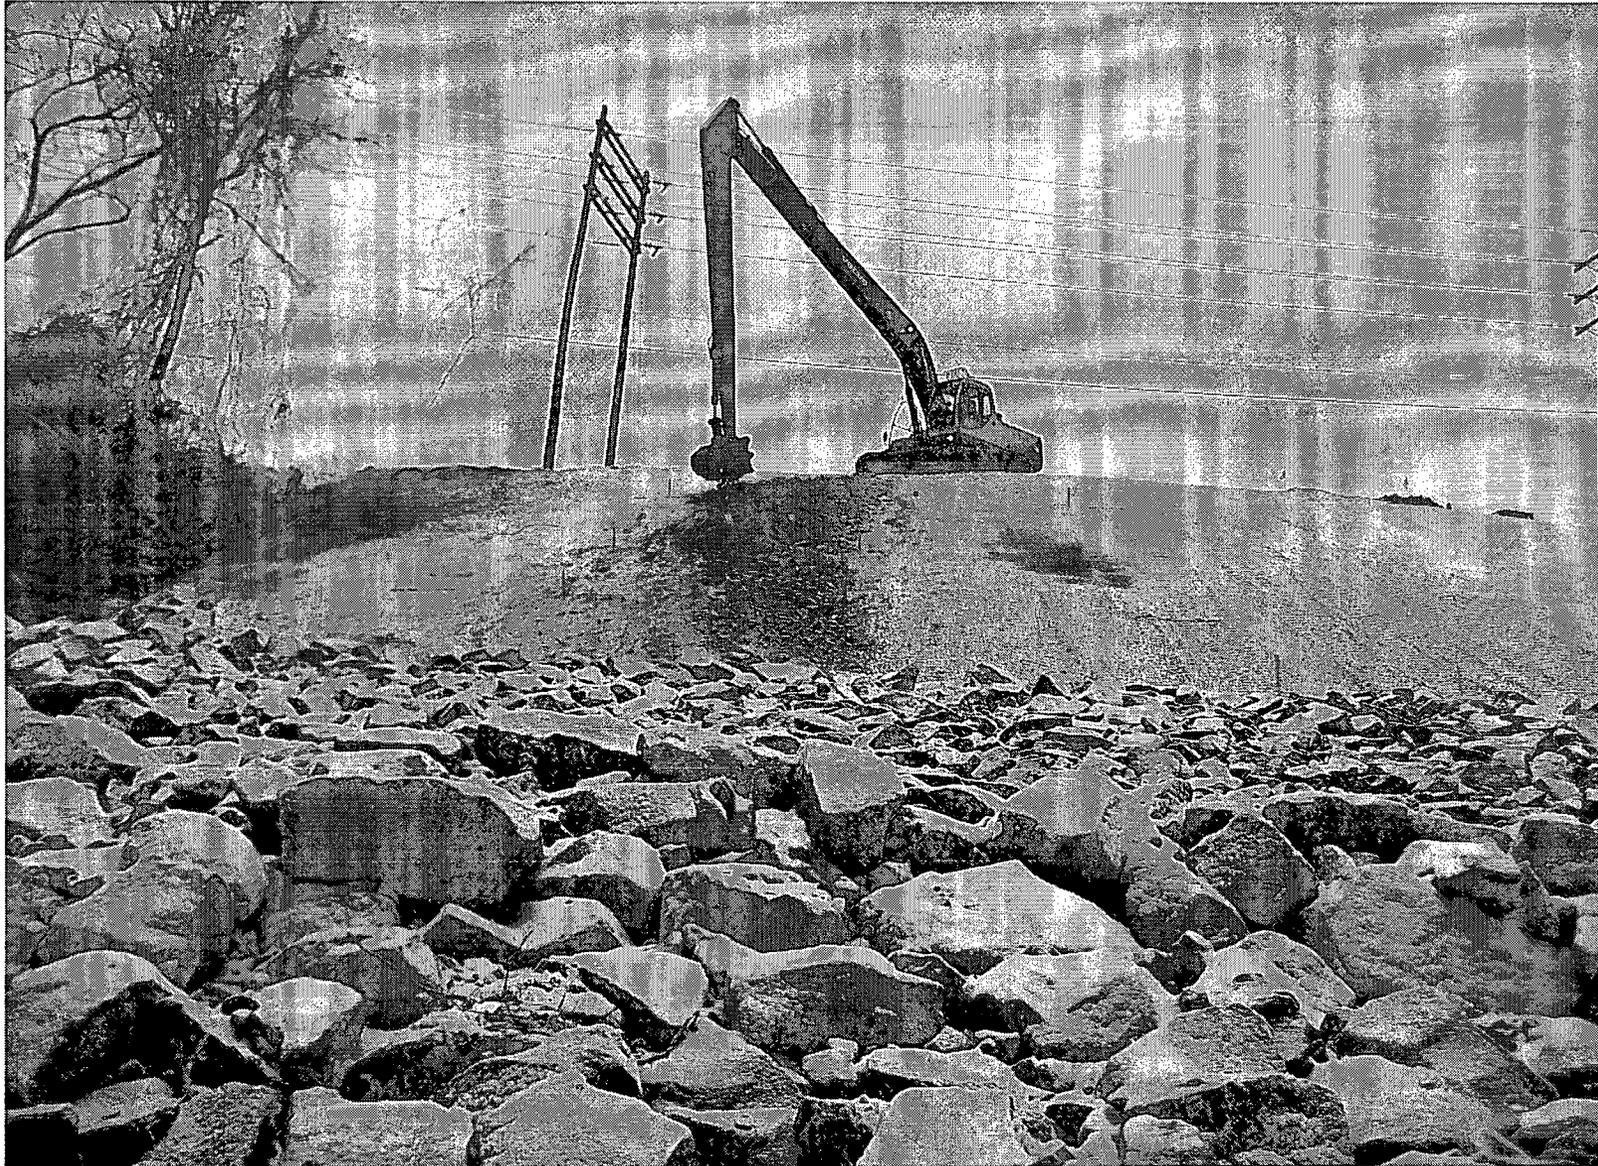
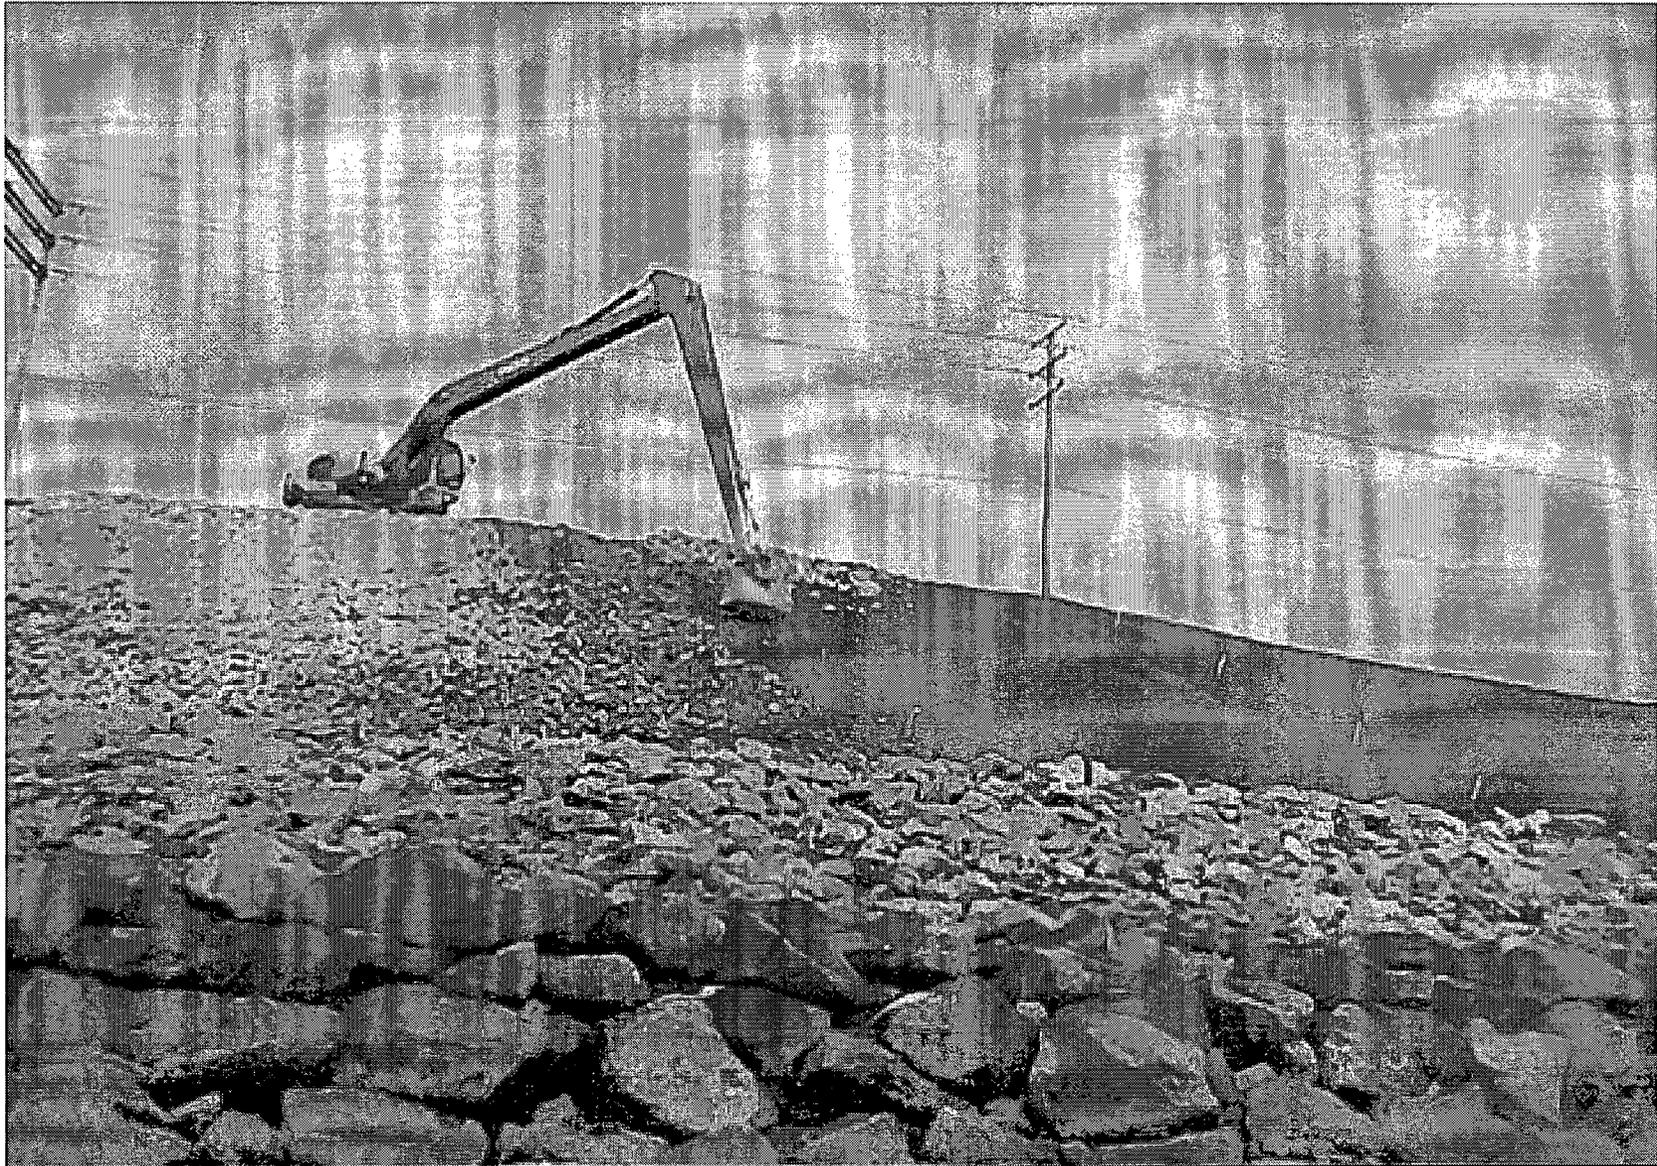
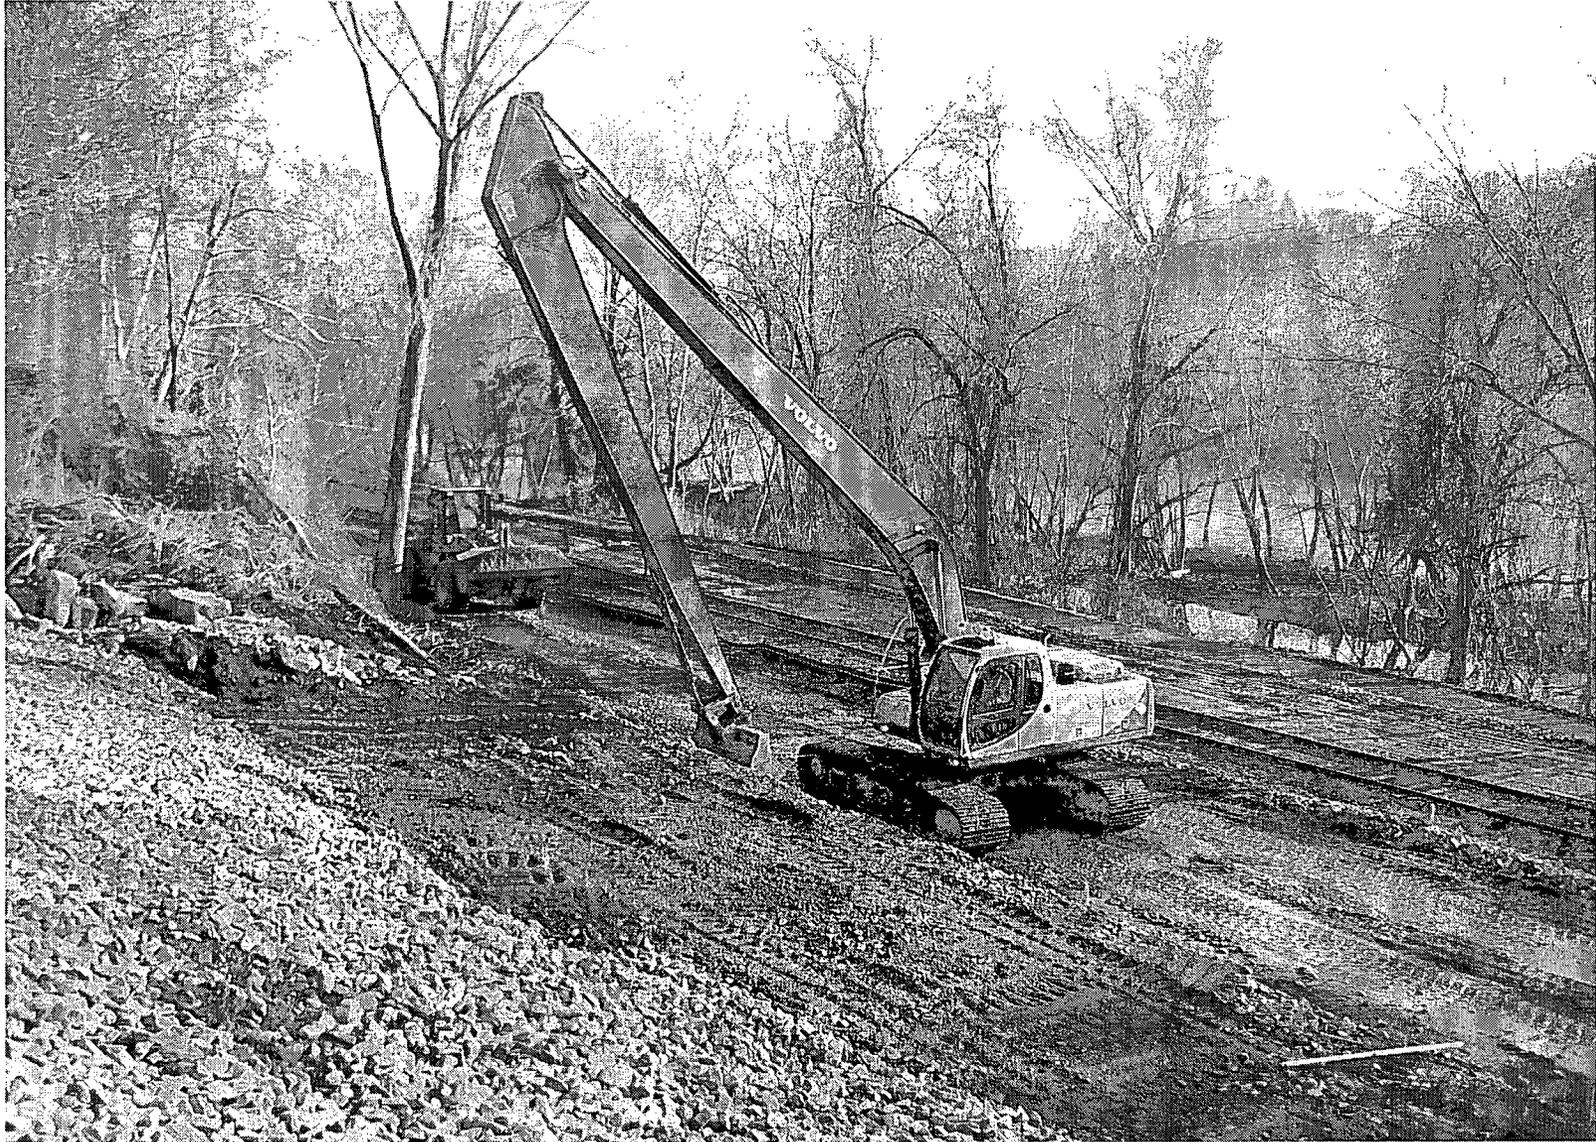
Construction of the R-6 and R-7 rip-rap cover layers proceeded in the same manner as the bedding layer. Areas approximately 30 feet by 30 feet were completed at a time to minimize compaction and disturbance of the bedding layer. The R-7 rip-rap portion of the cover began on October 30, 2007 with the construction of the test pad area and was completed on January 11, 2008. Construction of the R-6 cover area began on November 10, 2007 and was also completed on January 11, 2008. The R-4 cover began on November 12, 2007 and was completed on January 18, 2008.

Photos 3-25 through 3-32 show construction of the rip-rap layers of the cover.

PHOTO 3-25 ARMORING WEST EDGE OF COVER

PHOTO 3-26 ARMORING WEST EDGE OF COVER

PHOTO 3-27 R-6 PLACEMENT

PHOTO 3-28 R-4 PLACEMENT

PHOTO 3-29 R-4 PLACEMENT

PHOTO 3-30 R-4 PLACEMENT

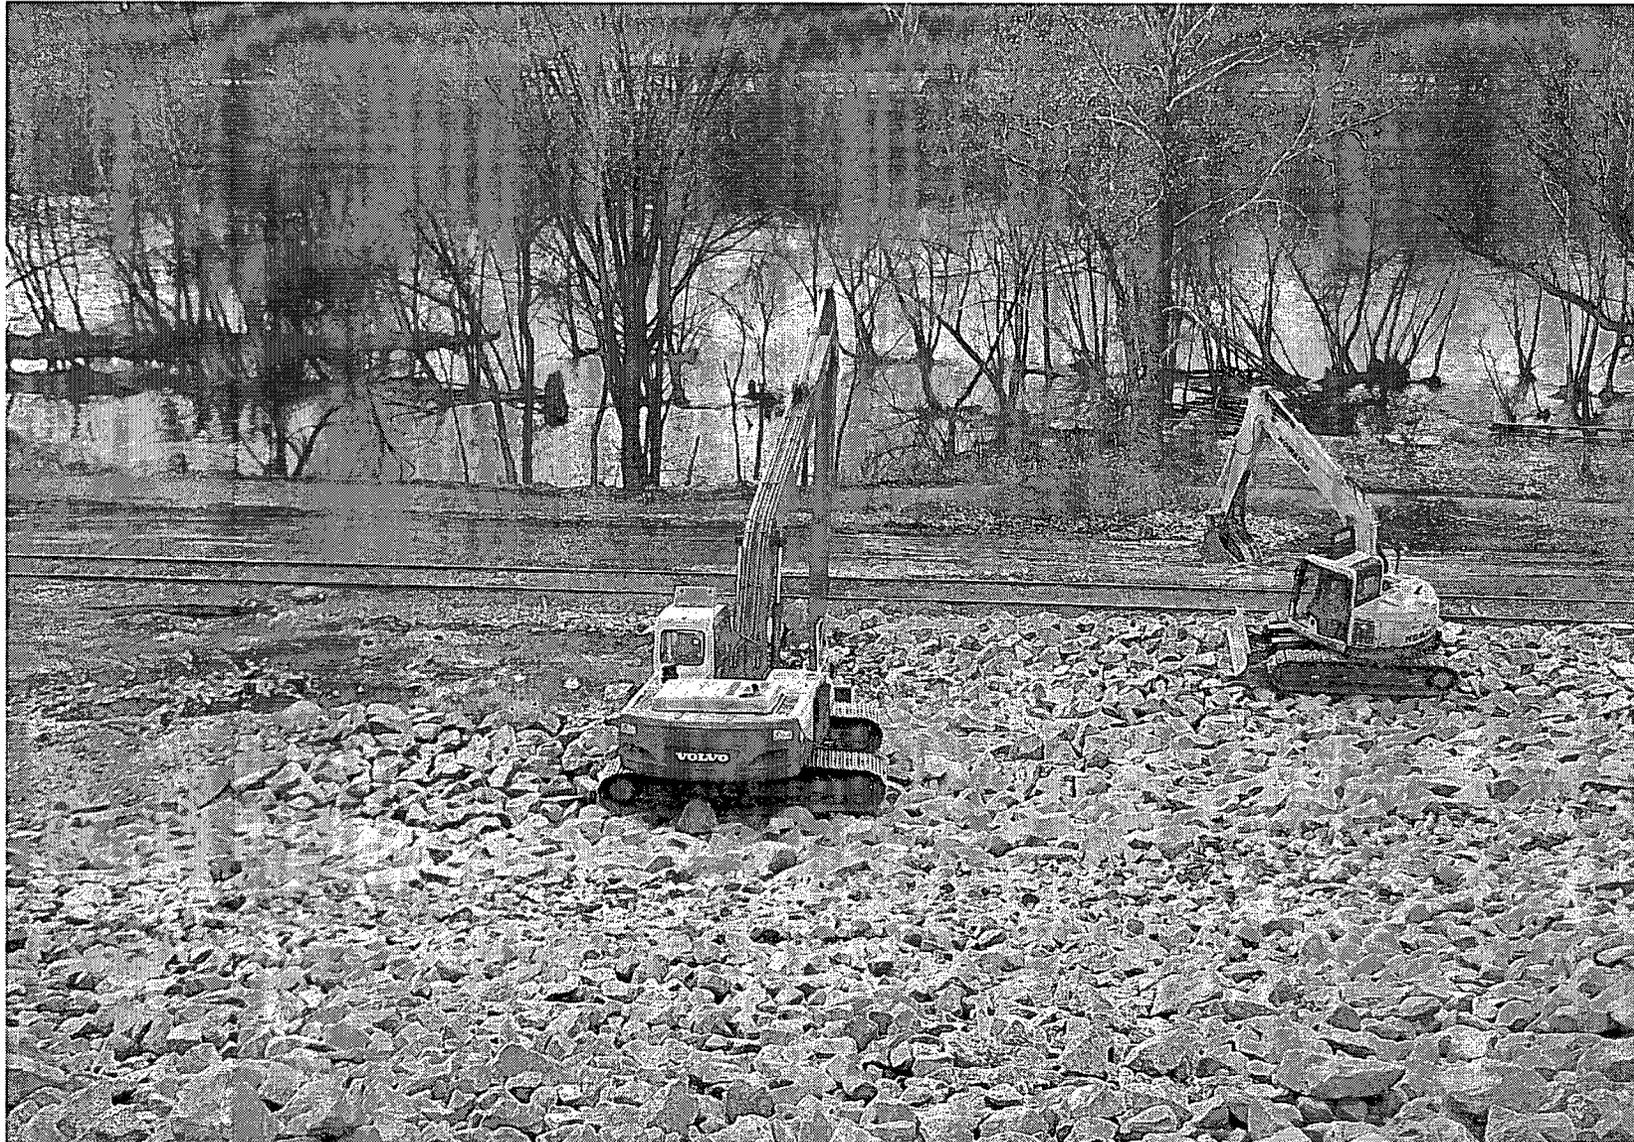
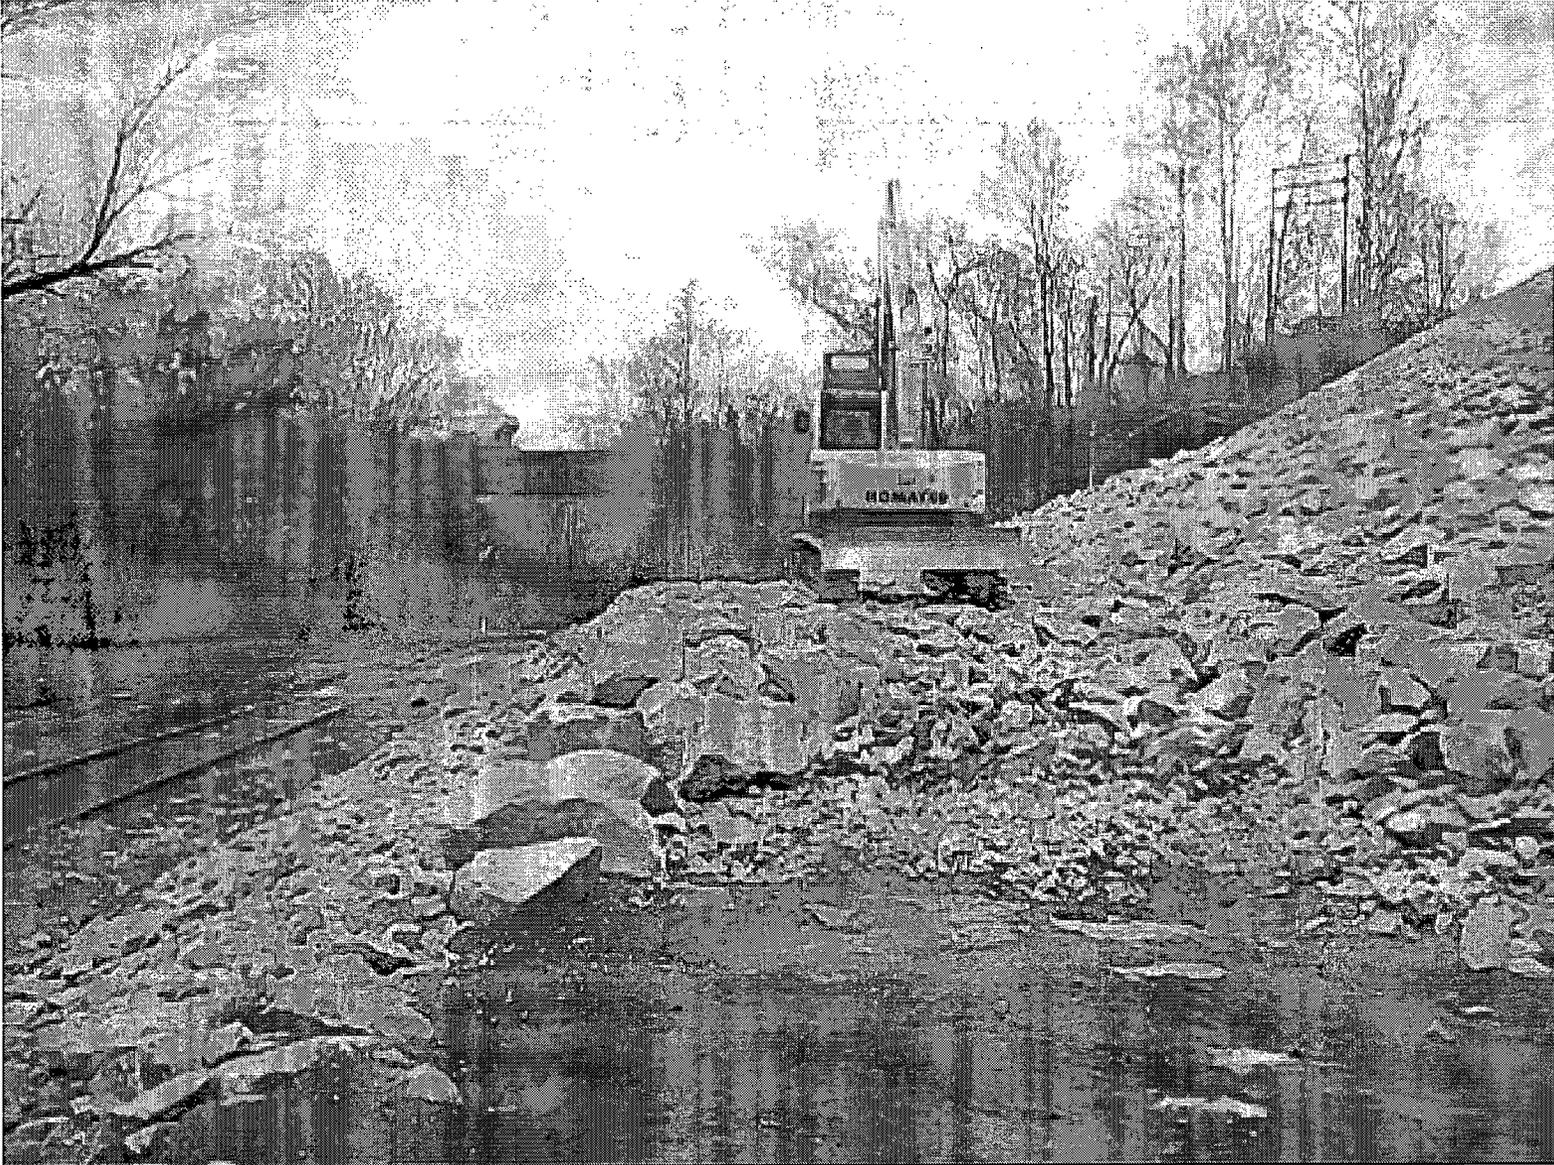
Generally, the construction of the rock cover proceeded from the bottom to the top of the embankment. The R-6 and R-7 rocks were placed individually by the operator using a track hoe equipped with a “thumb”. After initial placement of the rock, the excavator operator was able to use the gripping ability of the bucket and thumb to adjust and seat (“lock”) each rock in place. A spotter on the ground directed the operator of the excavator to achieve optimal placement. Once in place, the equipment operator would “tap” the rock with the track hoe bucket to ensure a solid interlock with the other rock. Manual adjustment was used only when the equipment could not achieve proper placement.

PHOTO3-31 R-7 PLACEMENT

PHOTO 3-32 R-7 PLACEMENT
