Subject: Draft Decommissioning Plan Completion Report for the Reading Slag Pile Site
License No. SMC-1562
Docket Number 40-9027

**READING SLAG PILE SITE
DECOMMISSIONING PLAN COMPLETION REPORT
SOURCE MATERIAL LICENSE SMC-1562**

**ST Environmental Professionals, Inc.
GeoSystems, Inc.
de maximis, inc.
Austin Masters, Inc**

Cabot Corporation

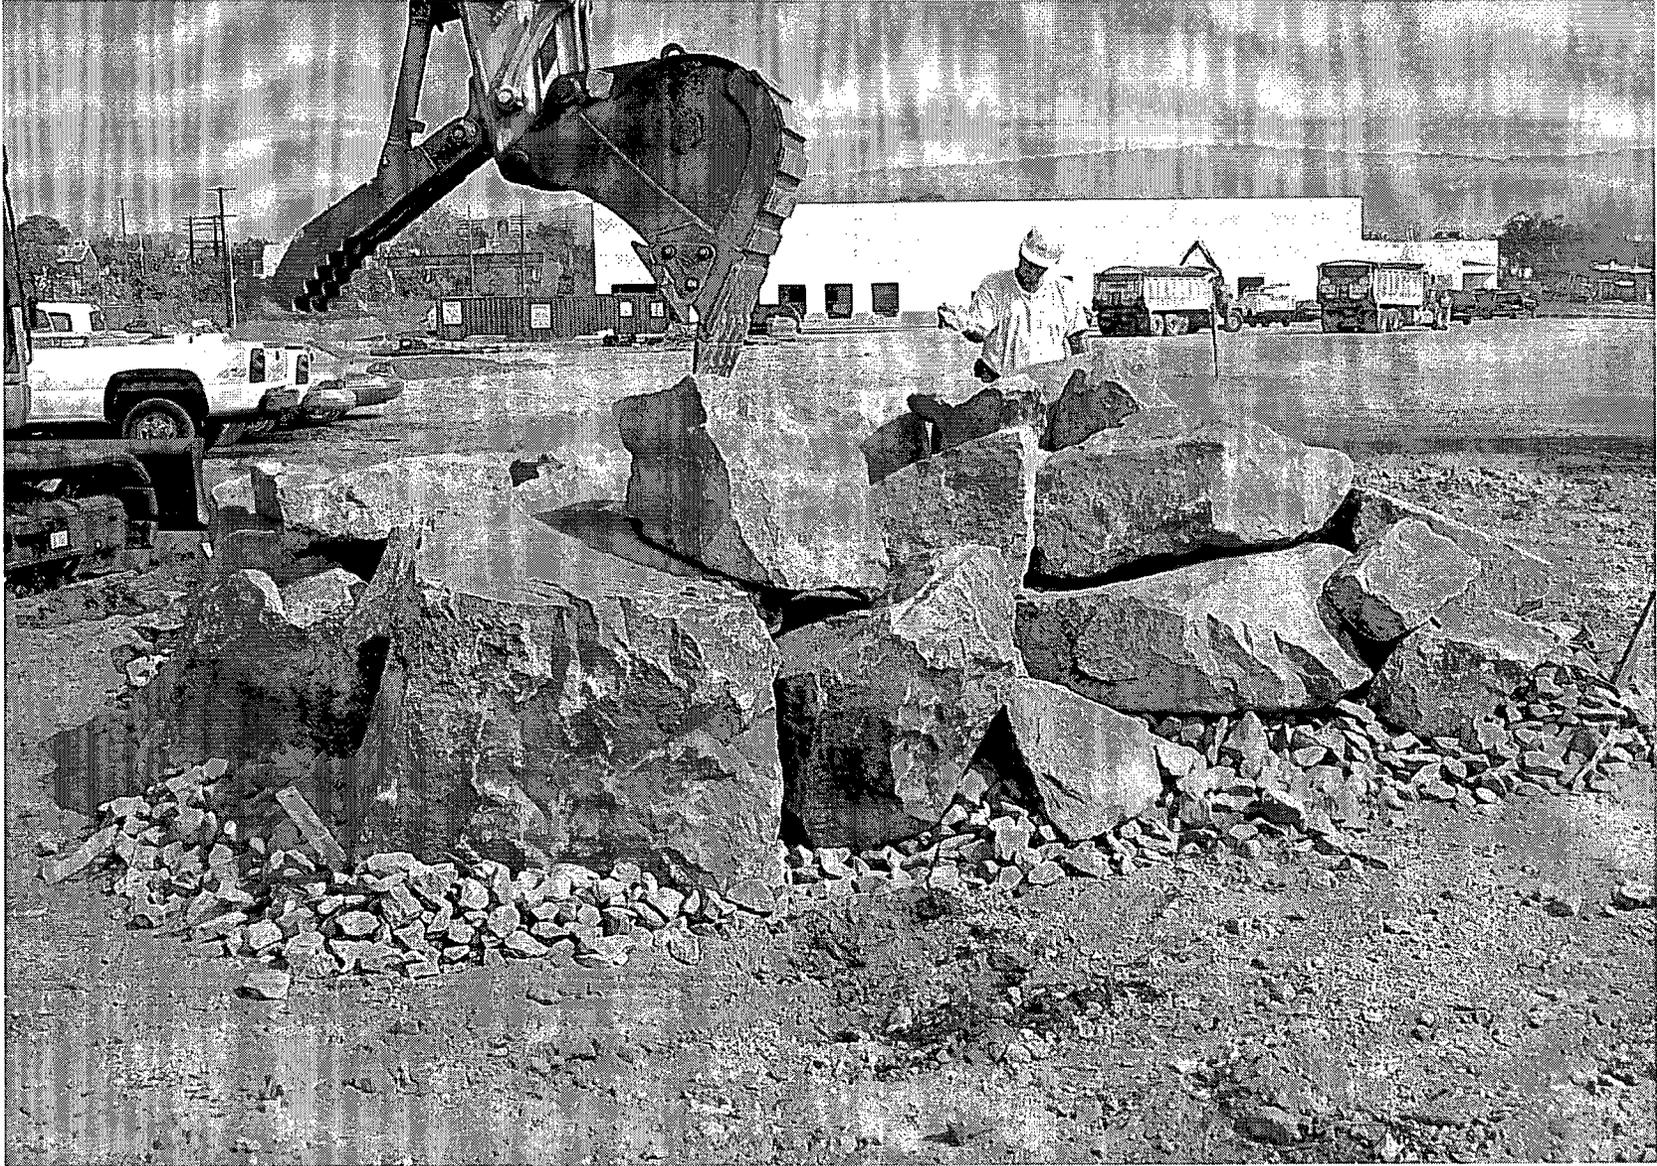
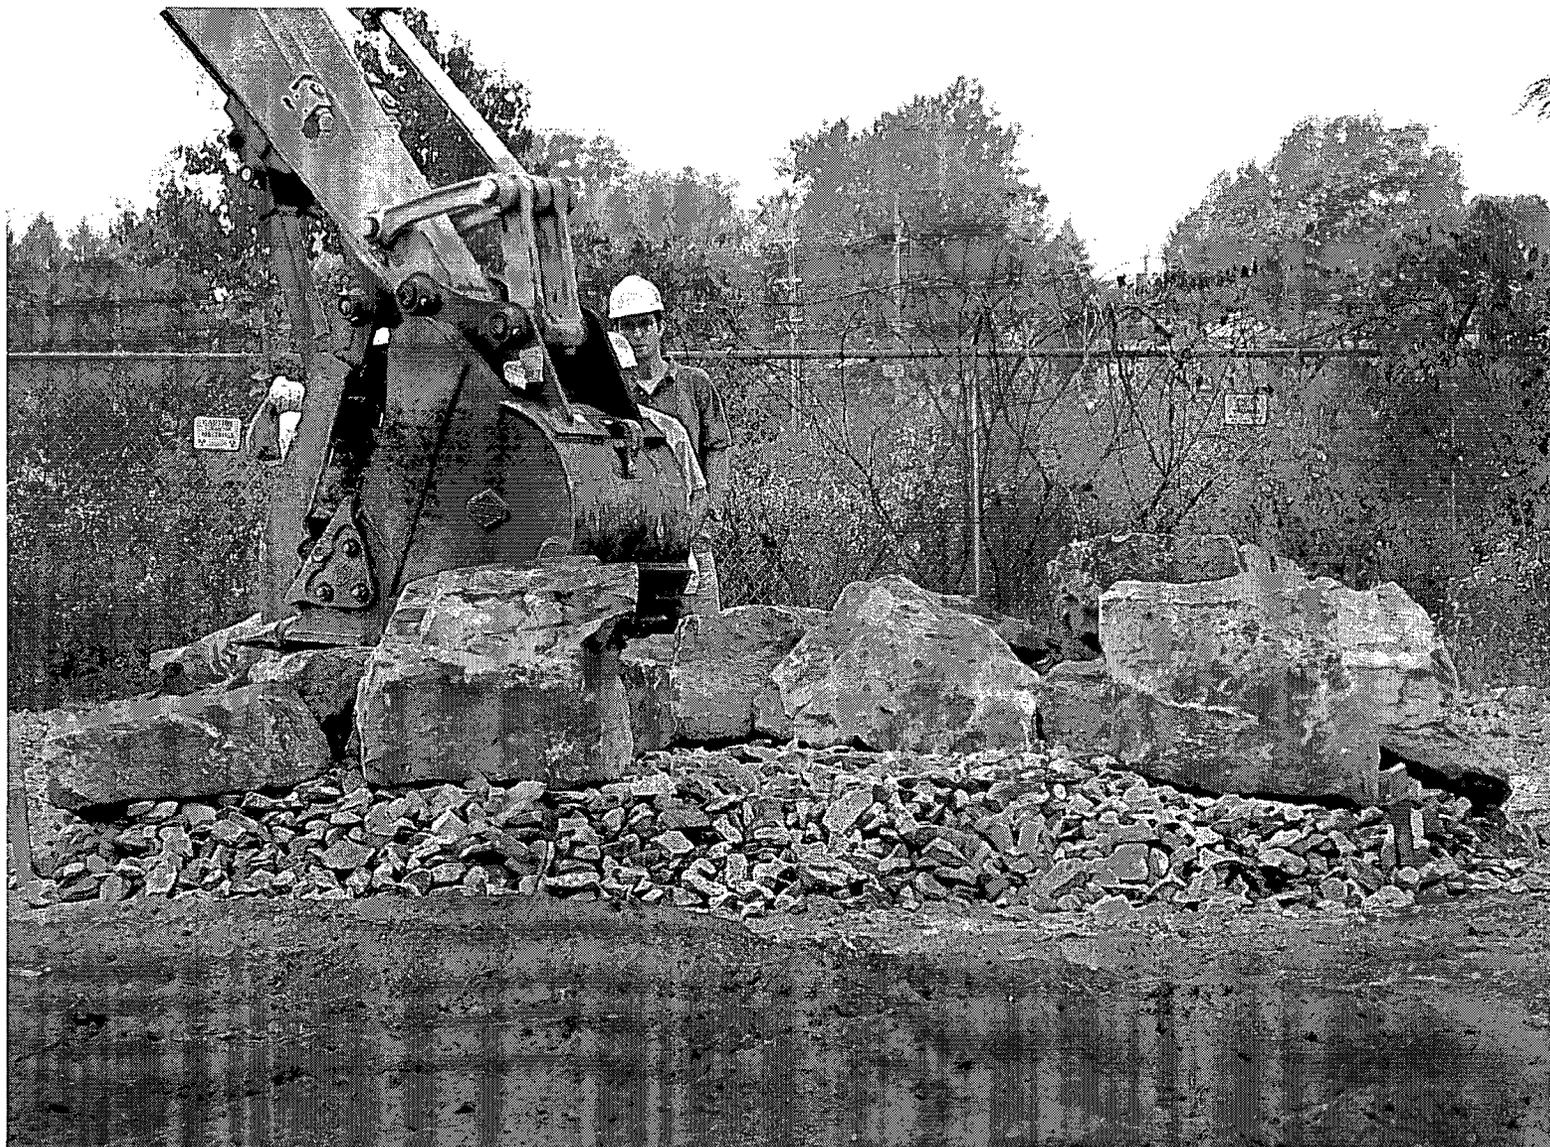
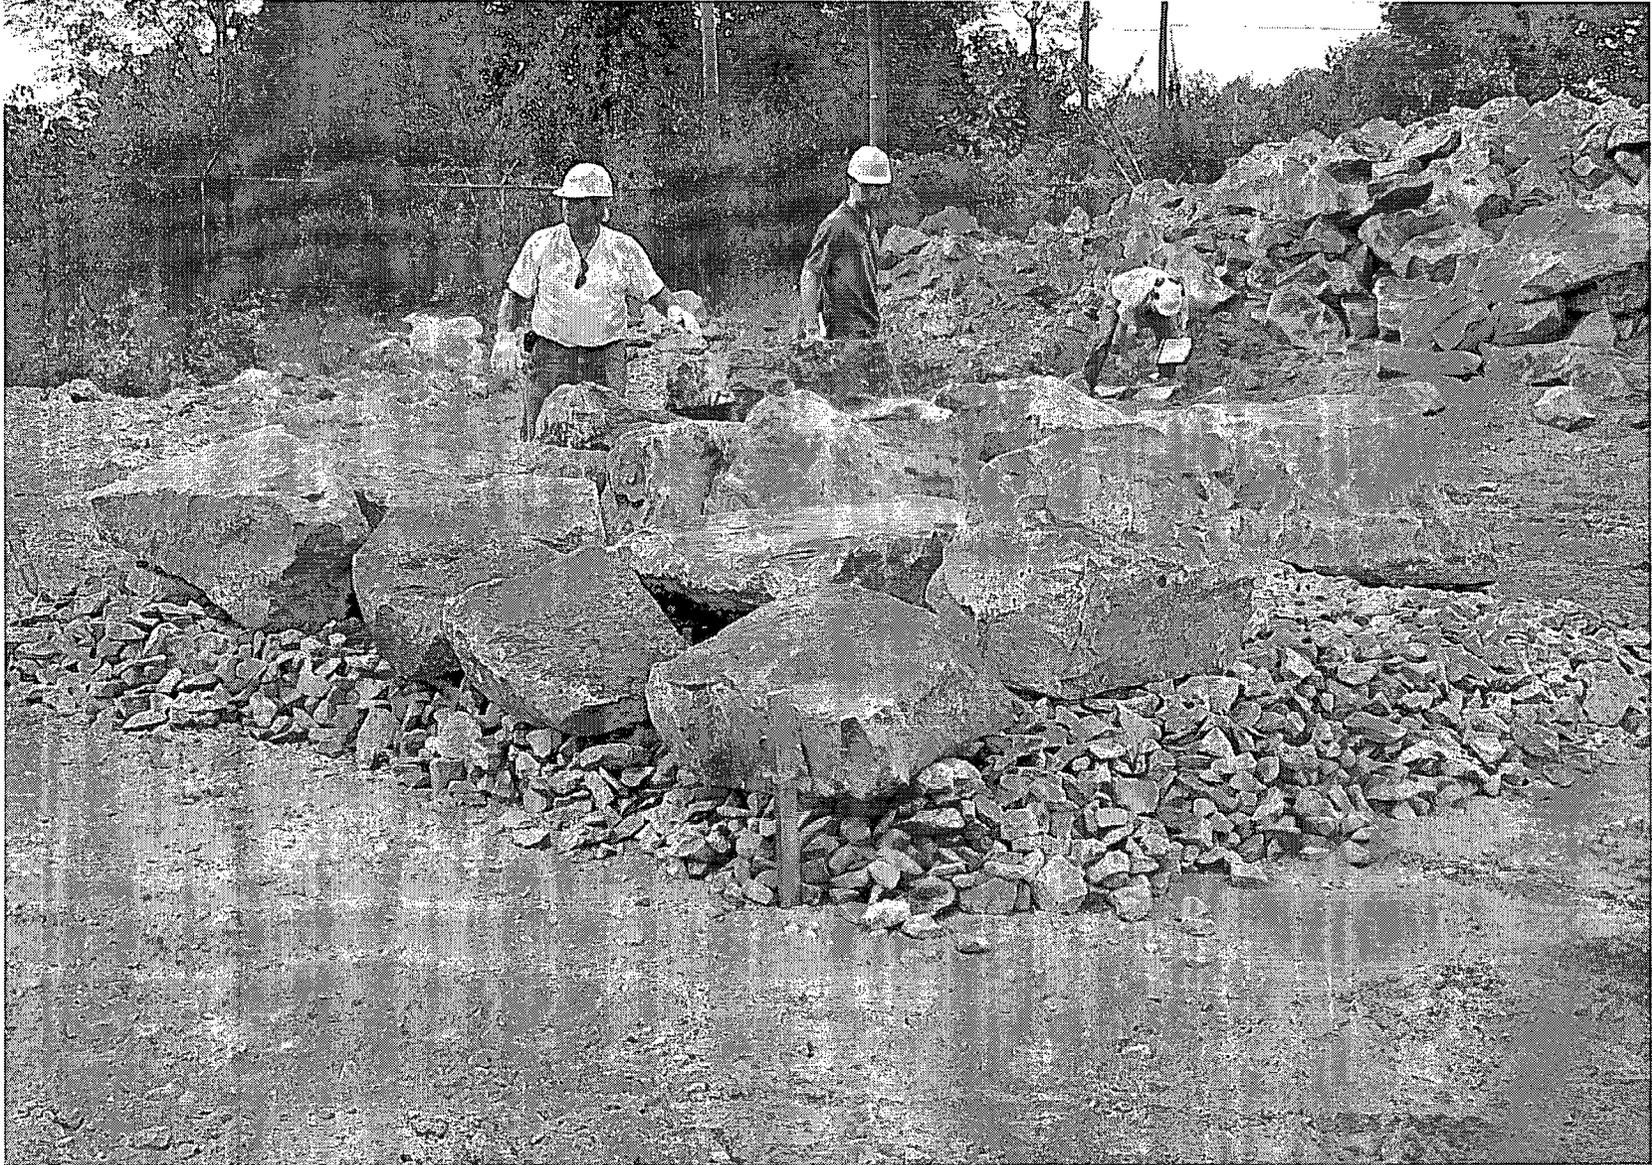
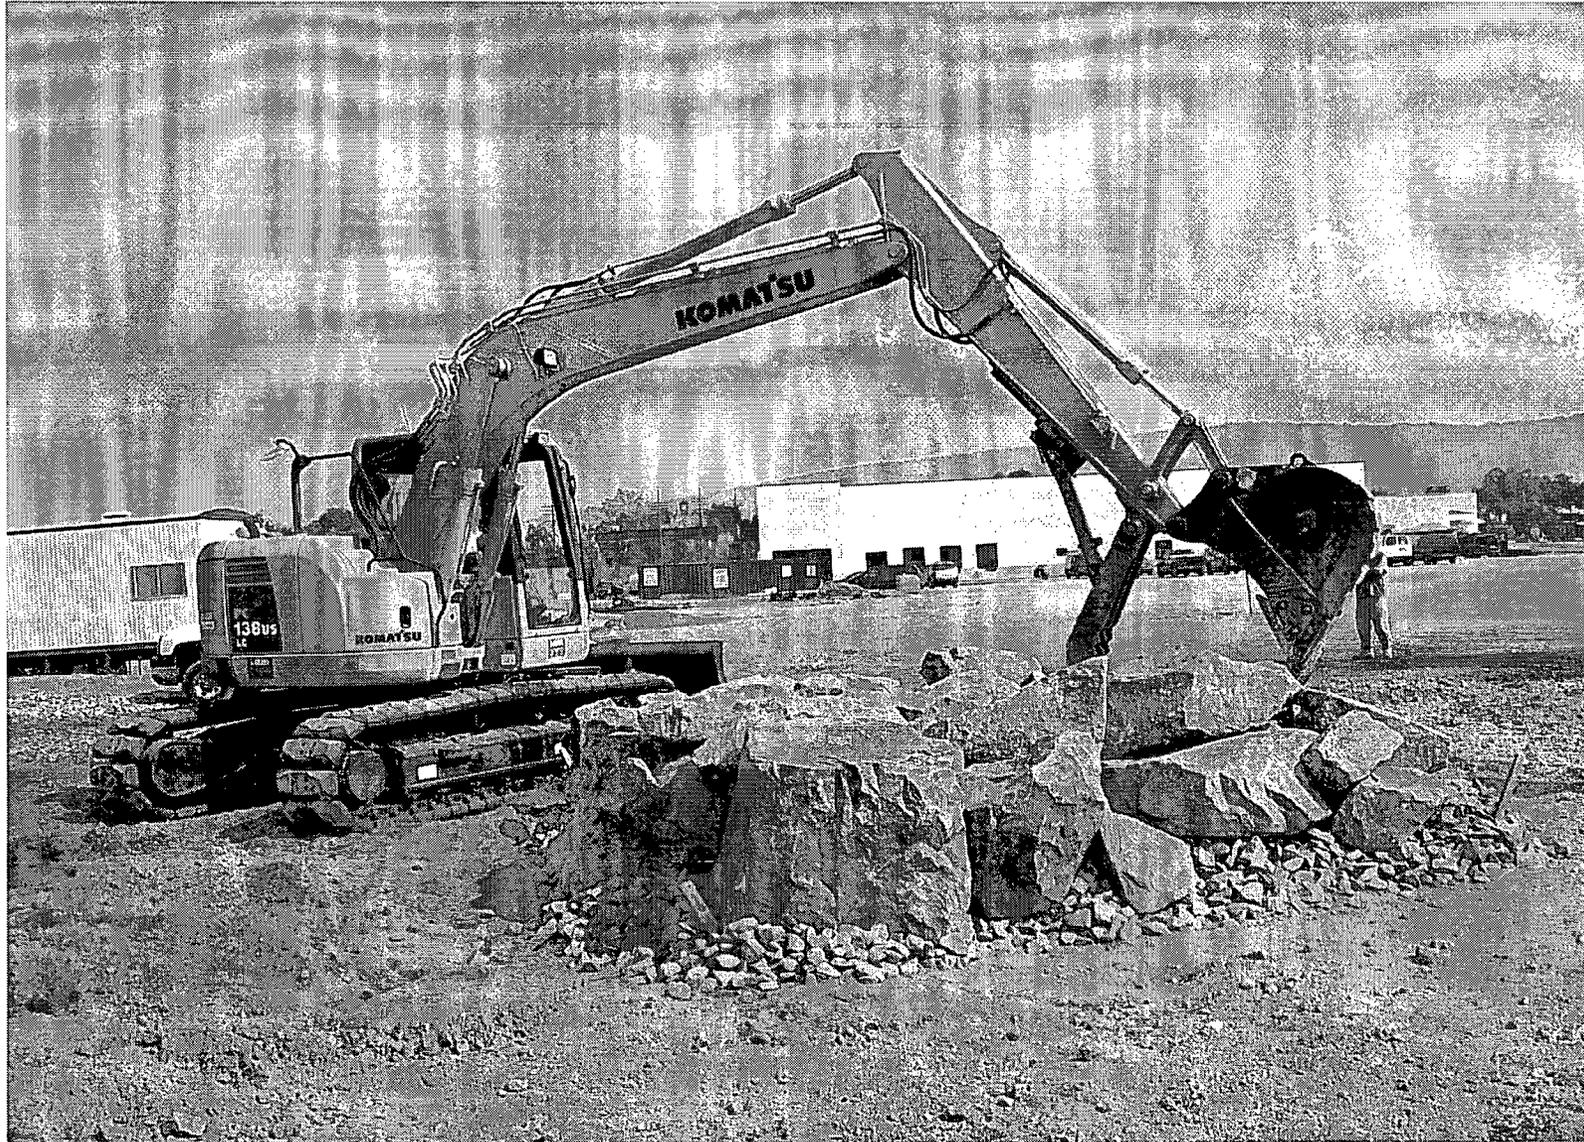
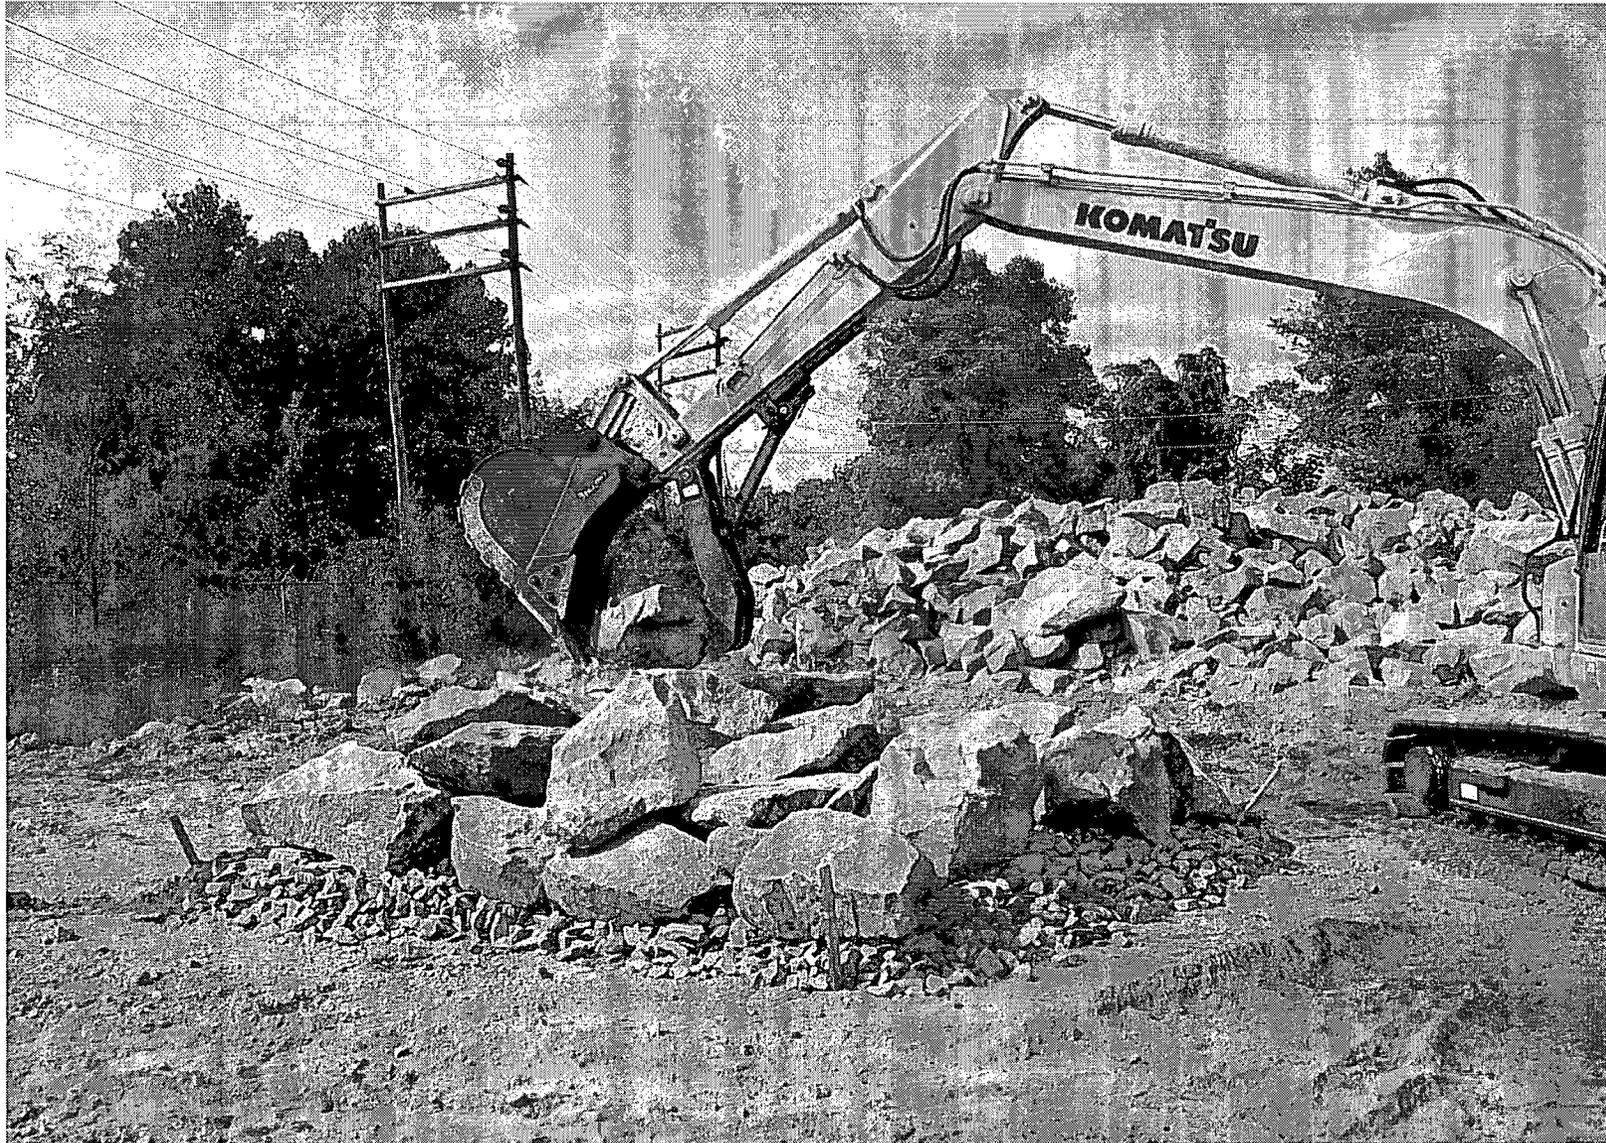
PHOTO 5-1 TRIAL SECTION

PHOTO 5-2 TIAL SECTION

PHOTO 5-3 TRIAL SECTION

PHOTO 5-4 TRIAL SECTION

PHOTO 5-5 TRIAL SECTION1
