Subject: Draft Decommissioning Plan Completion Report for the Reading Slag Pile Site
License No. SMC-1562
Docket Number 40-9027

**READING SLAG PILE SITE
DECOMMISSIONING PLAN COMPLETION REPORT
SOURCE MATERIAL LICENSE SMC-1562**

**ST Environmental Professionals, Inc.
GeoSystems, Inc.
de maximis, inc.
Austin Masters, Inc**

Cabot Corporation

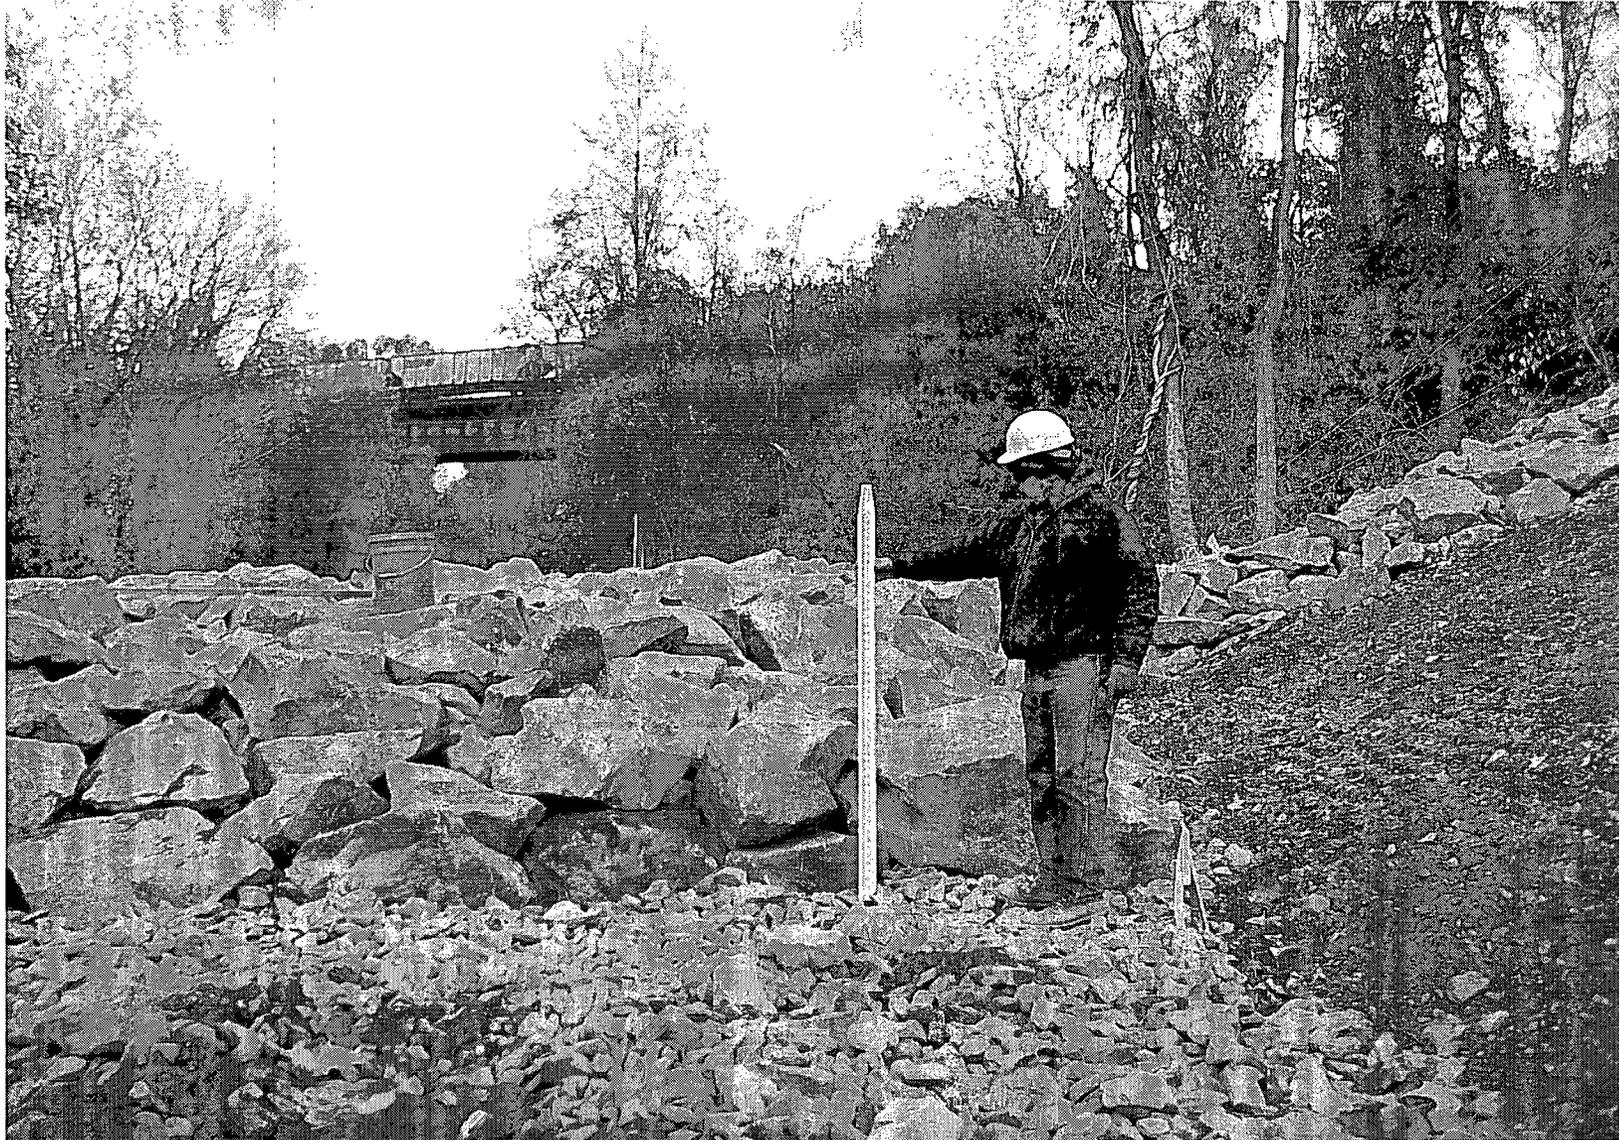
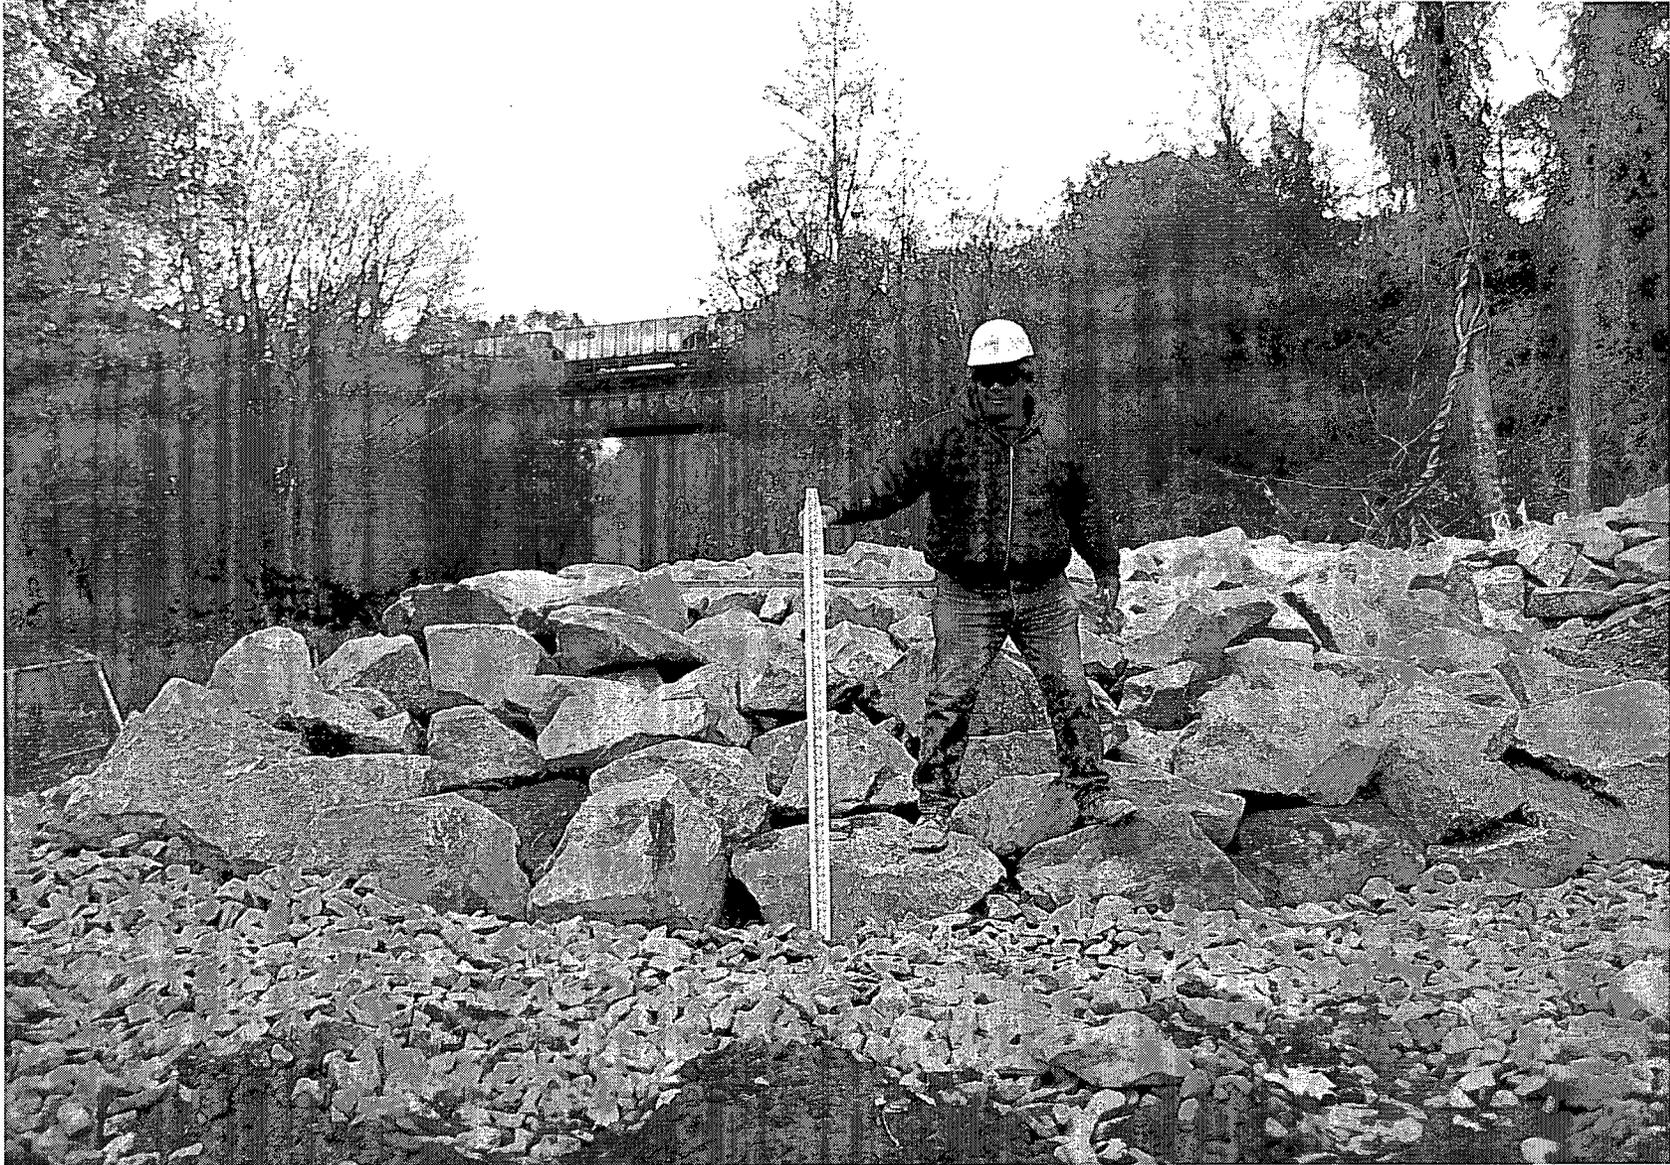
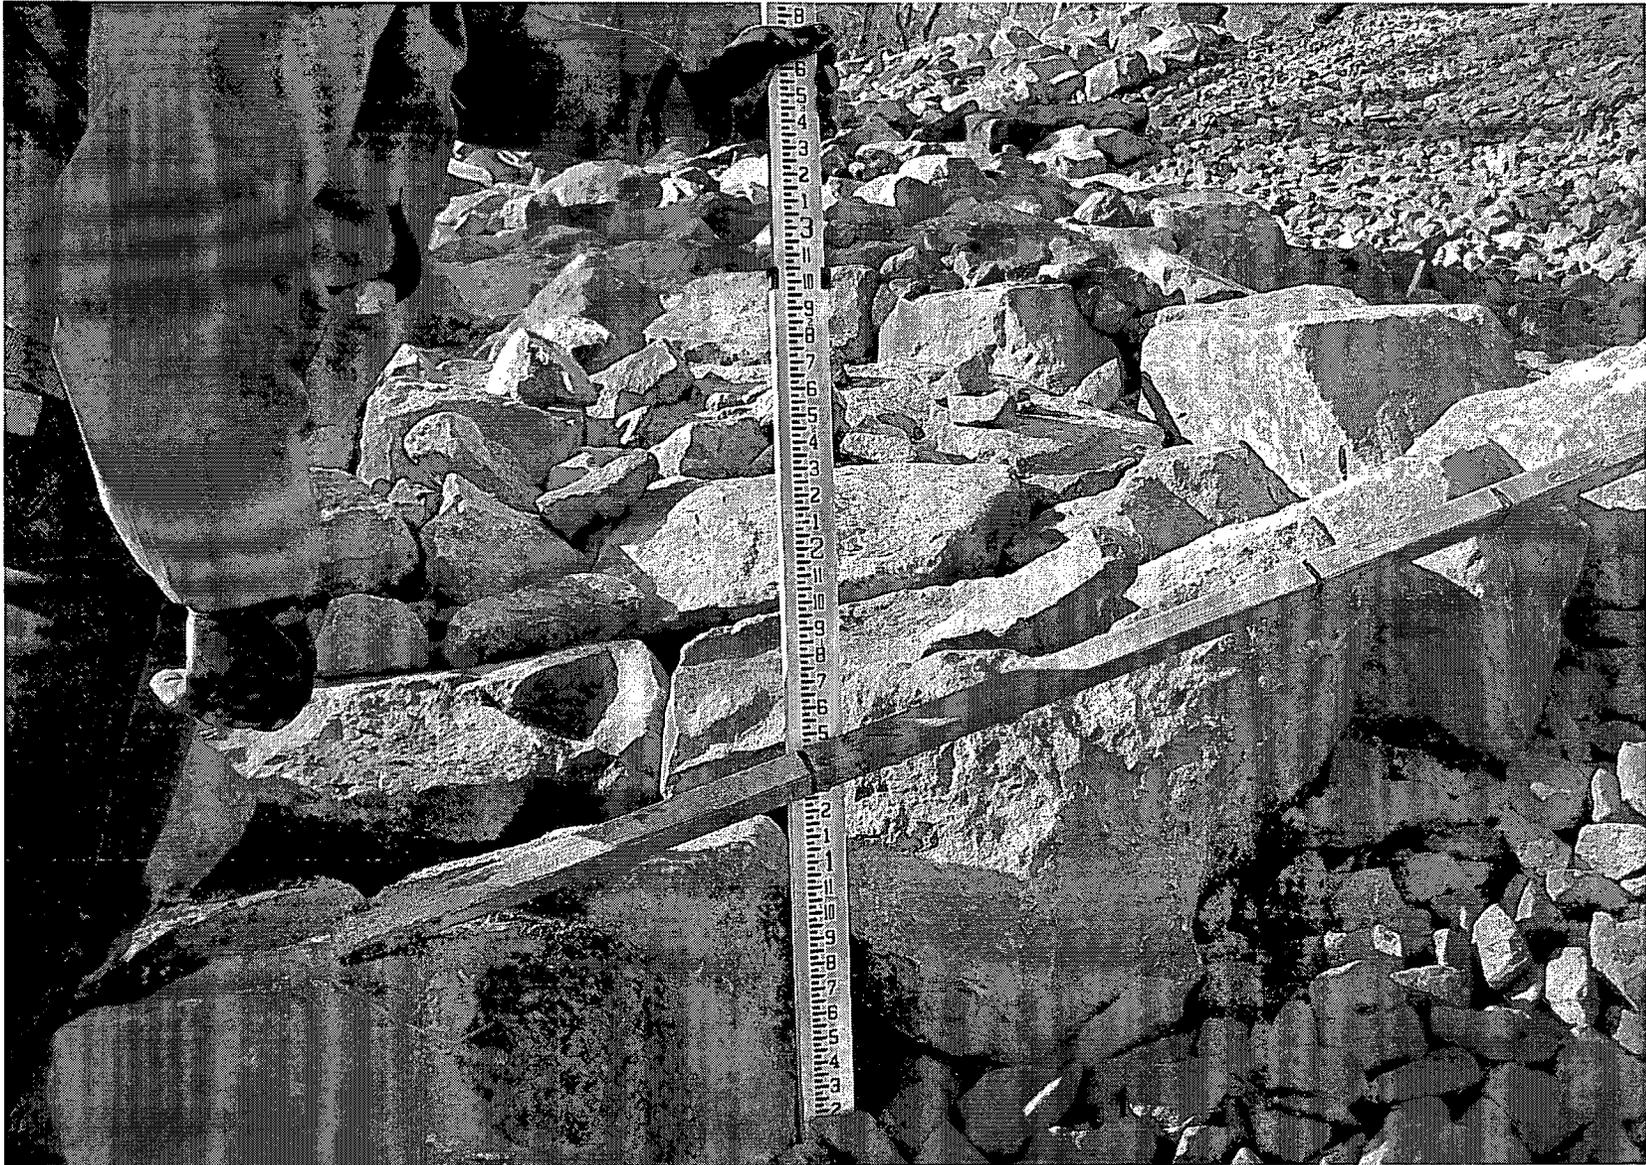
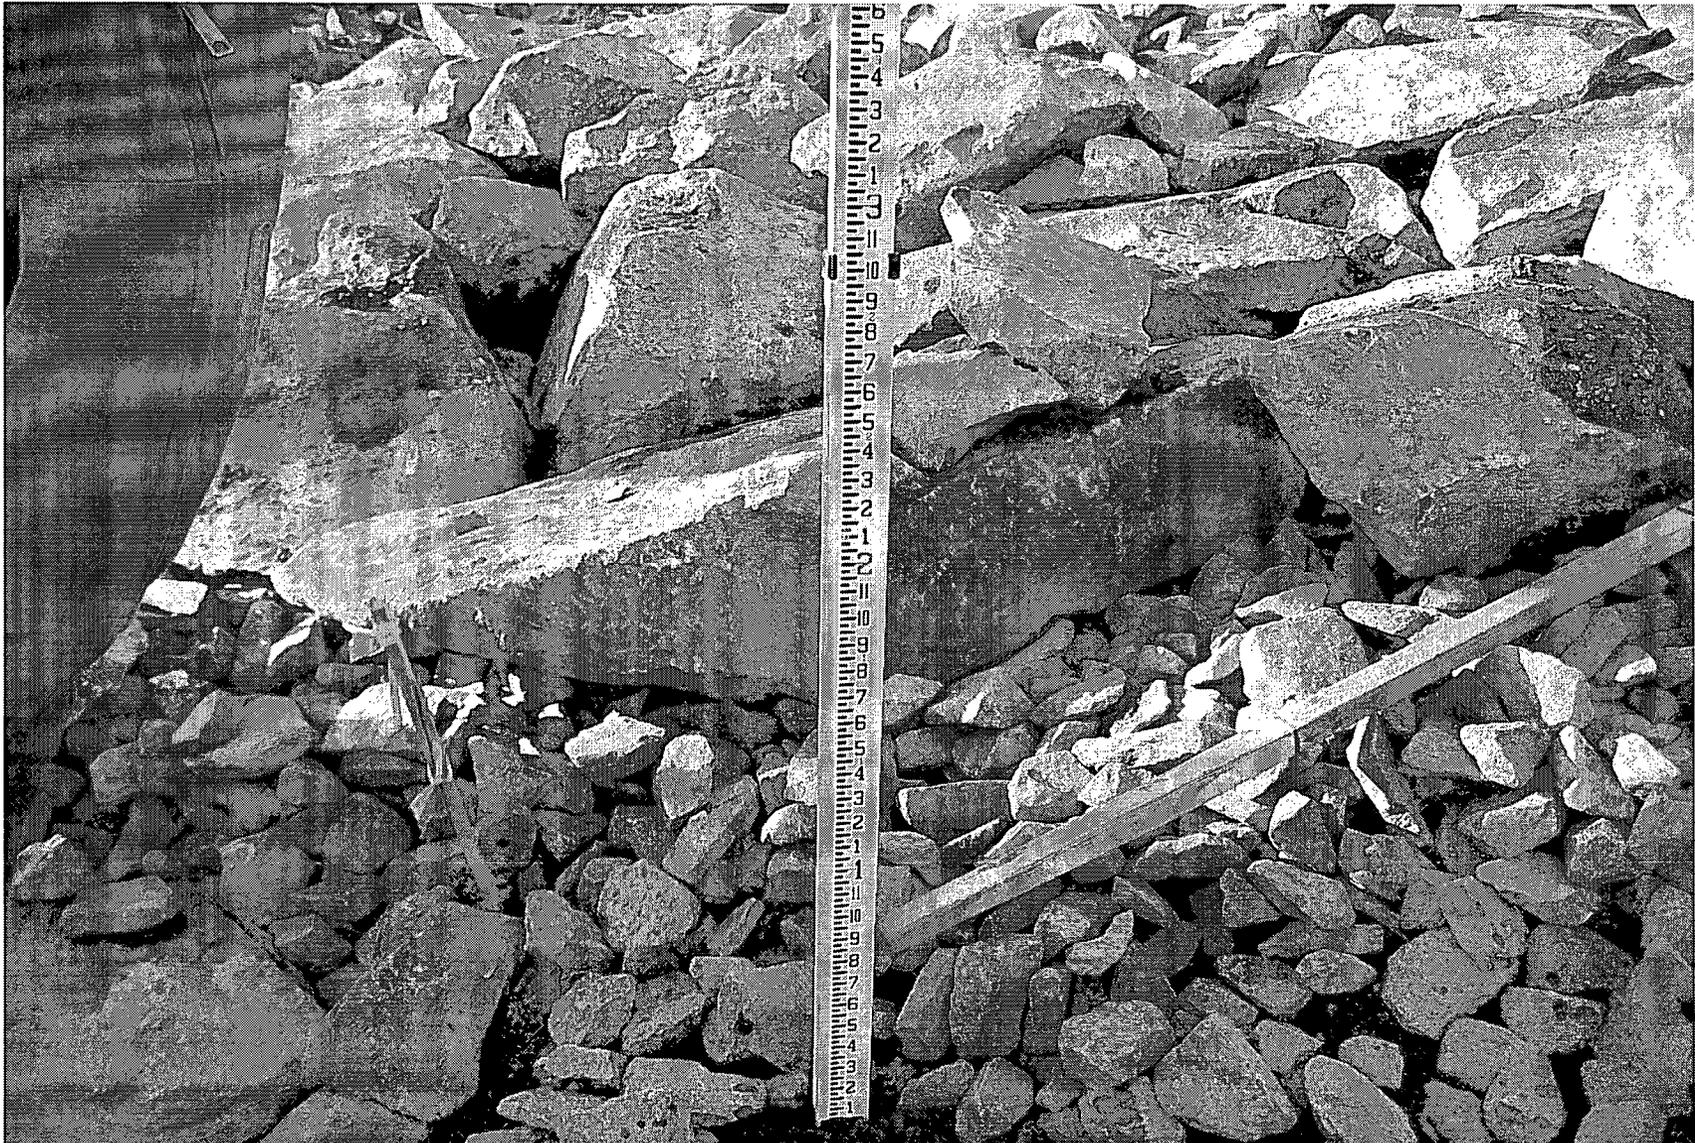
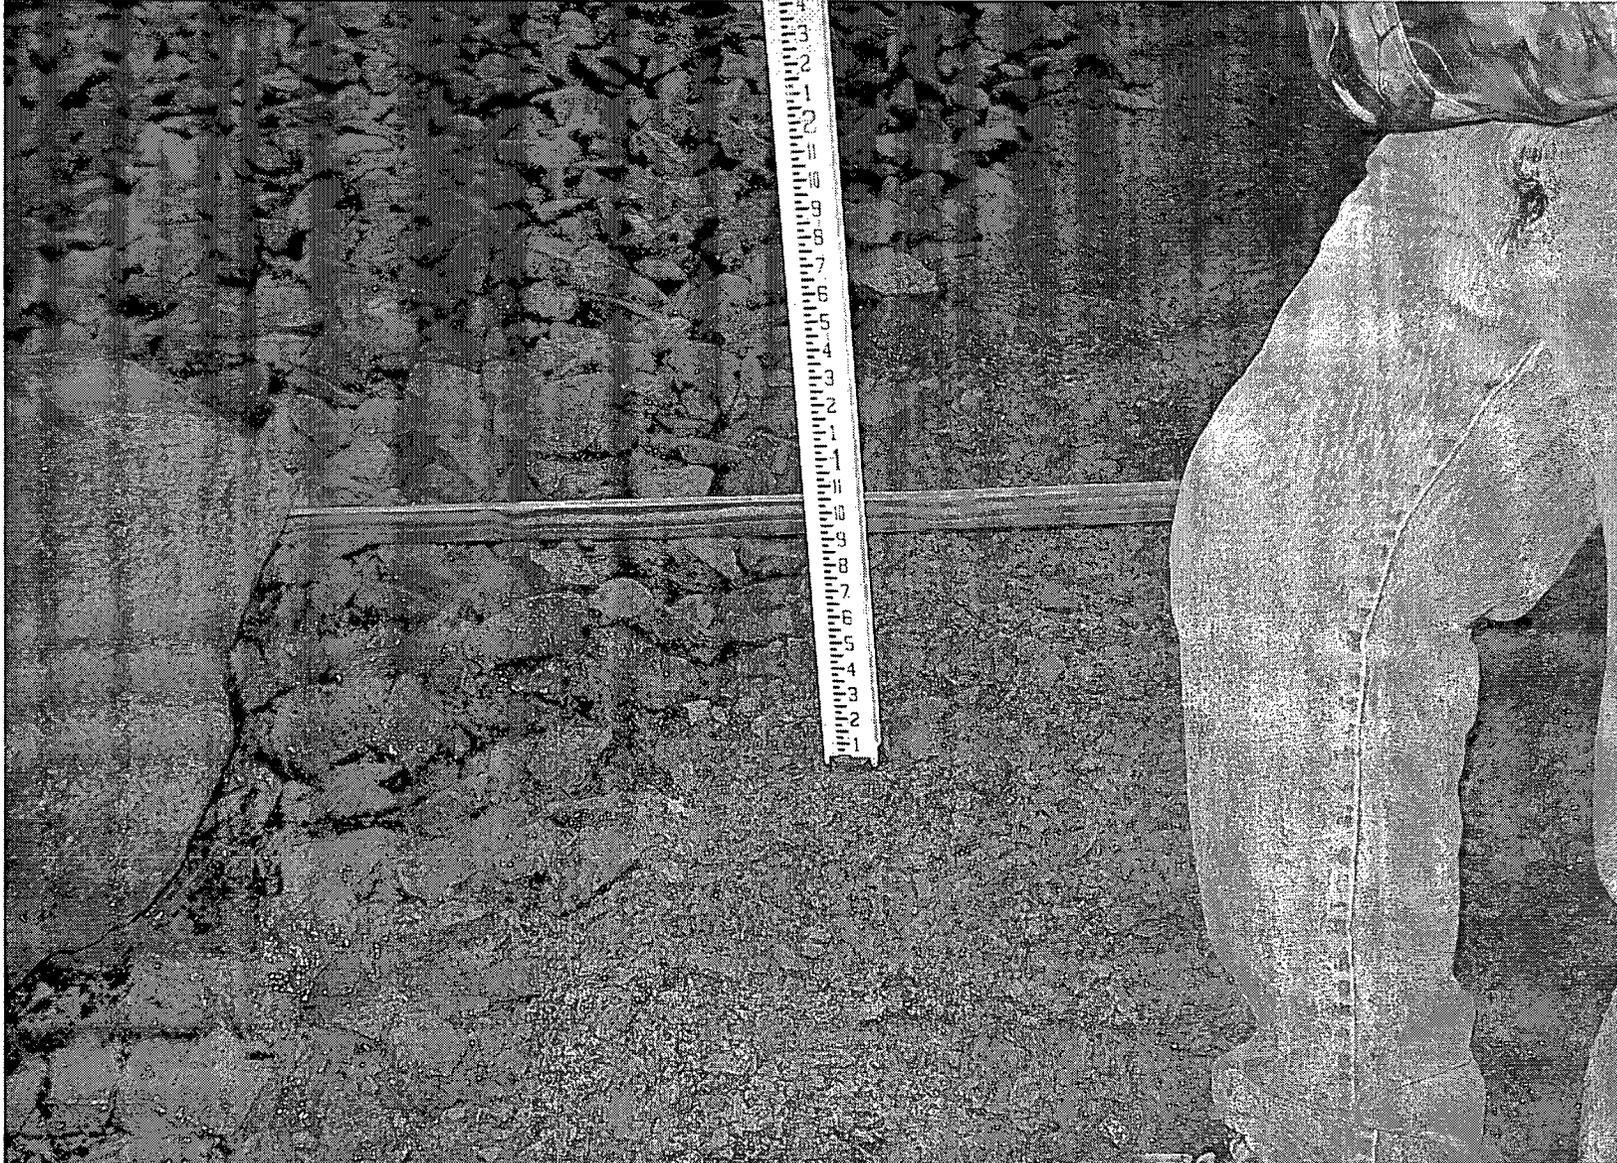
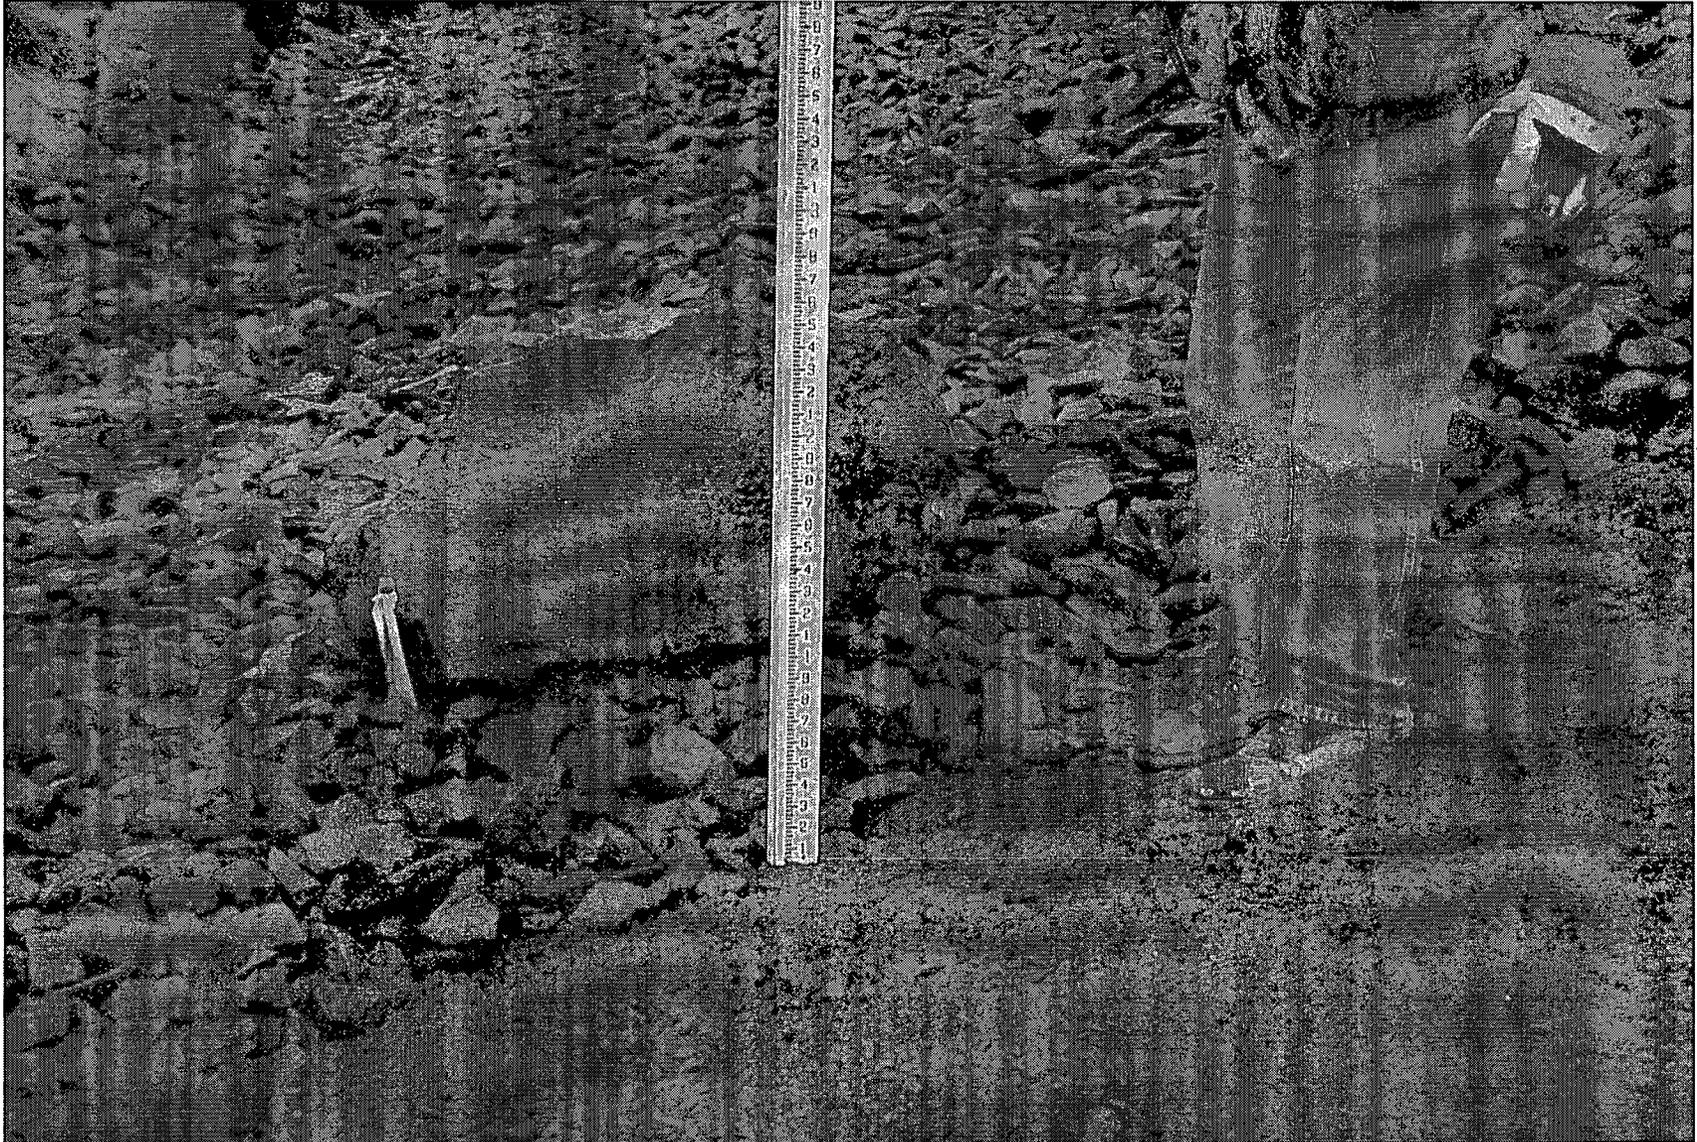
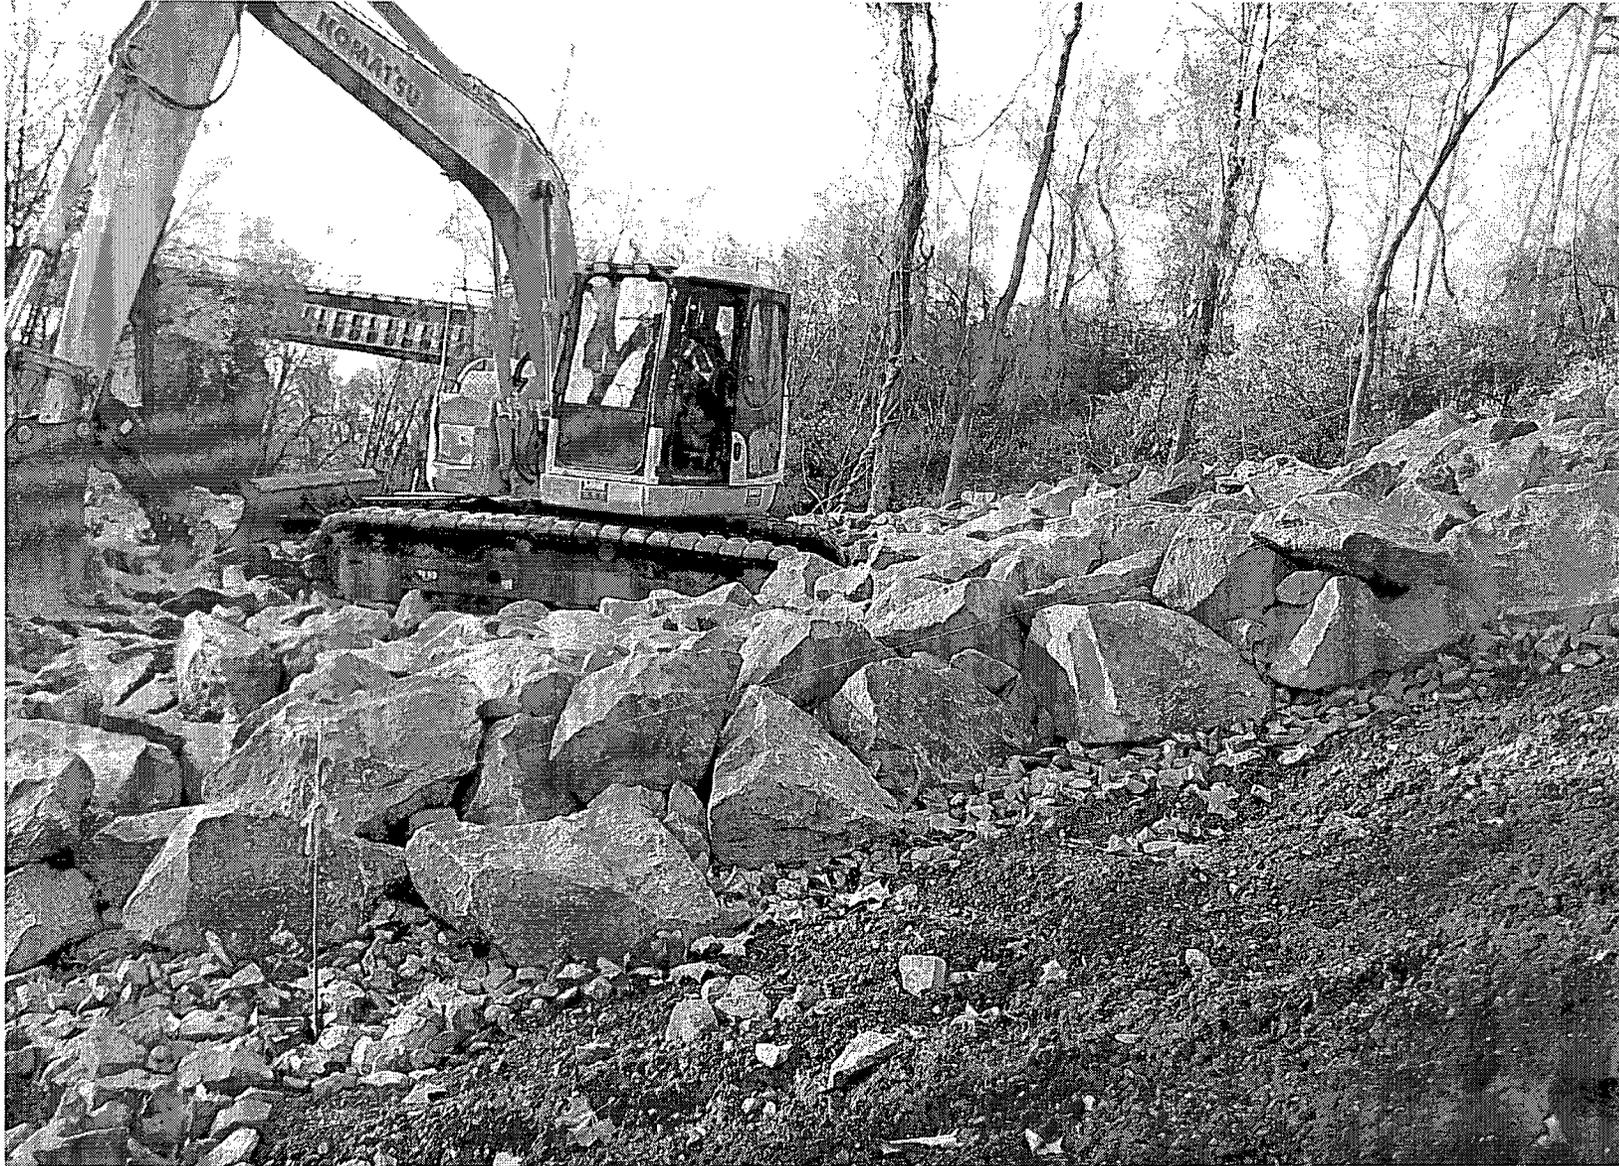
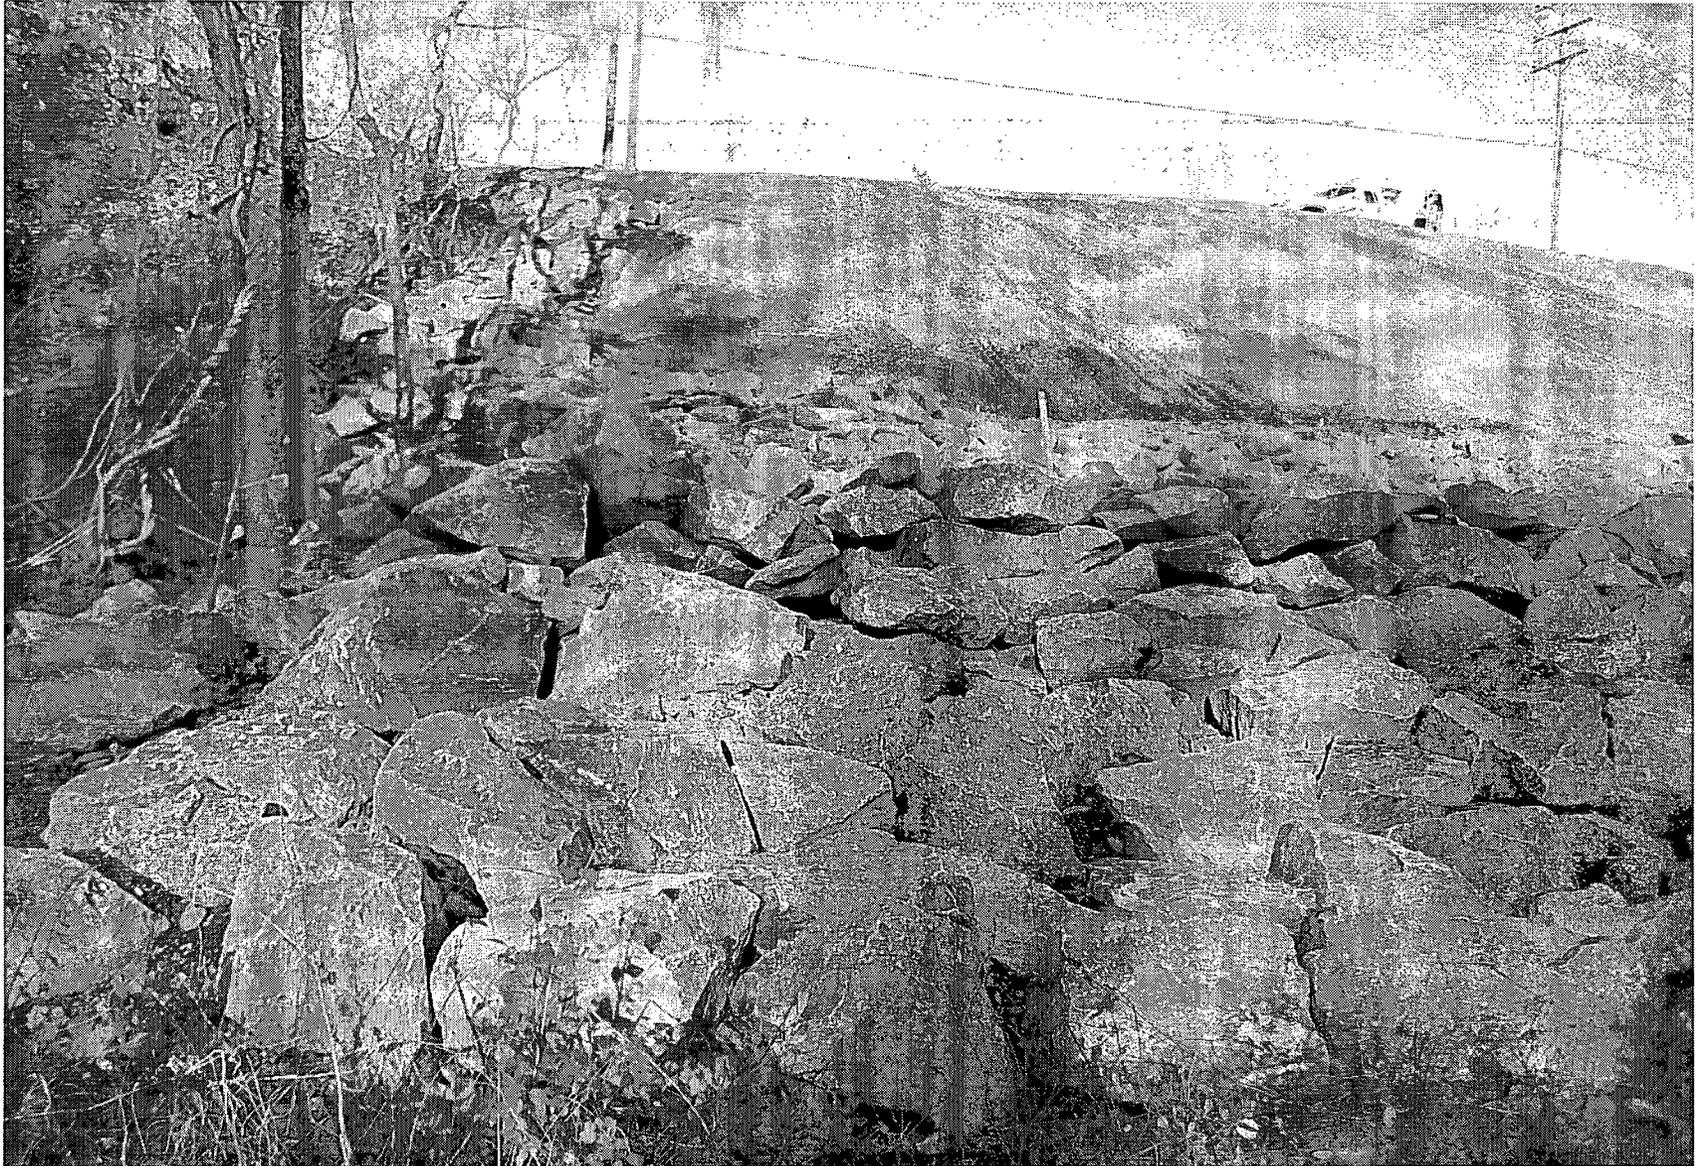
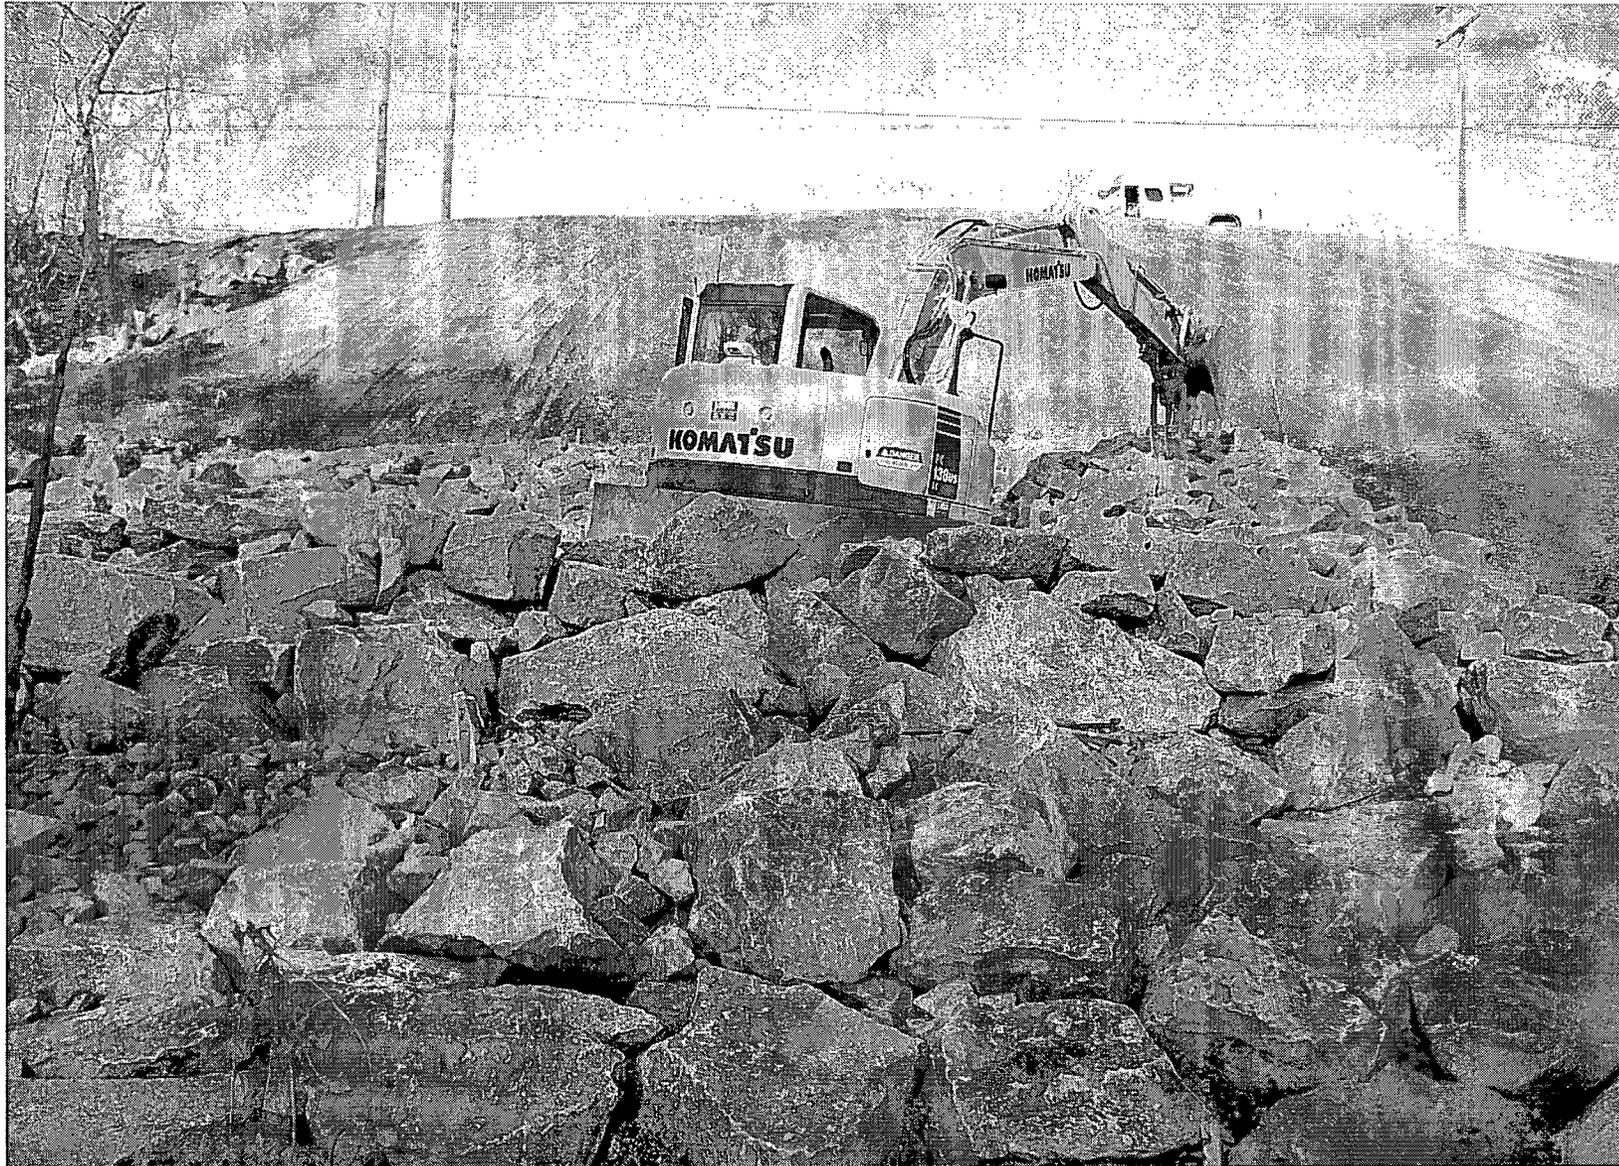
During construction, the thickness of each layer was periodically inspected by the Project Engineer. In addition, the Contractor would also measure the thickness with a survey rod. Photos 5-6 through 5-38 show field measurements being taken during construction.
