**CHARACTERIZATION REPORT  
FOR PLUM BROOK SEDIMENT IN  
STREAM MOUTH WETLANDS**

Prepared for  
Keith M. Peacock  
National Aeronautics and Space Administration (NASA)  
Glenn Research Center  
Plum Brook Reactor Decommissioning Program  
Plum Brook Station  
6100 Columbus Avenue  
Sandusky, Ohio 44870

Prepared by:  
Haag Environmental Company  
315 East Market Street  
Sandusky, Ohio 44870

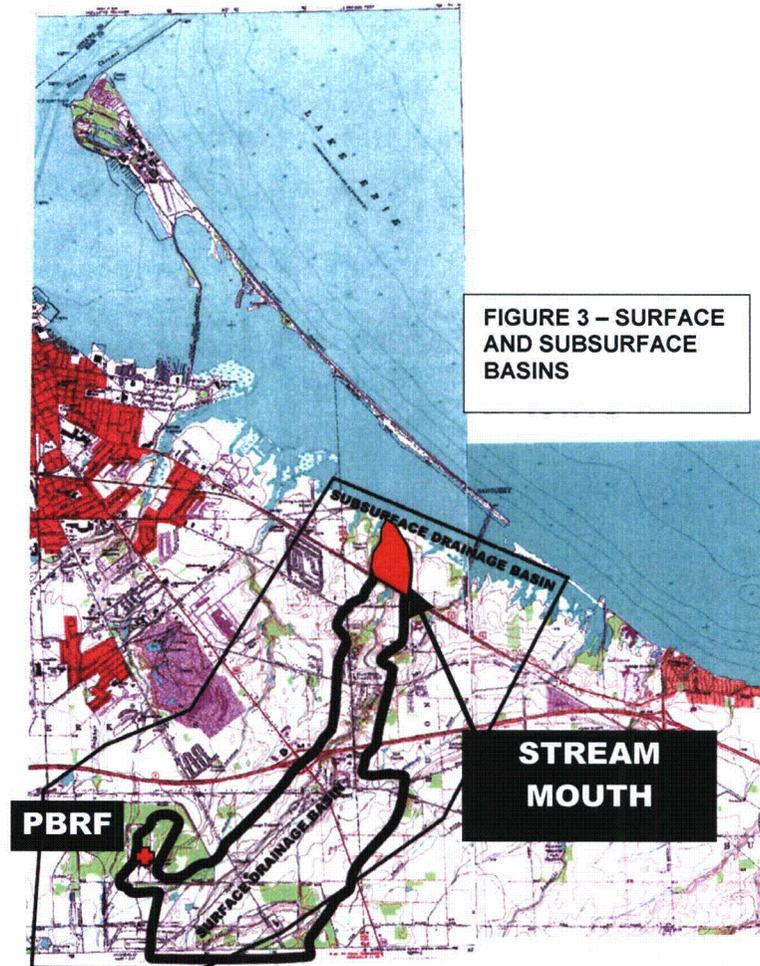
**Study Boundaries for Vertical and Lateral Extent** - To define the sediment depositional environments, the limits of the study area were determined to be (1) the surface drainage basin of Plum Brook, downstream of the PBRF, and (2) the groundwater basin in which the PBRF is located. These basins are illustrated in Figure 3.

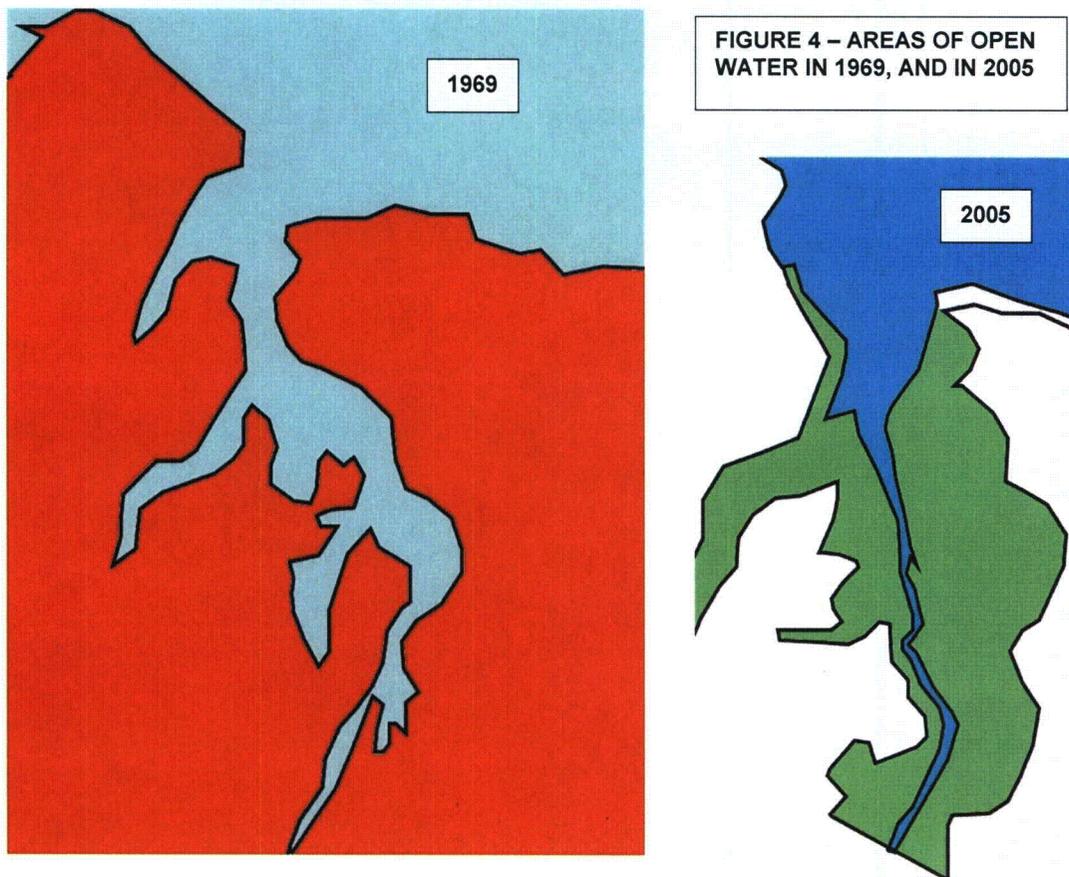
At the time of sampling, rising Lake Erie levels had flooded the fairly large flat area where the underfit Plum Brook entered the standing water behind the sand bar known as Cedar Point. Airphotos suggested that the now-flooded or “drowned” mouth of Plum Brook was formerly a floodplain wetland, but more recently became a fresh-water “estuary”, similar to the much-studied Old Woman Creek “estuary” nearby. Studies at Old Woman Creek indicated that sediment was deposited in that estuary when the Lake Erie level was high, and sediment was eroded and moved toward the lake when the lake level was low. Airphotos and maps suggested that the stream mouth area of Plum Brook was sometimes a braided distributary channel environment (mostly land), and at other times was a marsh environment (mostly water). Observed changes during and after the period of PBRF operation are illustrated in Figure 4.

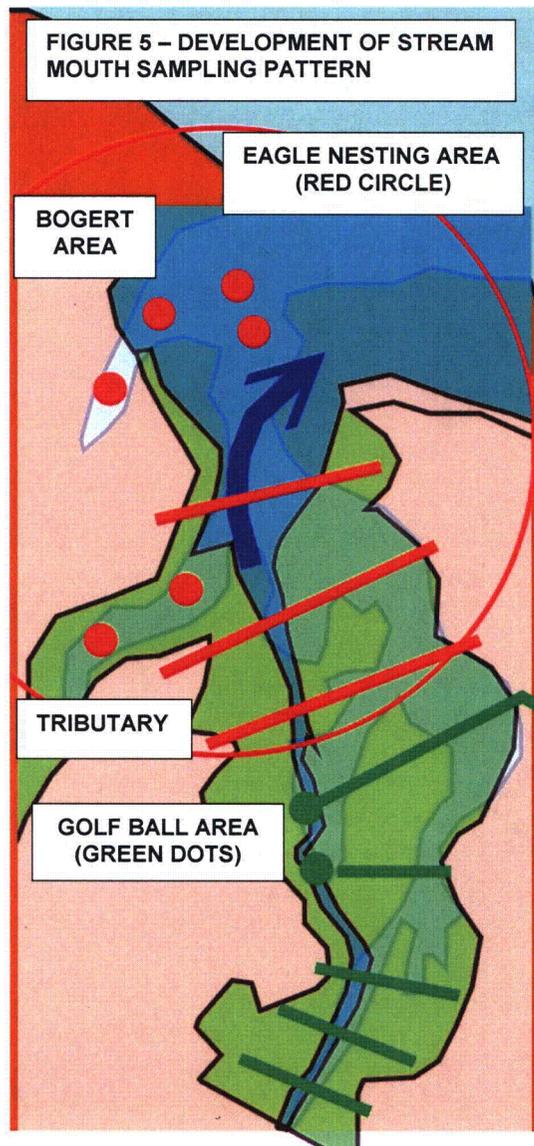
The sequence in which transects were sampled was controlled by bald eagle nesting times. Sample points and transects shown in red in Figure 5 were performed first.

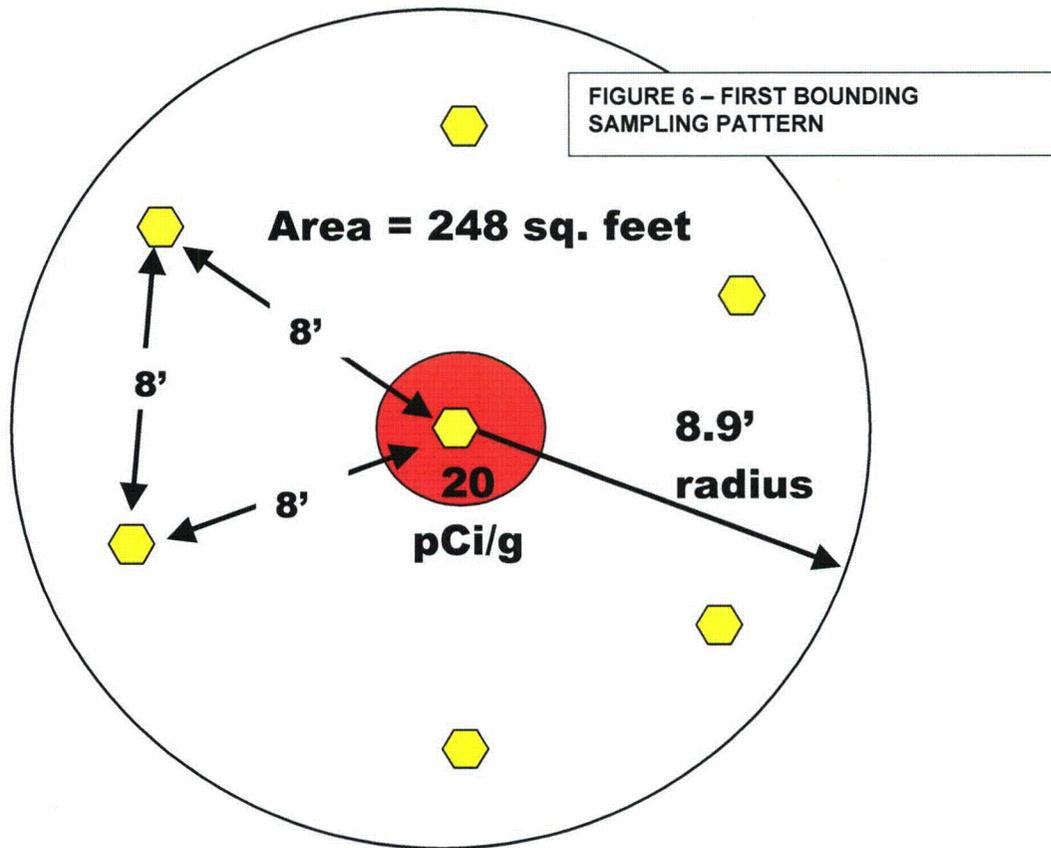
Using this rationale, the sampling pattern shown in Figure 6 was developed. For field practicality, it was determined that the central point would be re-located and sampled. Then 6 surrounding points, in an approximate 8-foot radius, would be sampled. Each location would be expected to yield 5 samples, from the following depth intervals, in inches: 0-6, 6-18, 18-30, 30-42, 42-54. This plan would yield a total of 35 samples.

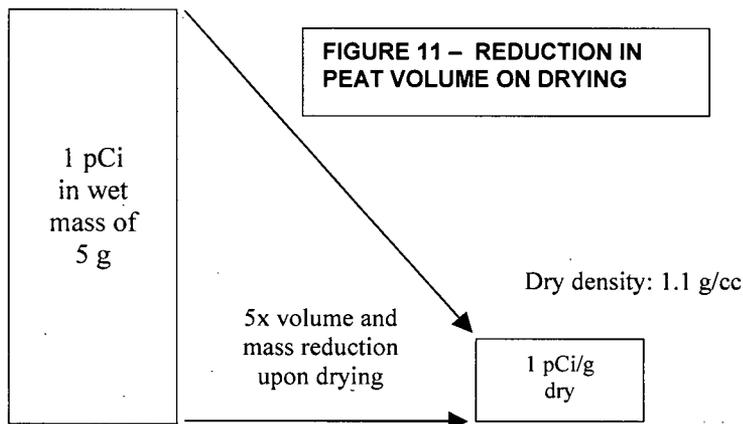
In the prior Bay investigation, it had been noted that samples of organic peat/muck lost a great deal of their volume and weight when they were dried, ground, and sieved for analysis. A typical weight reduction, for composite sample BY-7-83, was approximated in the bay study, and the final weight appeared to be only 17% of the starting weight. Such a reduction in weight could cause a significant increase in apparent Cs-137 activity, because that activity, in pCi, is reported per gram of dry soil. HaagEnviro's original assumption, before carefully documented volume and density reduction tests were performed in the stream mouth study, was that the typical weight reduction between the wet pre-testing samples and the dried samples ready for testing would be 5-to-1.

In that case, the resultant activity could be magnified 5 times between sampling and analysis, by comparison with mineral soils that would lose less volume and mass upon drying. This is illustrated by Figure 11. To check the preliminary assessment, three sets of measurements were made in the course of stream mouth sample preparation, to assess the reductions in volume and weight that were caused by sample processing. Three samples were measured and weighed before and after the processing described above.

Water density: 1.0 g/cc  
 Peat solids density: 1.1 g/cc  
 Total wet density: ~ 1 g/cc

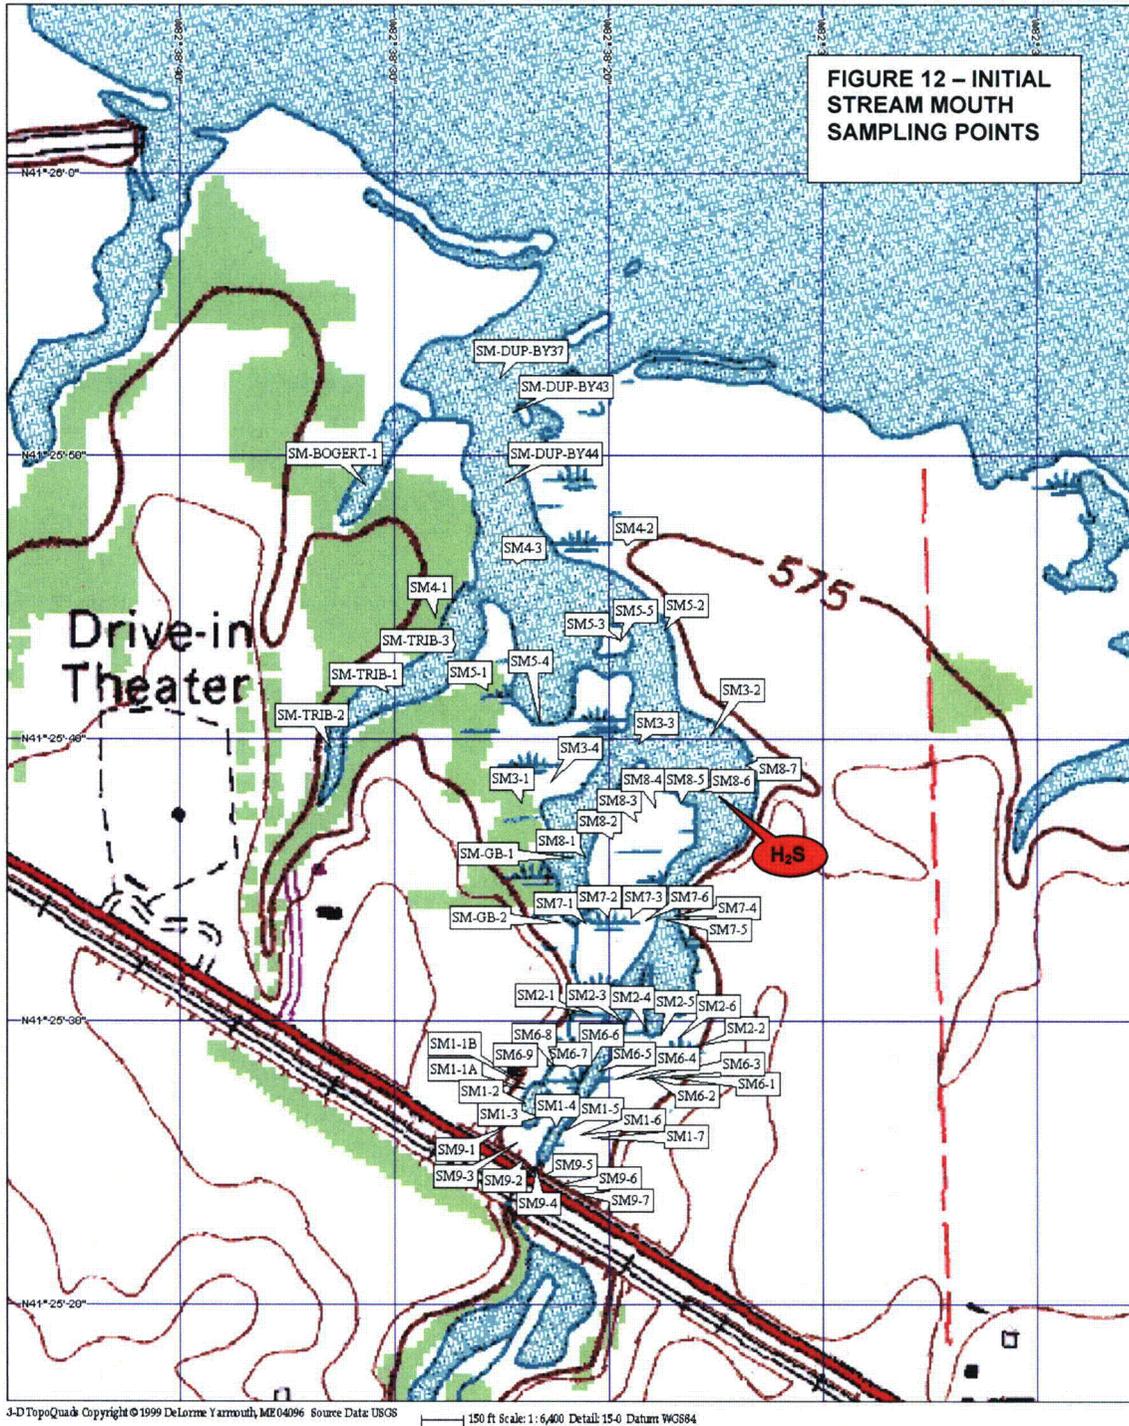
A MOTA RP Technician recorded the coordinates of the observed bubbles, as follows: North 41°, 25' 38.290", West 82°, 38' 15.226". This location is plotted in red on Figure 12.

As the staff returned with the meters to investigate, they observed bubbles coming up through the water. At ground level, the H<sub>2</sub>S meter indicated peak readings over 30 ppm (exceeding the PEL of 20). CO, LEL, and O<sub>2</sub> readings were below levels of concern. PID readings at ground level peaked at about 100 ppm (exceeding the exit guideline of 10). Readings obtained in the breathing zone were all below levels of concern.

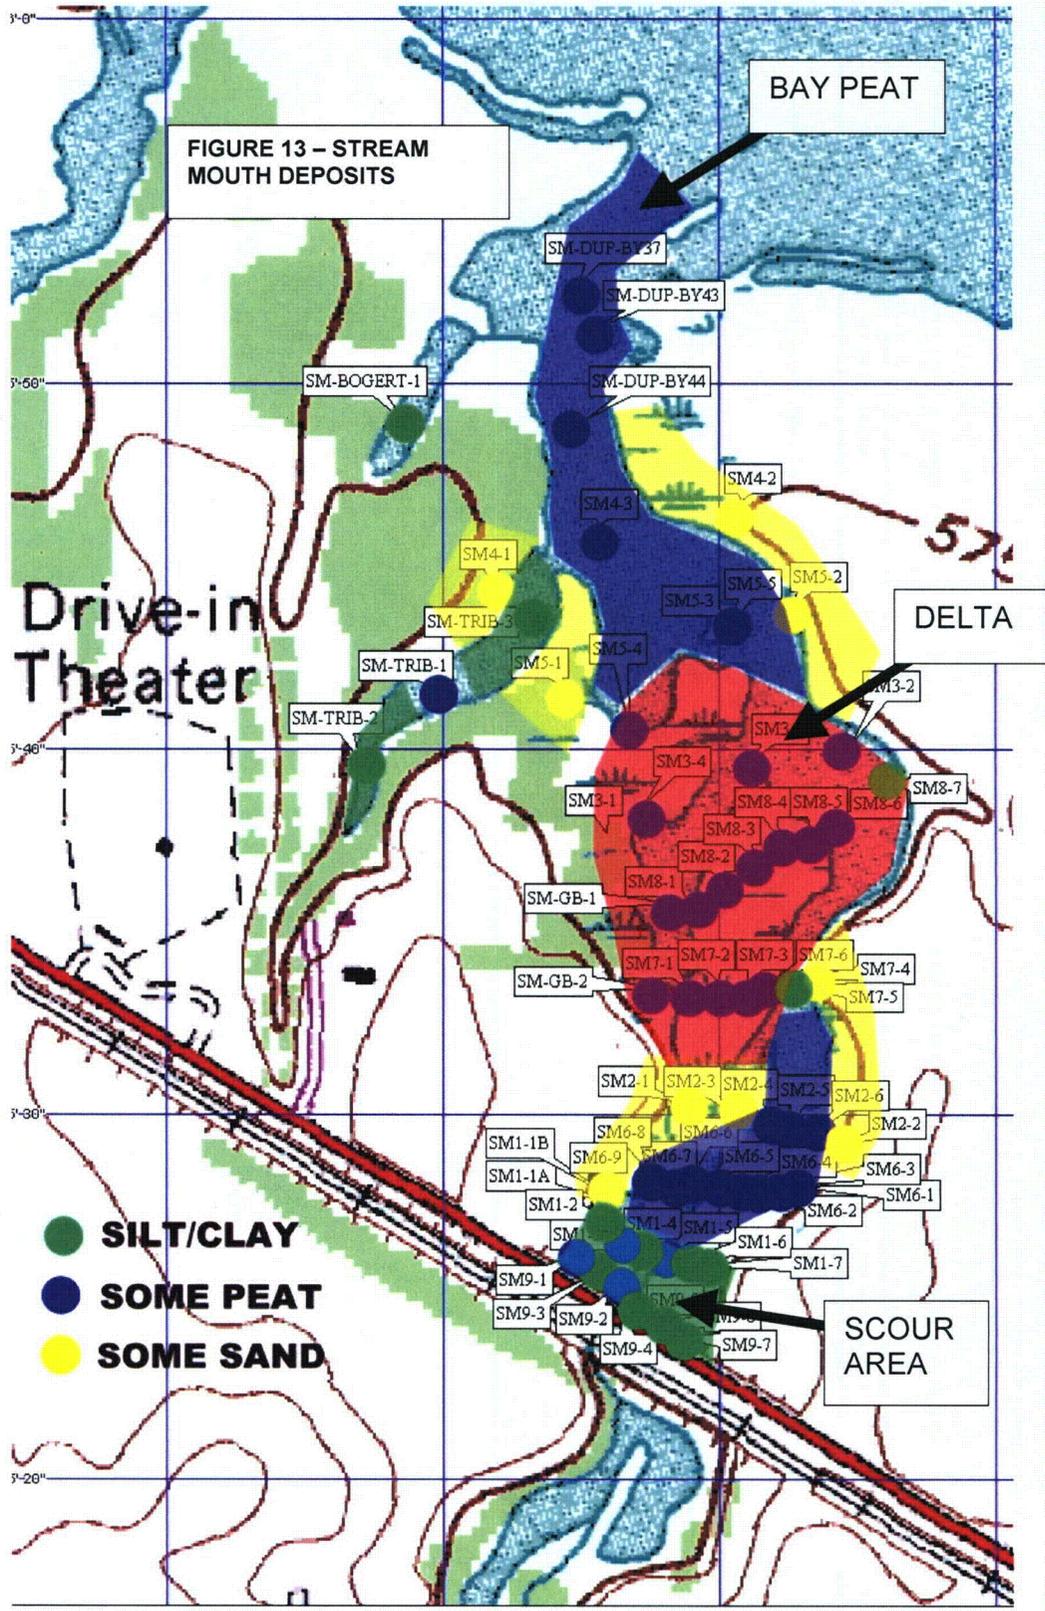
**General Sediment Patterns** – Based on the photographs obtained after the samples were extruded from the core tubing, the sediment types were seen to include sand, silt, peat, soft clay and dense clay. The dense clay, when found near the bottom of the core, was judged to be glacial till. The other sediments were considered to be post-glacial. Figure 13 illustrates the distribution of post-glacial sediment deposits in the stream mouth in map view. A corresponding soil survey map, with sand deposits highlighted, is provided in Figure 14. Figure 15 illustrates the character of the deposits that were found in the stream mouth environment.

**Sand Deposits** - Much of the sand observed exhibited an appearance associated with dune deposits, being light-colored and very fine-grained. Sand of this type was observed in samples obtained at the eastern or western extremes of transects, where the land surface was rising up out of the wetland. Sand was also noted in the center of transect 2.

**Peat Deposits** - Peat deposits dominated transects 6 and 5. Peat also dominated in 4 northerly points nearest the bay.

**Delta Deposits** – The delta is represented by transects 3, 7 and 8. In a central area, represented by transects 7 and 8, an alternation of layers of silt and peat could be observed, suggesting alternating dominance by stream deposits (silt) and bay deposits (peat). In the more upstream transect 7, the alternation between silt and peat was frequent and rhythmic. In transect 8, closer to the bay, the sequence was more typically silt overlying peat, suggesting that bay deposits had dominated in earlier years, and land-derived sediments had been more dominant in later years. Finding a delta area, where land-derived deposits encroached over still-water deposits, had been an early objective of the bay investigation. In the bay investigation, it had been expected that a delta would be found, where sand would advance over silt, and silt would advance over clay. Clay, at the bottom of that sequence of deposits, was expected to be the characteristic still-water deposit in the bay. However, in the bay study, it was instead found that the characteristic still-water deposit was peat, and no delta was identified in the bay. In the Stream Mouth, the central-area deposit of silt over peat appeared to be the actual form of the delta that the Characterization Plan had anticipated in the bay.

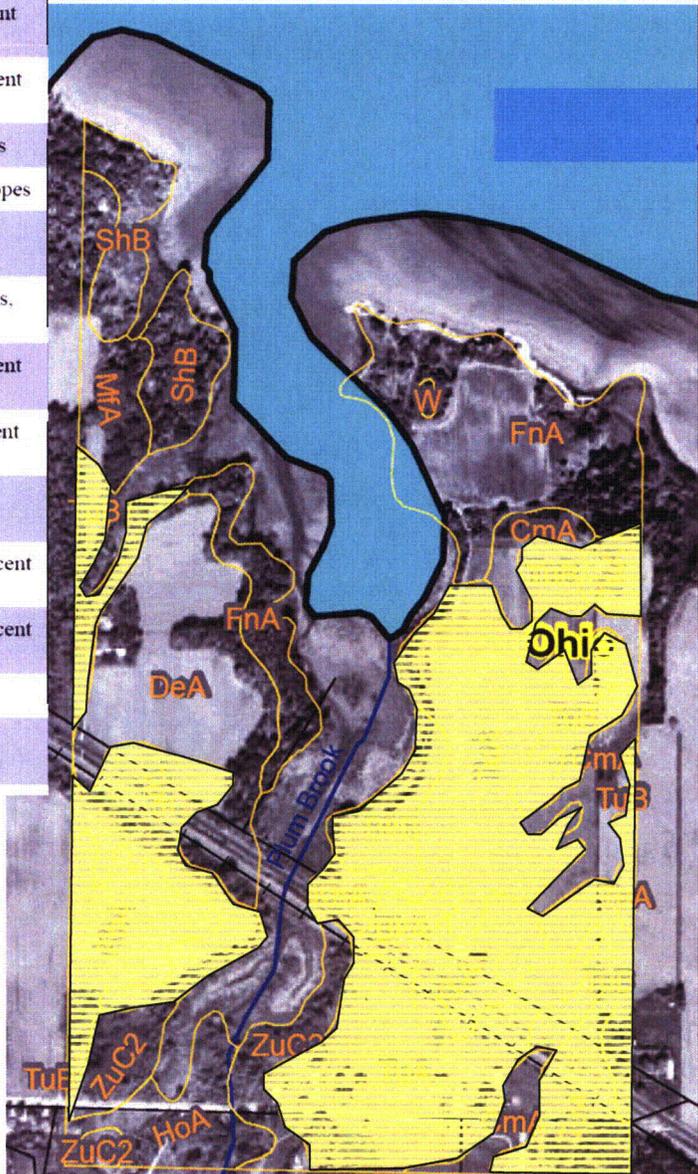
FIGURE 14 – STREAM MOUTH  
SOIL SURVEY

Web Soil Survey 1.1  
National Cooperative Soil Survey

**Soils with  
"Sand" in  
Name**

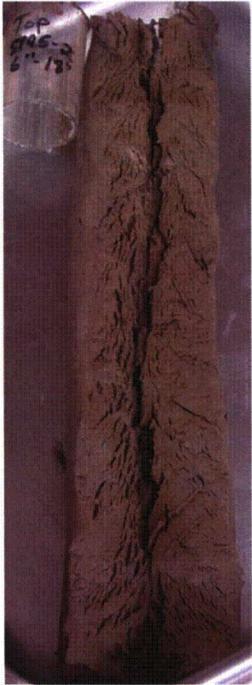
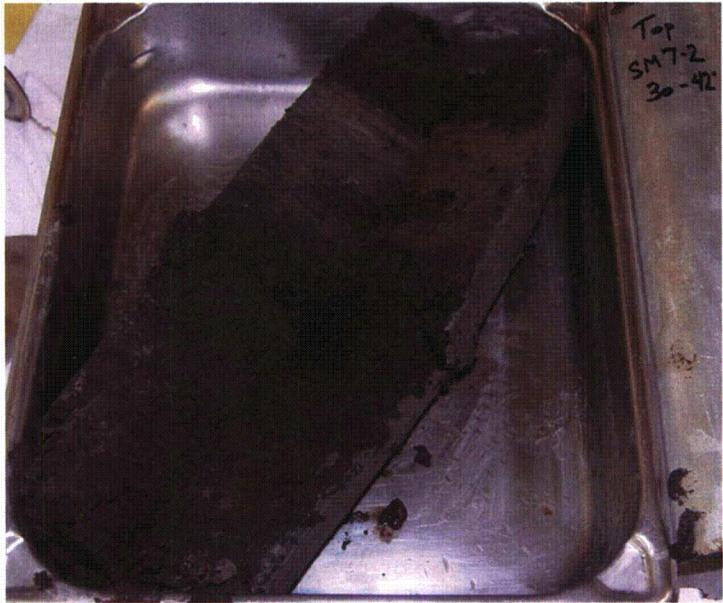
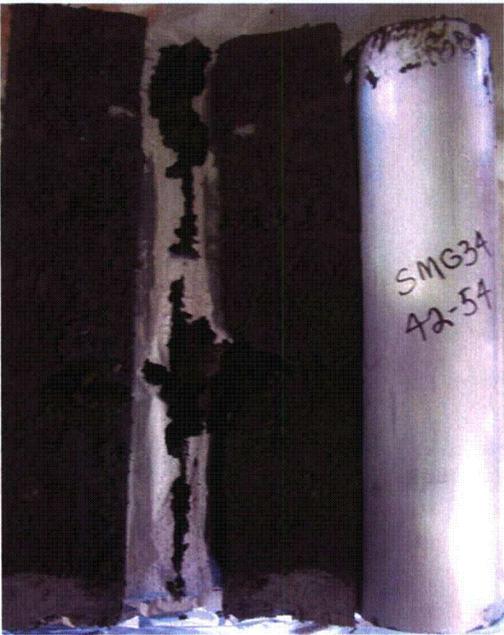
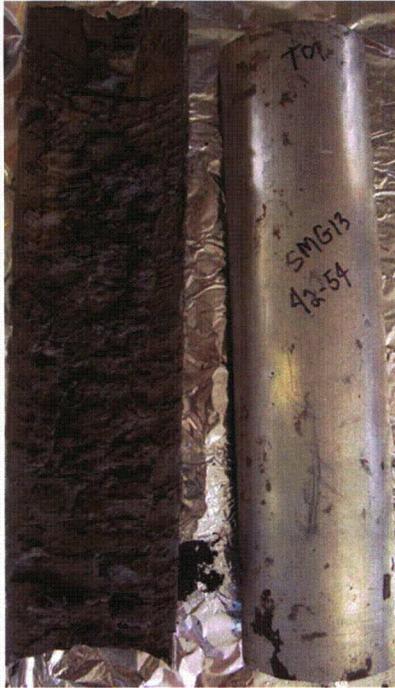
FIGURE 15 – STREAM MOUTH  
SEDIMENTS

FINE SAND  
AND SILT

INTERBEDDED PEAT AND CLAY

PEAT OVER CLAY TILL

DENSE  
GLACIAL  
TILL

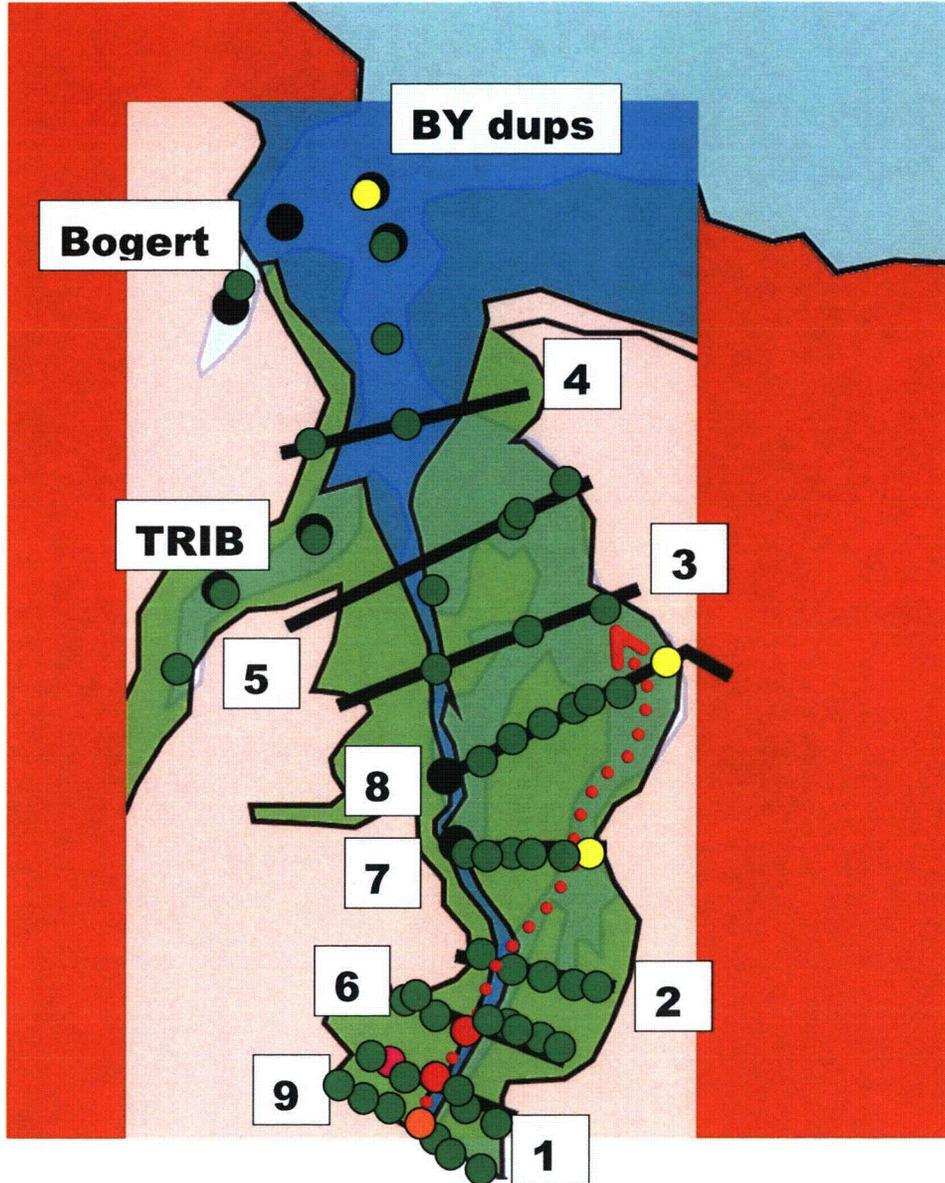
FIGURE 16 – HIGHEST RESULTS IN INITIAL TRANSECTS

**Cs-137 Results in Initial Transects** – As shown by Figure 16, peak Cs-137 results approached or exceeded 12 pCi/g in two locations in the initial transect sampling effort. One of these was found at Stream Mouth (SM) location 1-4, also called SM1-4, where a peak value of 11.7 pCi/g was detected. The second was found at SM location 6-6, where a peak value of 20.6 pCi/g was reported. Both of these EMAs were found in the existing stream channel. Downstream, the next highest Cs-137 values found were in an abandoned channel, which had carried the stream in 1969. These values were 3.9 pCi/g at SM location 7-5, and 3.4 pCi/g at SM location 8-7. A value of 2.54 pCi/g at SM location 5-5 may also be related to this channel, as may be a value of 2.32 pCi/g at SM location 4-3. The value of 11.7 pCi/g was found in the depth interval of 6-18” below the active stream bottom, the 20.6 pCi/g was found at 0-6” below the active stream bottom, the 3.9 pCi/g was reported at 6-18” below the in-filled land surface above the old channel, the 3.4 pCi/g was reported at 18-30” below the in-filled land surface above the old channel, and the 2.54 and 2.32 pCi/g values were reported 6-18” below the surface. The balance of the downstream detections of Cs-137 observed were scattered above and below 1 pCi/g (ranging from 0.3-1.3), and were generally found in the upper 18” of the sample column, with most of the highest values in the upper 6” sampled. Upstream from the EMA at location SM1-4, some Cs-137 detections extended to greater depths. In particular, a value of 1.2 pCi/g was found in the 42-54” interval at location 9-2, and a value of 2.6 pCi/g was found in the 42-54” interval at location 9-4.

- Cs-137 > 11.5 pCi/g
- Cs-137 = 7.7 pCi/g (at 5' in pond)
- Cs-137 = 6-11.5 pCi/g
- Cs-137 = 3-6 pCi/g
- Cs-137 detected, but < 3 pCi/g

A map-view illustration of the highest Cs-137 results found in the initial transects is provided by Figure 16. Sample locations where Cs-137 was still being detected at the bottom of a core in the original transects are indicated on Figure 17. A detailed cross-sectional plot of the sediment deposits along transect 1 is provided in Figure 18, and a generalized cross-section of sediments along nearby transect 6 is given by Figure 19. Both of the cross-sectional plots also provide Cs-137 results, including the two initial EMAs (locations 1-4 and 6-6).

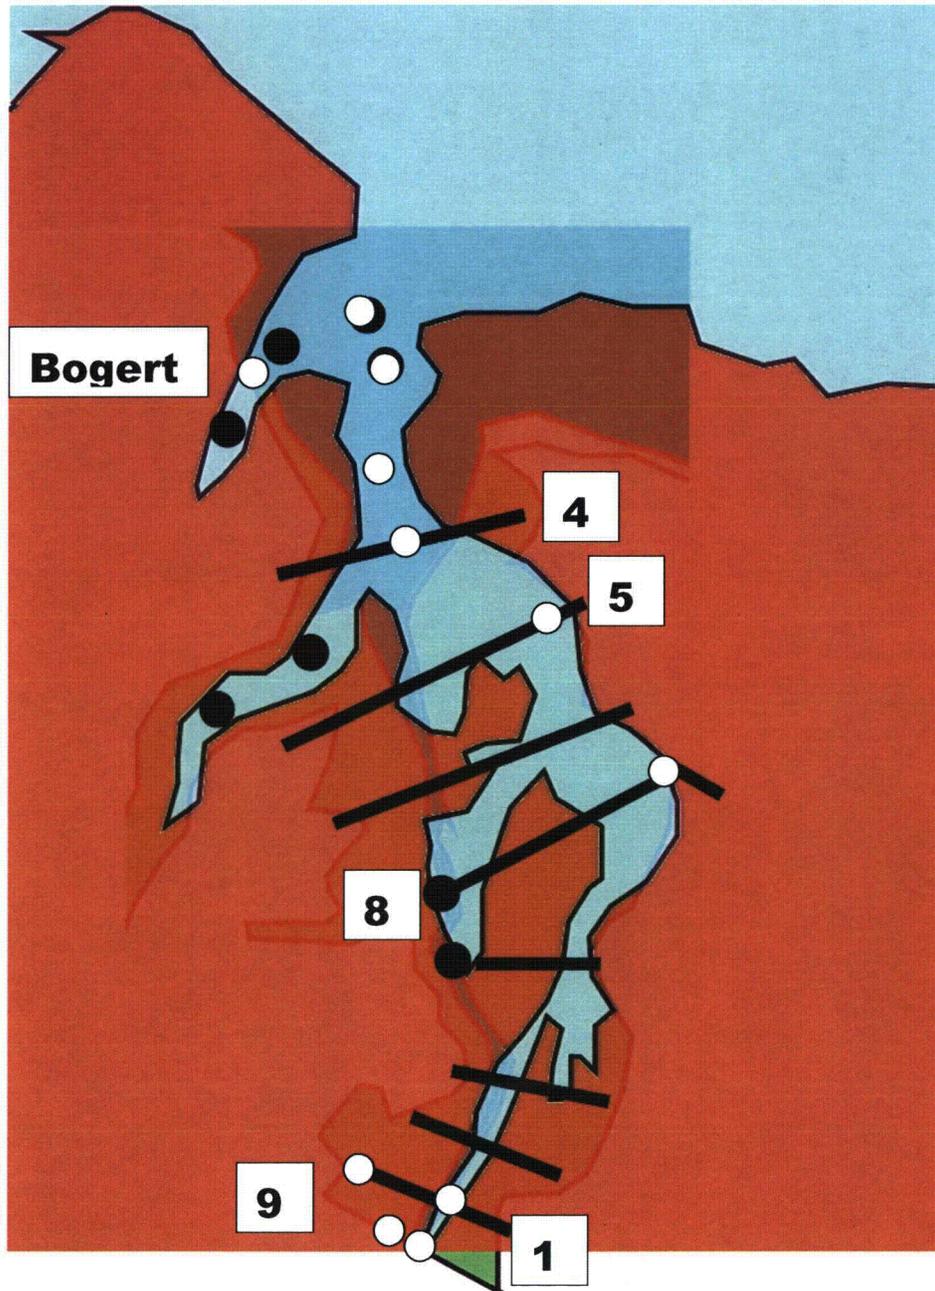
FIGURE 17 – LOCATIONS WHERE CS-137 WAS DETECTED AT BOTTOM OF CORE IN INITIAL TRANSECTS

In most sampling locations, Cs-137 values less than the Minimum Detectable Activity (MDA) were found at some depth below the surface. Figure 17 shows the locations where this was not achieved. In all such cases where the full vertical extent of the Cs-137 distribution was not defined, it was noted that all values at the bottom of the sample column were less than 12 pCi/g. However, it was not possible to assert that all of the patterns of detection versus depth were showing a declining concentration.

- Originally Planned Sample Locations and Transects
- Actual Locations Where Vertical Extent Was Not Fully Defined

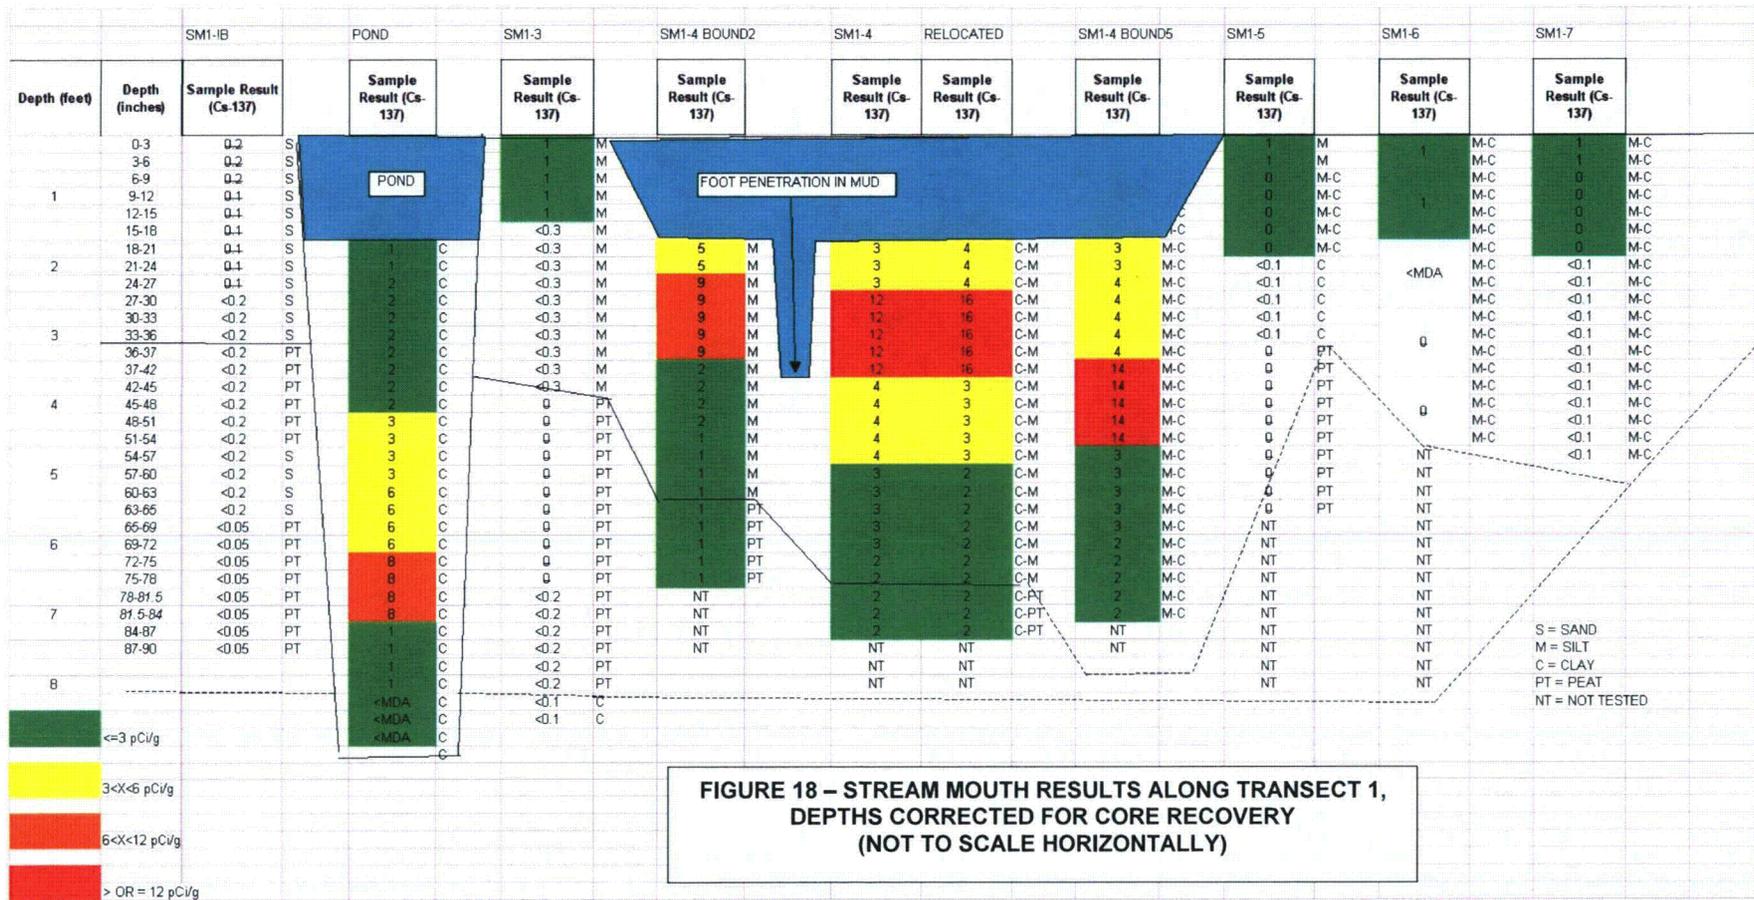
**FIGURE 18 – STREAM MOUTH RESULTS ALONG TRANSECT 1, DEPTHS CORRECTED FOR CORE RECOVERY (NOT TO SCALE HORIZONTALLY)**

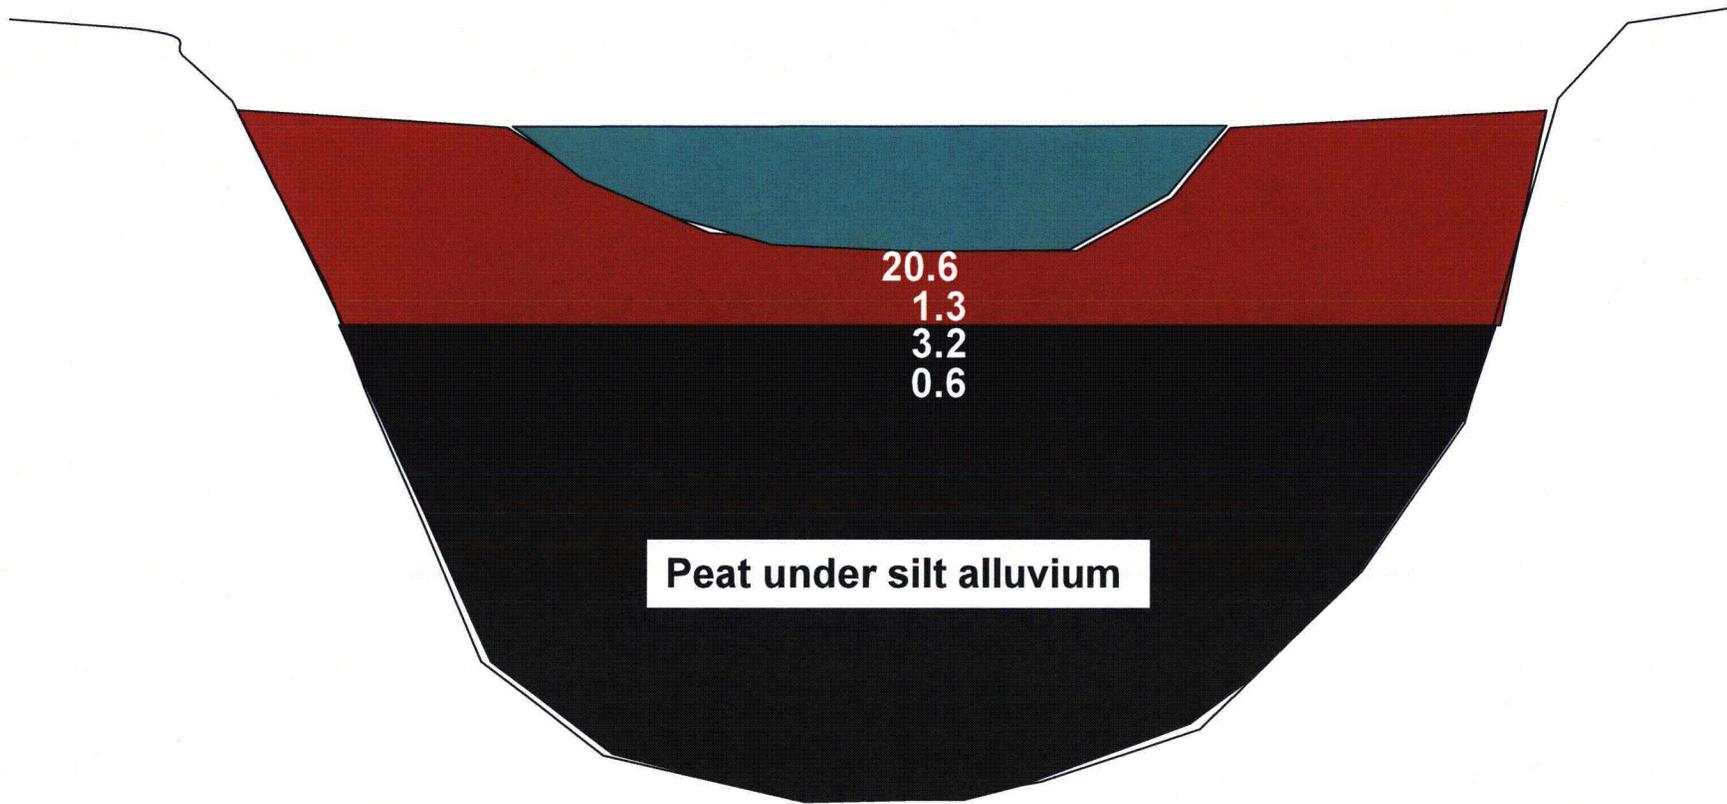
FIGURE 19 – HIGHEST STREAM MOUTH RESULTS IN ORIGINAL TRANSECTS, ON GENERALIZED CROSS-SECTION (NOT TO SCALE). RESULTS IN pCi/g.
