Progress Energy Carolinas
<b>Shearon Harris Nuclear Power Plant</b>
<b>Units 2 and 3</b>
<b>Part 2, Final Safety Analysis Report</b>
New Hill, North Carolina
Photograph of Lithofacies II Sandstone and Siltstone Exposed in the Emergency Service Water Discharge Channel at the HNP Site
FIGURE 2.5.1-234

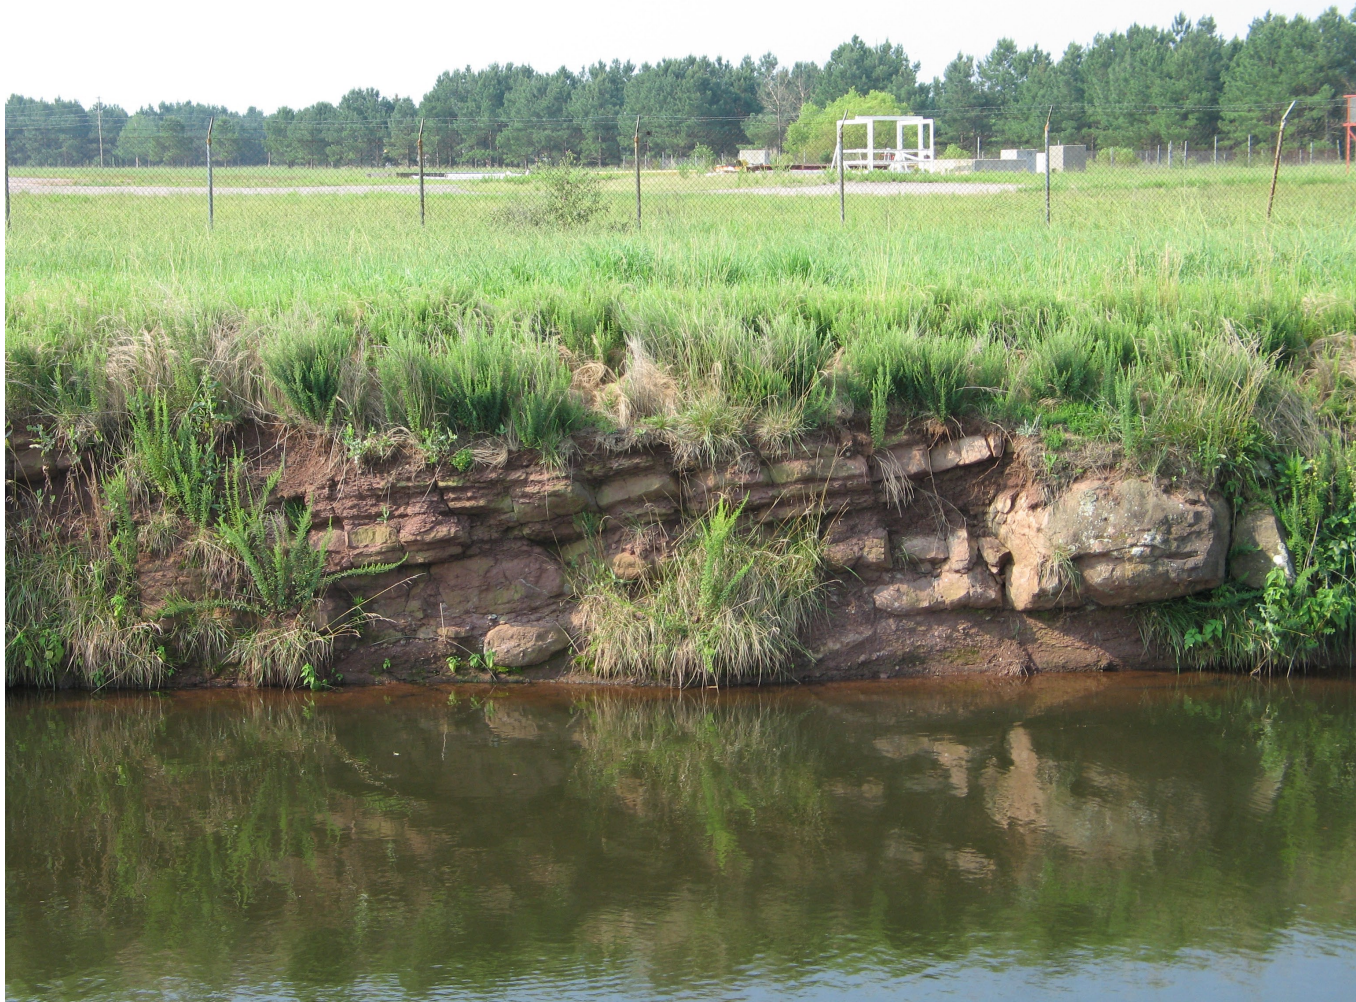
View South
