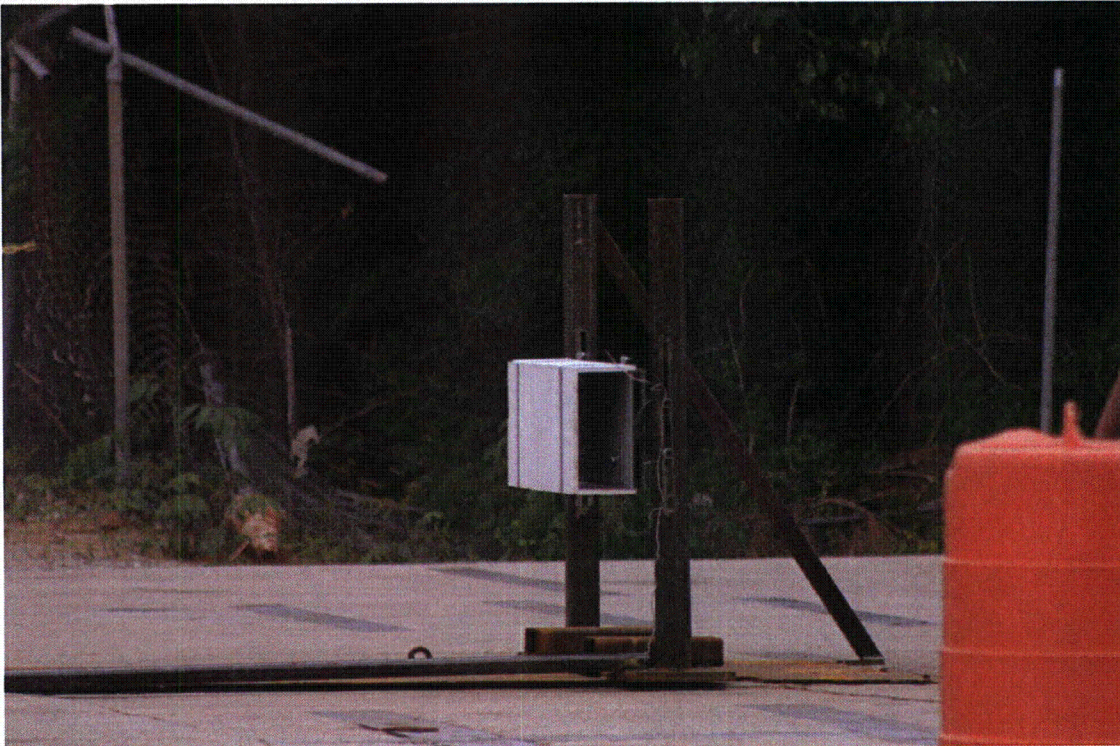
Figure A5-1 Marinite Test 1 Pre-Test Picture

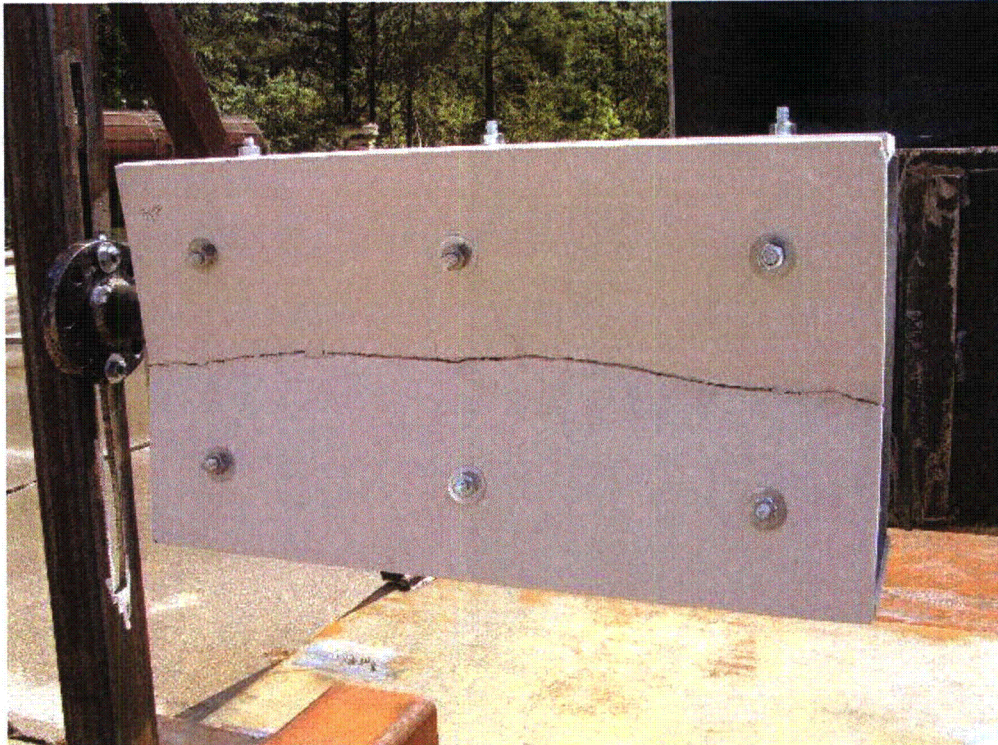
Figure A5-13 Marinite Test 6 Post-Test Picture

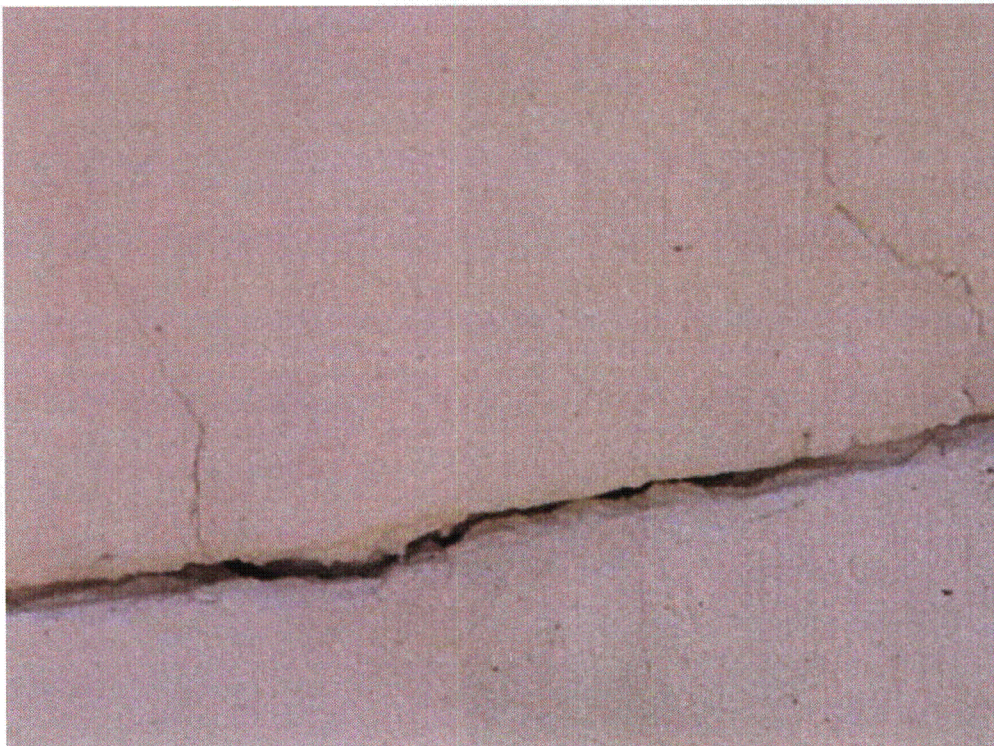
Figure A5-15 Marinite Test 6 Post-Test Picture

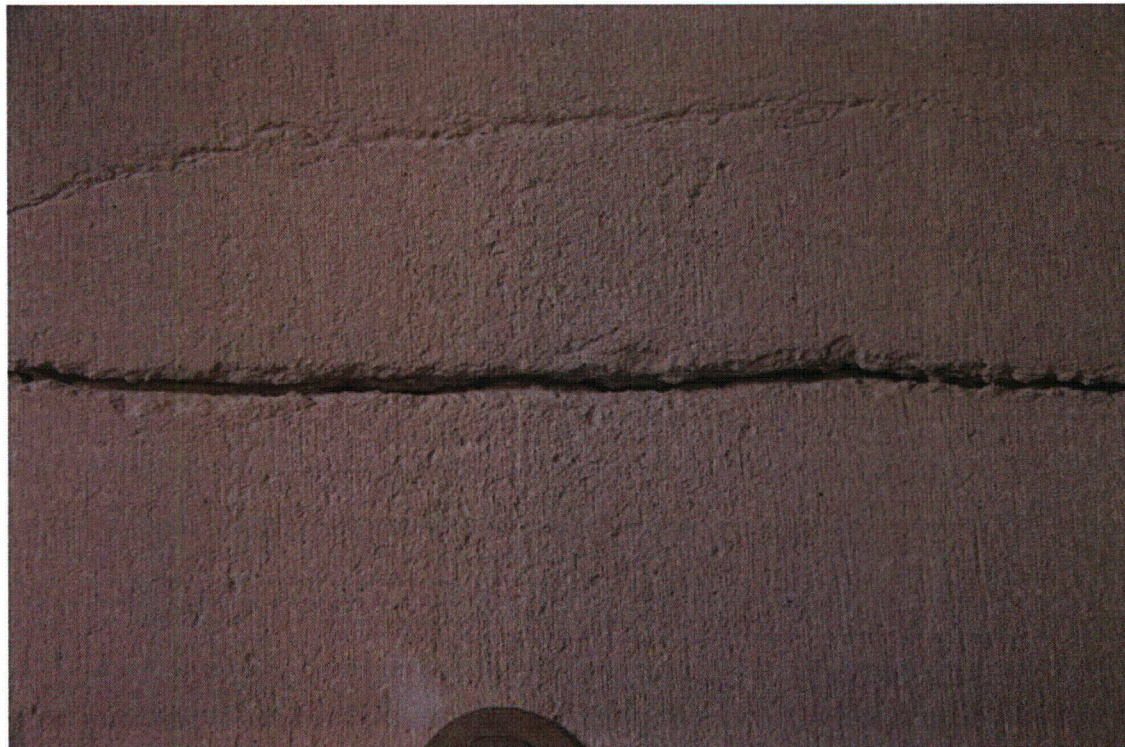
Figure A5-18 Marinite Test 7 Post-Test Picture

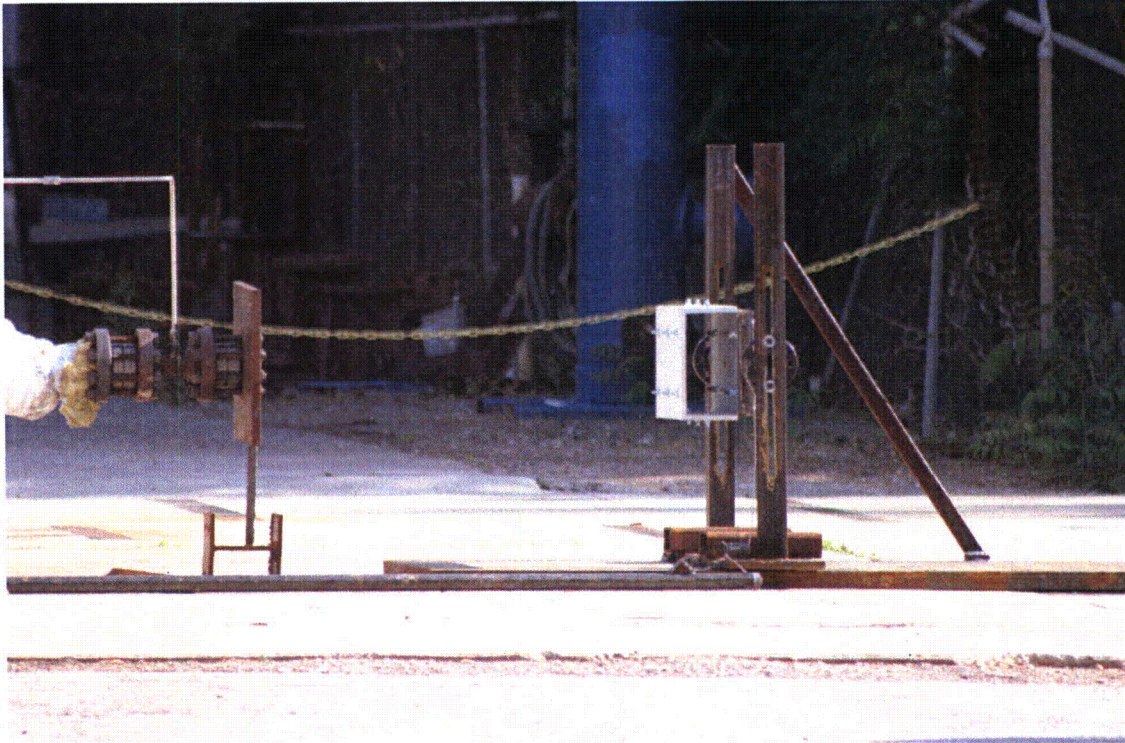
Figure A5-19 Marinite Test 8 Pre-Test Picture

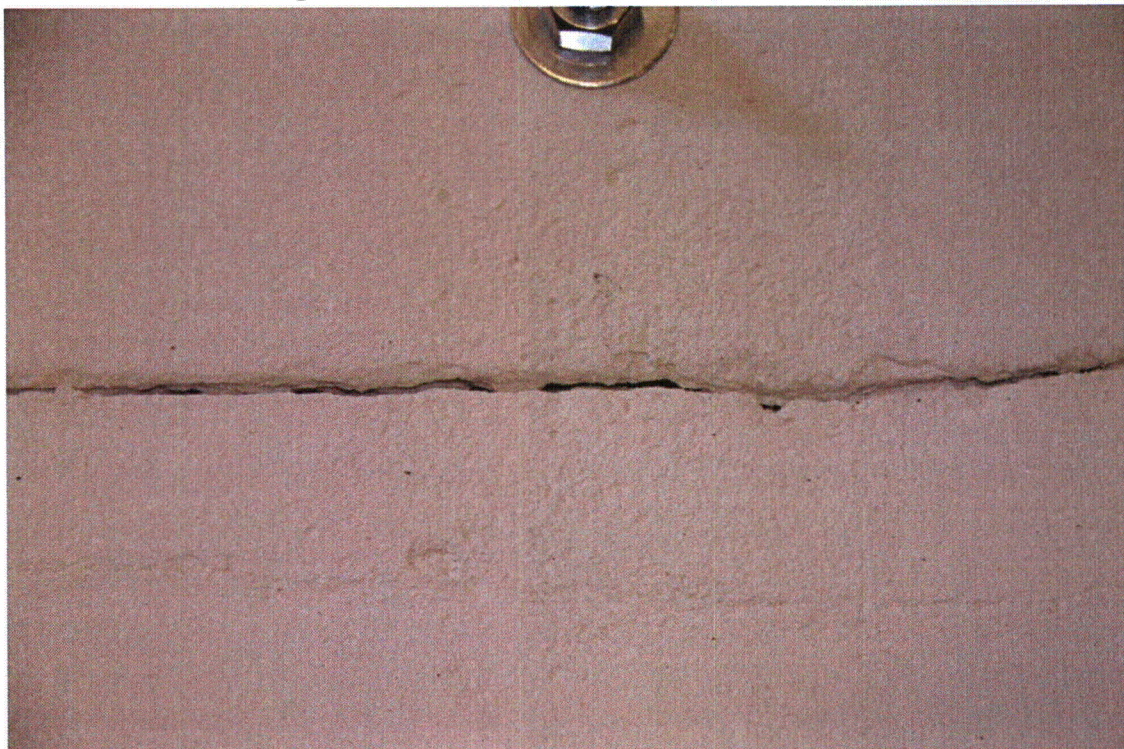
Figure A5-22 Marinite Test 8 Post-Test Picture

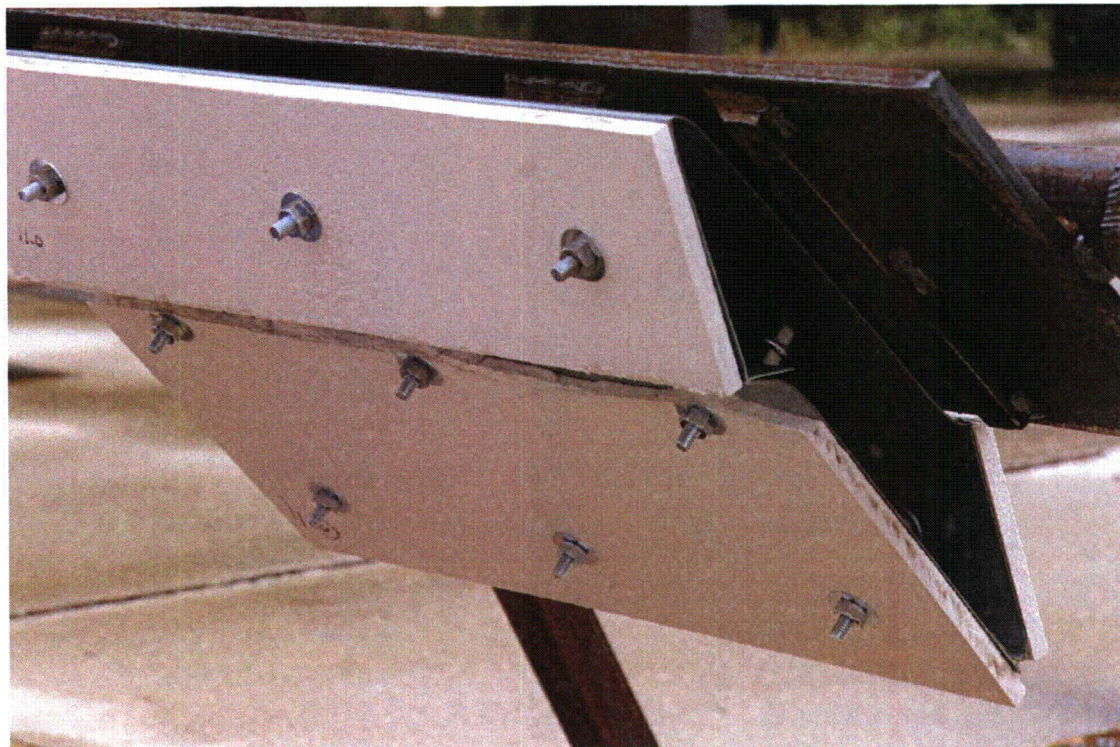
Figure A5-24 Marinite Test 9 Post-Test Picture

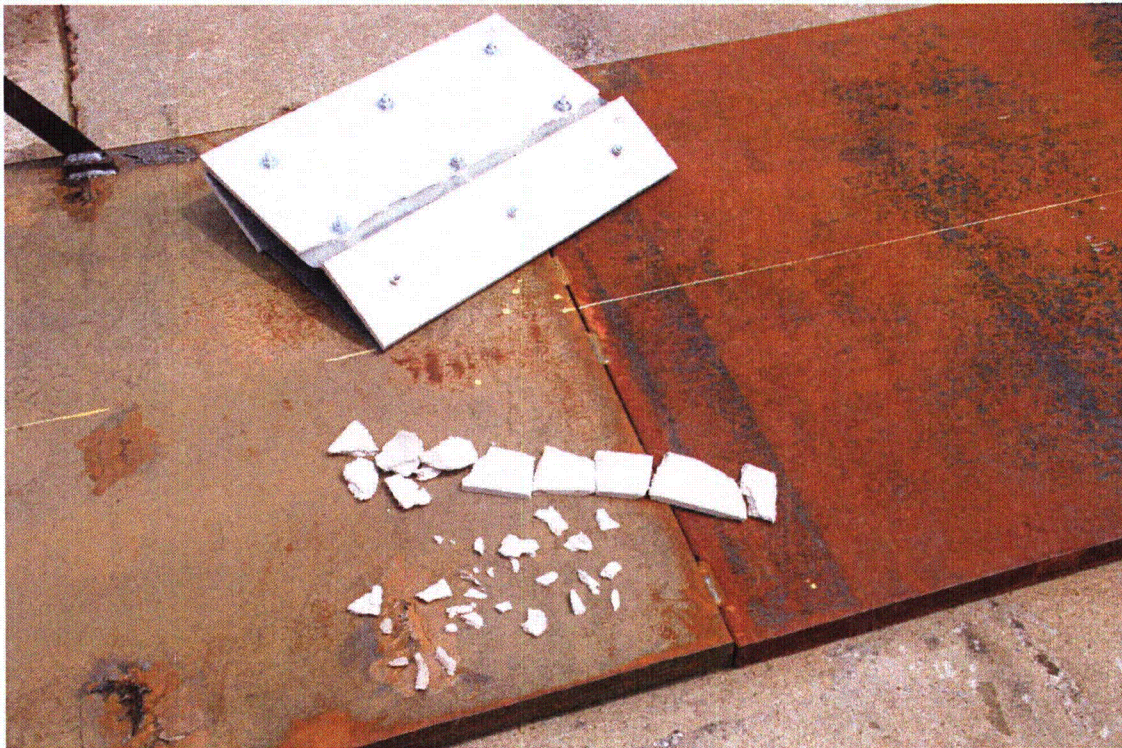
Figure A5-25 Marinite Test 9 Post-Test Picture

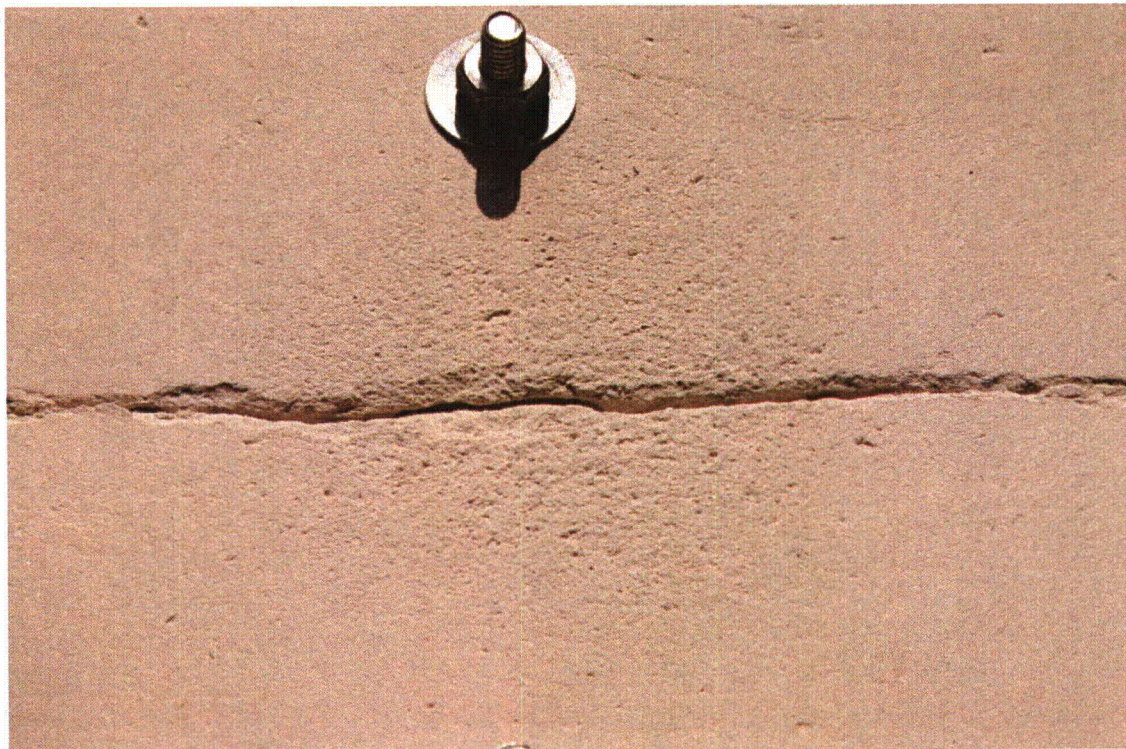
Figure A5-28 Marinite Test 10 Post-Test Picture

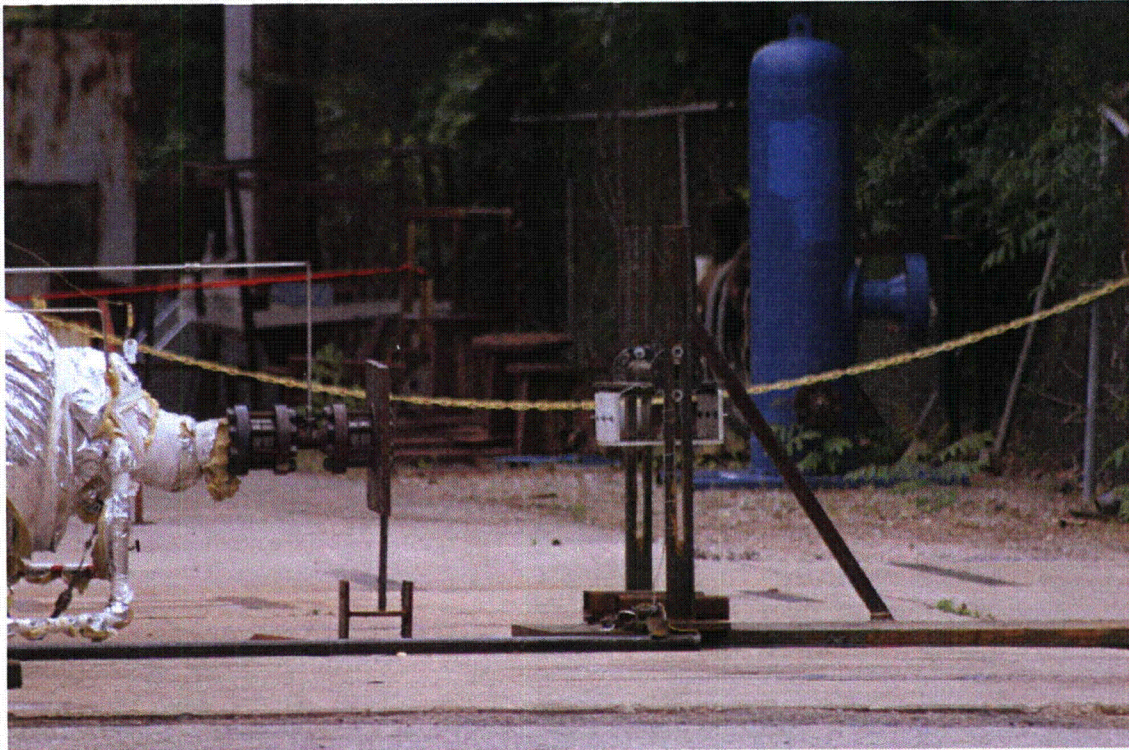
Figure A5-29 Marinite Test 11 Pre-Test Picture

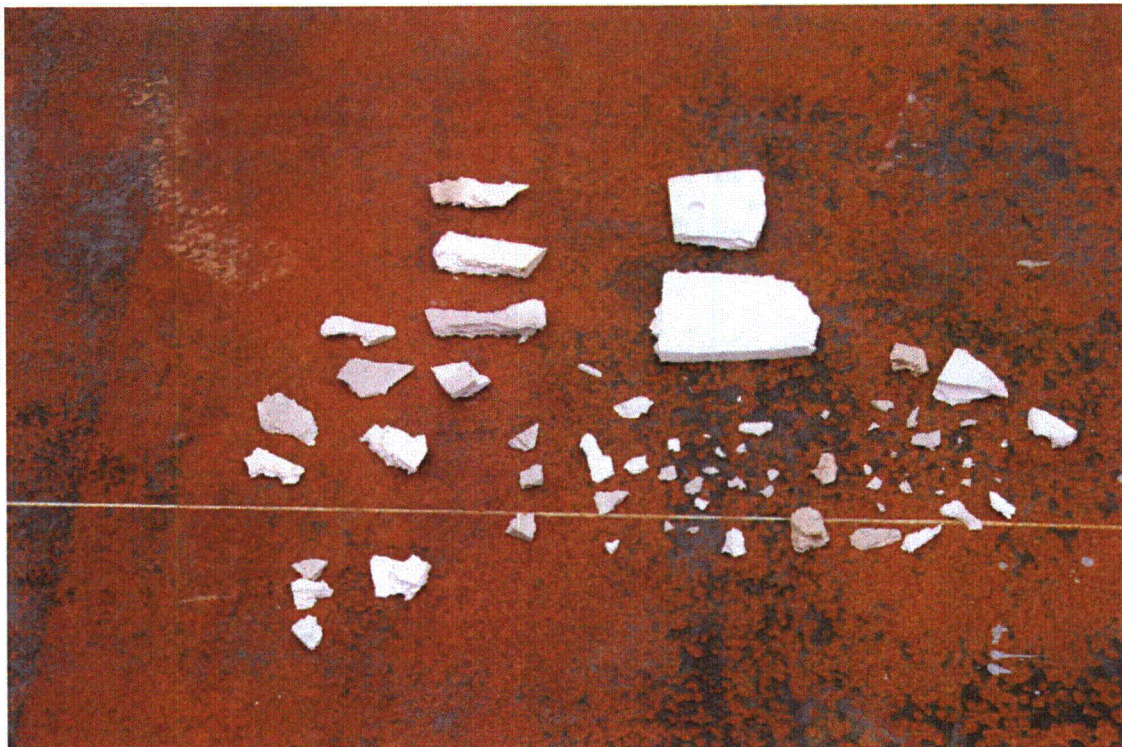
Figure A5-32 Marinite Test 11 Post-Test Picture

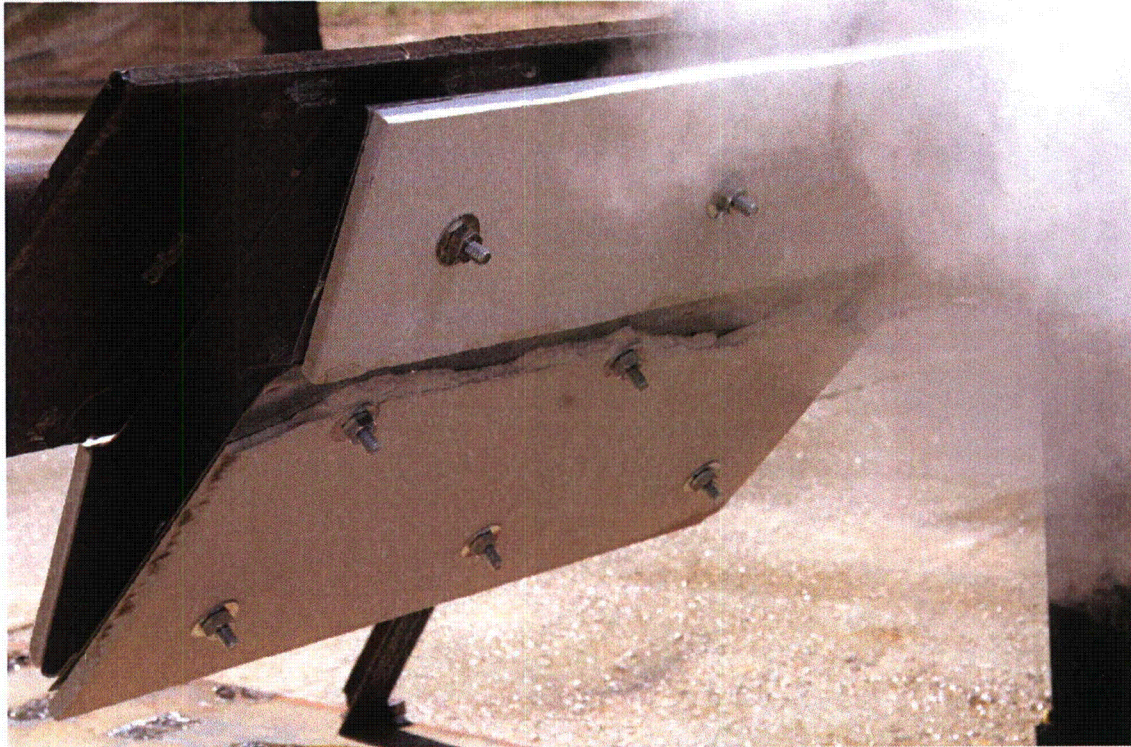
Figure A5-37 Marinite Test 13 Post-Test Picture

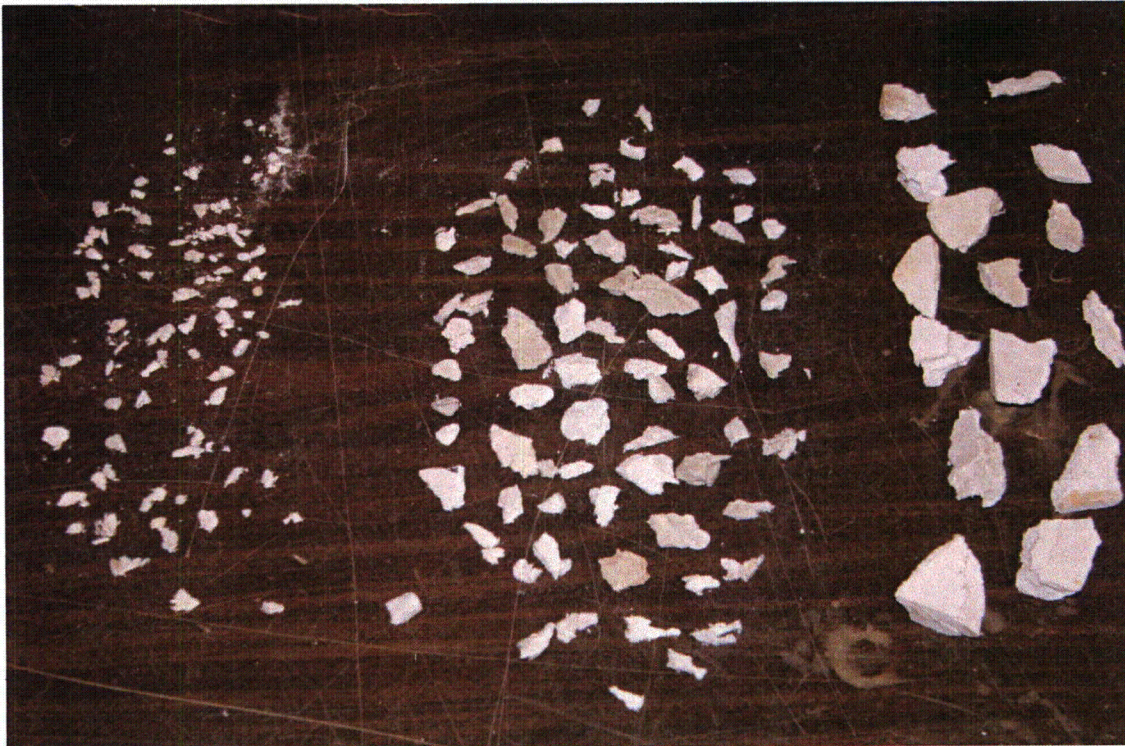
Figure A5-39 Marinite Test 13 Post-Test Picture

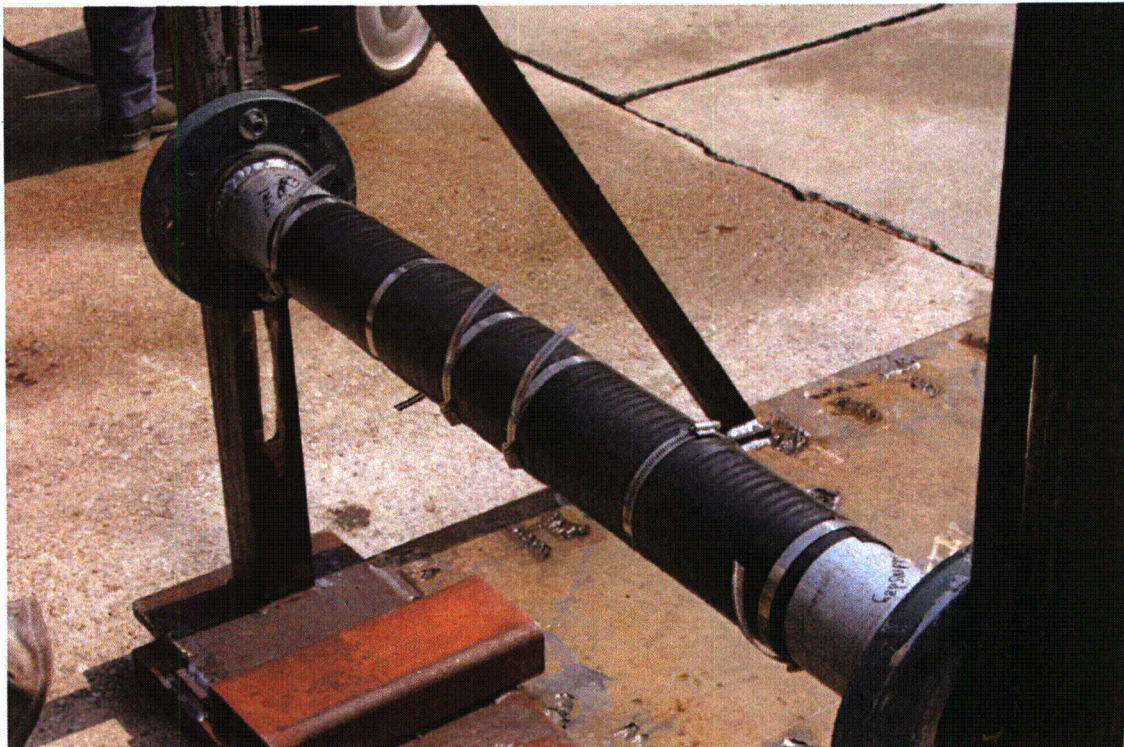
Figure A5-40 Scotch 77 Fire Retardant Tape Test 1 Pre-Test Picture
