2.5.3 Surface Faulting

2.5.3.1 Geological, Seismological, and Geophysical Investigations

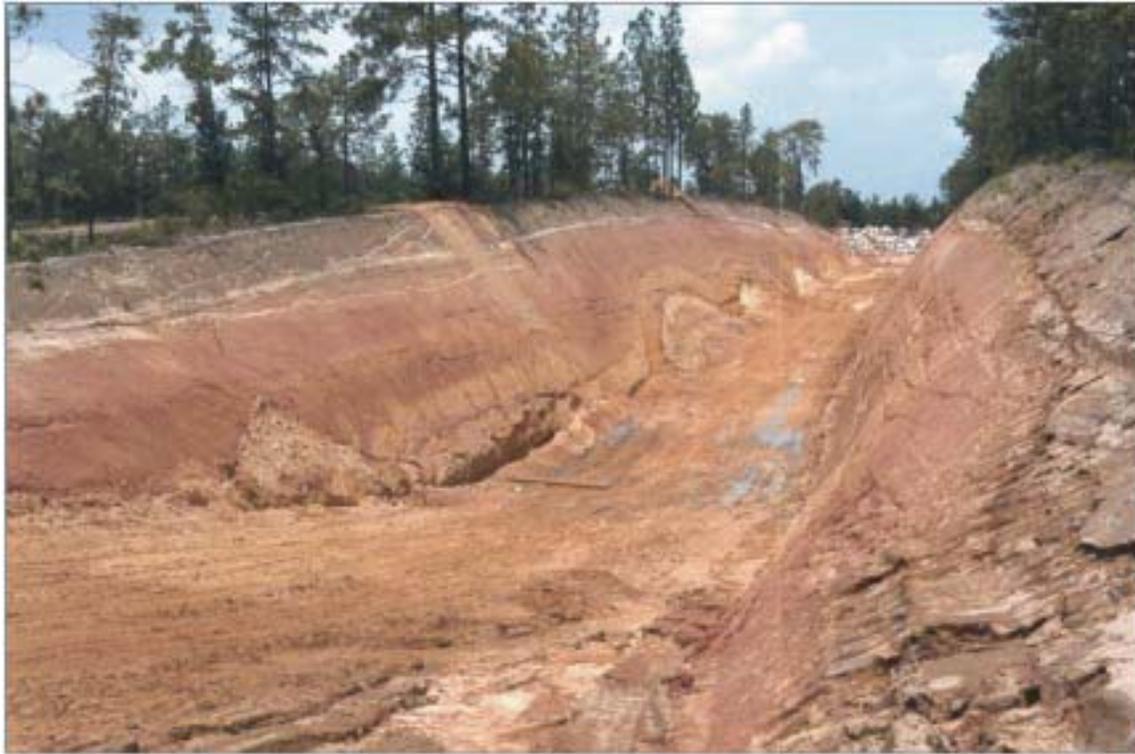
Figure 2.5.3-1 Contorted Bedding in Garbage Trench at VEGP Site

Source: Bechtel 1984b

The potential for non-tectonic deformation at the site resulting from near-surface dissolution-induced collapse has long been recognized as a possibility and has been the subject of several studies e.g., (**Bechtel 1981, 1984b**). Bechtel (1984b) identified the presence of a variety of small-scale deformation structures in the walls of a garbage trench on the VEGP site within Tertiary Coastal Plain sediments (Figure 2.5.1-34). These structural features, including warped bedding, fractures, joints, minor offsets, and injected sand dikes, were interpreted as local phenomena related to dissolution of the underlying Utley Limestone and resultant plastic and brittle collapse of overlying Tertiary sediments (**Bechtel 1984b**) (Figures 2.5.3-1 and 2.5.3-2).

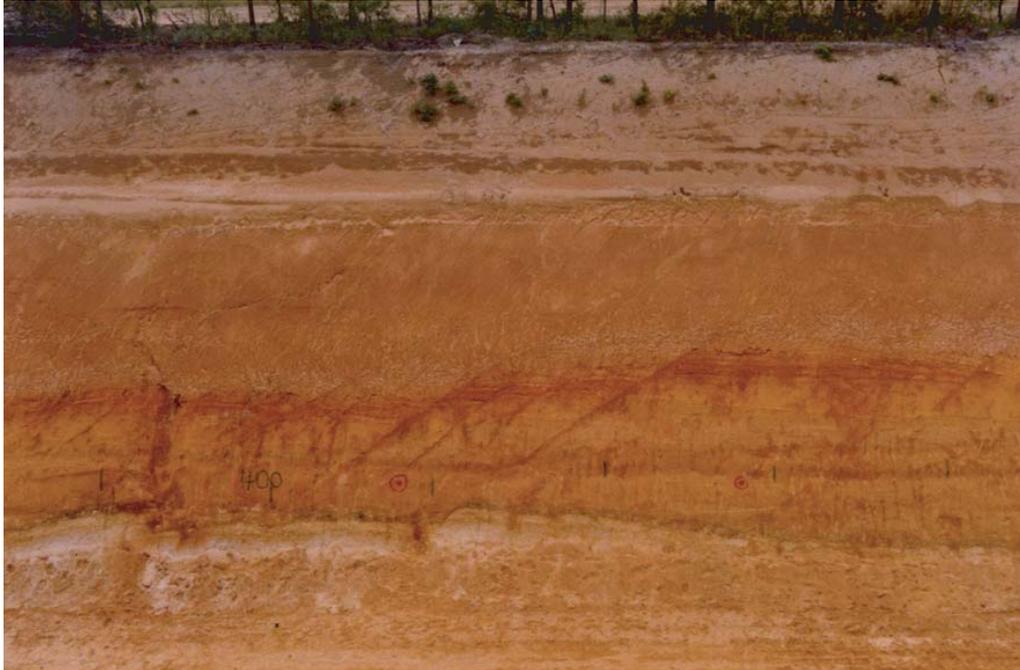
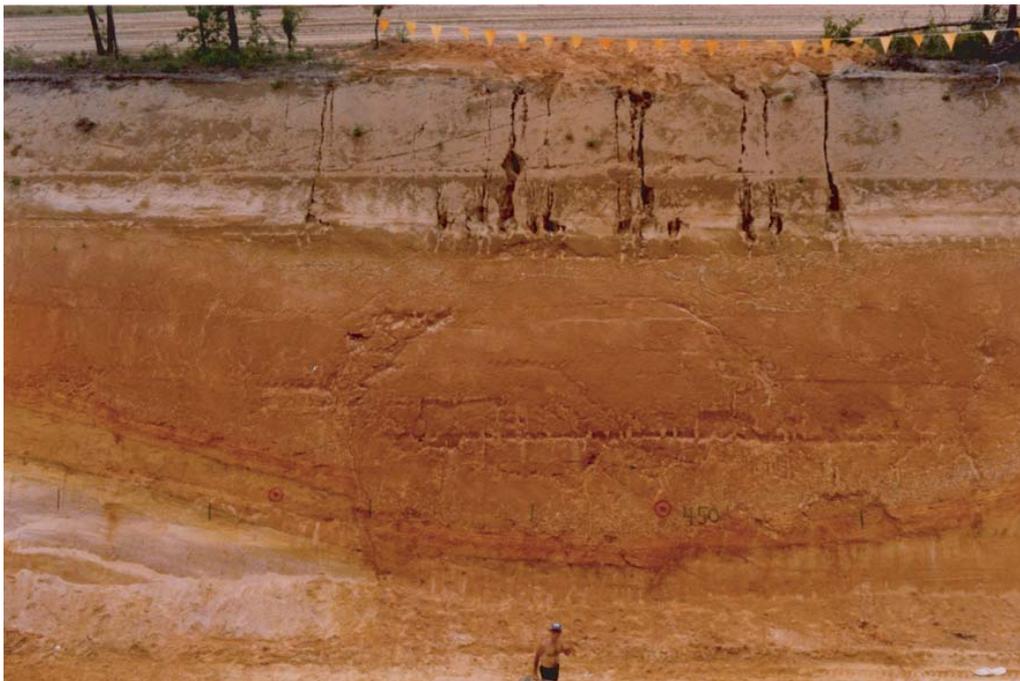
Figure 2.5.3-2 West Wall of Garbage Trench Showing Small Offsets (1–24 inches) (Upper) and Arcuate Fractures and Clastic Dikes Over Center of Depression (Lower)

Source: Bechtel 1984b

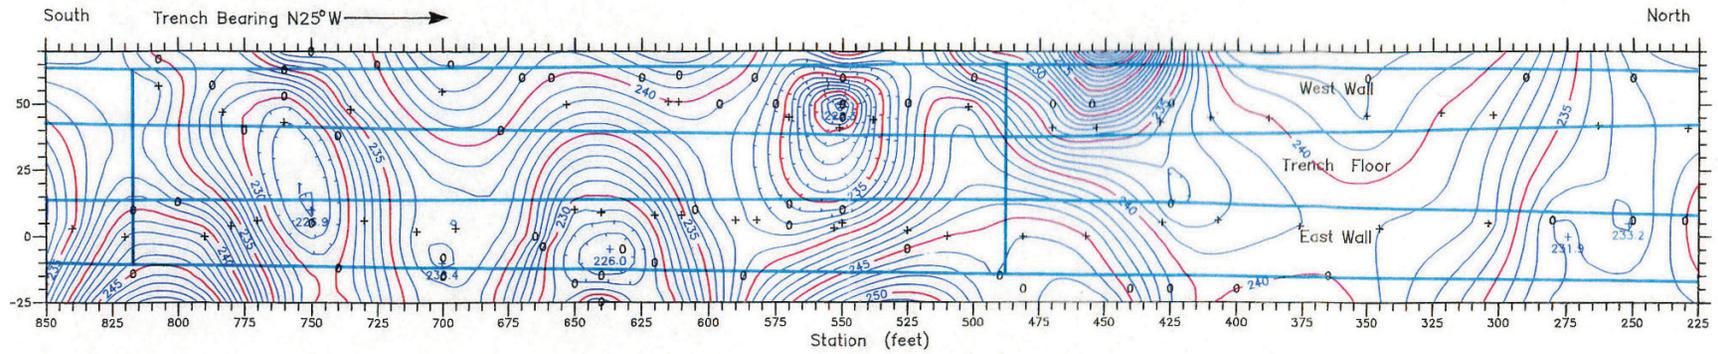
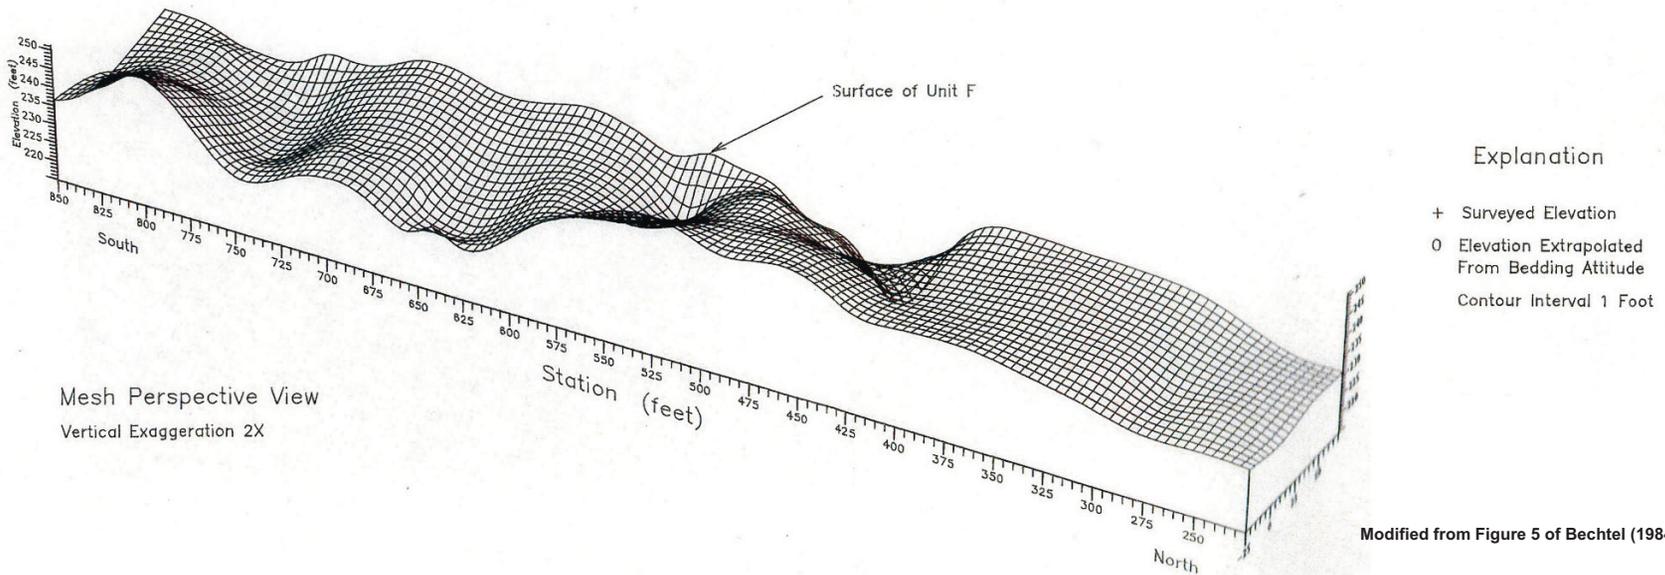
Figure 2.5.3-3 Surface Geometry of Unit F Illustrating Localized Nature of Deformation

Structure Contour Map, Surface of Unit F – Trench Plan View

The three-dimensional nature of the warped bedding, combined with the spatial and kinematic relationships of the small-scale faults and fractures along the margins of the more strongly warped depressions, clearly demonstrates a dissolution or sediment collapse origin. The highly irregular, discontinuous nature of folding is consistent with a non-tectonic dissolution origin and inconsistent with a tectonic origin, since there are no laterally persistent fold axes. For example, the upper contact of Unit F, a 1-to-2-ft-thick, moderately consolidated, laminated, red and yellow, silty fine sand, is folded into a highly irregular surface (**Bechtel 1984b**) (Figure 2.5.3-3). If this minor fold deformation was associated with the underlying Pen Branch fault, fold axes should be laterally persistent and parallel to the fault. The discontinuous nature of domes and depressions in an “egg carton” or “dimpled” pattern reflects the more random, non-tectonic process of dissolution (Figure 2.5.3-3).
