**CHARACTERIZATION REPORT
FOR PLUM BROOK SEDIMENT IN
STREAM MOUTH WETLANDS**

Prepared for
Keith M. Peacock
National Aeronautics and Space Administration (NASA)
Glenn Research Center
Plum Brook Reactor Decommissioning Program
Plum Brook Station
6100 Columbus Avenue
Sandusky, Ohio 44870

Prepared by:
Haag Environmental Company
315 East Market Street
Sandusky, Ohio 44870

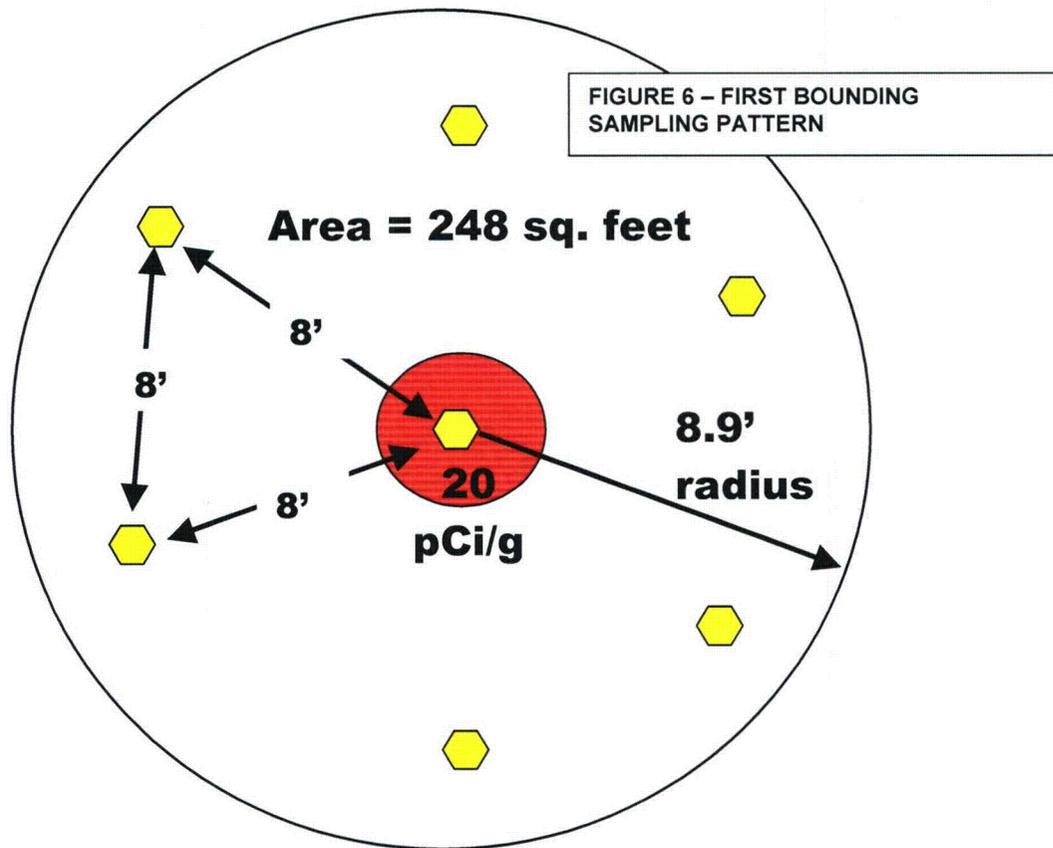
Using this rationale, the sampling pattern shown in Figure 6 was developed. For field practicality, it was determined that the central point would be re-located and sampled. Then 6 surrounding points, in an approximate 8-foot radius, would be sampled. Each location would be expected to yield 5 samples, from the following depth intervals, in inches: 0-6, 6-18, 18-30, 30-42, 42-54. This plan would yield a total of 35 samples.

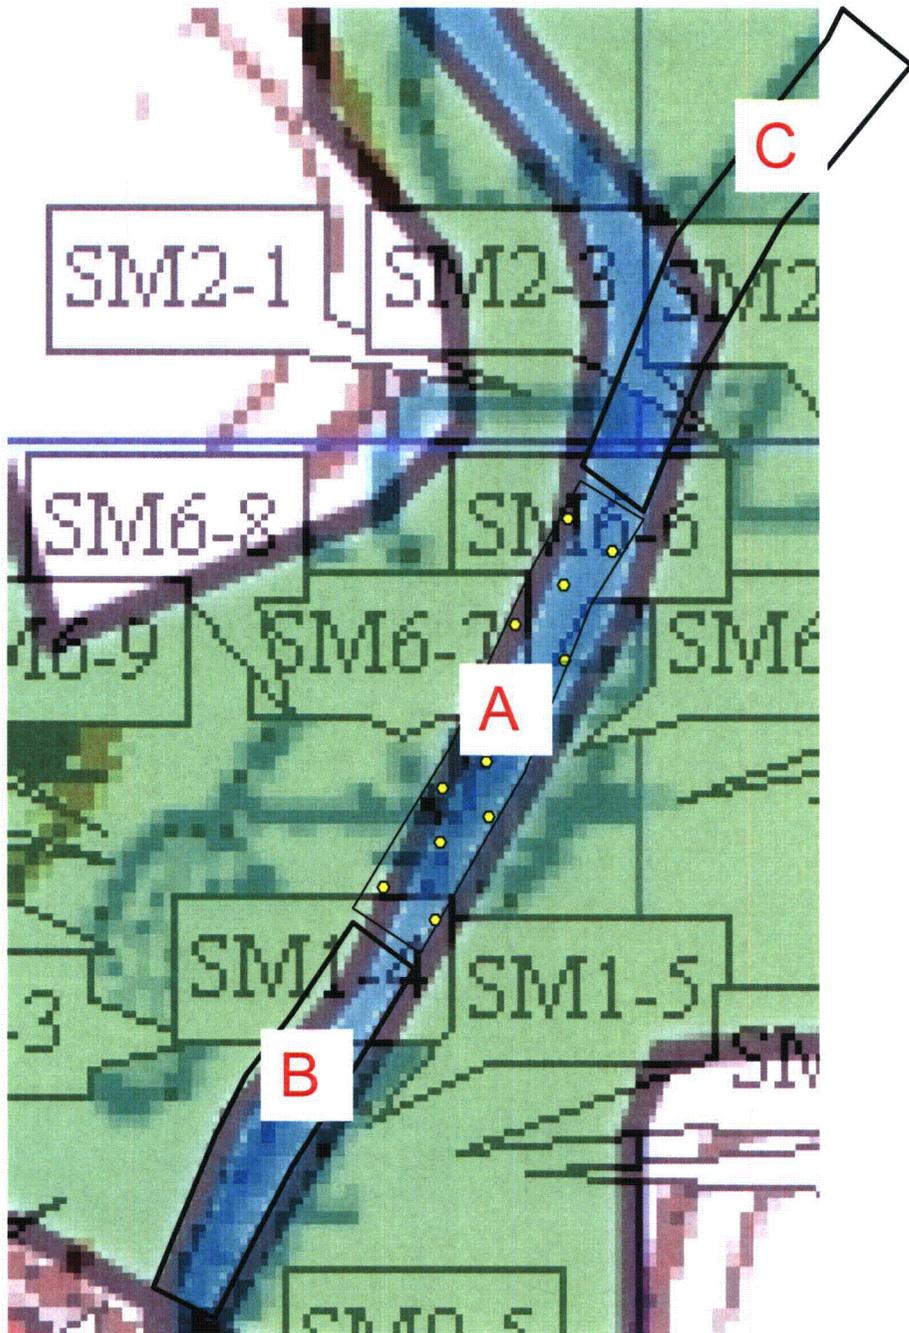
FIGURE 8 – RELATIVE LOCATIONS OF SECOND BOUNDING AREAS A, B AND C

The second survey area, labeled B, was upstream of A, and was centered on the EMA that had produced a peak Cs-137 measurement of 11.7 pCi/g. The third survey area, labeled C, was downstream from A. Area C began in the then-current stream channel, but deviated downstream to the east of the channel, following the path that the stream had followed in 1969. The relationships between areas A, B and C are illustrated by Figure 8.

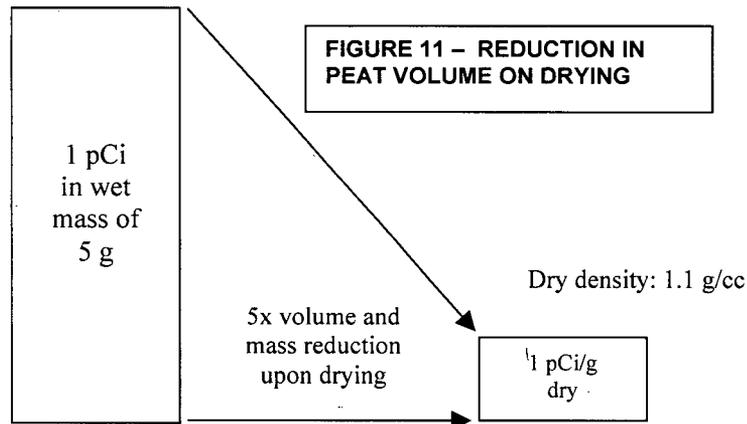
In that case, the resultant activity could be magnified 5 times between sampling and analysis, by comparison with mineral soils that would lose less volume and mass upon drying. This is illustrated by Figure 11. To check the preliminary assessment, three sets of measurements were made in the course of stream mouth sample preparation, to assess the reductions in volume and weight that were caused by sample processing. Three samples were measured and weighed before and after the processing described above.

Water density: 1.0 g/cc
 Peat solids density: 1.1 g/cc
 Total wet density: ~ 1 g/cc

In the prior Bay investigation, it had been noted that samples of organic peat/muck lost a great deal of their volume and weight when they were dried, ground, and sieved for analysis. A typical weight reduction, for composite sample BY-7-83, was approximated in the bay study, and the final weight appeared to be only 17% of the starting weight. Such a reduction in weight could cause a significant increase in apparent Cs-137 activity, because that activity, in pCi, is reported per gram of dry soil. HaagEnviro's original assumption, before carefully documented volume and density reduction tests were performed in the stream mouth study, was that the typical weight reduction between the wet pre-testing samples and the dried samples ready for testing would be 5-to-1.

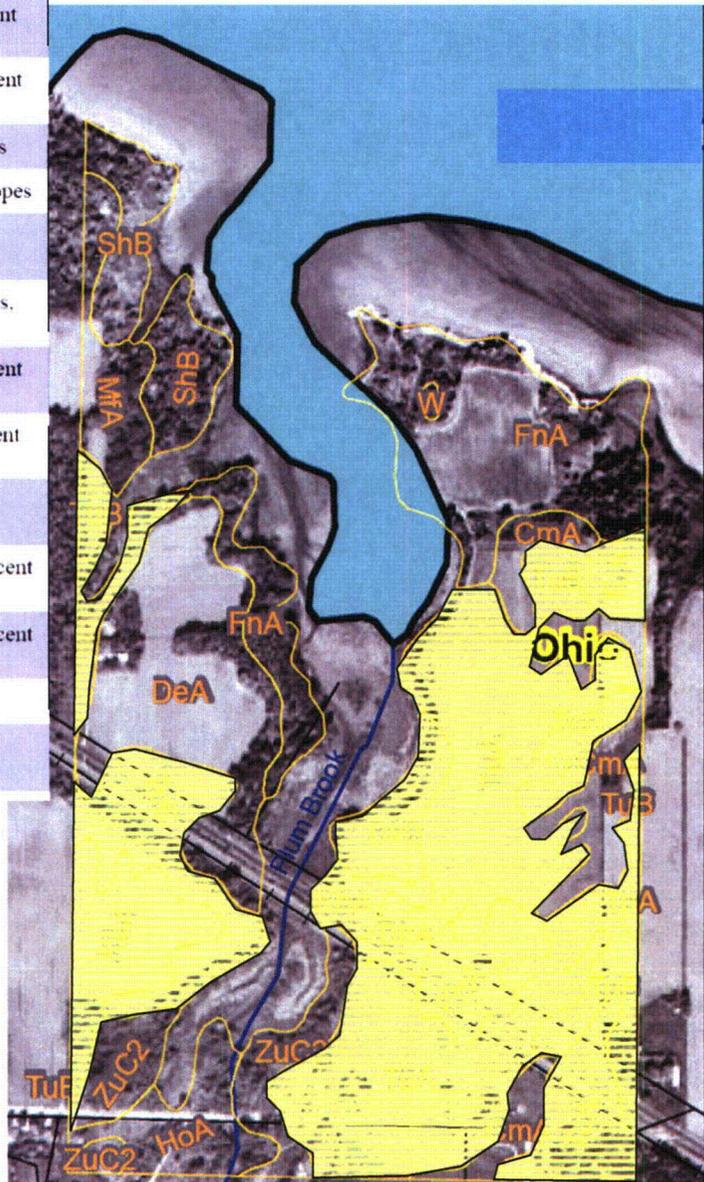
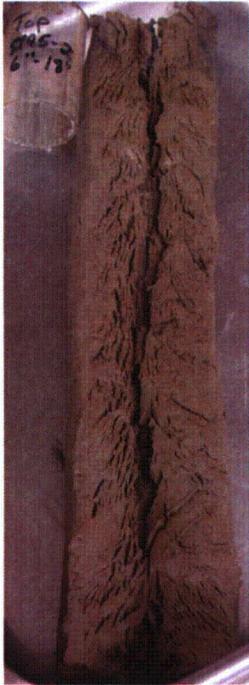
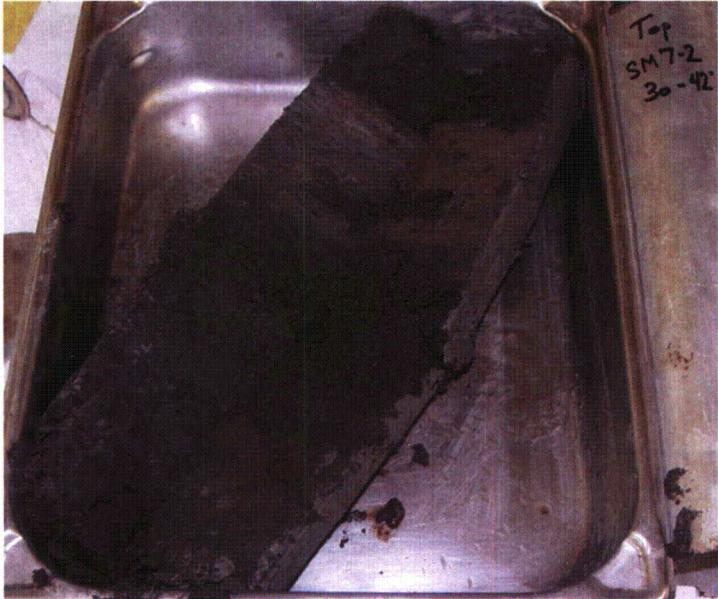
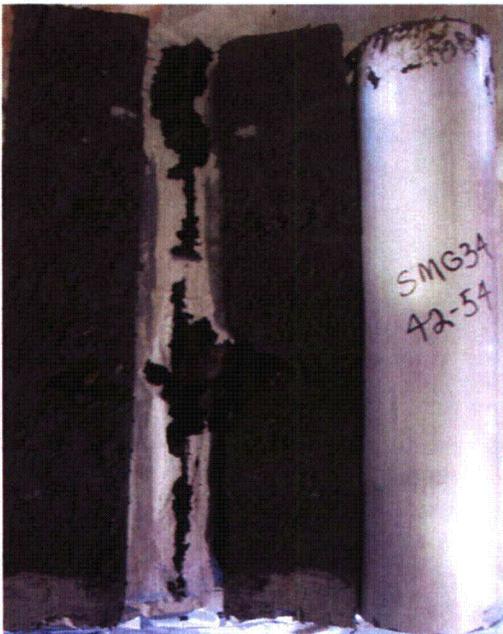
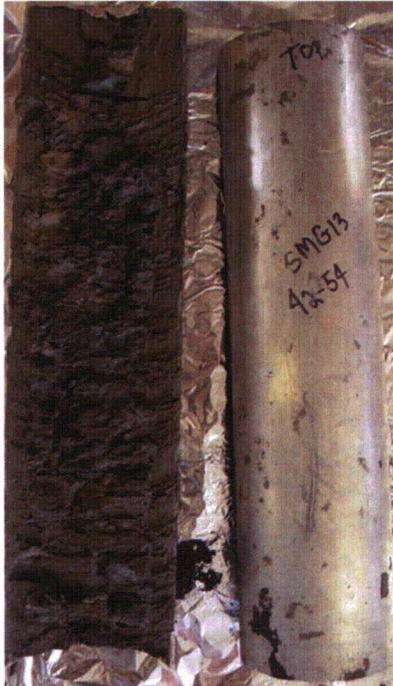
FIGURE 15 – STREAM MOUTH
SEDIMENTS

General Sediment Patterns – Based on the photographs obtained after the samples were extruded from the core tubing, the sediment types were seen to include sand, silt, peat, soft clay and dense clay. The dense clay, when found near the bottom of the core, was judged to be glacial till. The other sediments were considered to be post-glacial. Figure 13 illustrates the distribution of post-glacial sediment deposits in the stream mouth in map view. A corresponding soil survey map, with sand deposits highlighted, is provided in Figure 14. Figure 15 illustrates the character of the deposits that were found in the stream mouth environment.

FINE SAND
AND SILT

INTERBEDDED PEAT AND CLAY

PEAT OVER CLAY TILL

DENSE
GLACIAL
TILL

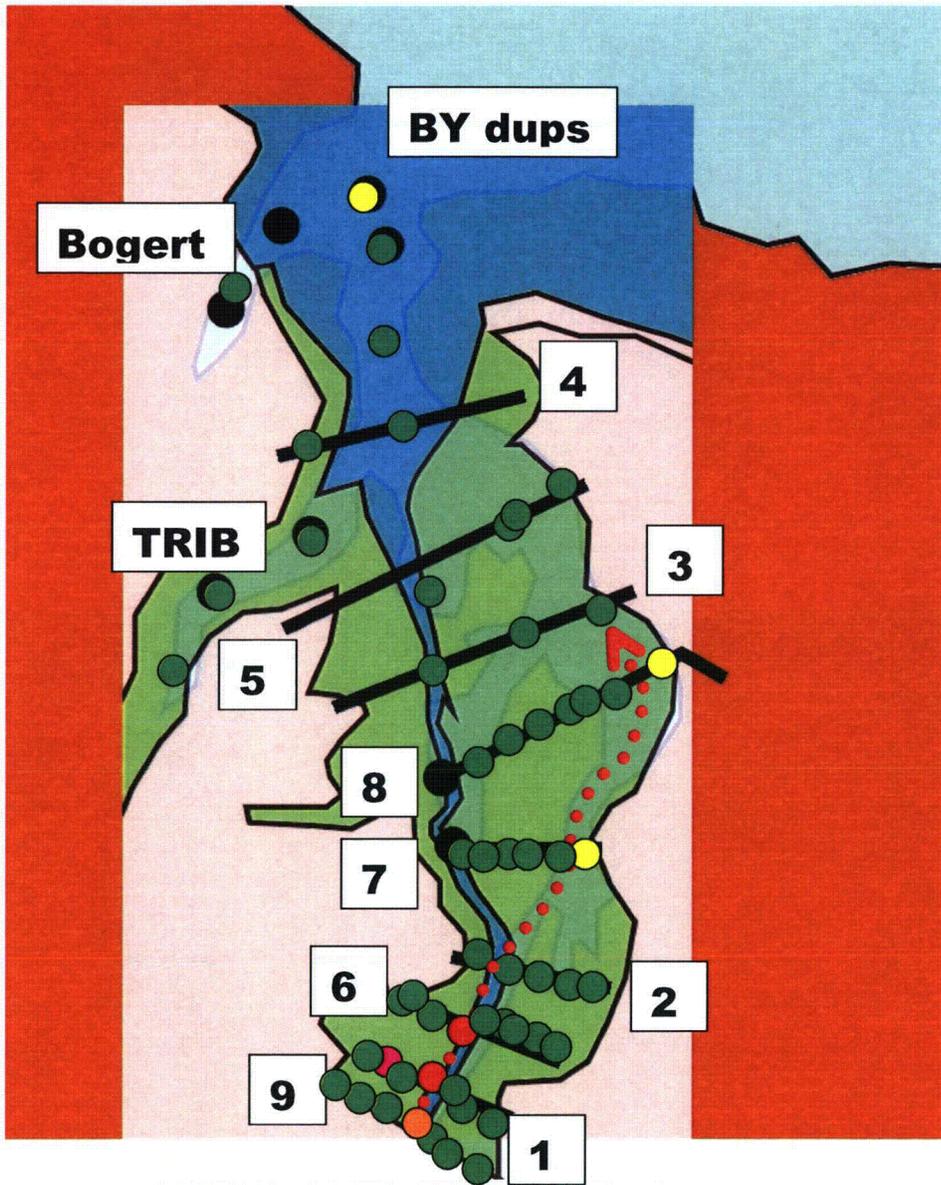
FIGURE 16 – HIGHEST RESULTS IN INITIAL TRANSECTS

Cs-137 Results in Initial Transects – As shown by Figure 16, peak Cs-137 results approached or exceeded 12 pCi/g in two locations in the initial transect sampling effort. One of these was found at Stream Mouth (SM) location 1-4, also called SM1-4, where a peak value of 11.7 pCi/g was detected. The second was found at SM location 6-6, where a peak value of 20.6 pCi/g was reported. Both of these EMAs were found in the existing stream channel. Downstream, the next highest Cs-137 values found were in an abandoned channel, which had carried the stream in 1969. These values were 3.9 pCi/g at SM location 7-5, and 3.4 pCi/g at SM location 8-7. A value of 2.54 pCi/g at SM location 5-5 may also be related to this channel, as may be a value of 2.32 pCi/g at SM location 4-3. The value of 11.7 pCi/g was found in the depth interval of 6-18” below the active stream bottom, the 20.6 pCi/g was found at 0-6” below the active stream bottom, the 3.9 pCi/g was reported at 6-18” below the in-filled land surface above the old channel, the 3.4 pCi/g was reported at 18-30” below the in-filled land surface above the old channel, and the 2.54 and 2.32 pCi/g values were reported 6-18” below the surface. The balance of the downstream detections of Cs-137 observed were scattered above and below 1 pCi/g (ranging from 0.3-1.3), and were generally found in the upper 18” of the sample column, with most of the highest values in the upper 6” sampled. Upstream from the EMA at location SM1-4, some Cs-137 detections extended to greater depths. In particular, a value of 1.2 pCi/g was found in the 42-54” interval at location 9-2, and a value of 2.6 pCi/g was found in the 42-54” interval at location 9-4.

- Cs-137 > 11.5 pCi/g
- Cs-137 = 7.7 pCi/g (at 5' in pond)
- Cs-137 = 6-11.5 pCi/g
- Cs-137 = 3-6 pCi/g
- Cs-137 detected, but < 3 pCi/g

A map-view illustration of the highest Cs-137 results found in the initial transects is provided by Figure 16. Sample locations where Cs-137 was still being detected at the bottom of a core in the original transects are indicated on Figure 17. A detailed cross-sectional plot of the sediment deposits along transect 1 is provided in Figure 18, and a generalized cross-section of sediments along nearby transect 6 is given by Figure 19. Both of the cross-sectional plots also provide Cs-137 results, including the two initial EMAs (locations 1-4 and 6-6).

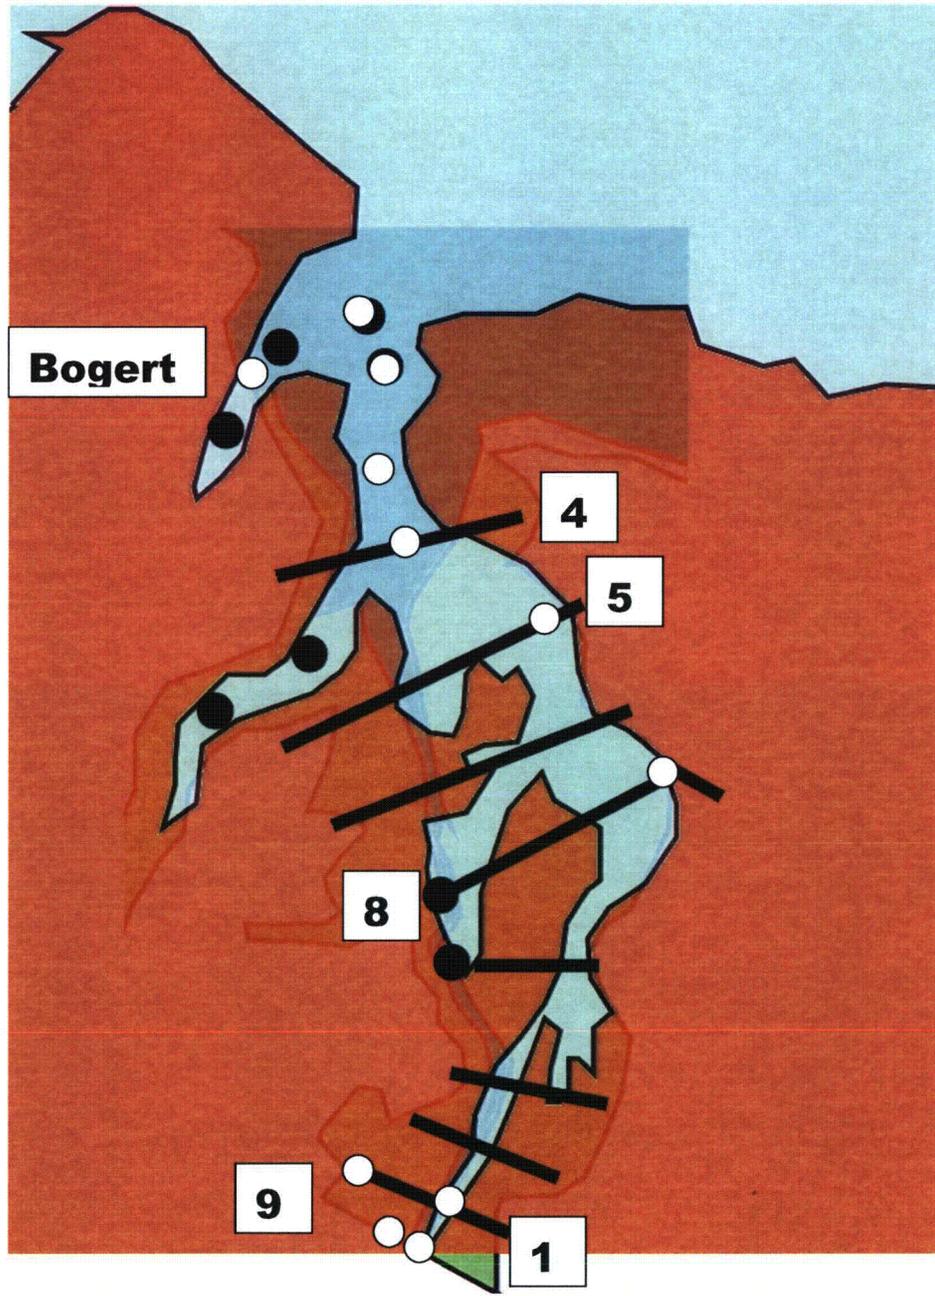
FIGURE 17 – LOCATIONS WHERE CS-137 WAS DETECTED AT BOTTOM OF CORE IN INITIAL TRANSECTS

In most sampling locations, Cs-137 values less than the Minimum Detectable Activity (MDA) were found at some depth below the surface. Figure 17 shows the locations where this was not achieved. In all such cases where the full vertical extent of the Cs-137 distribution was not defined, it was noted that all values at the bottom of the sample column were less than 12 pCi/g. However, it was not possible to assert that all of the patterns of detection versus depth were showing a declining concentration.

- Originally Planned Sample Locations and Transects
- Actual Locations Where Vertical Extent Was Not Fully Defined

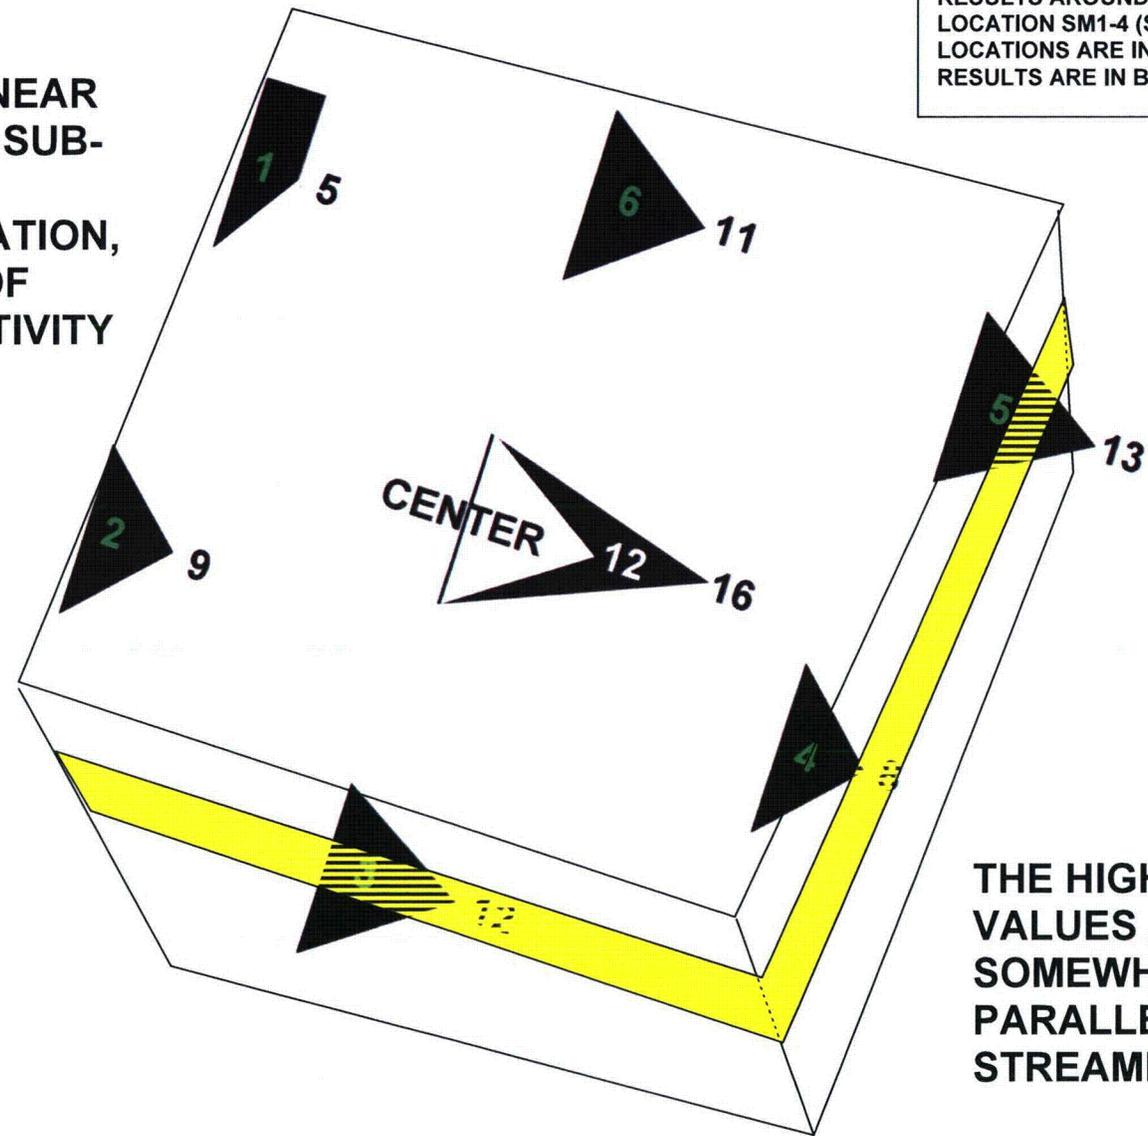
The results from the two EMAs, resampled in the first bounding efforts, are illustrated by Figures 20 and 21. As shown, the area near location SM1-4 has sub-surface contamination, beneath 6 inches of lower-activity stream-bottom sediment cover. This EMA originally produced a peak Cs-137 value of 11.7 pCi/g (rounded to 12 on the diagram); the re-located EMA produced a peak value of 16 pCi/g. The highest values detected in this sampling round were somewhat parallel to streamflow. The highest observed values, from upstream to downstream, were as follows: 12, (12 and 16), and 13 pCi/g.

THE AREA NEAR
SM 1-4 HAS SUB-
SURFACE
CONTAMINATION,
UNDER 6" OF
LOWER-ACTIVITY
COVER

THE HIGHEST
VALUES ARE
SOMEWHAT
PARALLEL TO
STREAMFLOW

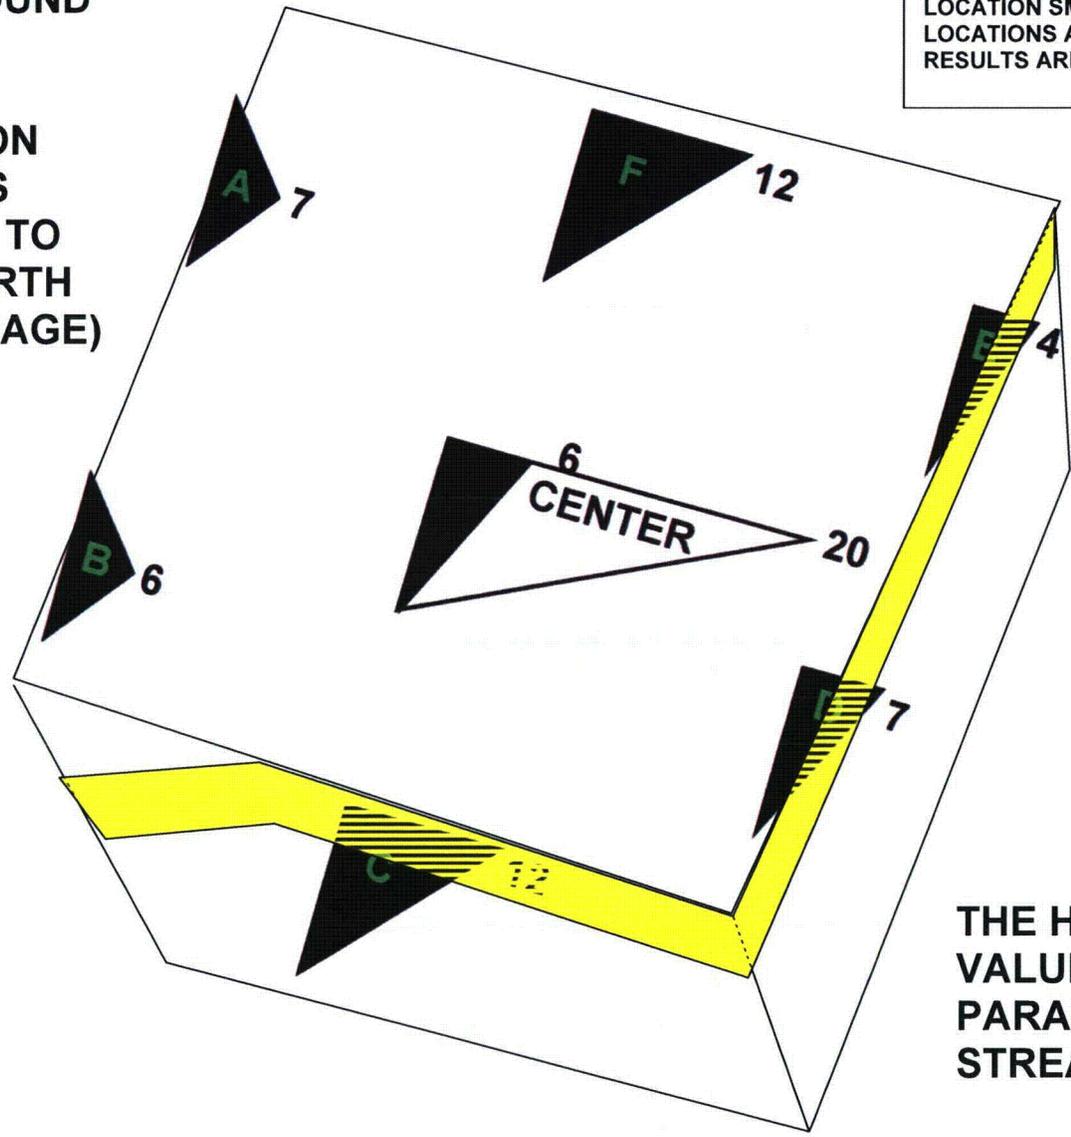
**FIGURE 21 – FIRST BOUNDING
RESULTS AROUND EMA AT
LOCATION SM6-6 (SAMPLE
LOCATIONS ARE IN GREEN,
RESULTS ARE IN BLACK)**

The area around the EMA at location SM6-6 had stream-bottom surface contamination that plunged under 6 inches of lower-activity cover to the west. This EMA originally produced a peak Cs-137 value of 20.6 pCi/g (rounded to 20 on the diagram); the re-located EMA produced a peak value of 6 pCi/g. The highest values were found parallel to streamflow. The highest observed values, from upstream to downstream, were as follows: 12, (20 and 6), and 12 pCi/g.

**THE HIGHEST
VALUES ARE
PARALLEL TO
STREAMFLOW**

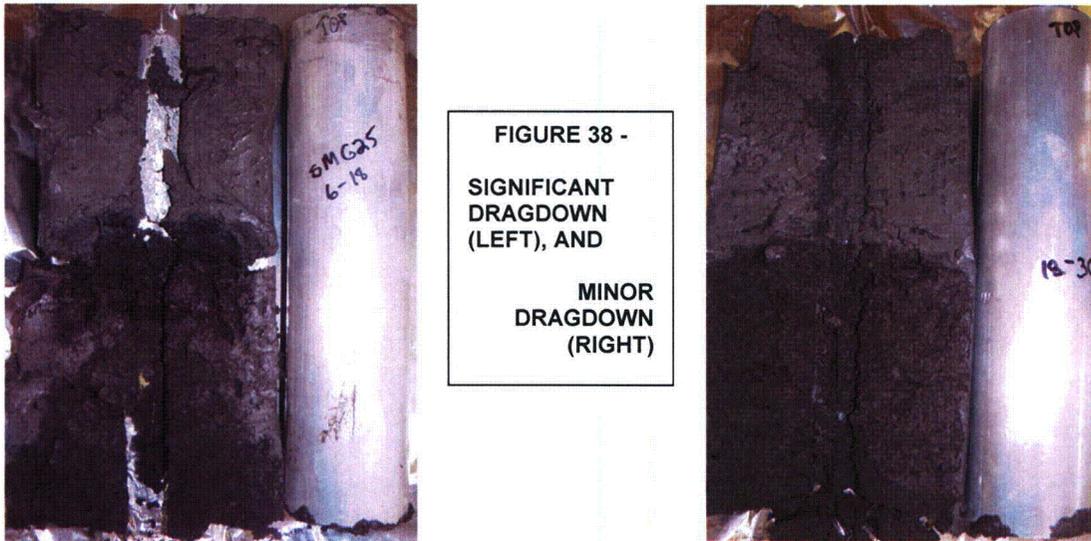
Laboratory blanks tested during the stream mouth wetlands investigation all produced results that were either less than the MDA, or were rejected upon data review. Blank results are included in the spreadsheet provided in Appendix B. Review of cores and corresponding testing results suggested that carry-down generally did not occur to a significant extent. Two examples in which drag-down did occur are shown in Figure 38.

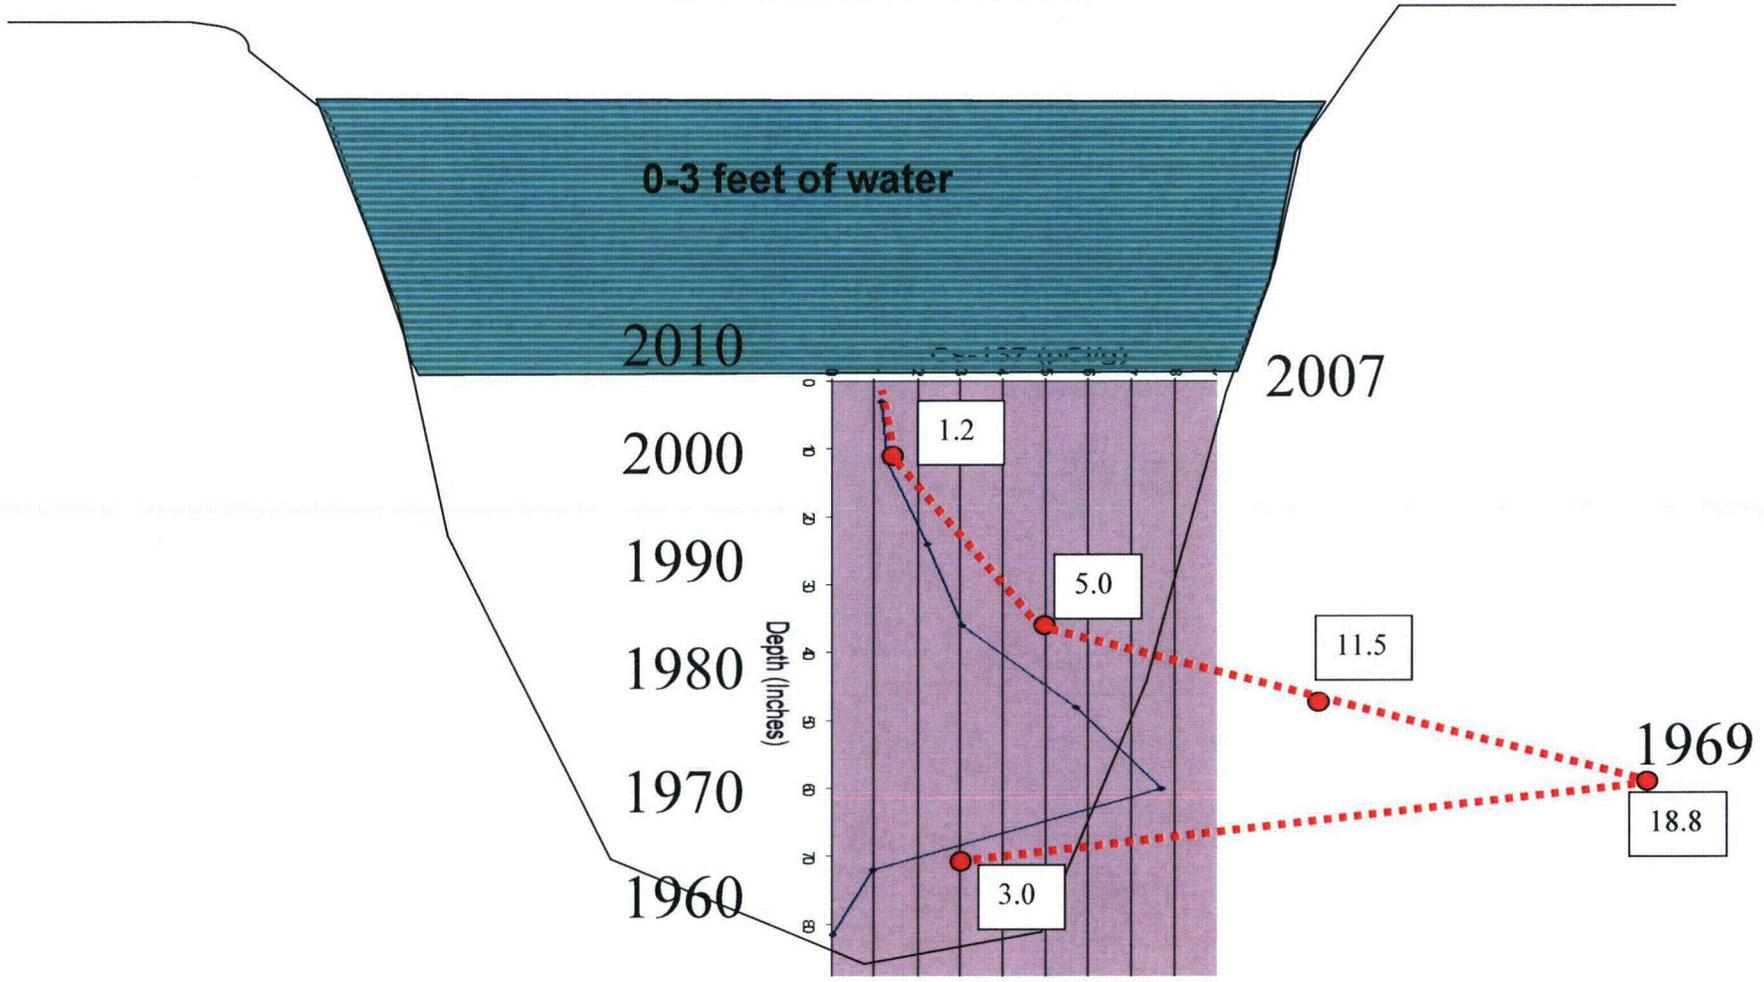
FIGURE 39 – INTERPRETED DEPOSITION RECORD IN A POND

Cs-137 Deposition Over Time - An underlying postulate of this work is that the peak Cs-137 levels were deposited downstream in 1969. Based upon this assumption, and drawing upon results obtained in the earlier Ponds report, Figure 39 provides an estimate of the activity deposited versus time. The solid line in the graph represents the actual testing results obtained, without correcting for nuclear decay. The dashed red line represents the Cs-137 activities at the time of deposition, correcting for decay using an Excel spreadsheet program supplied by NASA's Assistant RSO, Rod Case. This figure suggests that the activity in sediment being carried by floods peaked at 18.8 pCi/g in 1969, had dropped to less than 3 pCi/g by 1995, and was approaching a steady-state value just over 1 pCi/g by the year 2000.

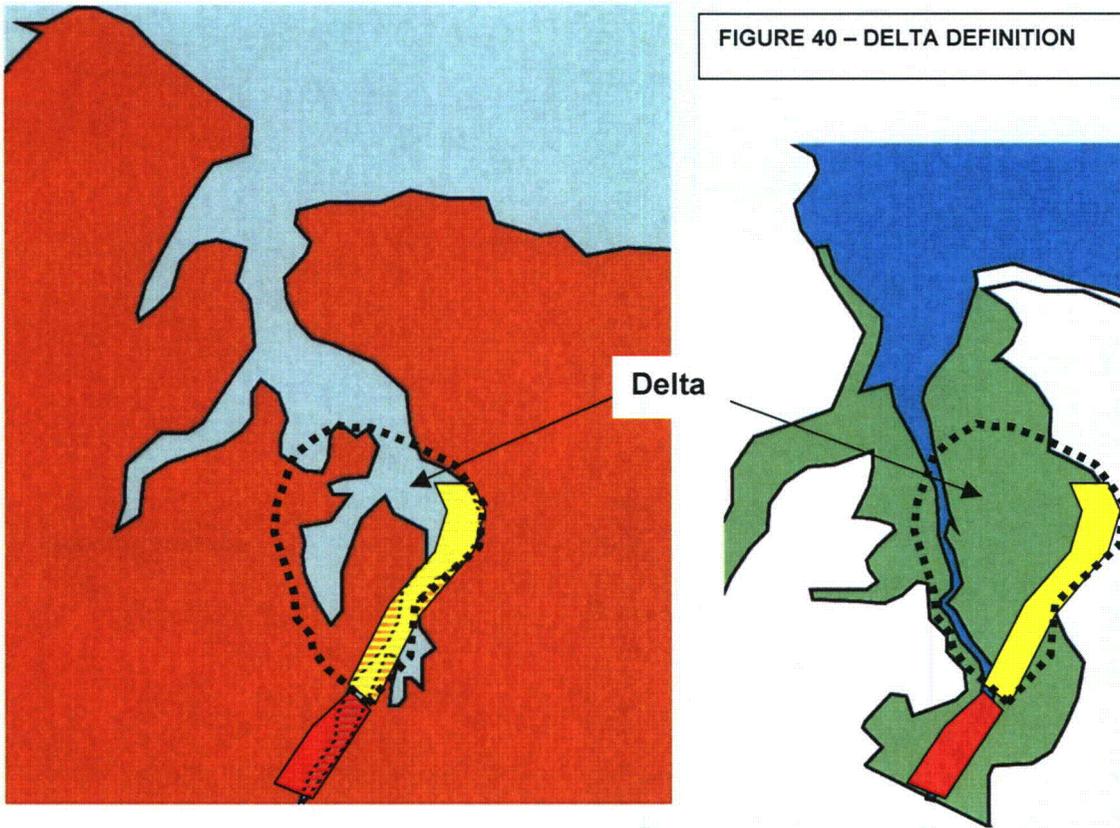
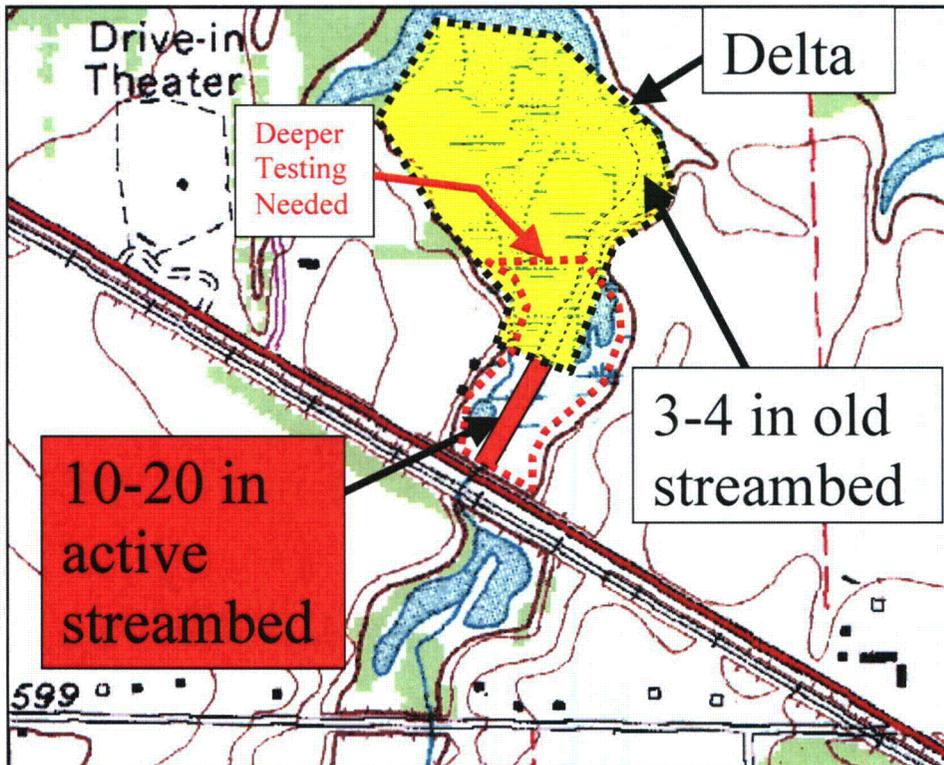
FIGURE 40 – DELTA DEFINITION

Location and Significance of Delta – In the Characterization Plan, it was assumed that the final resting place of clays bearing Cs-137 would be a delta, which would occur at the juncture of the stream and the bay. It was assumed that the delta would advance into the bay by laying down deposits of sand over silt, and silt over clay. It was expected that the Cs-137 would be trapped in the clay deposits, at the bottom of the delta sequence. However, no delta was found in the bay. A delta did appear to be present in the middle of the Stream Mouth area, as shown by Figure 40. The delta deposits in the Stream Mouth appeared to be composed only of mixed silt and clay, deposited over peat. Sand was found in other locations, but did not appear to be part of the delta sequence.

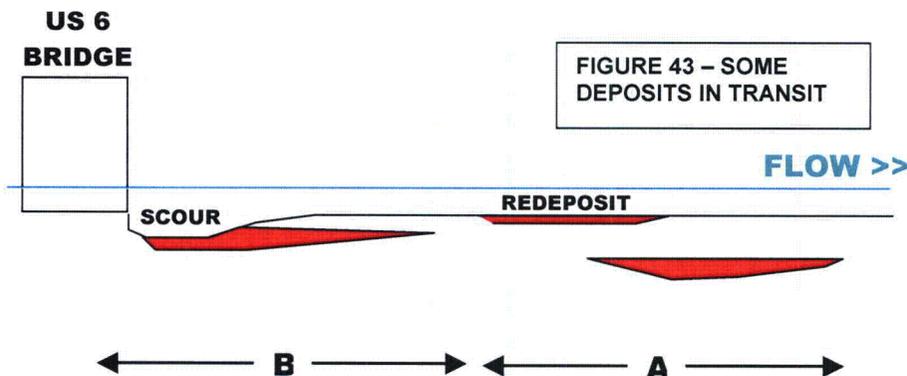
The immediate downstream side of the bridge over U.S. Route 6 appeared to be a location in which clays bearing Cs-137 were deposited, then scoured out and redeposited. As illustrated schematically in Figure 43 below, the scoured area of the stream bottom appeared to constitute less than a third of Area B, at its southern end. The depositional area for this scoured material appeared to be the upstream half of section A, marked

“redeposit” on Figure 43. The schematic illustrates two buried deposits that would not be expected to move unless they were reached by scour. The deeper deposit, in the

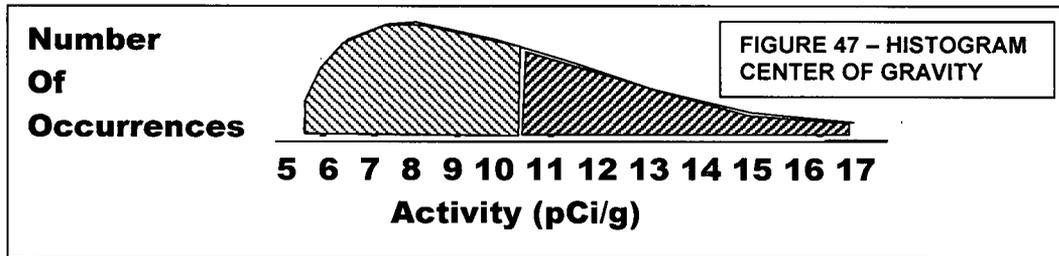
Without the original observations, we have the following curve, which we can divide into equal areas to the left and right of the “center of gravity” of the area under the curve.

By this analysis, the “representative” activity in the Area B sediment layer with the highest Cs-137 activities would be slightly greater than 10 pCi/g. Note that the “representative” value determined for this section, by fitting a line to the logs of the measurements, was 10 pCi/g (fairly close, considering the simplicity of this example).
