**SUBJECT: FINAL REPORT—RADIOLOGICAL FINAL STATUS SURVEY OF  
THE HAMMOND DEPOT, HAMMOND, INDIANA**  
**DCN: 0432-SR-01-0**

# RADIOLOGICAL FINAL STATUS SURVEY OF THE HAMMOND DEPOT HAMMOND, INDIANA

Prepared for the  
Defense National Stockpile Center  
of the  
Defense Logistics Agency

**FINAL REPORT**

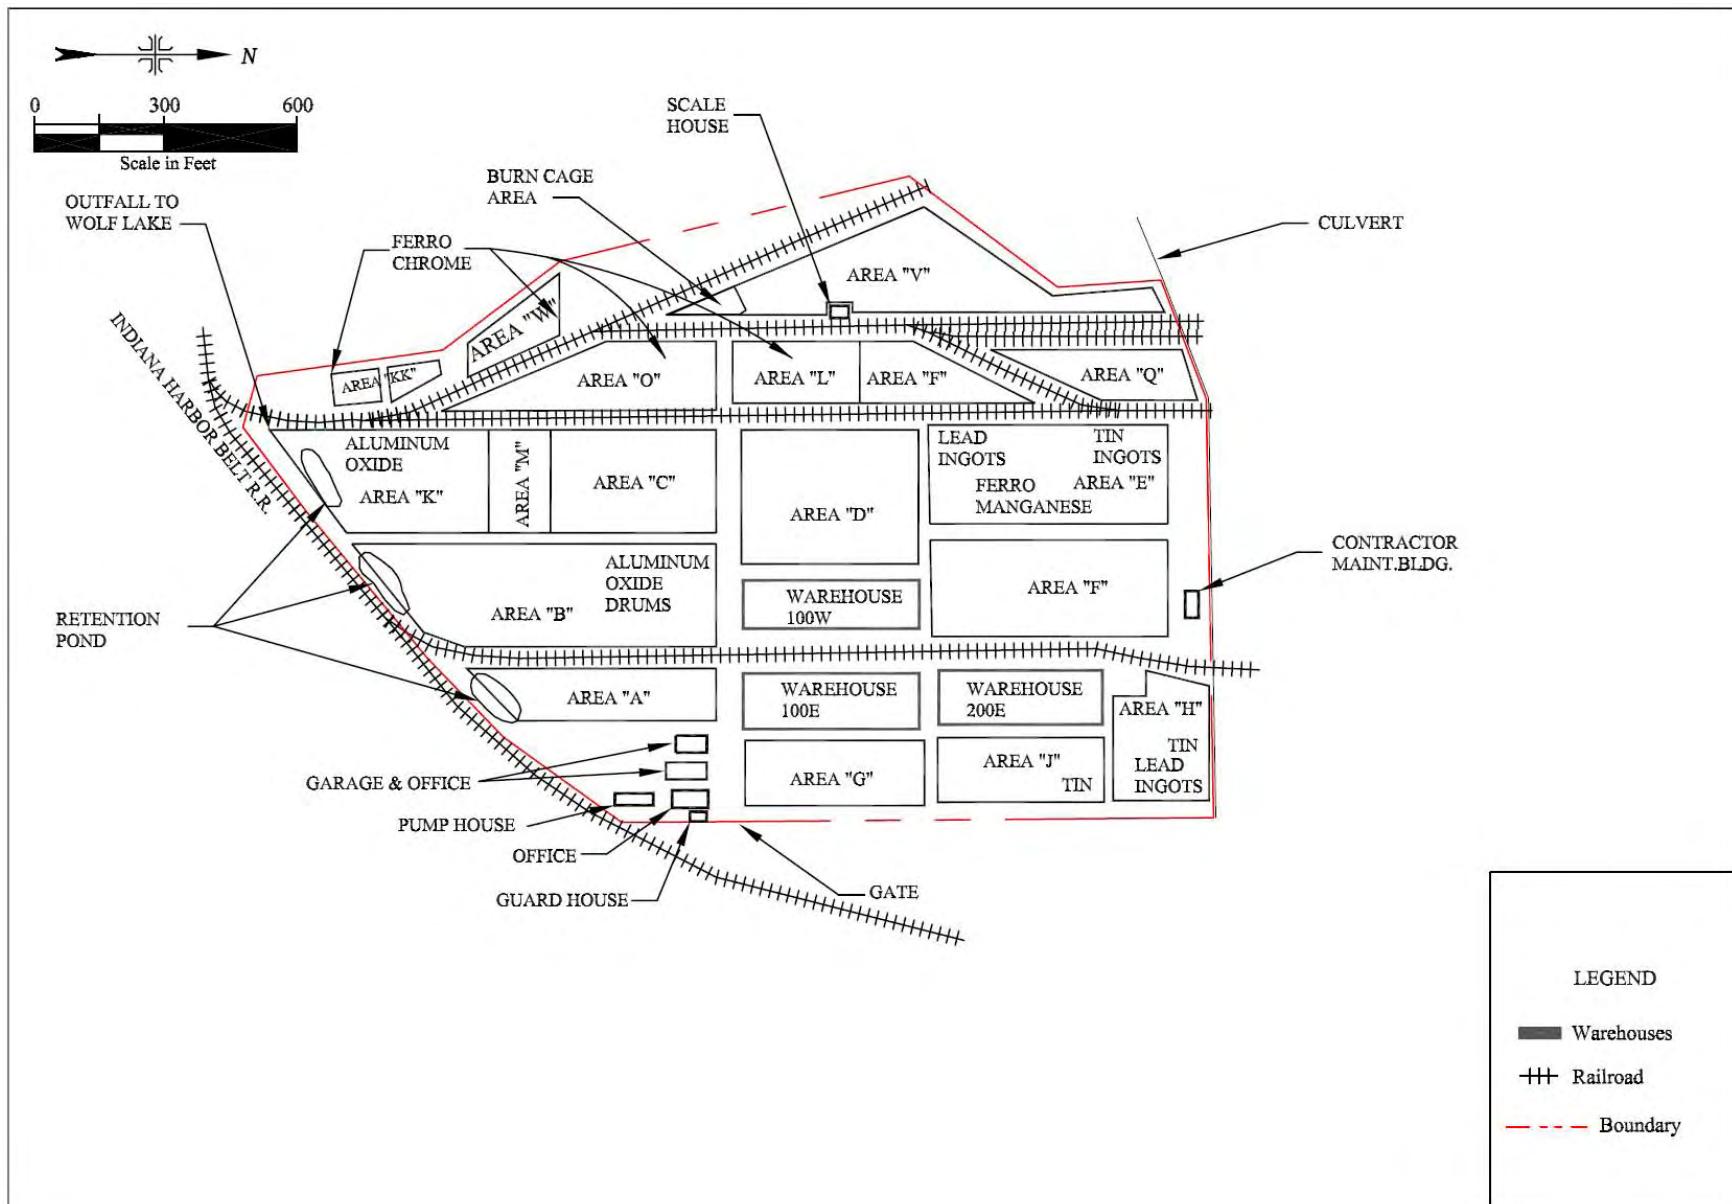
Figure A-1: Hammond Depot, Hammond, Indiana—Plot Plan

The Hammond Depot site is located on the west side of Hammond, Indiana on Sheffield Avenue—about 150 meters (500 feet) east of the Indiana-Illinois state line. The property currently consists of ten structures, mostly in good condition, including the three current warehouses used to store raw materials, and outdoor storage areas (Figure A-1). The depot is bounded on the east and southeast by the Indiana Harbor Belt railway, the Wolf Lake Industrial Center access road on the east, the Wolf Lake industrial/commercial complex on the north, Wolf Lake on the northern one-third of the western property boundary, and a drainage ditch on the west and southwest property boundary. A security fence encloses the facility. A number of

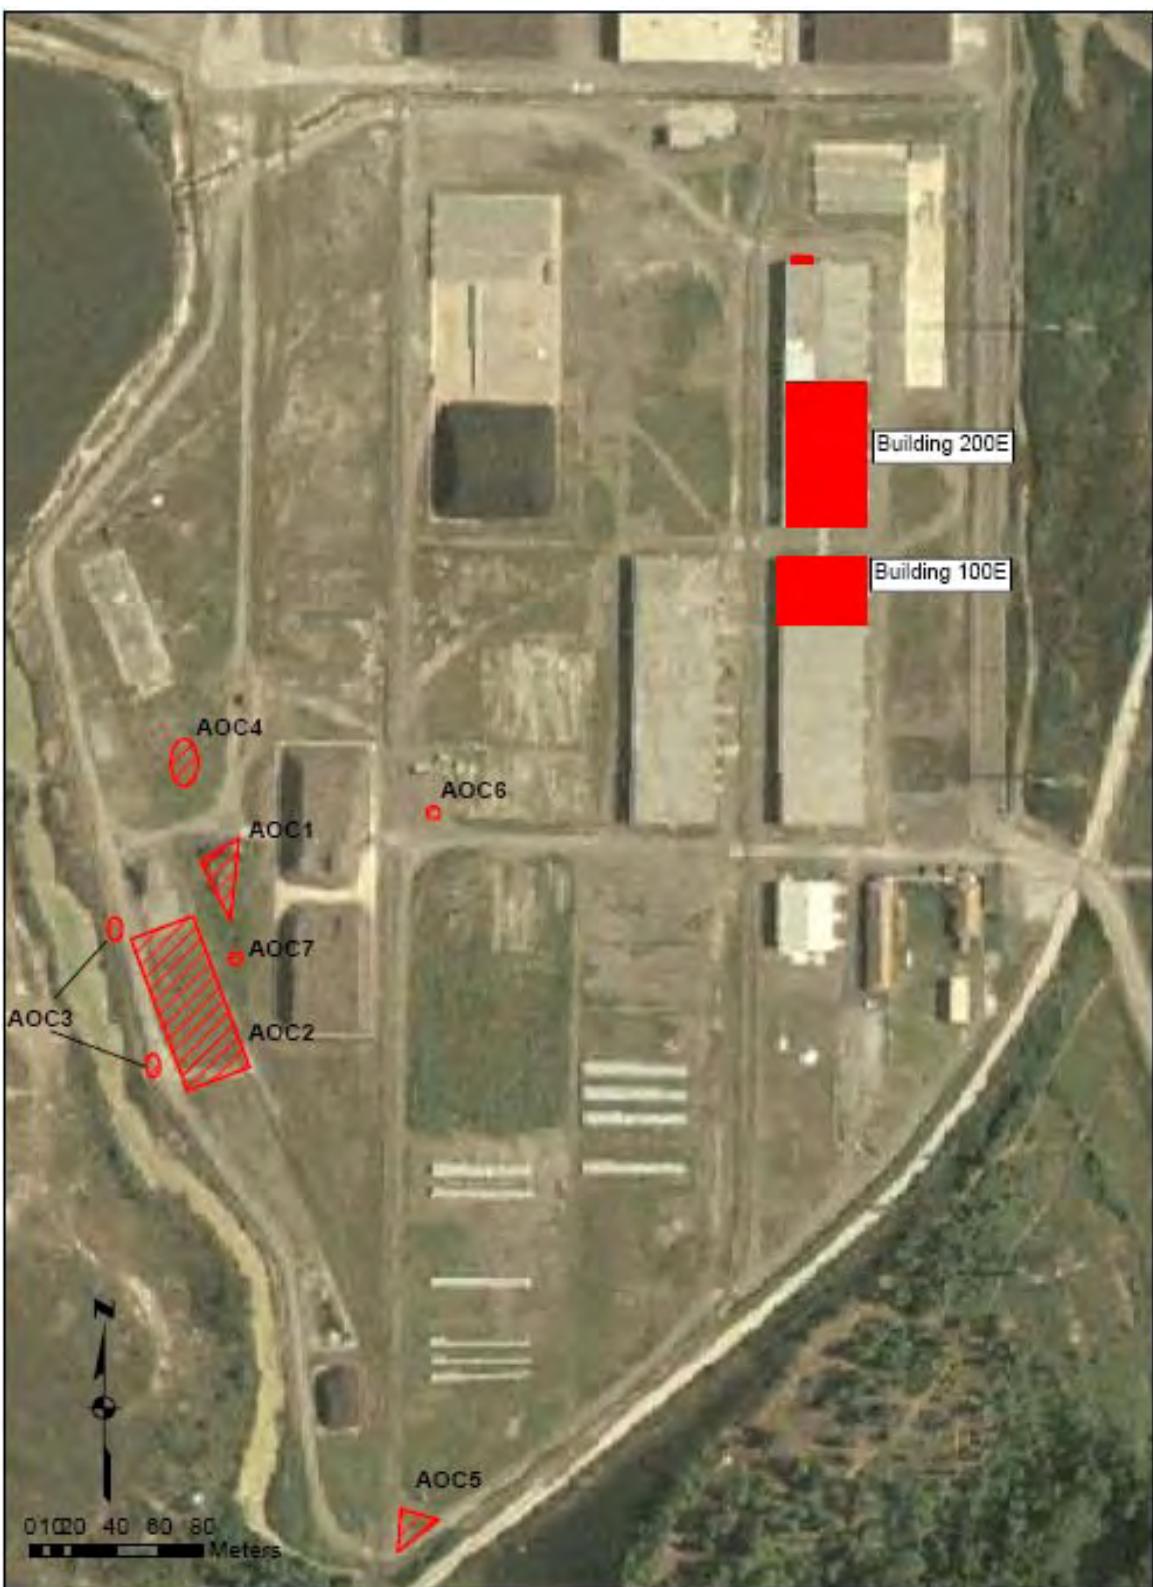
**Figure A-2:** Hammond Depot—Contaminated Buildings and Soil AOCs

The scoping and characterization surveys found extensive contamination on the floors of the south half of Building 200E where containers of ThN were stored and known to have leaked. The contamination was on the original concrete floor of the building, beneath the asphalt overlayer. Multiple small area and distributed locations of elevated gamma radiation were detected—indicating contamination beneath the asphalt—that ranged from 5,000 to 200,000 counts per minute (cpm). Investigations beneath the asphalt overlayer found that much of the contamination was associated with expansion joints and cracks in the original concrete floor slab. The contamination was also found to have migrated through these openings and spread to the monolithic slag layer that was immediately beneath the floor. Surveys confirmed the presence of contamination in excess of the DCGL<sub>W</sub> on overhead structural steel and pipes, support columns and bases, and isolated lower wall areas.

There was one Class 1 designated land area at the time of the scoping survey, the Burn Cage area. Gamma radiation surface scans which covered 100% of the Burn Cage area identified an approximately 50 m<sup>2</sup> area of elevated direct radiation to the immediate east of a large debris pile and a small area with lower gamma radiation levels next to the actual Burn Cage. Scoping survey gamma scans of the remaining site land areas were low density overall as they focused on roadways, railroads, and building vicinities.

The characterization survey high density gamma scans and investigation soil sampling began in the Burn Cage area and considerably expanded due to the identification of seven new AOCs in the western sector of the site. Additional high density characterization gamma scans were performed over these new Class 1 areas to better delineate the gamma radiation isopleths.

AOC 1 was associated with the former Burn Cage area in depot Area “V”. The excavation bounds covered approximately 1,050 m<sup>2</sup> with the excavation depth to approximately 0.5 meters. The monolithic slag layer was completely exposed. Isolated hotspots identified on the slag surface required chipping followed by scraping of the entire surface.

AOC 2 was contiguous with AOC 1 to the southwest. The 2,800 m<sup>2</sup> area was completely excavated of soil to the slag layer which varied in depth from a few centimeters to approximately one meter. As with AOC 1, a number of slag areas required chipping to remove surficial hot spots. The entire surface of the exposed slag was then scraped to remove residual contaminated soil. Contamination was also found to extend beneath the southern edge of the Ferrochrome #6 pile. This finding required that the ore be moved to allow for remediation of the contamination that had migrated beneath the pad.

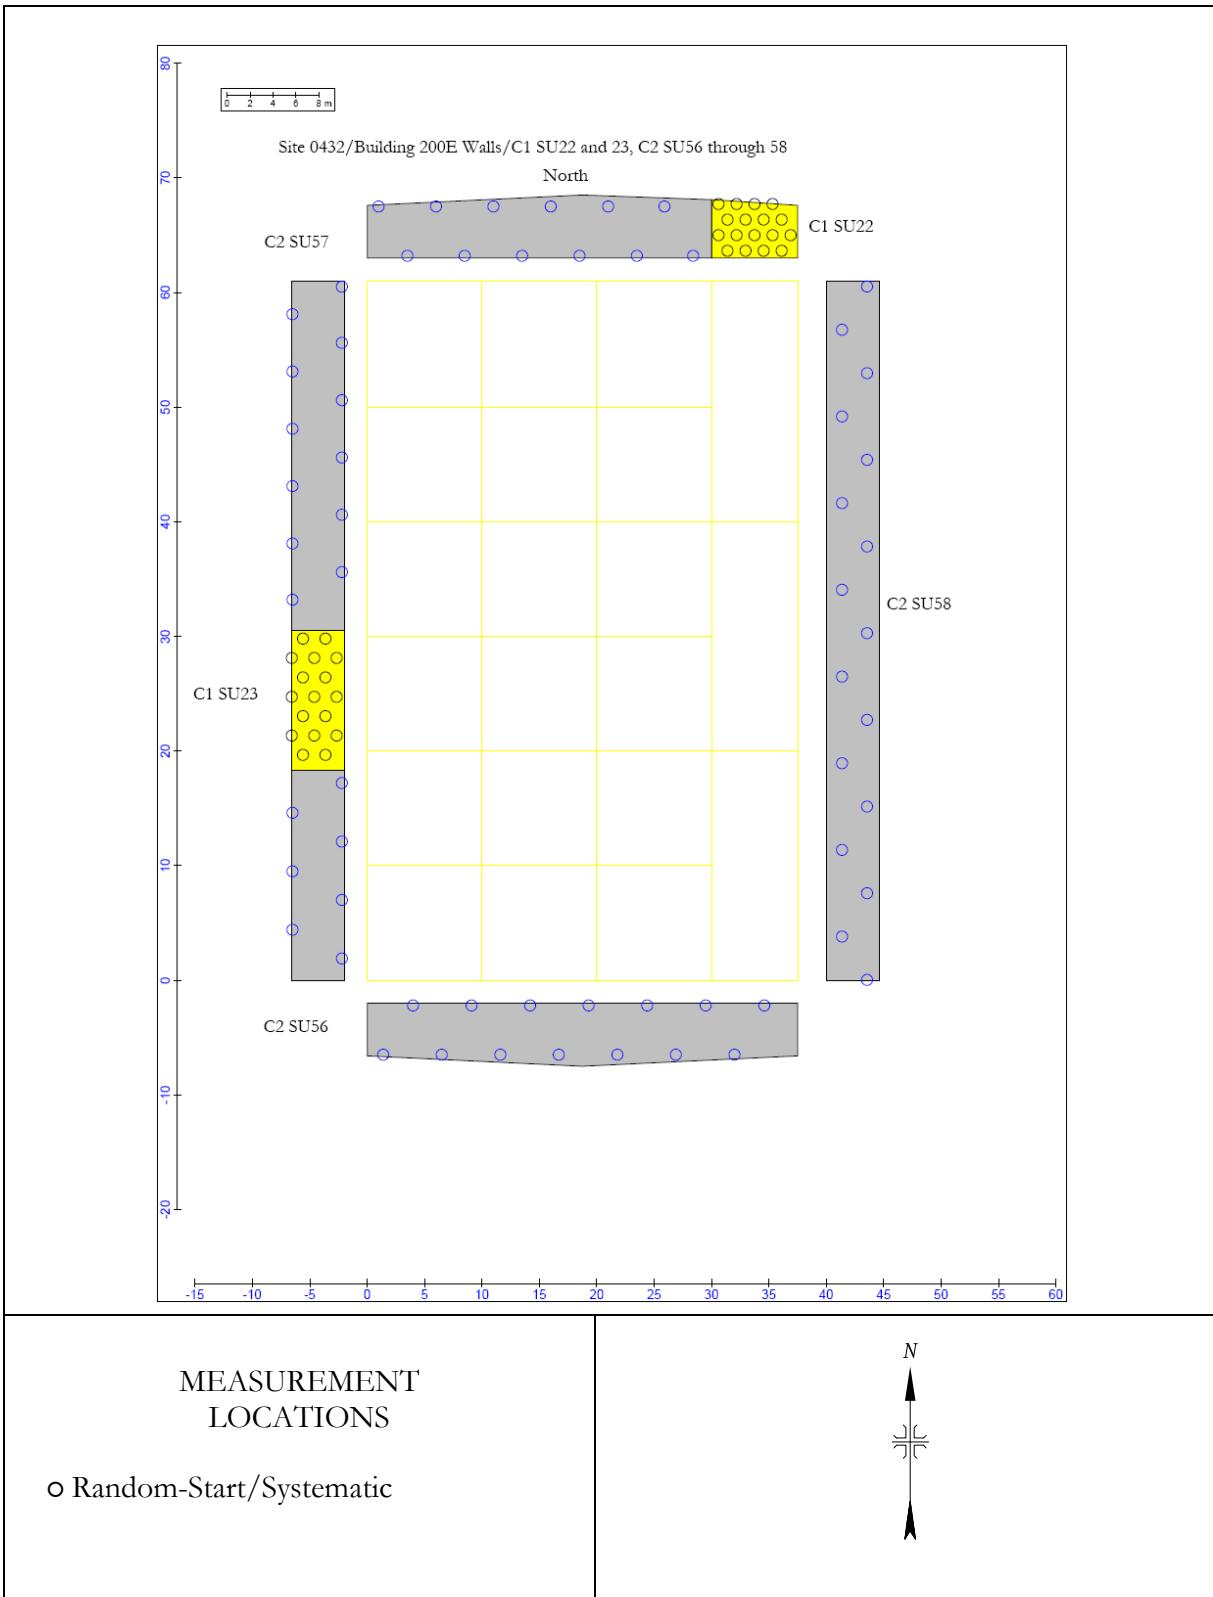
**Figure A-7:** Building 200E South, Walls (C1 SU22, 23, and C2 SU56 through 58)—  
FSS Survey Units and Direct Measurement Locations

- 1.) A portion of the survey unit may have been reclassified. The measurement in question, was the first lower wall measurement location adjacent to Class 1 survey unit C1 SU23. The activity level was less than the scan MDC. Because of the proximity of the lower walls to the previously heavily contaminated floor and the adjoining Class 1 wall survey unit, this and all other lower walls had been scanned 100%. No other contamination was noted or identified on any of the remaining lower walls.

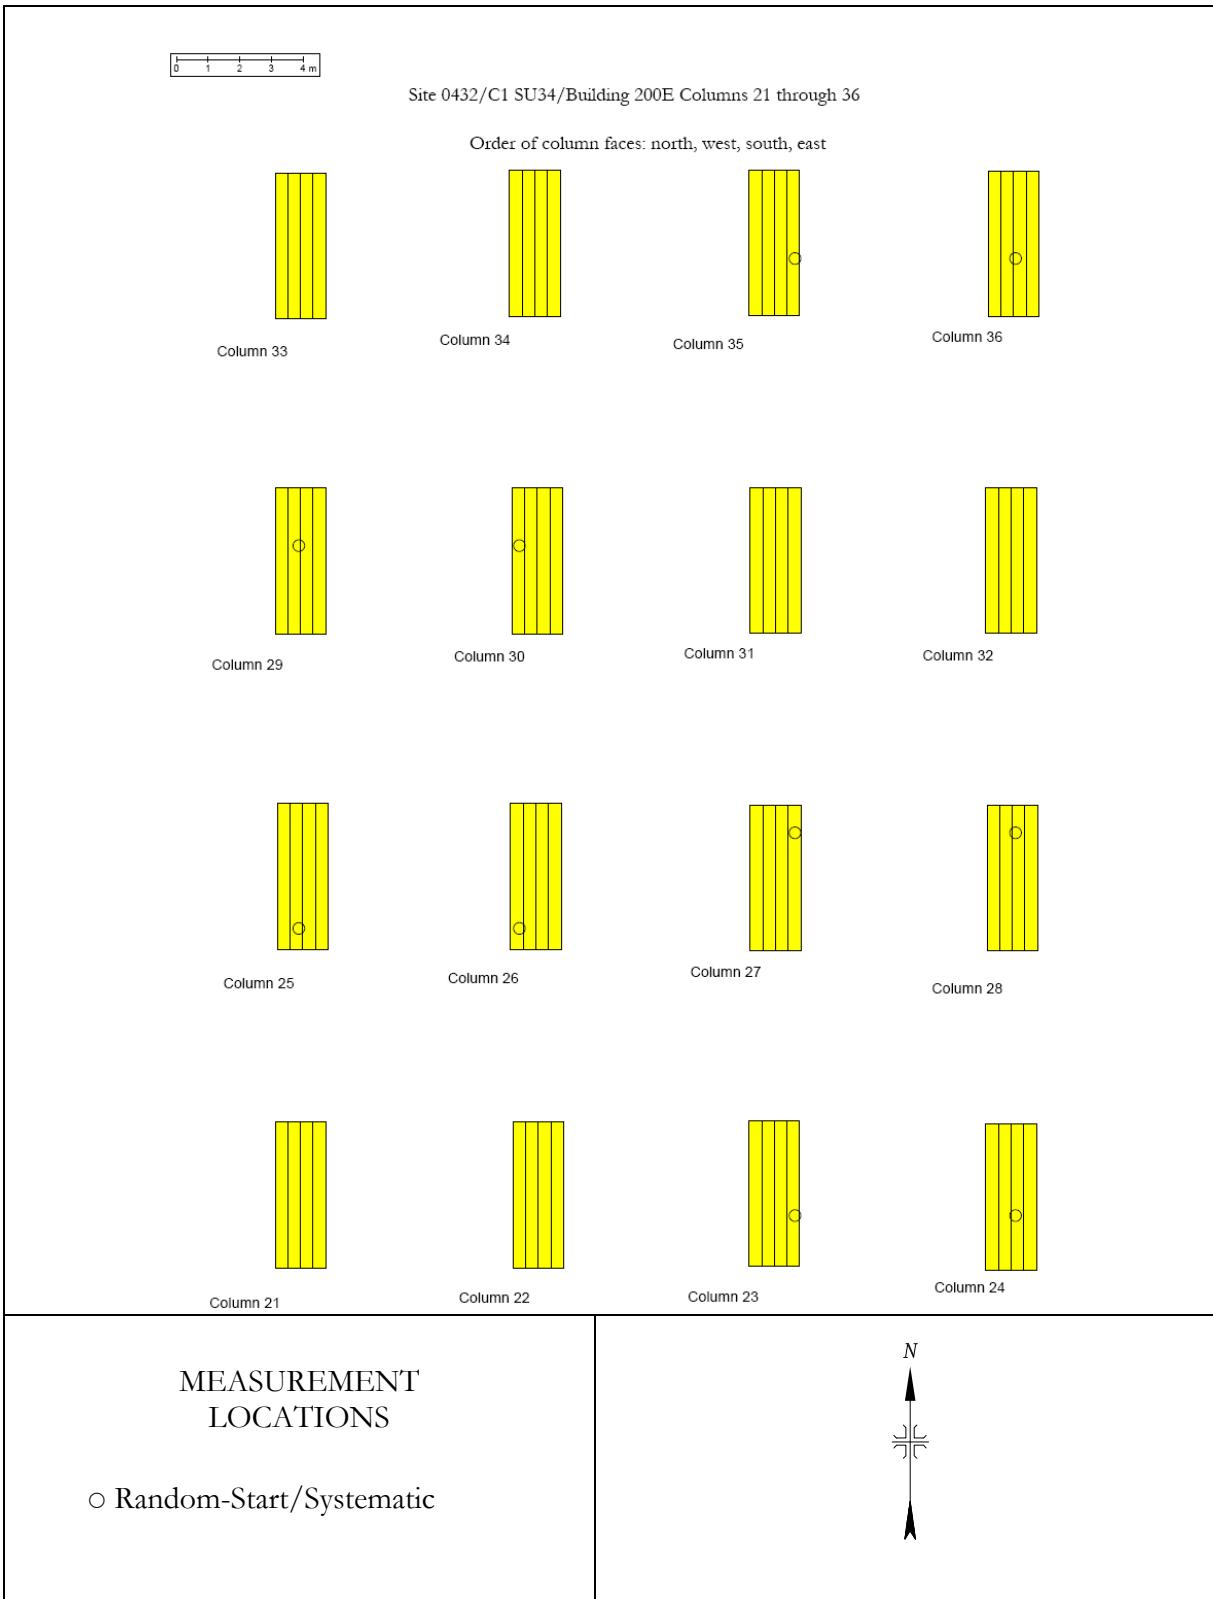
**Figure A-9:** Building 200E South, Columns 21 through 36 (C1 SU34)—  
FSS Survey Unit and Direct Measurement Locations

<b>Survey Unit</b>	<b>Class</b>	<b>Investigation Cause</b>	<b>Sample IDs</b>	<b>Initial Review</b>	<b>Further Investigation Required</b>	<b>Open/Closed Investigation</b>
C1 SU34	1	Contamination found on column 22 during FSS	NA	NA	Yes. World Environmental notified and decon of two small spots performed.	Closed
C1 SU14	1	Low-level contamination found at systematic measurement location	NA	NA	Yes. World Environmental notified and decontamination of one small spot performed.	Closed
C1 SU18	1	Low level contamination found at systematic measurement location	NA	NA	Yes. World Environmental notified and decontamination of one small spot performed.	Closed
C1 SU27-32	1	Low level contamination found during FSS scans in truss supports	NA	NA	Yes. World Environmental notified and all truss supports in northern 1/3 were decontaminated.	Closed

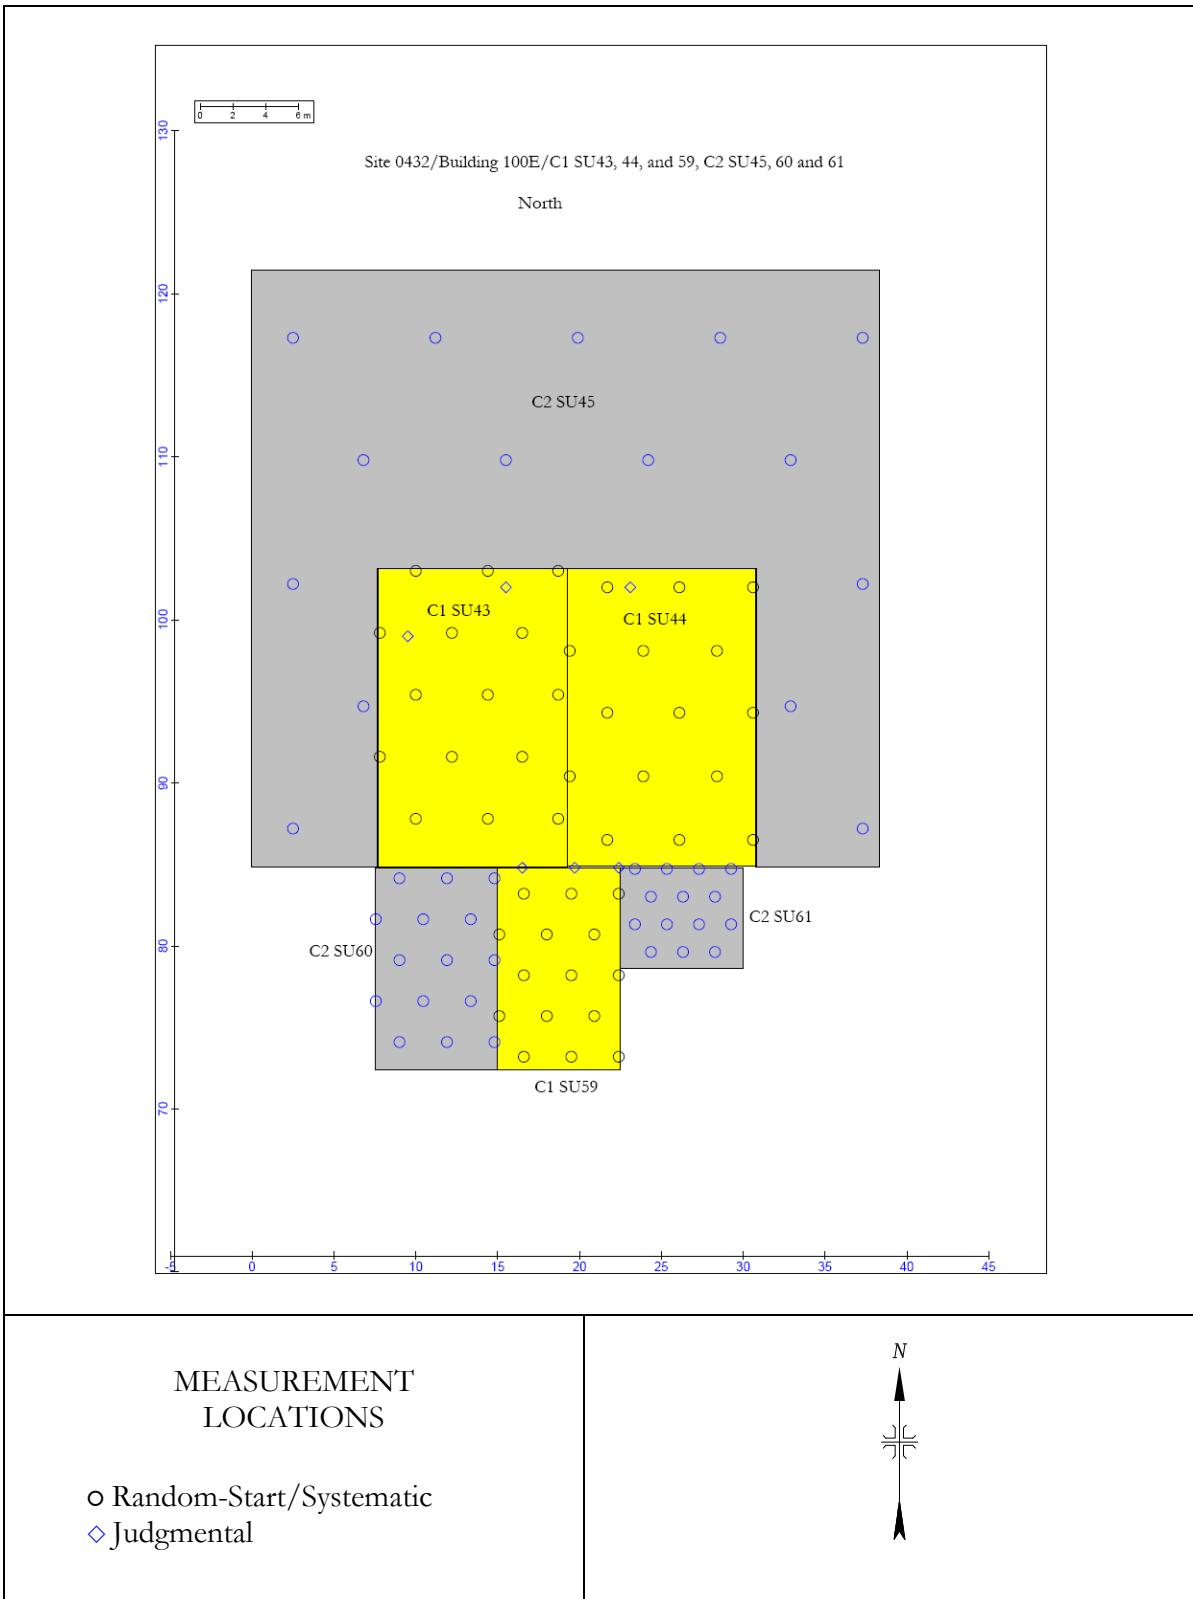
**Figure A-14:** Building 100E, North-end Floor (C1 SU43, 44, and 59; C2 SU45, 60, and 61)—FSS Survey Units and Direct Measurement Locations

Contaminated pallets were identified in Building 100E during the scoping survey within Bays 19 and 20. Once the pallets were surveyed and removed, the characterization survey identified three expansion joint locations with activity levels in excess of the DCGL<sub>W</sub>. Also, the pallets of tannin contaminated with monazite sand were present at this time but were not found until the FSS, after other materials had been moved out of the way. It is believed that the monazite sand was also the source of the contamination found within the expansion joints.

Building 100E was remediated by first removing the contaminated pallets during the interim cleanup action. The contaminated expansion joints were chipped out. The pallets of tannin that were found contaminated with monazite sand during the FSS were wrapped and disposed of as waste. The surrounding floor was vacuumed and an associated expansion joint required removal of the mastic and concrete.
