**CHARACTERIZATION REPORT
FOR PLUM BROOK SEDIMENT IN
FLOODPLAIN WETLANDS**

Prepared for
Keith M. Peacock
National Aeronautics and Space Administration (NASA)
Glenn Research Center
Plum Brook Reactor Decommissioning Program
Plum Brook Station
6100 Columbus Avenue
Sandusky, Ohio 44870

Prepared by:
Haag Environmental Company
315 East Market Street
Sandusky, Ohio 44870

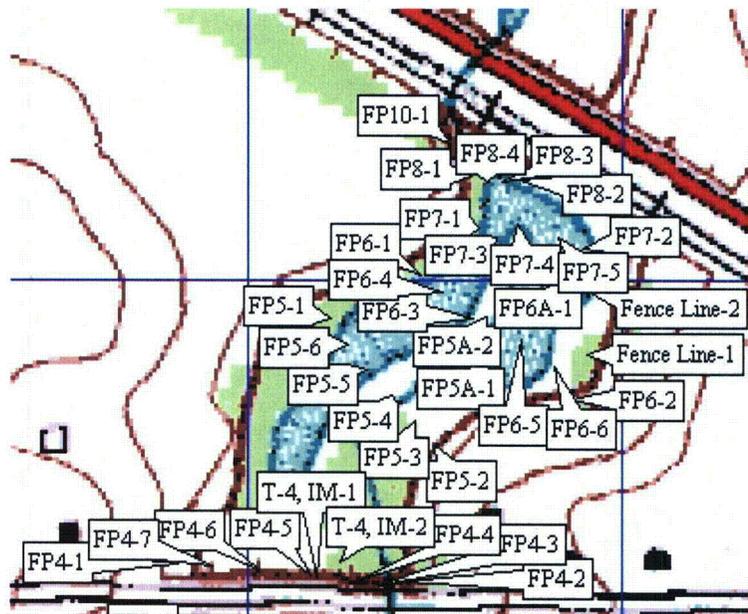
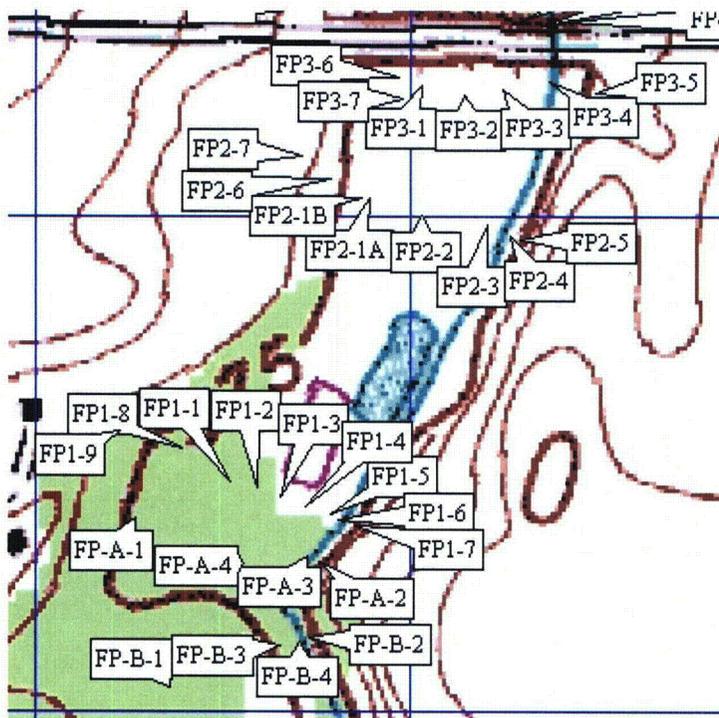
FIGURE 6 – FLOODPLAIN WETLAND TRANSECT SAMPLING LOCATIONS, IN NORTHERN FLOODPLAIN (ABOVE) AND SOUTHERN FLOODPLAIN (BELOW)

The East-West limit of each sampling transect was established by observing on topographic maps, and in the field, where the land rose from a low, flat surface characteristic of a wetland or a floodplain. Figures 5 and 6 illustrate the initial and final layout of transects. Lines marked in red were the primary transects, and those marked in green were possible alternates. Transects were arranged to yield cross-sections at right angles to the average direction of stream flow. Transect spacing, and the spacing of

samples within each transect, were based upon the hydrogeologist's judgment of the sample density needed to identify continuous layers and areas of deposition.

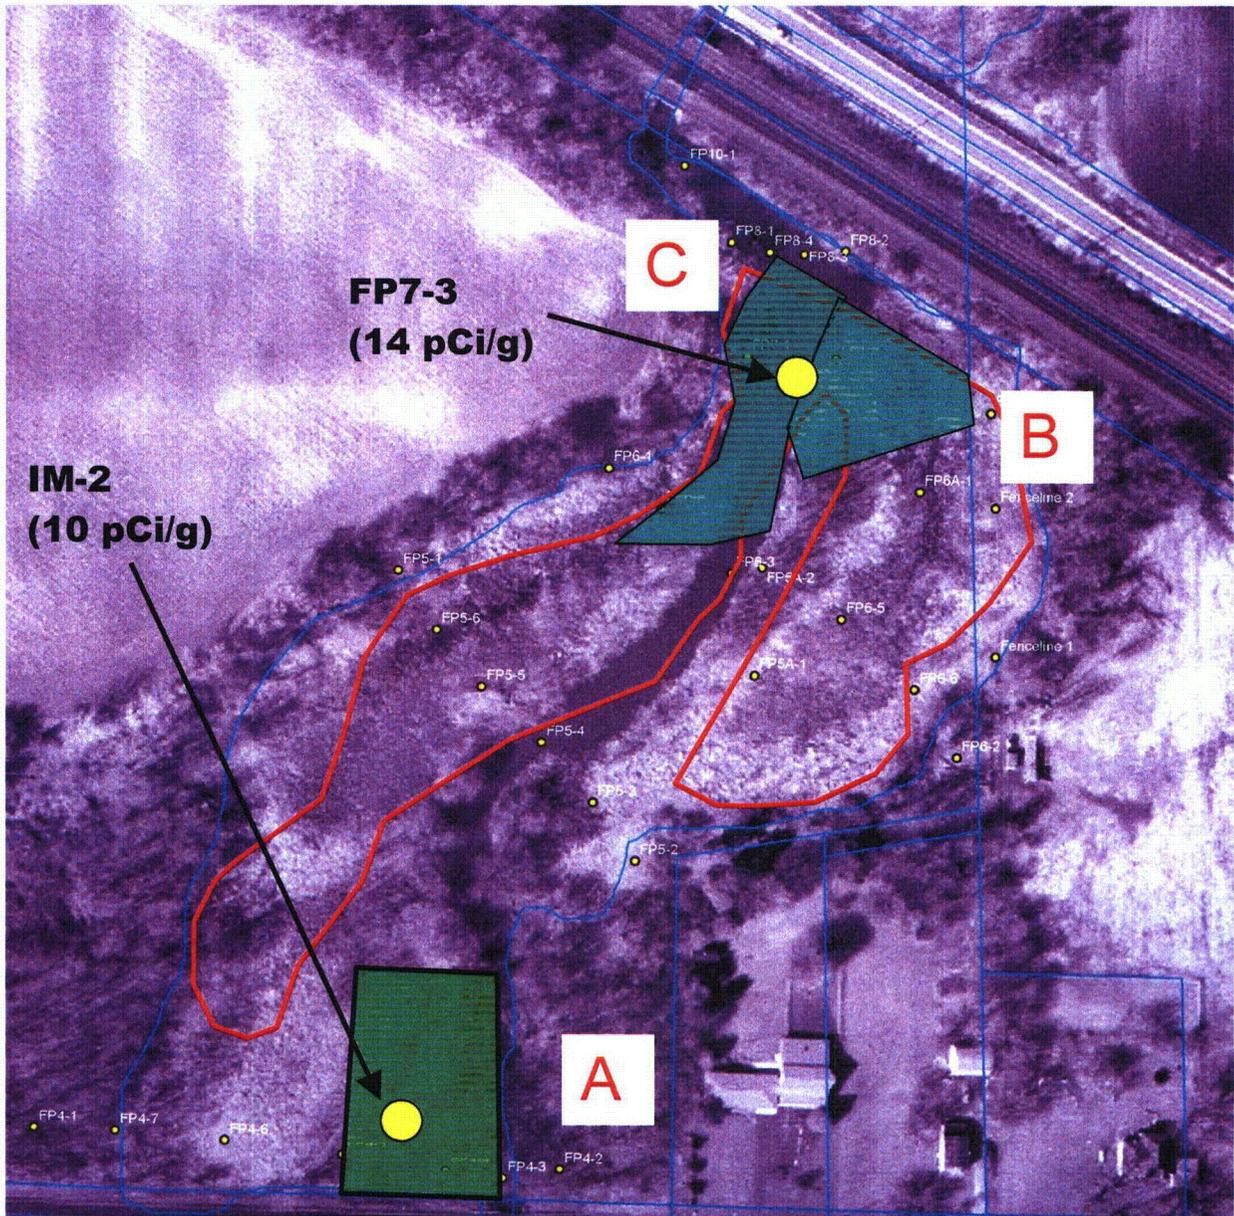
FIGURE 7 – BOUNDING SAMPLING AREAS

The first grid area, labeled Area A, was centered on an EMA on the stream bank, which had produced a peak Cs-137 measurement of 10.3 pCi/g (rounded to 10 in some figures). The second two survey areas, labeled B and C, flanked an EMA that had produced a peak Cs-137 measurement of 14.2 pCi/g (rounded to 14 in some figures). Figure 7 illustrates the relationships between areas A, B and C. Figure 7 also shows, by means of very small yellow dots, the locations of the original transect samples.

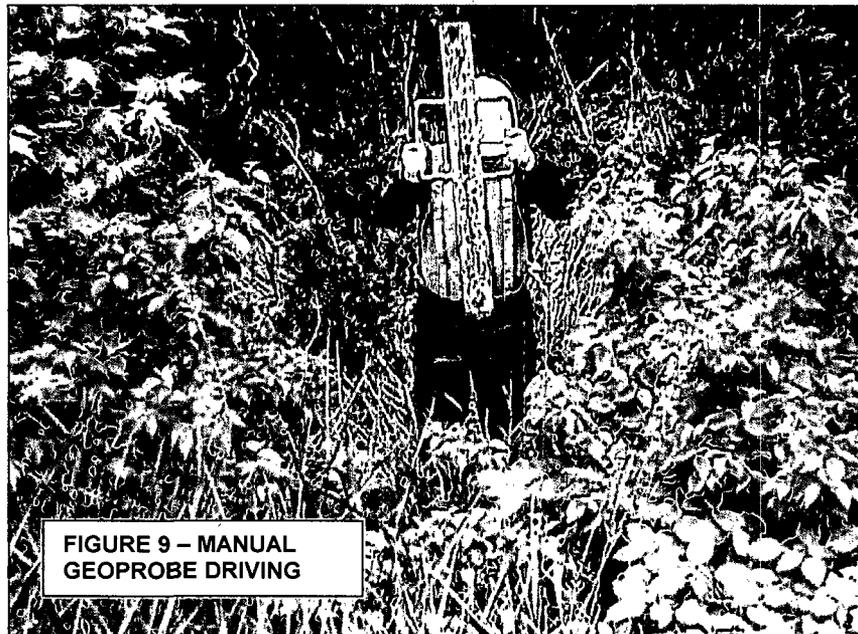
In the HaagEnviro Geoprobe approach, illustrated in Figure 9, a 5-foot-long dual-tube sampler was driven down to the desired depth, or to hard glacial till resistance.

The metal parts of the GeoProbe sampling equipment were decontaminated before each borehole was started. Each 5-foot-long sample was captured in a new plastic tube, which

was inserted inside the metal drive tube. When the sample was extracted in its plastic tube, the metal drive tube remained in place to keep the hole open. For a second 5-foot sampling run in the same hole, a new plastic tube was attached to drive rods and was lowered to the bottom of the hole. Additional drive rods and outer tube sections were then added to the top of the sampling string, and the sampler was driven to greater depth. After the last sample was obtained, the steel sampling tubes were extracted with the help of a tripod and winch, or a truck jack and chain.

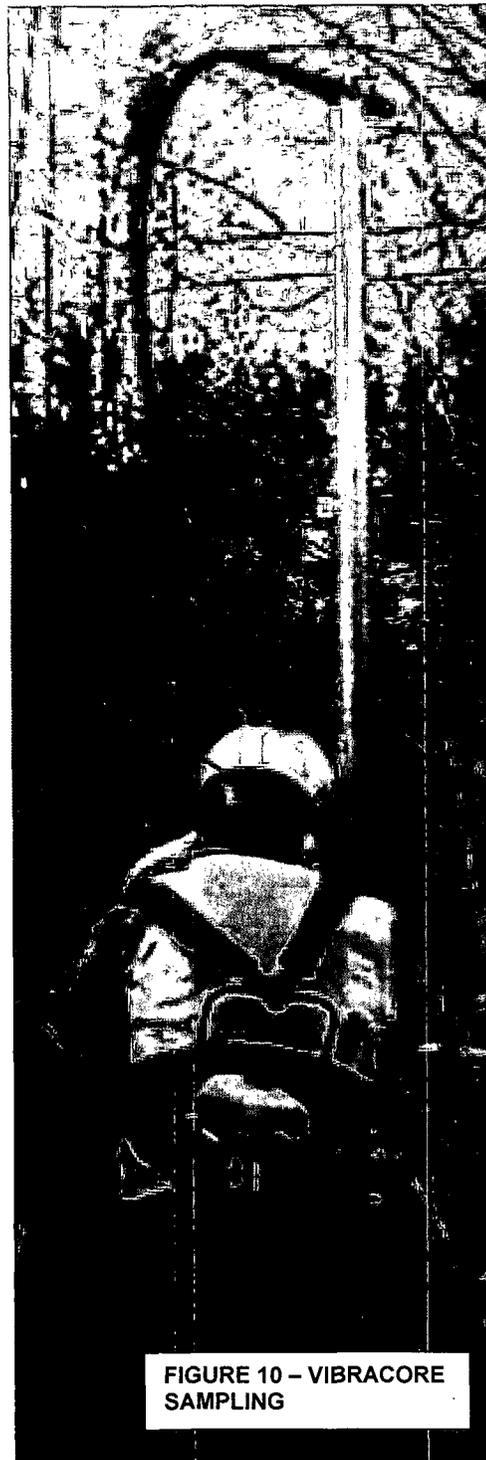
FIGURE 10 – VIBRACORE SAMPLING

In the vibracore approach, shown in Figure 10, HaagEnviro's backpack mounted, gas powered vibrator was attached to the top of a 3-inch-diameter, 10-foot-long, aluminum tube. Each tube was then vibrated down into the ground until refusal or the desired sample depth was reached. Sample compression, if any, was measured by lowering a tape measure into the top of the sample tube. A rubber worm-clamped cap was then placed on the top of the tube to create suction, and the tube was extracted from the ground. In dry areas, this was achieved initially with a tripod and winch, and later with a truck jack and chain. In water-covered areas, extraction was achieved by 2-3 people pulling up with pipe wrenches. After the tube was extracted from the ground, the bottom was capped, and the depth from the top of the tube to the top of the sample was again measured, to determine if any part of the sample had been lost from the bottom, or if any further sample compression had occurred. Any empty tubing at the top of the sample was cut off. The top of the tube was re-capped, and the tube was marked with an indelible pen. Initially, the top and bottom caps were duct-taped to avoid leakage; this later proved unnecessary and was discontinued.

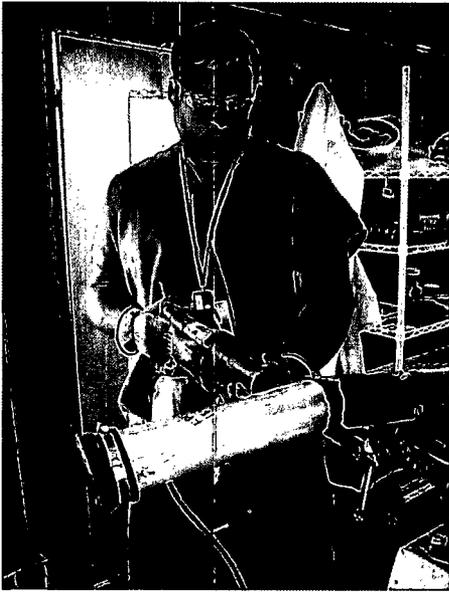
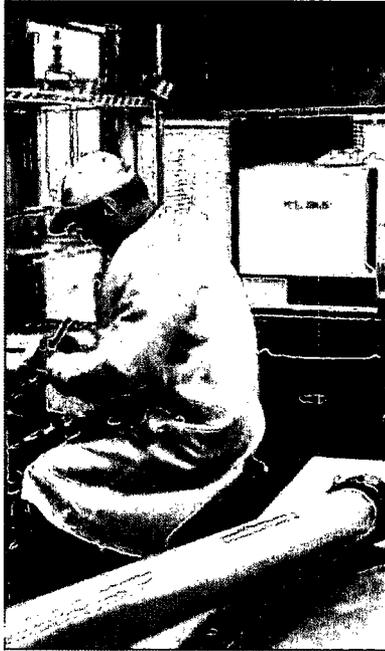
**FIGURE 11 – SAMPLE PROCESSING
(ABOVE) AND SCREENING/SAMPLING
FOR ORGANICS (BELOW)**

The processed samples were analyzed by gamma spectroscopy in the PBRF onsite laboratory following PBRF procedure RP-021. Samples sent to STL were processed by STL, and were analyzed by EPA Method 901.1 Modified.

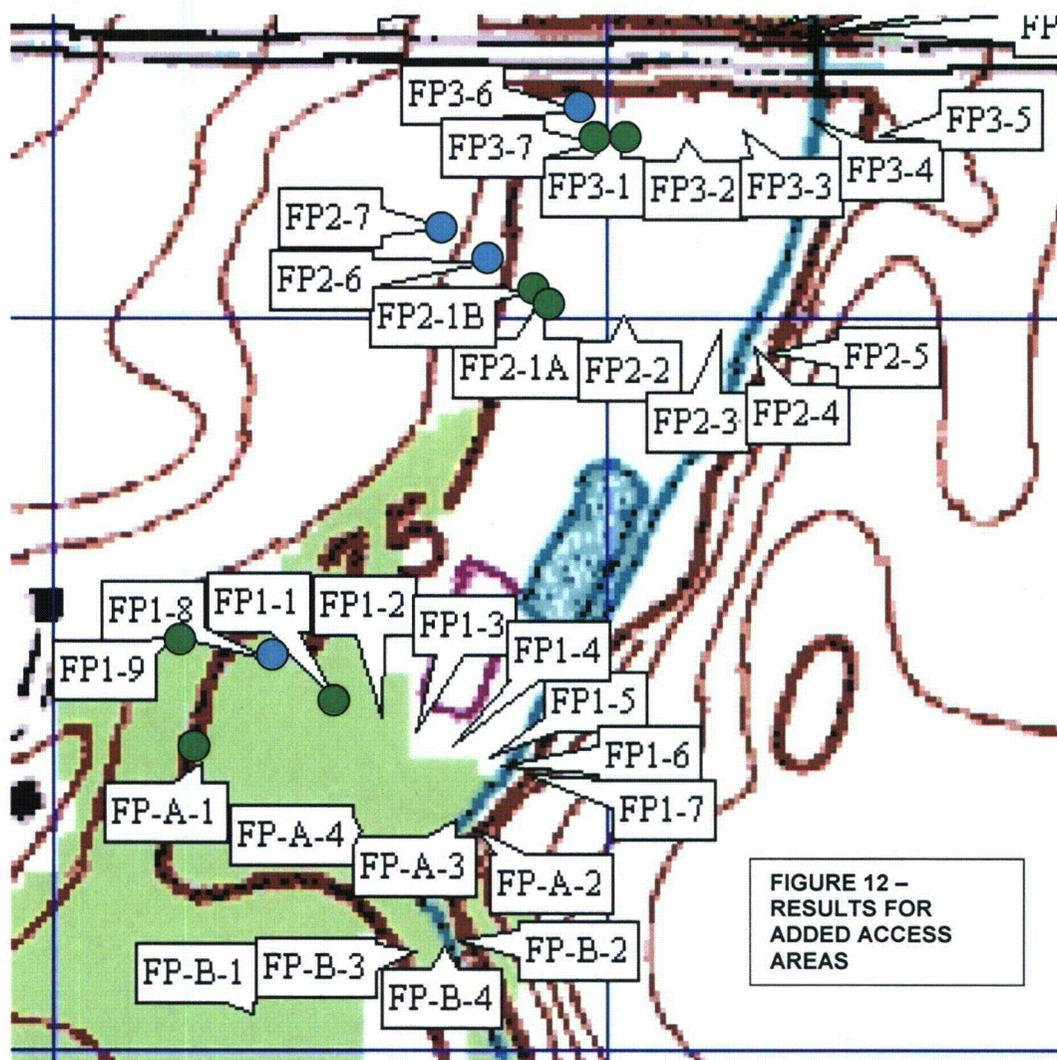
The sampling locations for which results were transmitted to property owners in response to a newspaper reporter's request are illustrated by Figure 12. All of the results transmitted to these added-access private property owners were relatively low, being closer to a background value of 1 pCi/g, than to the proposed effective DCGL of 12 pCi/g. The highest result observed among these sampling locations was 1 pCi/g, at location FP-A-1.

● Cs-137 not detected

● Cs-137 detected

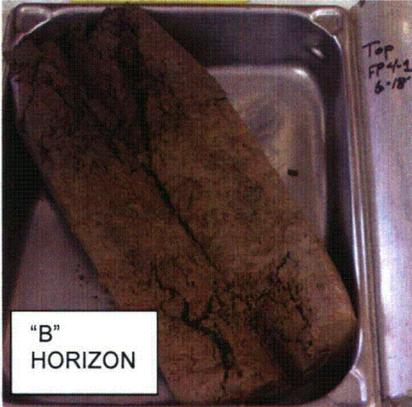
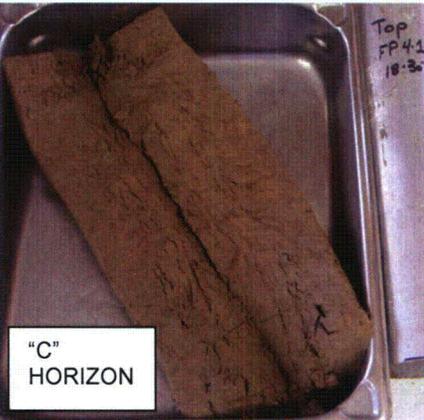
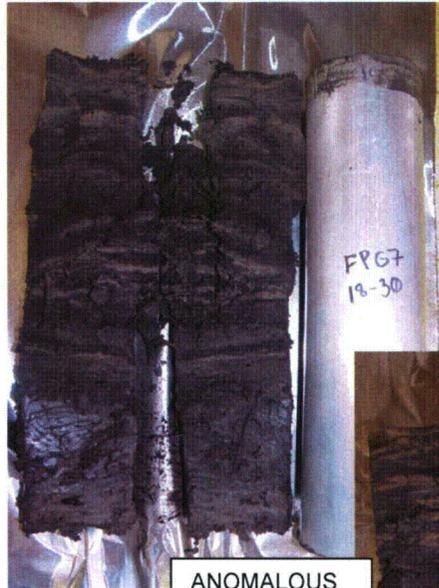
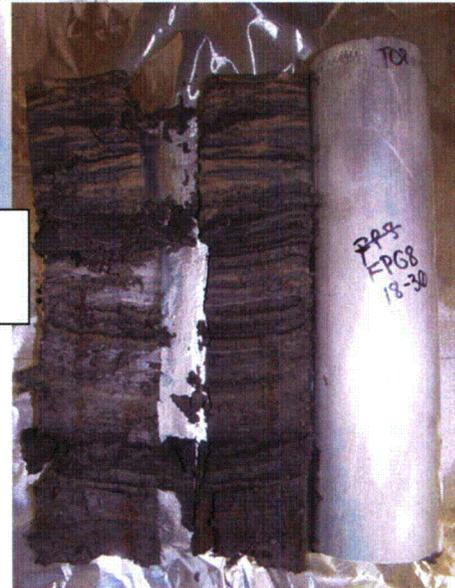
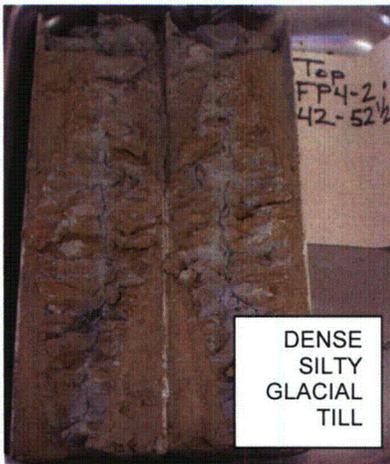
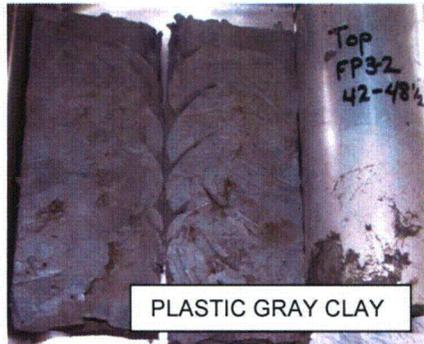
FIGURE 13 – FLOOD PLAIN
SEDIMENTS

General Sediment Patterns – Based on the photographs obtained after the samples were extruded from the core tubing, the dominant sediment types were seen to include fine sand, silt, and dense cemented silt. There were also some occurrences of soft gray clay, some peat, and an anomalous layered sand/peat deposit. The dense cemented silt, found near the bottom of the cores, was judged to be glacial till. Like glacial till, which is laid down beneath a glacier, the observed fine sand and silt could also have been contemporaneous with the glaciers. When this material was re-worked and re-deposited by the post-glacial stream, it became sand or silt alluvium. The soft clay and peat sediments were considered to be post-glacial. Figure 13 illustrates the character of the deposits that were found in the Floodplain wetland environment.

Sand and Silt Deposits – Most of the sand observed exhibited an appearance associated with wind-blown dune deposits, being light-colored (yellow and yellow-brown) and very fine-grained, often grading into a similar-colored silt. Sand of this type was observed in samples obtained at the eastern and western extremes of transects, where the land surface was rising up out of the wetland.

An anomalous type of sand deposit was observed in most of the grid samples obtained in area A. The 18-30" depth samples from area A generally contained a yellow sand interbedded with a black material, the latter having the appearance of peat. The sand in these deposits had the size and character of a typical mason's sand, much coarser than the fine sand found in the surrounding areas. One occurrence of this type of sand deposit was seen upstream from area A, at location FP2-3, and four occurrences were seen downstream from area A, in samples FP7-4, FP8-4, FPG32, and FPG37.

Dense Silt (Till) Deposits – The bottom samples in most locations showed a very dense silty material, which evidenced a blocky fracture pattern when the cores were cut in half, and the halves were pried apart. Most of these samples showed oxidized colors such as yellow and yellow-brown.

Peat Deposits - Peat deposits were relatively rare, by comparison with the Stream Mouth and Bay environments downstream. Peat deposits were seen at the northernmost (downstream) end of the study area, in grid-sampling areas B and C. In those areas, a fairly uniform depth to peat was noted, which was nominally 30-36 inches.

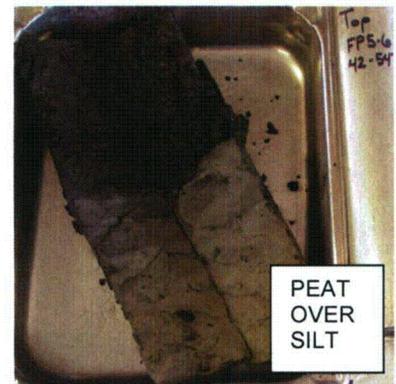
FINE SAND
AND SILT

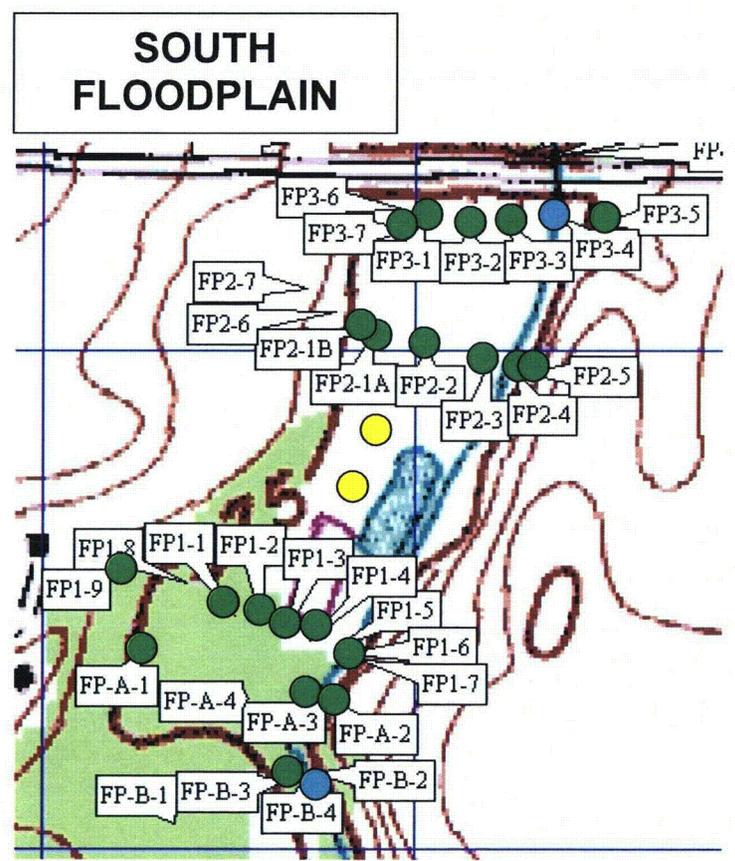
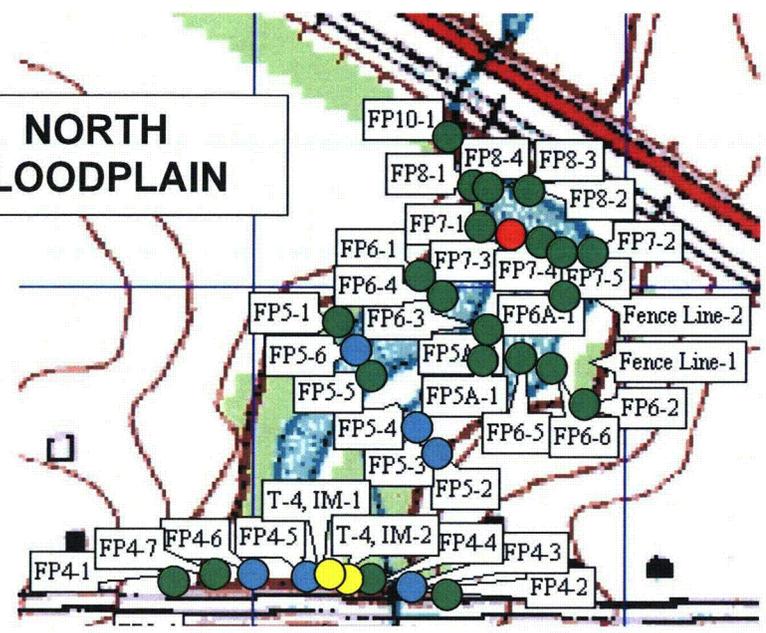
FIGURE 14 – HIGHEST RESULTS IN INITIAL TRANSECTS

Cs-137 Results in Initial Transects – Initial transect results are summarized in Figure 14. This figure demonstrates that, in the southern half of the area, no values approached the DCGL of 12 pCi/g, except in the materials excavated from the ponds, shown by two yellow dots in the center of the South Floodplain figure.

The only other EMAs found were in the North Floodplain area. Only 1 EMA had a Cs-137 result above the DCGL of 12 pCi/g. Location FP7-3 had a Cs-137 laboratory testing result of 14.2 pCi/g at a depth of 0"-6". This sample was obtained within the present stream channel. The second EMA, with a peak Cs-137 laboratory testing result of 10.3 pCi/g at a depth of 0"-6", was found adjacent to the present stream channel, at location IM-2.

- Cs-137 \geq 12 pCi/g
- Cs-137 6-11 pCi/g
- Cs-137 = 3-5 pCi/g
- Cs-137 0.2-2 pCi/g

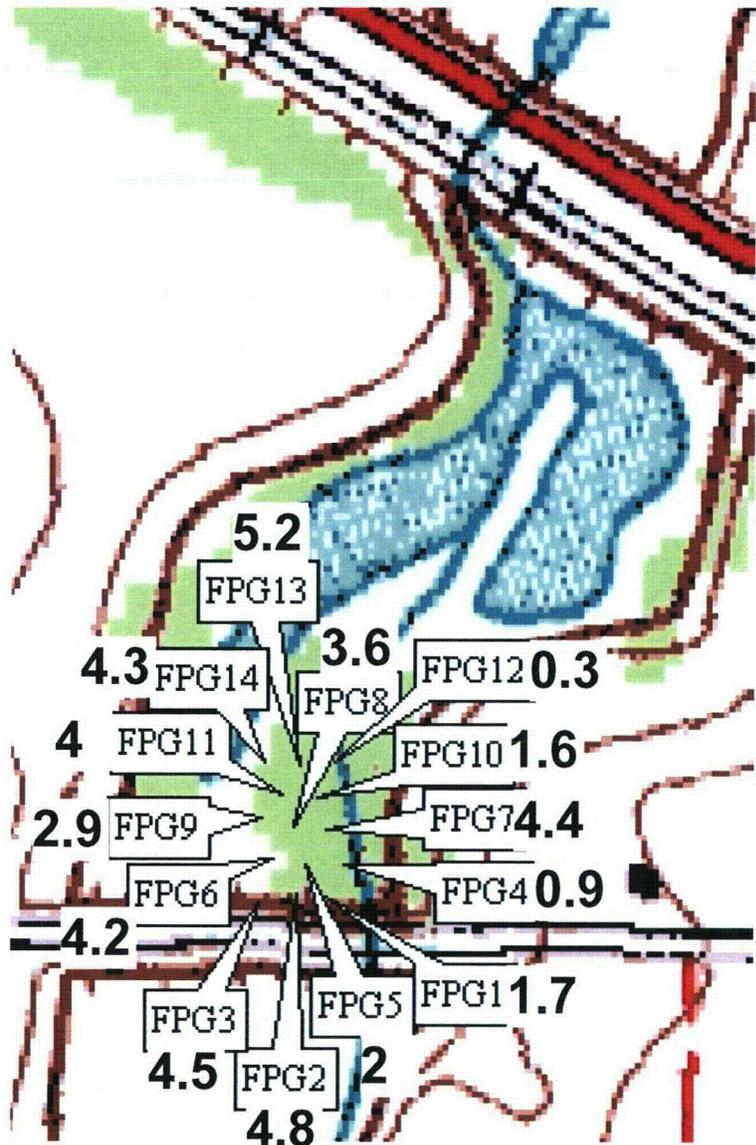
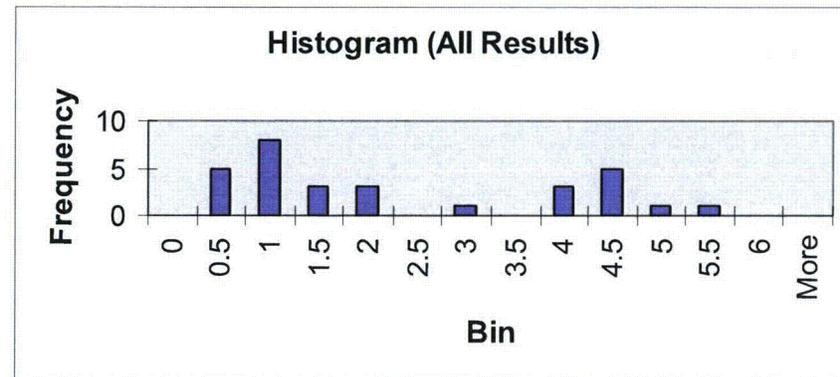
FIGURE 19 – HIGHEST BOUNDING RESULTS IN AREA A. ALL RESULTS IN pCi/G.

Area A – As shown by the figures, none of the results obtained from the area A grid sampling approached the prior EMA result of 10.3 pCi/g. Instead, the area results showed a bimodal lognormal distribution, with the most frequent results at approximately 1 pCi/g and 4.5 pCi/g. With one exception, all of the area A results >MDA were found in the upper 18 inches of soil. None of the area A samples were taken in the current streambed.

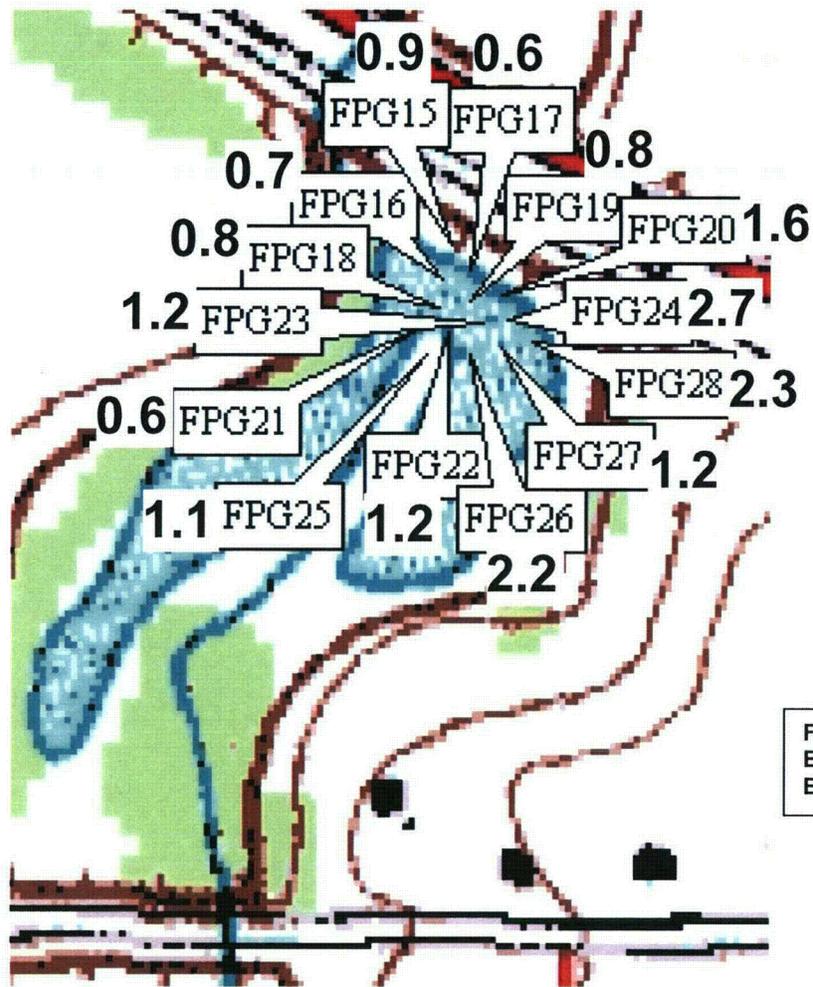
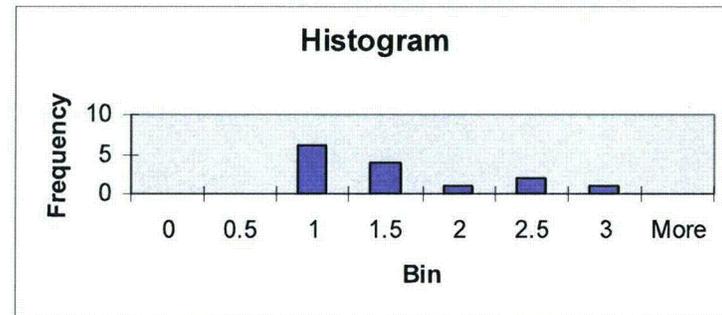
FIGURE 21 – HIGHEST BOUNDING RESULTS IN AREA B. ALL RESULTS IN pCi/G.

Area B – In area B, adjacent to the in-stream EMA of 14.2 pCi/g, none of the positive Cs-137 results exceeded 3 pCi/g. Those that were > MDA were all within the upper 18 inches of soil. None of the area B samples were taken in the current streambed.

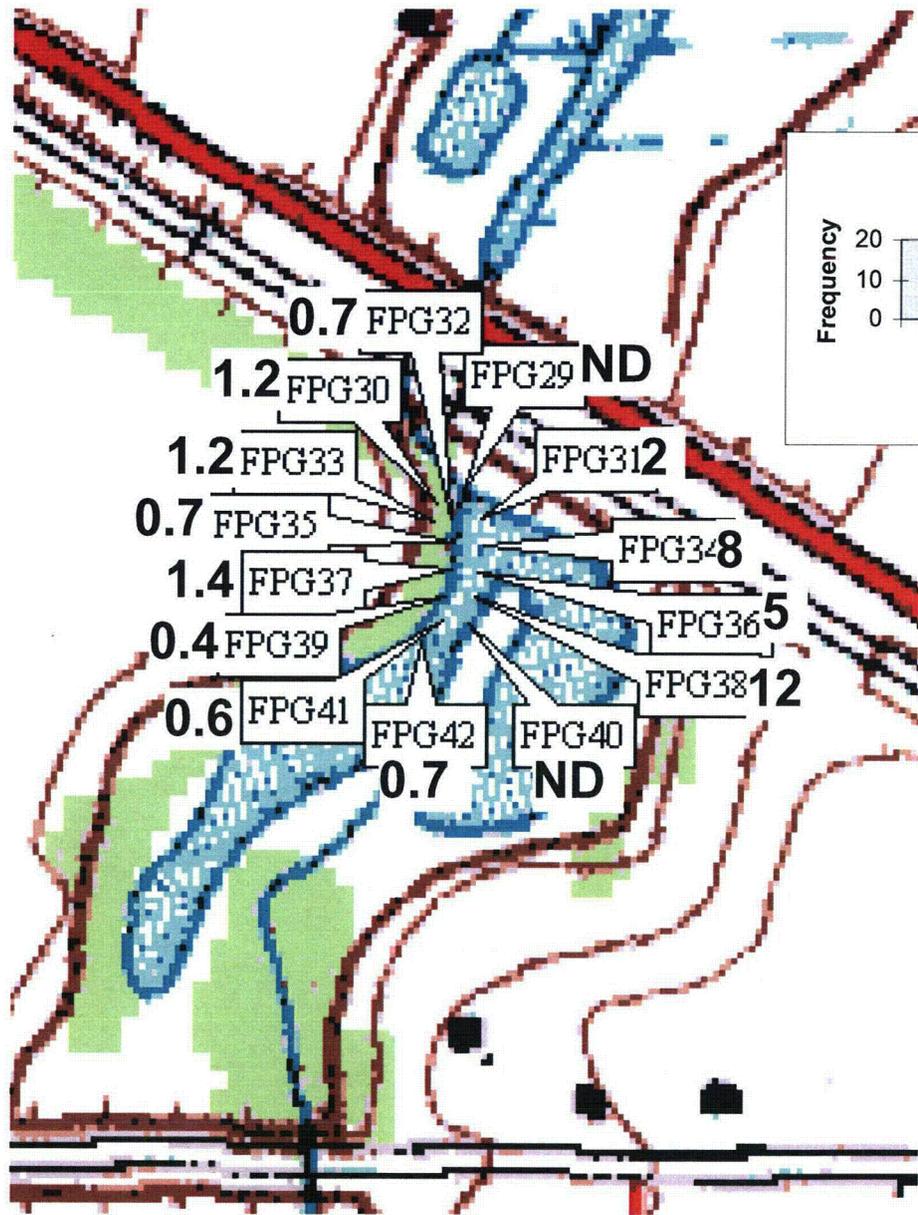
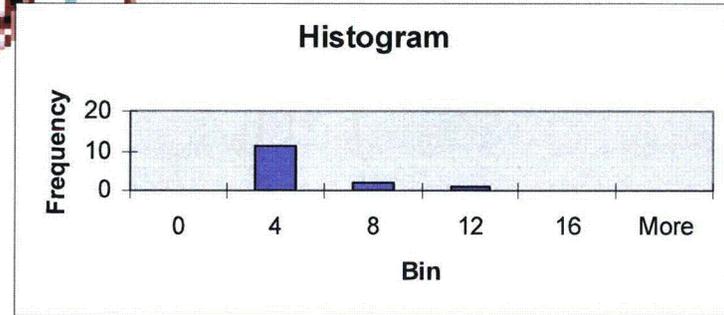
FIGURE 23 – HIGHEST BOUNDING RESULTS IN AREA C. ALL RESULTS IN pci/g. (ND=NOT DETECTED)

Area C – In area C, which included the current streambed and its western bank, three in-stream samples reflected the EMA of 14.2 pCi/g. One of those results was 12 pCi/g, found in the 0"-6" interval of location FPG38. The second was 7.67 (rounded to 8) pCi/g, found in the 0"-6" interval of location FPG34. Between these two stream locations, a value of 4.68 (rounded to 5) pCi/g was noted, in the 6"-18" interval of location FPG36. All of the results >3 pCi/g were in the current streambed. The most elevated results were in the top 6 inches of sediment in the streambed.

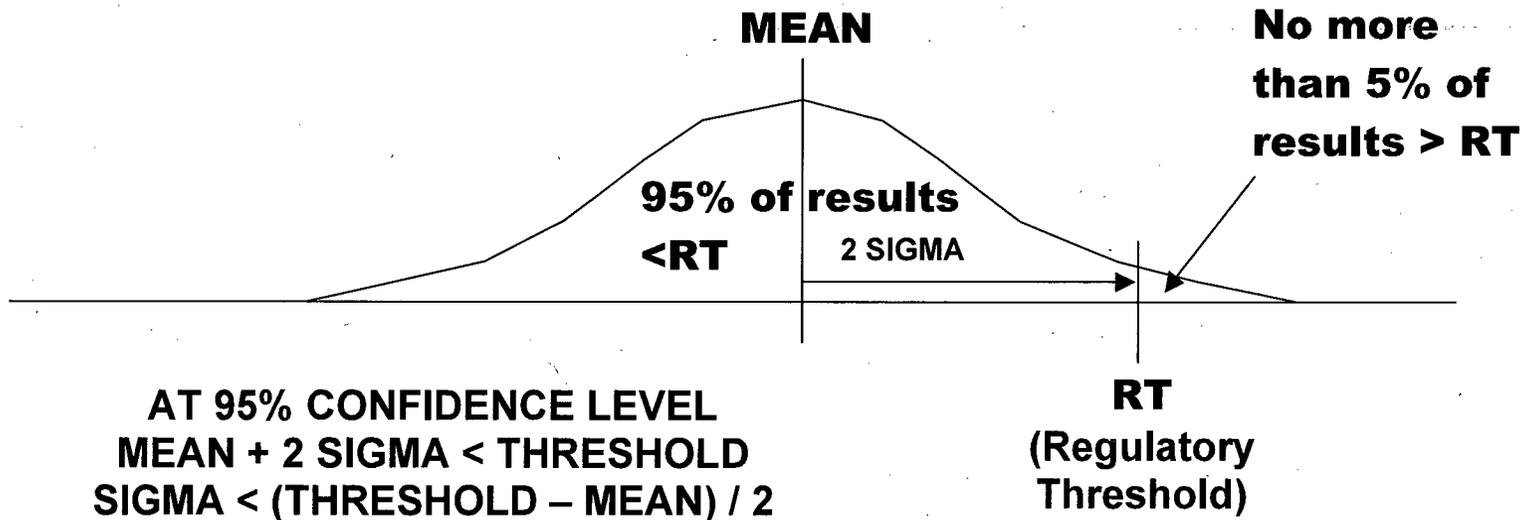
FIGURE 24 – CONCEPT FOR ASSESSING ACCURACY

As noted in the Methods section, when no trends were noted in a deposit, HaagEnviro considered accuracy acceptable if the standard deviation of the log-transformed results was less than half the following: the log of the regulatory threshold of 12 pCi/g (1.08), minus the mean of the log-transformed results. "Representative" values, provided in the Interpretations section of this report, were also inserted in this test, in place of the mean of the log-transformed results.

This test of accuracy was based upon a simple formula for defining confidence intervals, taken from USEPA's SW-846, and the assumption that the mean plus two standard deviations represented a 95% confidence interval. The concept is illustrated by Figure 24. The question being asked was essentially: "Is the scatter of results around the mean (or the "representative") value tight enough, so that 95% of the results will always be less

than the Regulatory Threshold (RT) of 12 pCi/g?” If the answer to this question was “Yes,” then the accuracy was sufficient to support the decision that the “representative” value was less than 12 pCi/g.

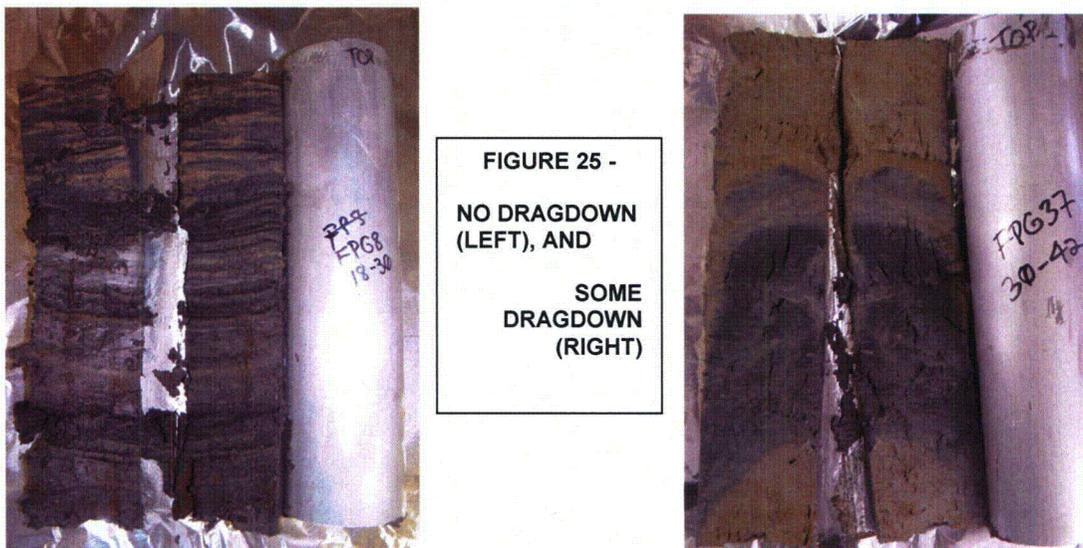
Review of core photos and corresponding testing results suggested that carry-down generally did not occur to any significant extent. Examples in which drag-down did and did not occur are shown in Figure 25. Based on the testing results for samples obtained at locations IM-1 and IM-2, near transect 4, some top-to-bottom cross contamination may have occurred there.

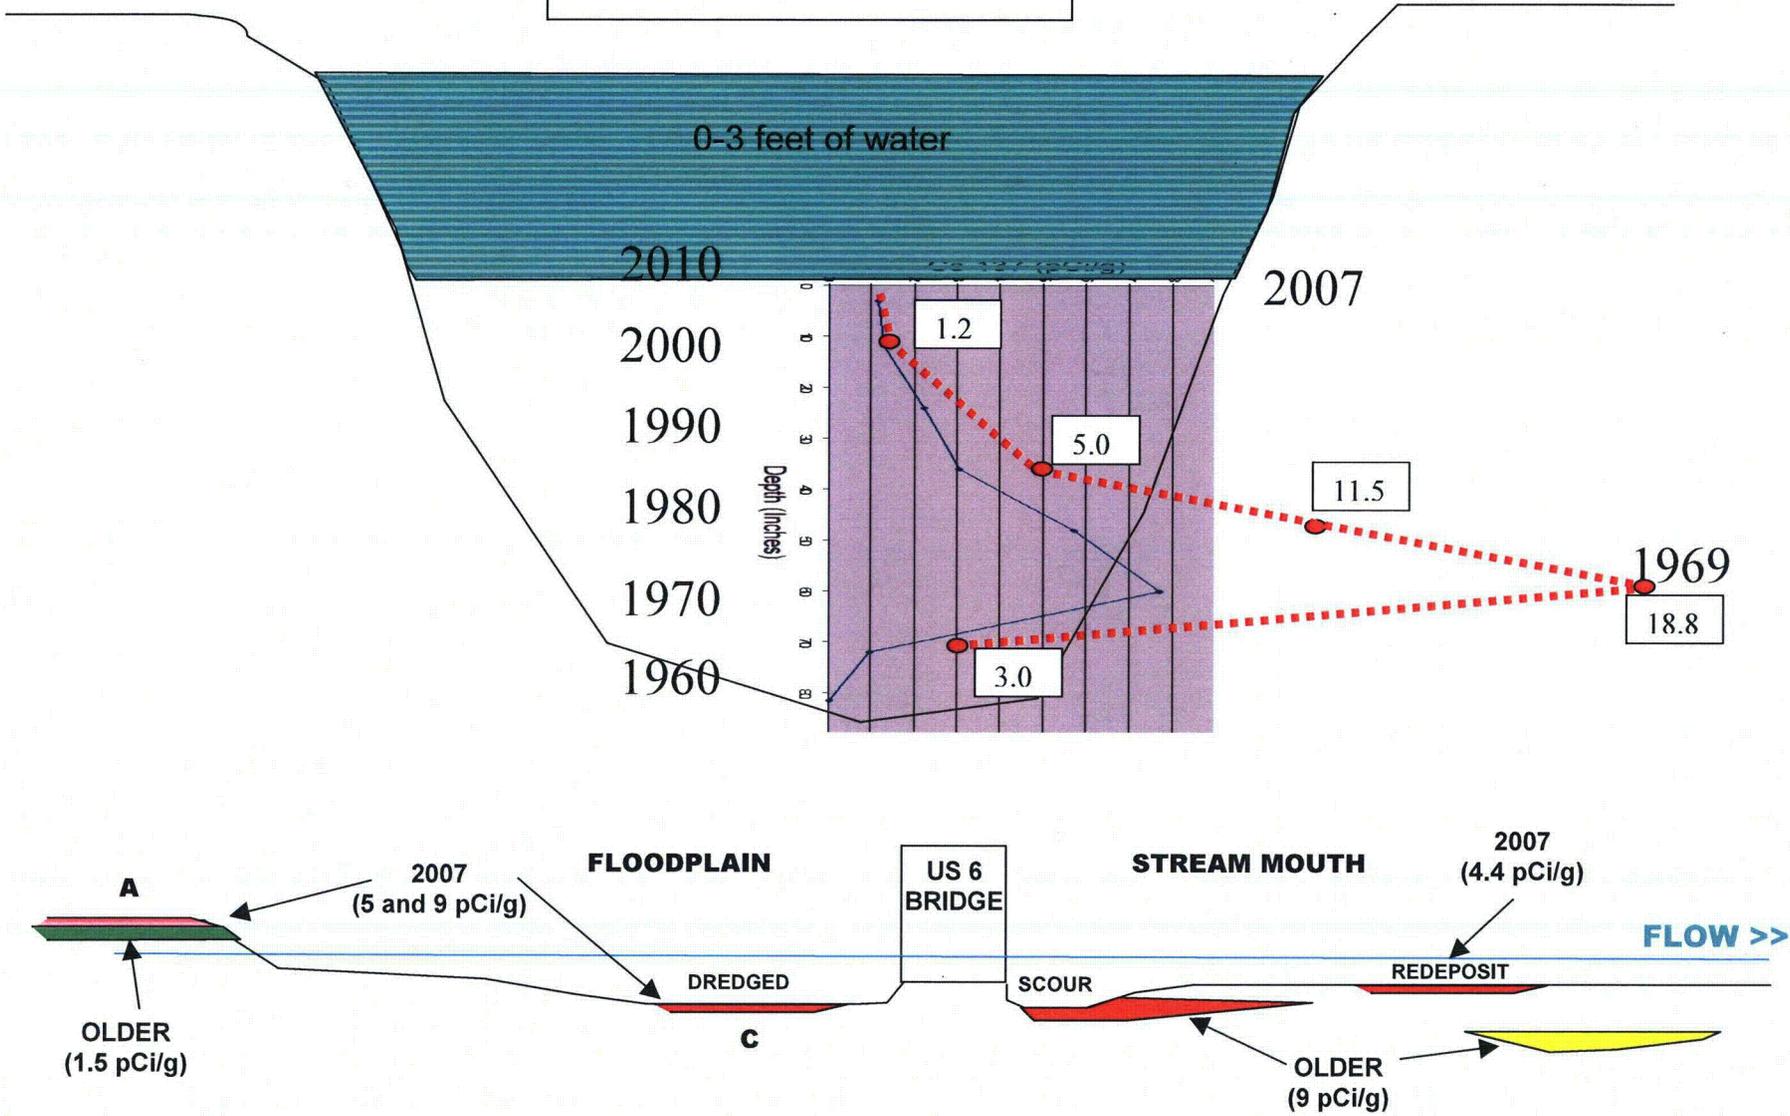
FIGURE 26 – INTERPRETED DEPOSITION RECORD IN A POND, AND IN THE STREAM

Cs-137 Deposition Over Time - An underlying postulate of this work was that the peak Cs-137 levels were deposited down Plum Brook in 1969. Based upon this assumption, and drawing upon results obtained in the earlier Ponds report, the top of Figure 26 provides an estimate of the activity deposited versus time, in a pond near Plum Brook, in the Stream Mouth depositional environment. The solid line in the graph represents the actual testing results obtained, without correcting for nuclear decay. The dashed red line represents the Cs-137 activities at the time of deposition, correcting for decay using an Excel spreadsheet program supplied by NASA's Assistant RSO, Rod Case. This figure suggests that the activity in sediment being carried by floods peaked at 18.8 pCi/g in 1969, had dropped to less than 3 pCi/g by 1995, and was approaching a steady-state value just over 1 pCi/g by the year 2000.

The distribution of Cs-137 results in Floodplain area B peaked around 1 pCi/g, and HaagEnviro therefore interpreted that this deposit was associated with the deeper deposit found in area A. The distribution of Cs-137 results in Floodplain area C peaked around 4 pCi/g, and HaagEnviro therefore interpreted that the Area C deposit was associated with the upper deposit found in Floodplain area A. The deposits peaking around 4-4.5 pCi/g in Floodplain areas A and C occurred in the top 6 inches of soil, and thus represented current and ongoing conditions.

The relative times of deposition in stream areas are illustrated at the bottom of Figure 26.

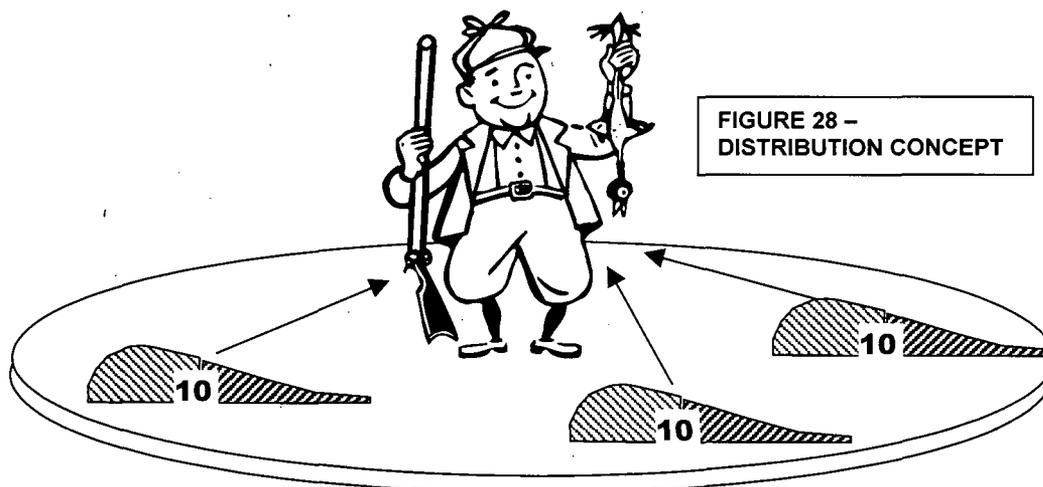
The key problem to be solved to make a reasonable comparison is to determine what is the “representative” activity emanating from a deposit that contains Cs-137 in a lognormal distribution. In evaluating the radiation dose delivered by a lognormal distribution, the “representative” activity should be considered the center of gravity of the distribution. This center of gravity is not determined by the arithmetic mean of the measurements. It can be determined by finding the equation of the distribution’s histogram curve, then finding the activity at which half the area under the curve lies to either side of that activity. An example was provided in the Stream Mouth report, in which the area under a lognormal distribution curve was divided into equal areas to the left and right of the “center of gravity” of the area under the curve. Figure 28 illustrates that concept.

Thus, one approach by which this discrepancy might be overcome would be to compare the “representative” value, as defined in this report, to the DCGL. Another way in which this discrepancy might be overcome would be to use a Cs-137 input with a lognormal distribution in the RESRAD computer model, to define the input that delivers a dose of 25 mRem/year. Yet another approach would be to take a dose approach to determining what sediment should be removed, rather than employing the DCGL concept. If any of these approaches were employed, it appears likely that the conclusion would be that removal of many sediment deposits would not be necessary in order to achieve the required dose <25 mRem/year. In particular, it does not appear that any of the sediments bearing Cs-137 in the Floodplain depositional environment would be candidates for removal.
