SUBJECT: License Termination

**SUBJECT: FINAL REPORT—HISTORICAL SITE ASSESSMENT OF THE
HAMMOND DEPOT, HAMMOND, INDIANA**

**HISTORICAL SITE ASSESSMENT
OF THE HAMMOND DEPOT
HAMMOND, INDIANA**

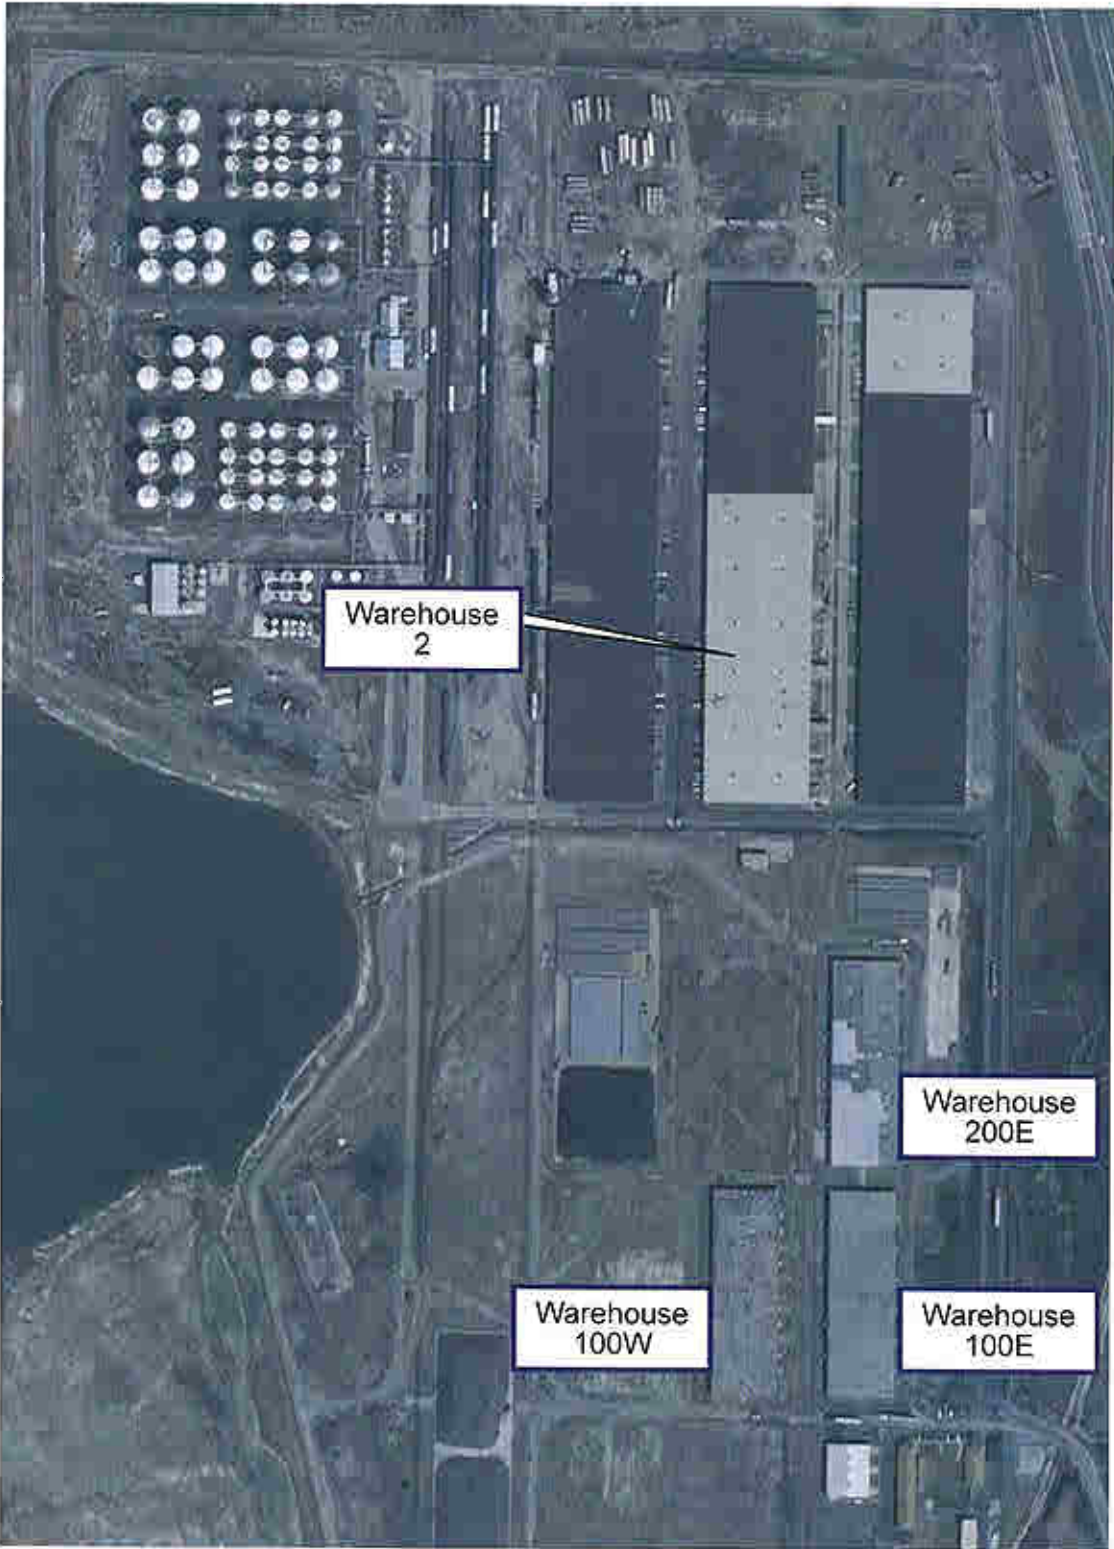
Figure 1- Hammond Depot - annotated aerial layout photo North view bottom to top

Warehouse 2, as it was referred to formerly, is located on private property adjacent to the north boundary of the Hammond Depot, as depicted on the annotated aerial layout (photo) labeled Figure 1. The property was formerly a part of the Hammond Depot, having been sold as excess property in the 1970s. The building dimensions are 201 ft by 1,006 ft (see middle building).

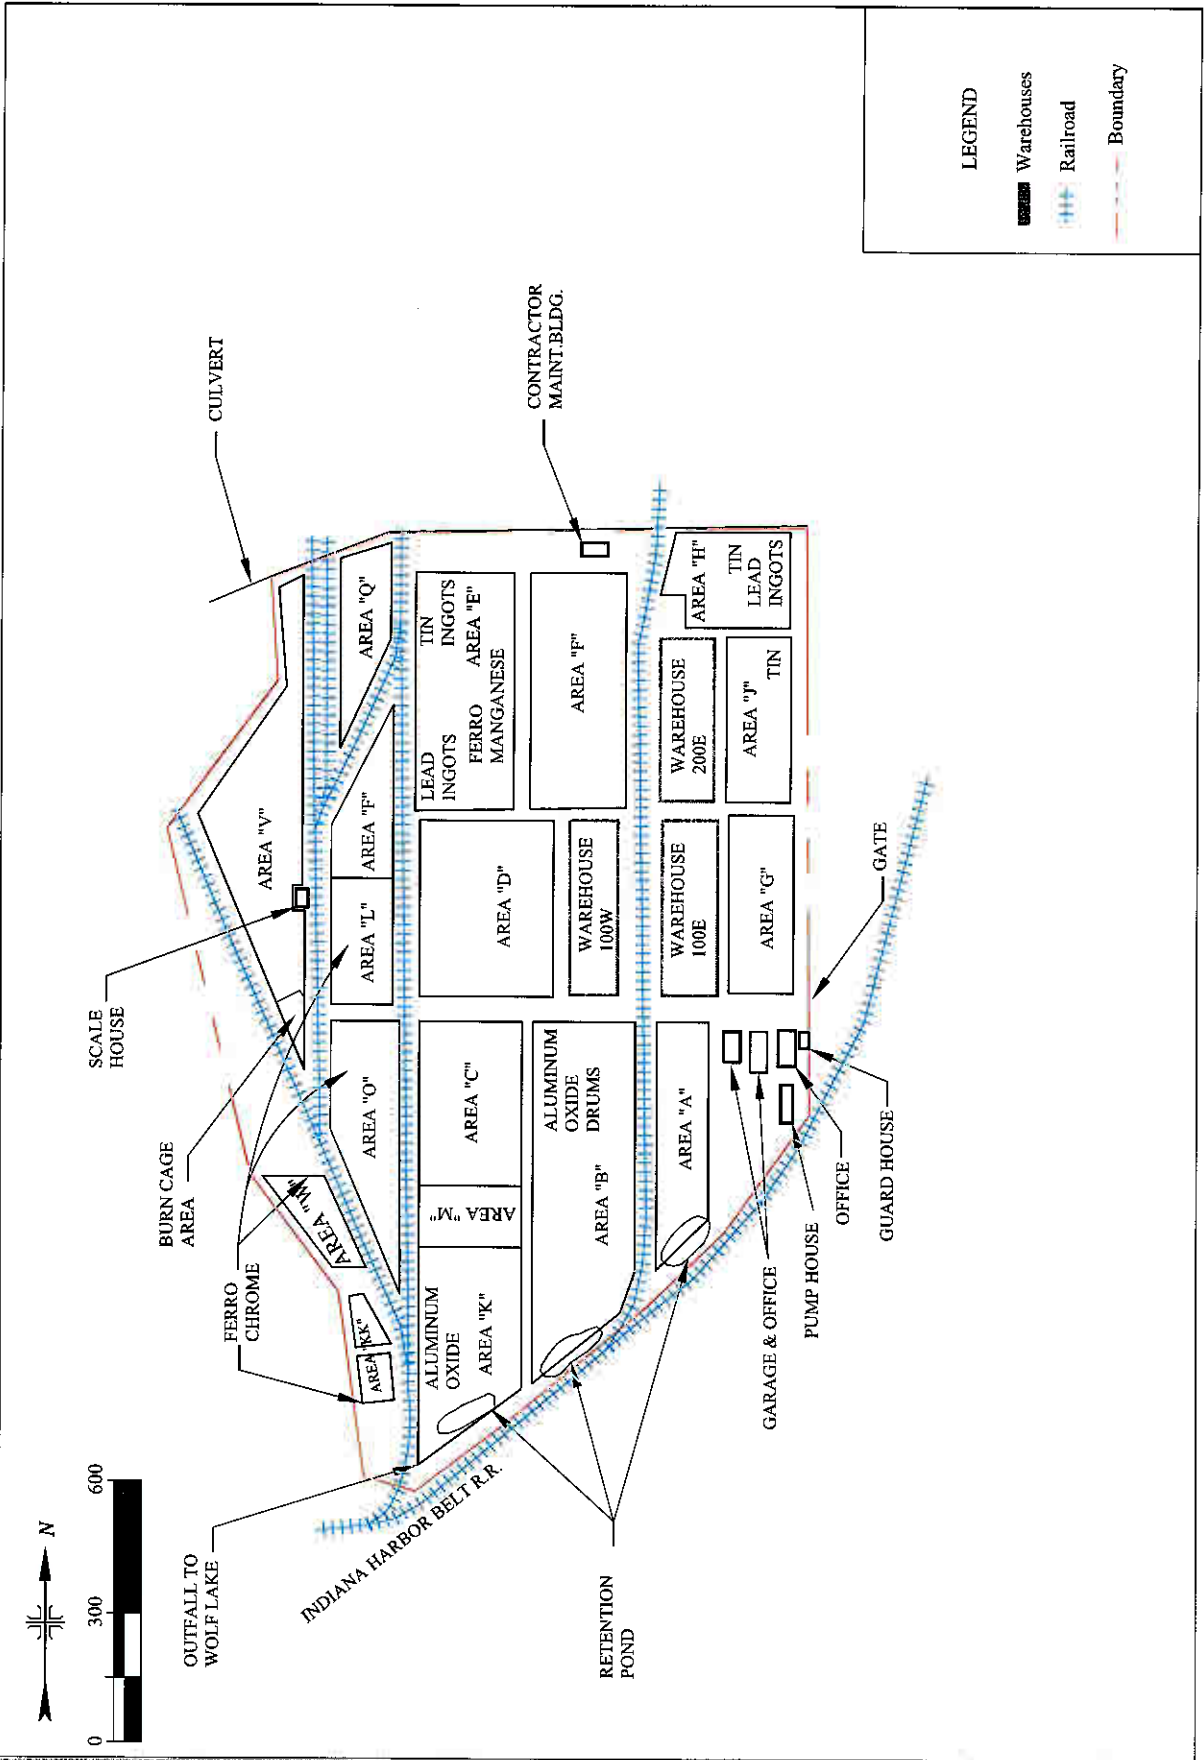
FIGURE 1: Hammond Depot, Hammond, Indiana - Plot Plan

The Hammond Depot property consists of a 57.3-acre parcel of land located on the west side of Hammond, Indiana—about 490 feet east of the Indiana-Illinois state line, within the city limits of Chicago. The depot has eight buildings, mostly in good condition, including three warehouses that are used to store raw materials. Currently, approximately 120,000 ft² of the available 150,000 ft² of indoor storage space is occupied, as well as 60% of the outdoor storage space. Figure 1 indicates the location of buildings and warehouses at the Hammond Depot [4].

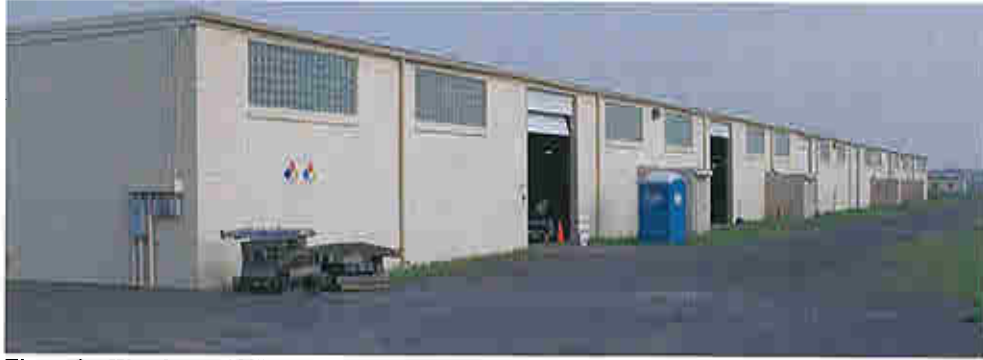
Figure 2 – Warehouse 100W

The warehouse is a concrete structure with dimensions of 401 ft by 126 ft. Exterior walls are cinder block with glass block windows, 14 overhead doors, and two personal doors on each end. The floor is concrete slab on grade and the structure is steel beams, columns, and roof joists. The roof deck is 3-ply gypsum board and the roofing is 3-ply built up asphalt with a smooth surface sloping to the perimeter gutters on the east and west elevations. Electrical conduits and light

fixtures hang from roof joists. A dry pipe sprinkler system is installed [4, 13]. Figure 2 shows Warehouse 100W.

Four commodities listed on the NRC Source License STC-133 (in October 1997) were stored in this warehouse: thorium nitrate in Bays 8 through 16 B, C, and D; tantalum natural minerals and concentrates (tantalum pentoxide (Ta_2O_5)) in Bays 15 D, 16 D, 17 A through D, and 18 A through D; columbium tantalum source material (tantalum natural minerals) in Bays 7 B, 8 A, and 8 B; and columbium tantalum source material (columbium natural minerals) in Bays 8 E and 9 E [14].

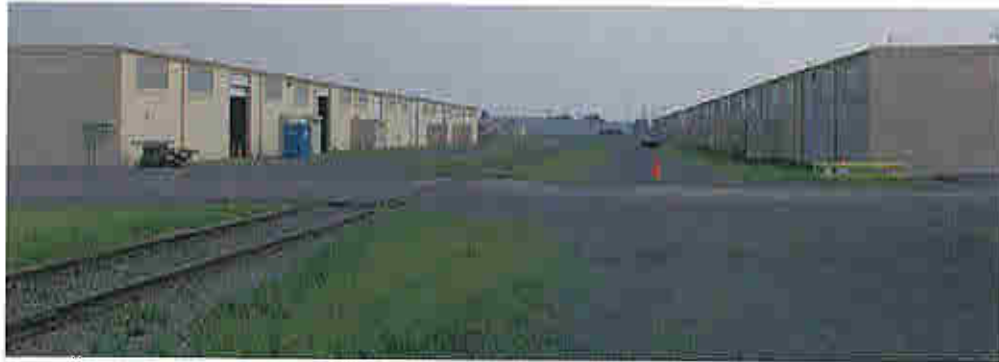
The warehouse is a concrete structure with dimensions of 401 ft by 126 ft. Exterior walls are cinder block with glass block windows, 14 overhead doors, and two personal doors on each end. The floor is concrete slab on grade and the structure is steel beams, columns, and roof joists. The roof deck is 3-ply gypsum board and the roofing is 3-ply built up asphalt with a smooth surface sloping to the perimeter gutters on the east and west elevations. Electrical conduits and light fixtures hang from roof joists. A dry pipe sprinkler system is installed [4, 13]. Figure 3 shows Warehouse 100E.

Figure 3 – Across the rail road tracks from Warehouse 100W (left) is Warehouse 100E (on the right).

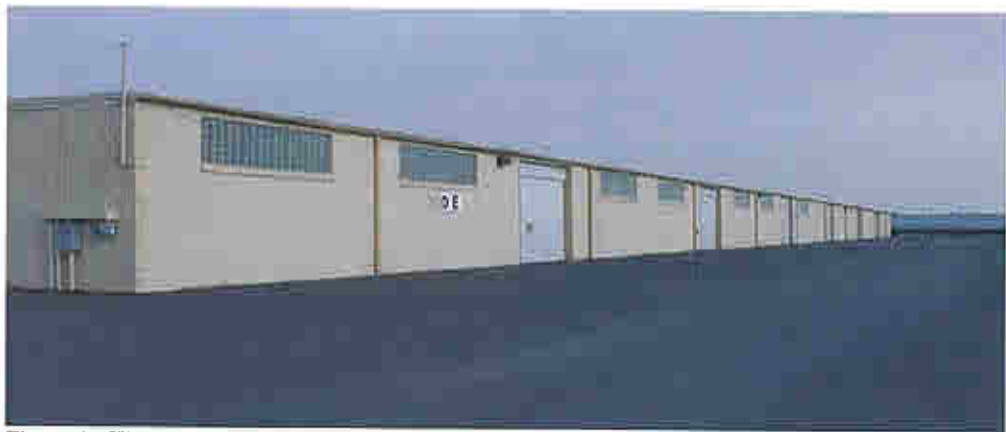
Figure 4 – Warehouse 200E

The warehouse is a concrete structure with dimensions of 401 ft by 126 ft. Exterior walls are cinder block with glass block windows, 14 overhead doors, and two personal doors on each end. The interior is divided into north and south sections by a cinder block partition firewall. The floor is concrete slab on grade except that the south side was completely covered with black-top after the top surface was remediated. The structure is steel beams, columns, and roof joists. The roof deck is 3-ply gypsum board and the roofing is 3-ply built up asphalt with a smooth surface sloping to the perimeter gutters on the east and west elevations. Portions of the roof gypsum board decking were replaced with metal decking after wind tore off the original roof. Electrical conduits and light fixtures hang from roof joists. A sheet metal return air duct is also hung below the roof deck in a north-south direction but is not operational. A dry pipe sprinkler system is installed [4, 13]. Figure 4 shows Warehouse 200E.

From the “Hammond Depot History of Radiological Material Storage”, Warehouse 200E was used to store ThN in Bays 1 through 10 A, B, C, D and E

[15]. Alpha survey records indicate that ThN drums leaked in this warehouse with residual contamination ranging from 100 to 500 dpm [18].

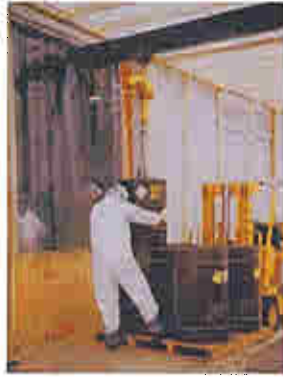
Figure 5 –Overpack Project

Thorium drums were overpacked from 55 to 85 gallon drums in an area west of and adjacent to the building [21]. Right after the overpackaging, the drums were moved to Warehouse 100W [6]. Figures 5 through 7 show the overpack project.

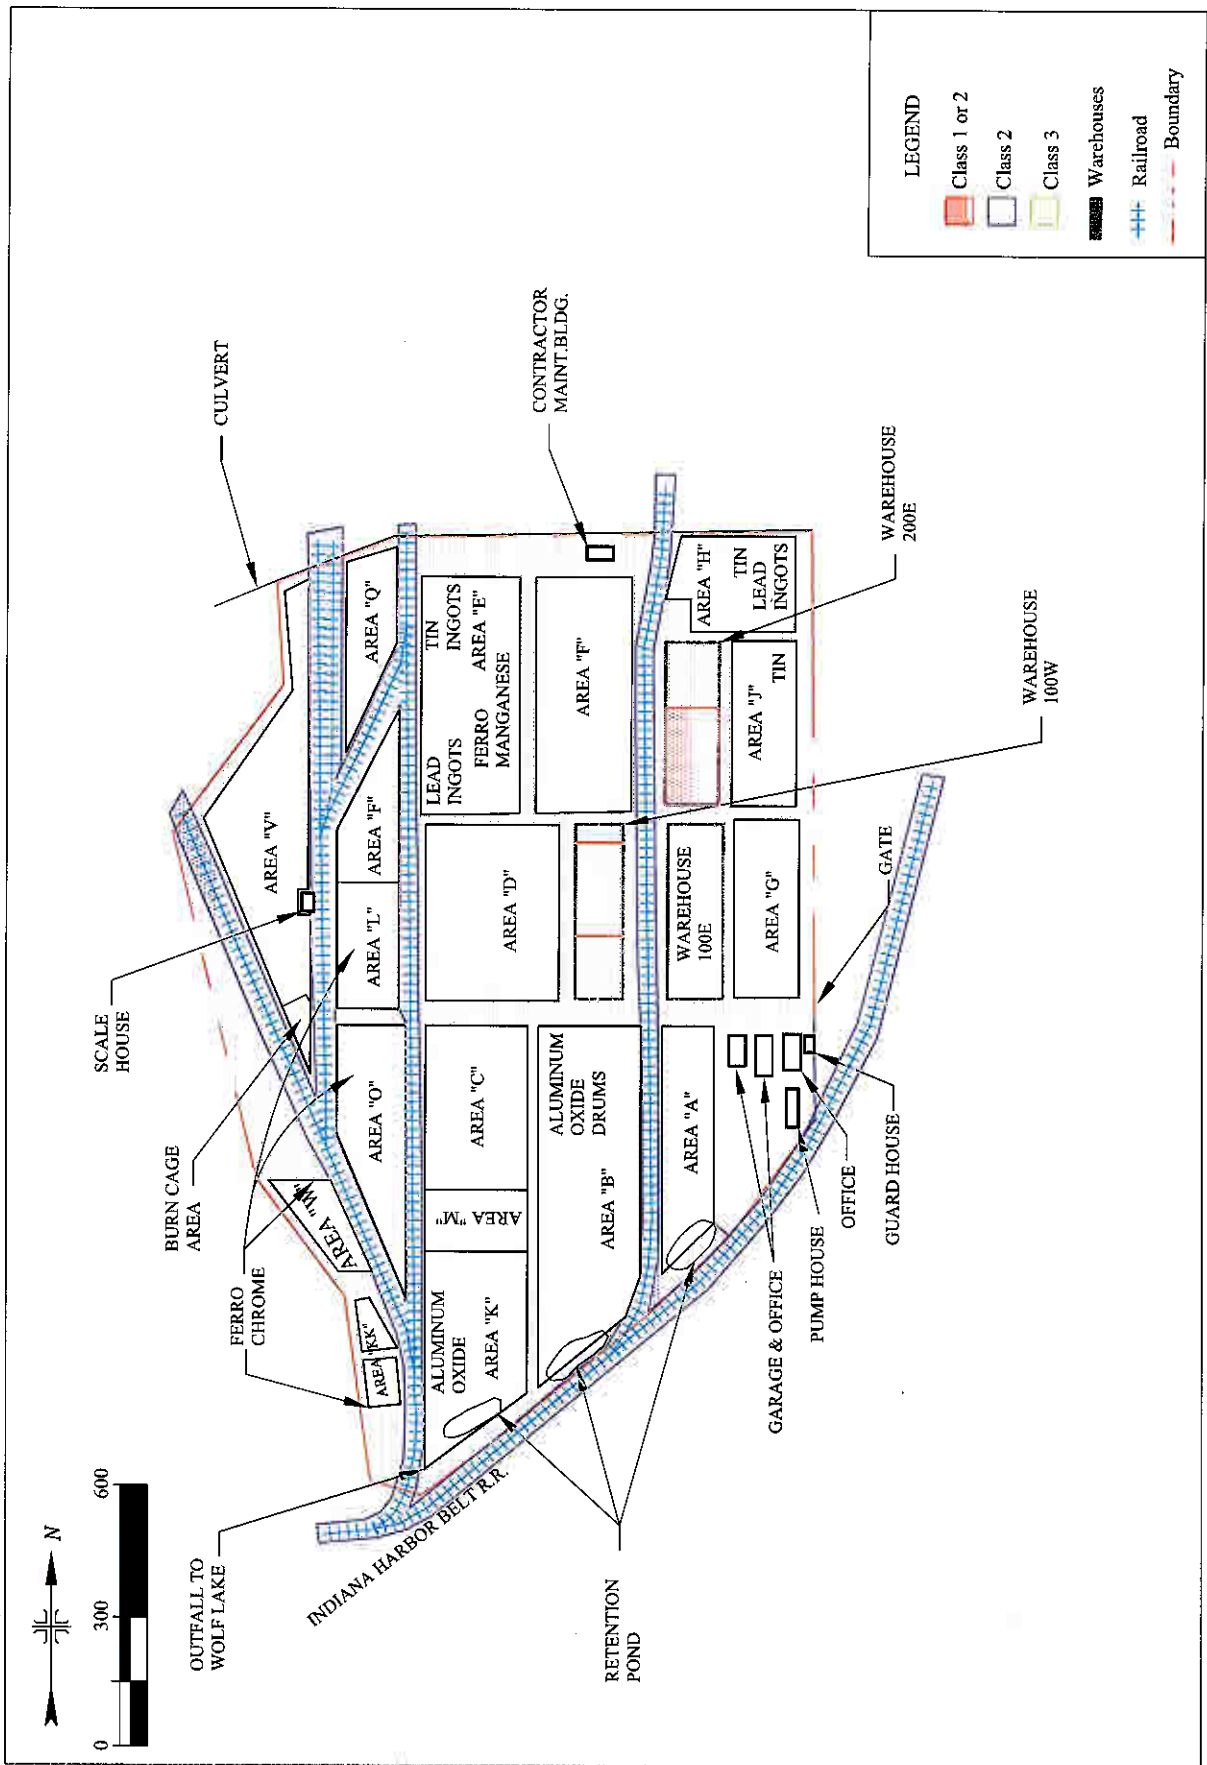
FIGURE 8: Hammond Depot - Conceptual Model

- Class 1 and 2 areas include areas that were previously contaminated and remediated (Warehouses 100W, 200E and the repackaging area outside 200E).
- Additional Class 2 areas that are considered to be potentially contaminated include the burn cage, existing roads and railroad lines, including where railroad lines have been removed, because they served as transportation routes.
- Class 3 areas include Warehouse 100E and the remaining land areas that are considered to have little potential for contamination, due to inadvertent spread of contamination.
