Figure 1.1-74. Hazard Curves at Reference Rock Outcrop for Peak Horizontal Ground Acceleration and 1 Hz Horizontal Spectral Acceleration

Figure 1.1-75. Deaggregation of Mean Seismic Hazard for Horizontal Spectral Acceleration at 10<sup>-4</sup> Annual Exceedance Probability for the Reference Rock Outcrop

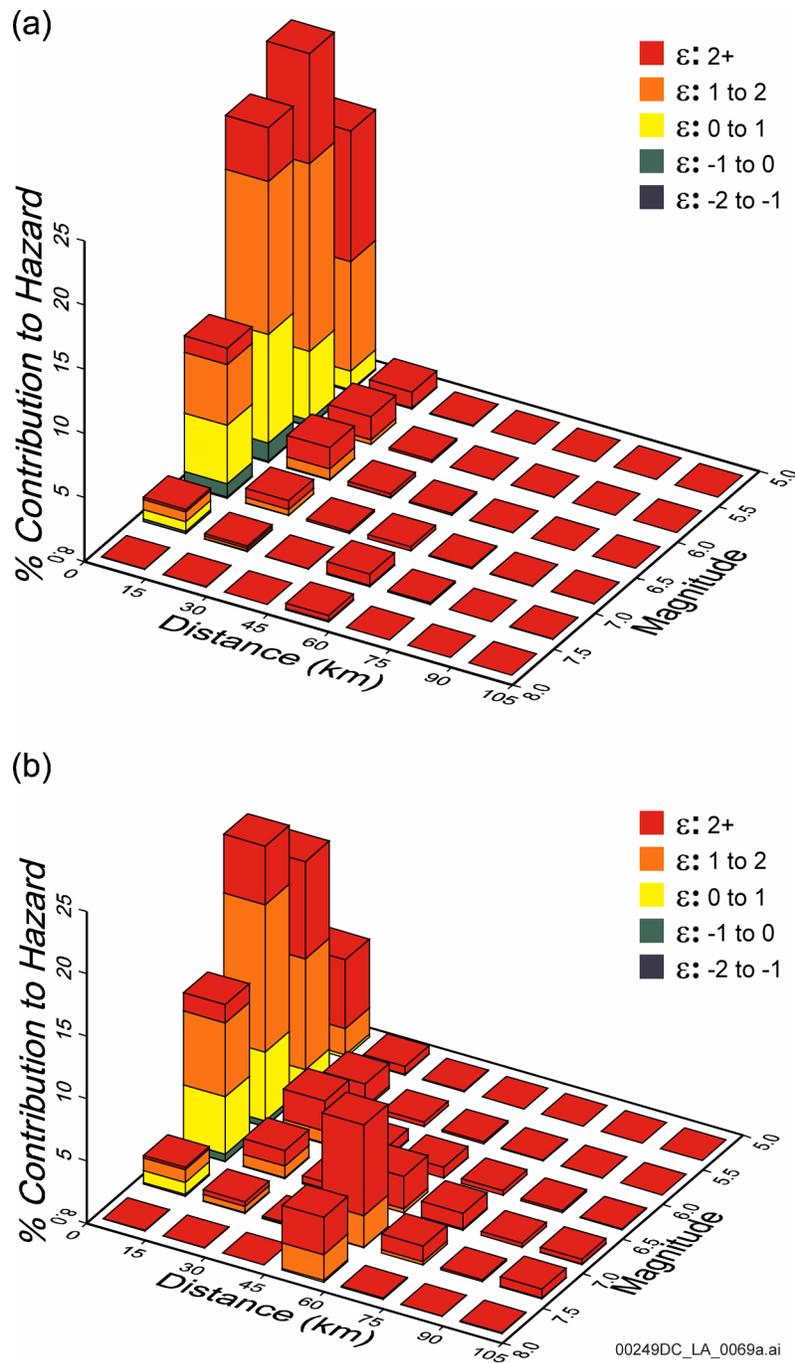
NOTE: Graph (a) is for 5 to 10 Hz horizontal spectral acceleration; graph (b) is for 1 to 2 Hz horizontal spectral acceleration.

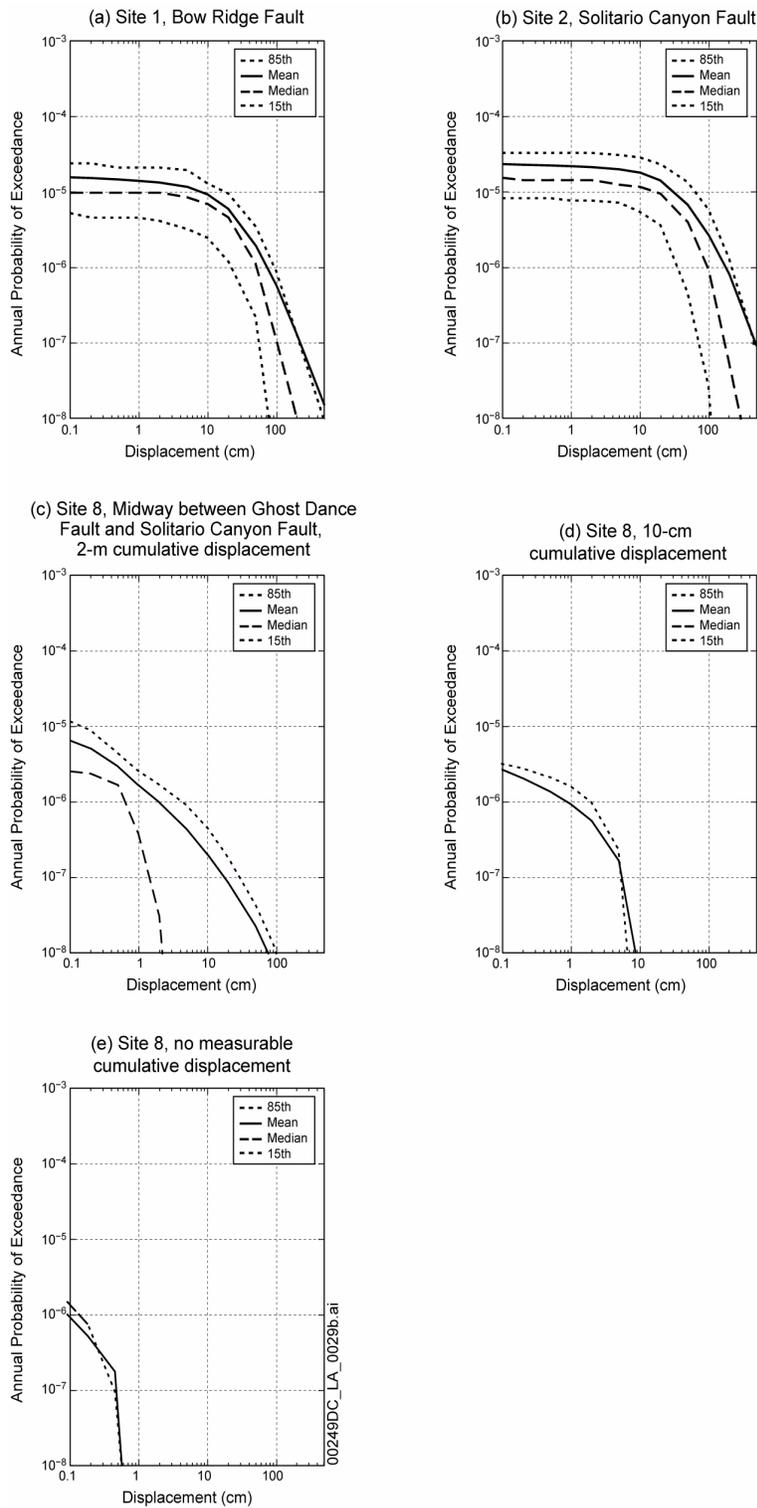
Figure 1.1-76. Example Summary Fault Displacement Hazard Curves for Yucca Mountain

NOTE: On some plots, the median and 15th percentile curves have an annual probability of exceedance of less than  $10^{-8}$  and are not shown.

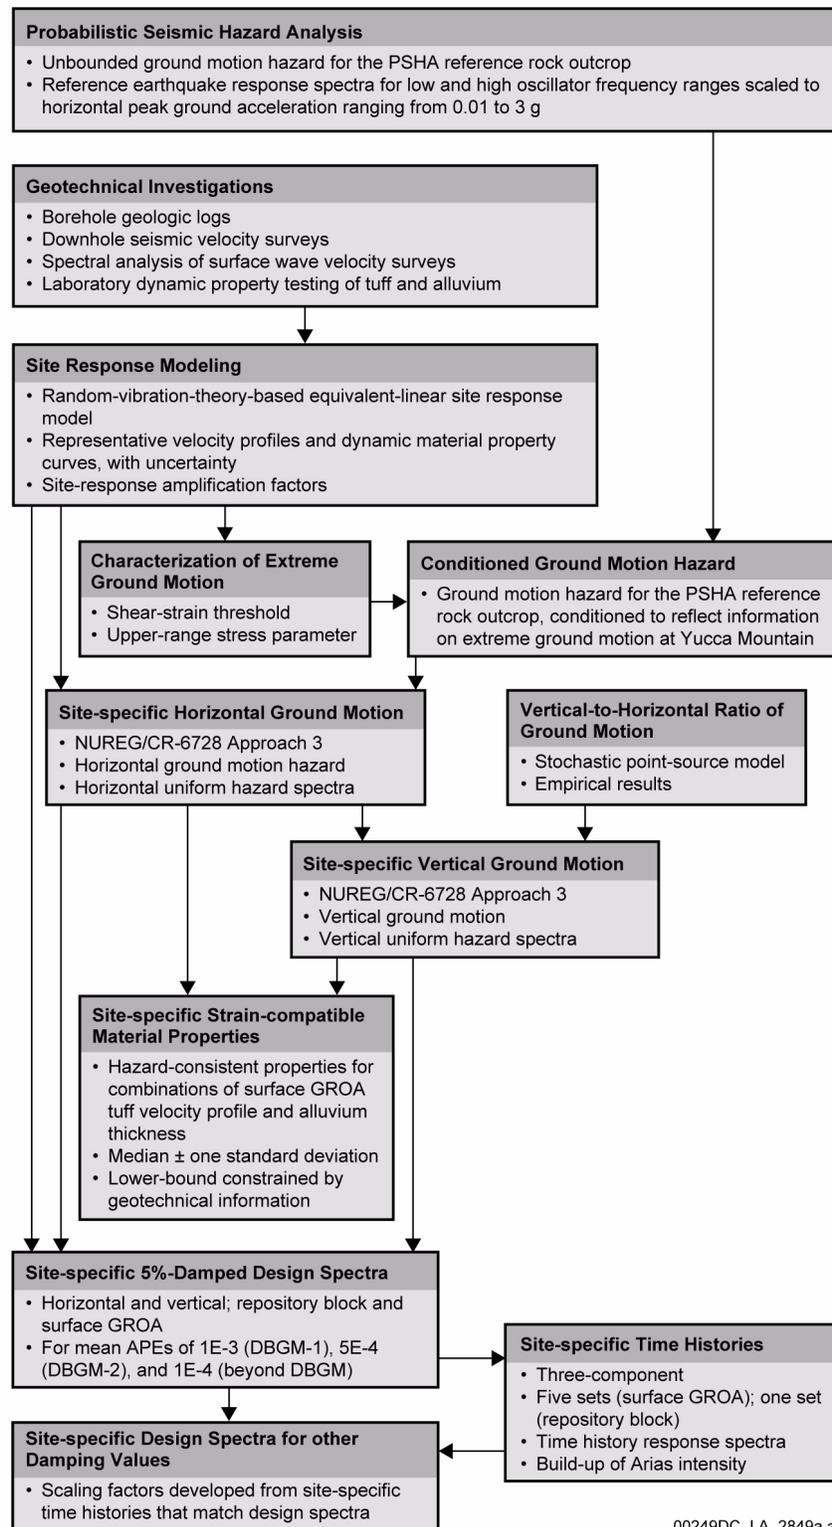
Figure 1.1-77. Schematic Representation of Development of Supplemental Ground Motions

NOTE: APEs = annual probabilities of exceedance

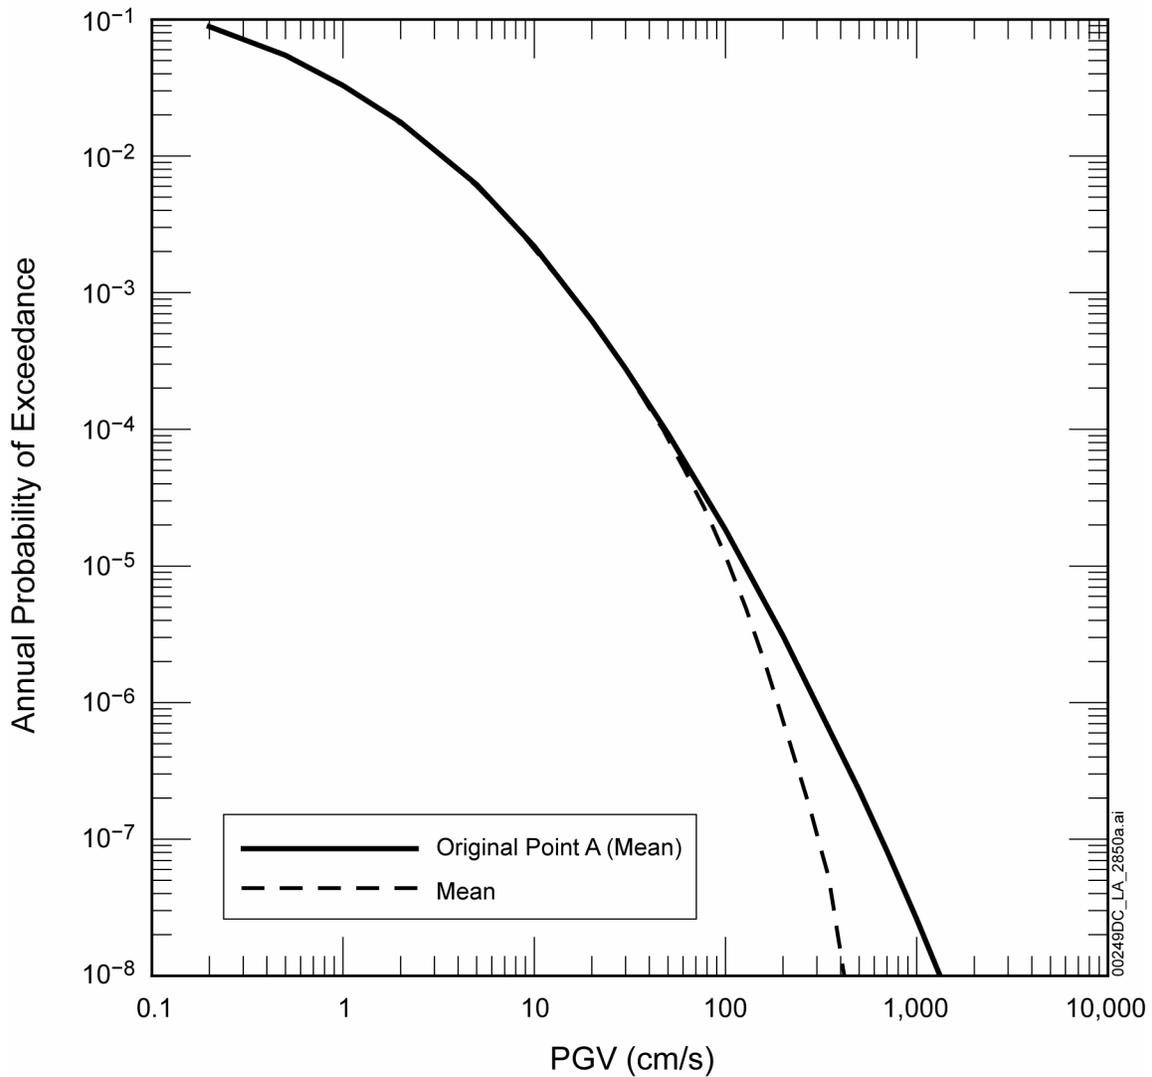
Figure 1.1-79. Conditioned and Unconditioned Reference Rock Outcrop Mean Horizontal Peak Ground Velocity Hazard Curves

NOTE: Point A = reference rock outcrop (see Figure 1.1-78); solid line = unconditioned peak ground velocity hazard curve; dashed line = conditioned peak ground velocity hazard curve.  
PGV = peak ground velocity.

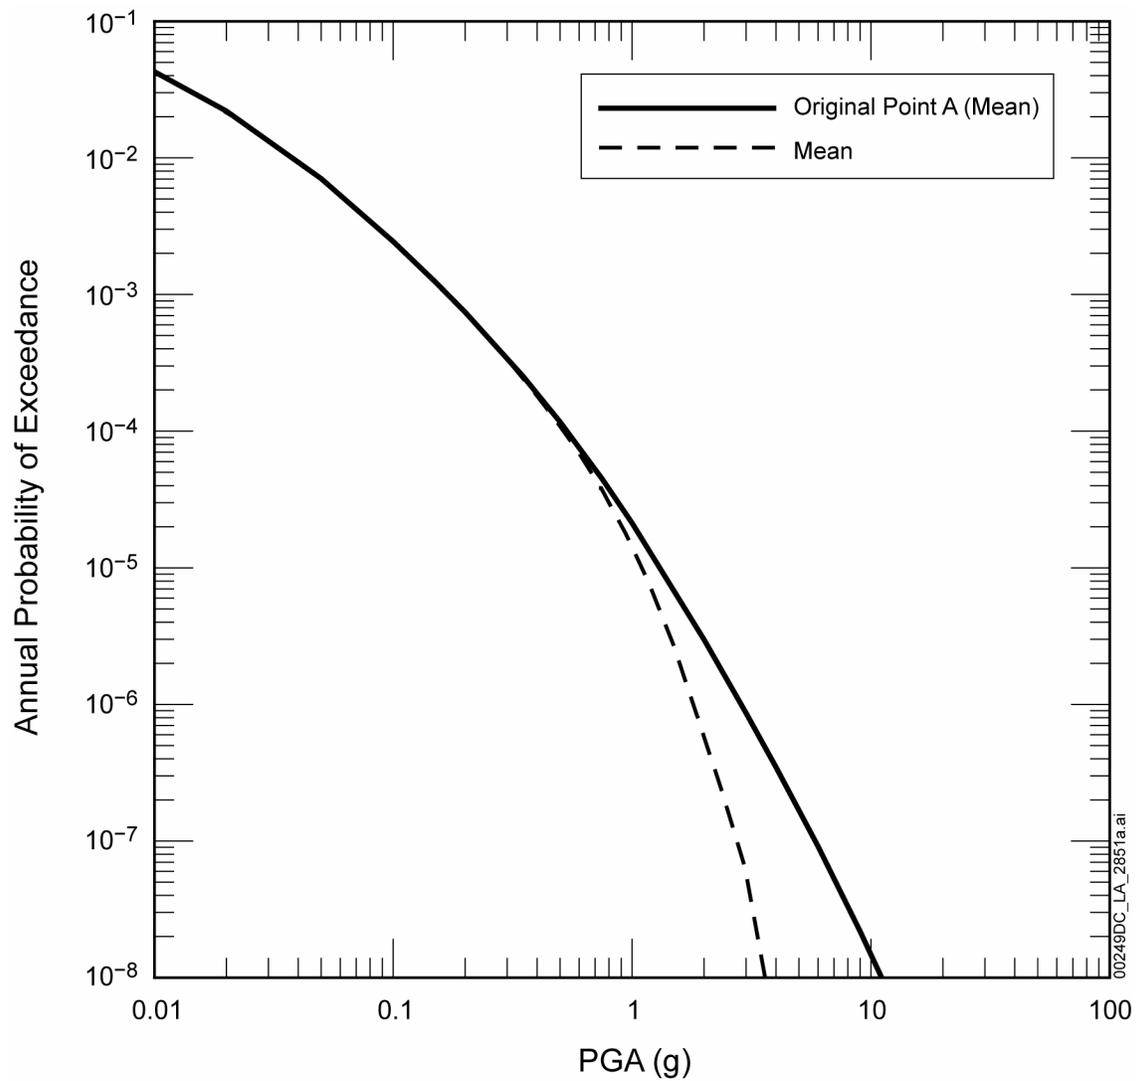
Figure 1.1-80. Conditioned and Unconditioned Reference Rock Outcrop Mean Horizontal Peak Ground Acceleration Hazard Curves

NOTE: Point A = reference rock outcrop (see [Figure 1.1-78](#)); solid line = unconditioned peak ground acceleration hazard curve; dashed line = conditioned peak ground acceleration hazard curve.  
PGA = peak ground acceleration.

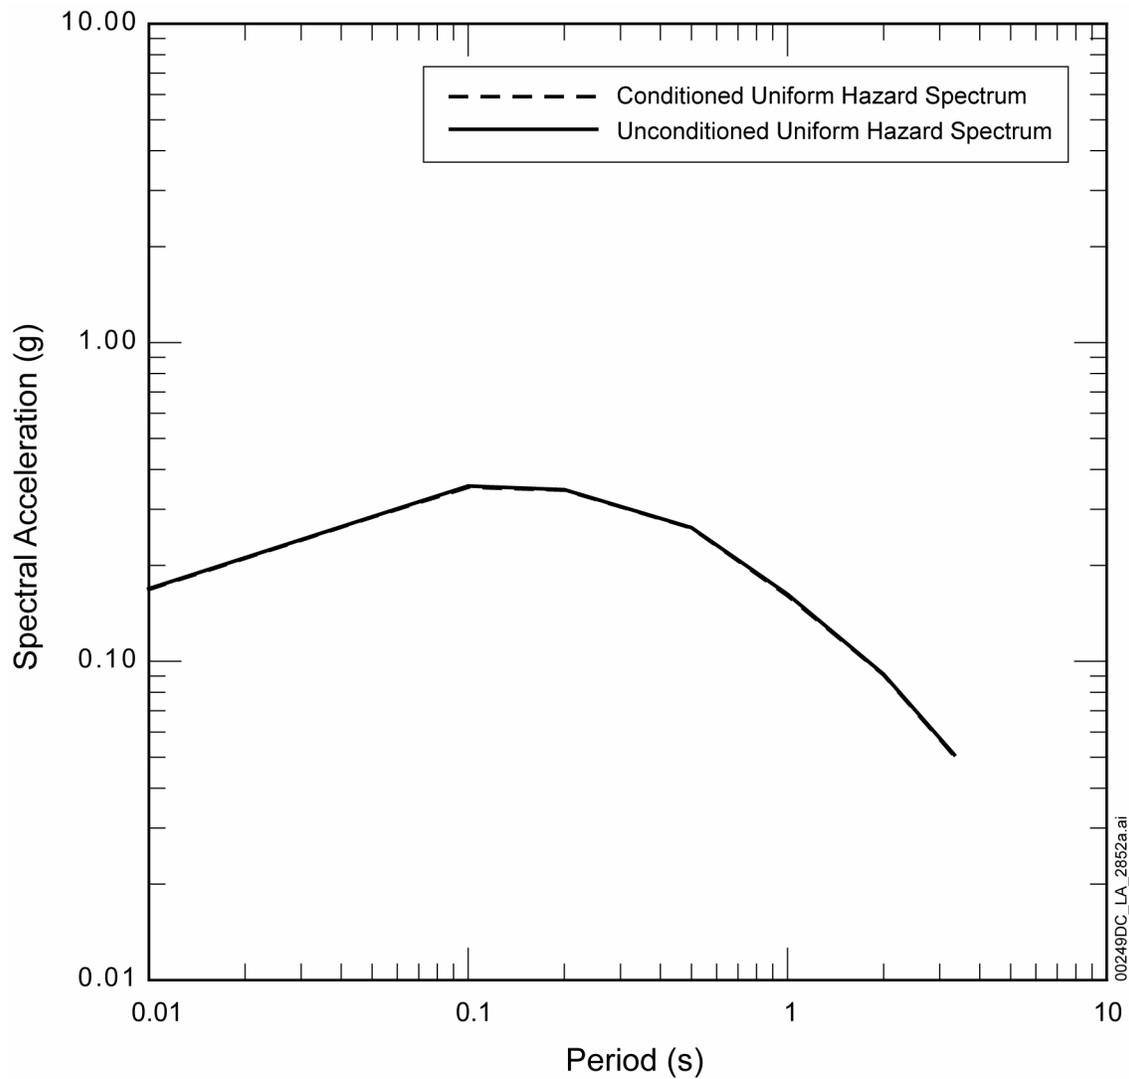
Figure 1.1-81. Reference Rock Outcrop Uniform Hazard Spectra Based on the Extreme-Stress-Drop and Shear-Strain-Threshold Conditioned and Unconditioned Hazard for an Annual Probability of Exceedance of  $10^{-3}$

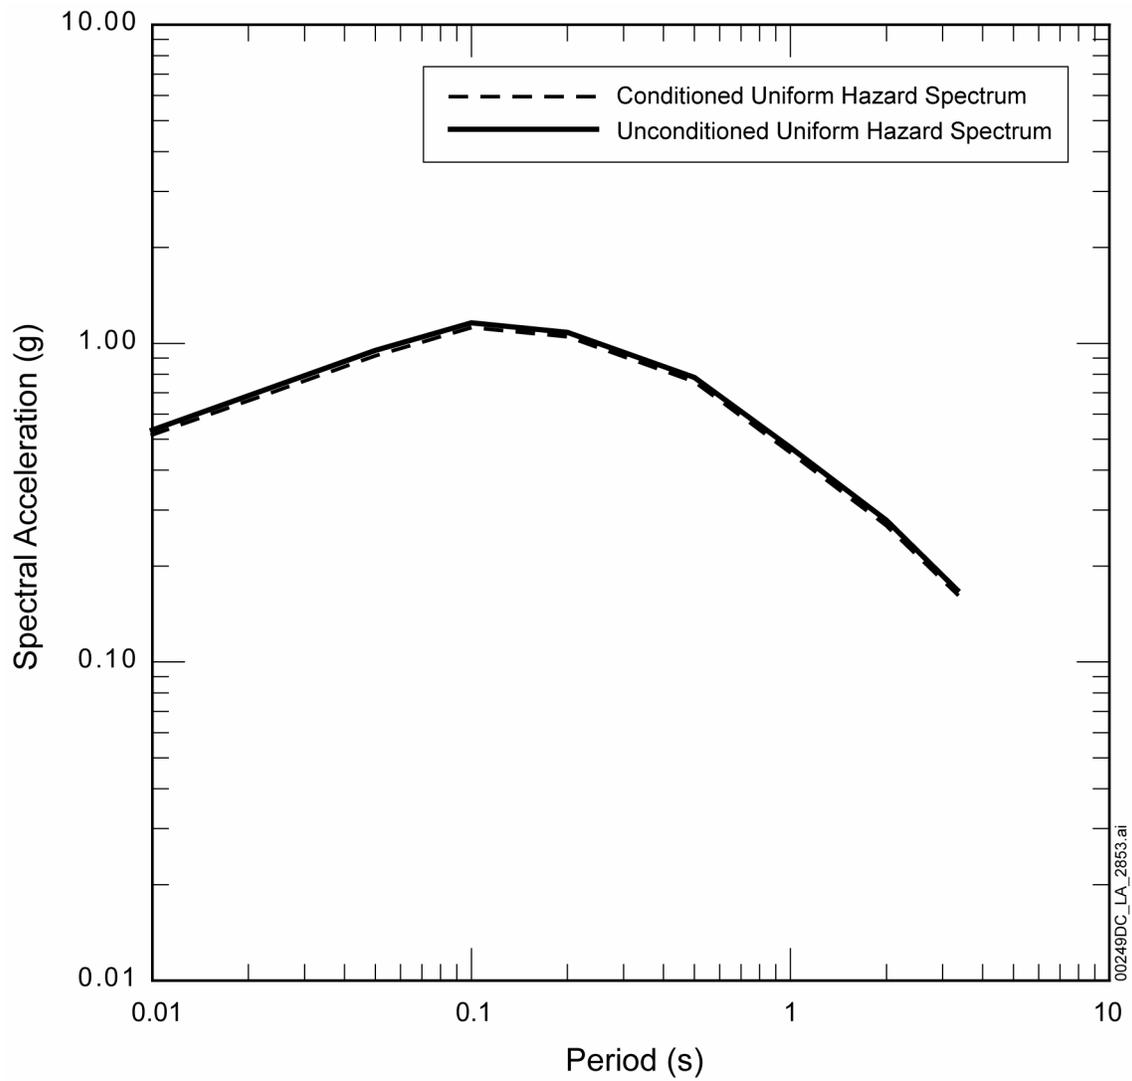
Figure 1.1-82. Reference Rock Outcrop Uniform Hazard Spectra Based on the Extreme-Stress-Drop and Shear-Strain-Threshold Conditioned and Unconditioned Hazard for an Annual Probability of Exceedance of  $10^{-4}$

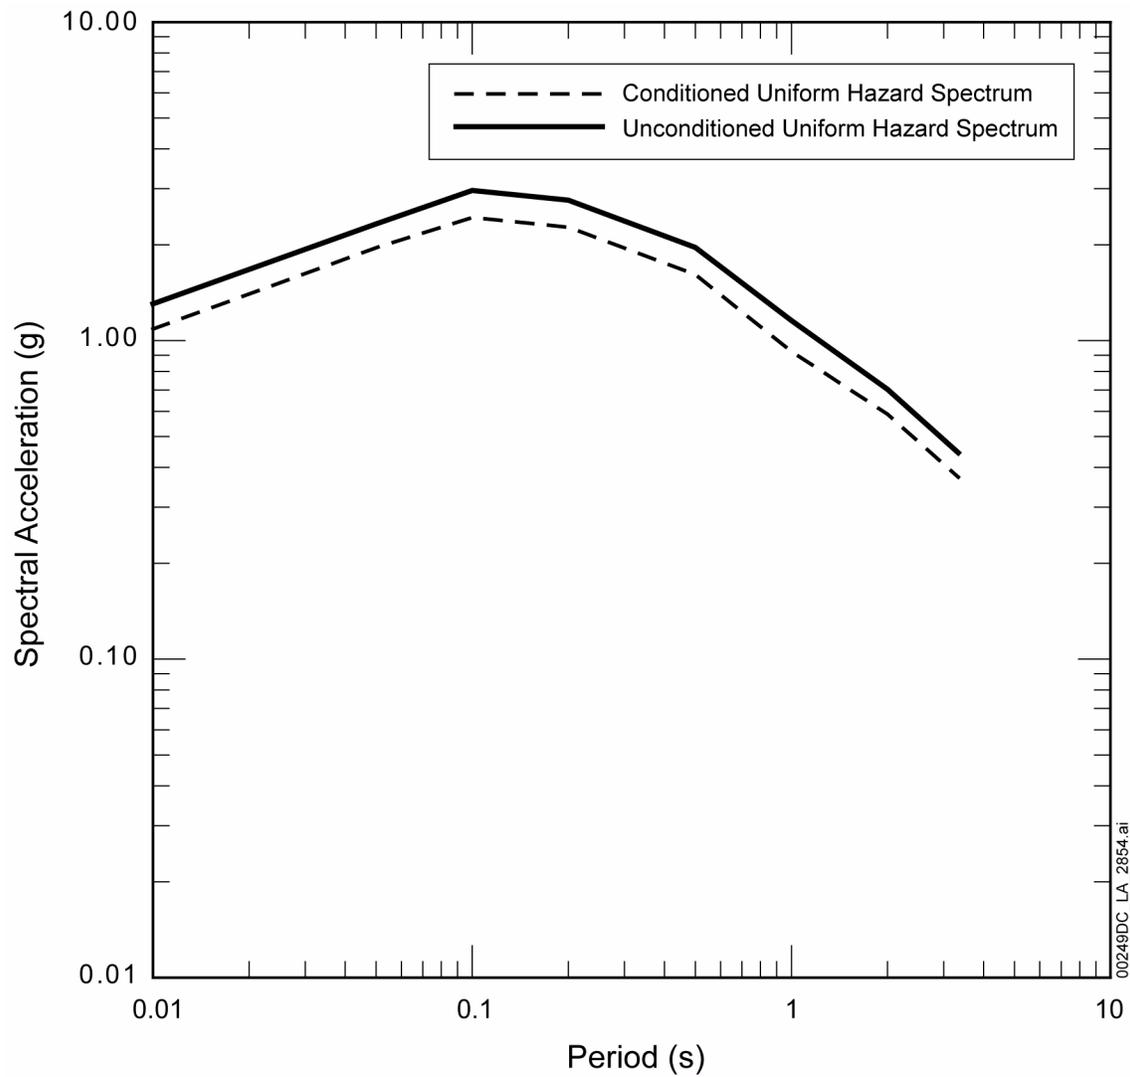
Figure 1.1-83. Reference Rock Outcrop Uniform Hazard Spectra Based on the Extreme-Stress-Drop and Shear-Strain-Threshold Conditioned and Unconditioned Hazard for an Annual Probability of Exceedance of  $10^{-5}$

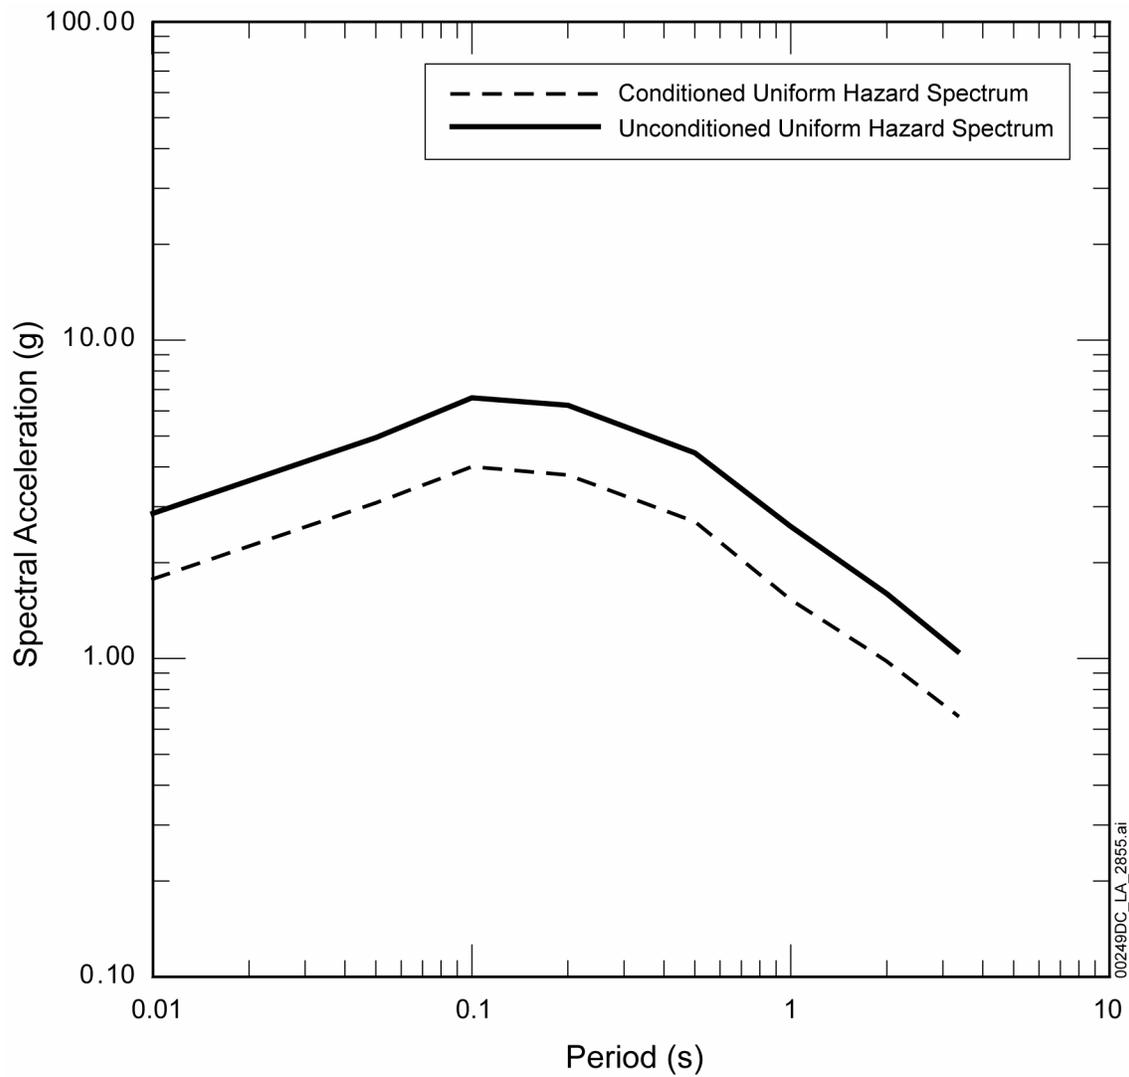
Figure 1.1-84. Reference Rock Outcrop Uniform Hazard Spectra Based on the Extreme-Stress-Drop and Shear-Strain-Threshold Conditioned and Unconditioned Hazard for an Annual Probability of Exceedance of  $10^{-6}$

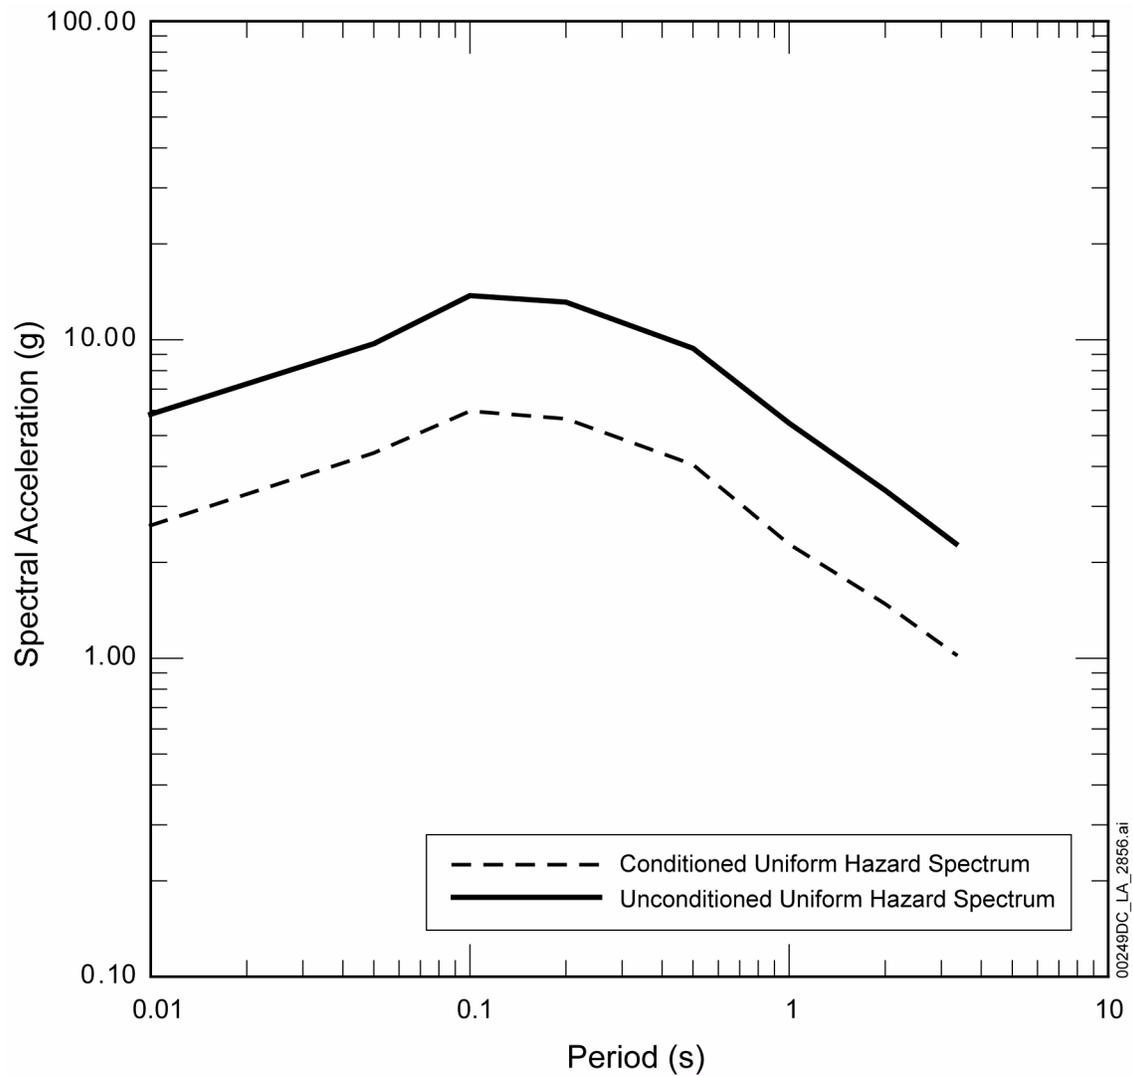
Figure 1.1-85. Reference Rock Outcrop Uniform Hazard Spectra Based on the Extreme-Stress-Drop and Shear-Strain-Threshold Conditioned and Unconditioned Hazard for an Annual Probability of Exceedance of  $10^{-7}$

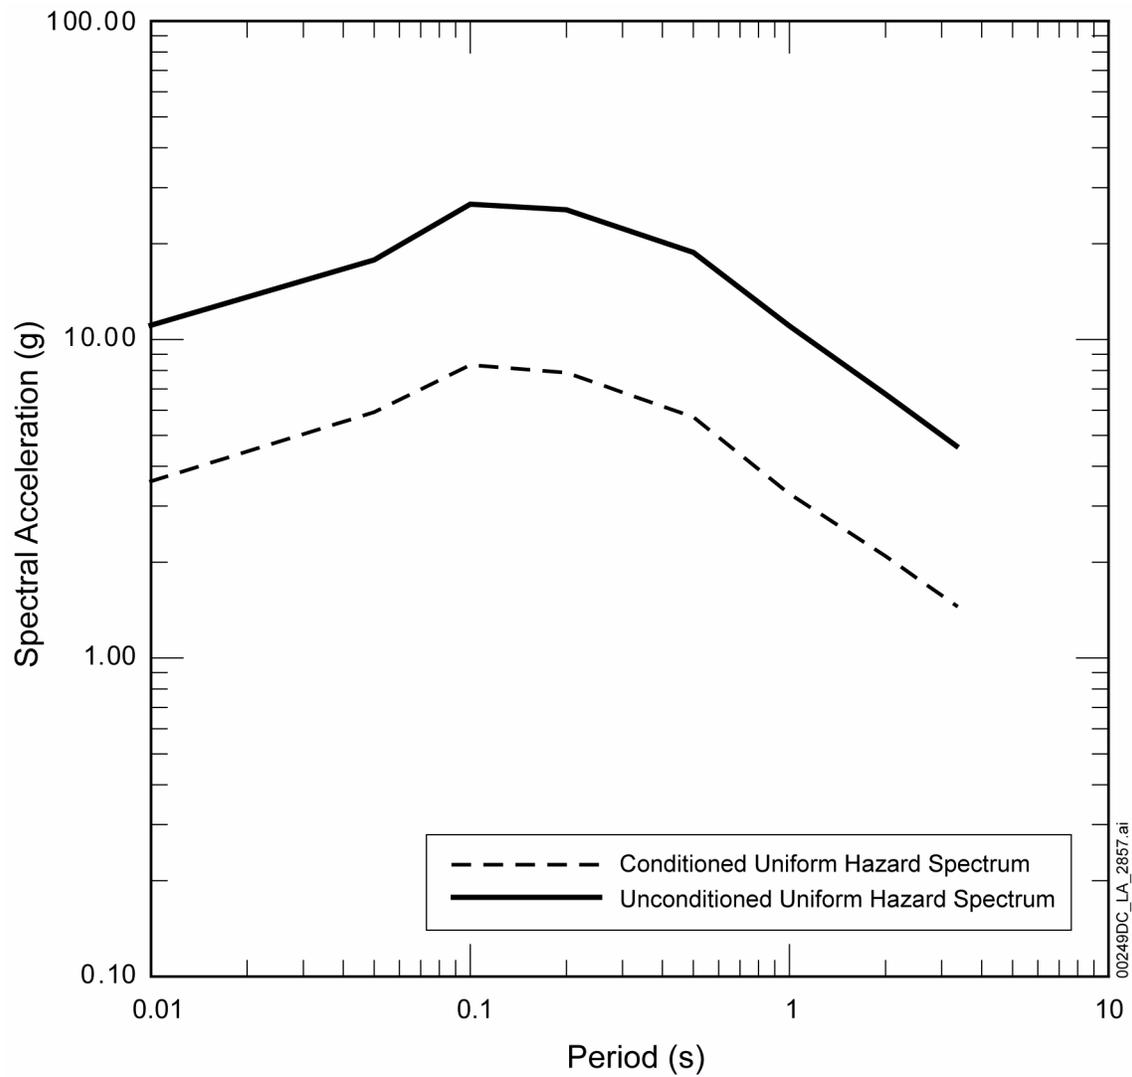
Figure 1.1-86. Reference Rock Outcrop Uniform Hazard Spectra Based on the Extreme-Stress-Drop and Shear-Strain-Threshold Conditioned and Unconditioned Hazard for an Annual Probability of Exceedance of  $10^{-8}$

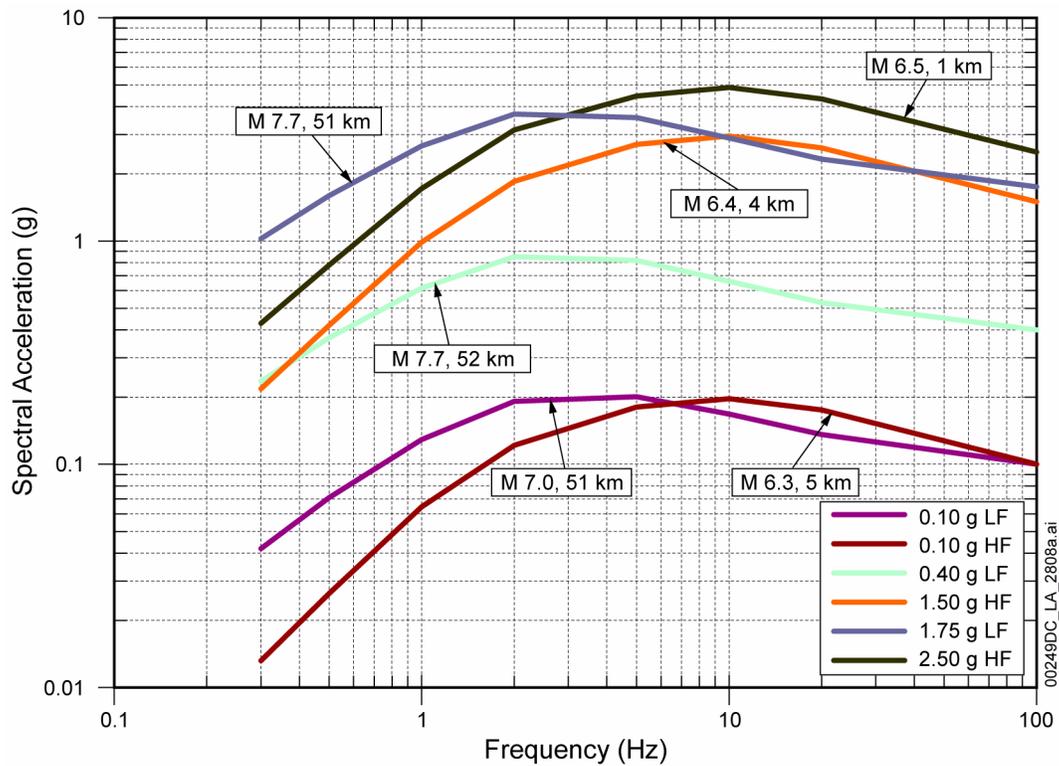
Figure 1.1-87. Representative Control Motion Response Spectra for Site Response Modeling

NOTE: 1. Labels indicate the magnitude and distance of the reference earthquake providing the response spectral shape that is scaled to the peak ground acceleration level of interest. 2. LF = low frequency (1 to 2 Hz) response spectrum; HF = high frequency (5 to 10 Hz) response spectrum.

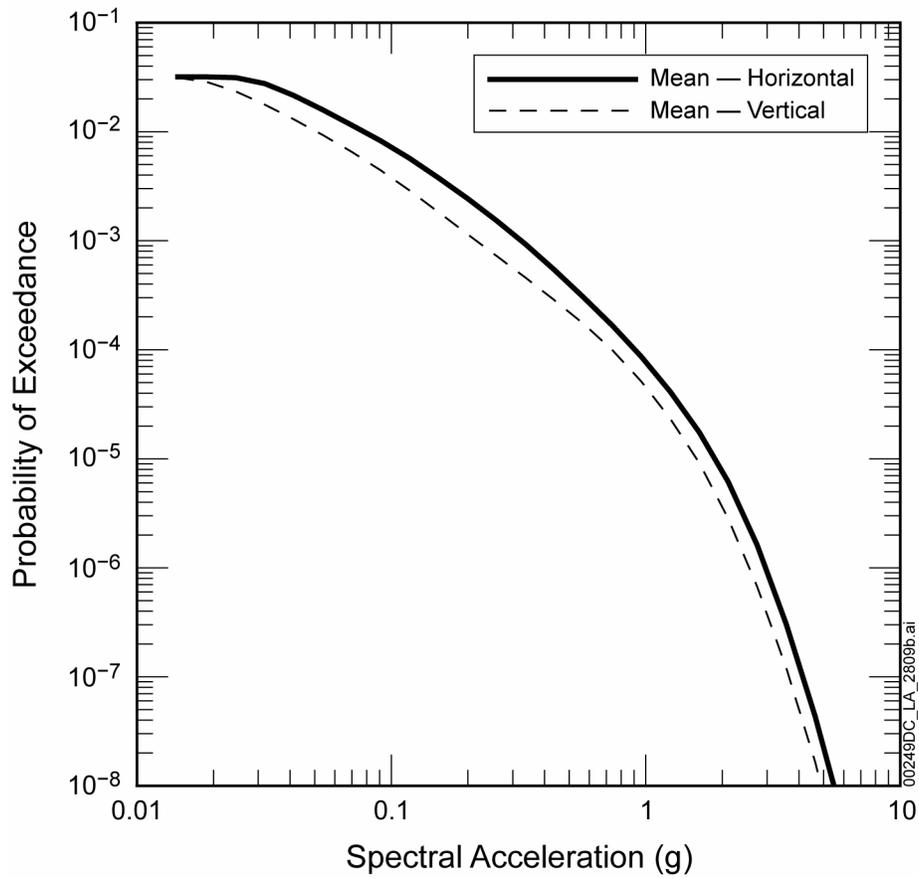
Figure 1.1-88. Mean Horizontal and Vertical Seismic Hazard Curves for Peak Ground Acceleration at the Surface Geologic Repository Operations Area

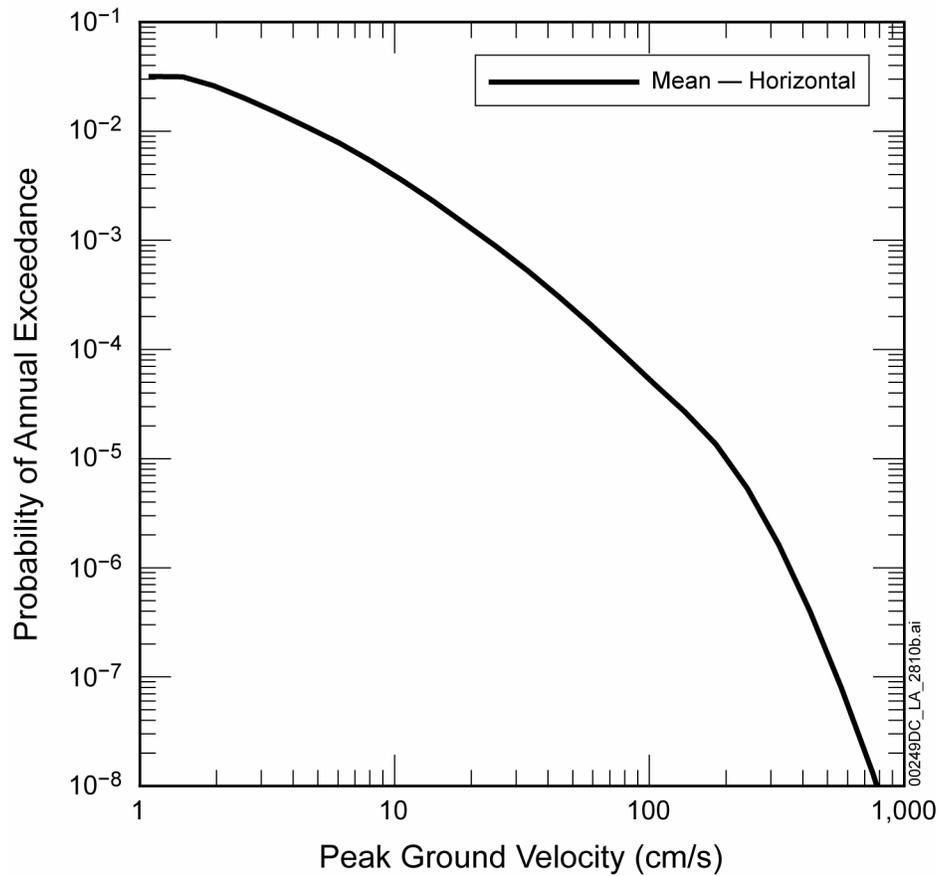
Figure 1.1-89. Mean Horizontal Seismic Hazard Curve for Peak Ground Velocity at the Surface Geologic Repository Operations Area

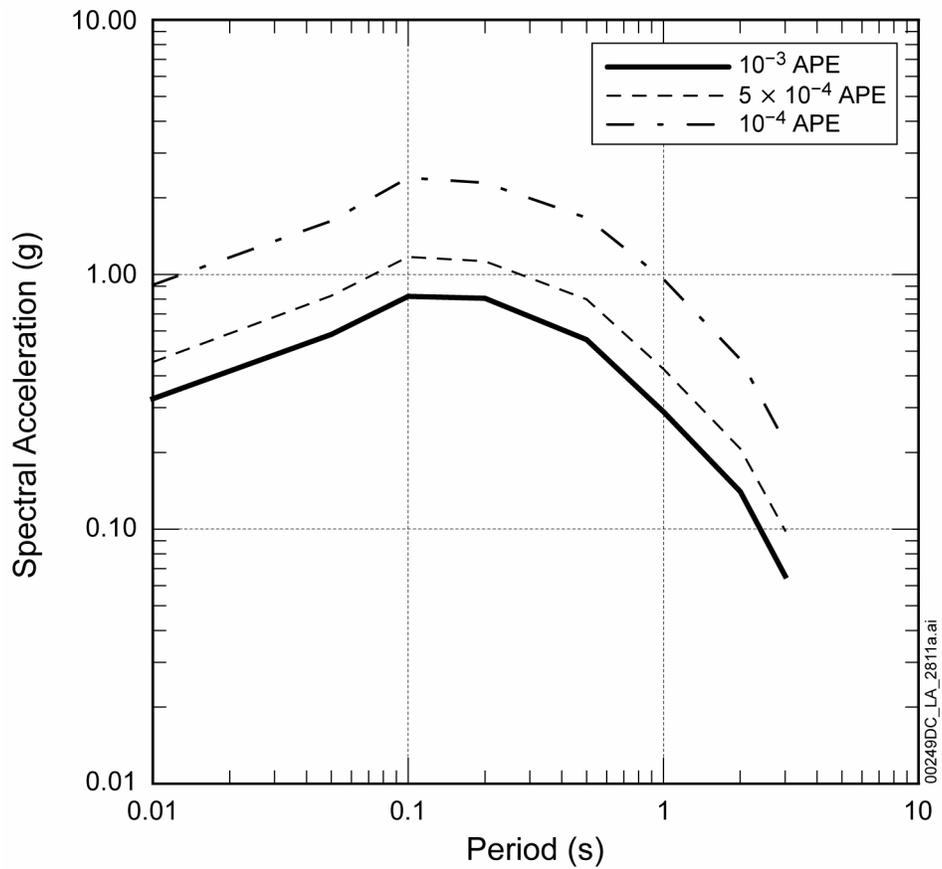
Figure 1.1-90. Surface Geologic Repository Operations Area 5%-Damped Horizontal Design Spectra for  $10^{-3}$ ,  $5 \times 10^{-4}$ , and  $10^{-4}$  Annual Probabilities of Exceedance

NOTE: APE = annual probability of exceedance.

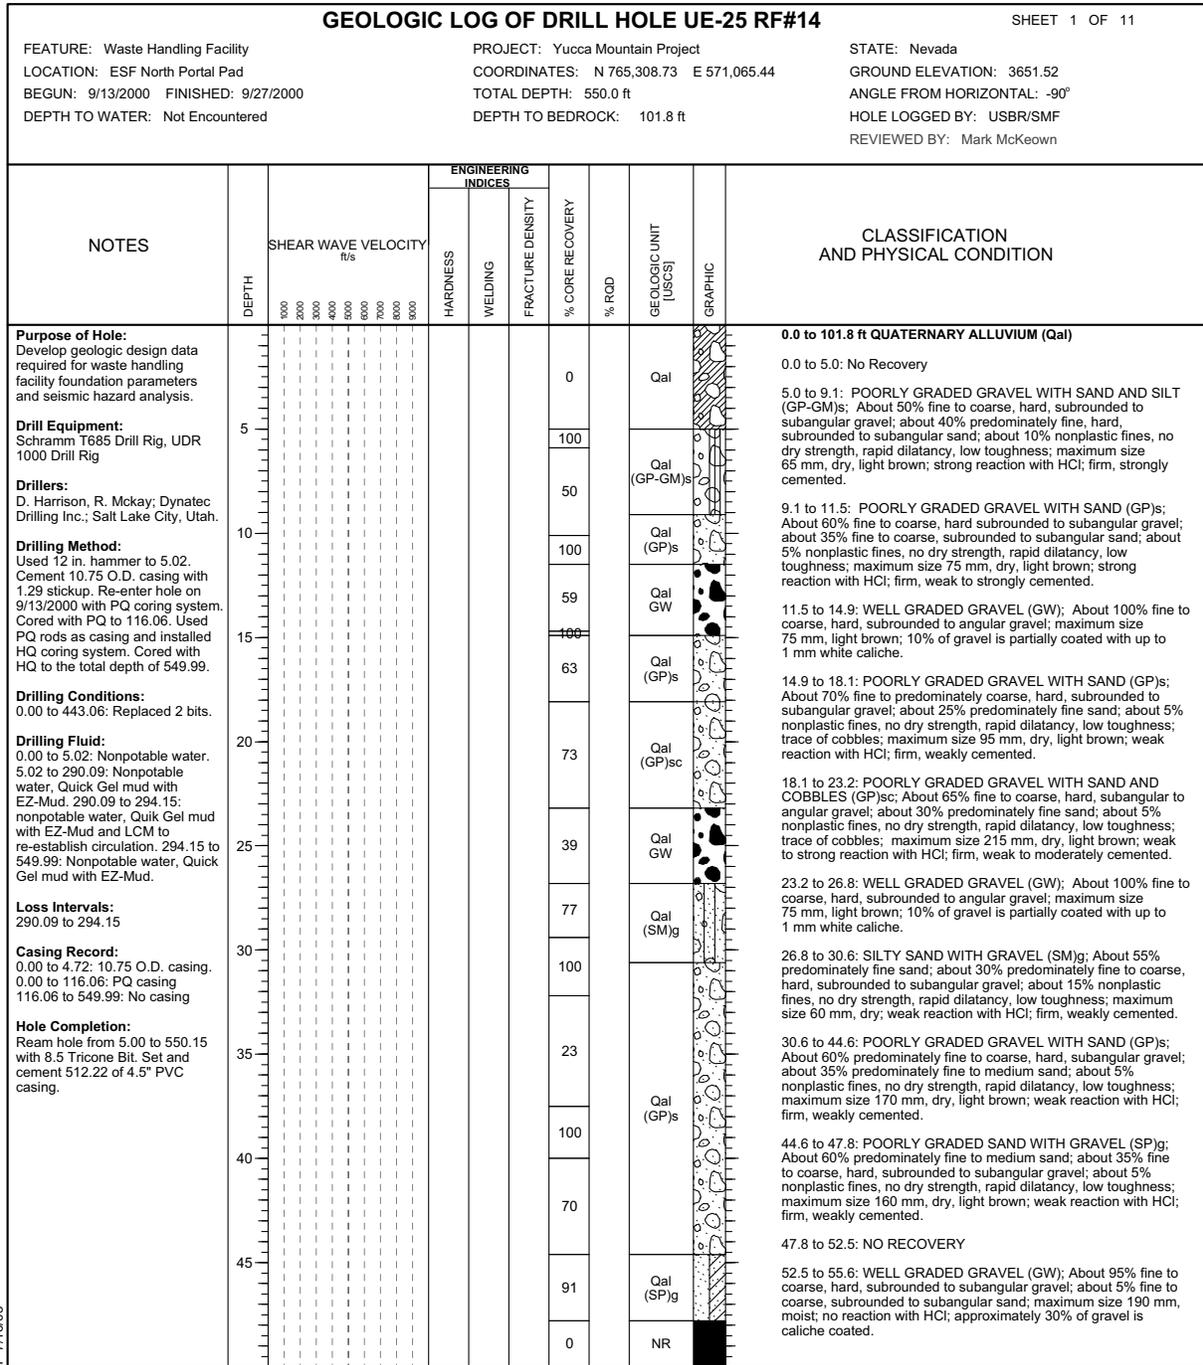
Figure 1.1-96. Geologic Log of Drill Hole UE-25 RF#14 (Sheet 1 of 11)

NOTE: All measurements are in feet unless noted otherwise. LCM (Lost Circulation Material) consists of cellophane cuttings. USCS classifications were determined in the field, with limited access to samples to keep samples intact for future tests. Shear Wave Velocity data from GeoVision suspension logging. Data acquired from downhole survey conducted after PVC casing installed. USCS soil classifications are based on USBR 5005-86, *Procedure for Determining Unified Soil Classification (Visual Method)*. RQD = rock quality designation; USCS = Unified Soil Classification System.

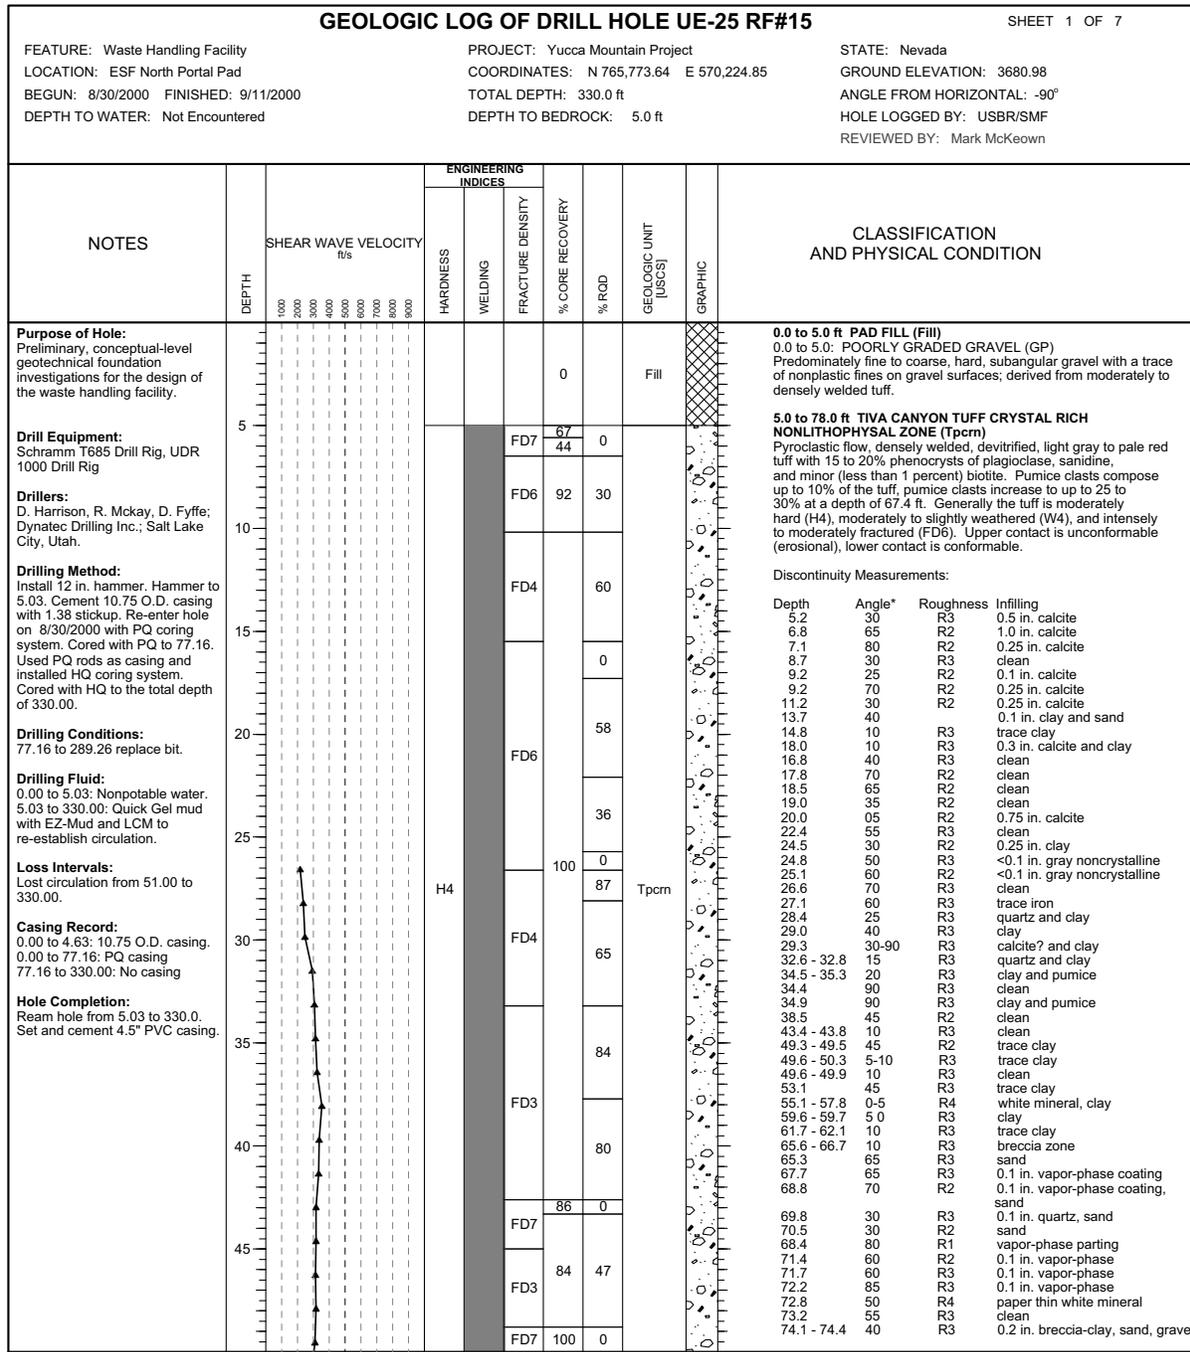
Figure 1.1-97. Geologic Log of Drill Hole UE-25 RF#15 (Sheet 1 of 7)

NOTE: All measurements are in feet unless noted otherwise. No attempts to re-establish circulation were made below 278 ft. LCM (Lost Circulation Material) consists of cellophane cuttings. USCS classifications were determined in the field, with limited access to samples to keep samples intact for future tests. Shear Wave Velocity data from GeoVision suspension logging. Data acquired from downhole survey conducted after PVC casing installed. USCS soil classifications are based on USBR 5005-86, *Procedure for Determining Unified Soil Classification (Visual Method)*. RQD = rock quality designation; USCS = Unified Soil Classification System.

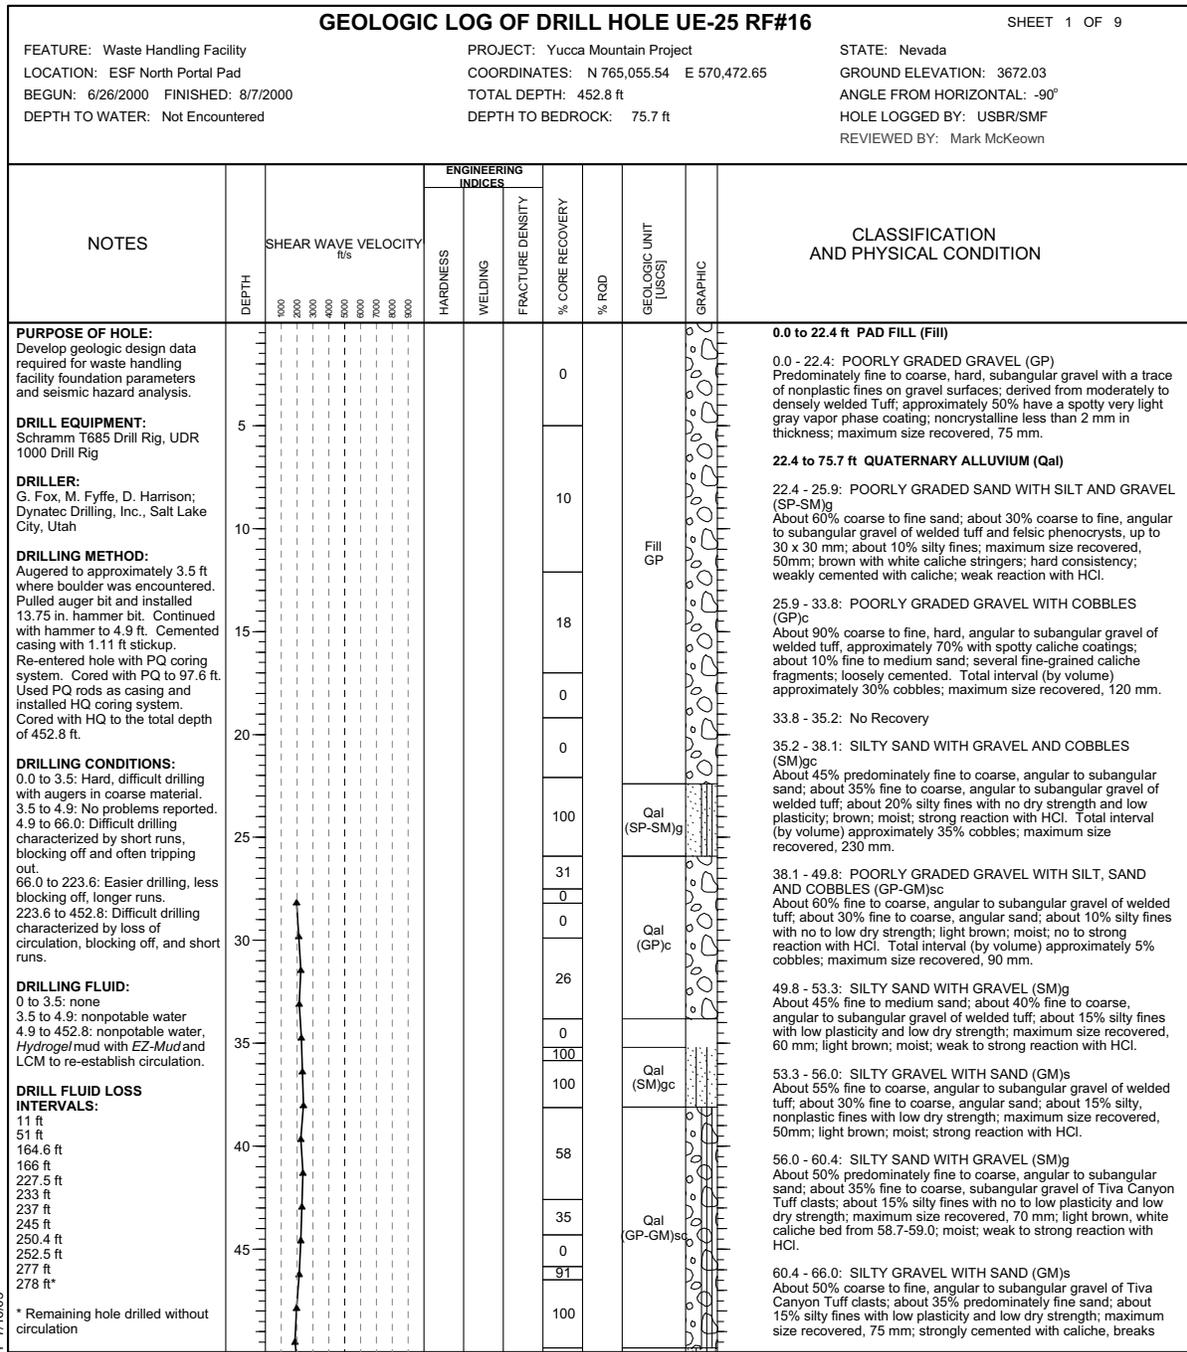
Figure 1.1-98. Geologic Log of Drill Hole UE-25 RF#16 (Sheet 1 of 9)

NOTE: All measurements are in feet unless noted otherwise. No attempts to re-establish circulation were made below 278 ft. LCM (Lost Circulation Material) consists of cellophane cuttings. USCS classifications were determined in the field, with limited access to samples to keep samples intact for future tests. Shear Wave Velocity data from GeoVision suspension logging. Data acquired from downhole survey conducted after PVC casing installed. USCS soil classifications are based on USBR 5005-86, *Procedure for Determining Unified Soil Classification (Visual Method)*.  
 RQD = rock quality designation; USCS = Unified Soil Classification System.
