Figure 1.1-74. Hazard Curves at Reference Rock Outcrop for Peak Horizontal Ground Acceleration and 1 Hz Horizontal Spectral Acceleration

Figure 1.1-75. Deaggregation of Mean Seismic Hazard for Horizontal Spectral Acceleration at 10<sup>-4</sup> Annual Exceedance Probability for the Reference Rock Outcrop

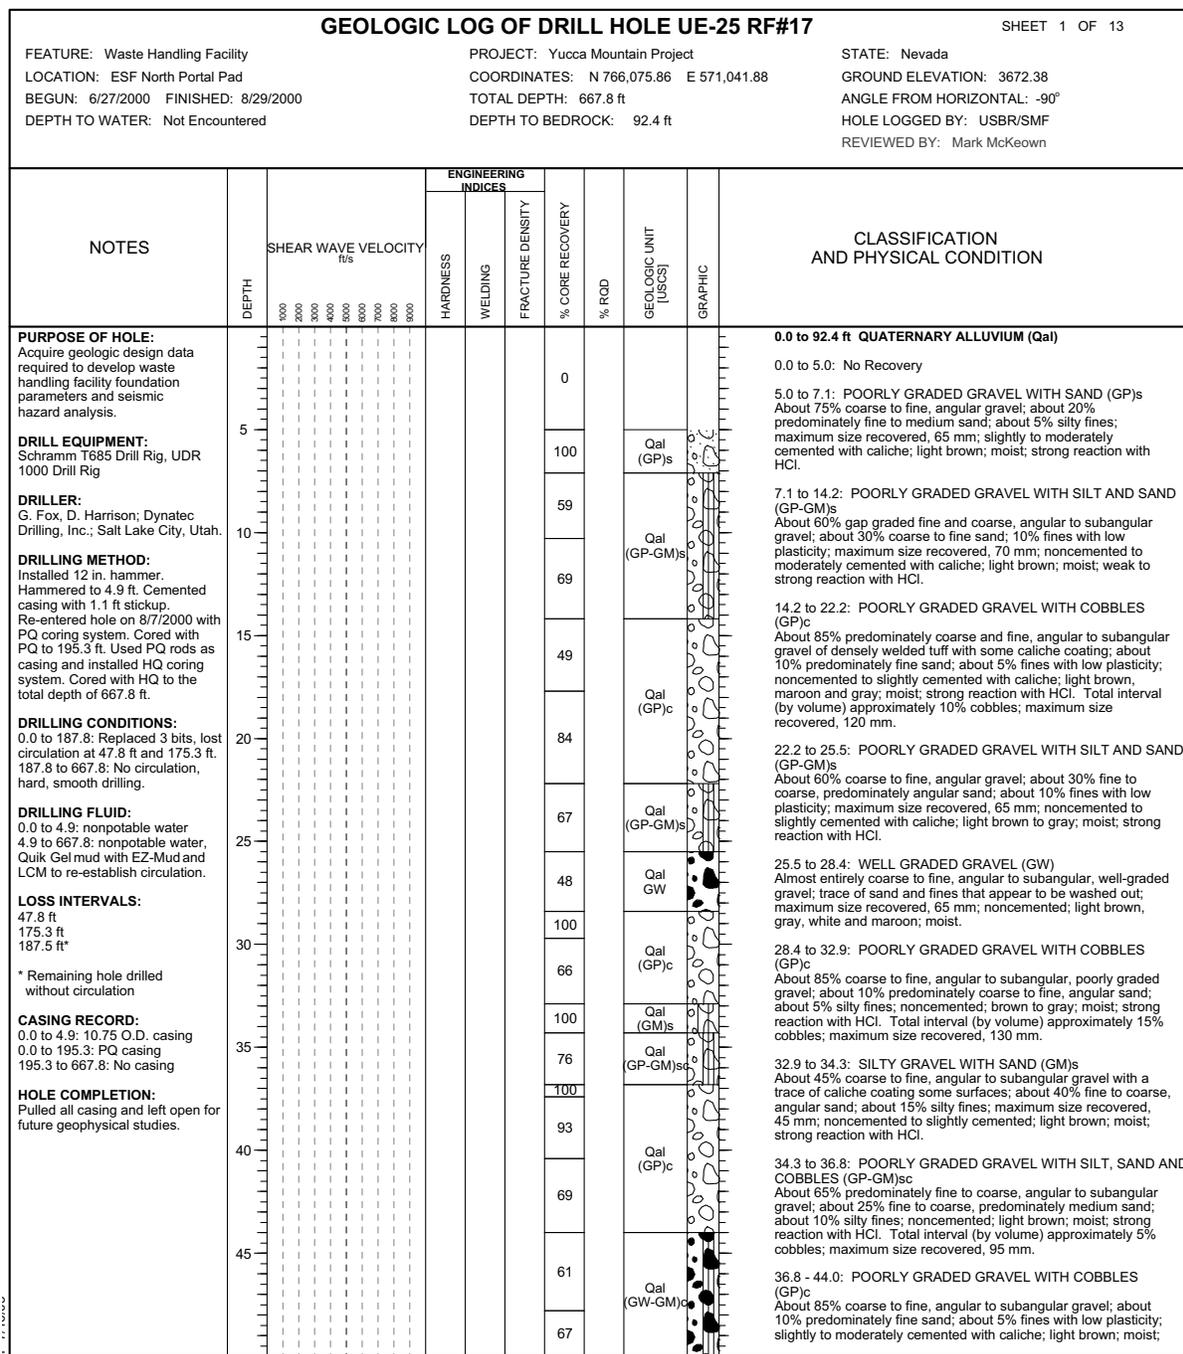
Figure 1.1-99. Geologic Log of Drill Hole UE-25 RF#17 (Sheet 1 of 13)

NOTE: All measurements are in feet unless noted otherwise. No attempts to re-establish circulation were made below 187.5 ft. LCM (Lost Circulation Material) consists of cellophane cuttings. USCS classifications were determined in the field, with limited access to samples to keep samples intact for future tests. Shear Wave Velocity data from GeoVision suspension logging. Data acquired from downhole survey conducted after PVC casing installed. USCS soil classifications are based on USBR 5005-86, *Procedure for Determining Unified Soil Classification (Visual Method)*.  
RQD = rock quality designation; USCS = Unified Soil Classification System.

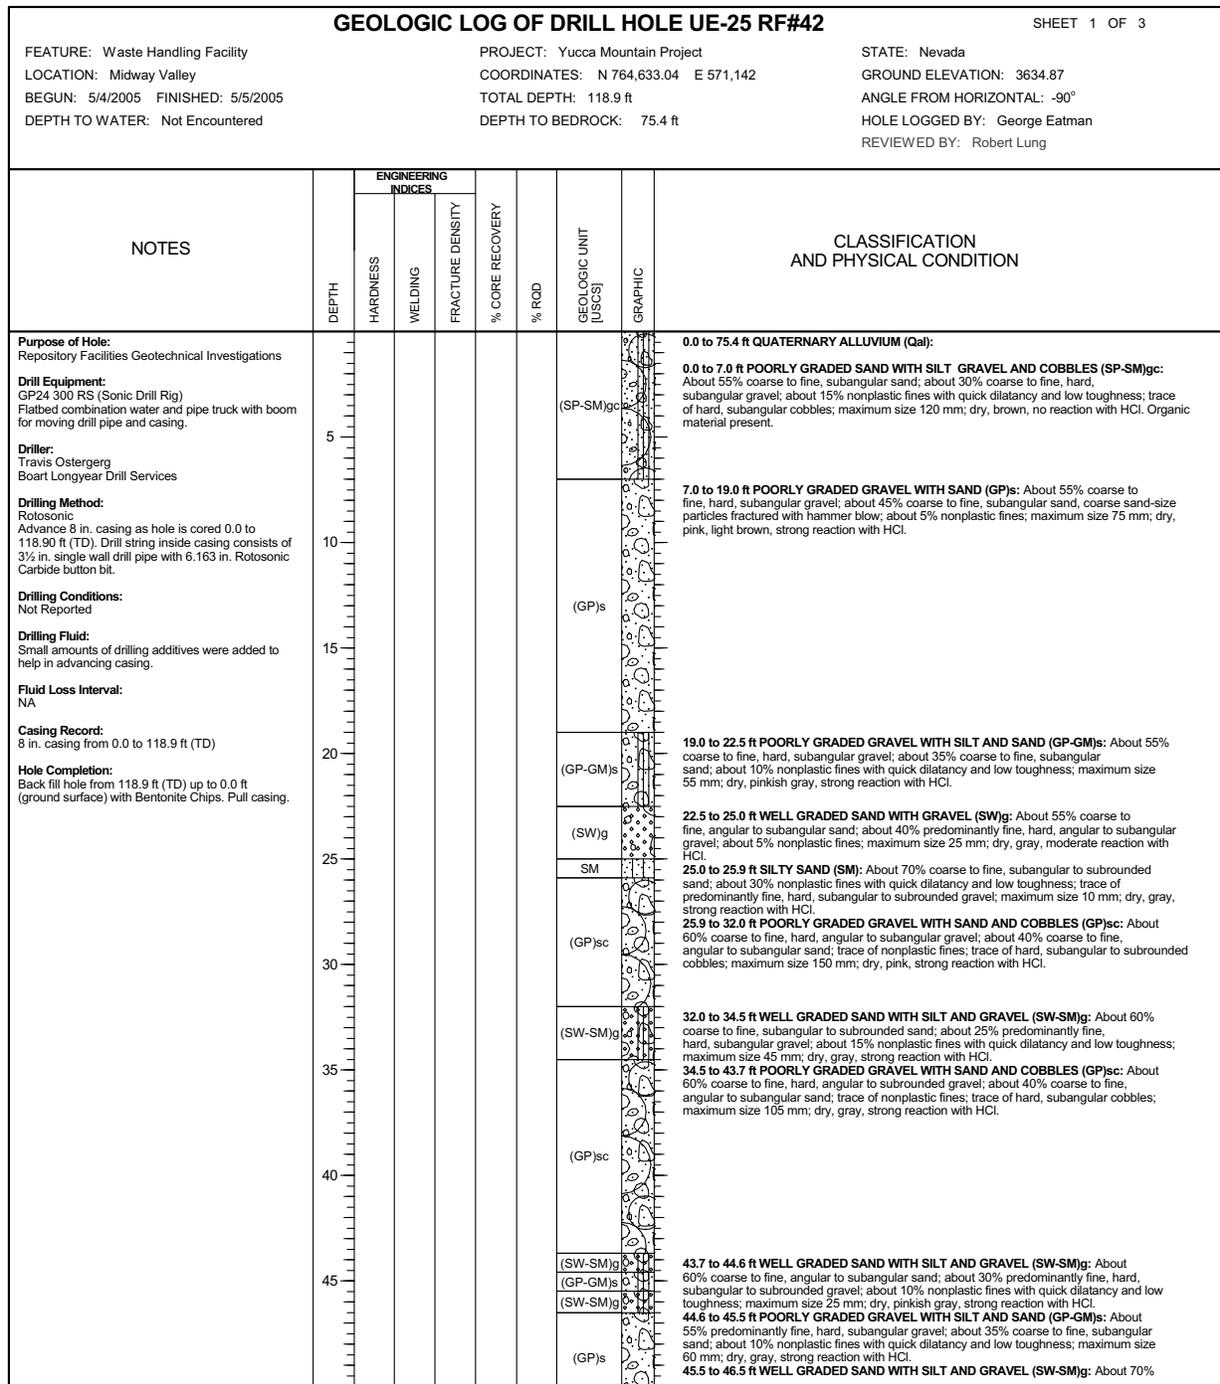
Figure 1.1-111. Geologic Log of Drill Hole UE-25 RF#42 (Sheet 1 of 3)

NOTE: Descriptions of the material may not reflect in situ geologic conditions due to mechanical degradation of the sample by the Sonic drilling method; TD = total depth.

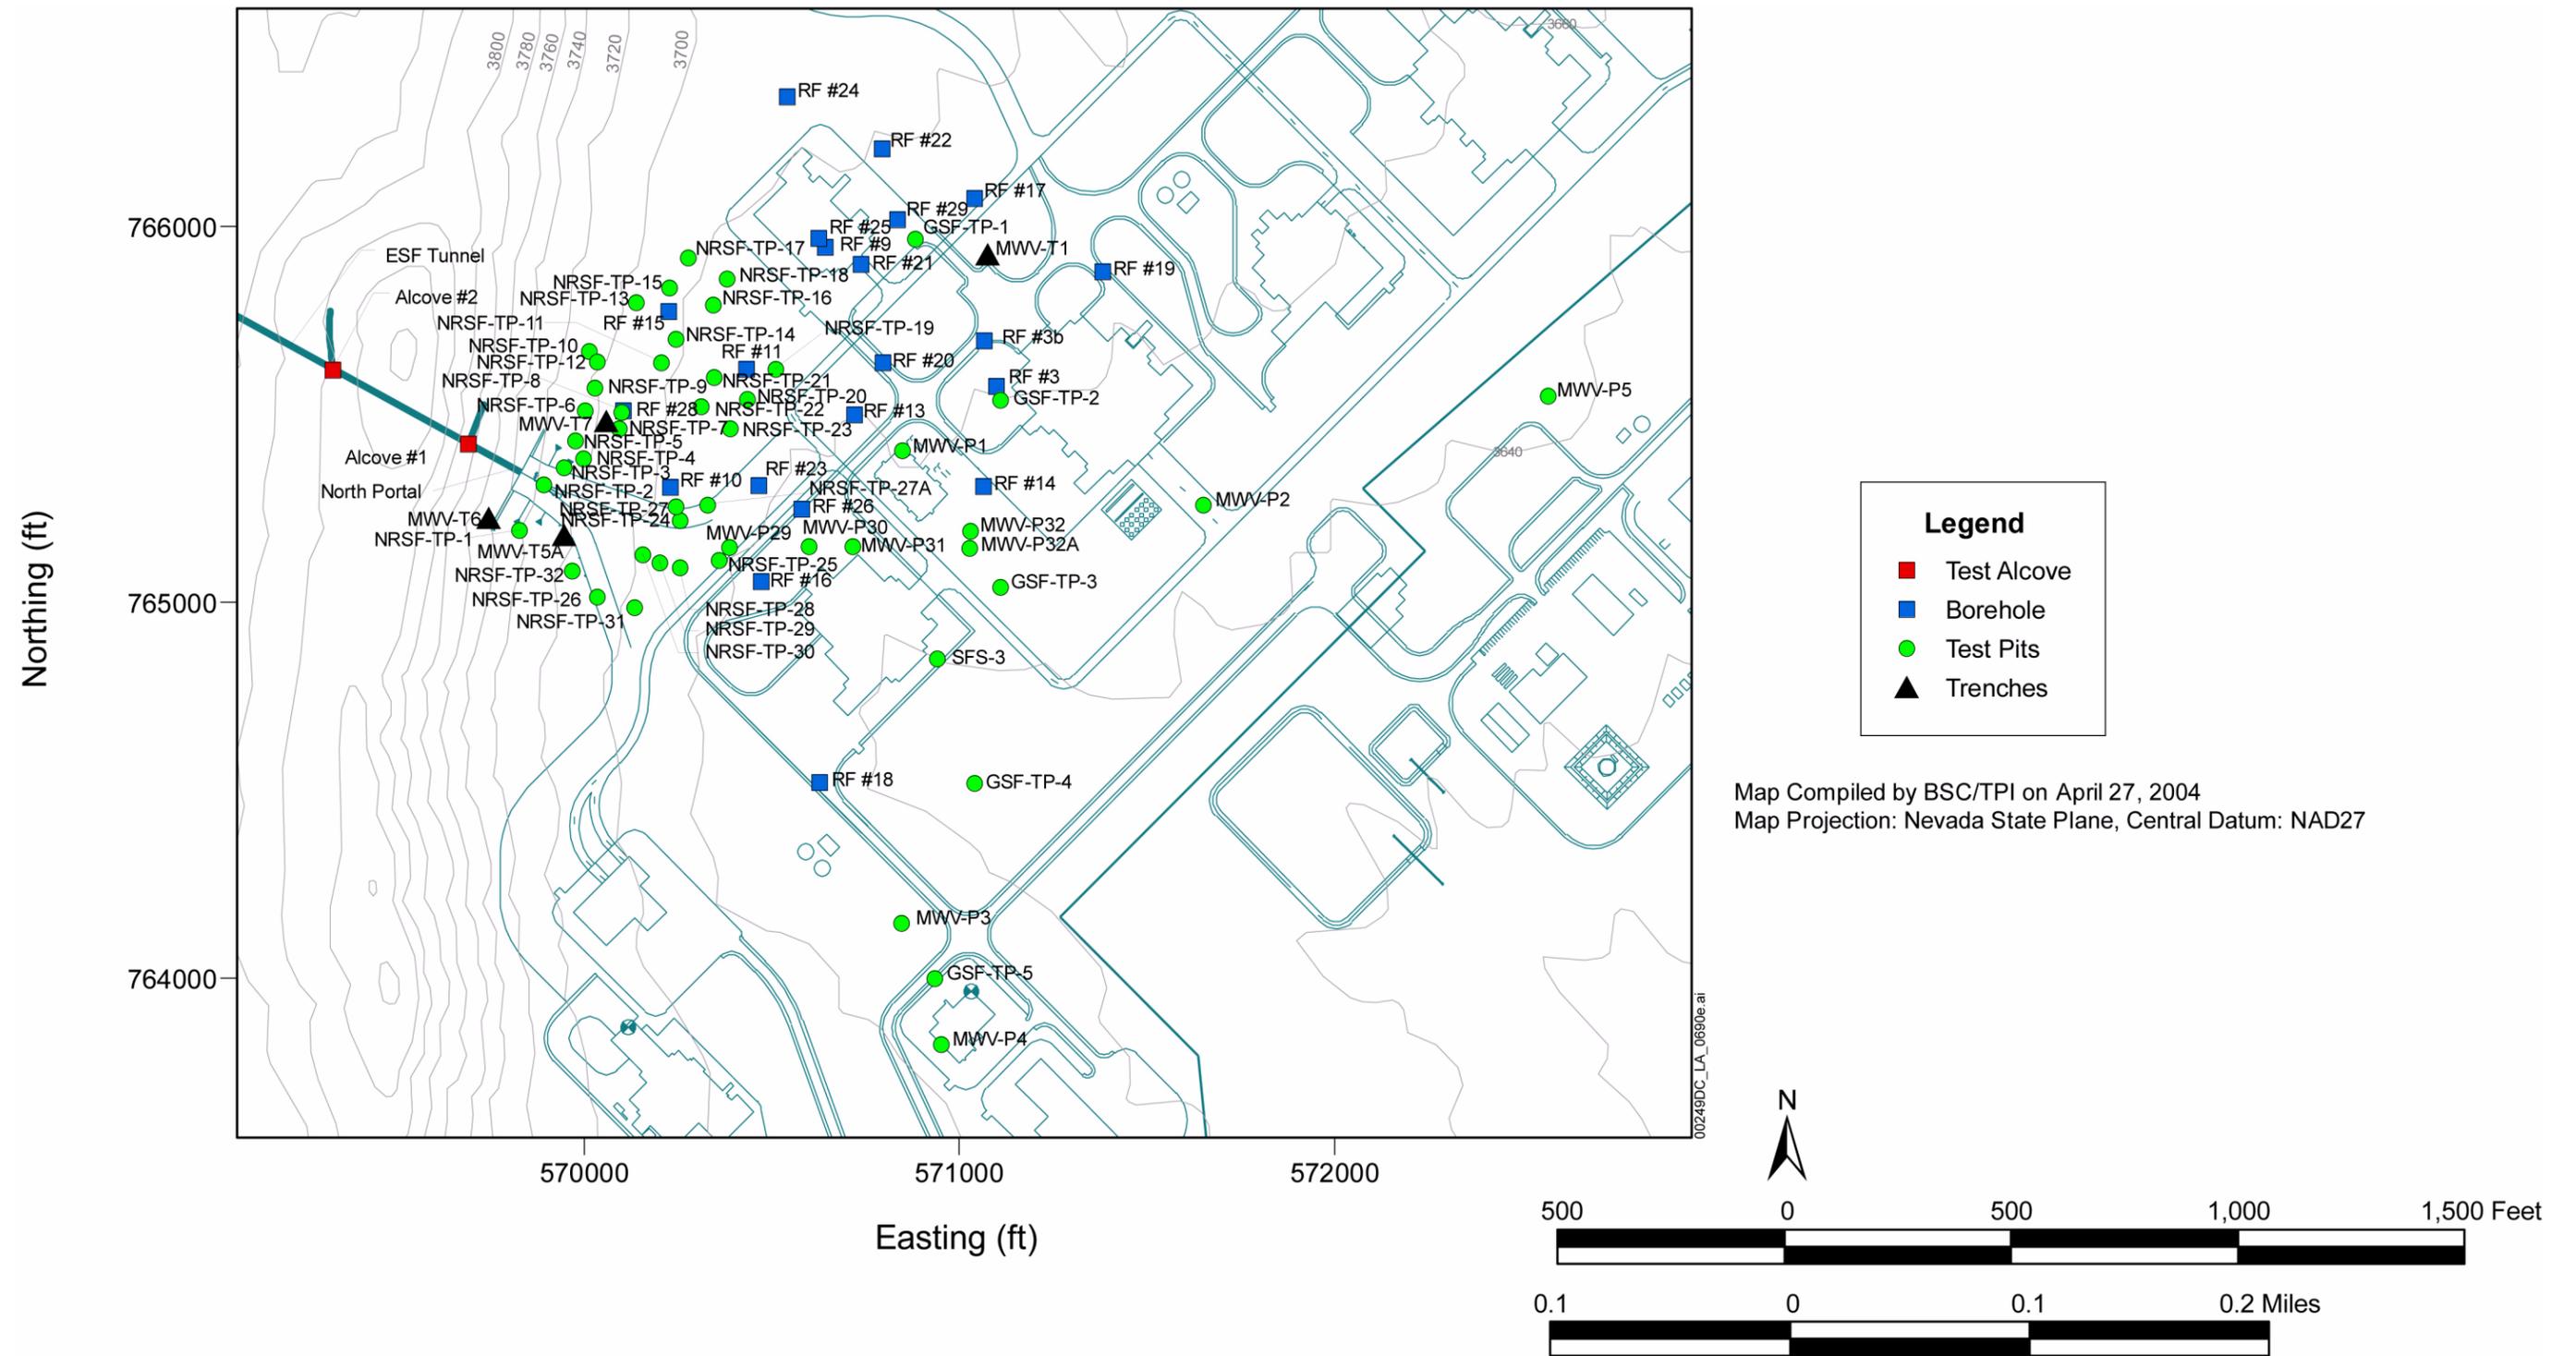
Figure 1.1-145. Locations of Pre-2004 Boreholes and Test Pits Relative to the Surface Geologic Repository Operations Area
