**Rancho Seco**  
**Final Status Survey Summary Report**  
**April 1, 2008**  
**Diesel Tank Storage Pad**  
**Survey Unit F8320001**

F8320001, Diesel Tank Storage Pad

Operating History: This land area contained the diesel tank which was used to fuel the diesel generators on site.

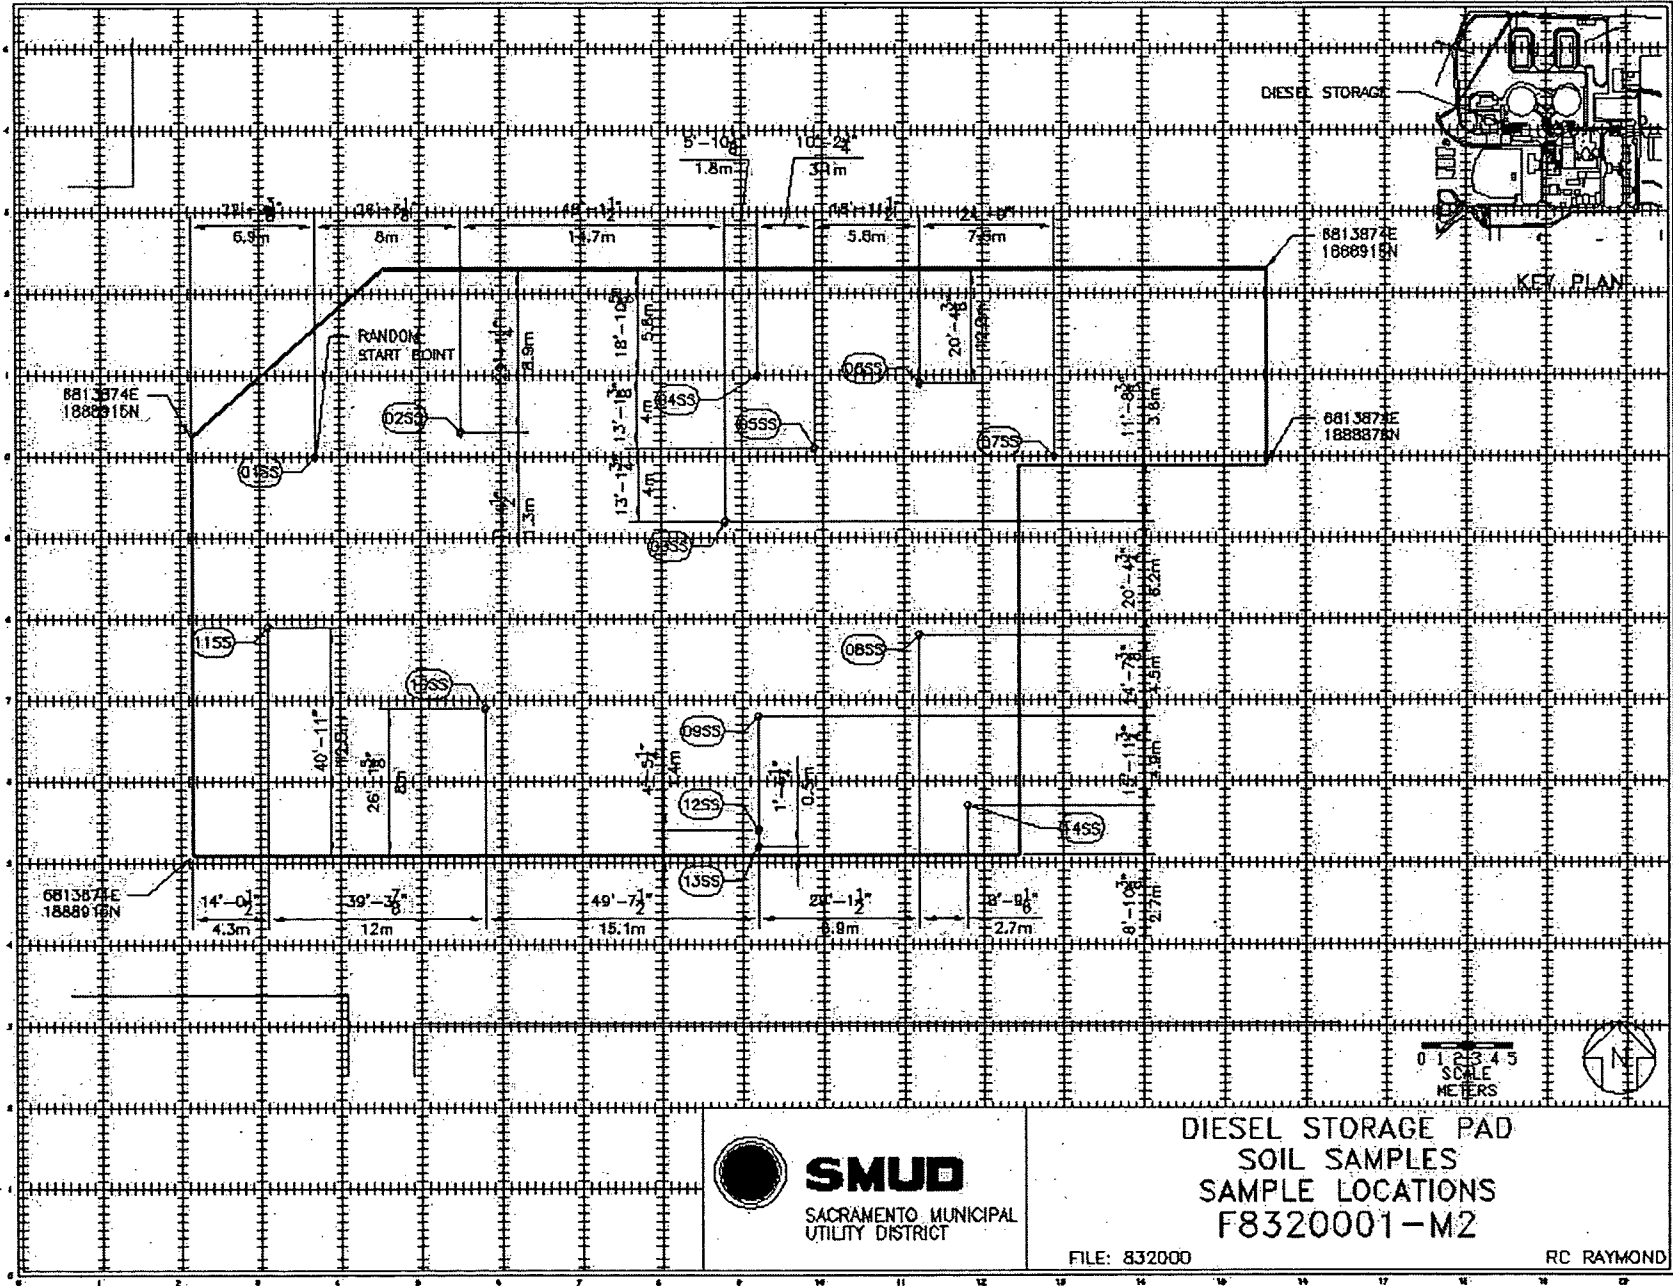
DIESEL STORAGE PAD  
GENERAL ARRANGEMENT  
SURFACE AREA ESTIMATE  
F8320001-M3

The Survey Unit Design Parameters are presented in Table 1 below. The survey unit and measurement locations are depicted on the maps in Attachment 1. Direct measurement locations were randomly determined and 141 m<sup>2</sup> were scanned for approximately 9% coverage. Soil samples were collected at 14 randomly determined locations and analyzed by HPGe detector. The instrumentation used for the survey along with the MDC values are listed in Tables 2-1 and 2-2 in Attachment 2.
