**Rancho Seco**  
**Final Status Survey Summary Report**  
**March 12, 2008**  
**RC Drain Tank (V-600) Room (lowers)**  
**Survey Unit F8130051**

F8130051, RC Drain Tank (V-600) Room (lowers)

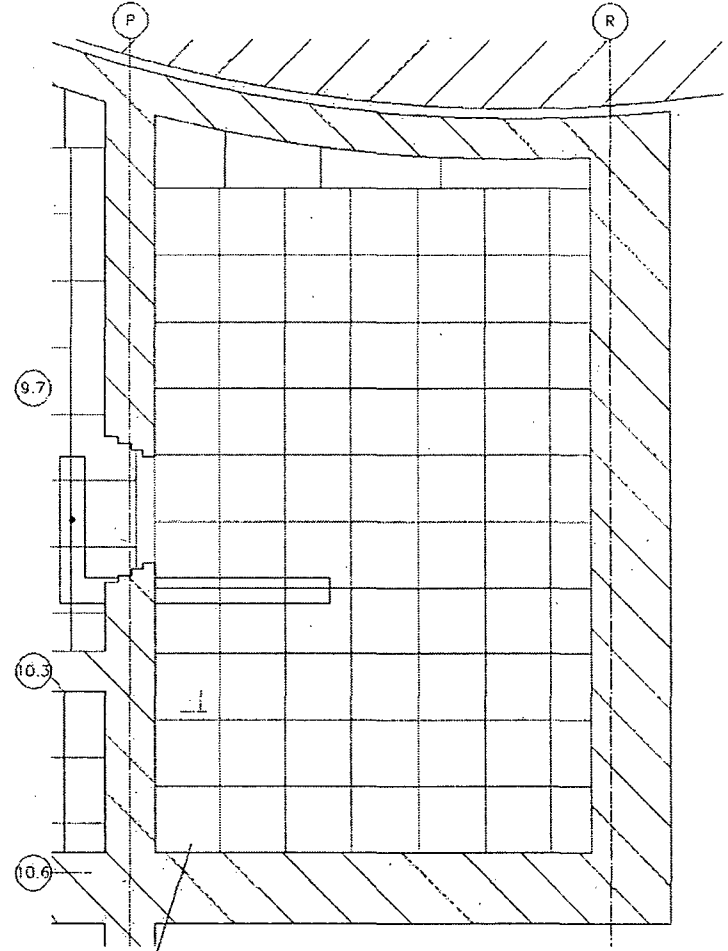
AUXILIARY BUILDING EL. -47'  
RC DRAIN TANK (V-600) ROOM  
SURFACE AREA ESTIMATE  
8130051-M1

FLOOR PLAN  
72 SQ M  
CONCRETE

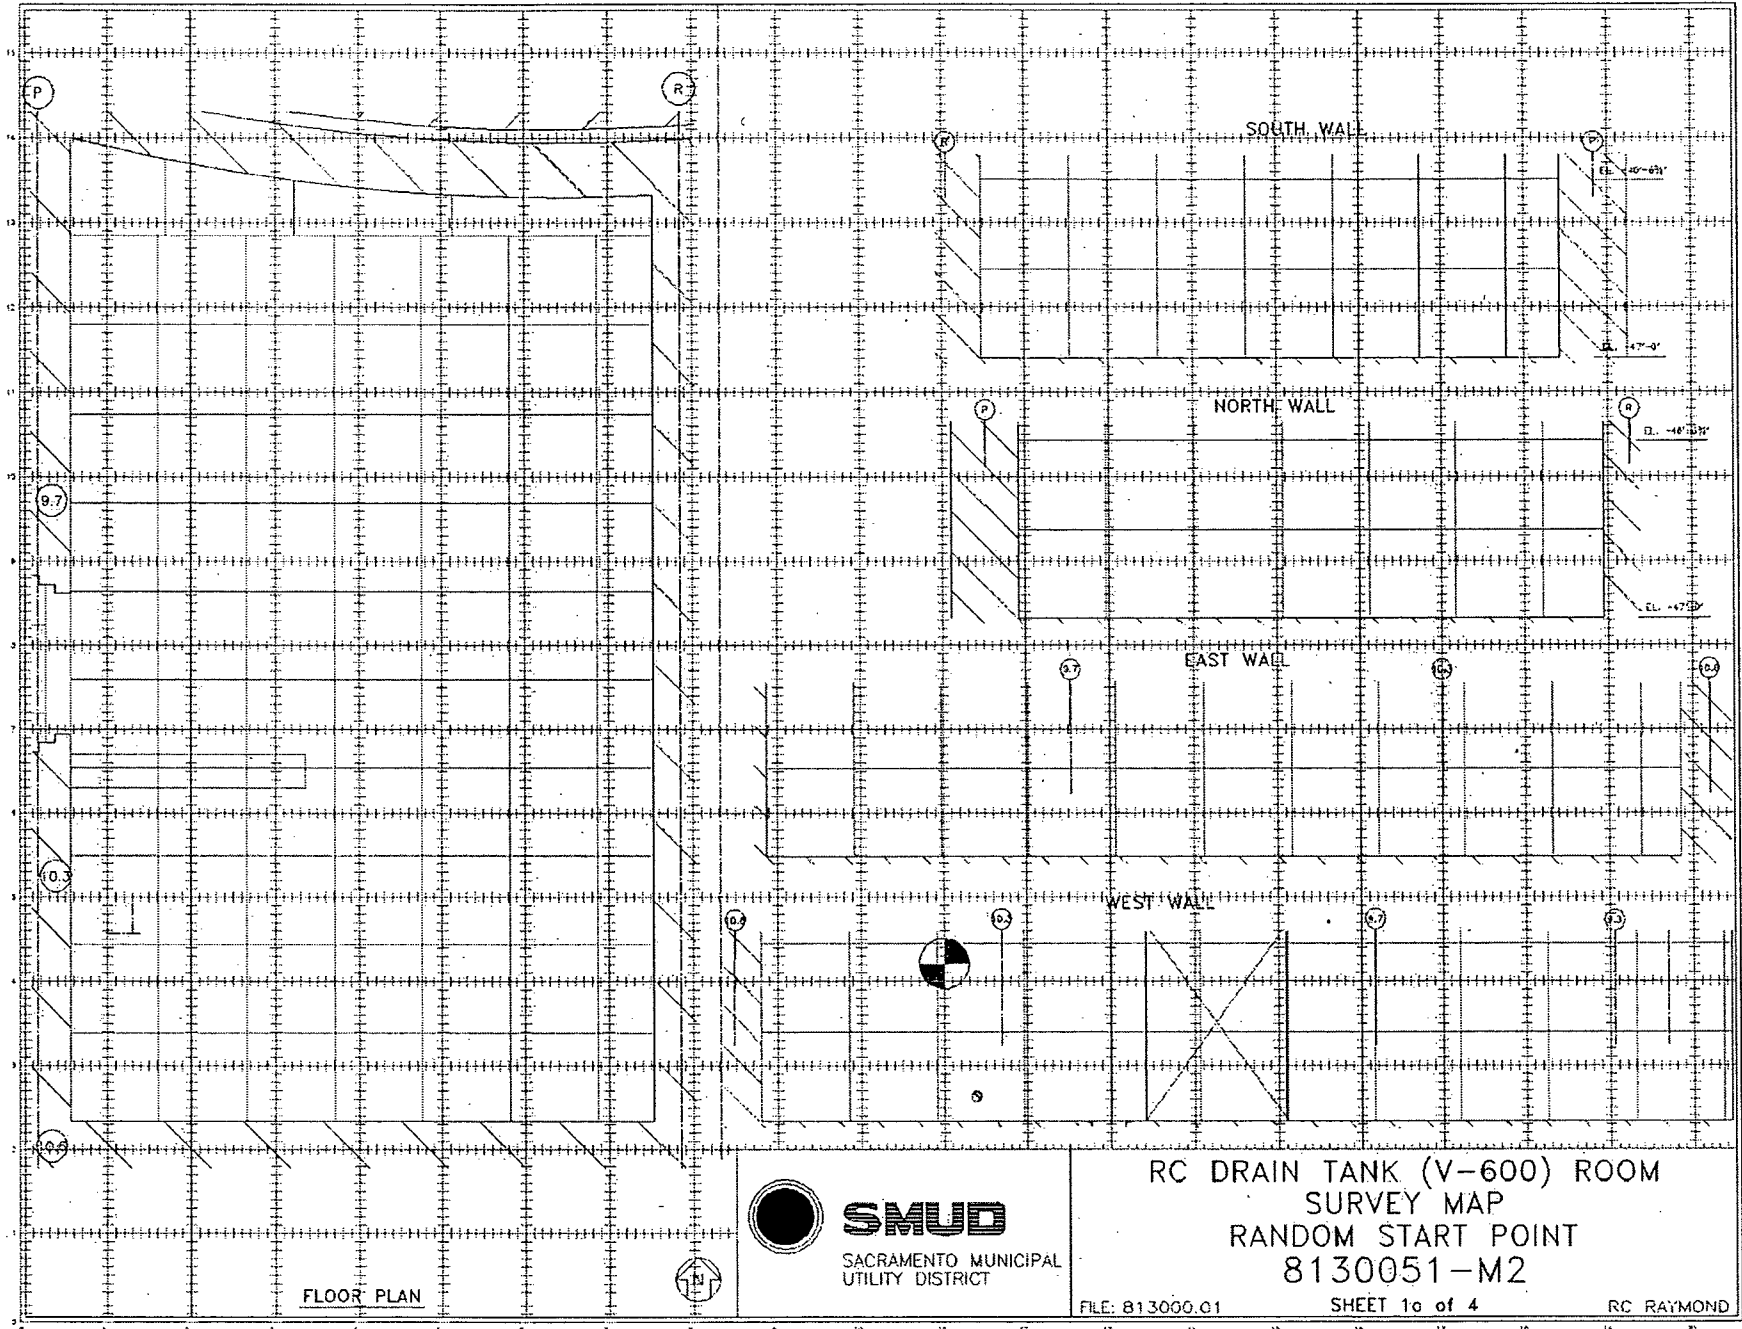
RC DRAIN TANK (V-600) ROOM  
 SURVEY MAP  
 RANDOM START POINT  
 8130051-M2

FLOOR PLAN

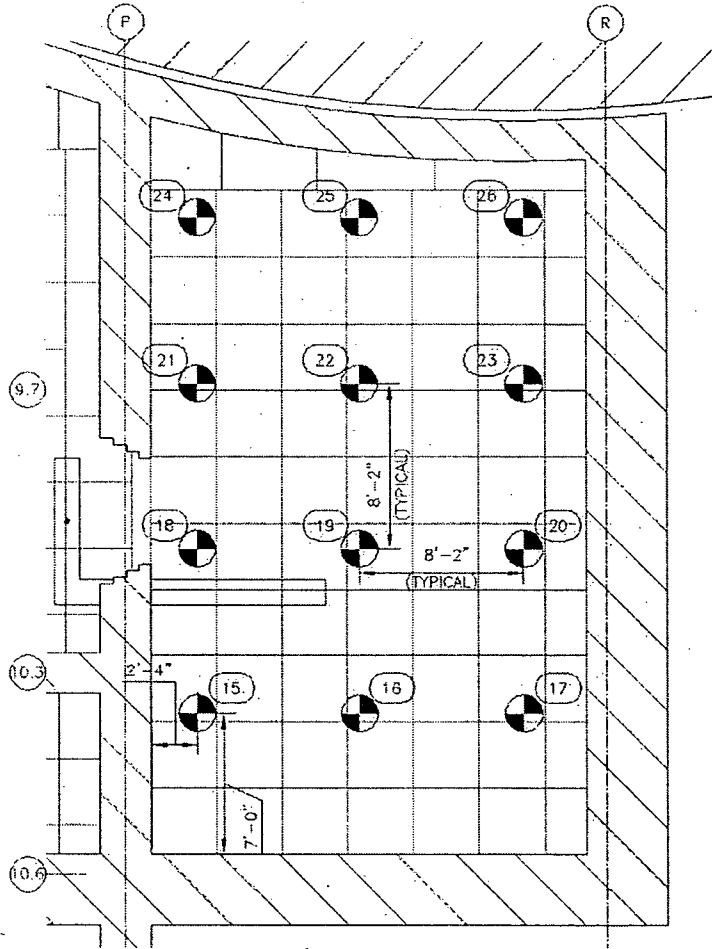
RC DRAIN TANK (V-600) ROOM  
SURVEY LOCATION MAP  
BETA DIRECT/REMOVABLE ACTIVITY  
8130051-M2

FLOOR PLAN

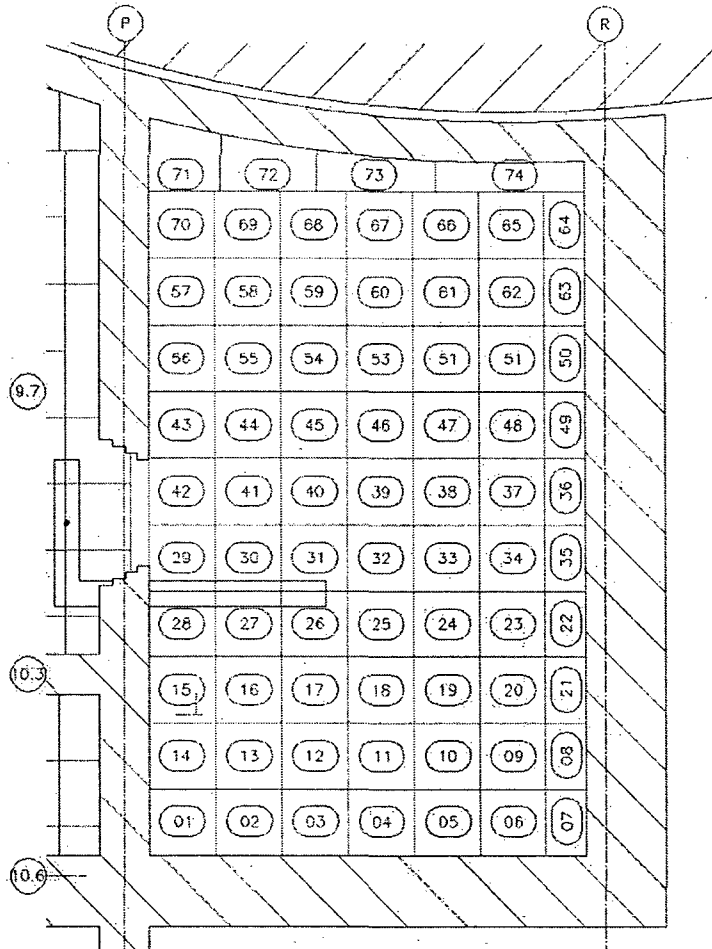
RC DRAIN TANK (V-600) ROOM  
SURVEY LOCATION MAP  
BETA SCAN  
8130051-M3

FLOOR PLAN

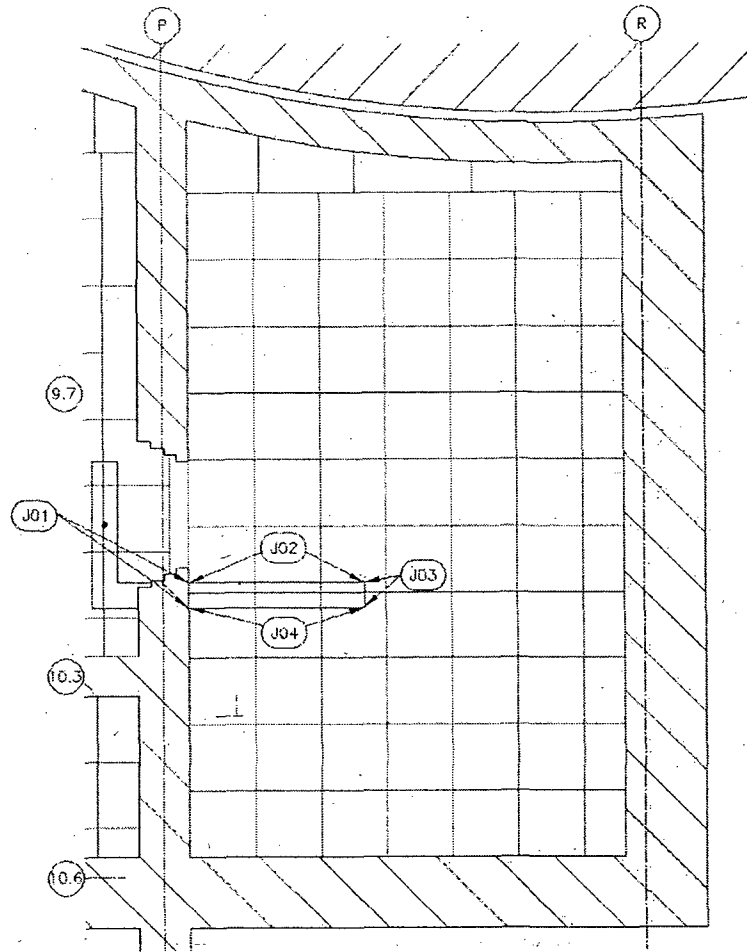
RC DRAIN TANK (V-600) ROOM  
SURVEY LOCATION MAP  
JUNCTURE SCAN  
8130051-M4

J01 - 04  
BOTTOM OF  
TRENCH BELOW  
FLOOR GRADE

FLOOR PLAN

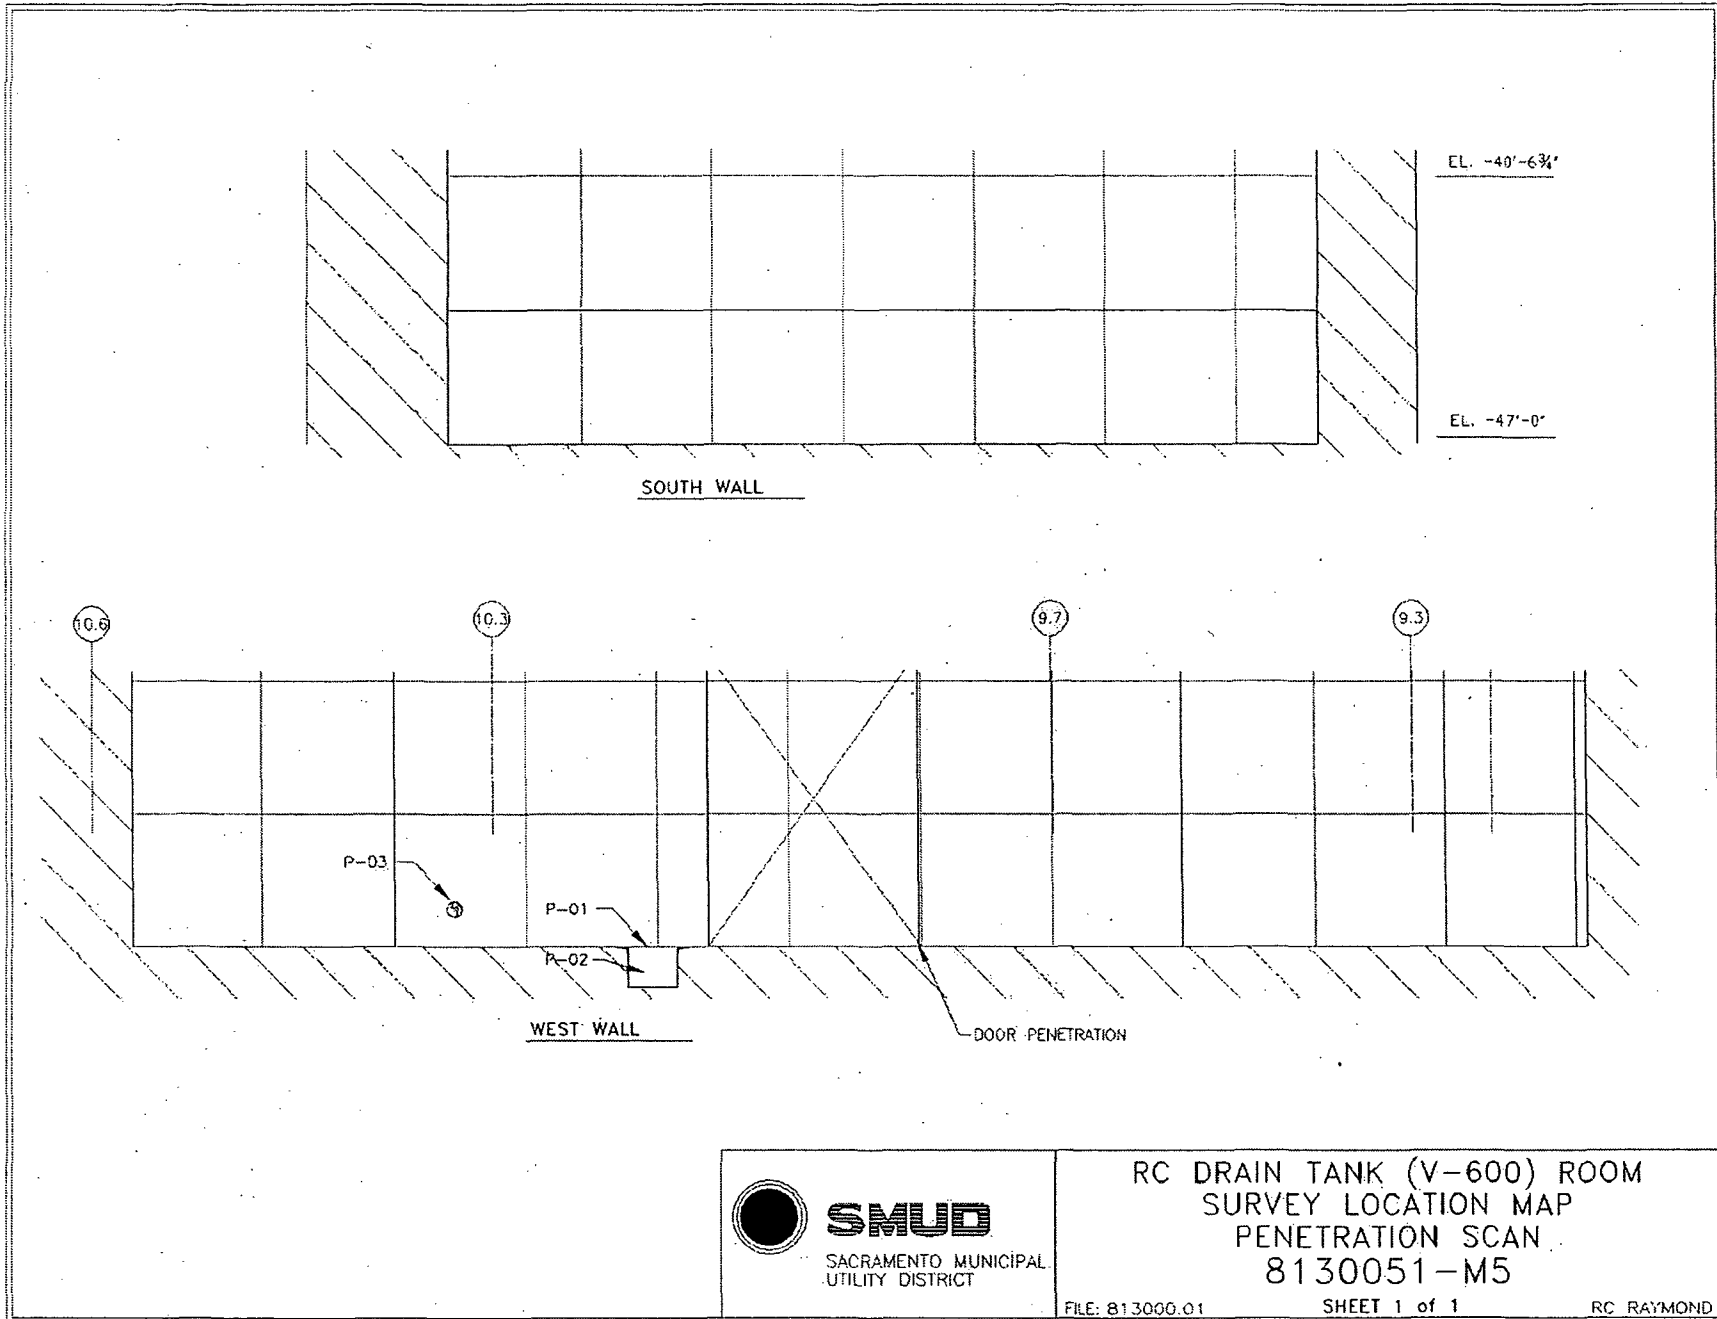
RC DRAIN TANK (V-600) ROOM  
SURVEY LOCATION MAP  
PENETRATION SCAN  
8130051-M5

Six (6) investigations (scan grids 019, 143, 145, Junctions 02, & 42, and Penetration 02) were required for the scan measurements and the results are reported in Attachment 3. The EMC unity rule was not exceeded as shown in Table 3-1.
