Rancho Seco
Final Status Survey Summary Report
March 20, 2008
Letdown Filter/Backwash Tank Room
Survey Unit F8130131

FINAL STATUS SURVEY SUMMARY REPORT

F8130131, Letdown Filter/Backwash Tank Room

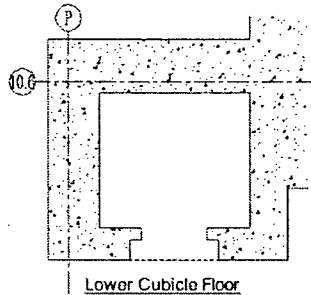
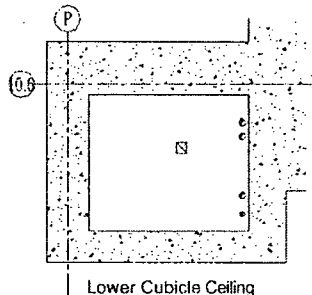
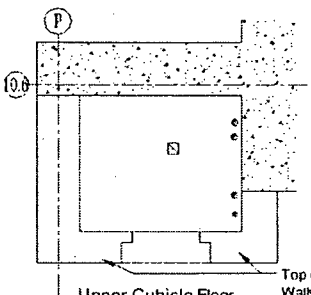
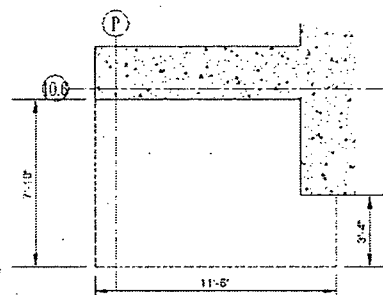
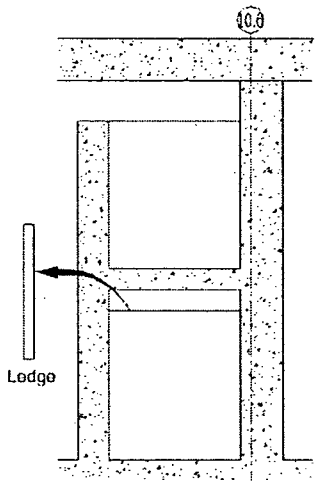
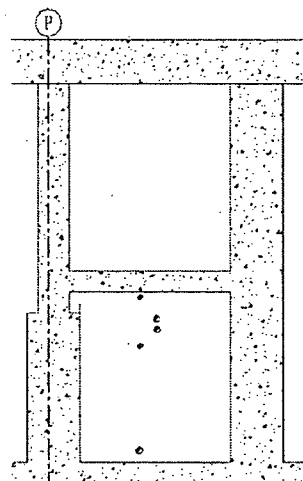
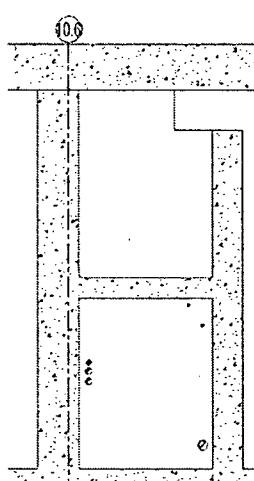
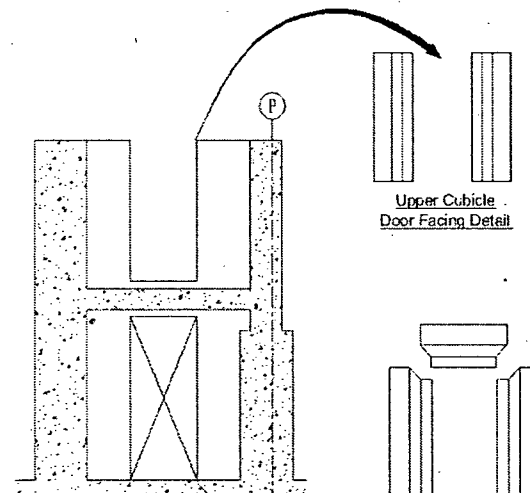
F8130131-M1

SURVEY LOCATION MAP
LETDOWN FILTER/BACKWASH TANK ROOM
SURFACE AREA ESTIMATE

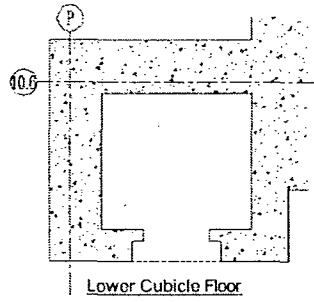
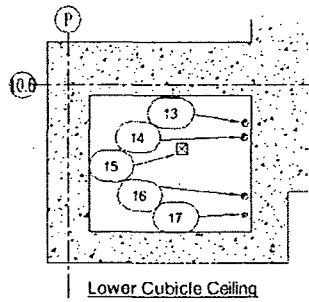
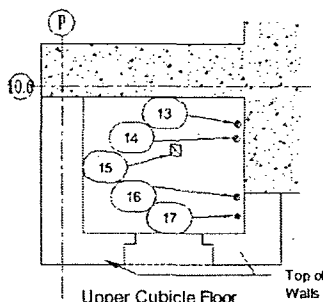
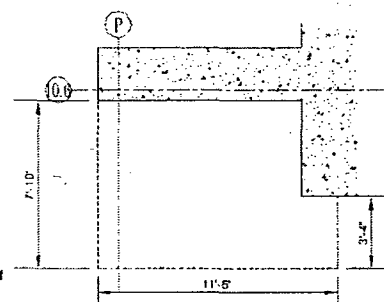
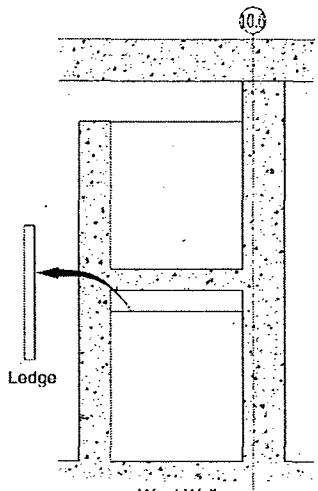
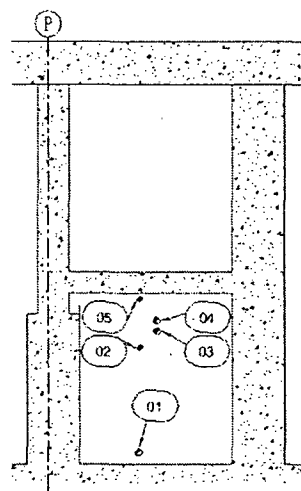
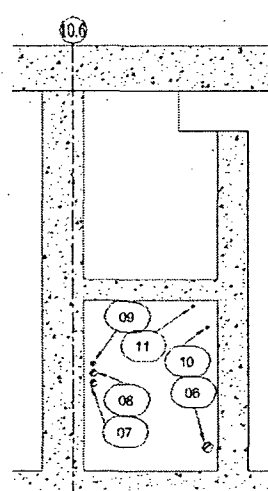
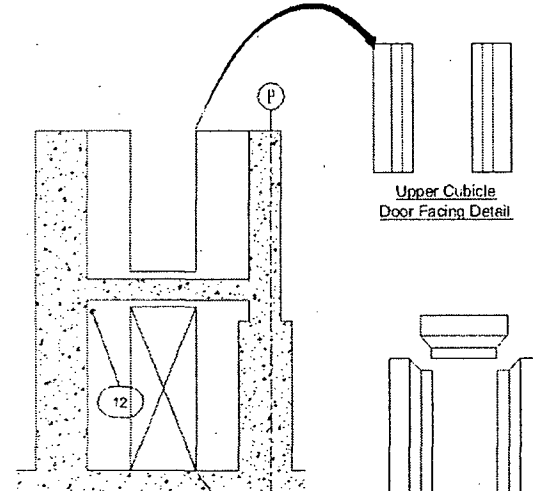
SURVEY LOCATION MAP
 LETDOWN FILTER/BACKWASH TANK ROOM
 PENETRATION SCANS
 F8130131-M5

One investigation (Penetration Scan P0011) was required and the results are reported in Attachment 3. The EMC unity rule was not exceeded as shown in Table 3-1.

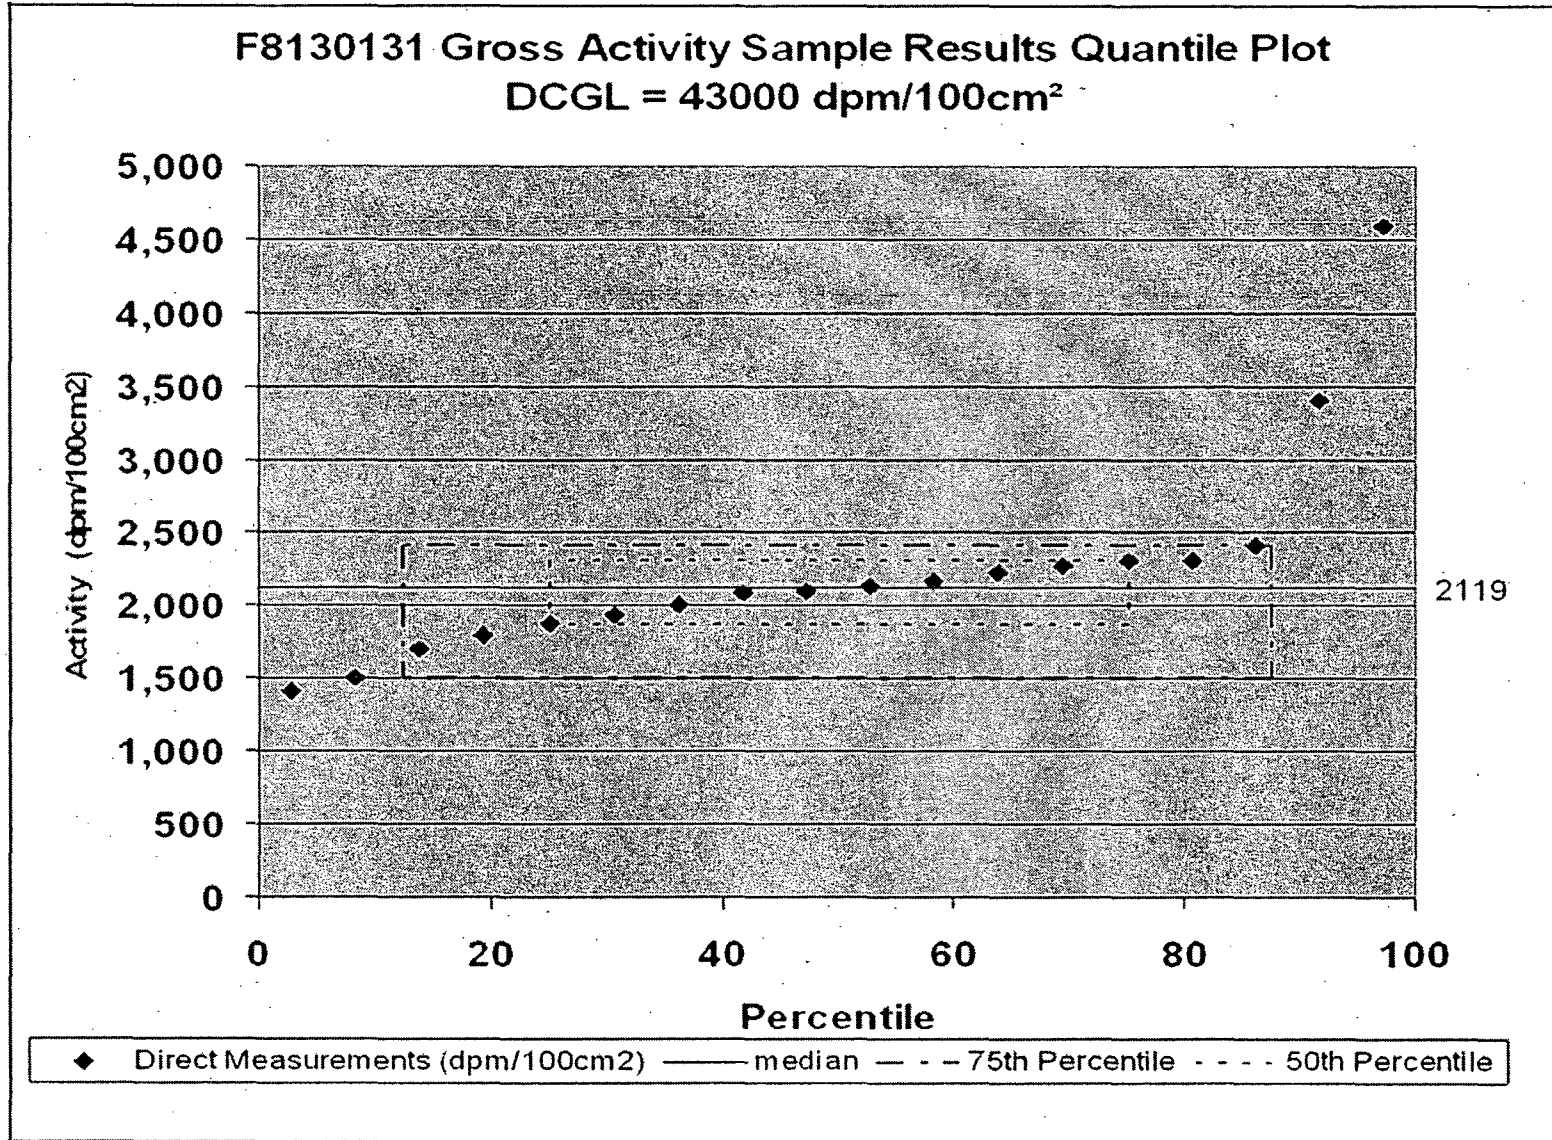
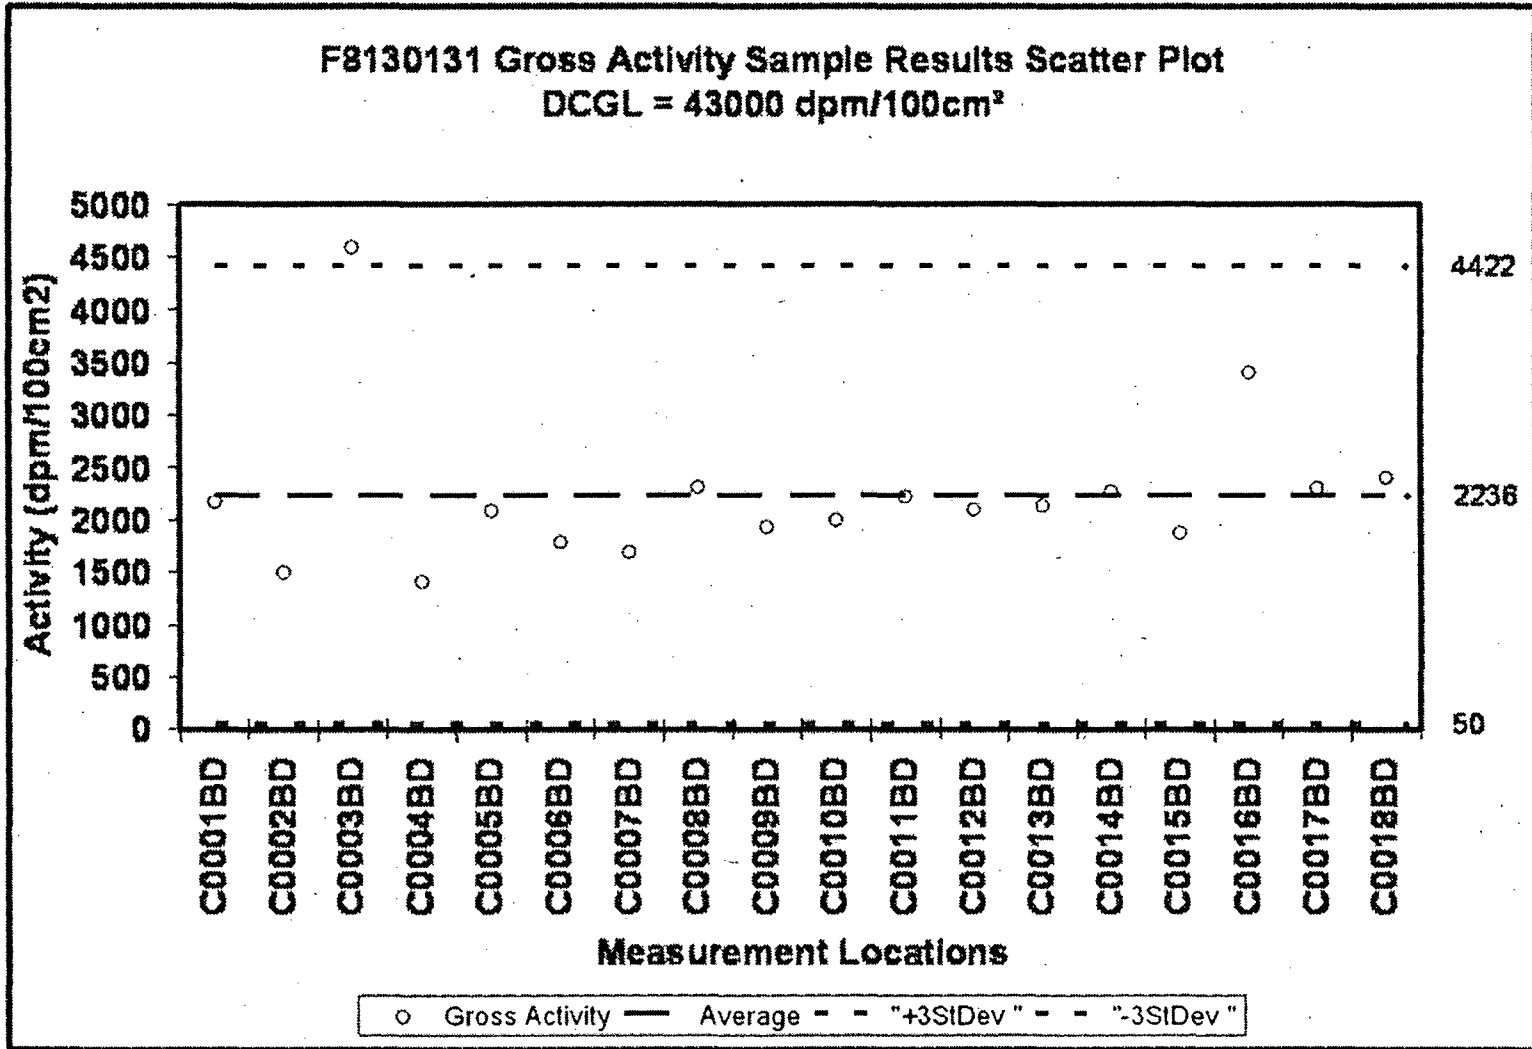
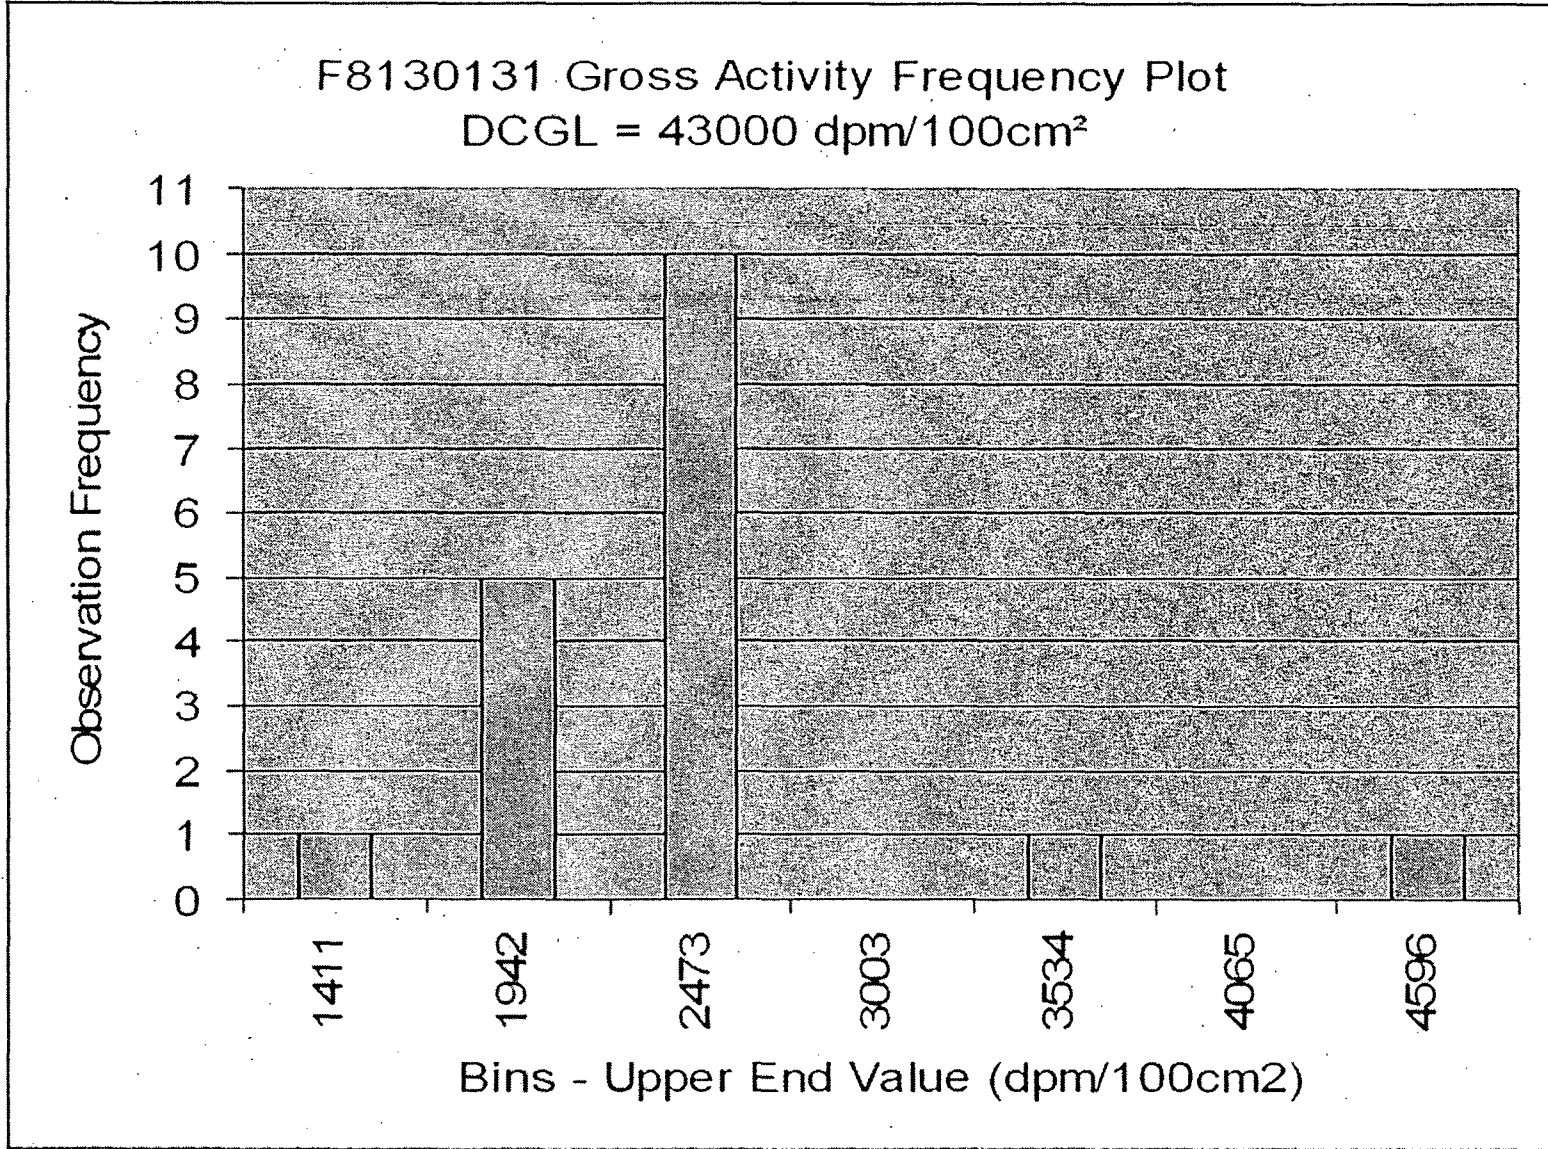
Survey Unit F8130131

The Survey Unit Design Parameters are presented in Table 1 below. The survey unit and measurement locations are depicted on the maps in Attachment 1. Direct measurement locations were determined using a random-start, fixed grid pattern and 68.2 m² were scanned for 100% coverage. Samples of removable contamination were collected at each direct measurement location. The instrumentation used for the survey along with the MDC values are listed in Tables 2-1 and 2-2 in Attachment 2.
