Rancho Seco
Final Status Survey Summary Report
March 20, 2008
Flash Tank Room
Survey Unit F8130141

FINAL STATUS SURVEY SUMMARY REPORT

F8130141, Flash Tank Room

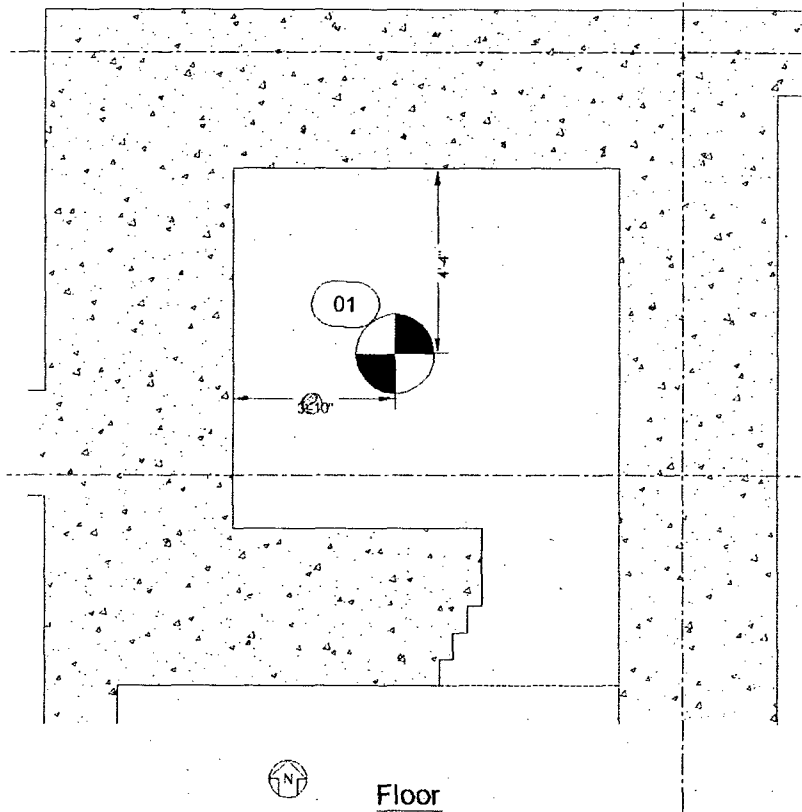
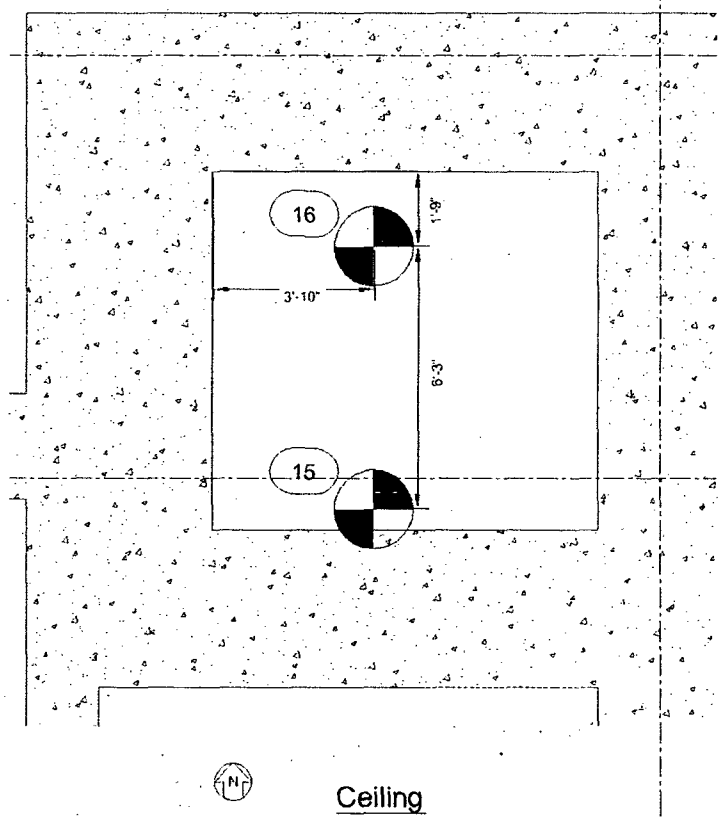
SURVEY LOCATION MAP
FLASH TANK ROOM
BETA DIRECT/REMOVABLE ACTIVITY
F8130141-M2

The Survey Unit Design Parameters are presented in Table 1 below. The survey unit and measurement locations are depicted on the maps in Attachment 1. Direct measurement locations were determined using a random-start, fixed grid pattern and 61.6 m² were scanned for 100% coverage. Samples of removable contamination were collected at each direct measurement location. The instrumentation used for the survey along with the MDC values are listed in Tables 2-1 and 2-2 in Attachment 2.

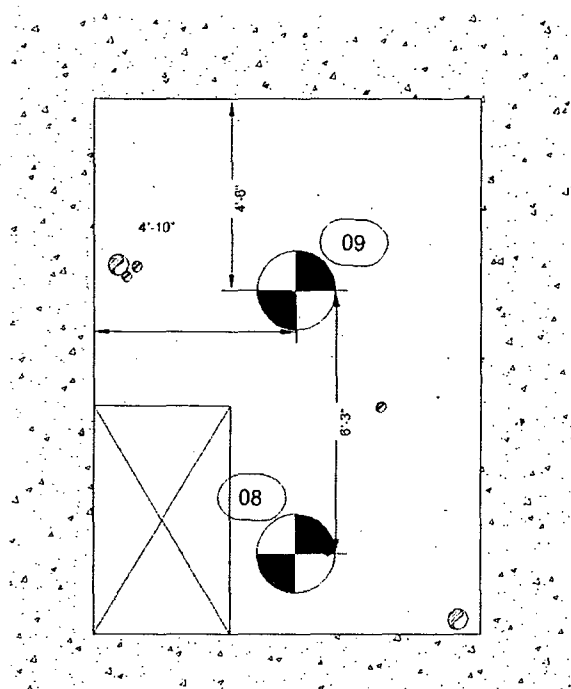
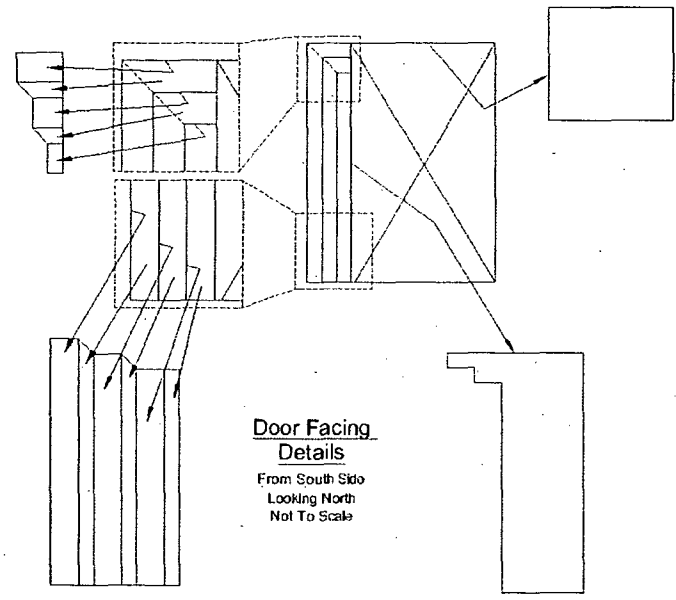
SURVEY LOCATION MAP
FLASH TANK ROOM
BETA DIRECT/REMOVABLE ACTIVITY
F8130141-M2

Door Facing
Details
From South Side
Looking North
Not To Scale

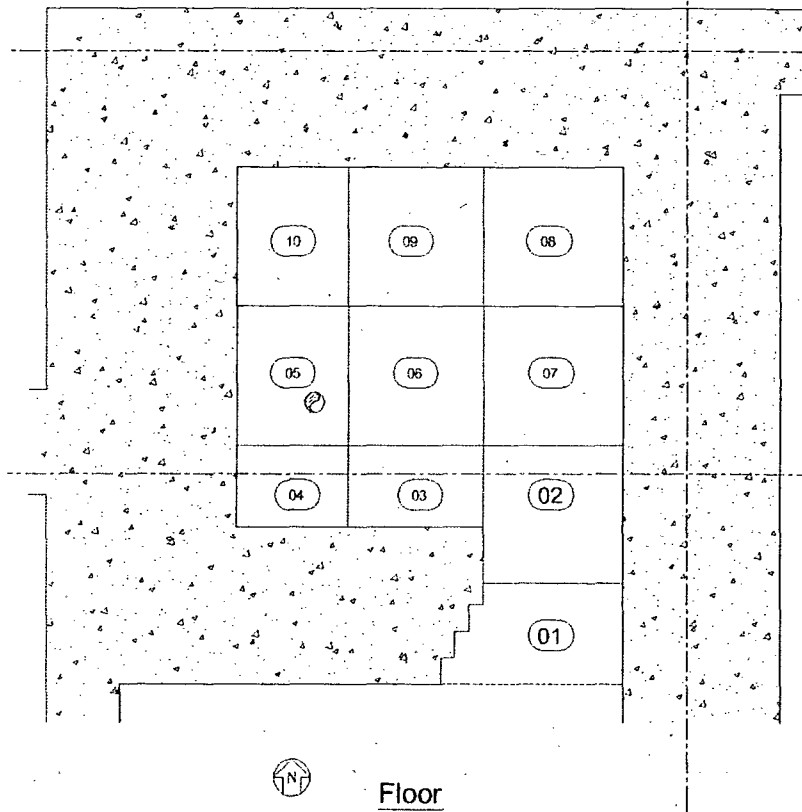
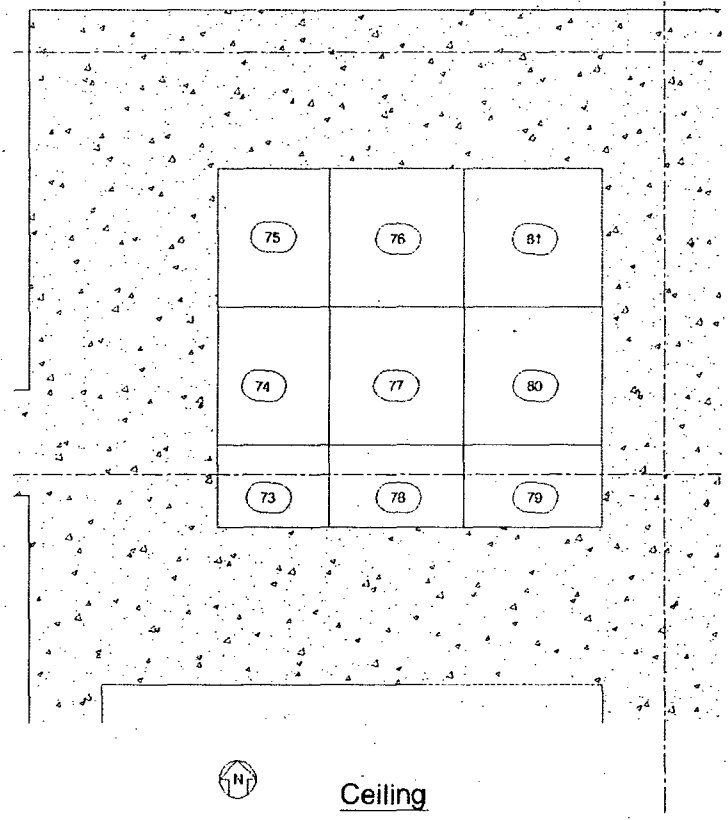
SURVEY LOCATION MAP
FLASH TANK ROOM
BETA SCAN
F8130141-M3

Five investigations (scan grids 03, 05, 20, 21, & penetration scan P07) were required based on an Investigation Level set conservatively at the DCGL_w in the survey design for the Beta scan measurements and the results are reported in Attachment 3. The EMC unity rule was not exceeded as shown in Table 3-1.
